5.4.4 Canada Del Oro & Big Wash

For the purposes of this study, this watershed includes the Canada Del Oro and two of its largest tributaries the Big Wash and the Sutherland Wash. This system drains the western slopes of the Santa Catalina Mountains and the eastern slopes of the Tortolita Mountains. The Canada del Oro and Big Wash enter Pima County from Pinal County into the community of Catalina. The Canada del Oro passes under Interstate 10 and railway before its confluence with the Santa Cruz River. Within Pima County, it is comprised of 86,362 acres (134.9 square miles), of which 16,503 acres are in the Town of Oro valley and 564 acres in the Town of Marana.

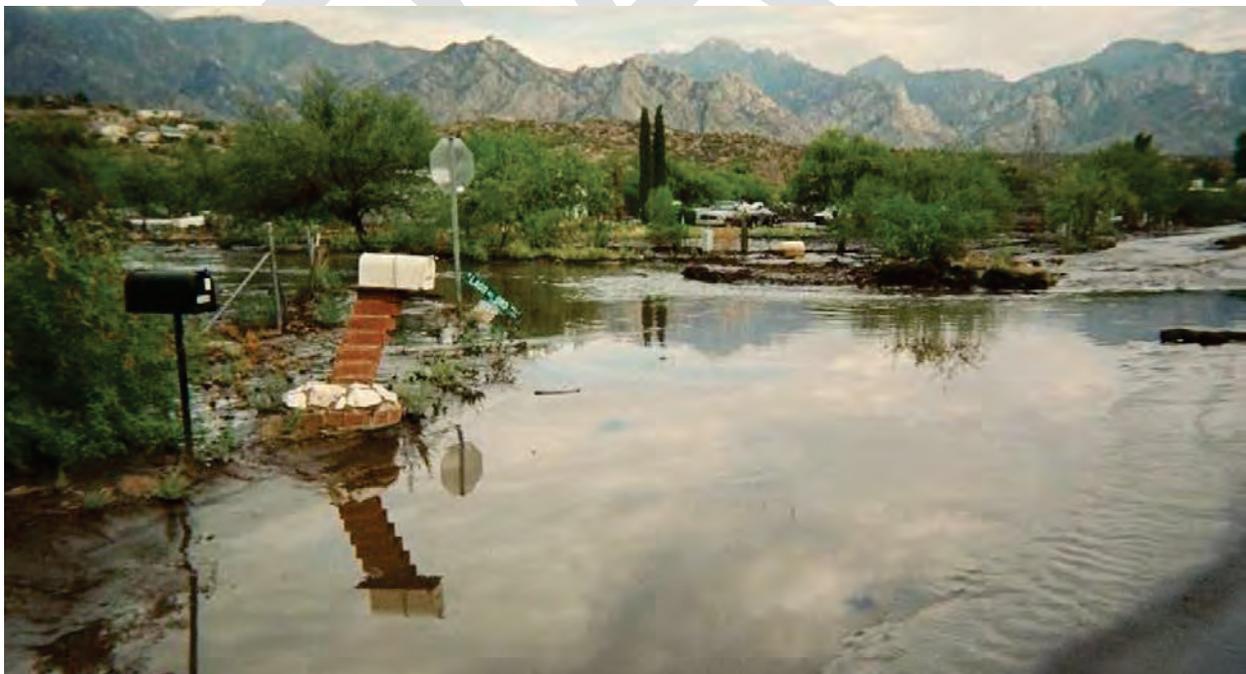
Figure 53 - Canada Del Oro & Big Wash SFHA in Acres

In addition to the 4,758 acres of SFHA included on the chart above, there are also 1,023 acres of District Special Studies Floodplains and 5.54 acres of local sheet flood area in this watershed. Together these mapped floodplain areas are 6 percent of the total watershed area. The CDO in particular has very steep and rocky upper slopes within the Catalina Mountains and thus flash flooding is a significant concern.

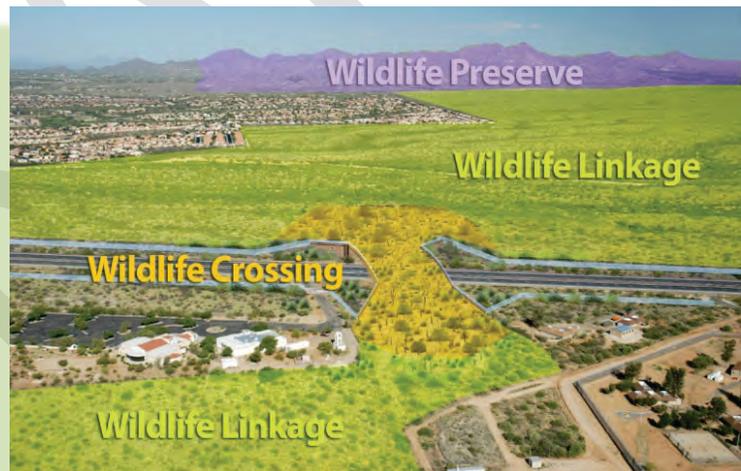
The District assisted with design and management, and recently assumed ownership of a private mitigation restoration in Big Wash. The project

successfully utilized Low Impact Development techniques in funneling rooftop and parking stormwater into the restoration project, enabling rapid recovery of mesquite bosque in a former agricultural field.

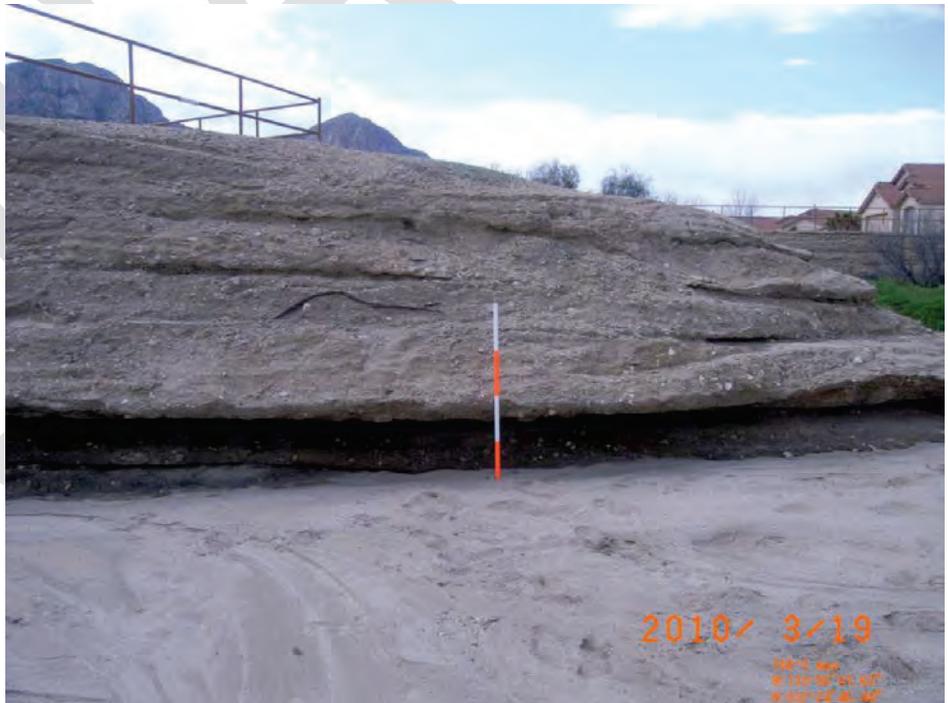
Exposed Bank Protection Toe

The CDO is a major watercourse that originates in National Forest, passes through unincorporated Pima County into Oro Valley, and then back into the County near the confluence with the Santa Cruz River. Because of this interjurisdictional coordination is an important component of a successful mitigation program. Bank protection and use of acquisition has been the focal point of management in this area especially since growth, wildfires and associated debris movement have been significant.

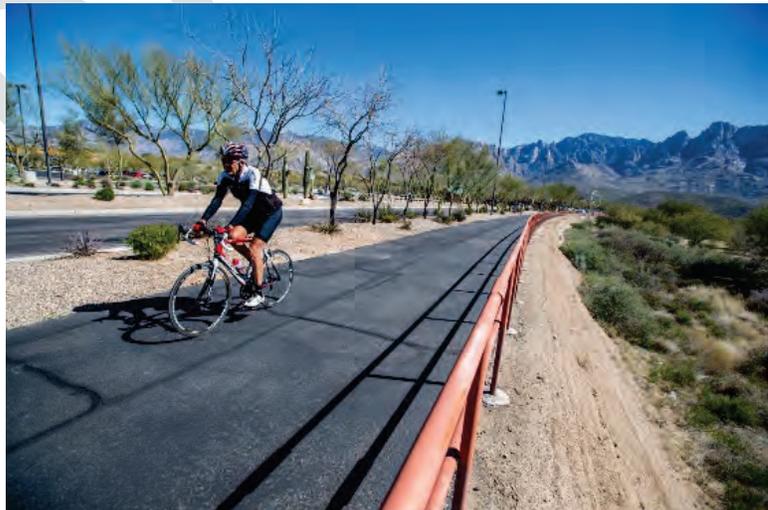
Downstream within the commercialized and more densely developed residential areas bank protection projects have complemented the development of linear parks known locally as the Loop. This consists of an interconnected set of river paths for walkers, biking and equestrians with additional park amenities including recreation, education and riparian restoration projects.

The Big Wash Levee is a soil cement levee upstream of Tangerine Road along the eastern side of the Big Wash floodplain and west of the Oro Valley Hospital. Additional freeboard was added to the levee because of the hospital, a Critical Facility and because the Big Wash is in a conservation easement.
