5.4.8 Pantano Wash

5.4.8.1 Flood Characteristics

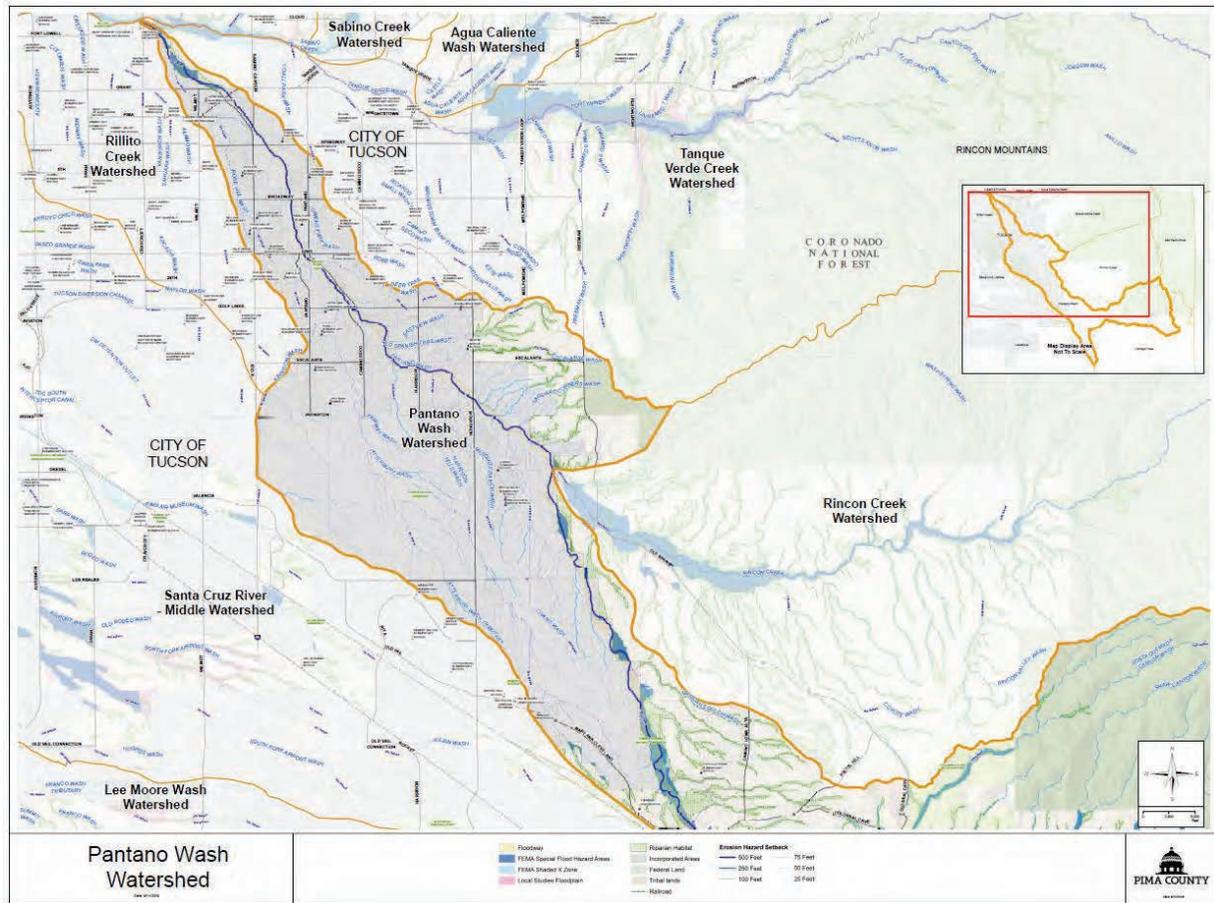
Figure 91 - Pantano Wash Watershed Map

The Pantano Wash begins in the community of Vail at the confluence of Cienega and Agua Verde Creeks near Davidson Canyon. Below the confluence, the watershed is predominately the geologic floodplain and lower bajada associated with this major watercourse. The watershed originates high in the Rincon Mountains near Rincon Peak at over 8,000 above mean sea level and includes the sub basin flowing to the Agua Verde Creek. It is comprised of 64,649 acres (101 square miles), of which 24,815 acres are within the City of Tucson. In addition, Rincon Creek (87.3 square miles) and Cienega Creek (324.1 square mile) are tributaries to the Pantano Wash.

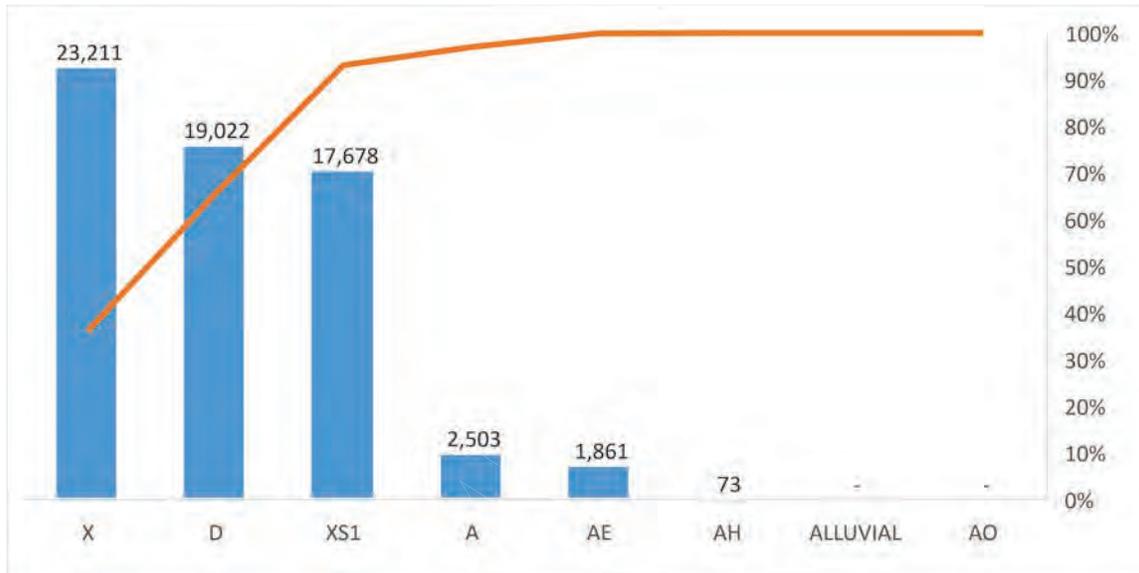
Figure 92 - Pantano Wash SFHA in Acres

In addition to the 4,437 acres of SFHA included on the chart above, there are also 317 acres of District Special Studies Floodplains, and 228 acres of sheet flood area in this watershed. Together these mapped floodplain areas nearly 8 percent of the total watershed area!

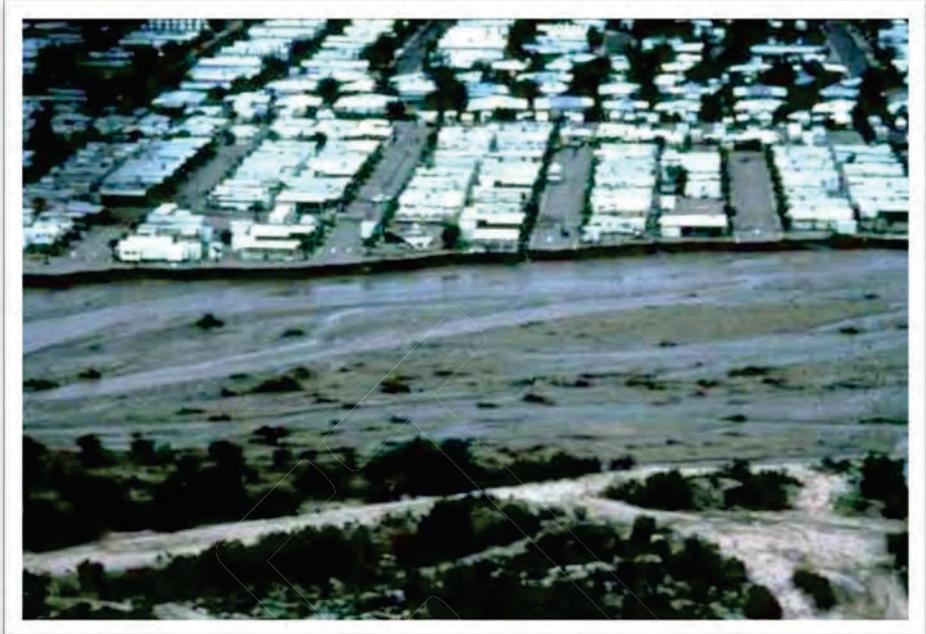
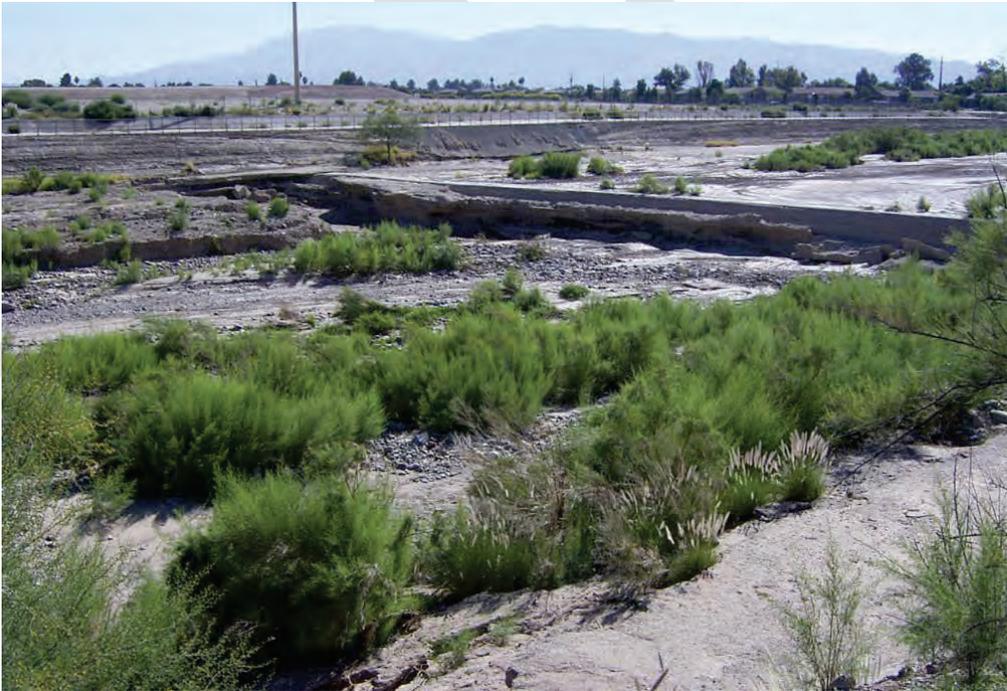
The District has completed major projects including bank protection, maintenance, restoration and acquisition in this area. The picture on the right shows erosion after the 1983 flood and the picture below bank protection and grade control adjacent to a capped landfill.

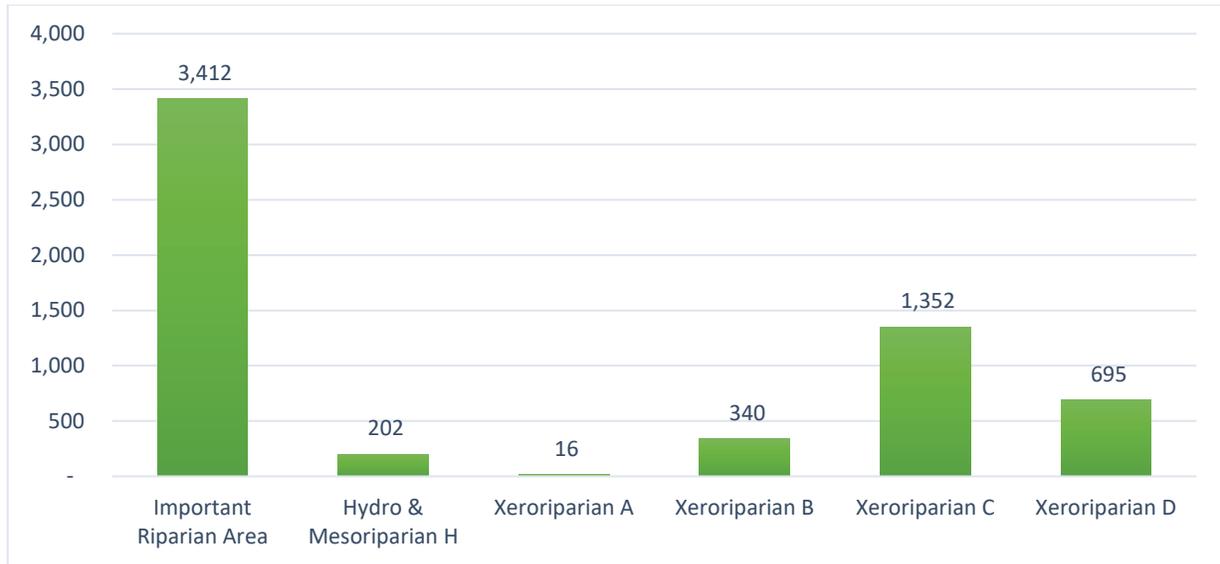
Figure 98 - Pantano Wash Watershed Riparian Habitat in Acres

As shown on the figure below, there are 2,605 acres of Pima County Regulated Riparian Habitat in this watershed. In addition, 3,412 acres is IRA. There are also 20,640 preserved acres in this watershed, including 1,128 in regulatory floodplain.

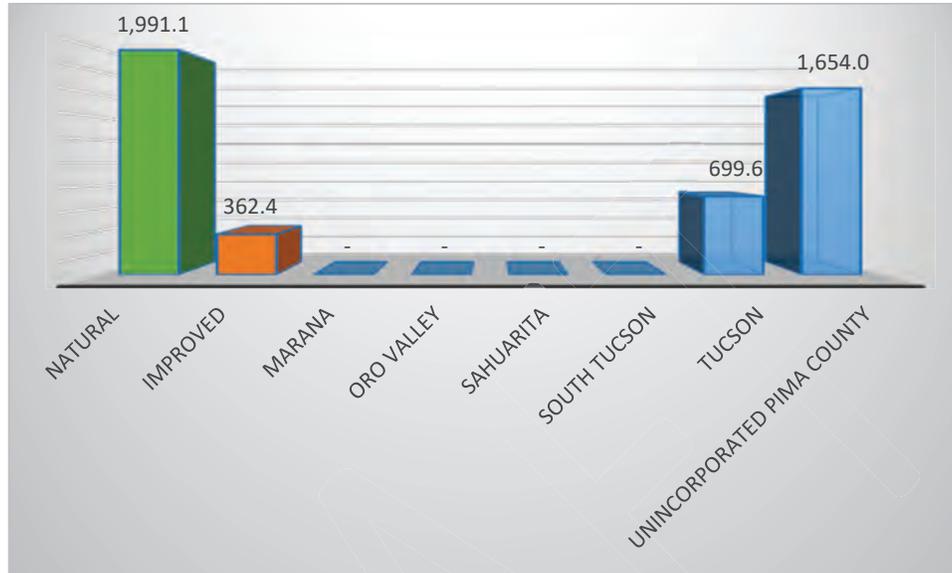
Figure 99 - Pantano Wash Drainageway Acreage

The figure below shows the split between natural and improved drainageways, and how many acres the District is responsible for in each jurisdiction.

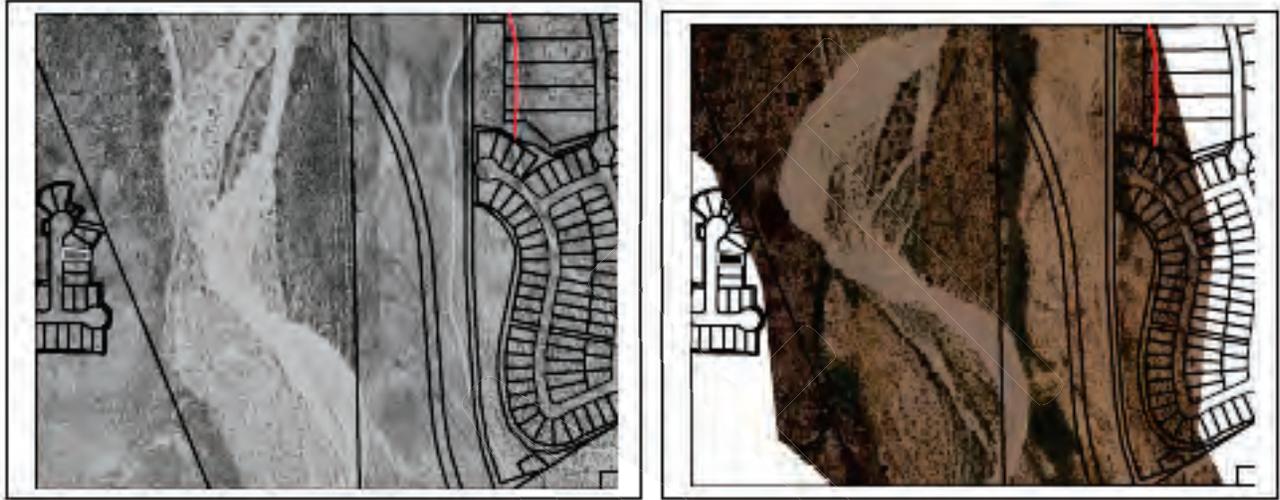
1998 and 2008 photograph from the Pantano wash Management Study showing lateral migration

Downstream of the Pantano Dam to about Houghton Rd, there has been considerable down cutting, most of it associated with sand and gravel mining. Evaluation in 2014 showed active head cuts near the Valencia Road alignment. Downstream of Houghton Road, the channel is generally bank protected and grade controls stabilize the bed. The biggest risk of flood occurs downstream of Colossal Cave Rd and upstream of Houghton Road. Historically, floods from tributaries such as Rincon Creek occur from short-duration, high intensity storms, such as during the Monsoon. Furthermore, the flood of record on the Pantano occurred during the Monsoon, which originated in Rincon Creek. Because of the history of down cutting along the Pantano, grade control structures all up and down the channel are important. The Pantano Dam acts as a grade control with over a 20’ drop on the downstream side. Downstream of the Dam, sand and gravel mining has contributed to instability in the Pantano.
