5.4.10 Rincon Creek

5.4.10.1 Flood Characteristics

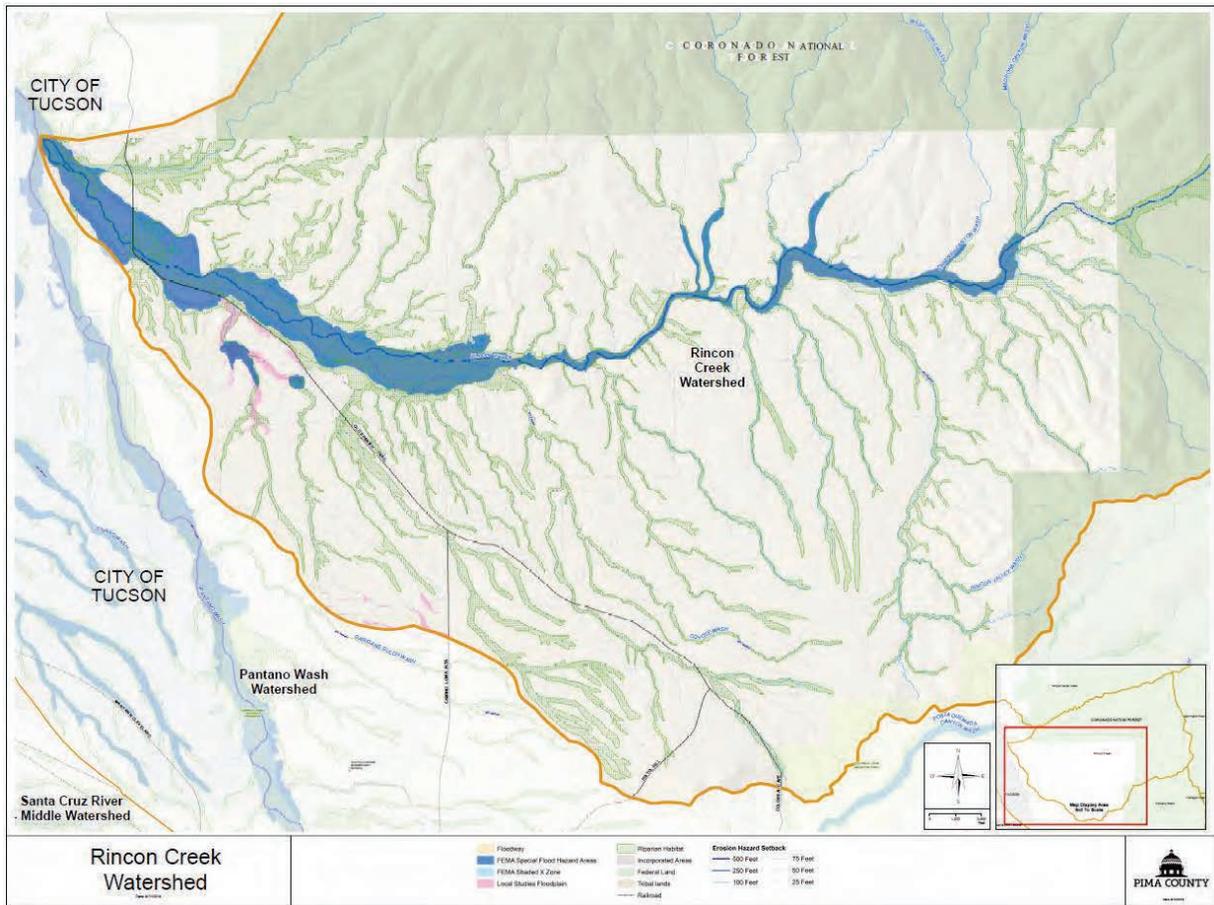
Figure 110 - Rincon Creek Watershed Map

This watershed originates high in the Rincon Mountains near Rincon Peak at over 8,000 above mean sea level. It also drains the southern slopes of the Tanque Verde Mountains before passing through Rincon Valley and its confluence with Pantano Wash. It is comprised of 55,876 acres (87.3 square miles).

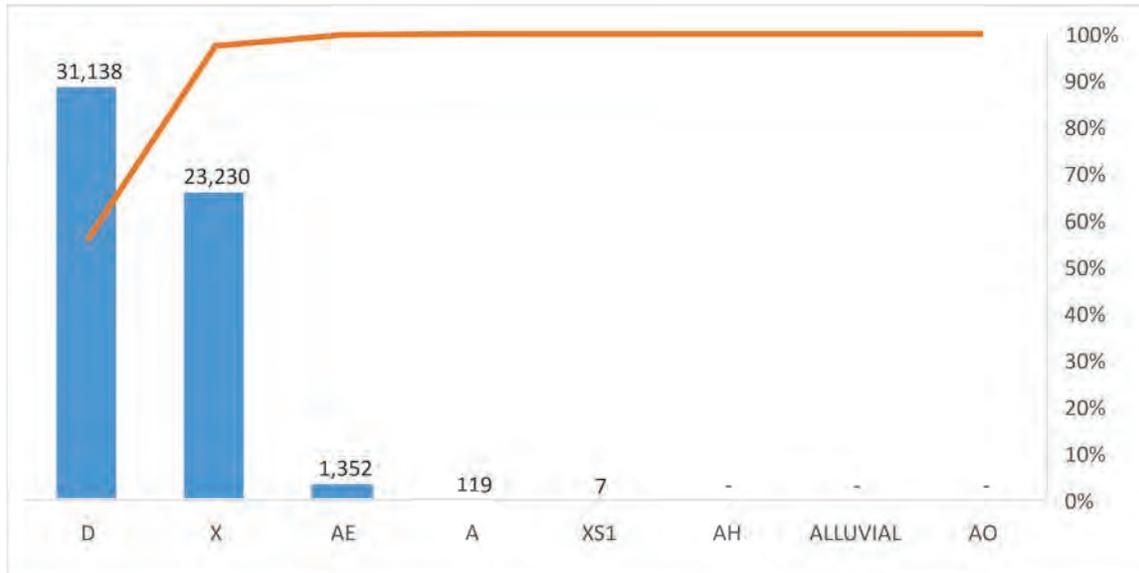
Figure 111 - Rincon Creek SFHA in Acres

In addition to the 1,471 acres of SFHA zones included on the chart above, there are also 635 acres of locally mapped sheet flood area.

The Flood Insurance Rate Maps designate floodplains for Rincon Creek (AE) and portions of five unnamed tributaries (A). In addition, Rincon Creek has a mapped Floodway. The floodplain mapping utilized 1986 topography on NGVD-29 vertical datum. No additional floodplain mapping is available for the named watercourses in the watershed.

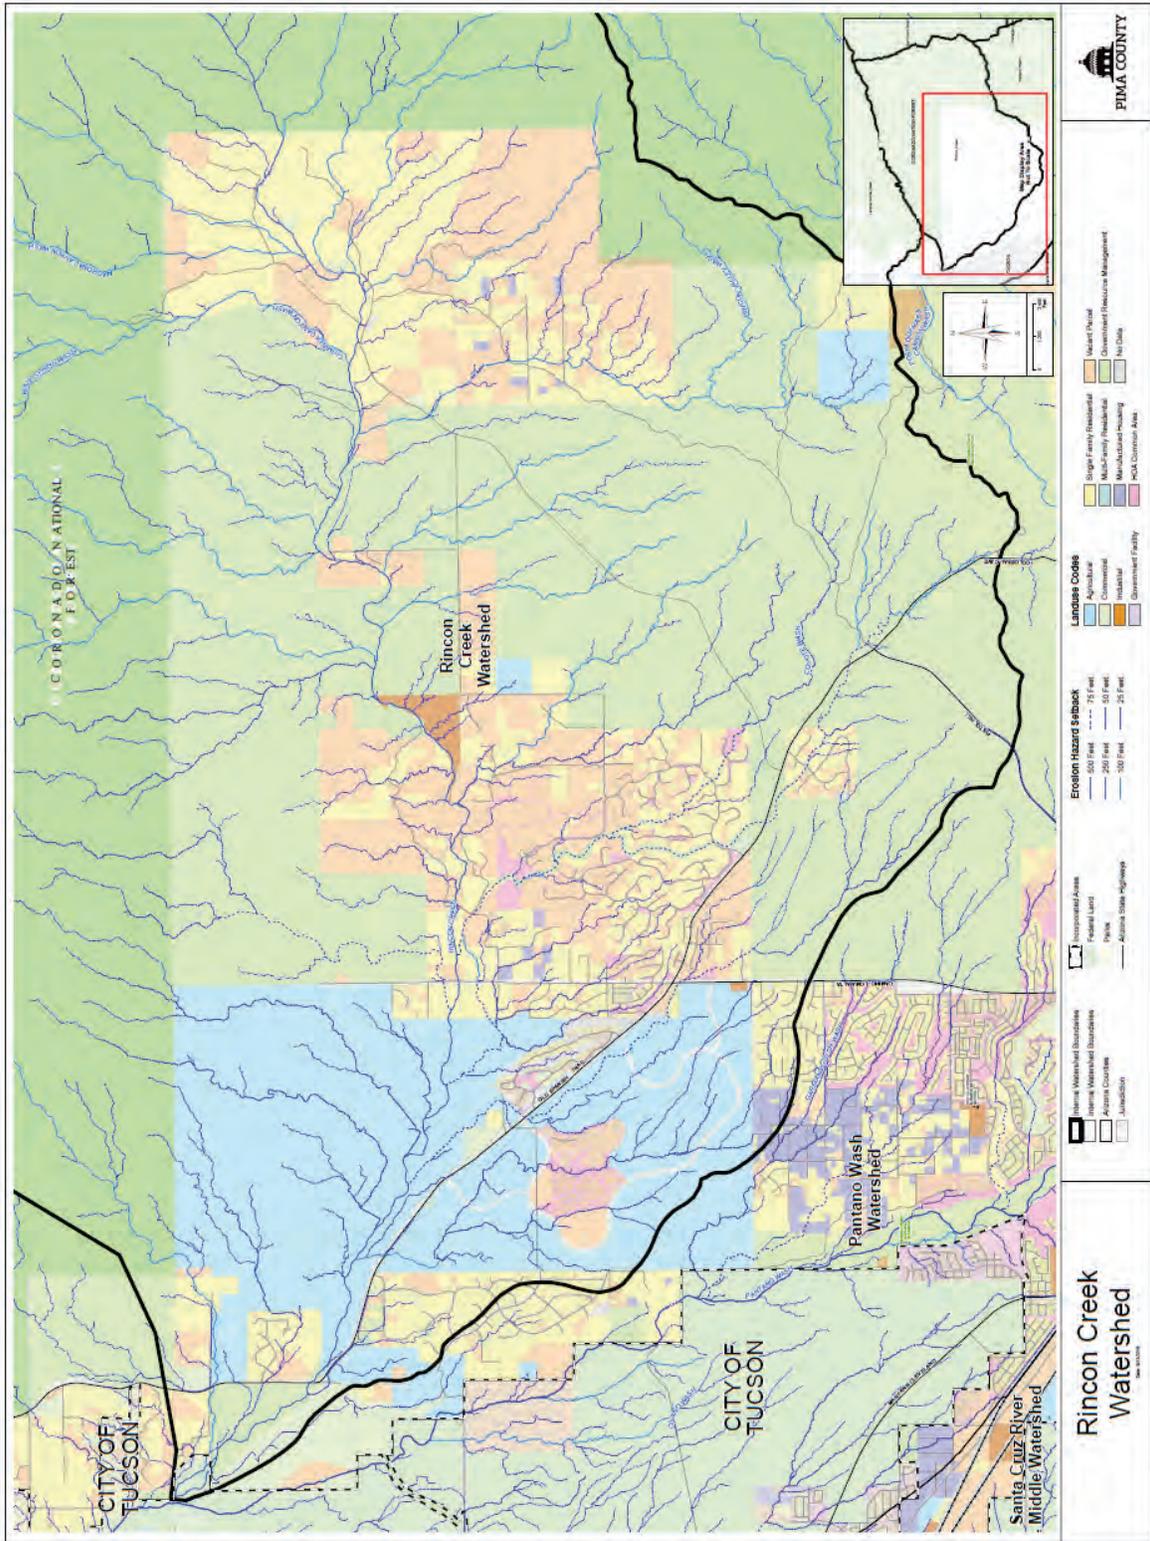
Figure 115 - Rincon Creek Land Use Map

The map below shows the distribution of these uses.

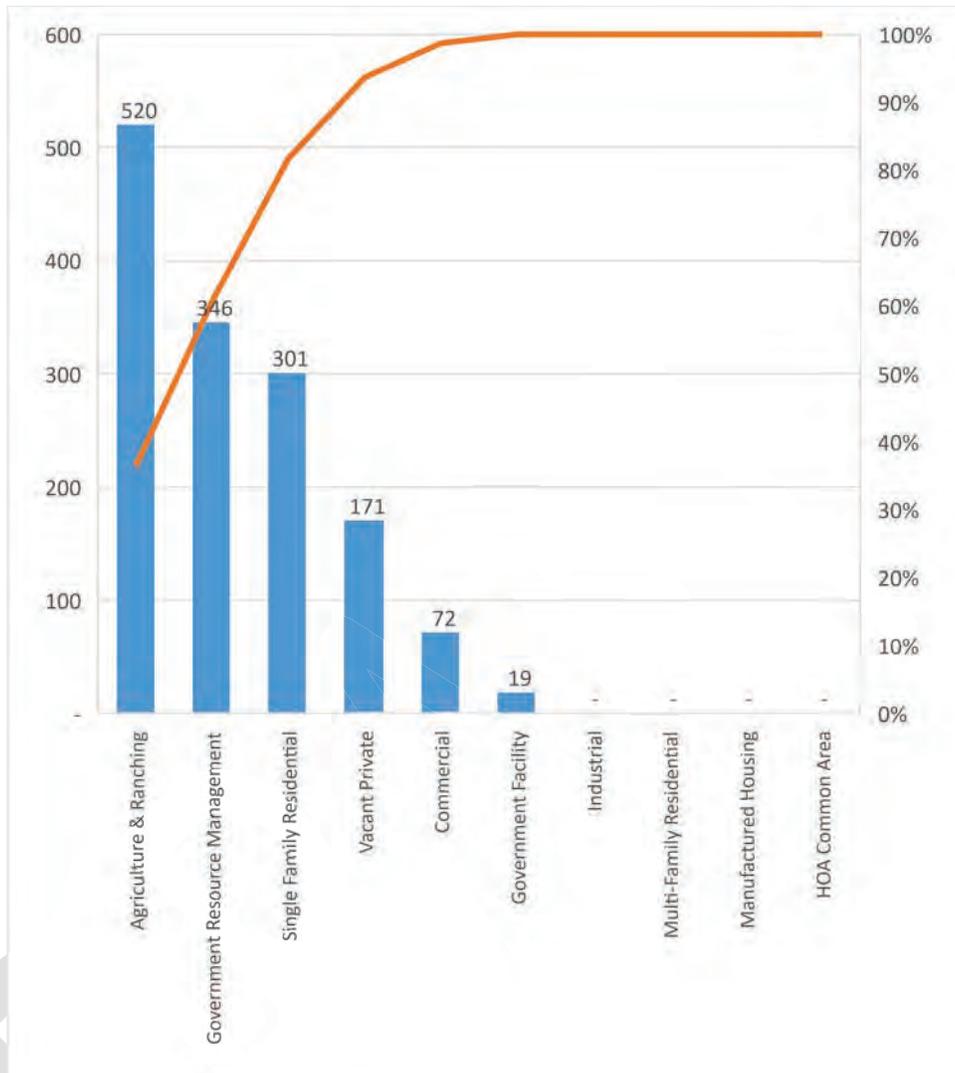
Figure 116 - Rincon Creek Floodplain Land Use

Downstream floodplain land use is still largely agricultural. Clusters of residential development exist around minor upstream tributaries that FEMA, the District nor landowners have mapped.

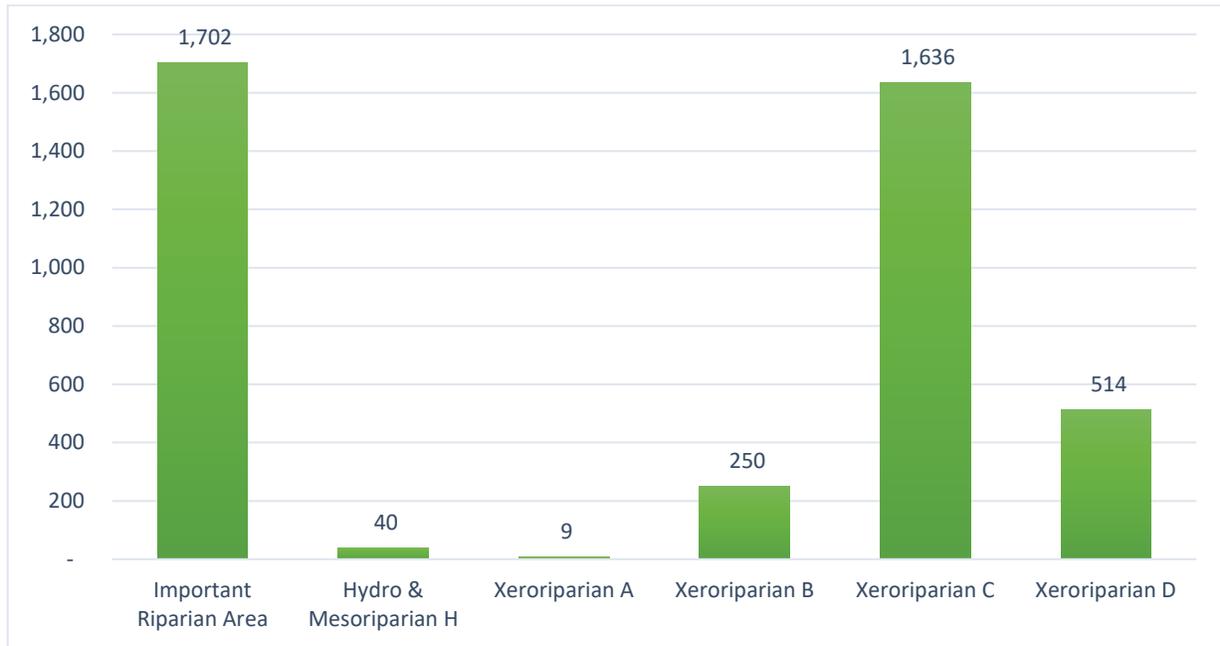
Figure 117 - Rincon Creek Watershed Riparian Habitat in Acres

As shown on the figure below, there are 3,978 acres of Pima County Regulated Riparian Habitat in this watershed. There are also 34,924 preserved acres in this watershed, including 325 in regulatory floodplain.

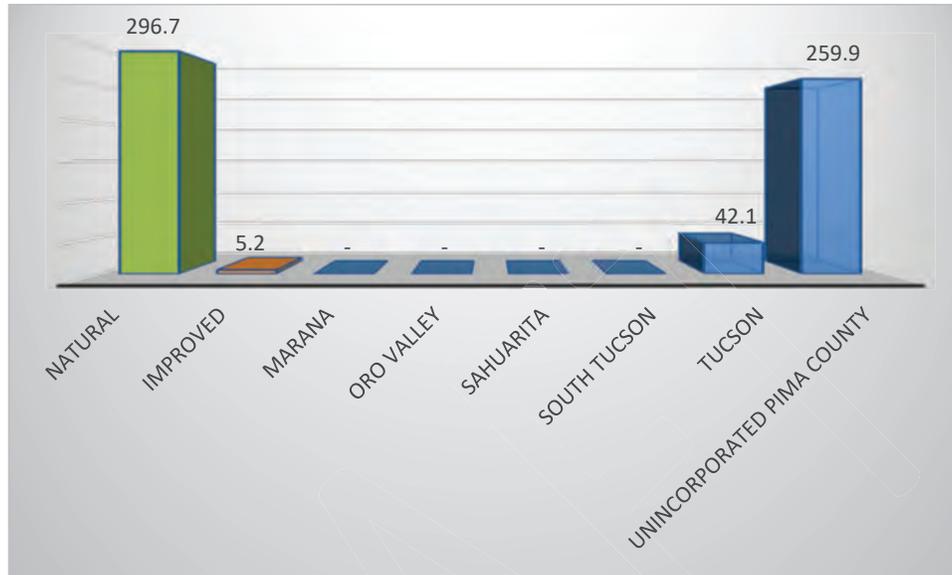
Figure 118 - Rincon Creek Drainageway Acreage

The figure below shows the split between natural and improved drainageways, and how many acres the District is responsible for in each jurisdiction.
