### 5.4.13 Santa Cruz River - Middle

### 5.4.13.1 Flood Characteristics

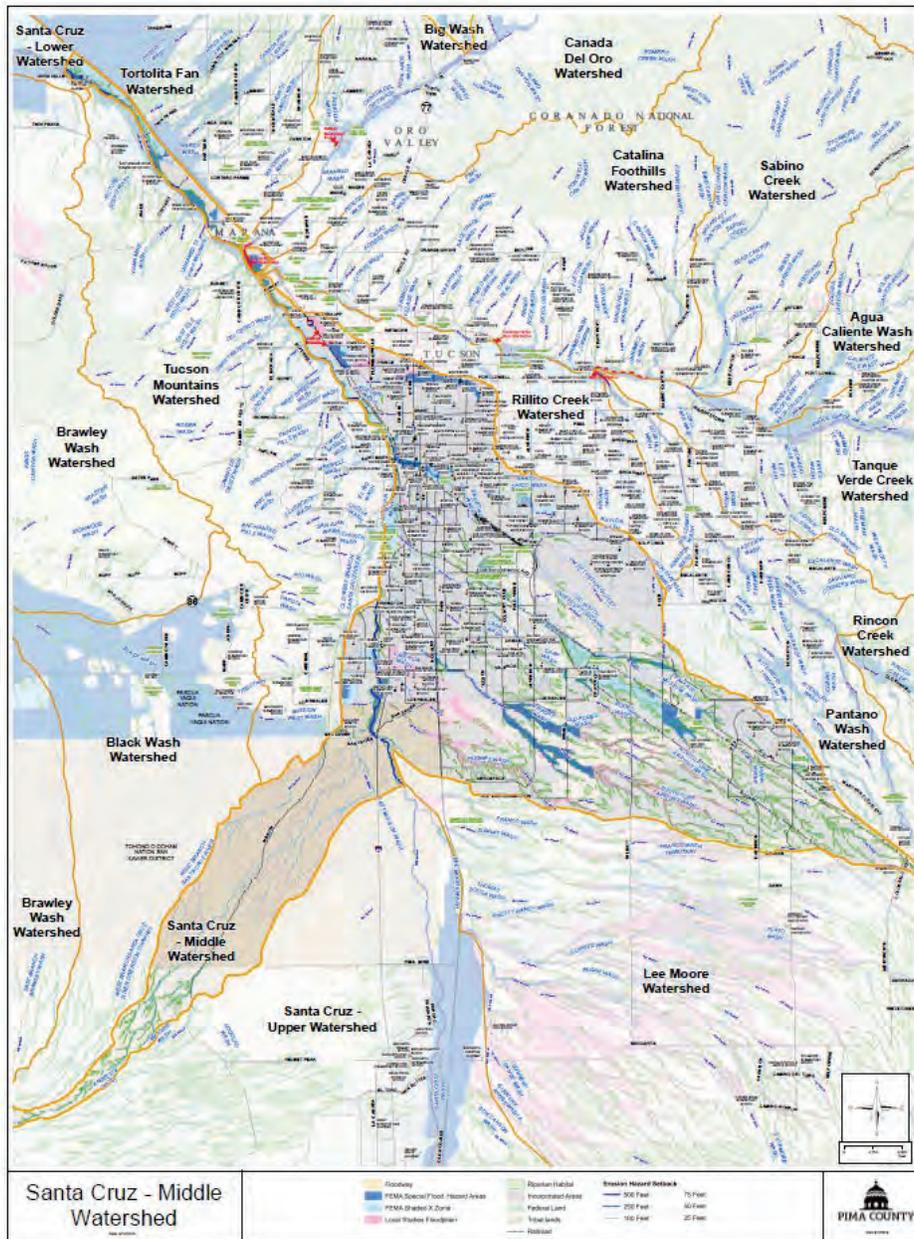
Figure 137 - Middle Santa Cruz River Watershed Map

This watershed extends southerly across the San Xavier District of the Tohono O’odham Nation along a lengthy tributary of East Mission Wash along Mission Road to the Sierrita Mountains in the southwest and the Julian Wash along the Interstate 10 Corridor to State Route 83 in the southeast. These branches coalesce along the Santa Cruz River near Valencia. Its northern terminus is Avra Valley Road. It is comprised of 107,767 acres (168.4 square miles), of which 66,005 (103 square miles) is in the City of Tucson, 2,332 in the Town of Marana and 655 in the City of South Tucson.

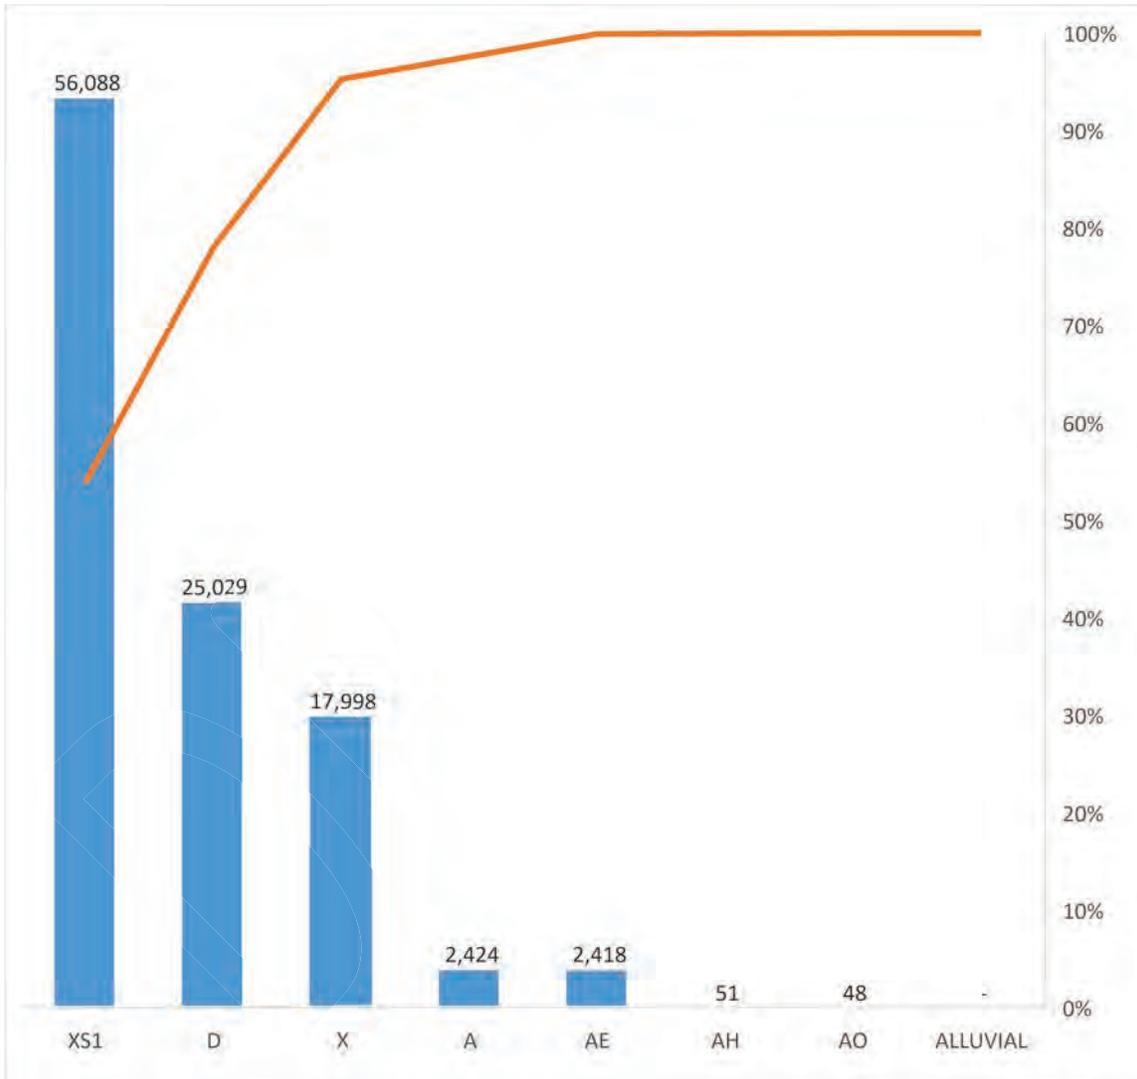
Figure 138 - Middle Santa Cruz River SFHA in Acres

There are 4,942 acres of FEMA Special Flood Hazard Area. The FEMA Flood Insurance Study (FIS) indicates a peak discharge of 60,000 cfs at Congress Street near the midway point and 70,000 cfs upstream of the confluence with the Canada del Oro Wash. Interestingly it is also 70,000 downstream of the confluence at Cortaro Farms Road near the downstream terminus. The FIS drainage area is 3,503 square miles at this location.

In addition to the SFHA zones included on the chart above, there are also 6,145 acres of District Special Studies Floodplains, and 682 acres of sheet flood area in this watershed. Special studies floodplains in distributary areas in the downstream reaches date to 2 decades ago. Distributary flow modeling can better assess flood hazards in these areas. The Santa Cruz River floodplain and floodway south of Los Reales Road and west of Interstate 19 within the San Xavier District of the Tohono O’odham Nation is the only tribal land that FEMA has mapped.

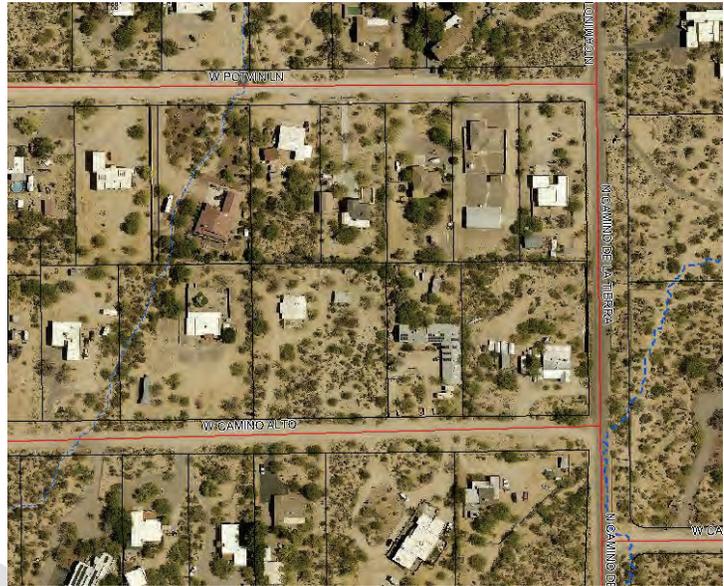
Most intense development is within the floodplain management jurisdiction of the City of Tucson or the Town of Marana. Within unincorporated Pima County, much residential development is within lots outside of platted subdivisions. The picture shows typical larger lots with no planned drainage infrastructure in distributary flow areas. The map below shows the land use and drainage patterns.

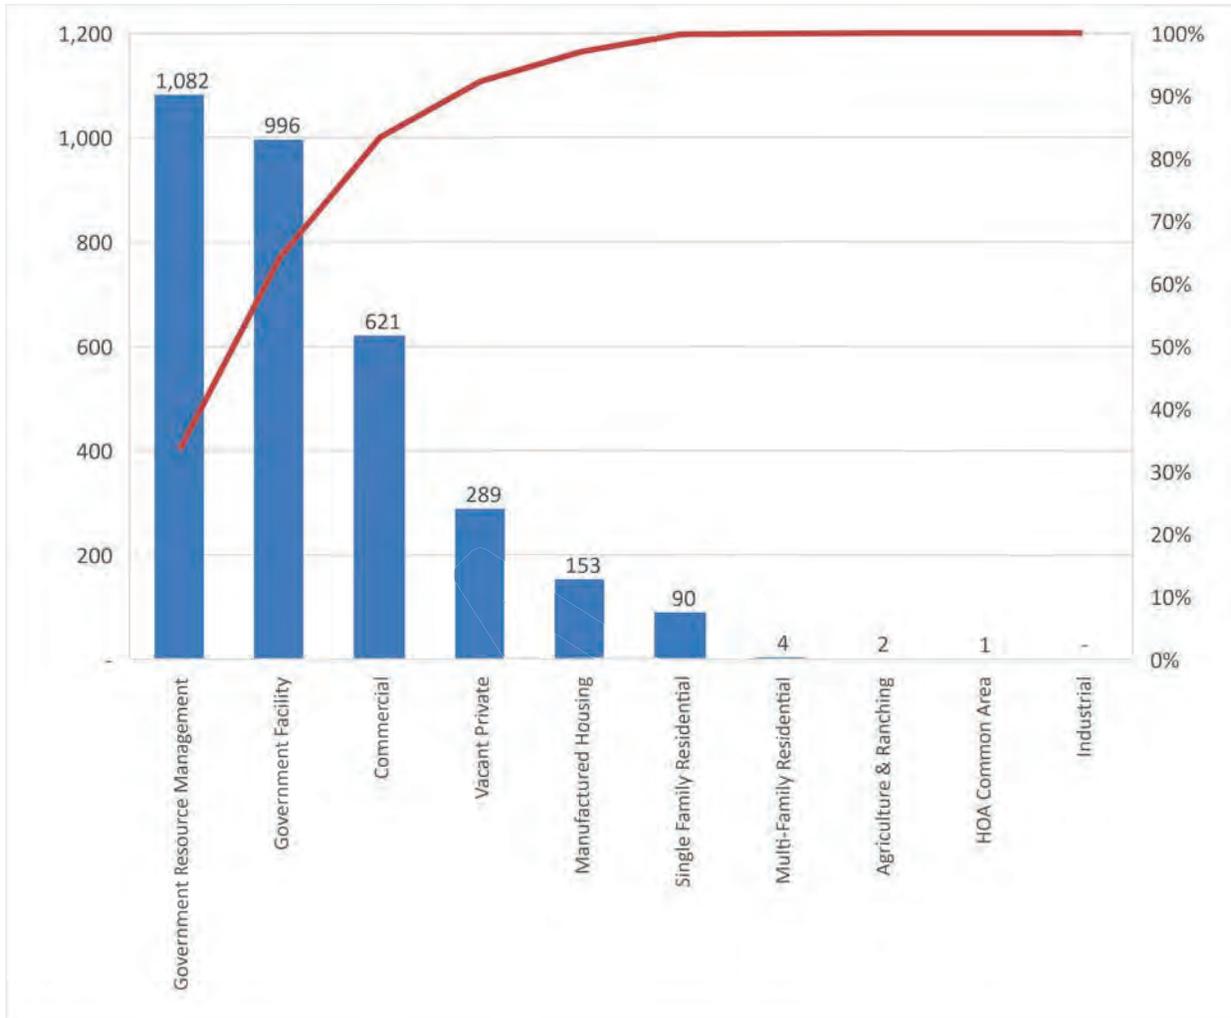
Figure 143 - Middle Santa Cruz River Floodplain Land Use

The following chart shows the land use mix within floodplains in this watershed.

As noted above both major transportation corridors serving Tucson; Interstates 10 and 19, and the railway parallel the river and explains the relatively higher percentage occupied by commercial and industrial sectors as well as multi-family housing.

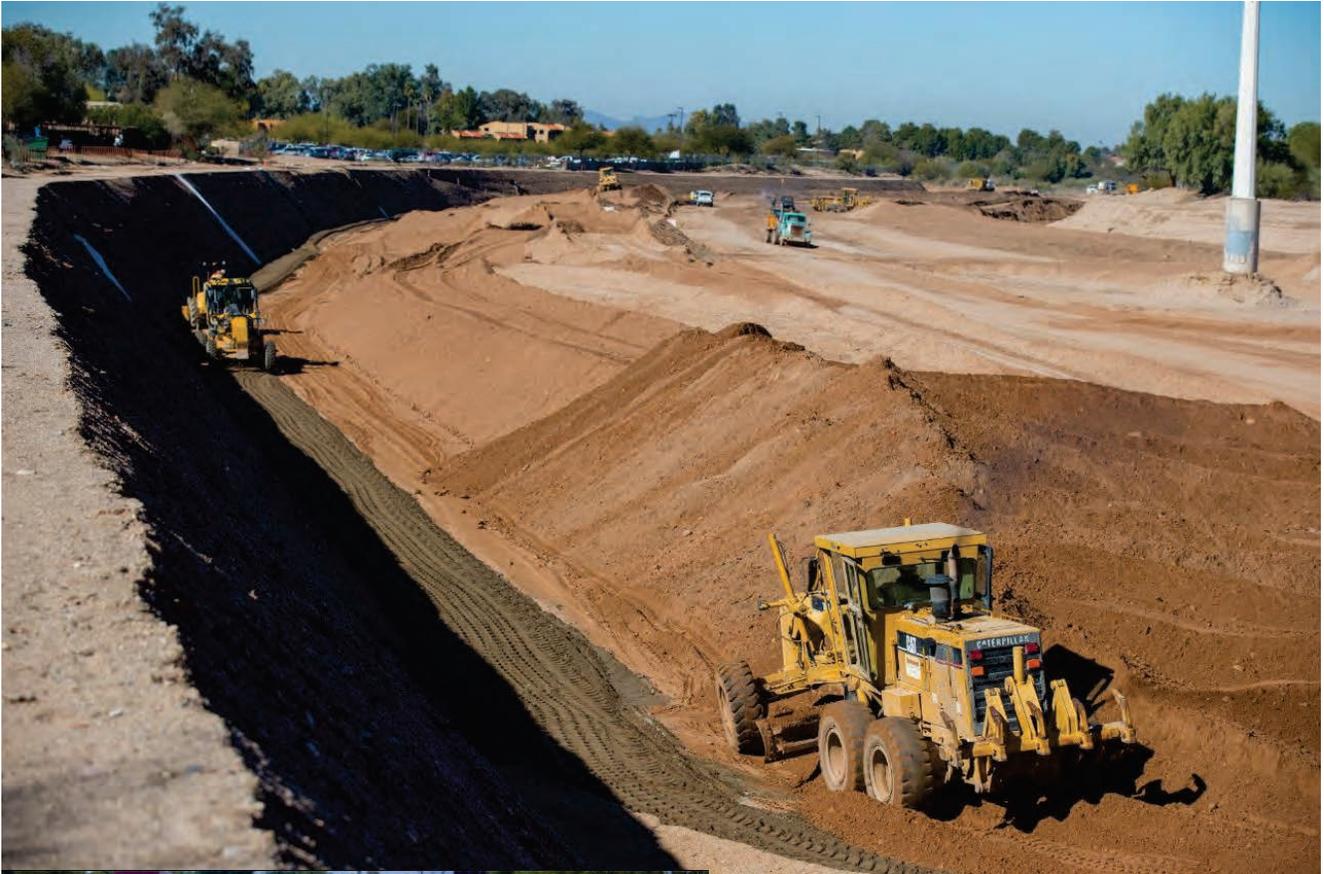
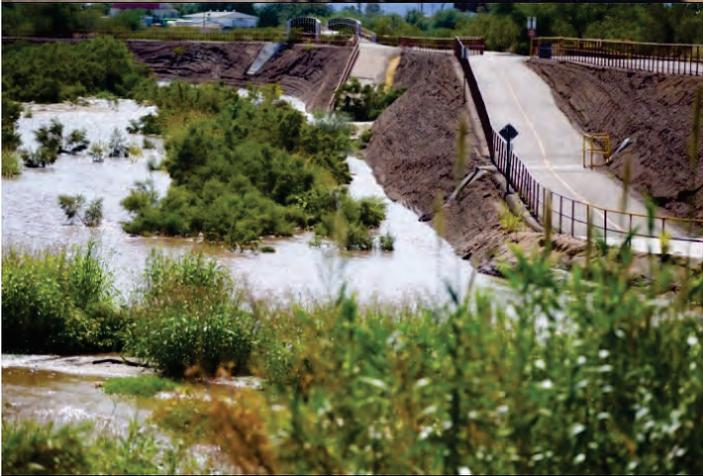
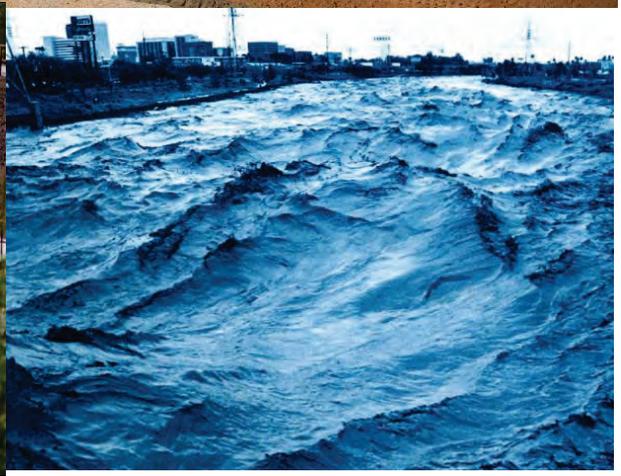
*Bank Protection Construction, Low and High Flow*

In historic times, significant entrenchment occurred along the Santa Cruz from San Xavier road to the confluence of the Rillito, which has acted as a pivot point. Most of this reach is urbanized on both sides and bank protected. Through the most northern part of the reach from Cushing Street to Grant Road, where the older structures are, the channel is more encroached and constrained. A levee exists on the eastern bank about ½ mile upstream of Grant Rd and extends about a mile downstream of Grant into the downstream reach.

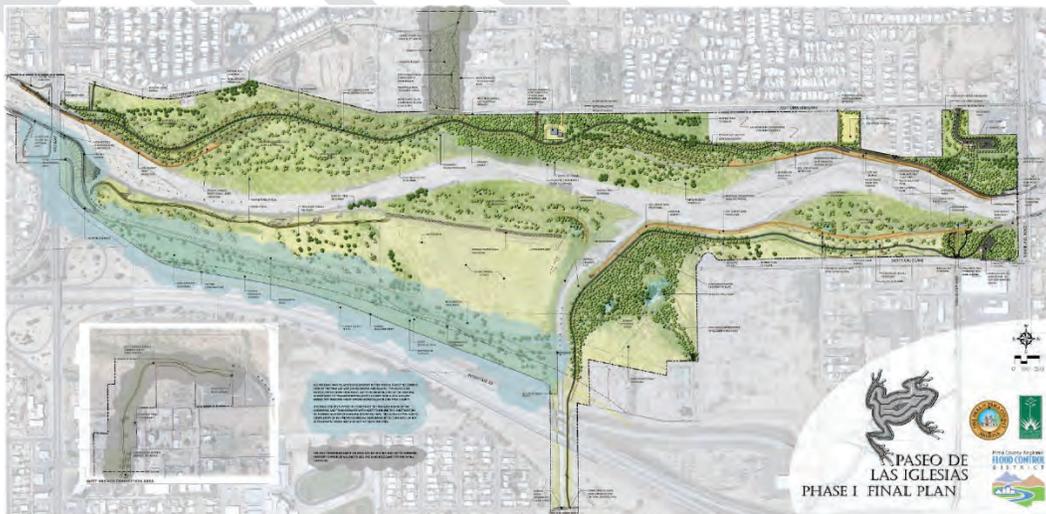
Figure 145 - Paseo de las Iglesias Multi-Purpose Restoration Project

The largest habitat restoration efforts of the District in this area include the 120-acre Kino Environmental Restoration project and the 350-acre Paseo de las Iglesias along the Santa Cruz River. The former project, constructed in a pre-existing detention basin, contains a series of ponds and native vegetation plus a pumping system that both circulates stormwater within the basin and removes excess stormwater to irrigate turf at the Kino Sports Complex and surrounding landscape areas. Due to a limited urban encroachment, the Paseo de las Iglesias project takes a softer approach to major urban river management by introducing habitat restoration on the overbanks and broad terraces and relies less on bank protection. This project enhanced a pre-existing ephemeral toad-breeding habitat that supports six species of native toads.

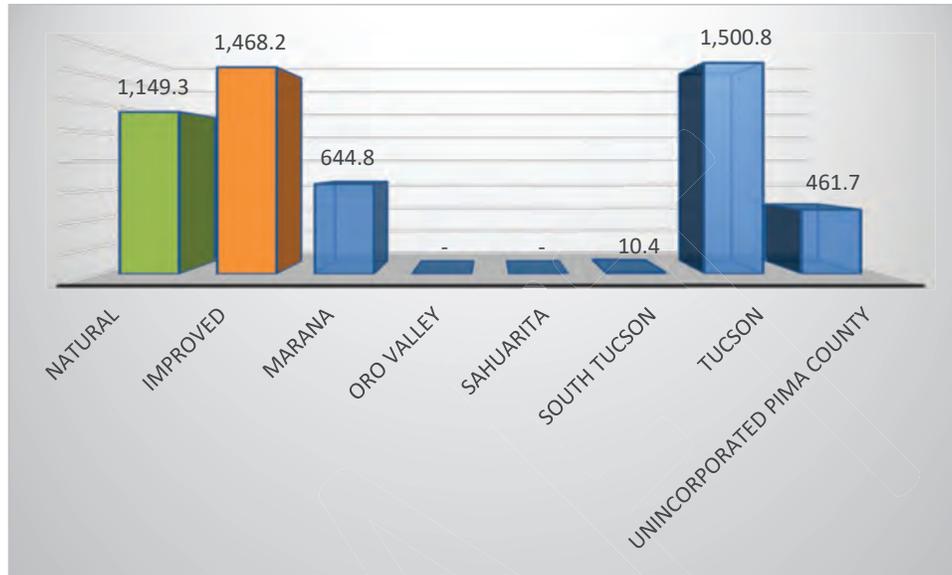
Figure 146 - Middle Santa Cruz River Drainageway Acreage

The figure below shows the split between natural and improved drainageways, and how many acres the District is responsible for in each jurisdiction.

In upper, more urbanized reaches, following the floods of 1983, the district embarked on a major program of bank protection to prohibit lateral migration of the riverbed. Currently most of this reach has been bank protected. However, as mentioned above in the more recent projects, wherever possible a wider floodplain maintained to facilitate habitat restoration as well as reduction of encroachment, and bank protection height. While the District is responsible for the Santa Cruz throughout Pima County, much of this watershed is within the City of Tucson.

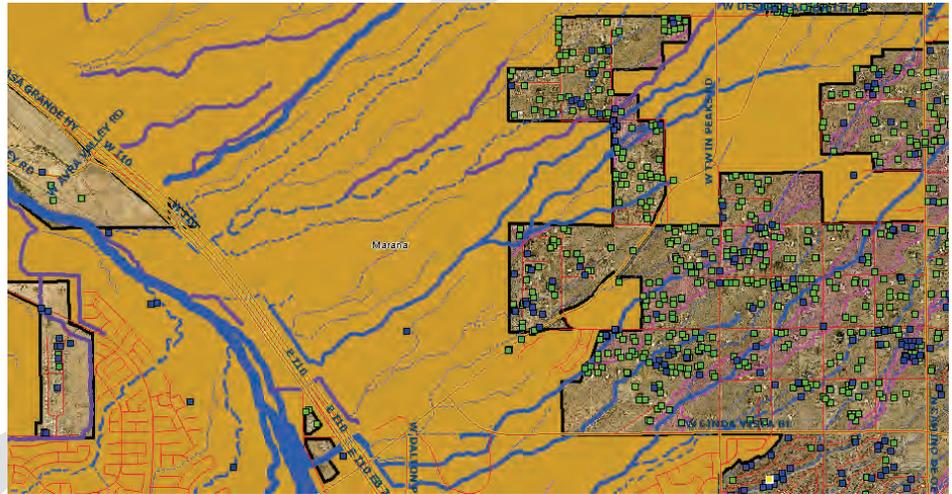
In the downstream less urbanized reaches of the watershed, infrastructure is limited. The MapGuide excerpt below shows typical residential development without planned infrastructure. The green squares mark the locations of individual floodplain use permits. When project-scale or regional infrastructure is has been put in place by the District of private developers, flood hazards have been defined and mitigated during project development by the District, and it is not necessary to issue numerous individual permits.
