FINAL EXISTING CONDITIONS REPORT

Airport Wash

BASIN MANAGEMENT STUDY PHASE 2

FINAL EXISTING CONDITIONS REPORT
AIRPORT WASH BASIN MANAGEMENT STUDY
PHASE 2

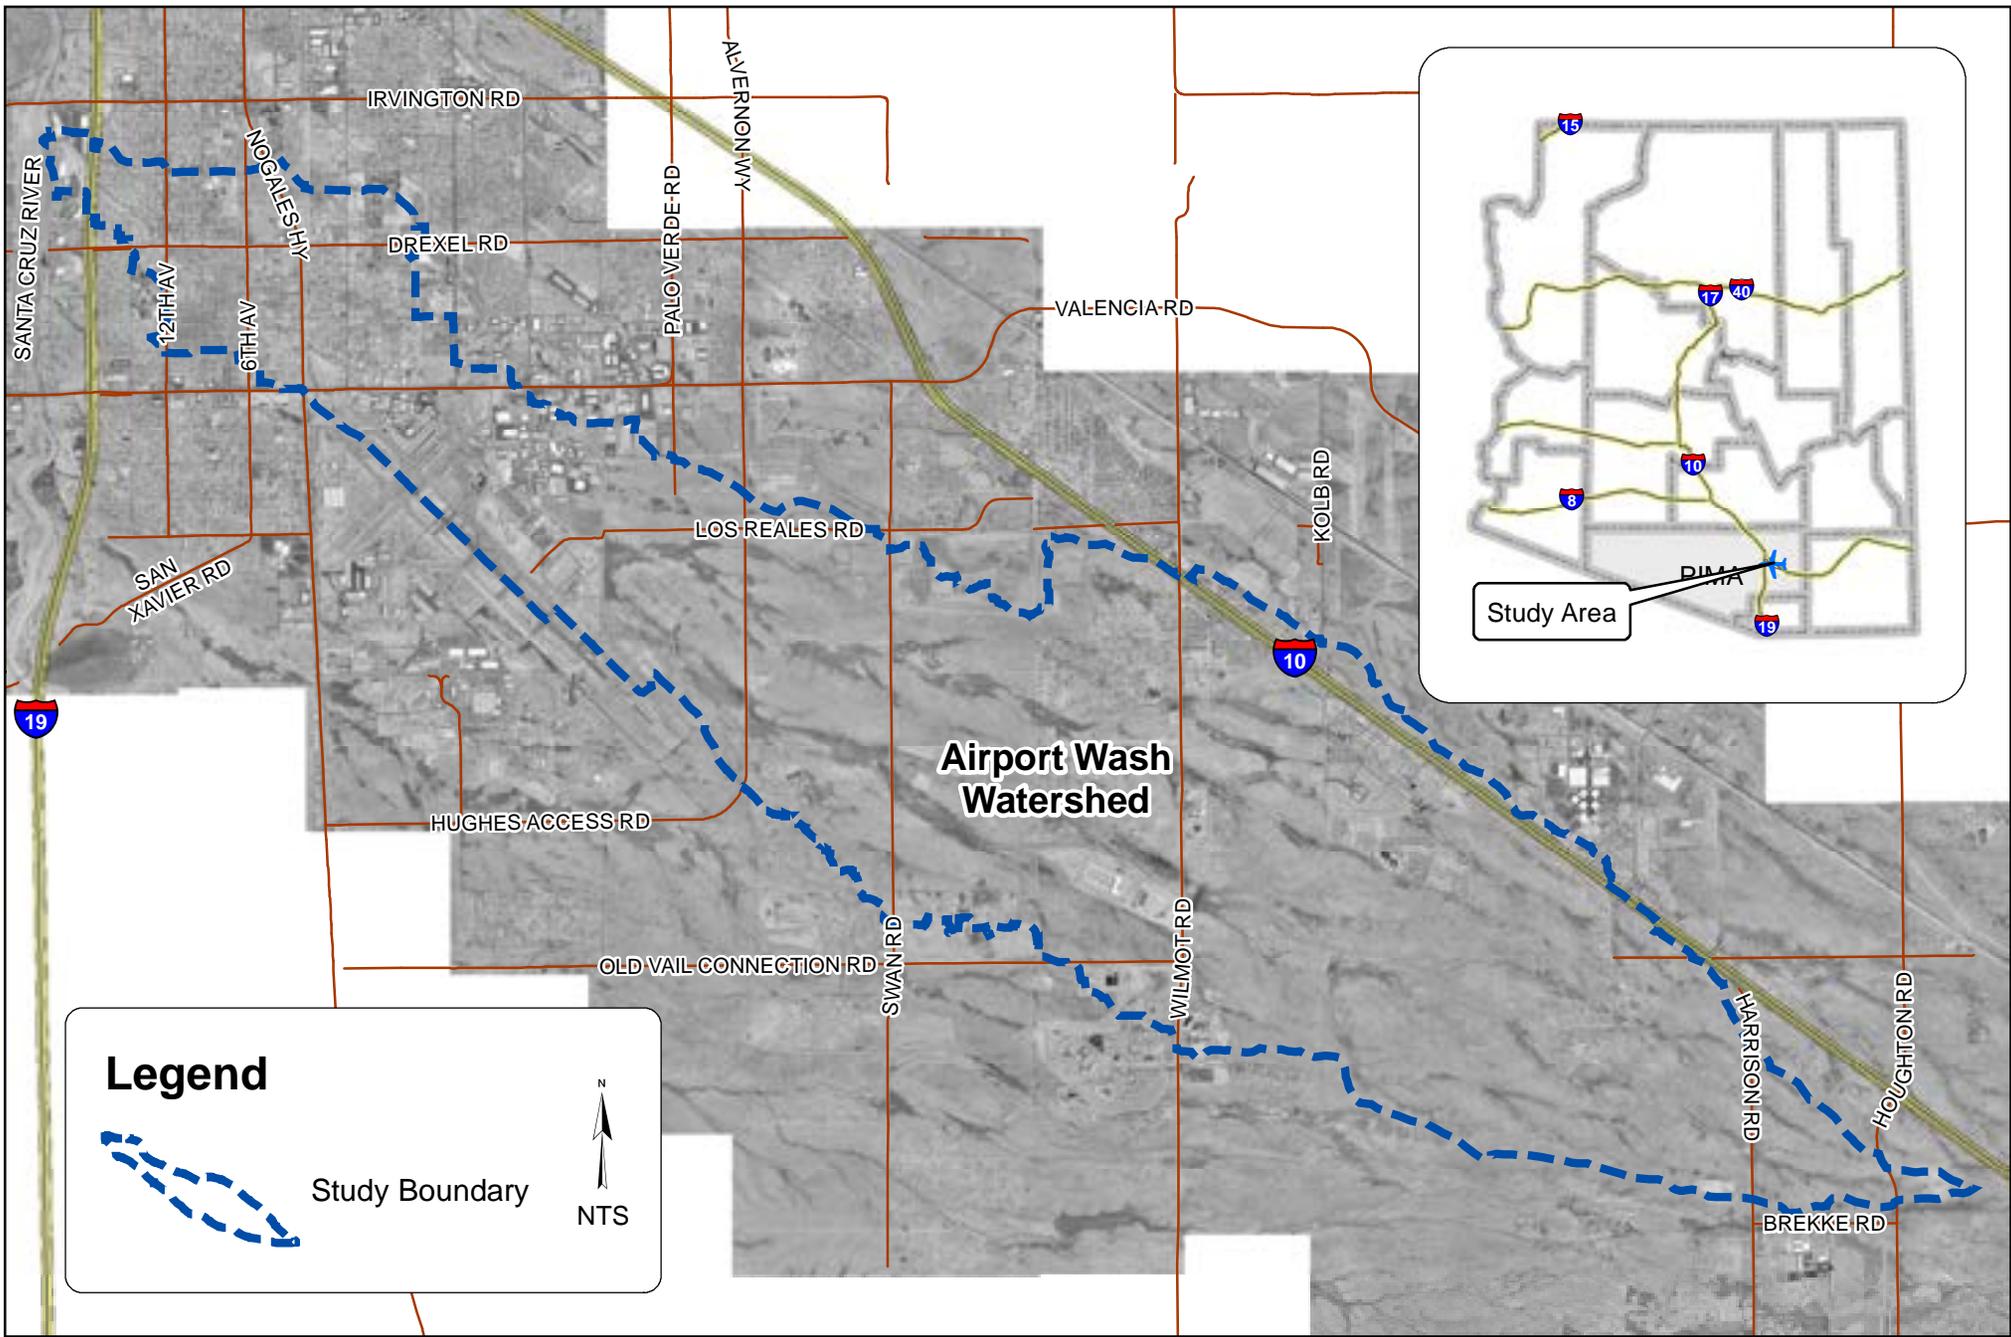
The limits of the Airport Wash Basin Management Study Phase 2 project area cross the jurisdictional boundaries of Pima County (County) and the City of Tucson (City). The study is bordered on the north by the Wyoming, Rodeo, and Julian watersheds with I-10 and E. Brekke Rd serving as the eastern and southern boundaries, respectively. All flow outfalls to the Santa Cruz River, which is the western boundary of the project. A location map for the project is provided on **Figure 1** and the jurisdictional boundaries are shown on **Figure 2** in **Appendix A**.

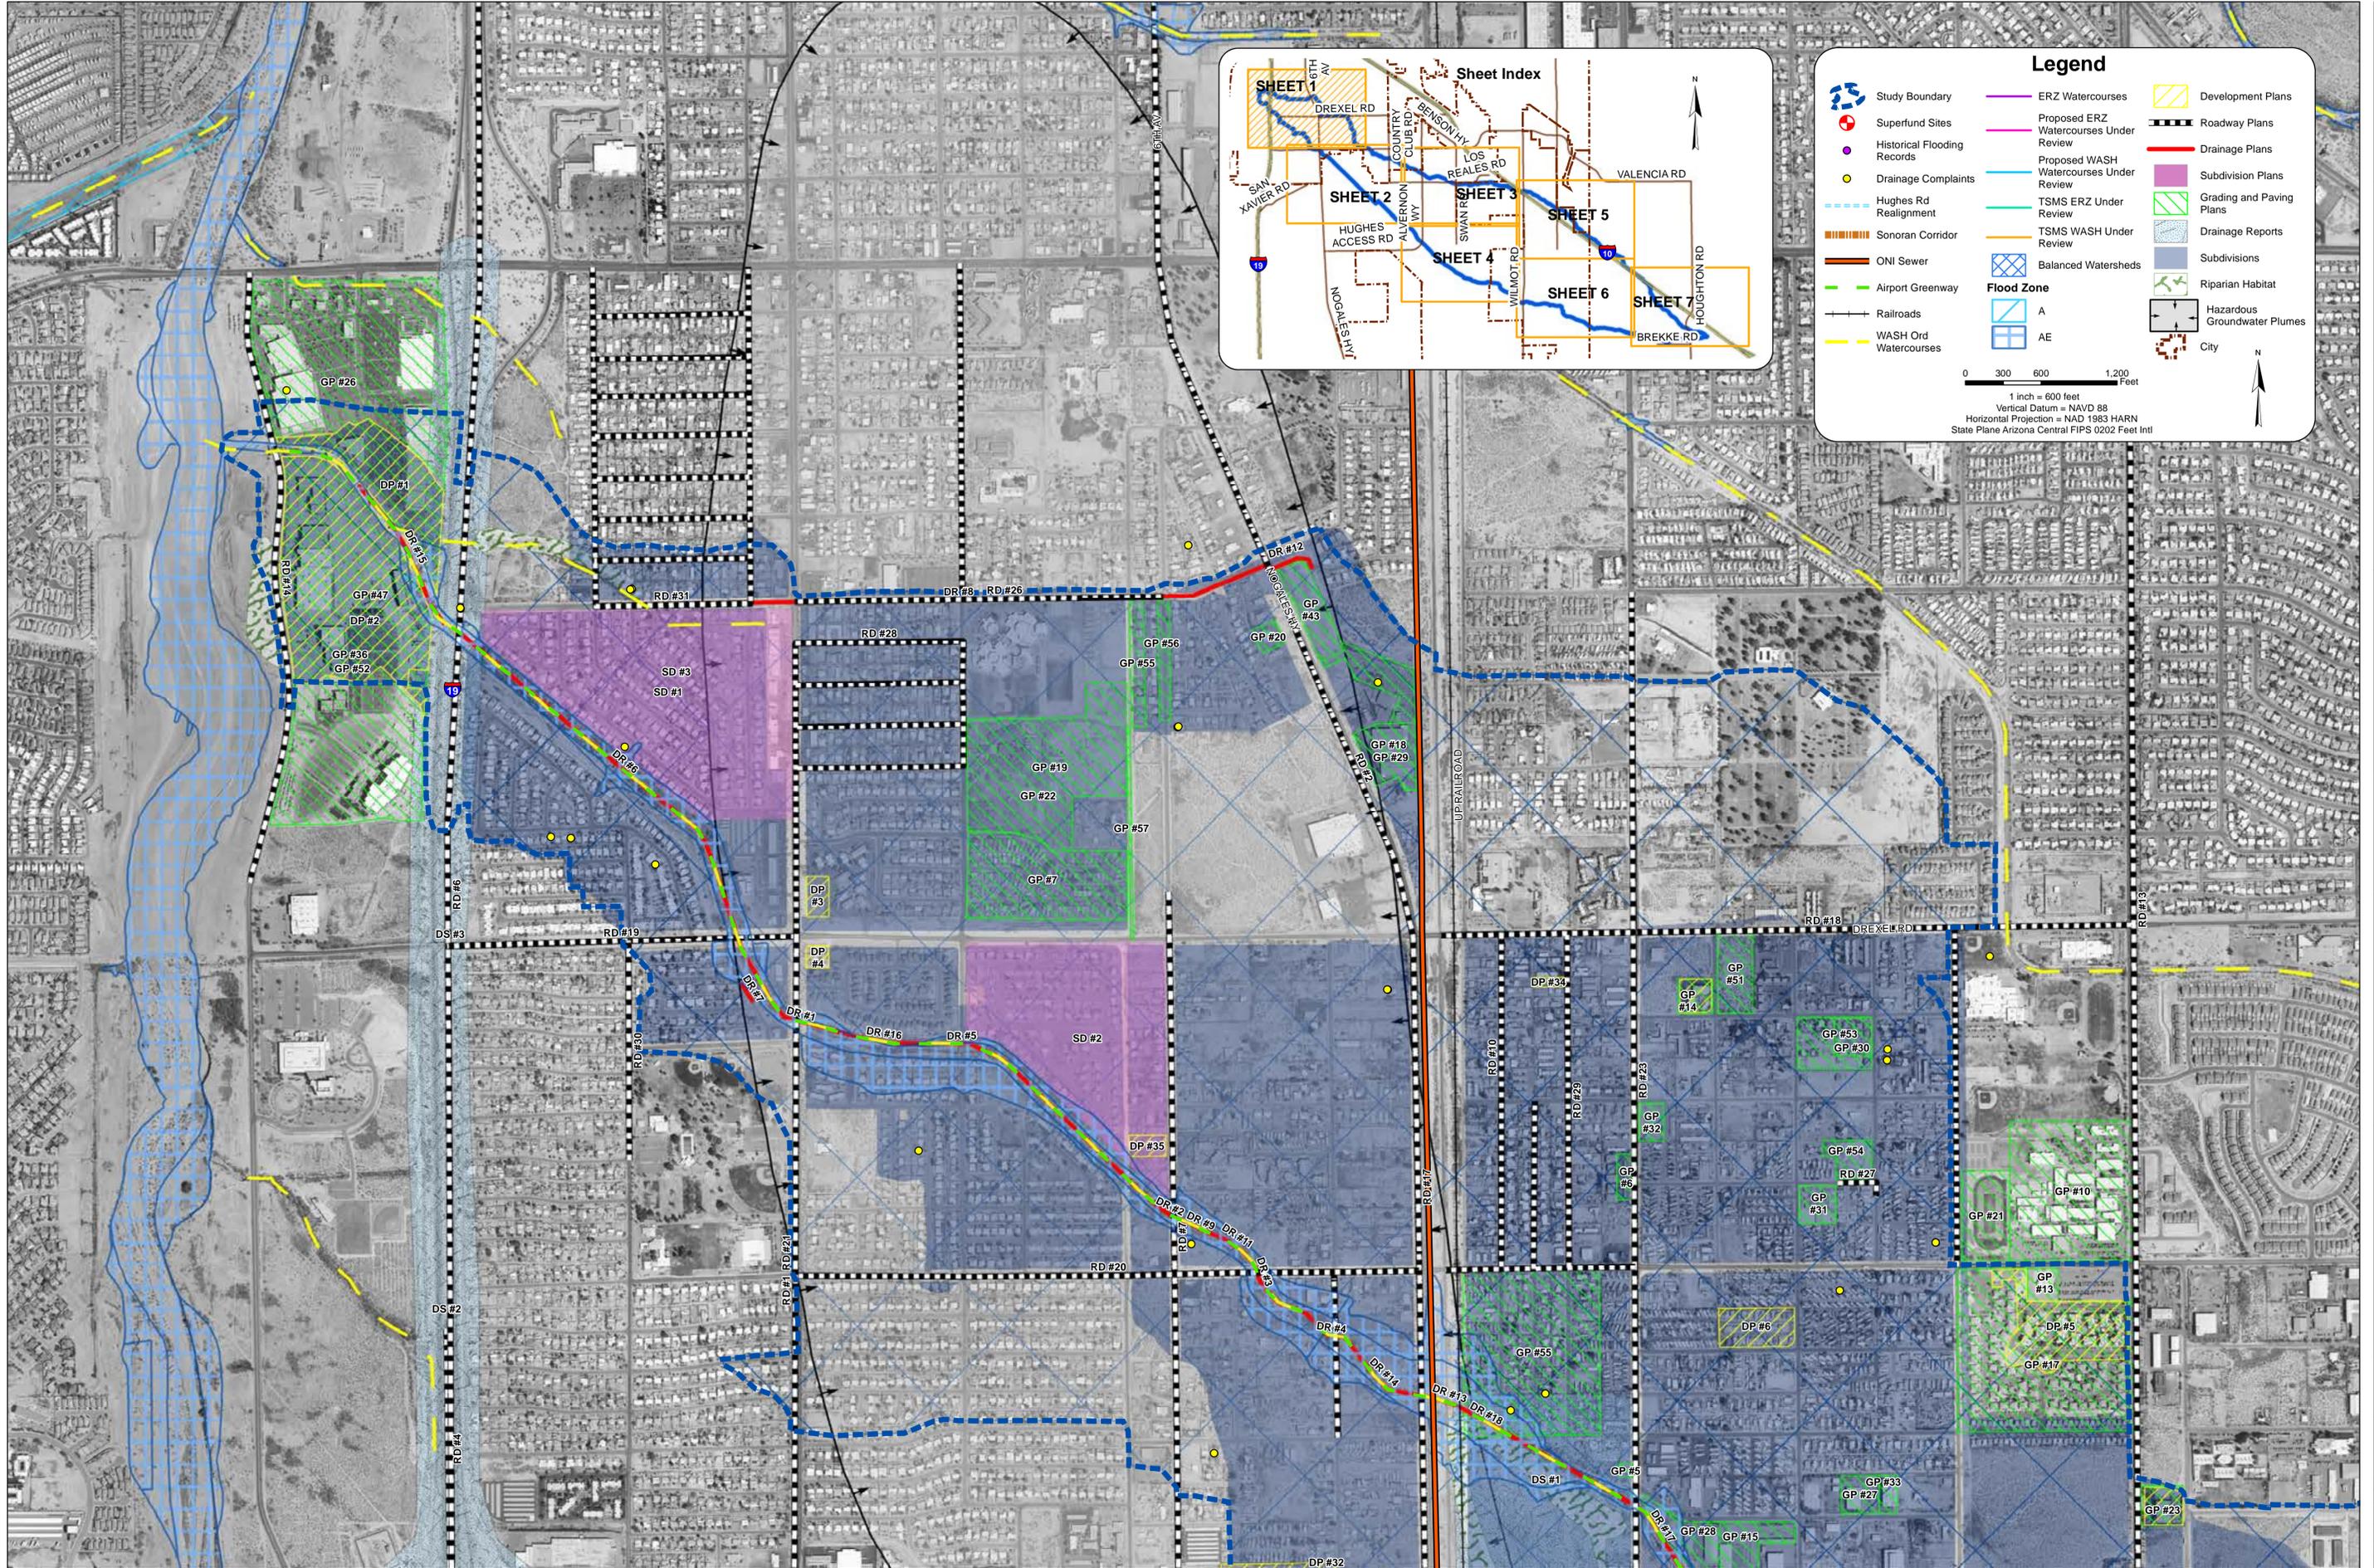
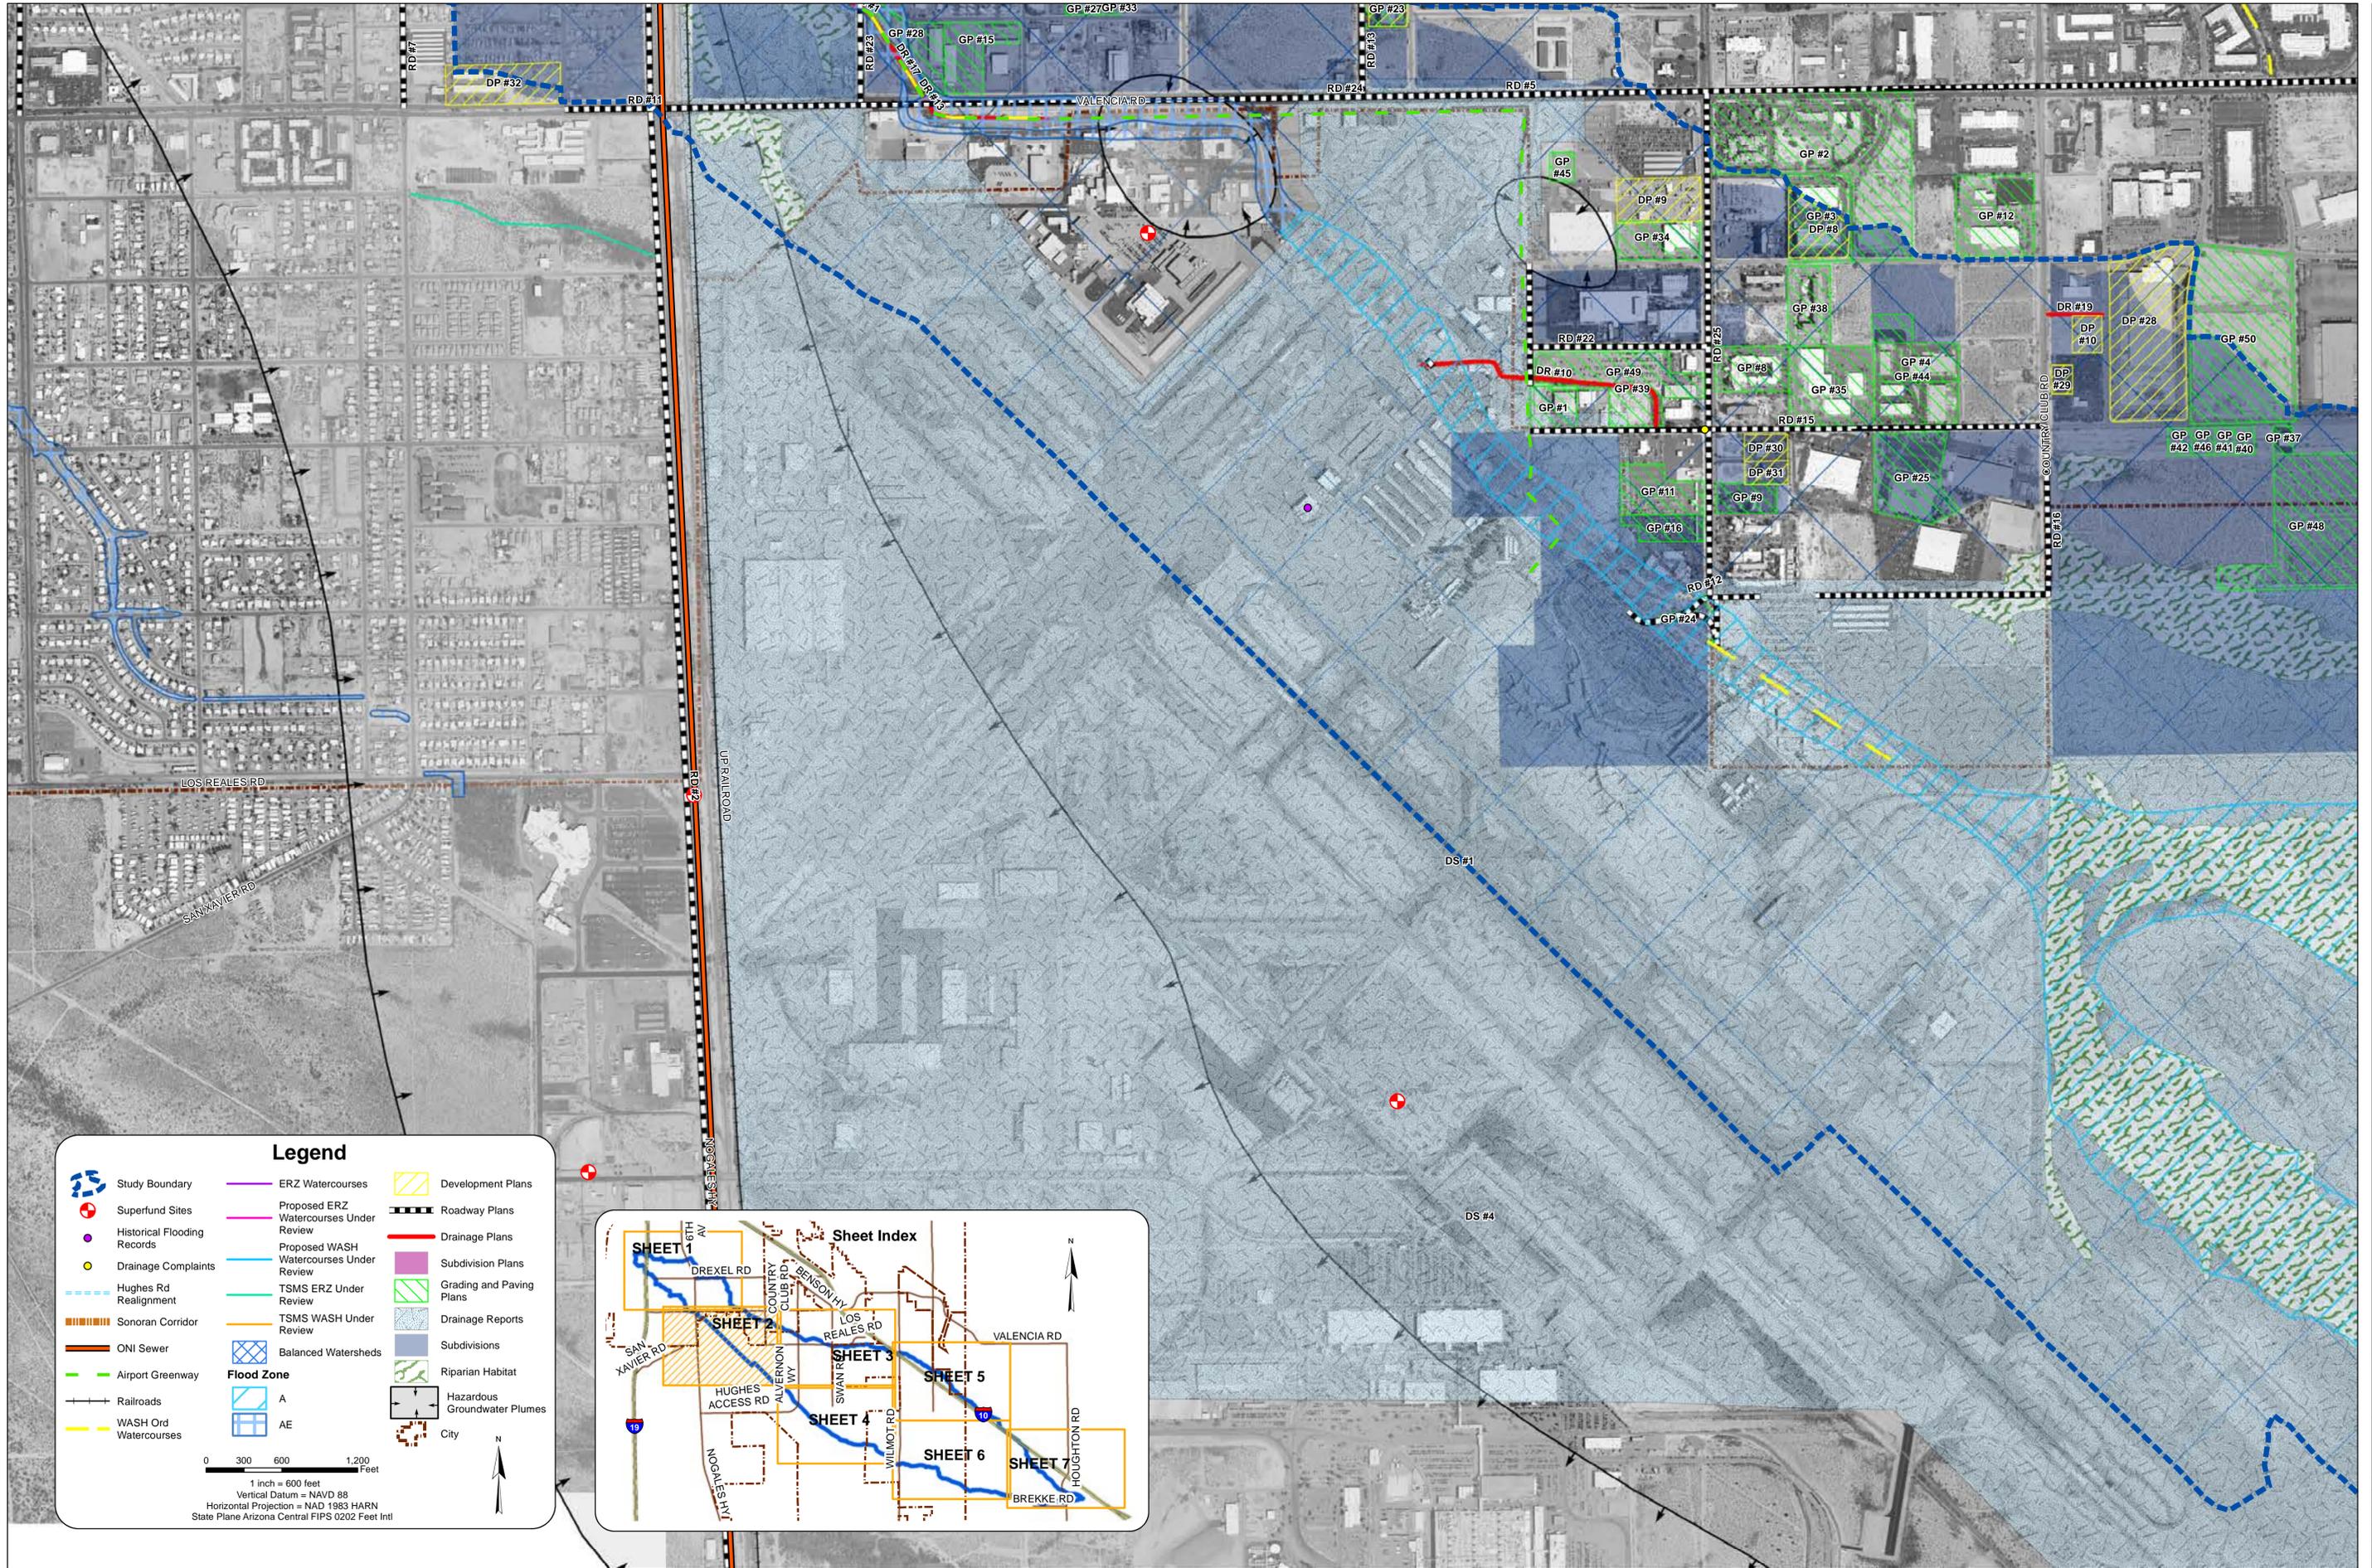
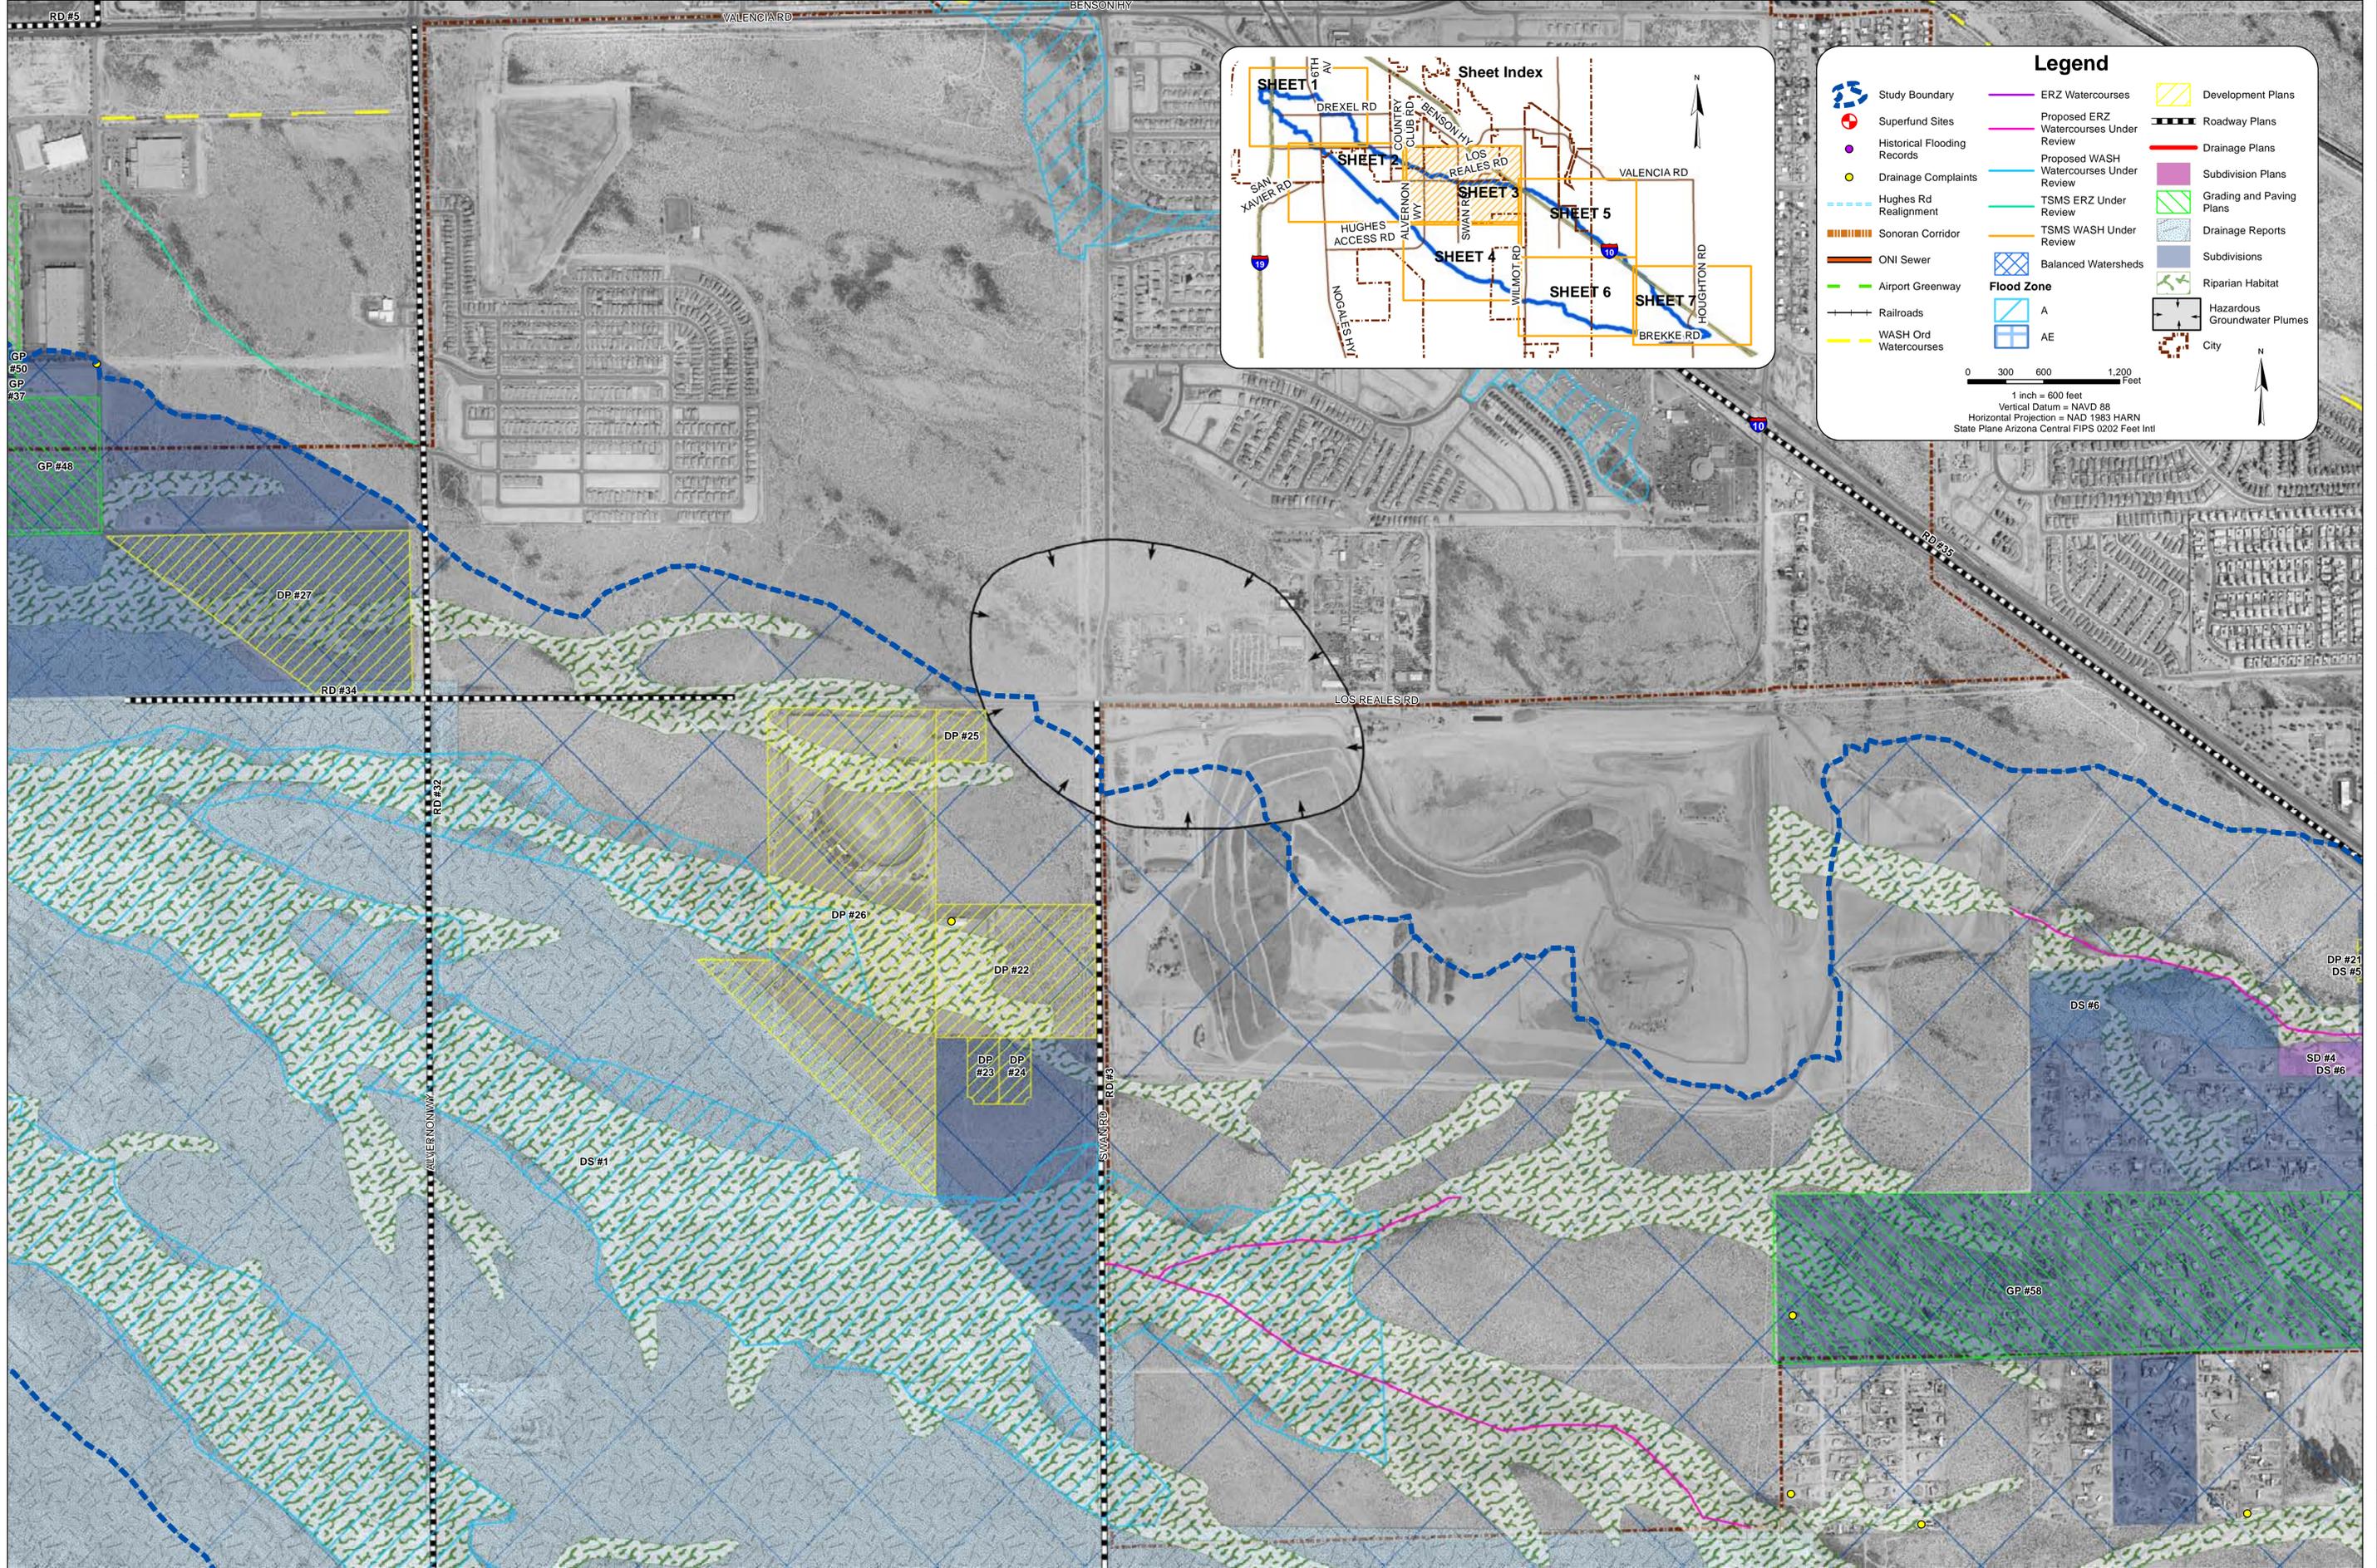
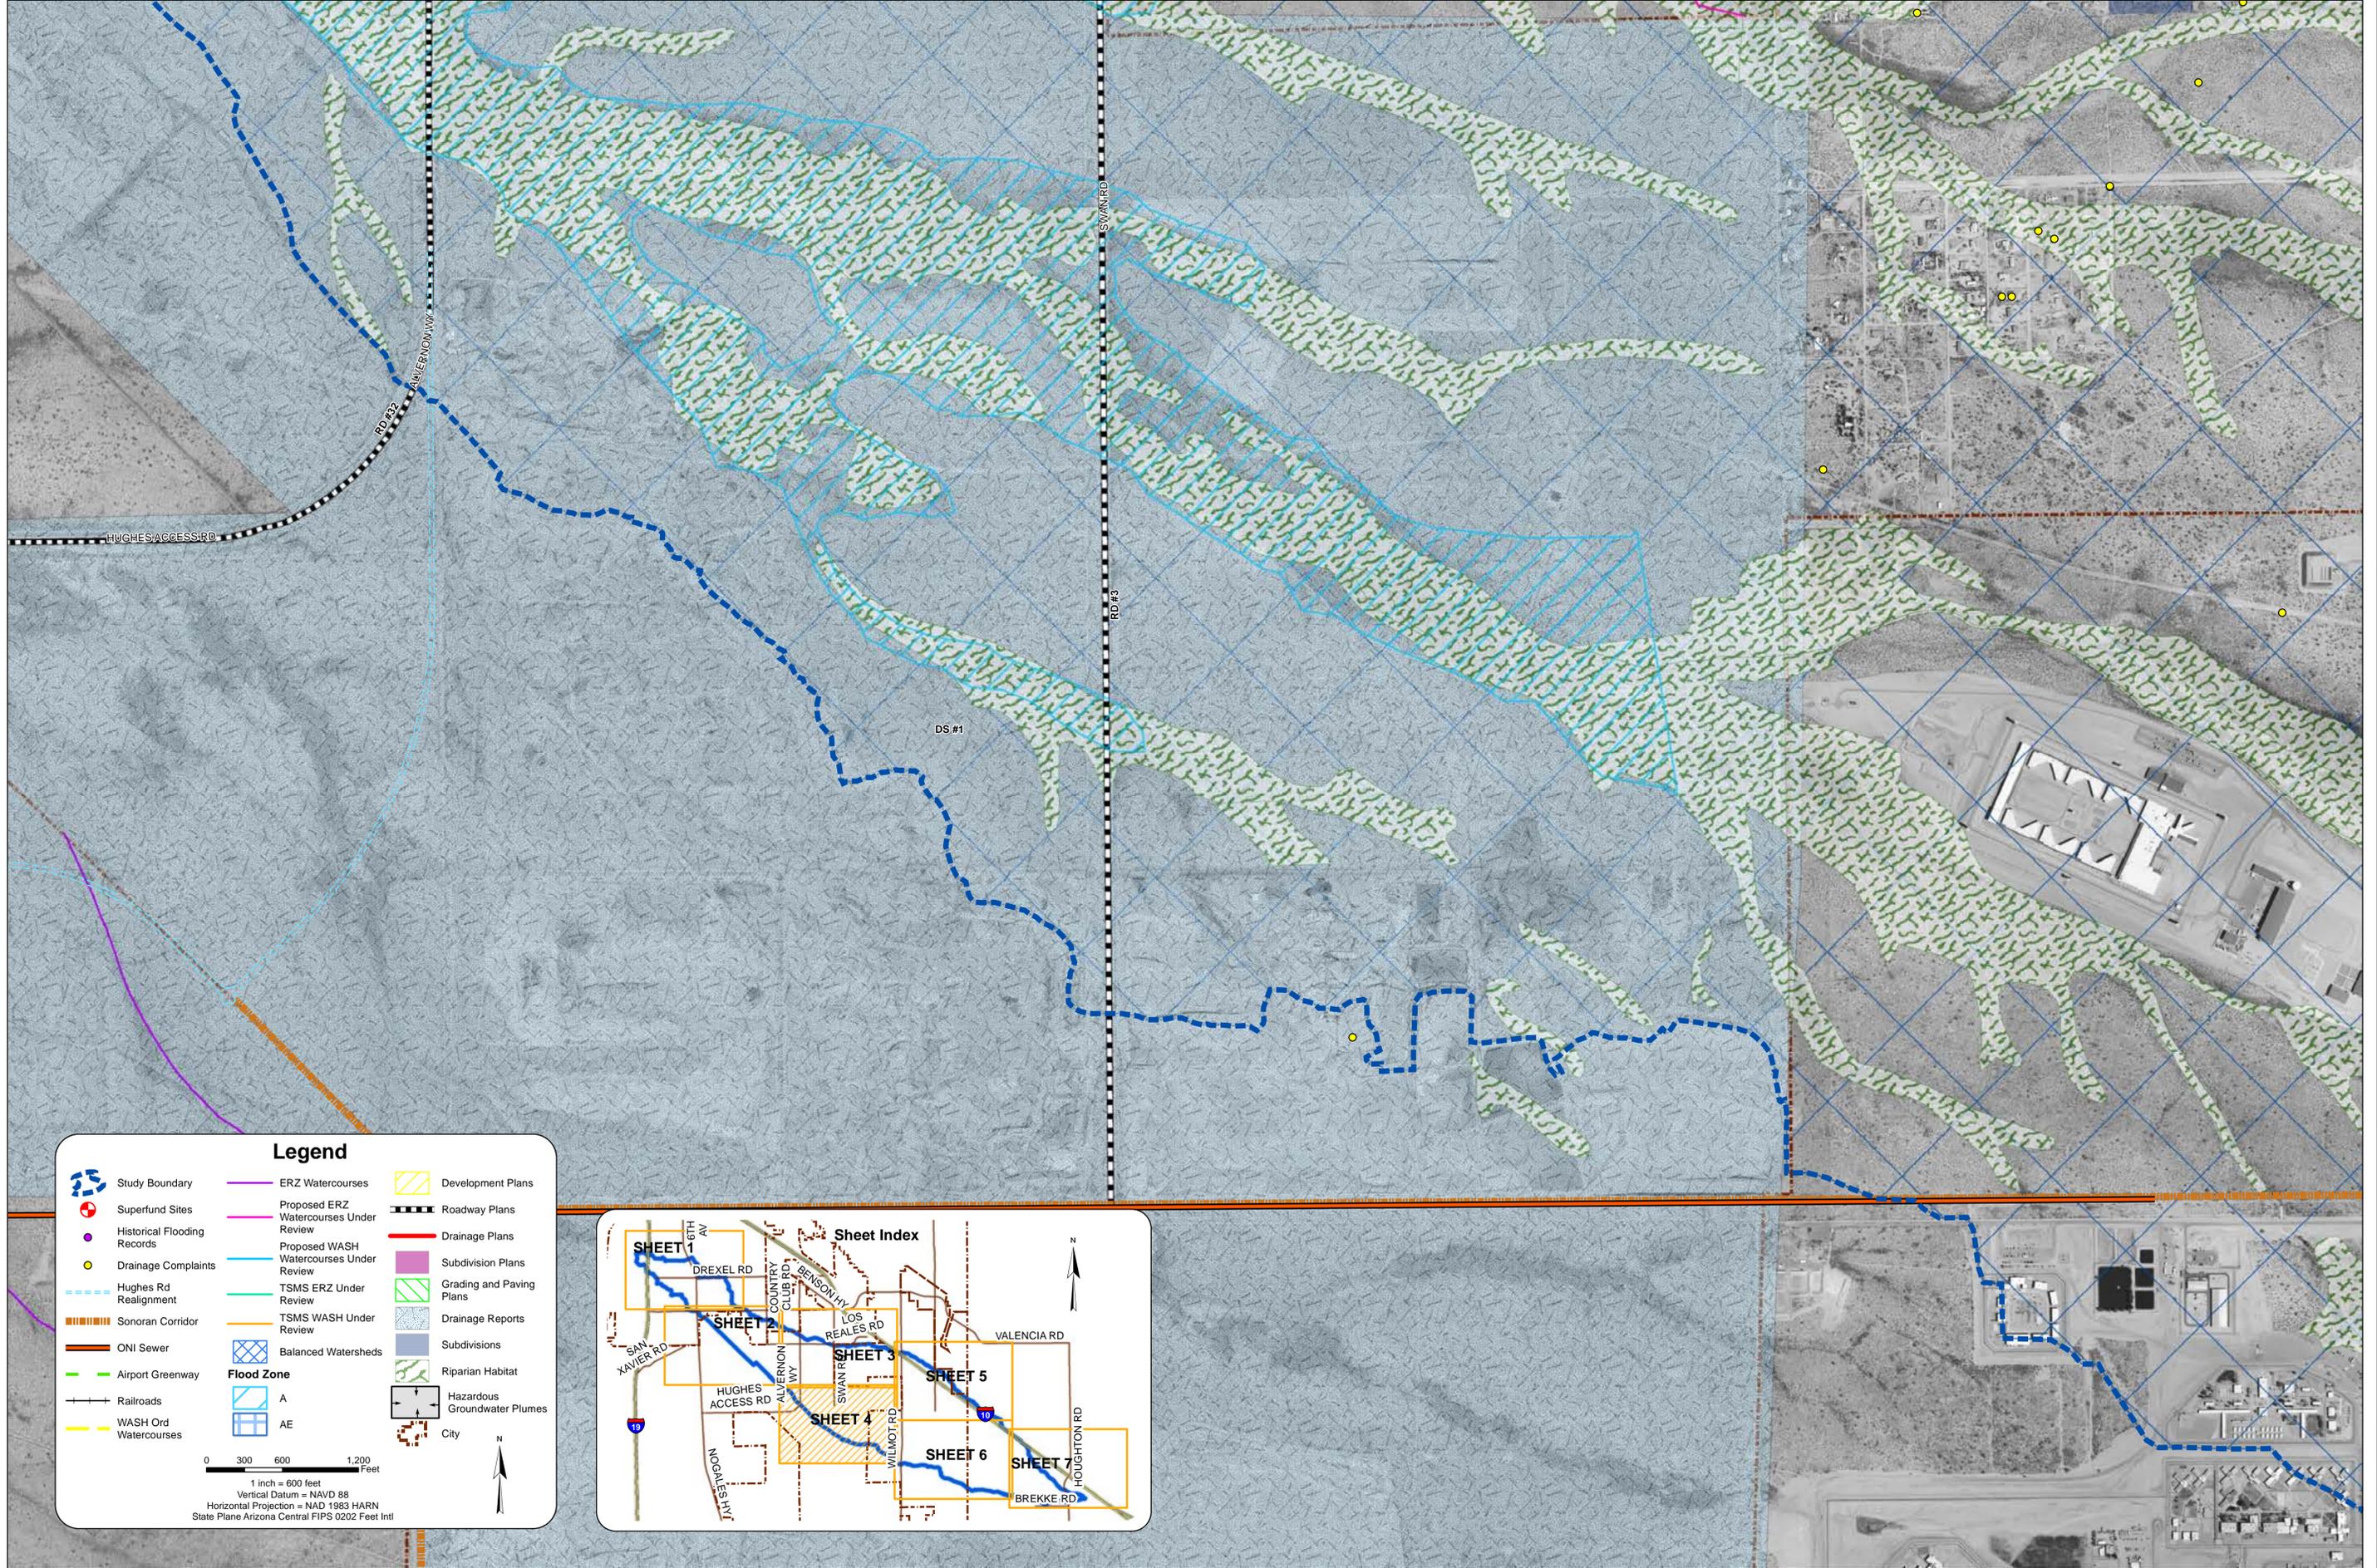
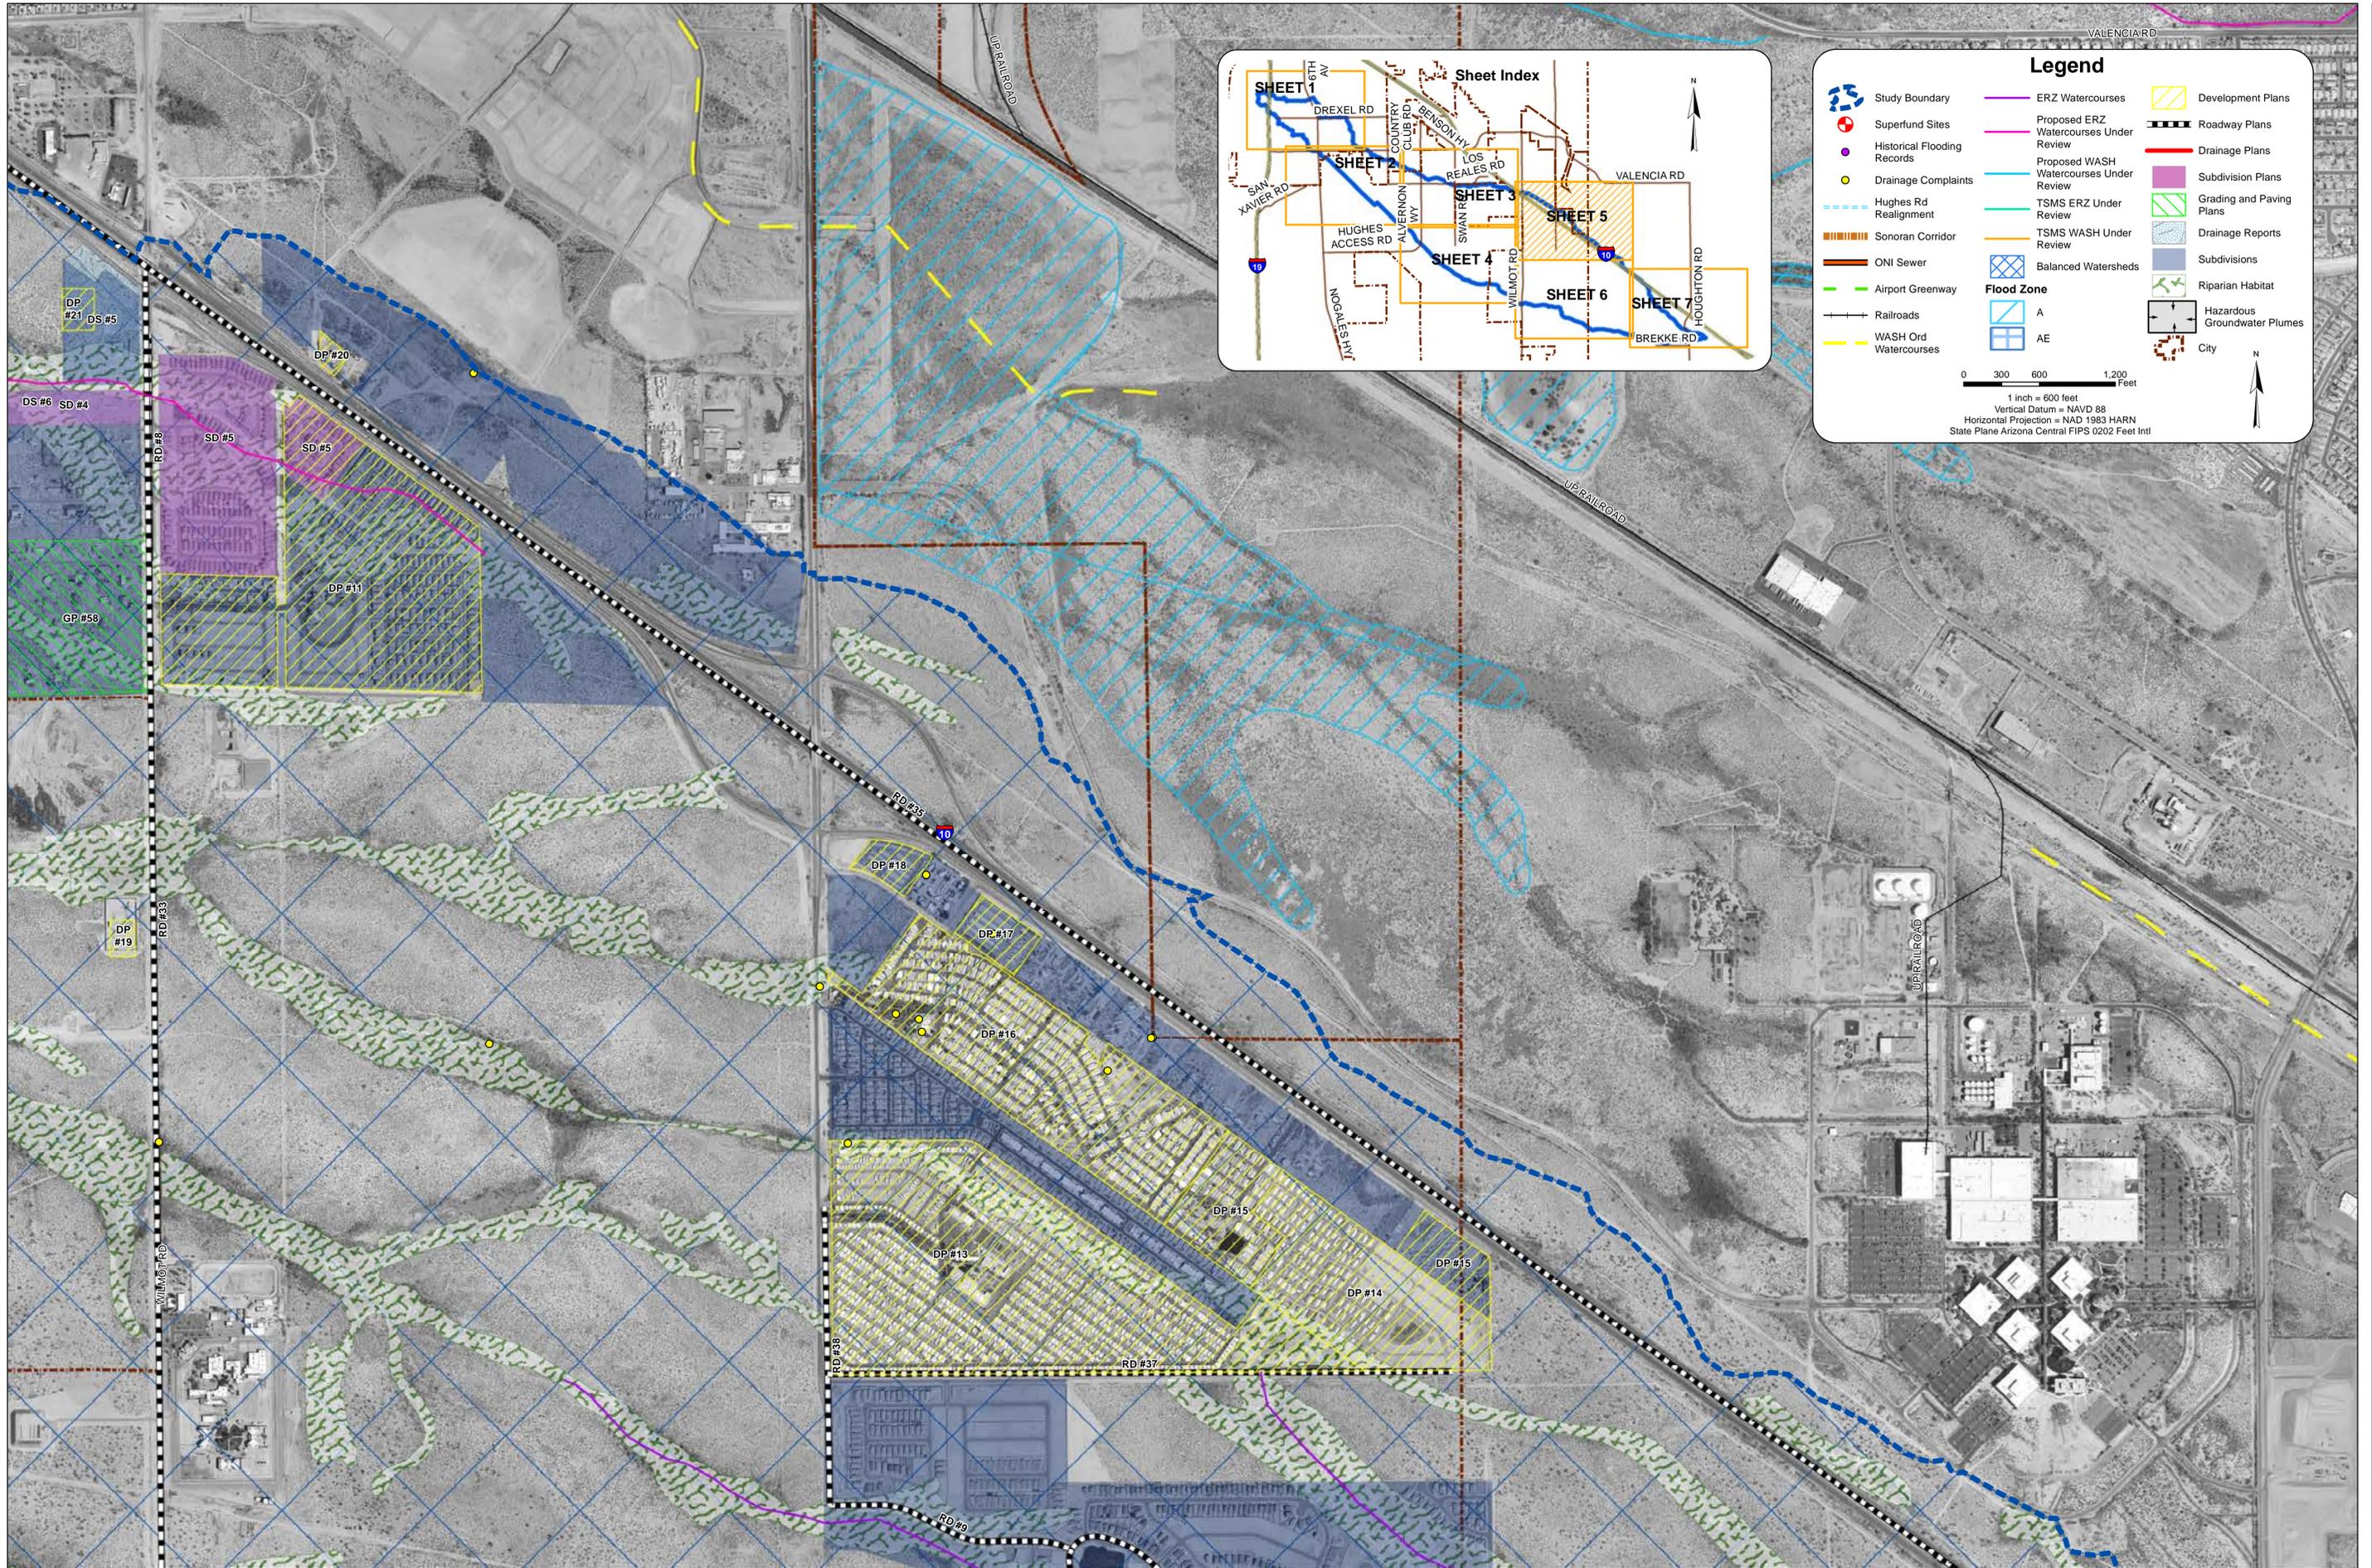
Figure 7 – Data Collection Exhibit

Drainage complaints, compiled between 1983 and 2014 by the City of Tucson and Pima County, were reviewed to determine if the complaints correspond with existing issues. Reviewed drainage complaints include paper records and electronic databases, with paper complaints dated from 1983 to 2005 and electronic records dated from 1989 to 2014. Drainage complaints below were collected by the City. County drainage complaints were too extensive to include in this report and are documented in **Appendix B**. Locations of drainage studies and flooding concerns can be found on **Figure 7** in **Appendix A**.

Environmental conditions including ERZ and WASH Watercourses, Balanced/Critical Basins, and Riparian Areas are shown on **Figure 7** in **Appendix A**.
