FINAL EXISTING CONDITIONS REPORT

Airport Wash

BASIN MANAGEMENT STUDY PHASE 2

FINAL EXISTING CONDITIONS REPORT
AIRPORT WASH BASIN MANAGEMENT STUDY
PHASE 2

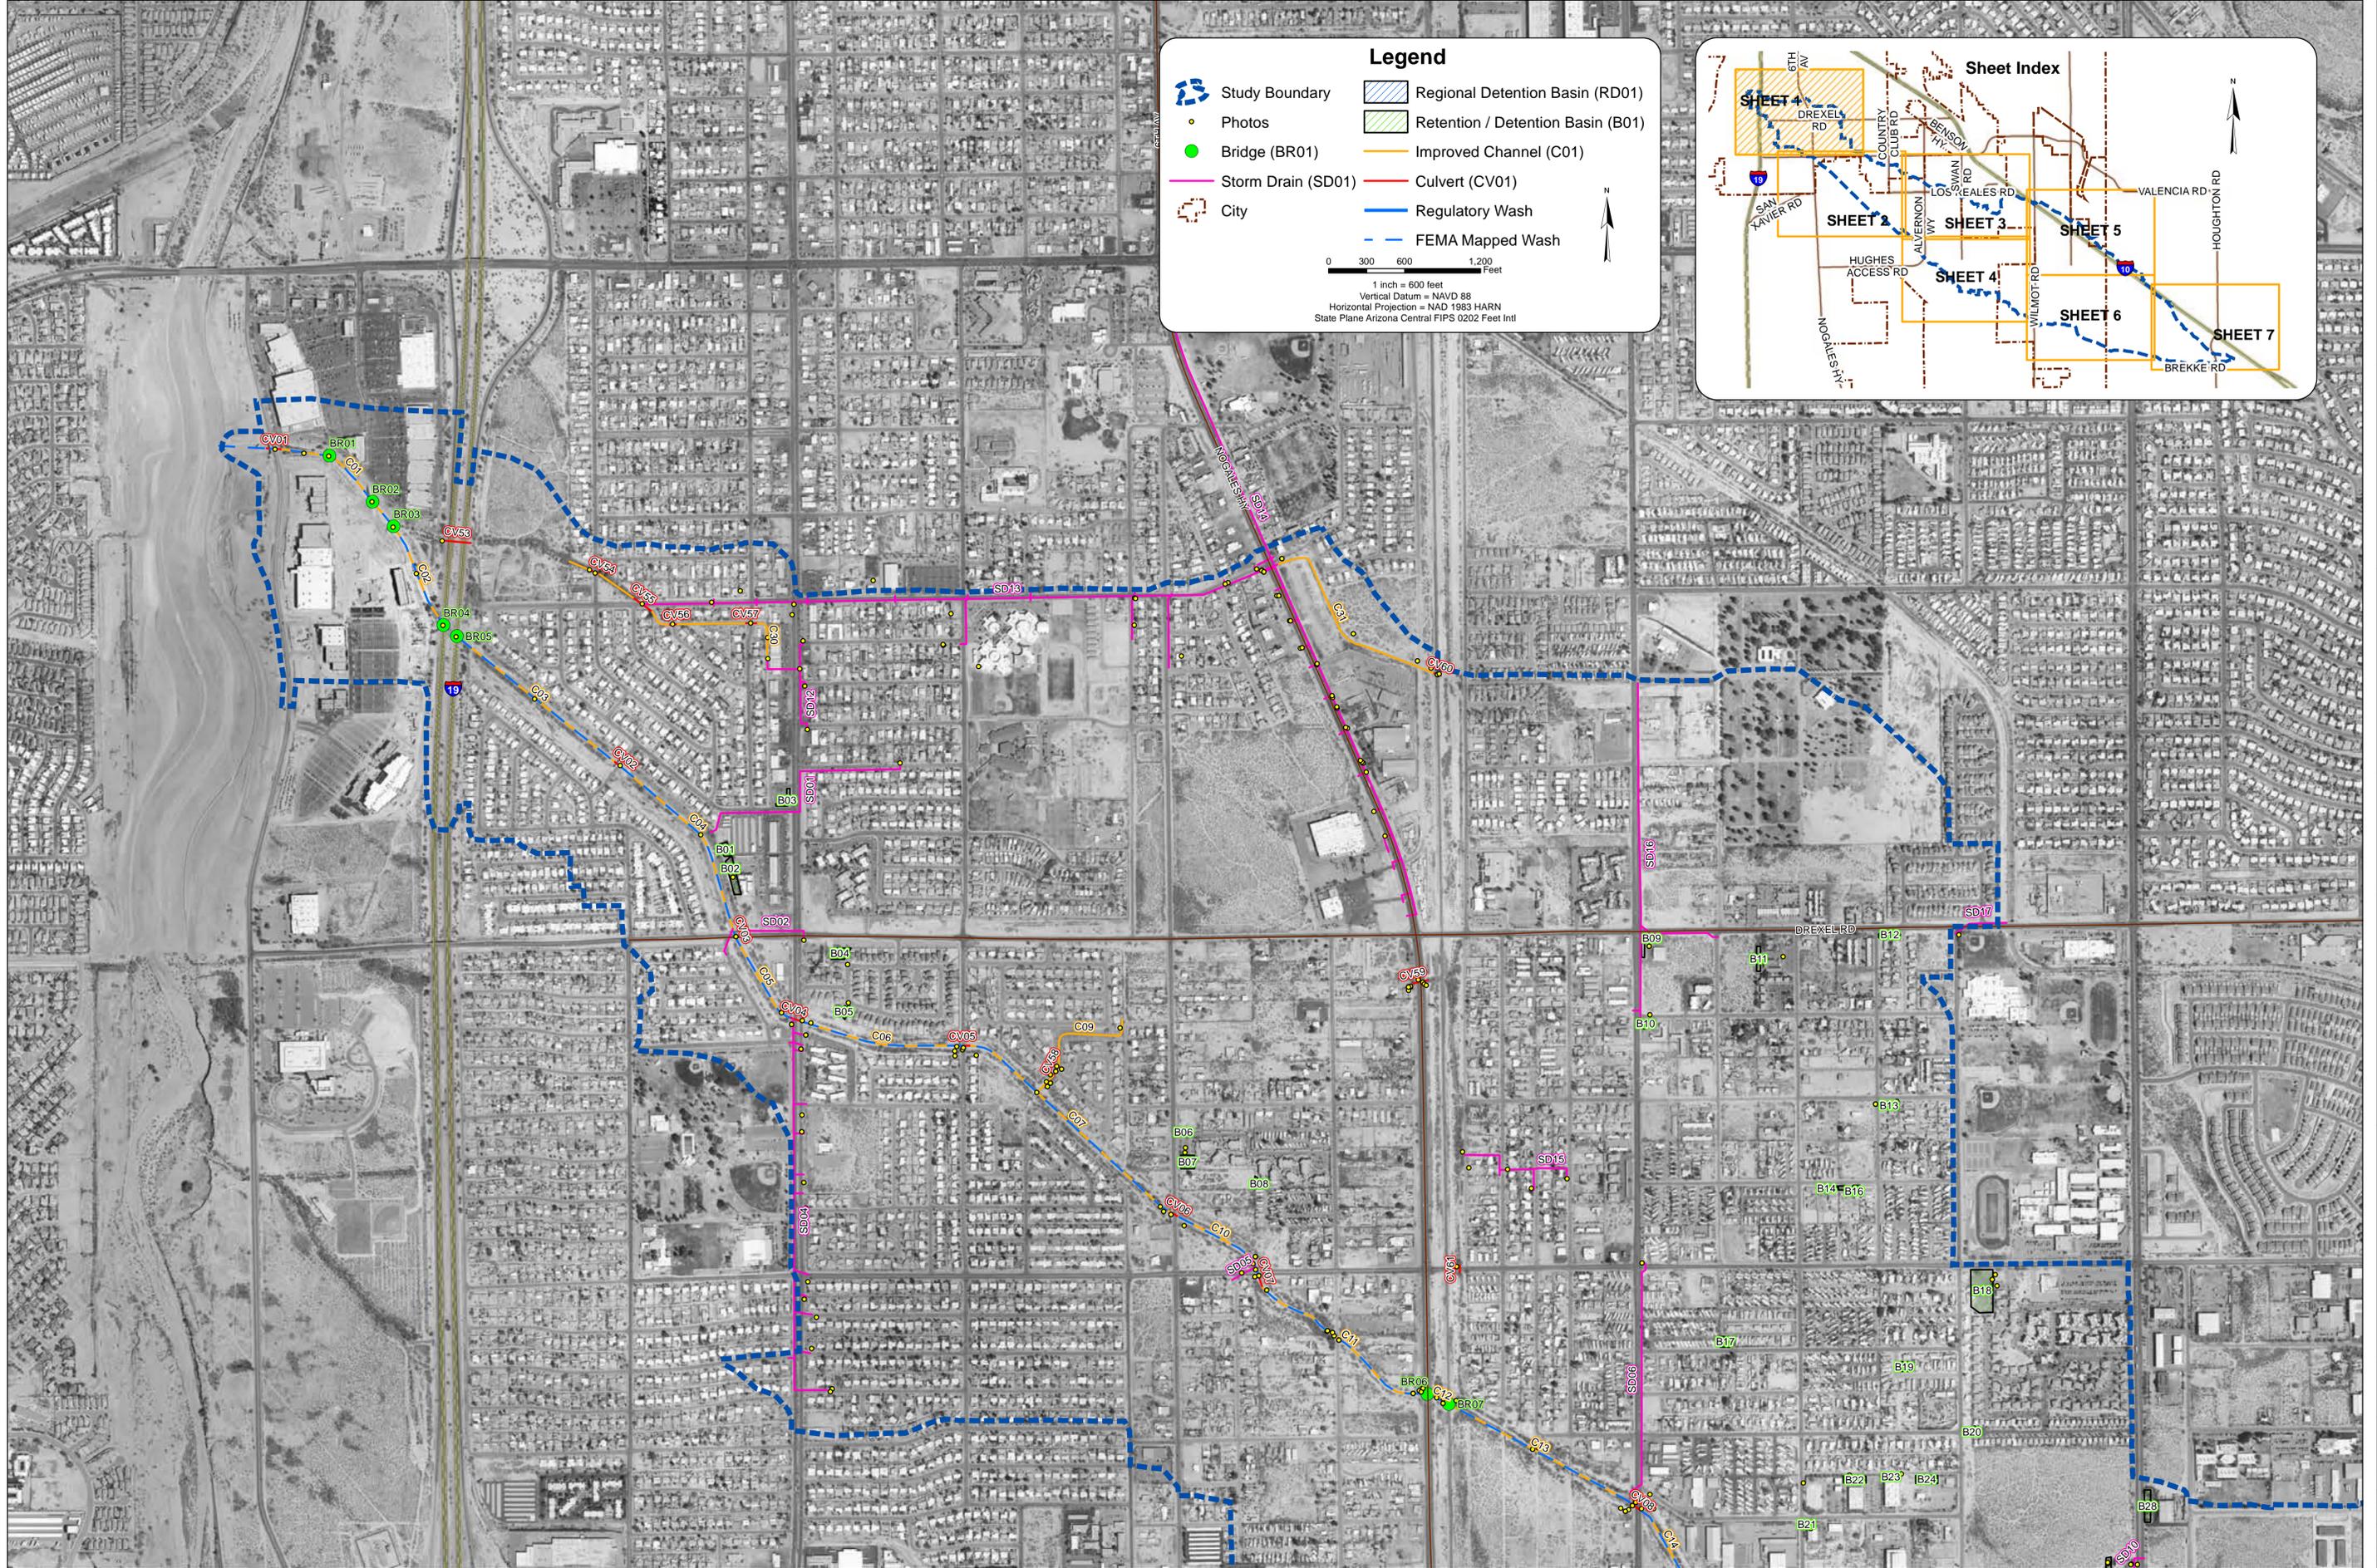
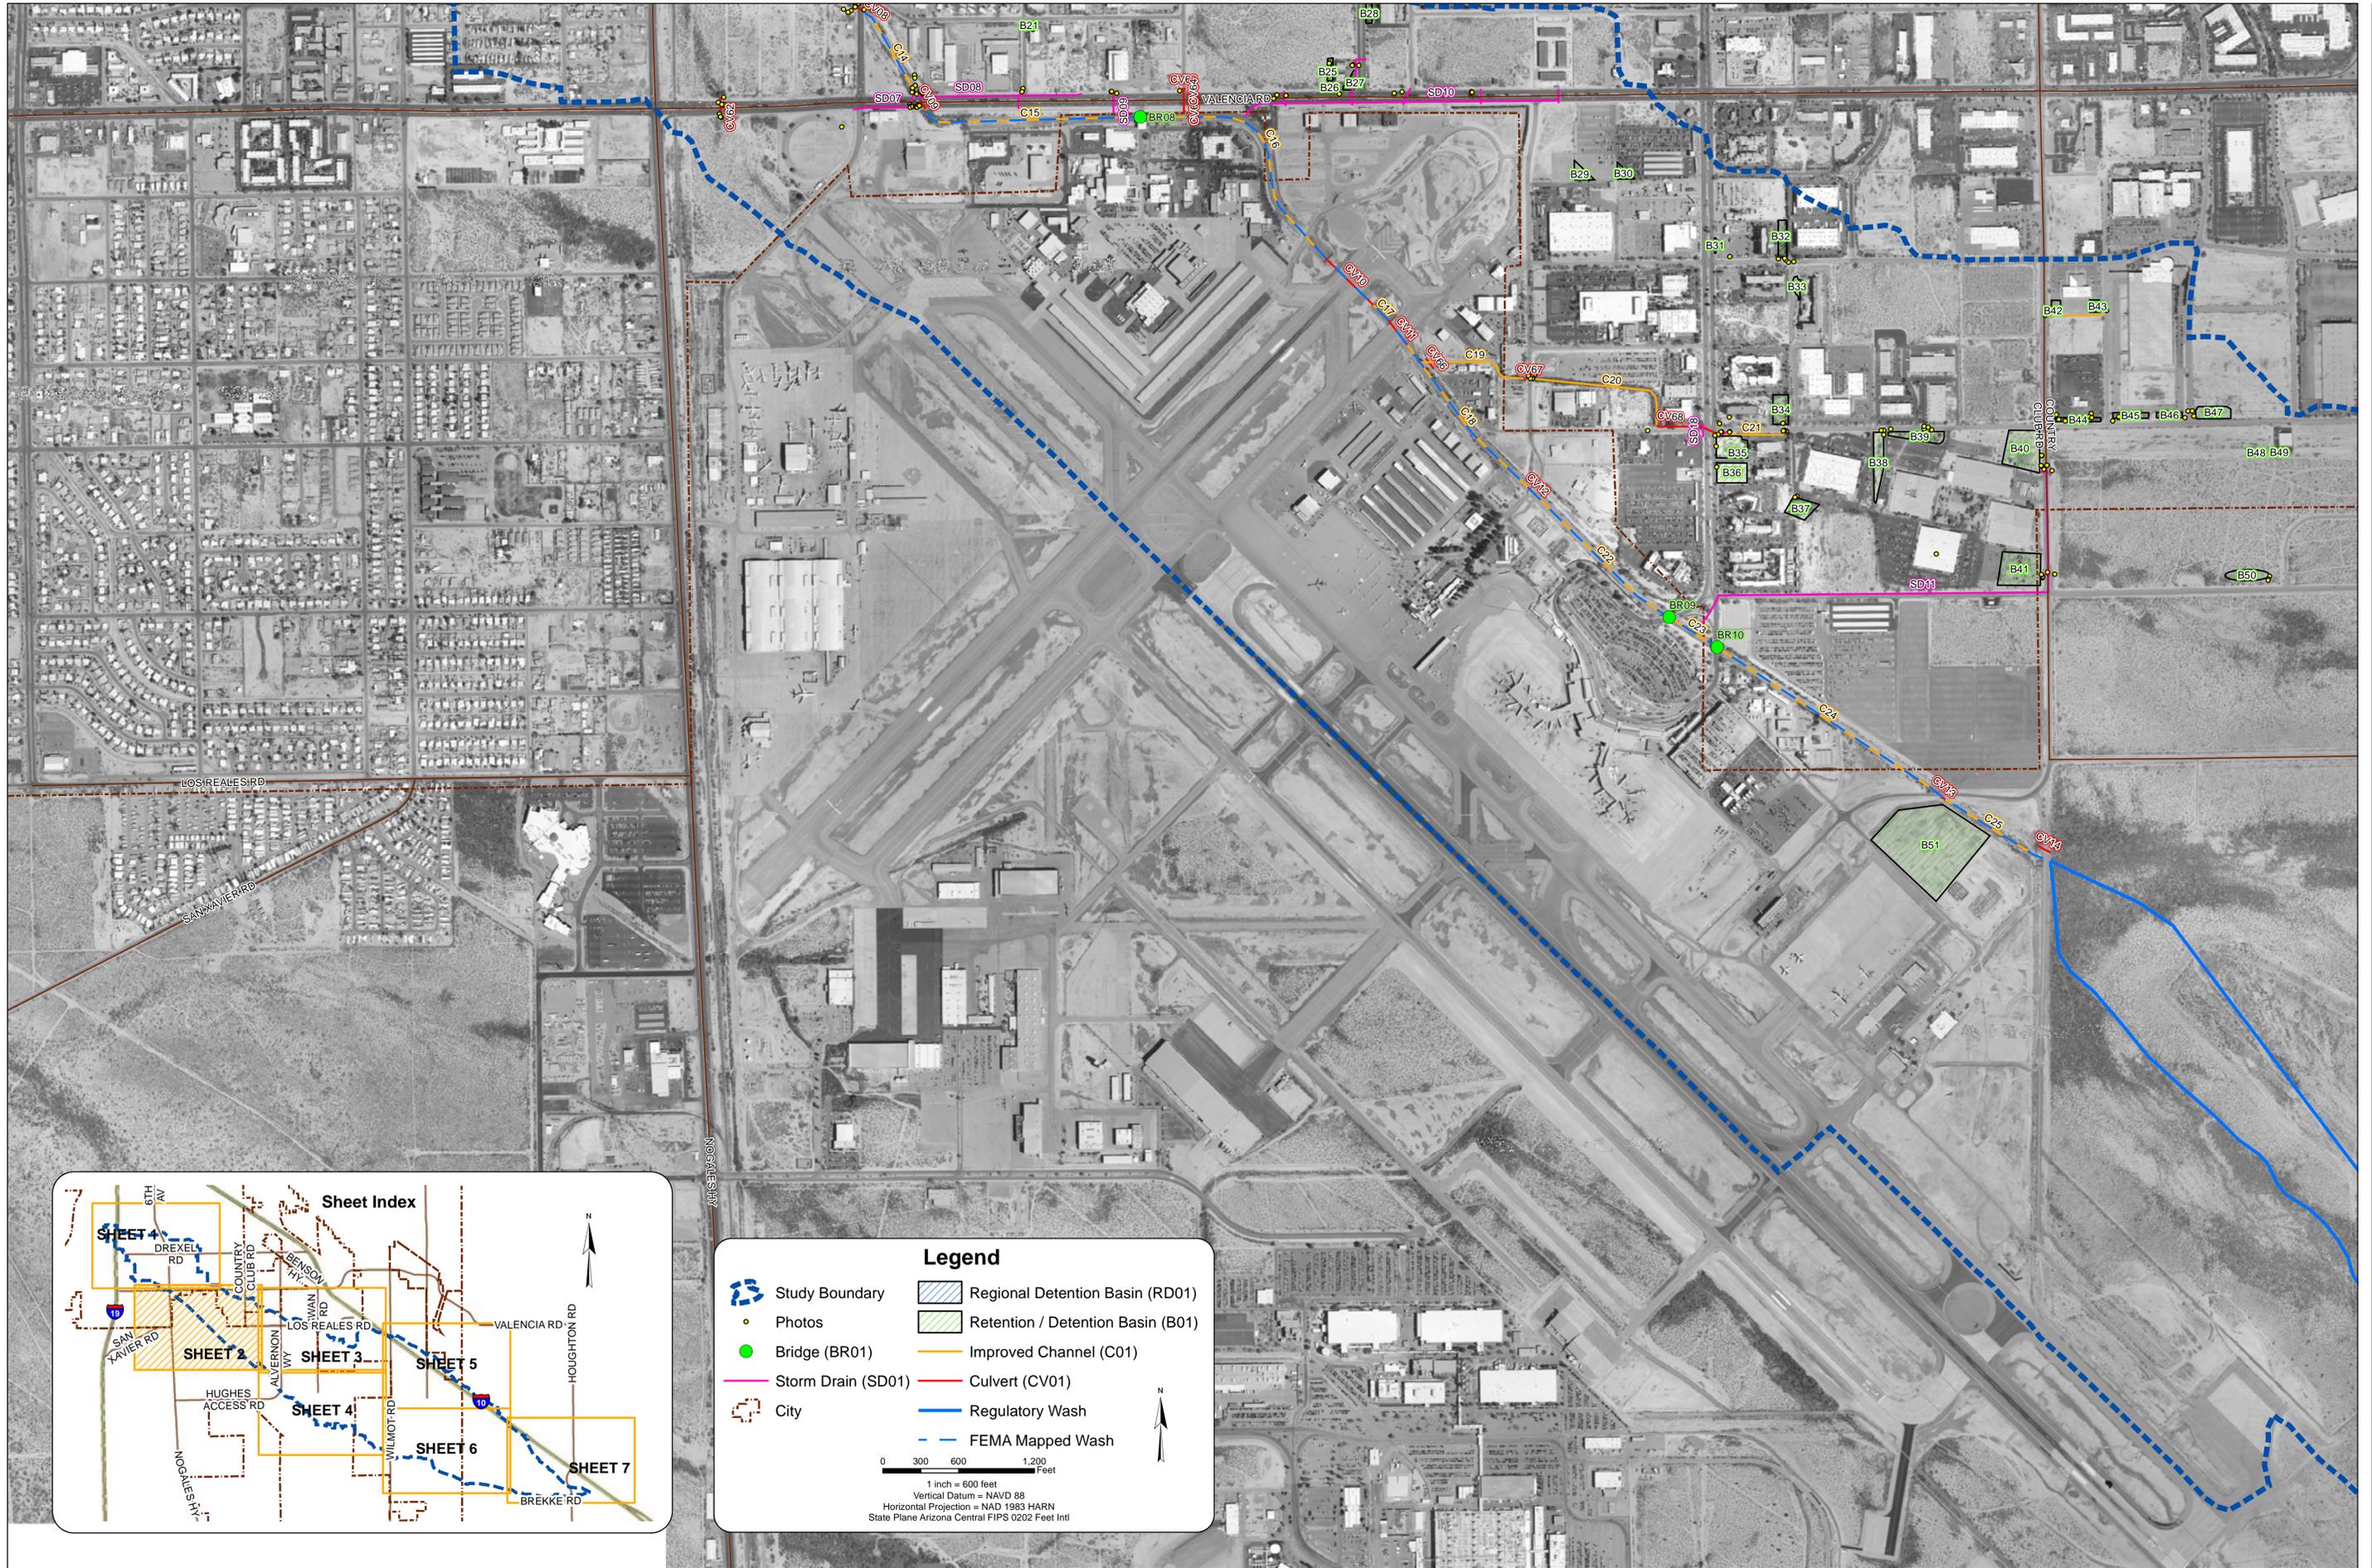
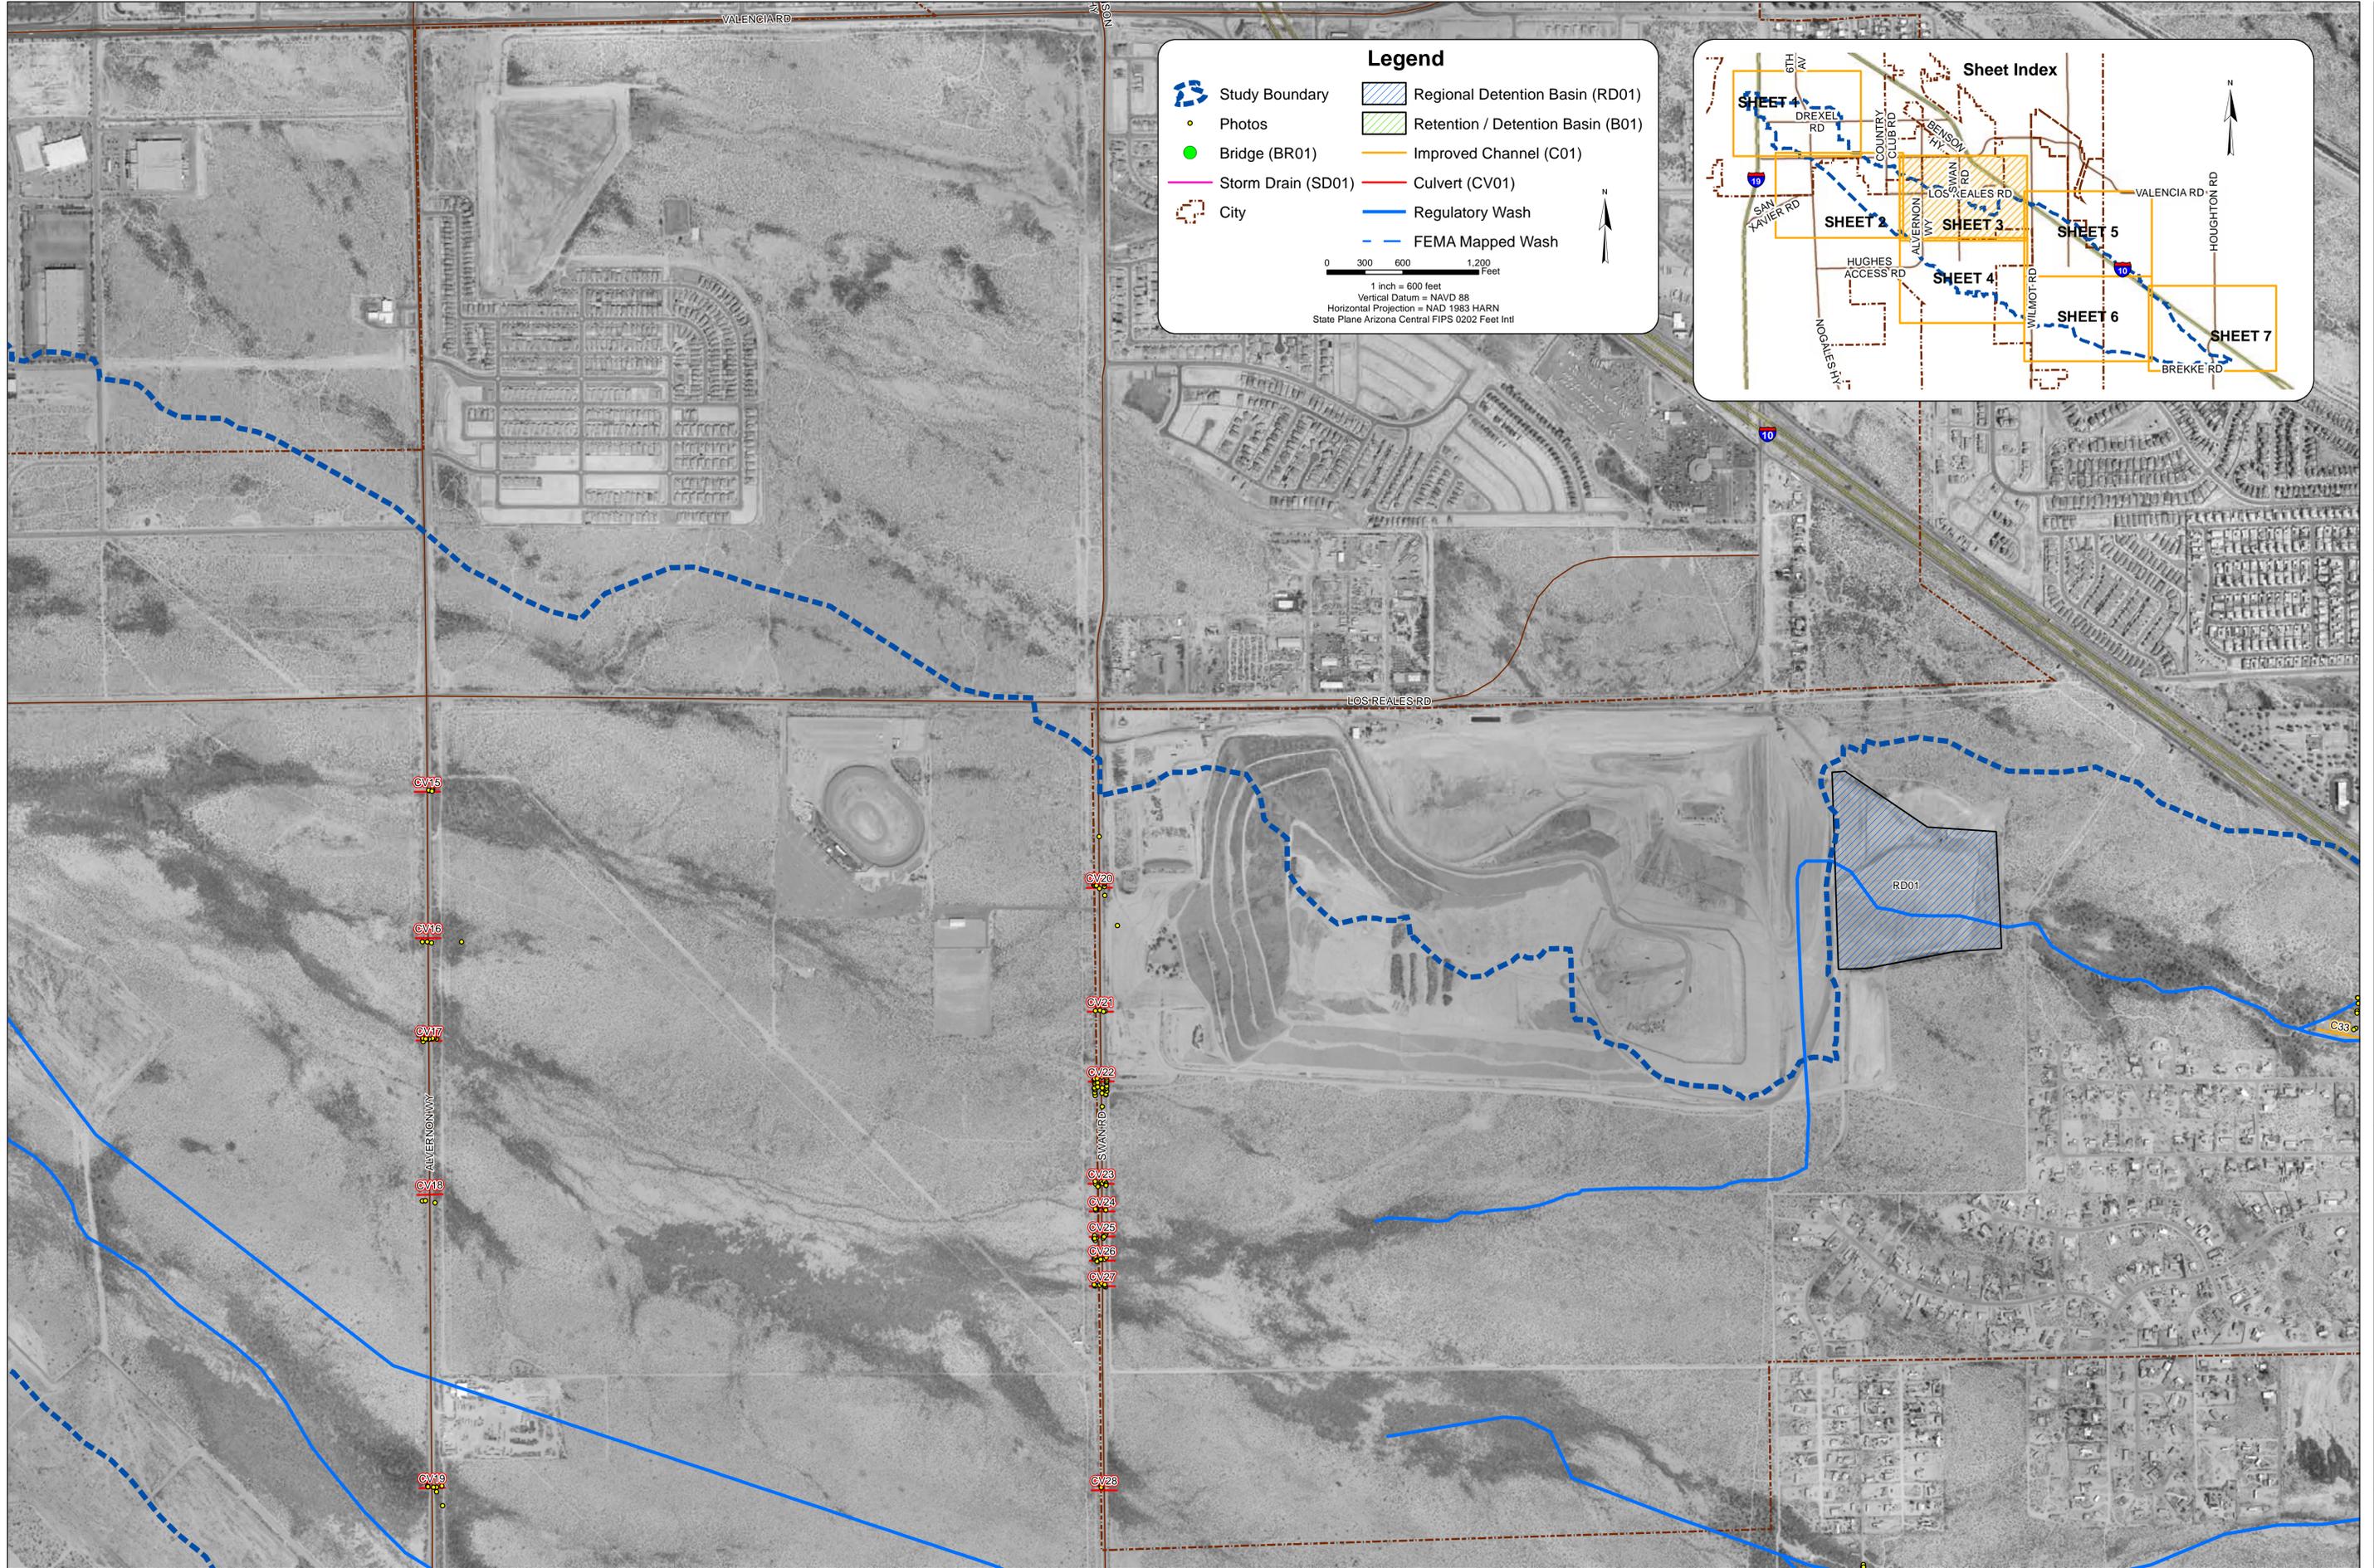
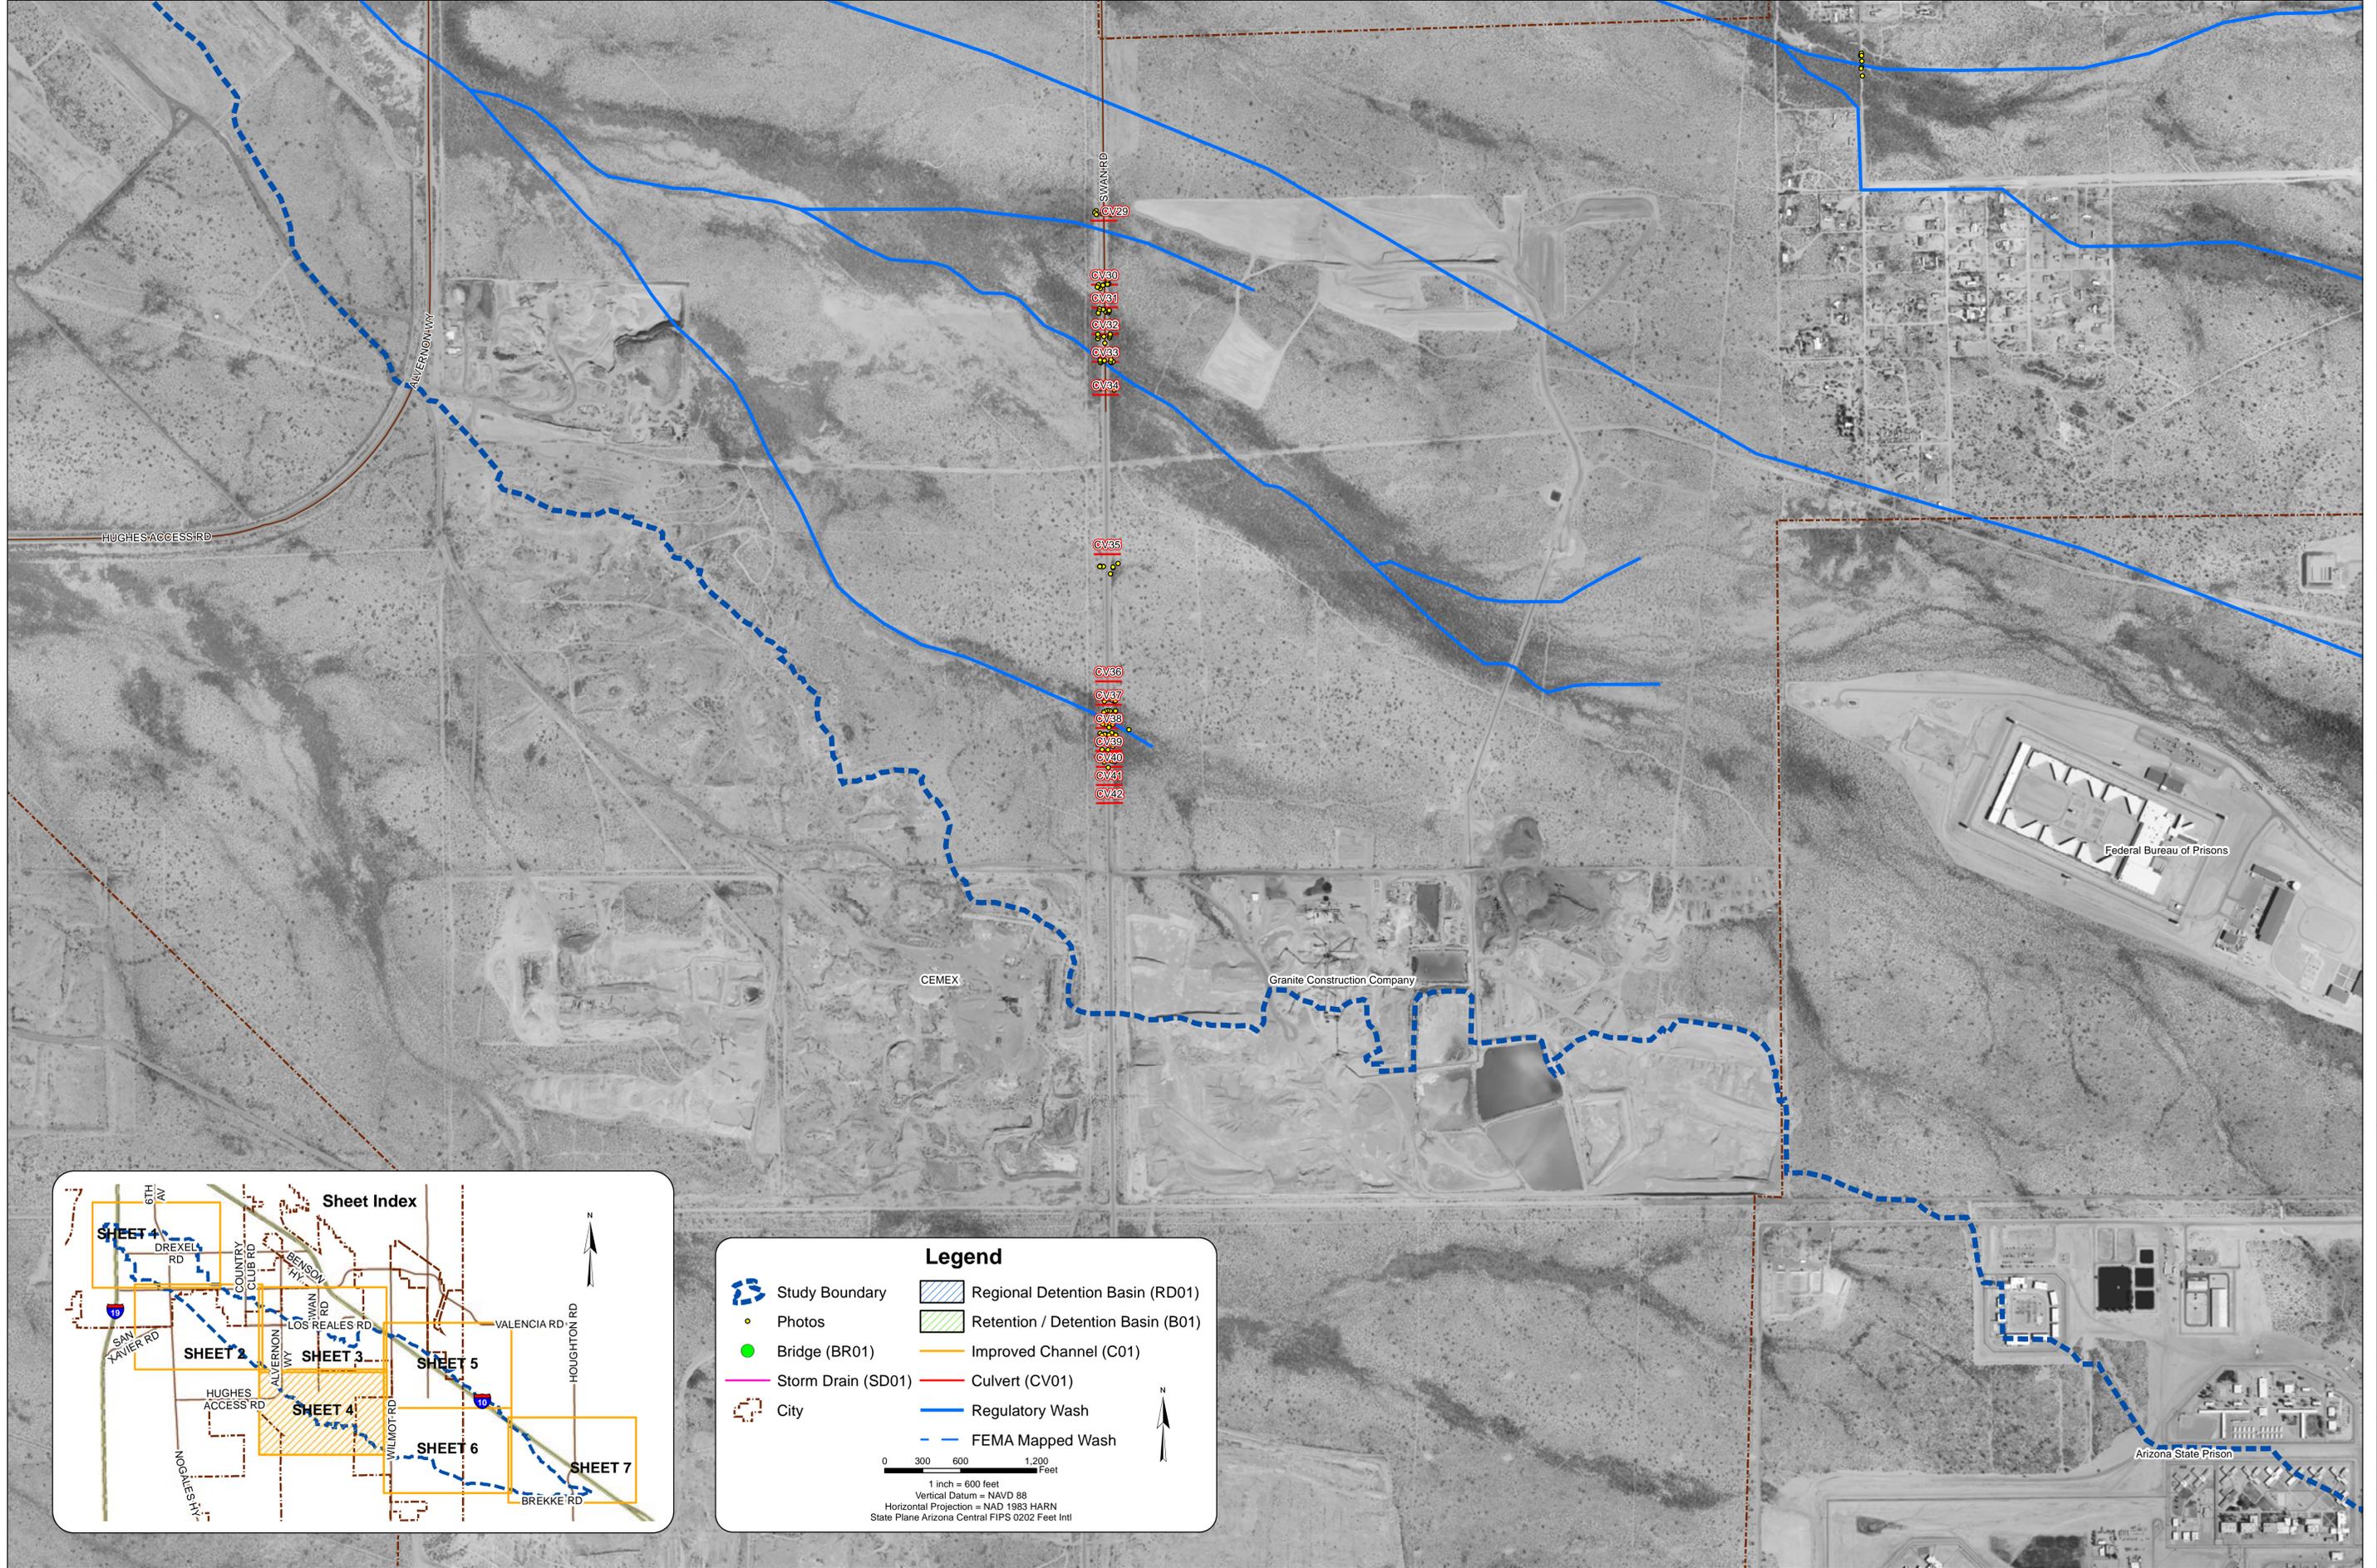
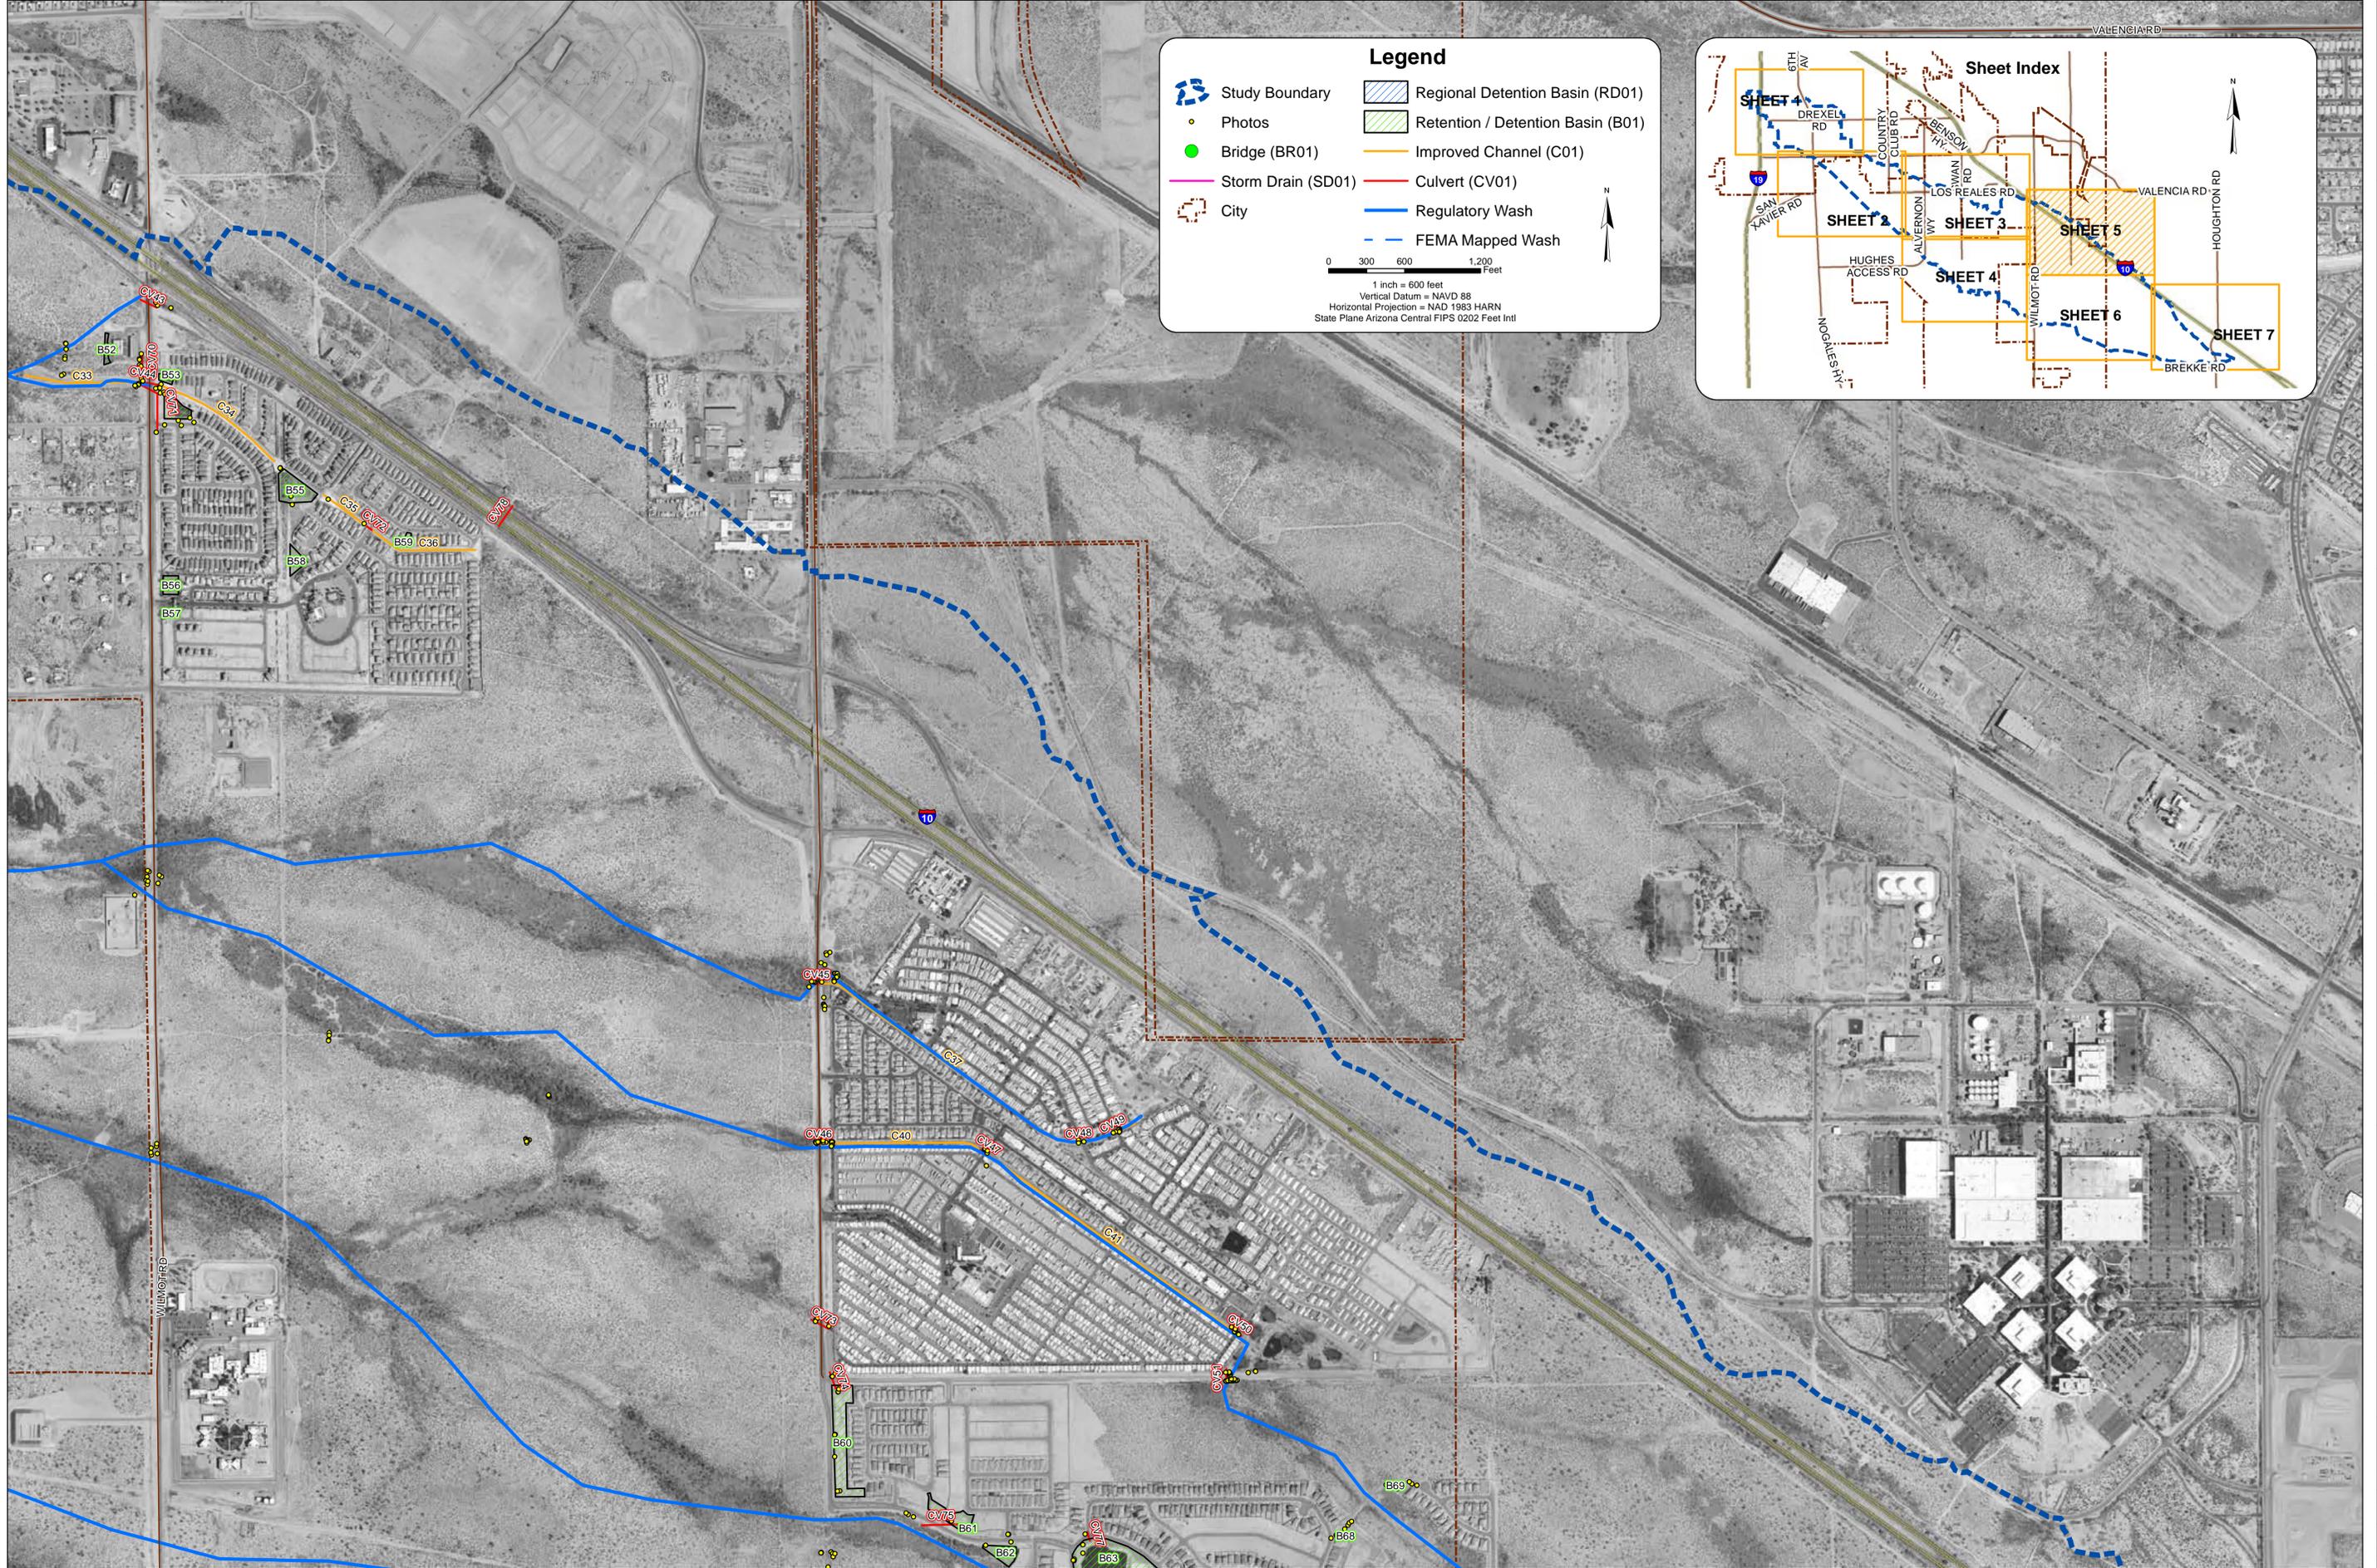
Figure 8 – Drainage Inventory Exhibit

Locations of existing drainage infrastructure can be found in **Figure 8** in **Appendix A**. Maintenance concerns at roadway crossings are shown in **Appendix B**.
