Update for Construction Work (11/16/2010) for members of the
Canoa Ranch Community Trust/Oversight Committee of the Pima County
Board of Supervisors

Simon Herbert
Pima County Office of Cultural Resources and Historic preservation

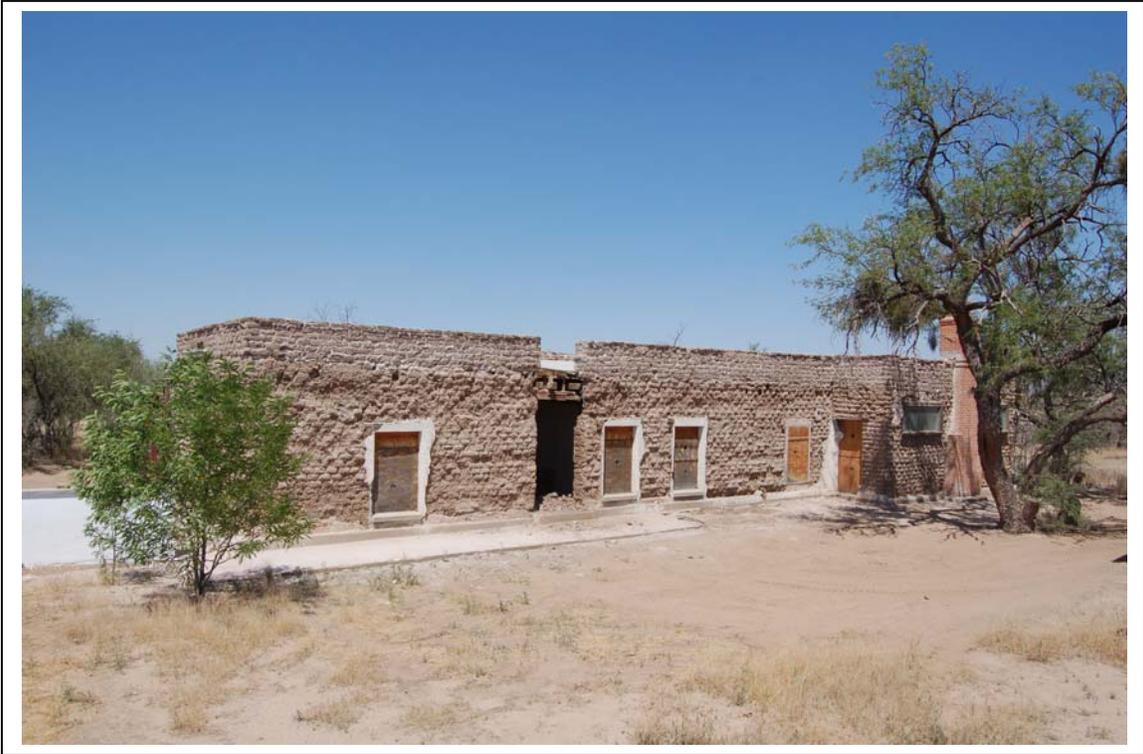
Building 110 after removal of plaster

- Replace roof framing and install new roof surface, drain-ways, scuppers and canales.
- Install new wall cap and flashing
- Remove surface plaster to elicit numerous structural repairs to wall
- Rebuild fireplace
- Remove half of slab under porch and re-pour concrete.
- Re-level all porch posts, repair roof decking and install new fiberglass shingles
- Install new screens on full length of porch, repair both ends of porch screen
- Fill-in windows on east end of south wall
- Re-level walls with earthen plaster and re-coat "pebble-dash".
- Repair, re-glaze and paint windows and doors
- Trim back trees that have encroached onto building

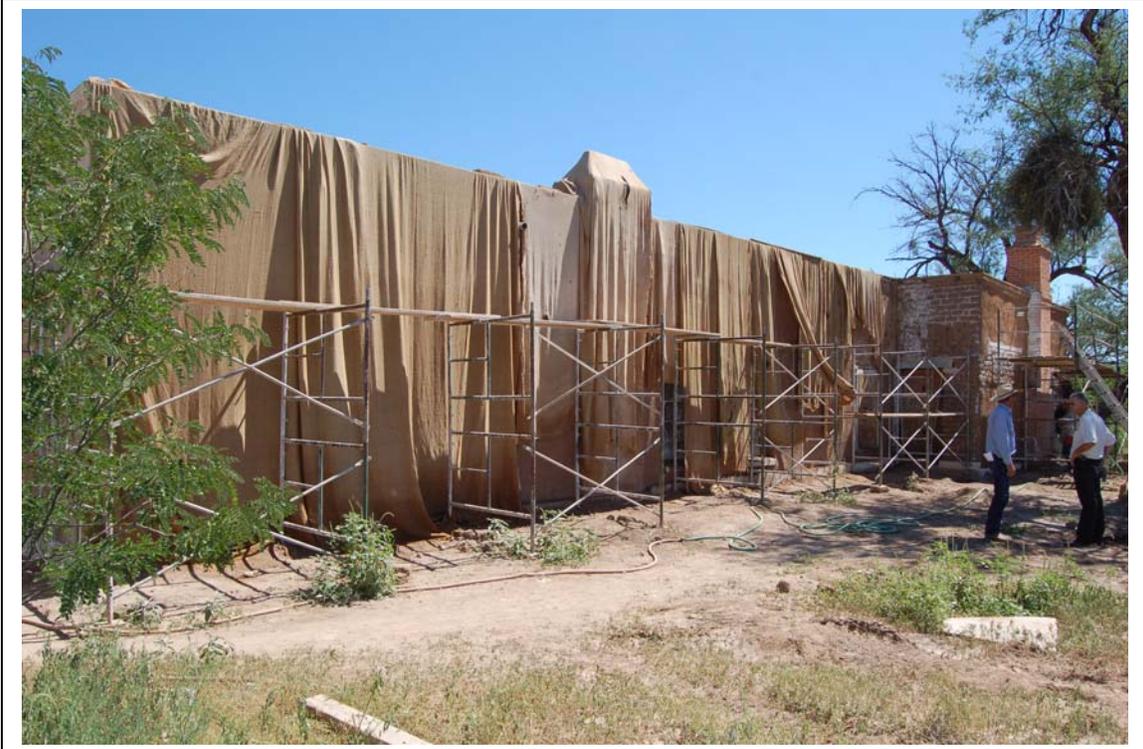
Building 110: Burlap draped over the walls helps with the during the curing process of earthen plaster.

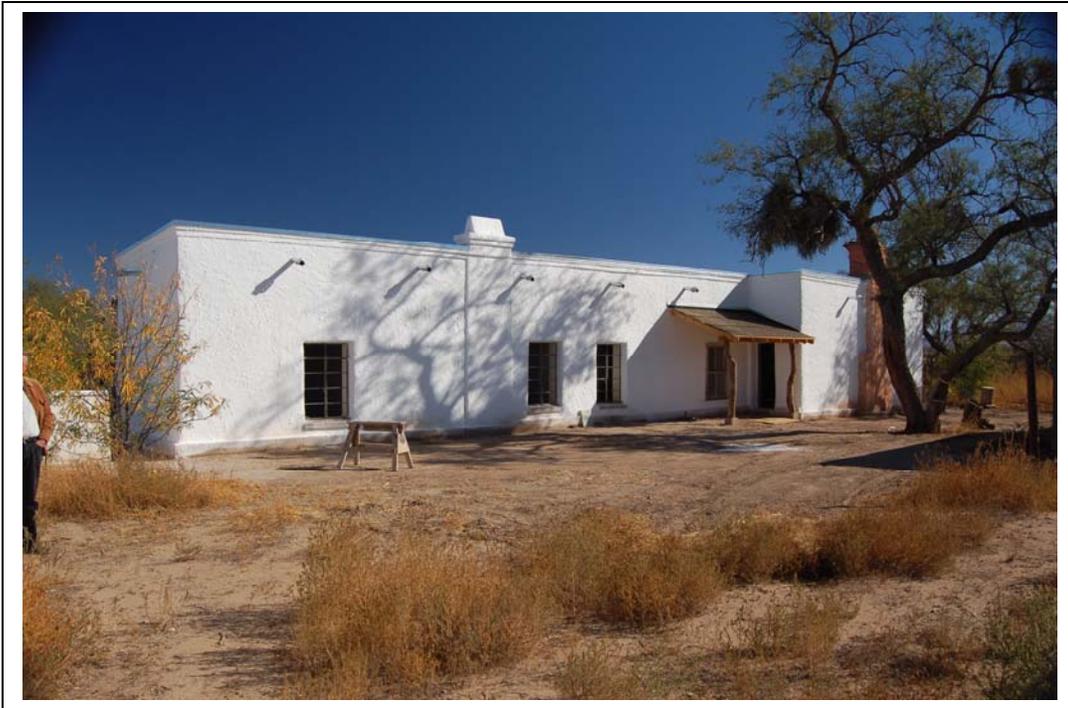
Appearance today of Building 110. Rear Final plaster coat has been installed, and the rear porch reconstructed

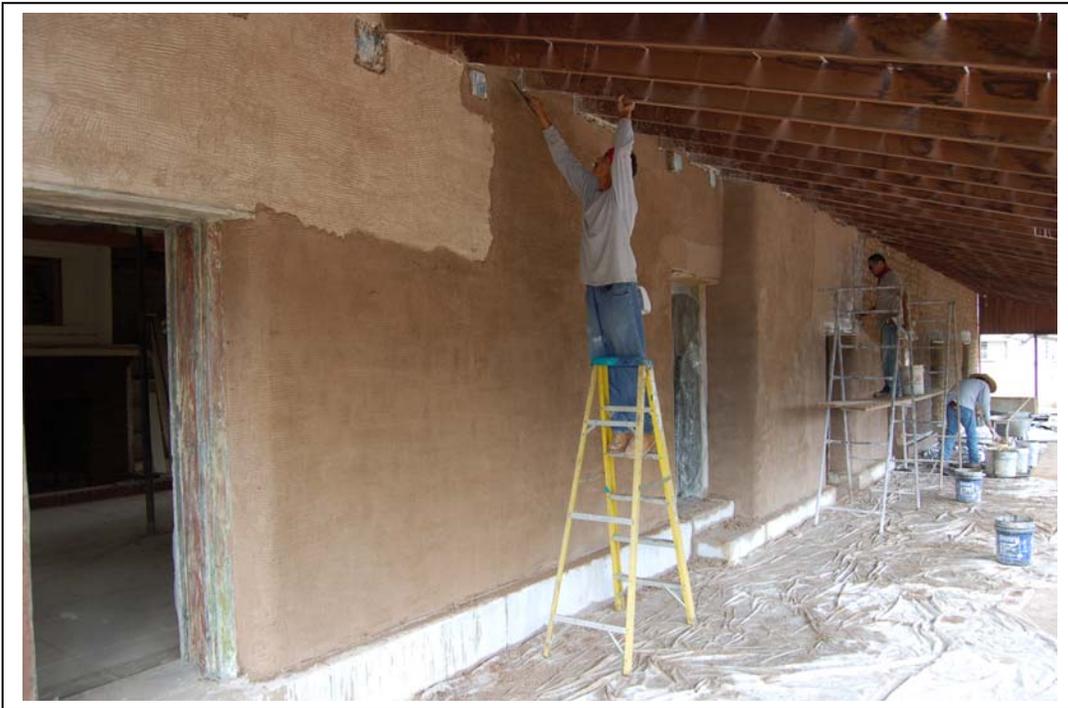
Repairing earthen plaster wall under porch of 110

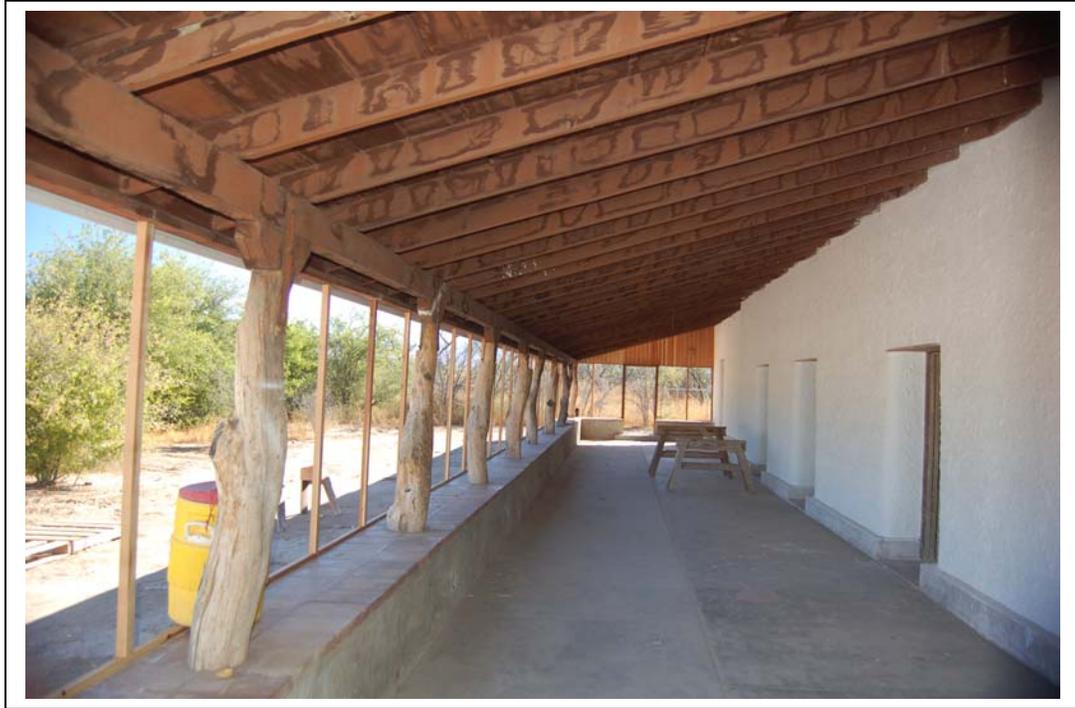
Porch of 110 following leveling, repair, and before painting and installation of screen

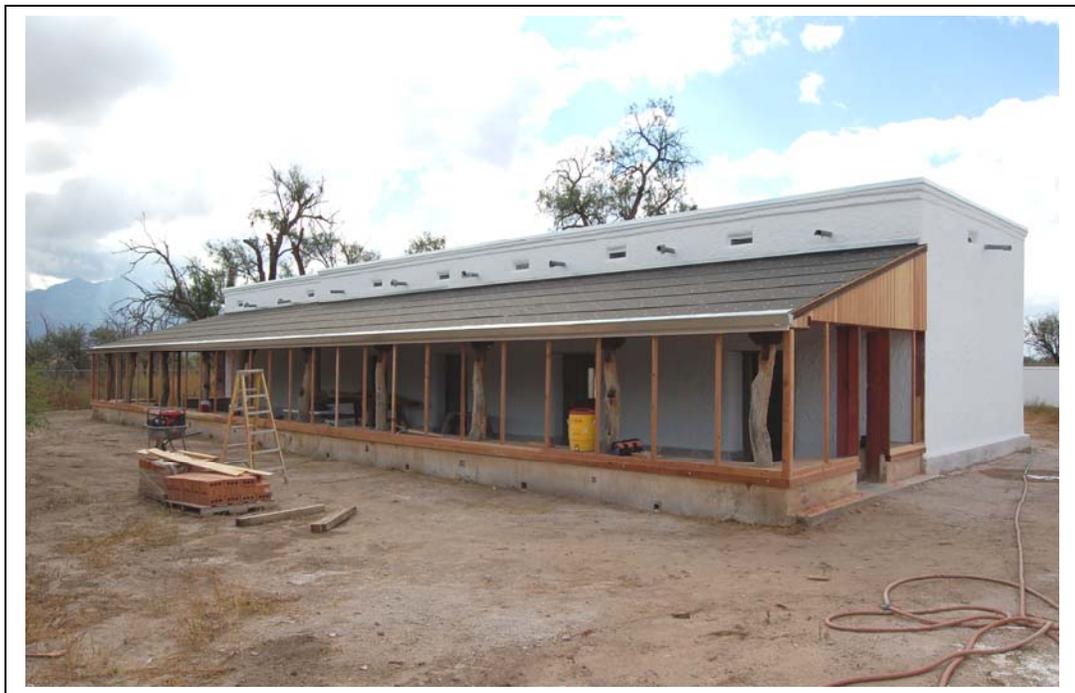
Building 110: Repaired porch before application of roofing shingles

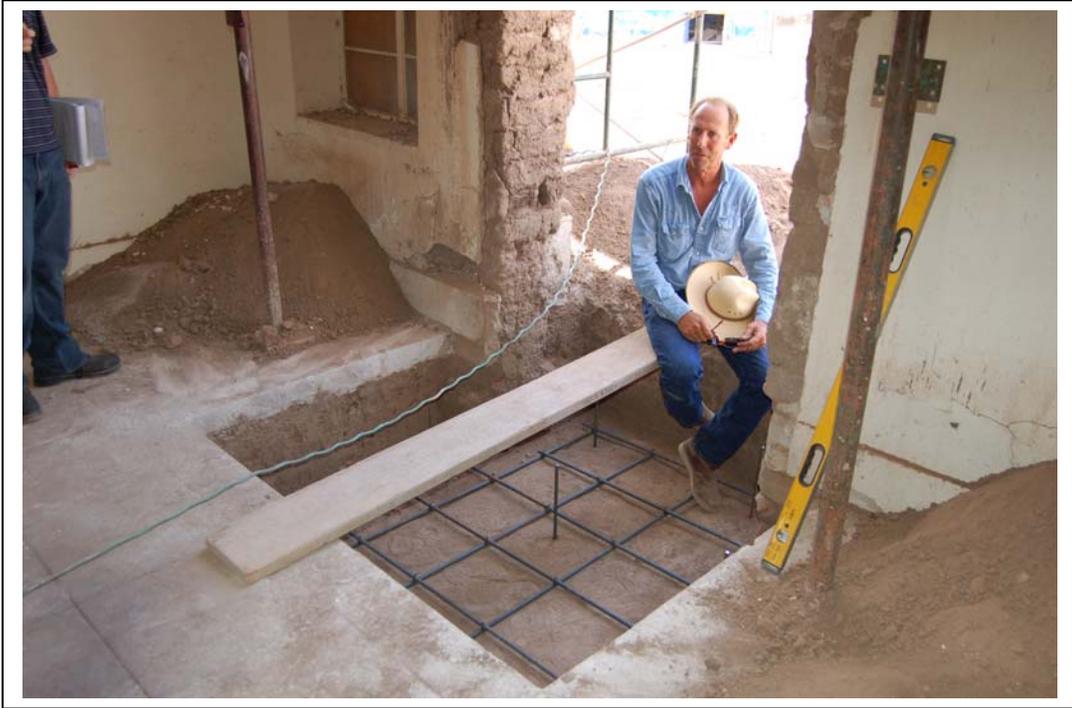
Sub-contractor Randy Oden discusses progress of new foundation for chimney on Building 110

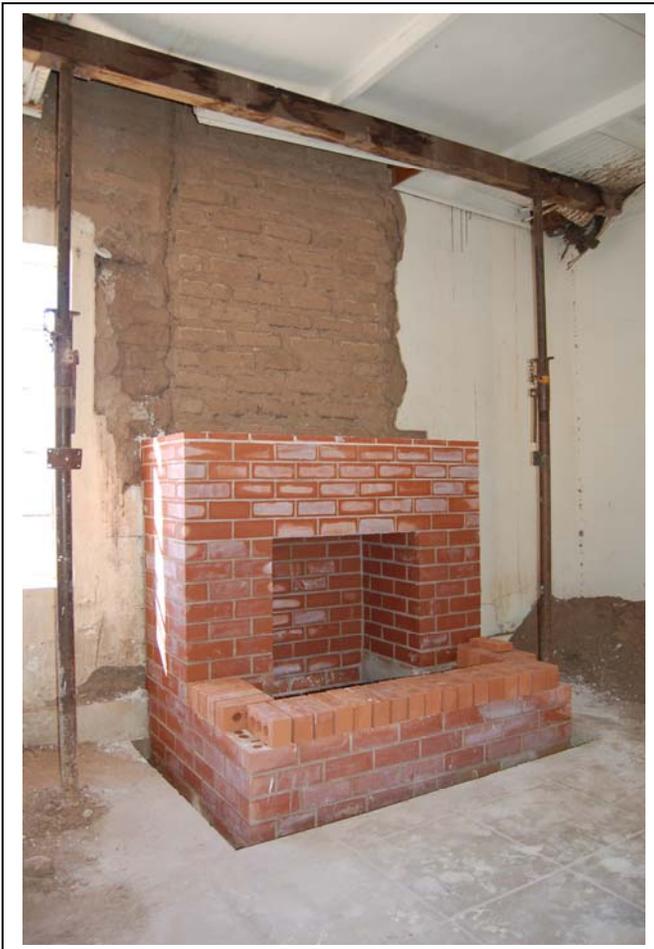
New chimney inside Building 110 nearing completion

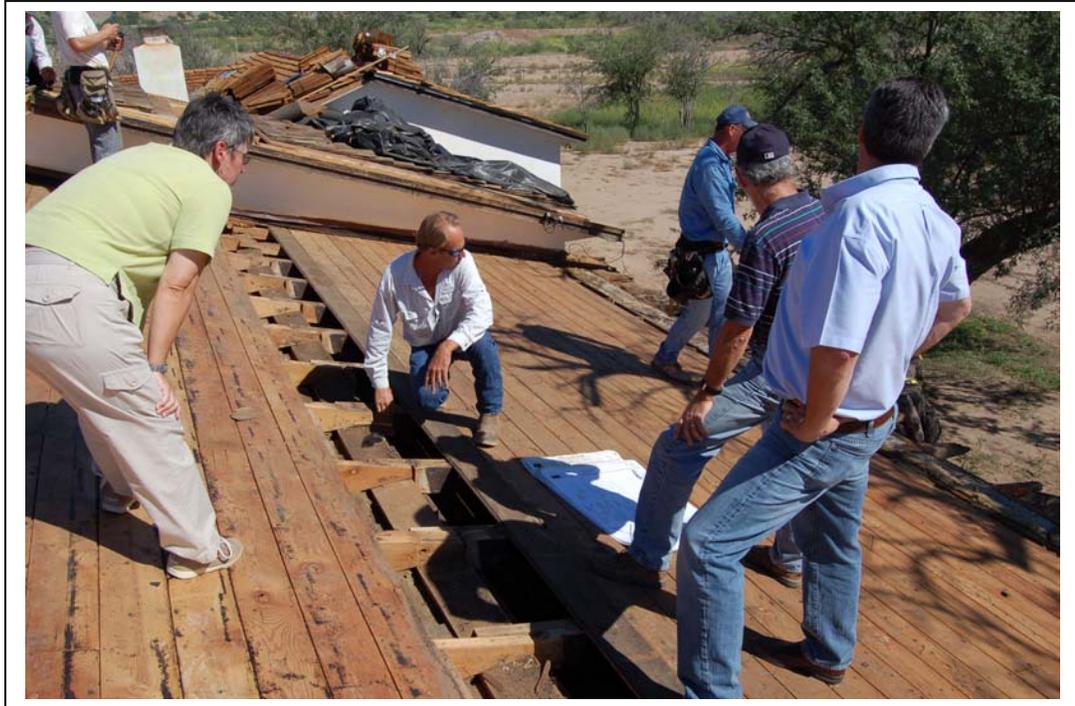
Discussion of roofing issues on Building 101

- Remove existing wood shakes, repair decking, and replace flashing
- Install roof membrane and new wood shakes to match original
- Reinstall guttering and downspouts
- Remove vegetation deemed too close to building, trim trees
- Additional repair work to sunroom of Bldg 104 following discovery of extensive rot in supporting beam and posts. Includes removal of entire roof of sunroom and replacement in-kind

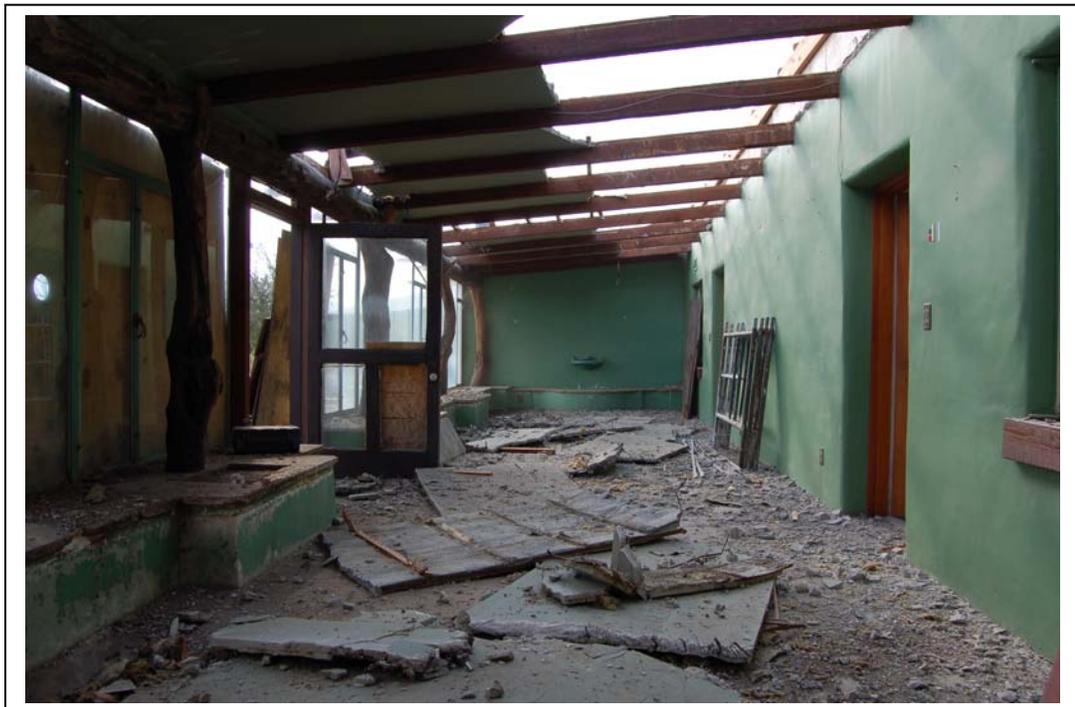
Building 104. Sunroom roof in process of being taken down

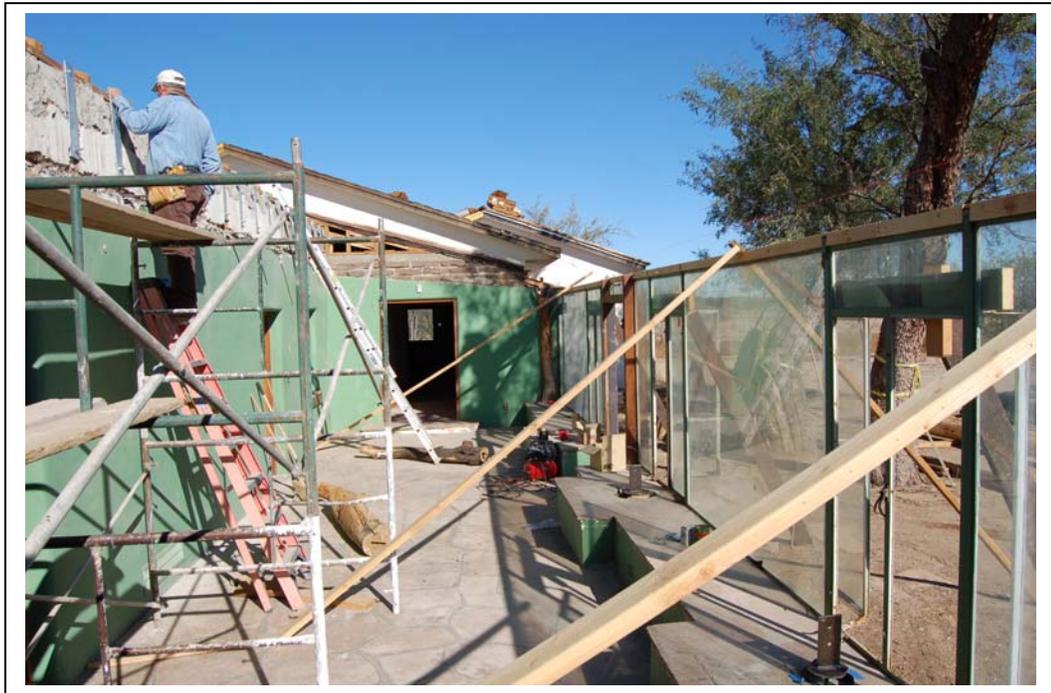
Sunroom of Building 104 exposed, and start of rebuild

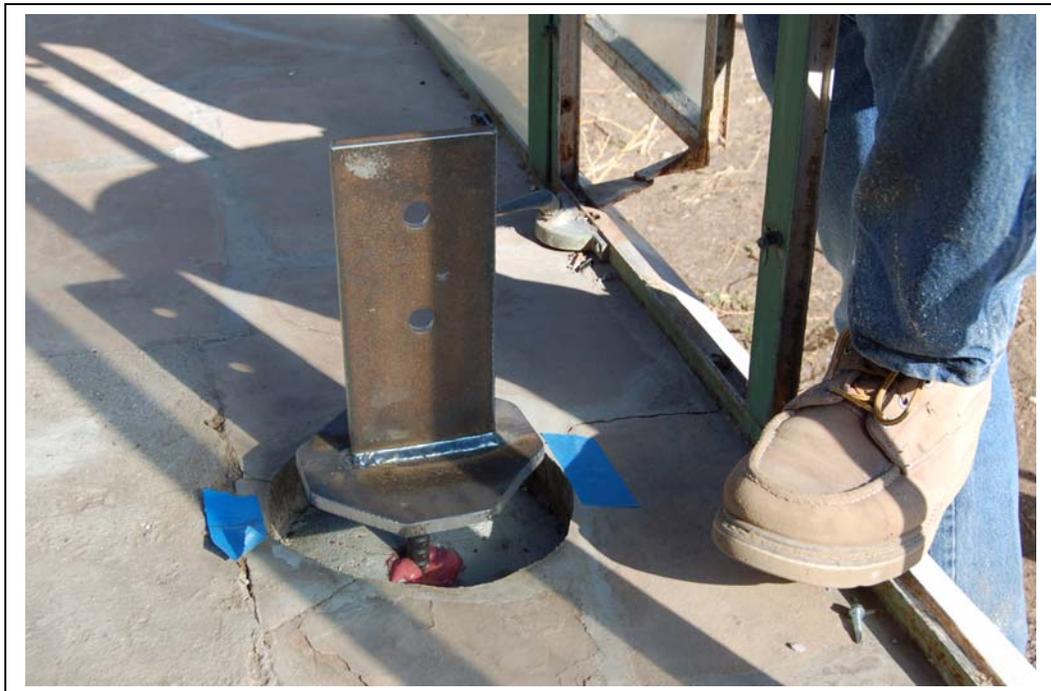
New custom-made supports for anchoring the original wooden post supports for the roof. Building 104
