HISTORIC PROPERTY INVENTORY FORM

Historic Name(s): Adkins Residence (contiguous with Ft. Lowell, Tucson)
(Enter the name(s), if any, that best reflects the property's historic importance.)

Address: 5460 E. Ft. Lowell Road

name of property Adkins Residence

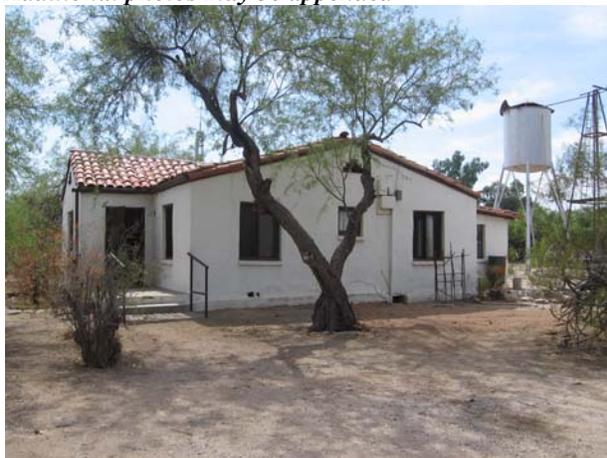
Date of photo: July 12, 2007
View Direction (*looking towards*)
south
Negative No.: IMG_1561

Fair (*some problems apparent*) Describe: Water infiltration from poor eave roof flashing has caused some adobe damage; undercutting of walls from drainage intrusion at one bedroom; rodent intrusion through holes in wall bases; some wall cracking

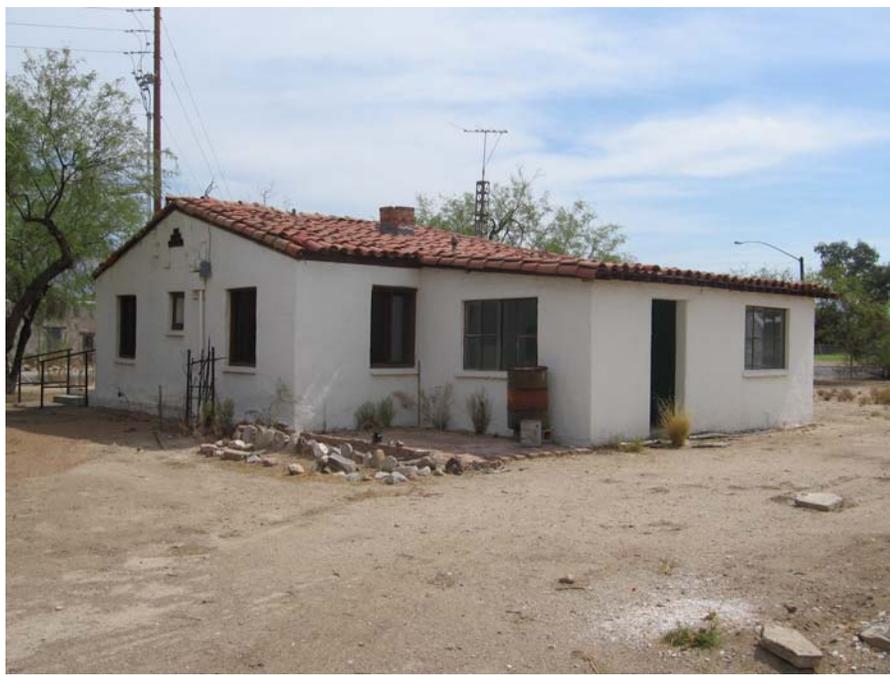
House has concrete foundations and clay mission tile roof. A CMU addition put on sometime and originally used as a bedroom (Harry had 4 brothers and 2 sisters), and eventually as a workroom.

This shows the house from the rear side (the south). The door enters into the CMU addition of two rooms that was added sometime in the late 30's. The original adobe house comprised a kitchen, dining room, living room, two bedrooms, closet, and bathroom.

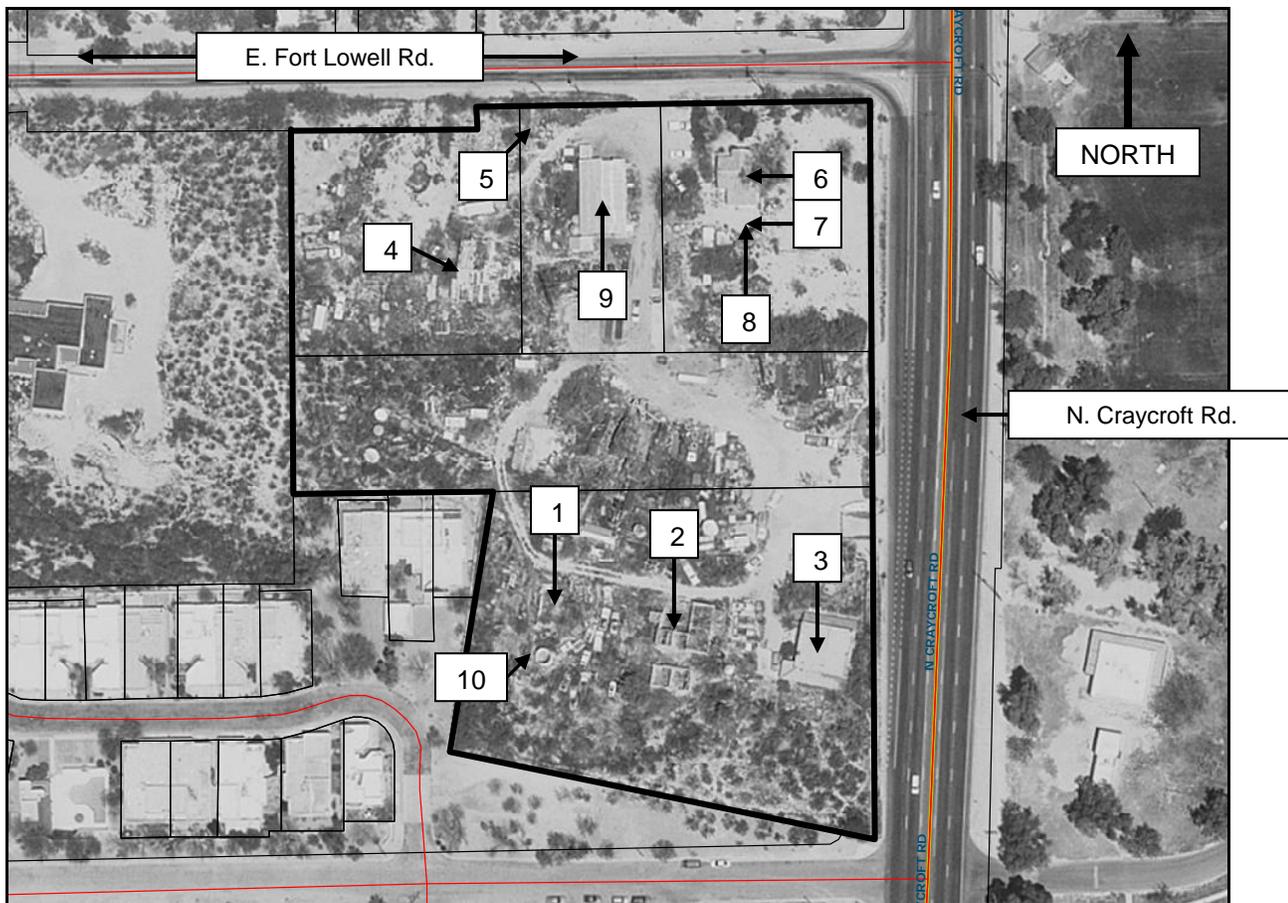
Location of Buildings and Structures

1. Officers' Quarters No. 1 (ruin, includes kitchen remains)
2. Officers' Quarters No. 2 (partial ruin, includes kitchen building)
3. Officers' Quarters No. 3 (intact)
4. Adobe Building (located west of the Steel Tank Fabrication Shed).
5. Guard House (ruin located north-west of the Steel Tank Fabrication Shed).
6. Adkins Residence (located east of the Steel Tank Fabrication Shed)
7. Water Tower
8. Windmill base
9. Steel Fabrication Shed
10. Circular concrete structure (located south of Officers' Quarters No.1)
