HISTORIC PROPERTY INVENTORY FORM

Historic Name(s): Fort Lowell Officer's Quarters No. 3
(Enter the name(s), if any, that best reflects the property's historic importance.)

Address: 2951 N. Craycroft Road

name of property Fort Lowell Officers' Quarters No. 3 Continuation Sheet No. 1

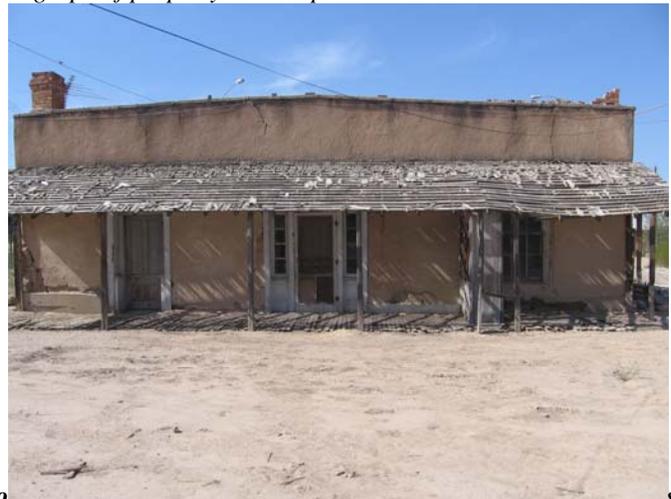
Negative No.: Jpeg Img_1453

Poor (major problems; imminent threat) Describe: severe water infiltration from parapets and through adobe walls w/subsequent adobe deterioration; wall cracking; roof structure collapse in areas

south

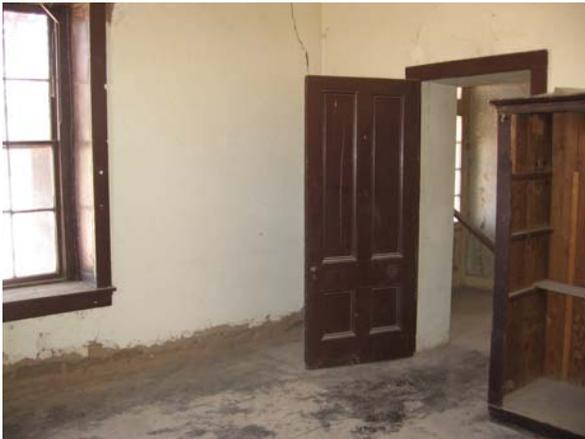
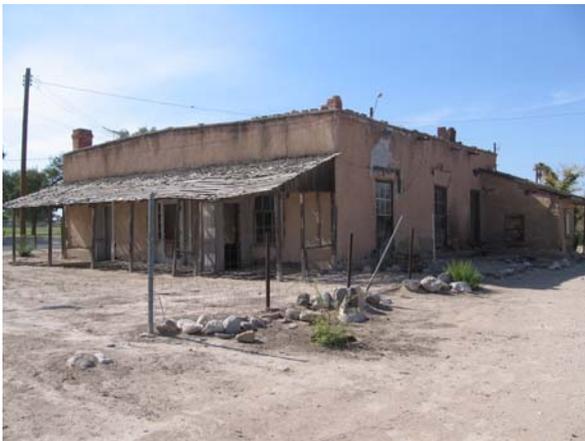
Officers' Quarters No. 3 is the only intact structure remaining from Fort Lowell and possesses significant historical integrity. Many of the building features reflect original construction.

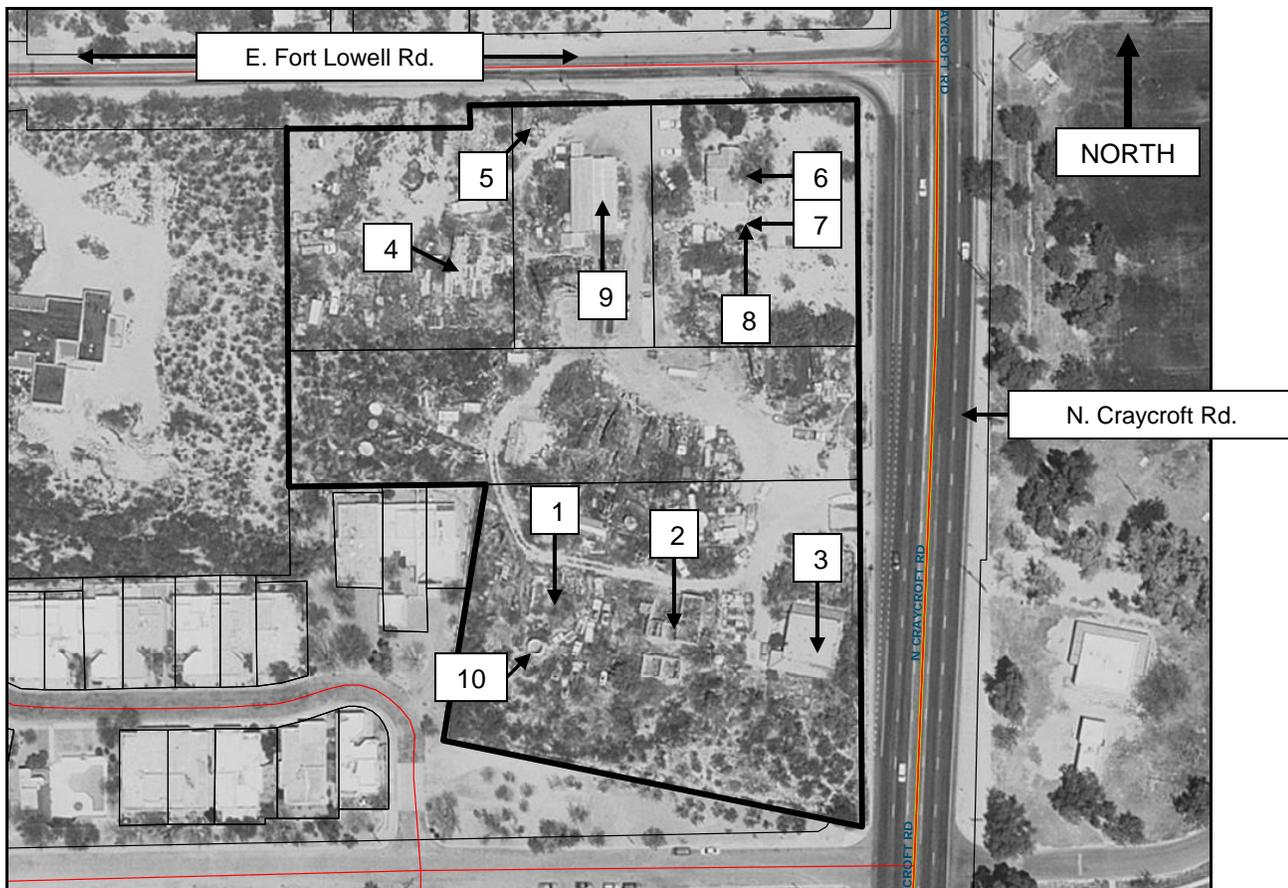
Location of Buildings and Structures

The following location map shows Officers' Quarters No. 3 (#3).

1. Officers' Quarters No. 1 (ruin, includes kitchen remains)
2. Officers' Quarters No. 2 (partial ruin, includes kitchen building)
3. Officers' Quarters No. 3 (intact)
4. Adobe Building (located west of the Steel Tank Fabrication Shed).
5. Guard House (ruin located north-west of the Steel Tank Fabrication Shed).
6. Adkins Residence (located east of the Steel Tank Fabrication Shed)
7. Water Tower
8. Windmill base
9. Steel Fabrication Shed
10. Circular concrete structure (located south of Officers' Quarters No.1)
