Colossal Cave Road Improvement Project: Acacia Elementary School to Old Vail Road

Environmental Assessment and Mitigation Report *Volume II*

Submitted to:
Pima County
Department of Transportation

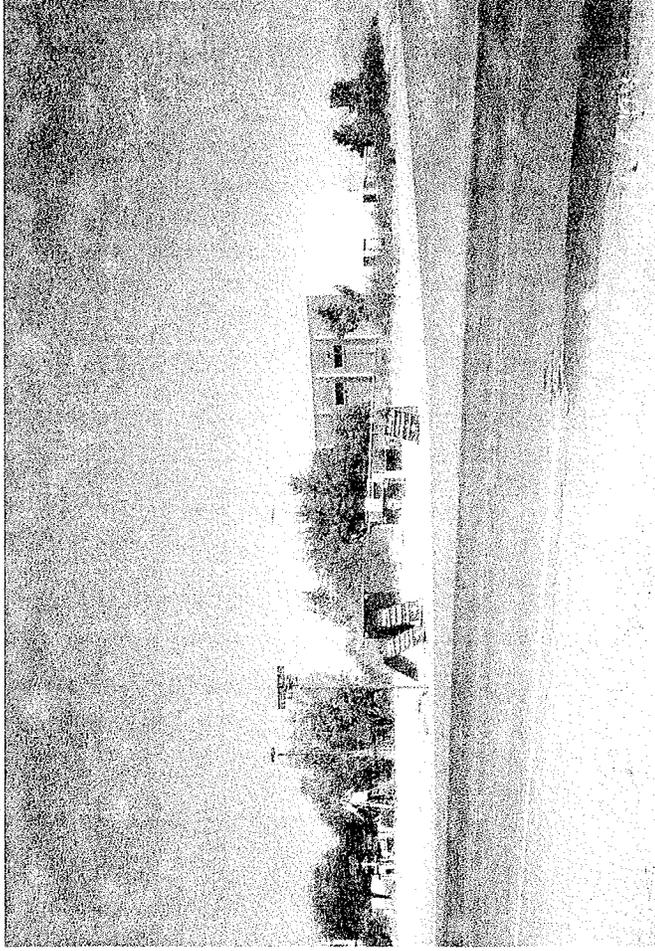
PHOTO 1: Northwest-facing view of the northern terminus of the subject property.

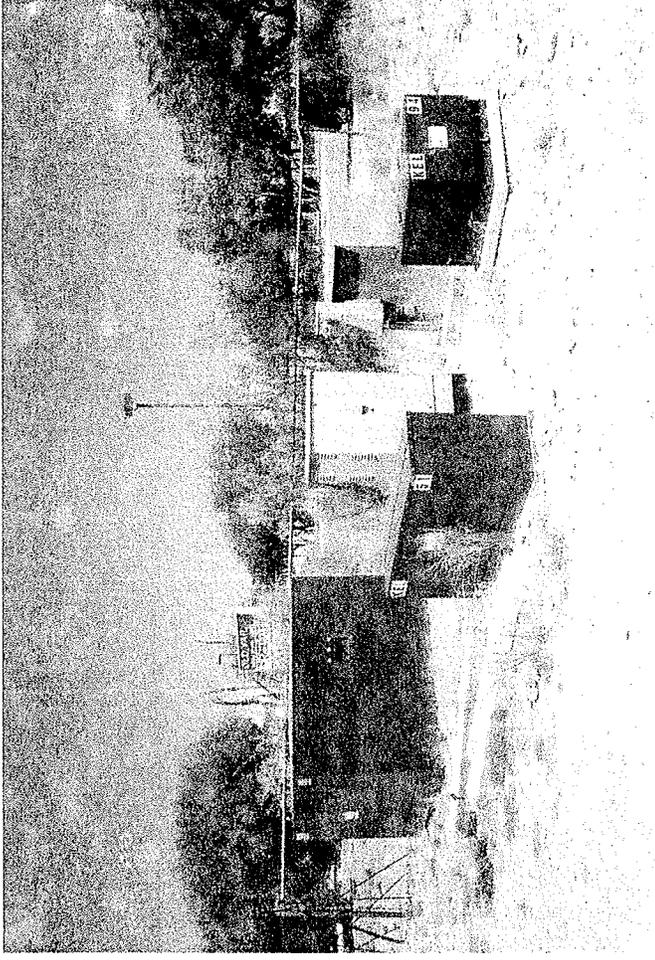
PHOTO 2: View of the pad-mounted transformers and electrical meter pedestals located in the northern portion of the property.

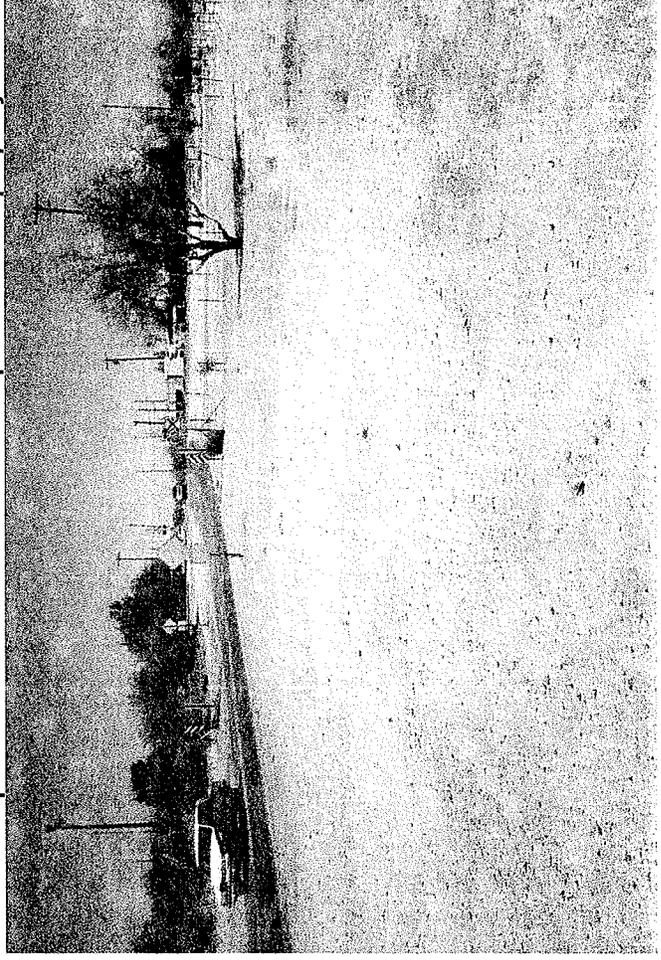
PHOTO 4: Area of incidental surface staining from automotive fluids.

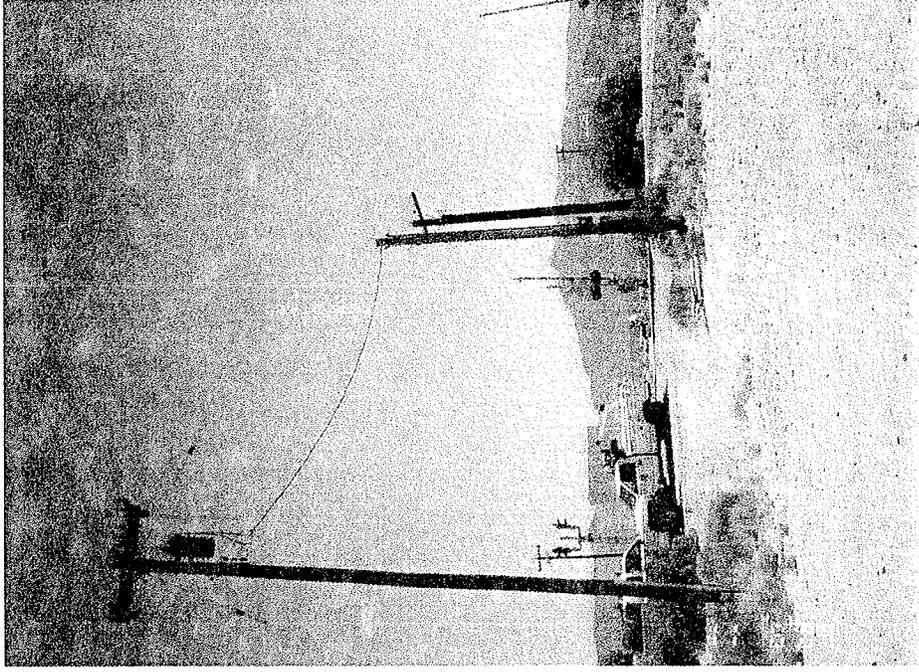
PHOTO 6: View of the pole-mounted electrical transformer.

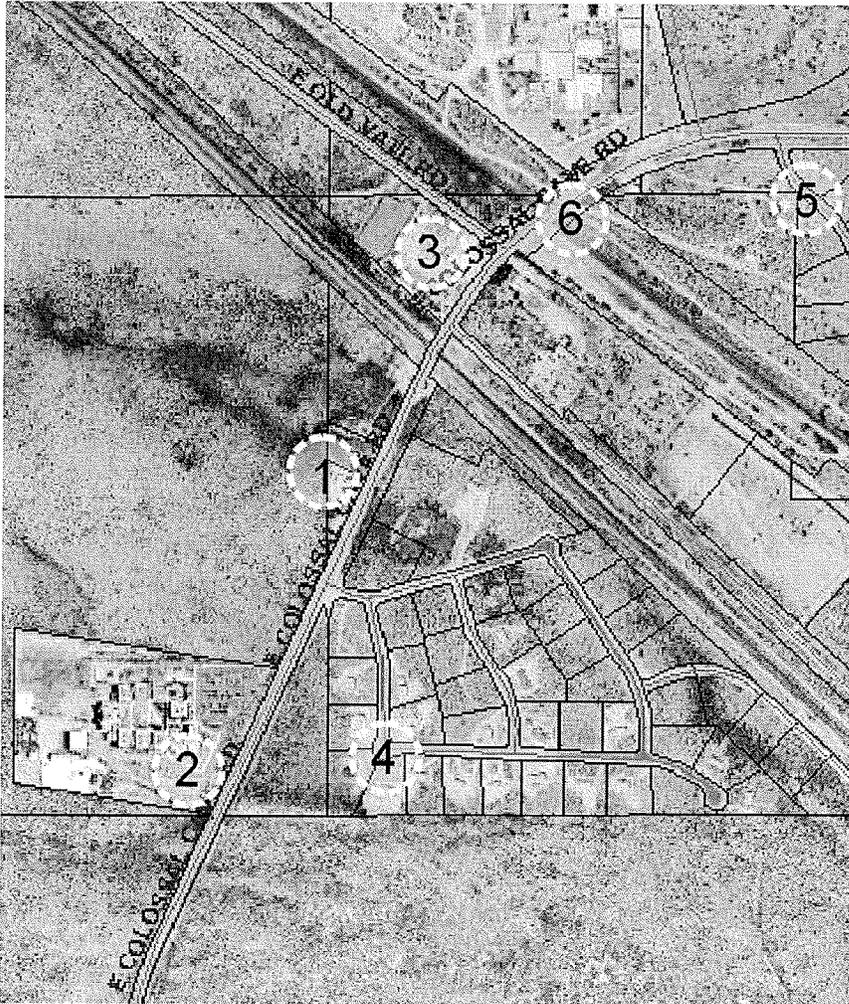
To gauge the viewers sensitivity, 6 Key Observation Points (KOP) were selected per Pima County Roadway Design Guidelines (2003). KOP were selected to gauge the sensitivity of locations along the roadway and off the roadway. See Figure 3 for location of KOP along the project area:

Figure 3: Location of Key Observation Points

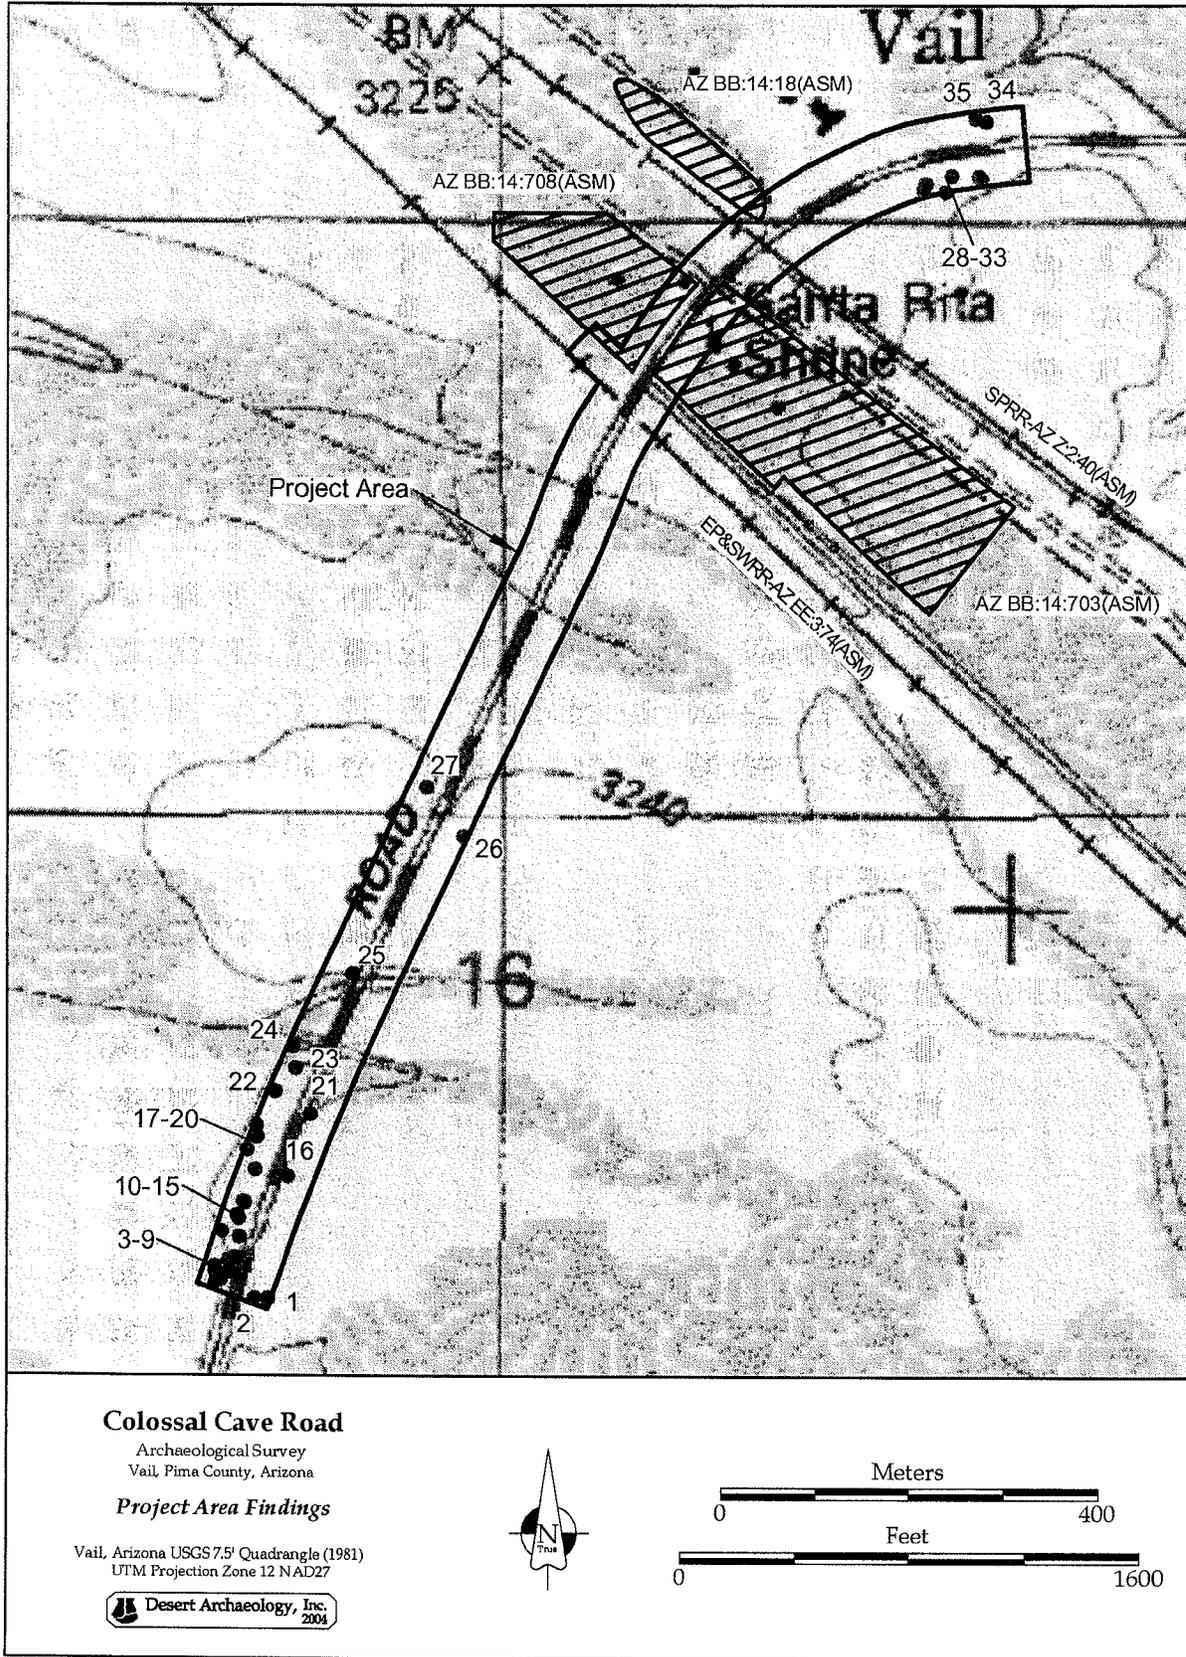
Approximately 33 acres were evaluated for the Colossal Cave Road project (Figure 4). Survey expectations for the area were confirmed: no new sites were identified. However, portions of five previously known cultural properties within the APE were reinspected: the Vail Railroad Station site (BB:14:18), the Southern Pacific Railroad tracks (Z:2:40), the El Paso & Southwestern Railroad tracks (EE:3:74), the old Vail Post Office (reported in Wright 2002), and the Shrine of Santa Rita (BB:14:703).

Figure 4. Project area findings – sites and isolated artifacts.

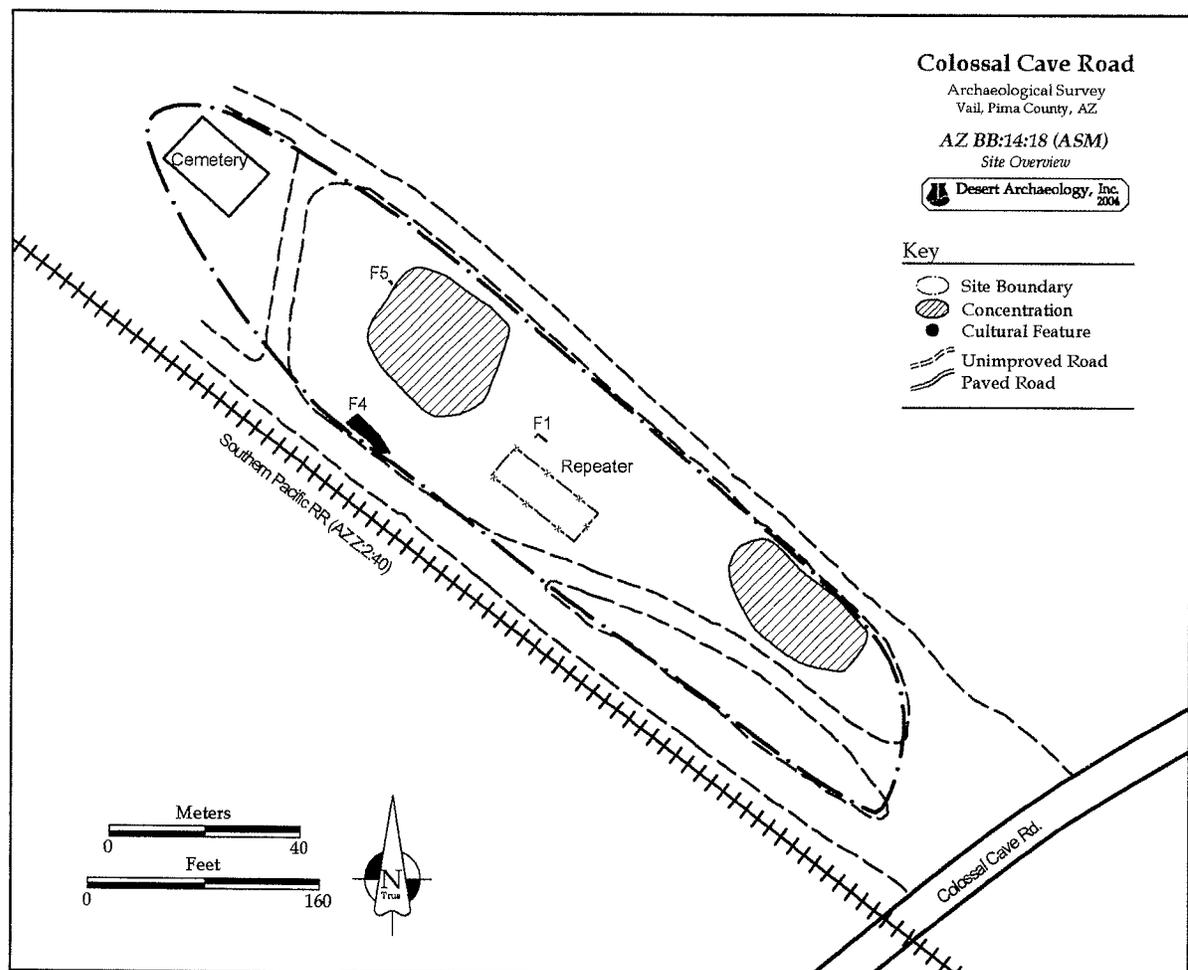
Remains of the Vail Railroad Station are located immediately north of the original Southern Pacific rail grade, approximately 120 m northwest of Colossal Cave Road (Figure 5). The site lies between service roads that parallel the railroad tracks. The site is manifested primarily as two artifact concentrations, remains of the station facilities, and a small cemetery plot. The 1989 recording of BB:14:18 discussed the small cemetery located immediately northwest of the railroad station property, but these remains were not assigned an archaeological site number. As a result of the current survey, the boundary of BB:14:18 has been enlarged to include the cemetery. BB:14:18 measures approximately 210 m by 40 m and encompasses 1.8 acres. Much of the site is overgrown with scrub vegetation, and some of the site has been graded.

Figure 5. Site map of AZ BB:14:18 (ASM).

Dames and Moore reported six features during their data recovery investigations (Bruder et al. 1990:96-112). The concrete foundation of the station building (Feature 1) is located centrally in the site. A well and a probable utility box (Features 2 and 3) were a few meters to the east. Feature 4 is a disturbed concrete pad. Its size and location are consistent with a passenger or freight-loading platform. At the far western portion of the site, Feature 5 is a low pile of rounded river cobbles. This material is similar to the capstones of the nearby, marked graves, and Feature 5 could be a material store for the cemetery. Feature 6 is located between the station (Feature 1) and the loading platform (Feature 4). It consists of a concrete slab with a 3-inch-hole or socket in its center. It is thought to have been the base for a flagpole or utility pole.

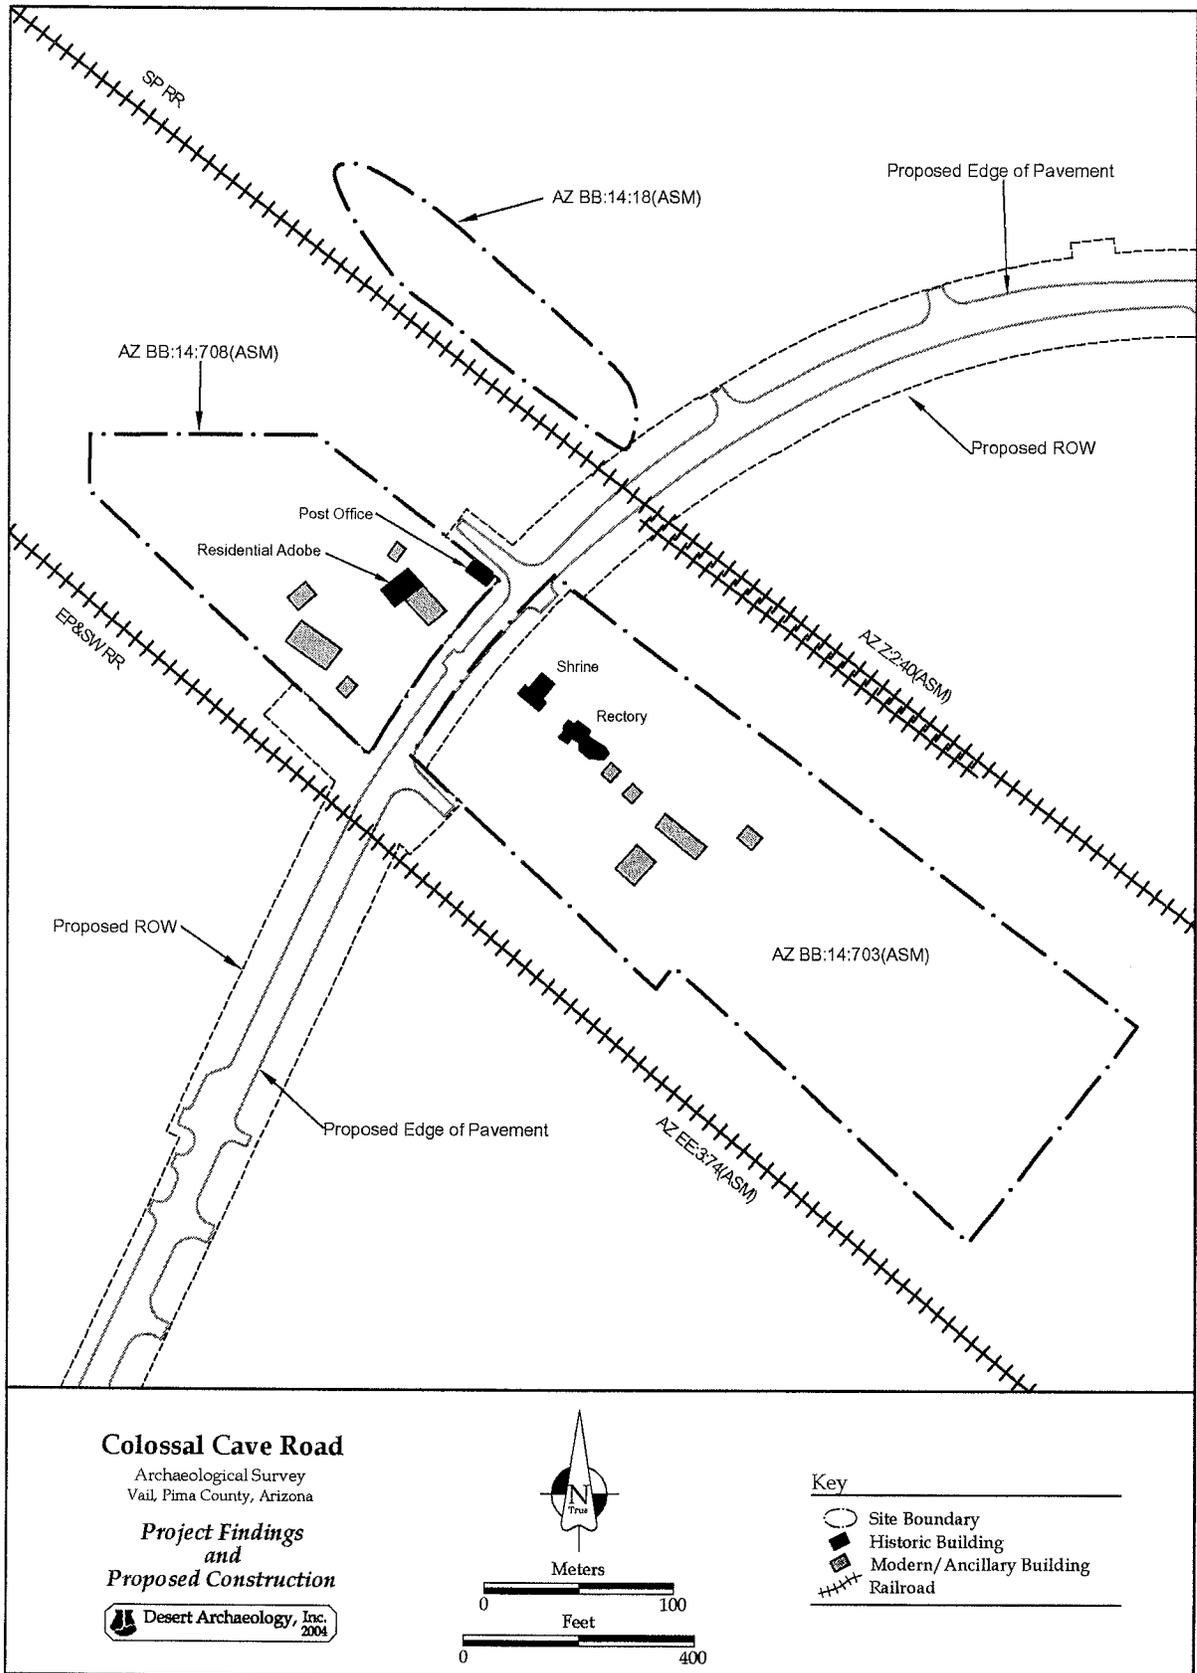
The building is rectangular in plan and lies perpendicular to Colossal Cave Road (Figure 7). The original structure, reportedly constructed in the 1890s, was a 31-ft by 21-ft mud brick adobe with a stucco exterior. Historical photos depict a flat, sparsely vegetated setting. In the 1920s, a 19-ft by 21-ft cobble walled addition with a stucco exterior was added. The building has a side gabled roof, sheeted with corrugated metal that was probably installed with the addition. The interior of the original mud brick structure is finished with mud plaster, while walls of the newer addition are cement plastered. The interior ceiling is capped with a layer of earth, presumably as insulation. A 1973 newspaper article indicates that gas and electricity were installed in the late 1950s (Keating 1973). The utilities apparently fell into disuse, because the current owners report that they installed electricity to the structure in 1976. In that same year, cement was poured, replacing the original dirt floor.

Figure 7. Site map of AZ BB:14:703 (ASM) and AZ BB:14:708 (ASM), showing proposed new right-of-way.
