Re: **Marana Area Odor Complaints in the Vicinity of County Regional Wastewater Reclamation Facilities**

RE: Marana Area Odor Complaints

RE: Facility Inspection and Odor Assessment Report - Permit 1903

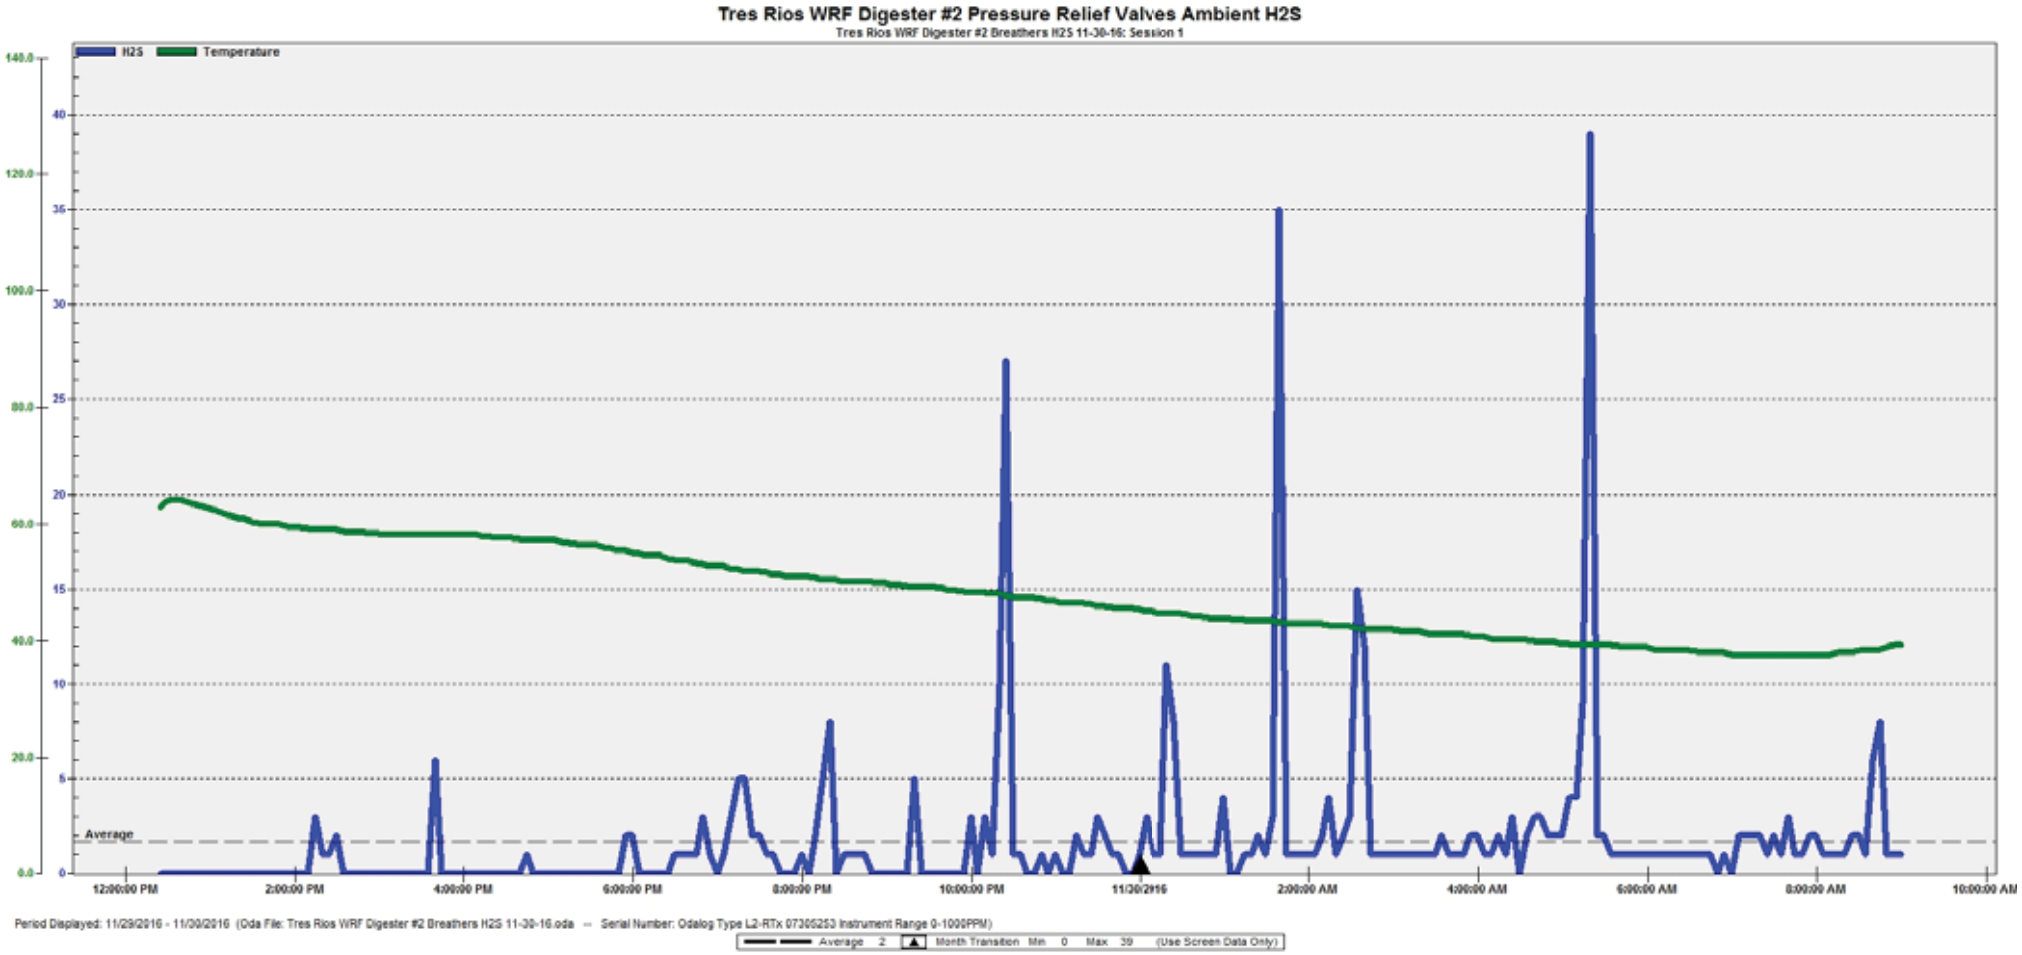
During a recent news interview, Mr. Warner described these as "burps" and the data depicted in Figures 2 and 3 accurately demonstrate this occurrence. In these figures the gas monitoring draw point was located 18" below the pressure relief valve breather and demonstrates routine venting of excess pressure. The location of the pressure relief valve is directly in the center of the digester domed cover. These digesters are approximately 90' in diameter. These charts cover the time from form 11/29/2016 through 12/1/2016.

Figure 2. This chart depicts the period from noon on 11/29/2016 through 9:00 am on 11/30/2016. These concentrations were obtained by placing the air monitoring sample tube approximately 18" below the pressure relief valve breather on Tres Rios Digester #2. The blue trace represents detectable hydrogen sulfide emissions indicating that the pressure relief valve consistently releases to maintain pressure. The large peaks are representative of changes in the internal volume of the digester as new material is being fed into the digester.

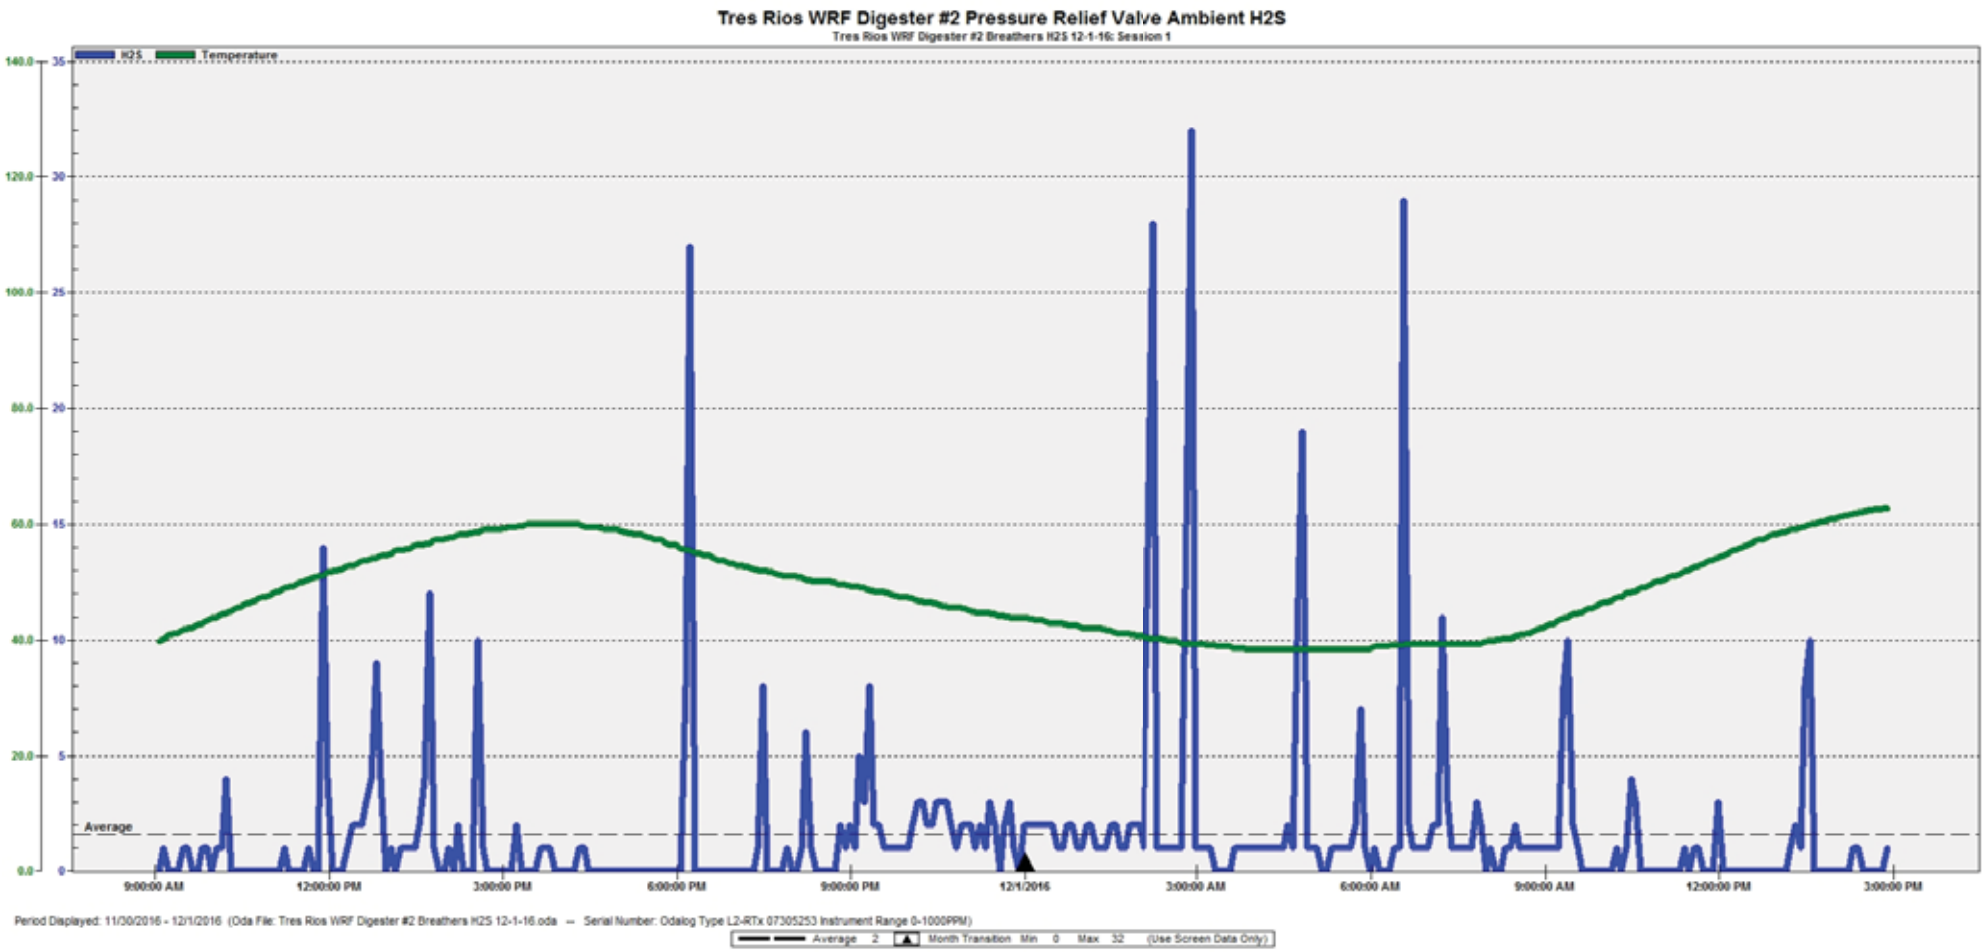
Figure 3. This chart reflects the period from 9:00 am on 11/30/2016 through 2:00 pm on 12/1/2016. Again, the sample monitoring tube was placed 18" below the pressure relief valve breather indicating the pressure relief valves routinely open and close maintaining internal digester pressure.

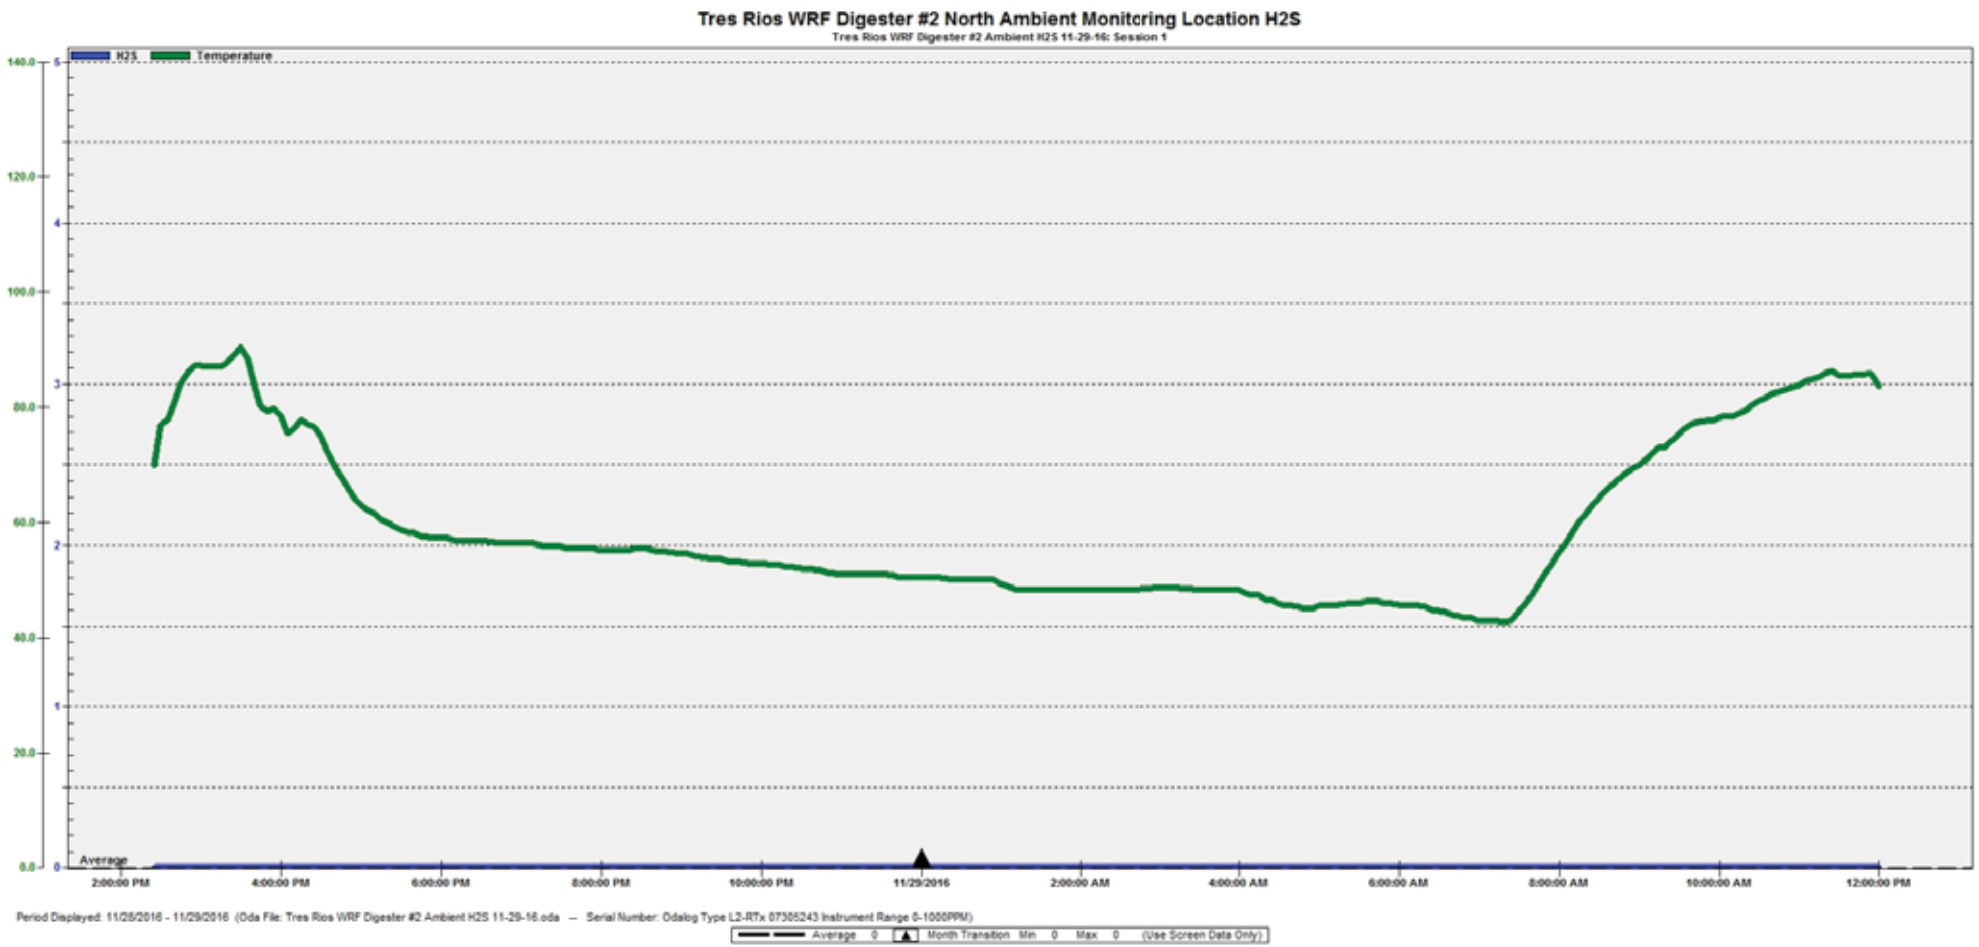
Figures 4 and 5 depict the hydrogen sulfide odor concentrations observable along the top of the outer rim of the digester. Treatment staff perform inspections of the digesters dialing along this location which is approximately 45' from the pressure relief valves. These figures clearly demonstrate that despite routine venting of the digester biogas, only miniscule odors are detectable 50' away from the source. These charts cover the time period from 11/28/2016 through 11/30/2016 and only one detectable odor value.

Figure 4. Ambient air sampling along north hand rail on the top deck of Tres Rios Digester #2. Time period depicted is from noon on 11/28/2016 through noon on 11/29/2016. The green trace depicts ambient air temperature while the blue trace along the baseline depicts no detection of hydrogen sulfide emissions. This location is approximately 45' from a pressure relief valve located in the center of each digester dome cover and represents the traffic area in which treatment staff are exposed to during routine inspection of the digesters.

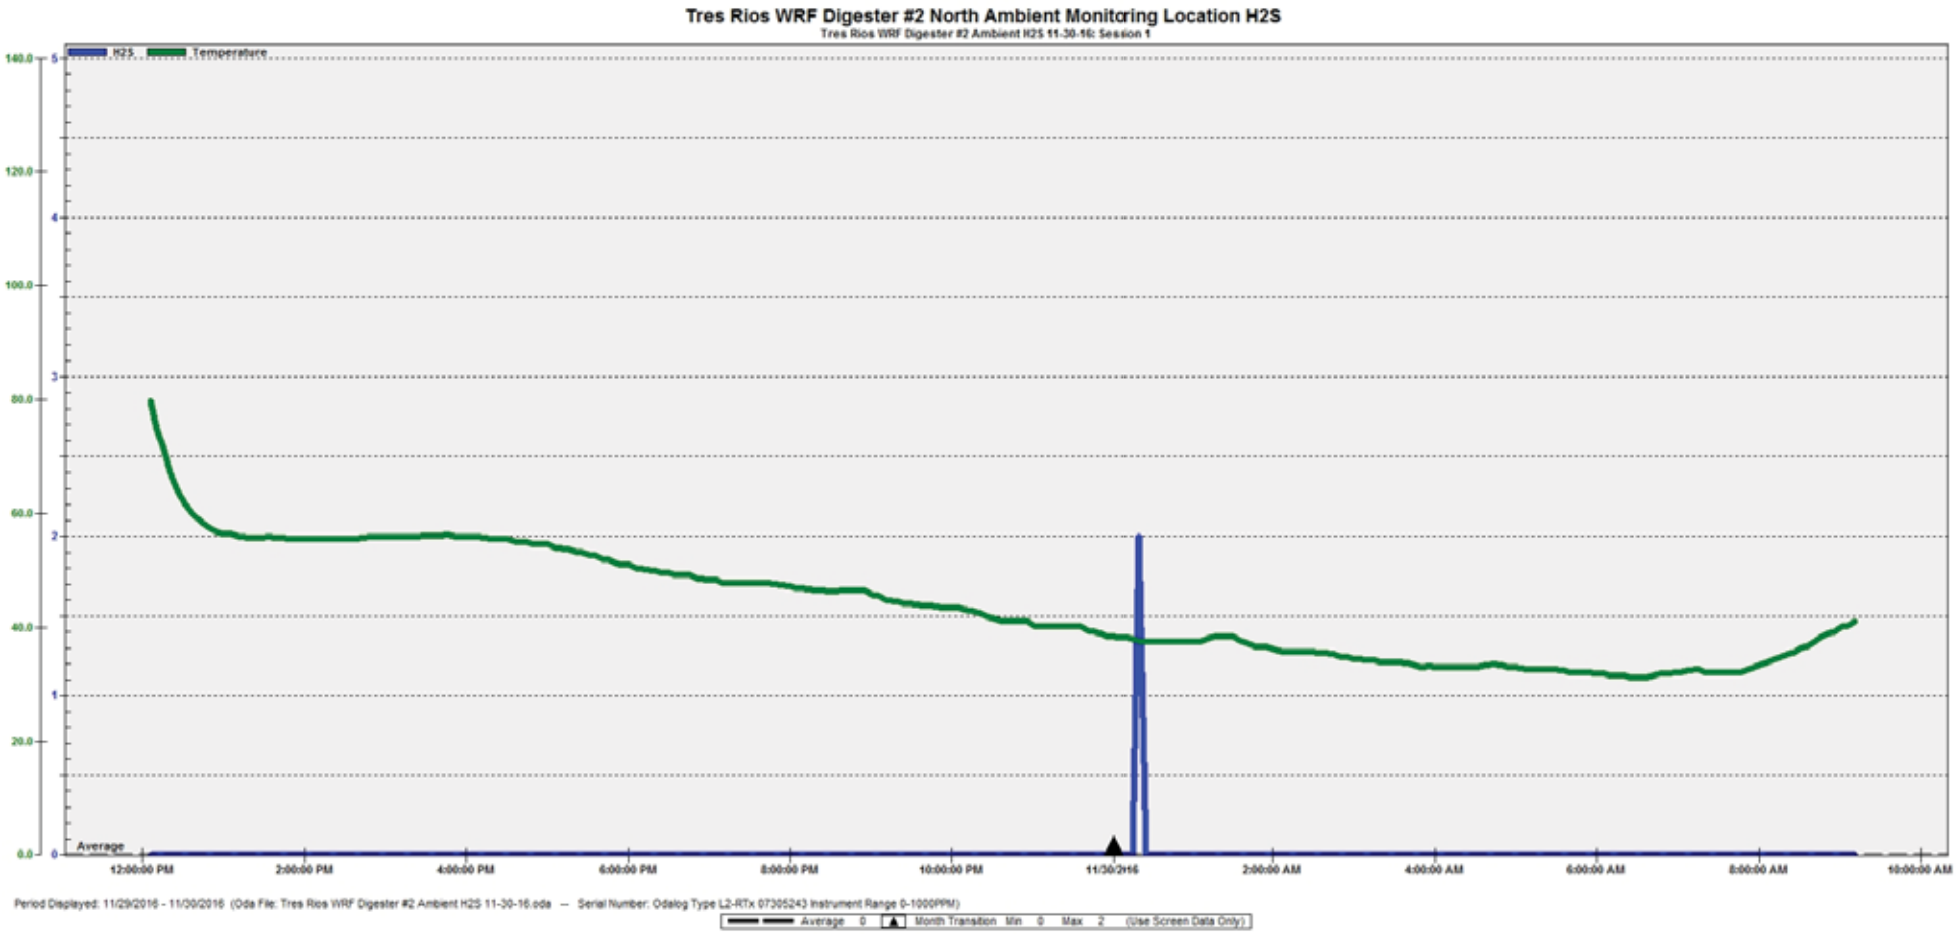
Figure 5. Ambient air quality monitoring taken on top of Tres Rios Digester #2 for the period from noon on 11/29/2016 through 9:00 on 11/30/2016. The green trace depicts ambient temperature while the blue trace depicts a single detection of a momentary 2 ppm hydrogen sulfide emission just after midnight on 11/30/2016. This emission is representative of a digester pressure relief valve maintaining internal digester pressure. This location is approximately 45' from the pressure relief valve.

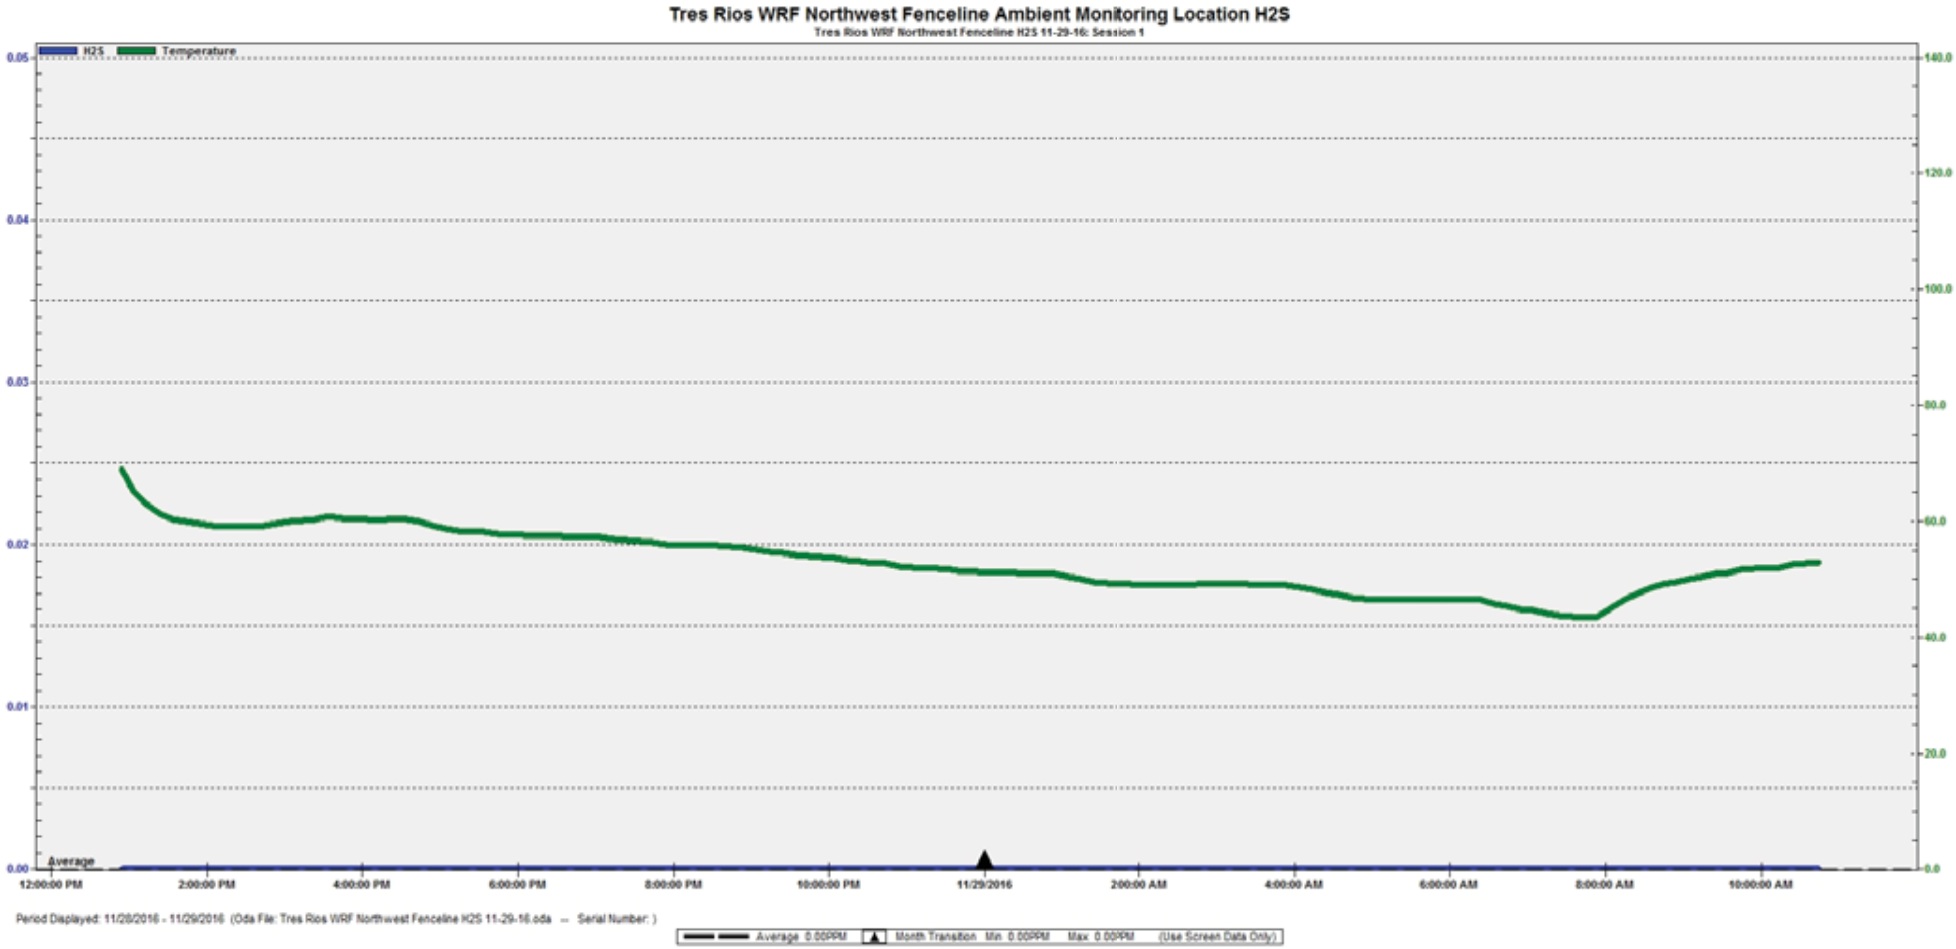
Figures 6 and 8 depict hydrogen sulfide odor concentrations observable at the northwest fence line in closest proximity to both the digester complex and the enclosed combustion flare. These charts cover the time period from 11/28/2016 through 11/30/2016. The only observable correlation with digester gas venting is a 12/1/2016 peak at just after 2:00 am. In each instance however, the recorded values of 10ppb are well within the permissible compliance limit of 30 ppb indicated by permit.

Figure 6. Ambient air monitoring along the northwest fence line for documenting potential odors leaving the Tres Rios WRF for the period from noon on 11/28/2016 through noon 11/29/2016. The green trace depicts ambient air temperature while the blue trace along the baseline indicates no detection of hydrogen sulfide emissions. Routine fence line monitoring is conducted to evaluate odors leaving the Tres Rios facility.

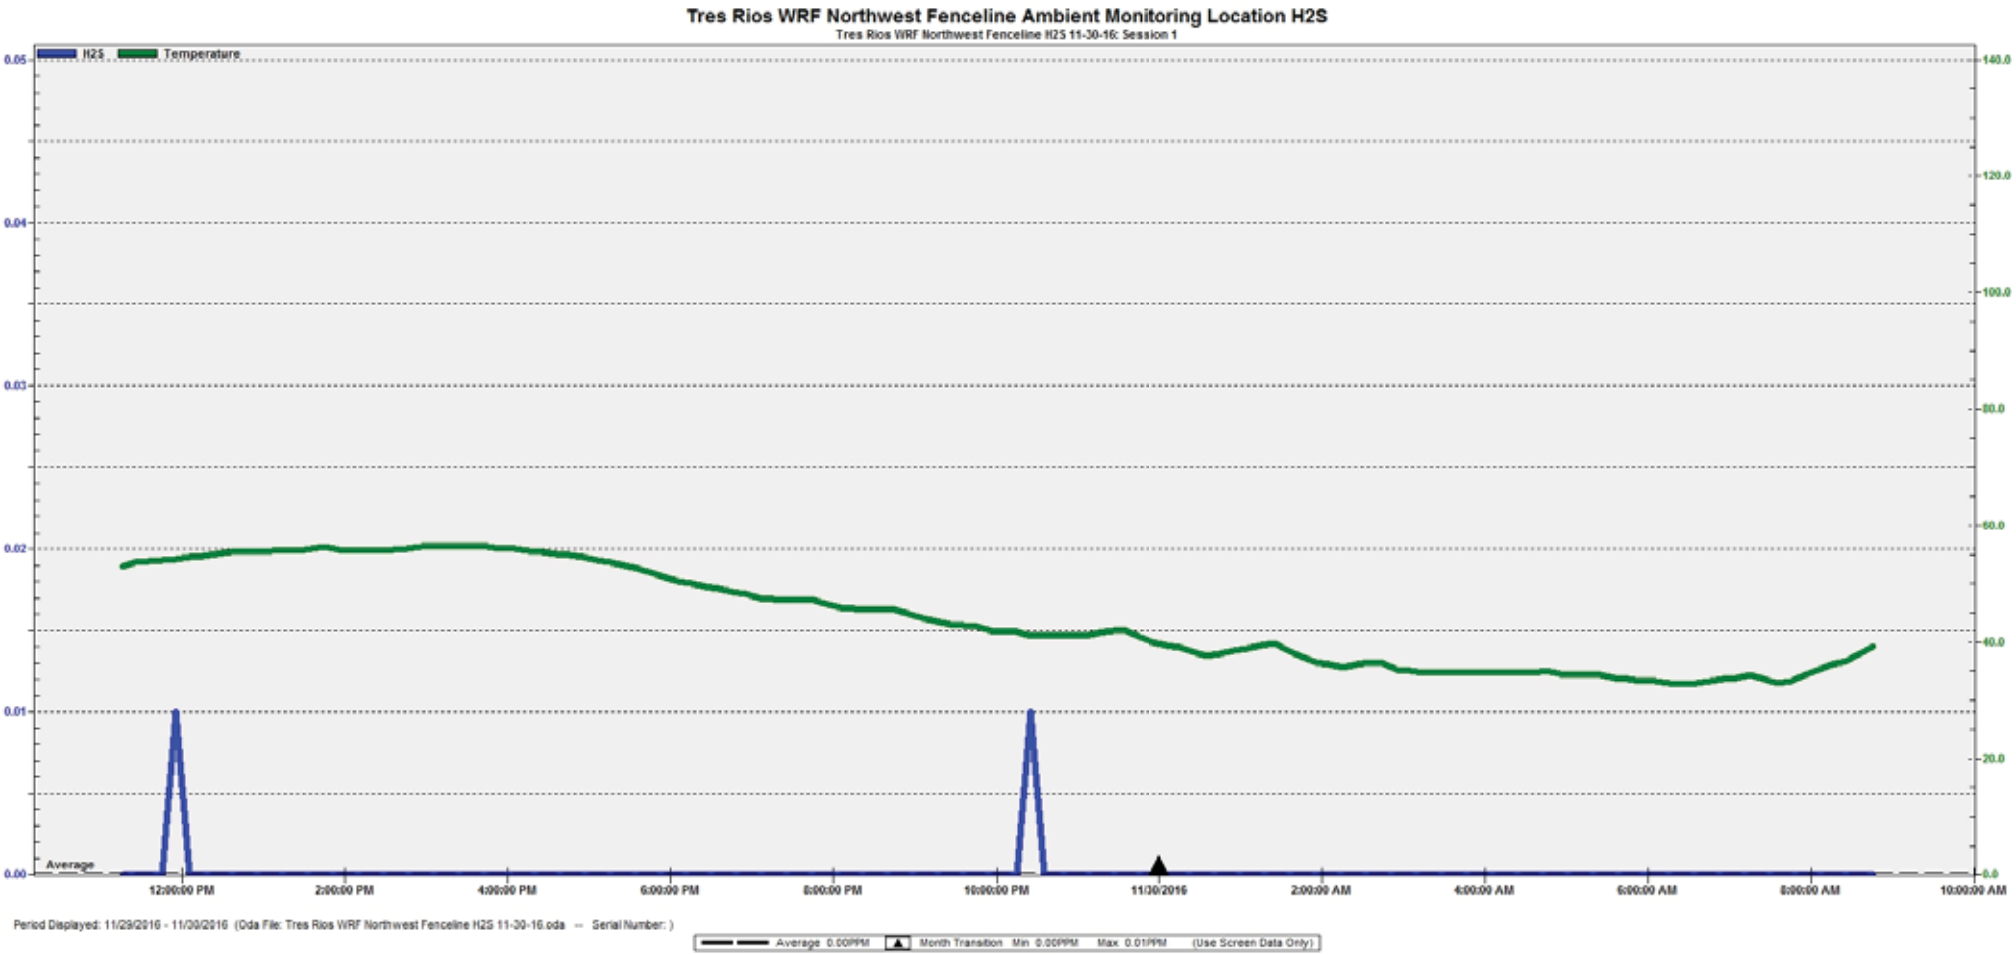
Figure 7. Ambient odor monitoring along the northwest Tres Rios WRF fence line depicting only two detectable hydrogen sulfide emissions under 10 ppb and in compliance with the air quality permit limit of 30 ppb.

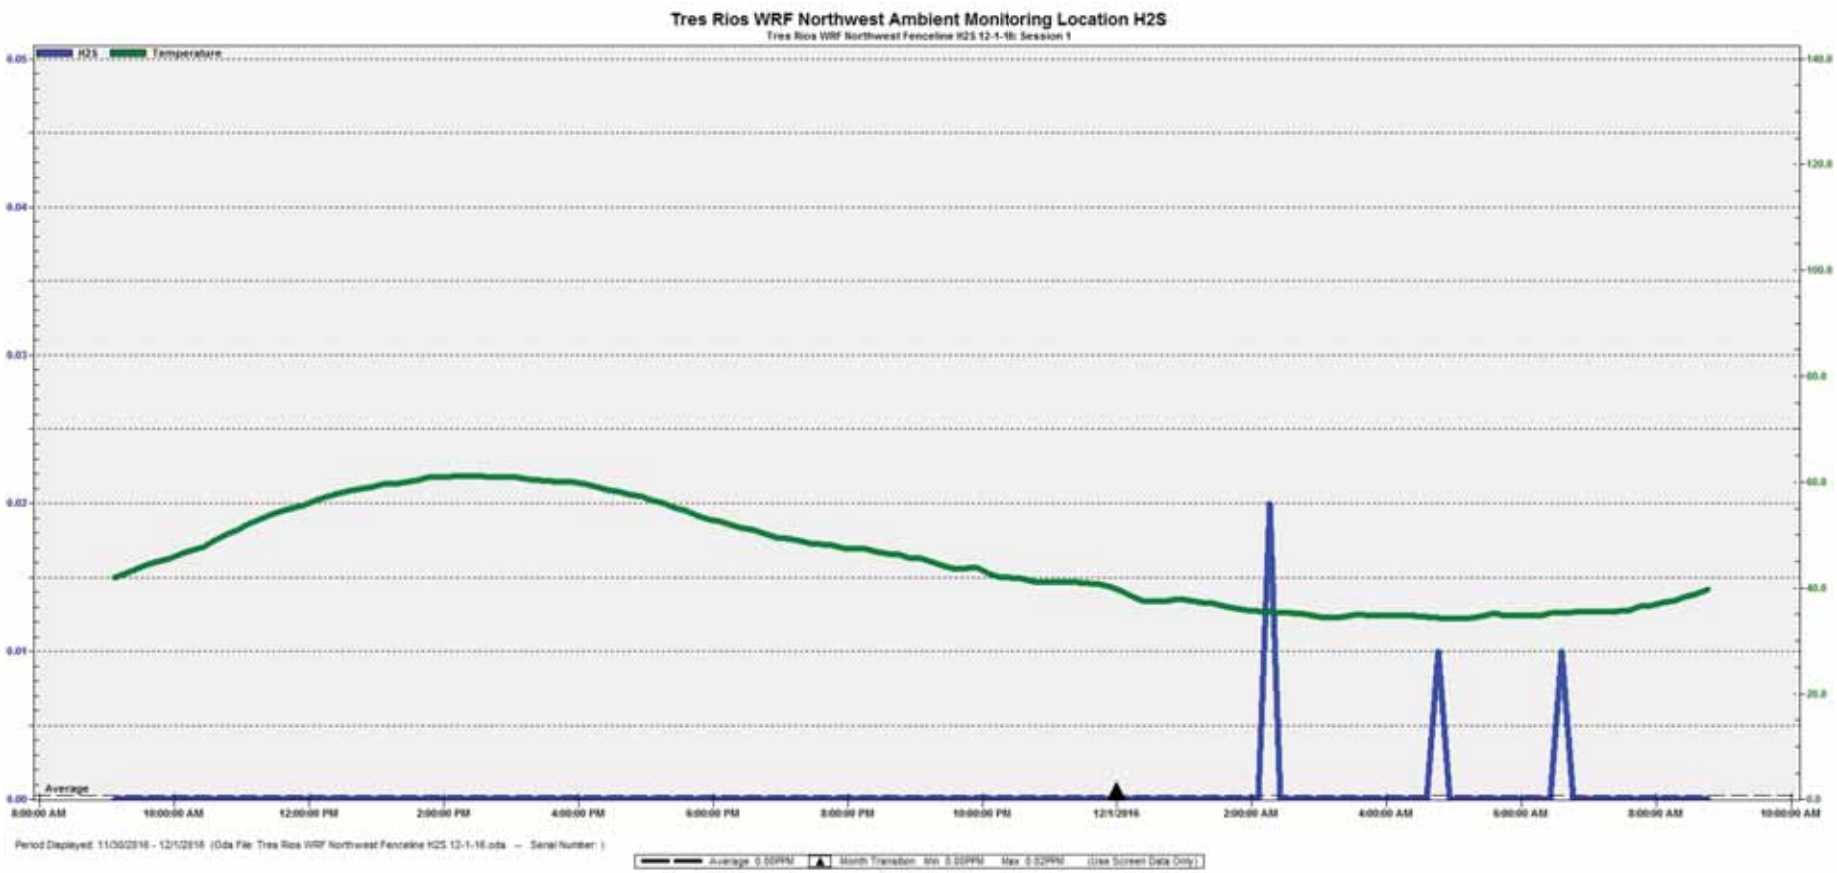
Figure 8. Ambient odor monitoring along the northwest Tres Rios WRF fence line depicting three detectable hydrogen sulfide emissions under 20 ppb and in compliance with the air quality permit limit of 30 ppb.

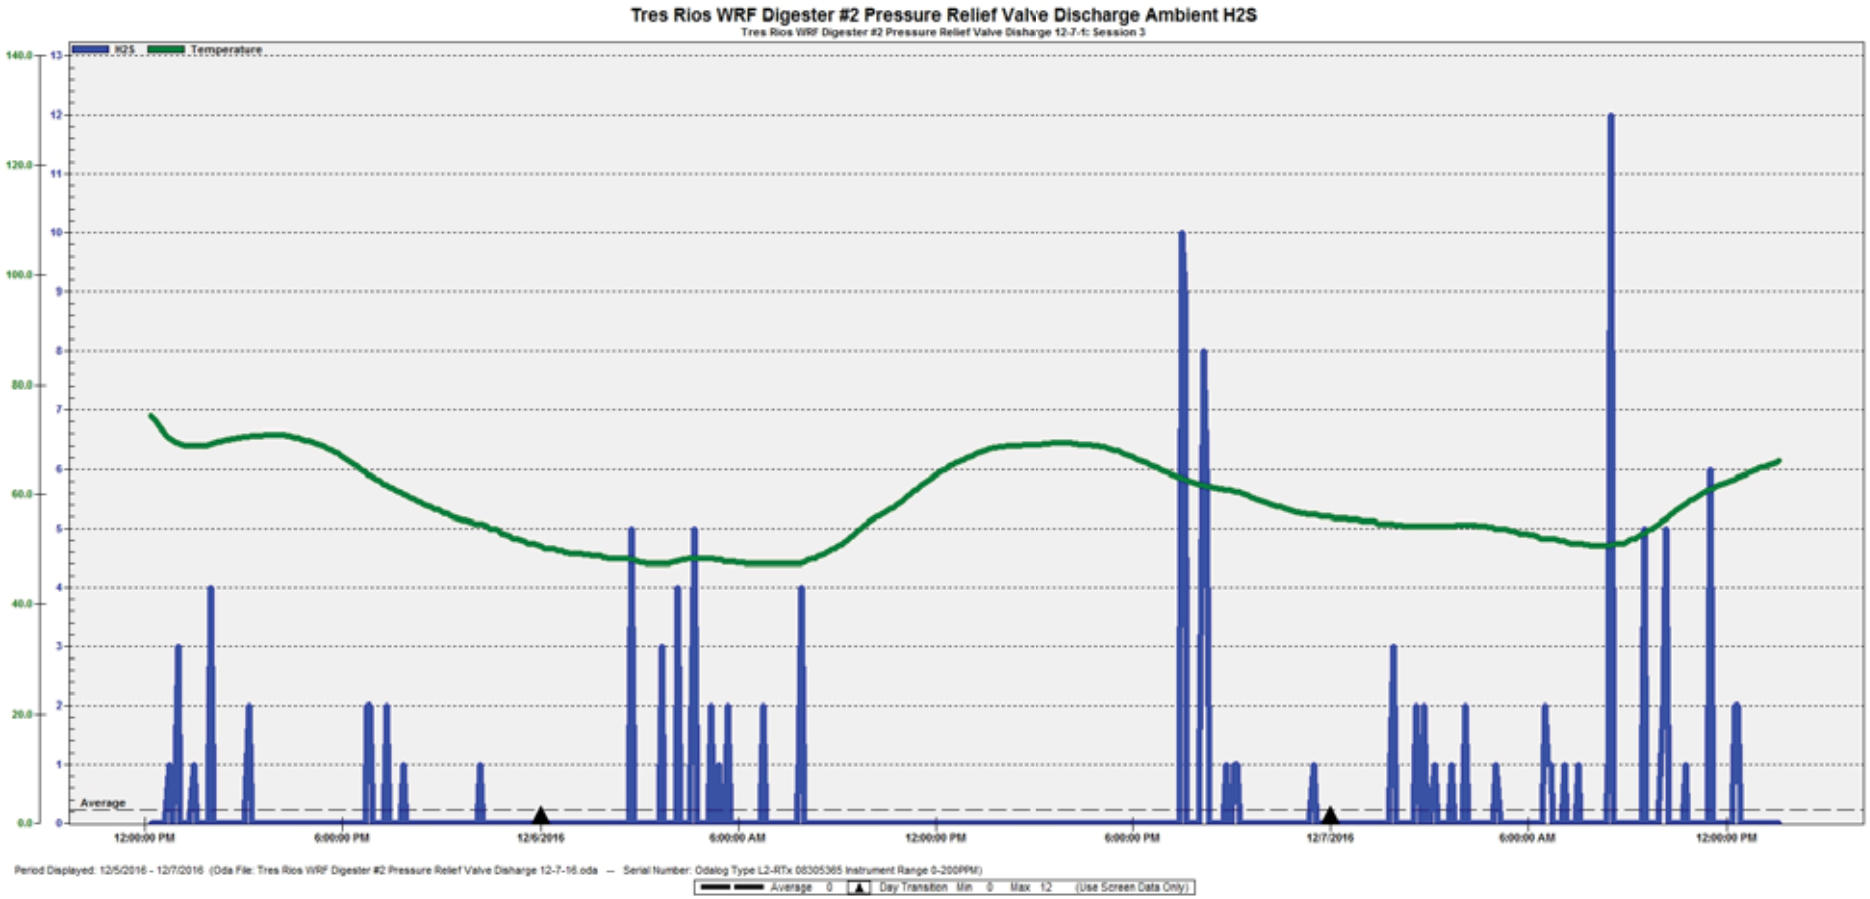
Figure 9. This data represents ambient odor monitoring from on top of the digester near the pressure relief valve after adjustment was made to the flow equalization valves between digesters 1, 2 and 3. The data depicts a significant decrease in the concentration of hydrogen sulfide emissions resulting from this change in operation.

On 12/2/2016 staff adjusted equalization valves between the three digesters and additional monitoring was again conducted on 12/5/2016 through 12/7/2016. Figure 9 demonstrates a three-fold decrease in the concentration of hydrogen sulfide odor emissions as a result of this response. This strategy will be discussed and evaluated in upcoming staff meetings for possible further reductions in odor emissions.

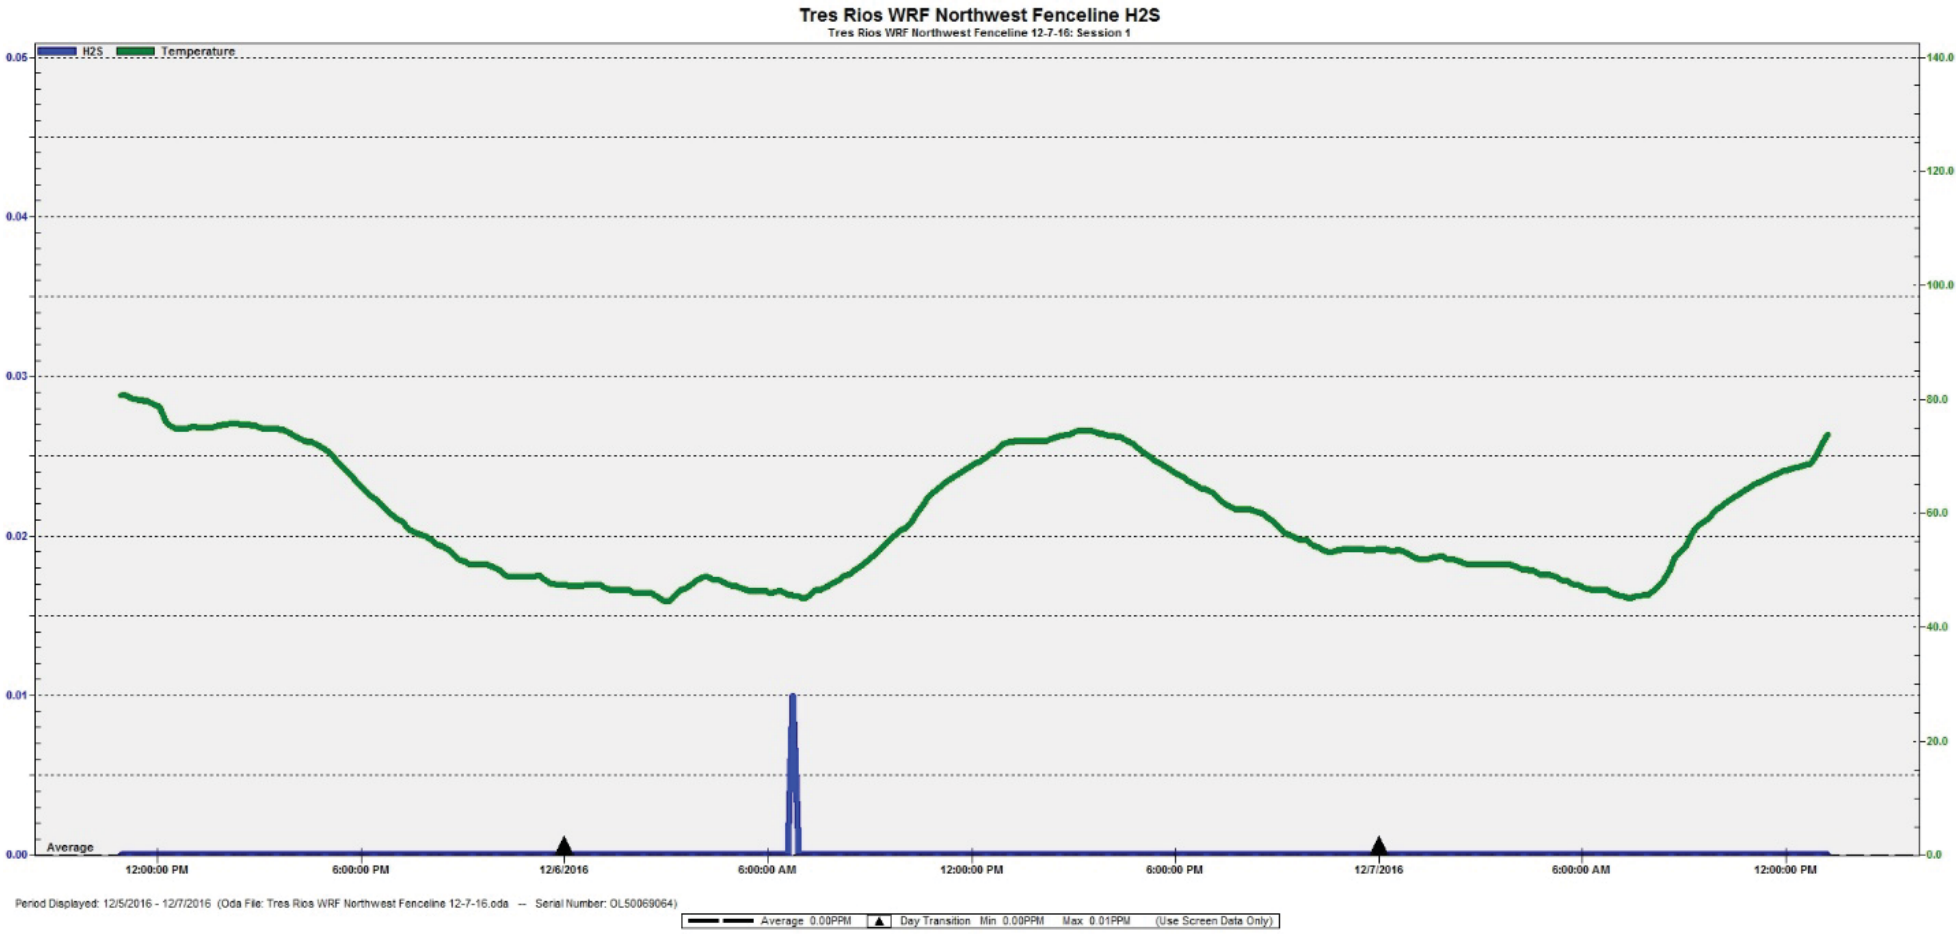
Figure 10. Ambient air quality monitoring along the northwest fence line in close proximity to the digester complex and enclosed combustion flare. Only one observable emission is noted and at 10 ppb it is within the compliance limit of 30 ppb.

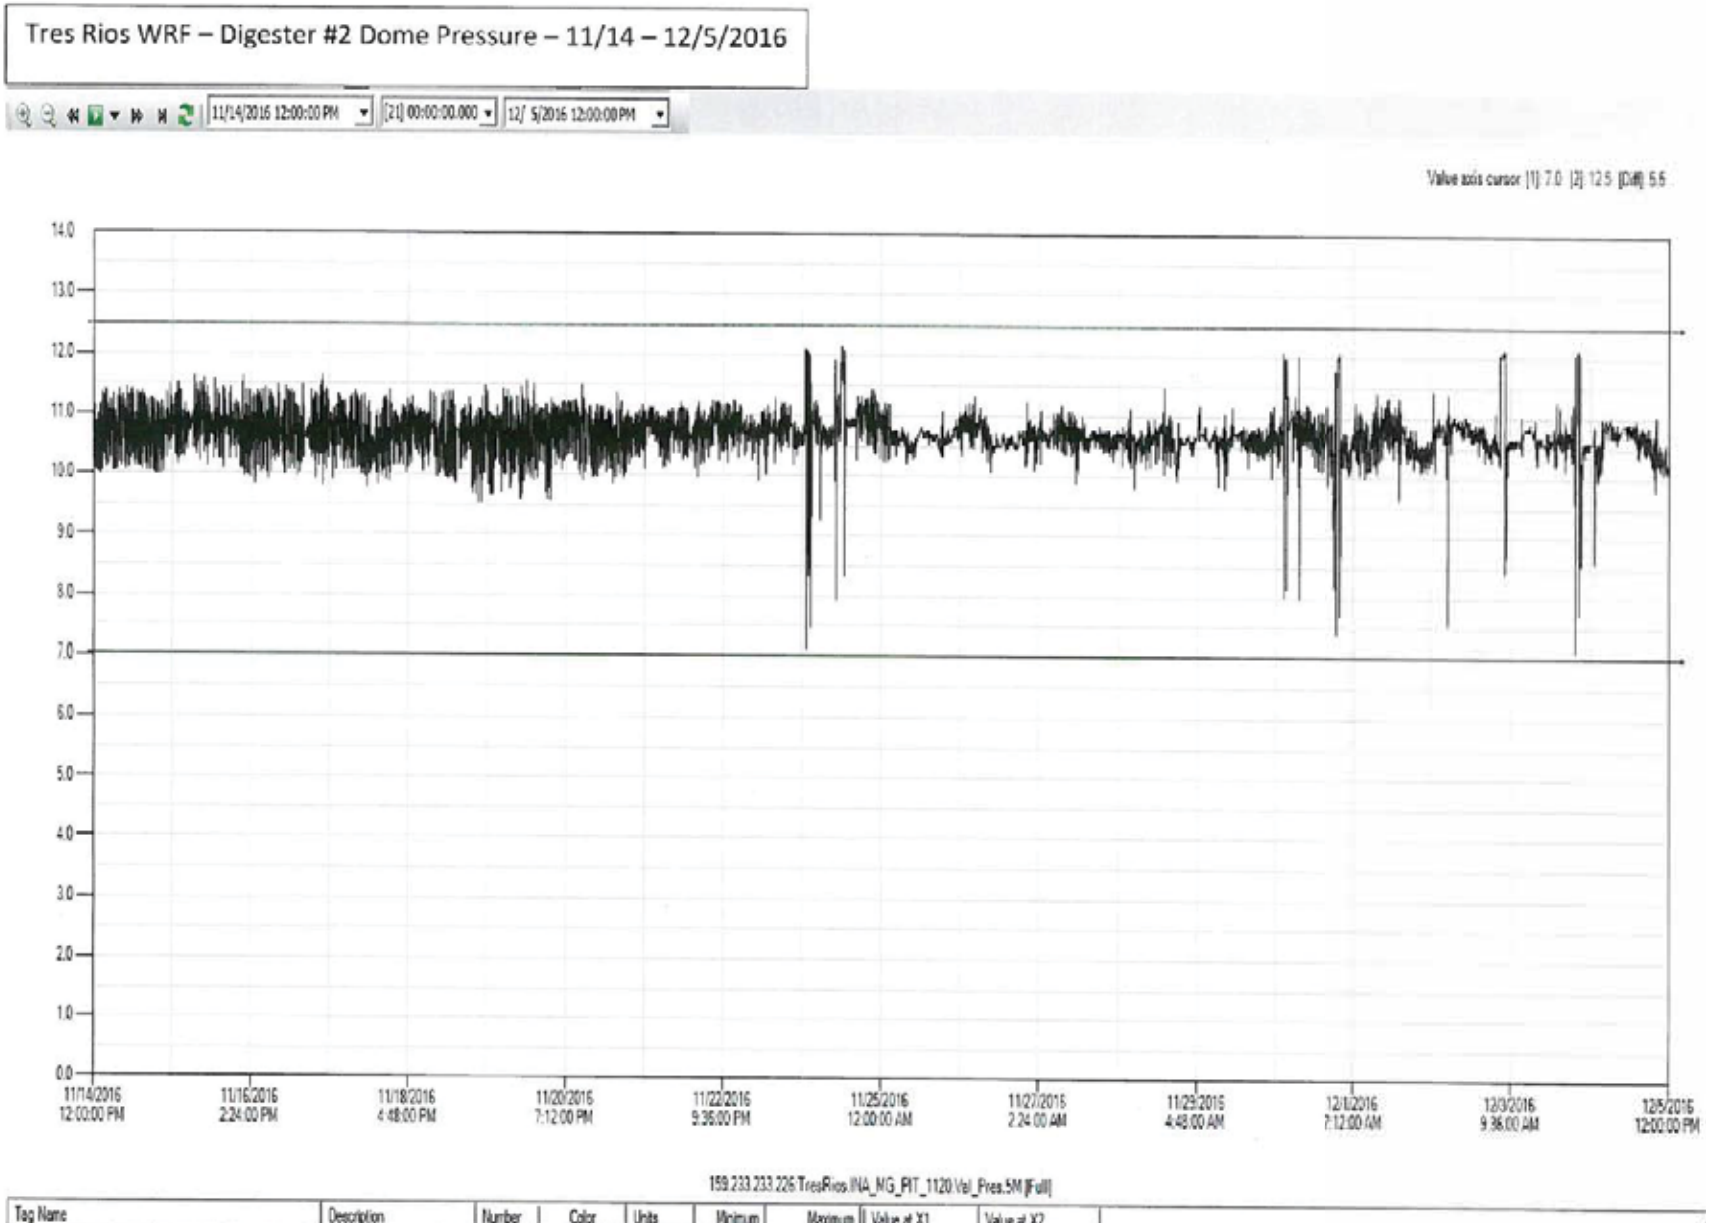
Figure 11. Digester #2 dome pressure for the period from 11/14/2016 through 12/5/2016.

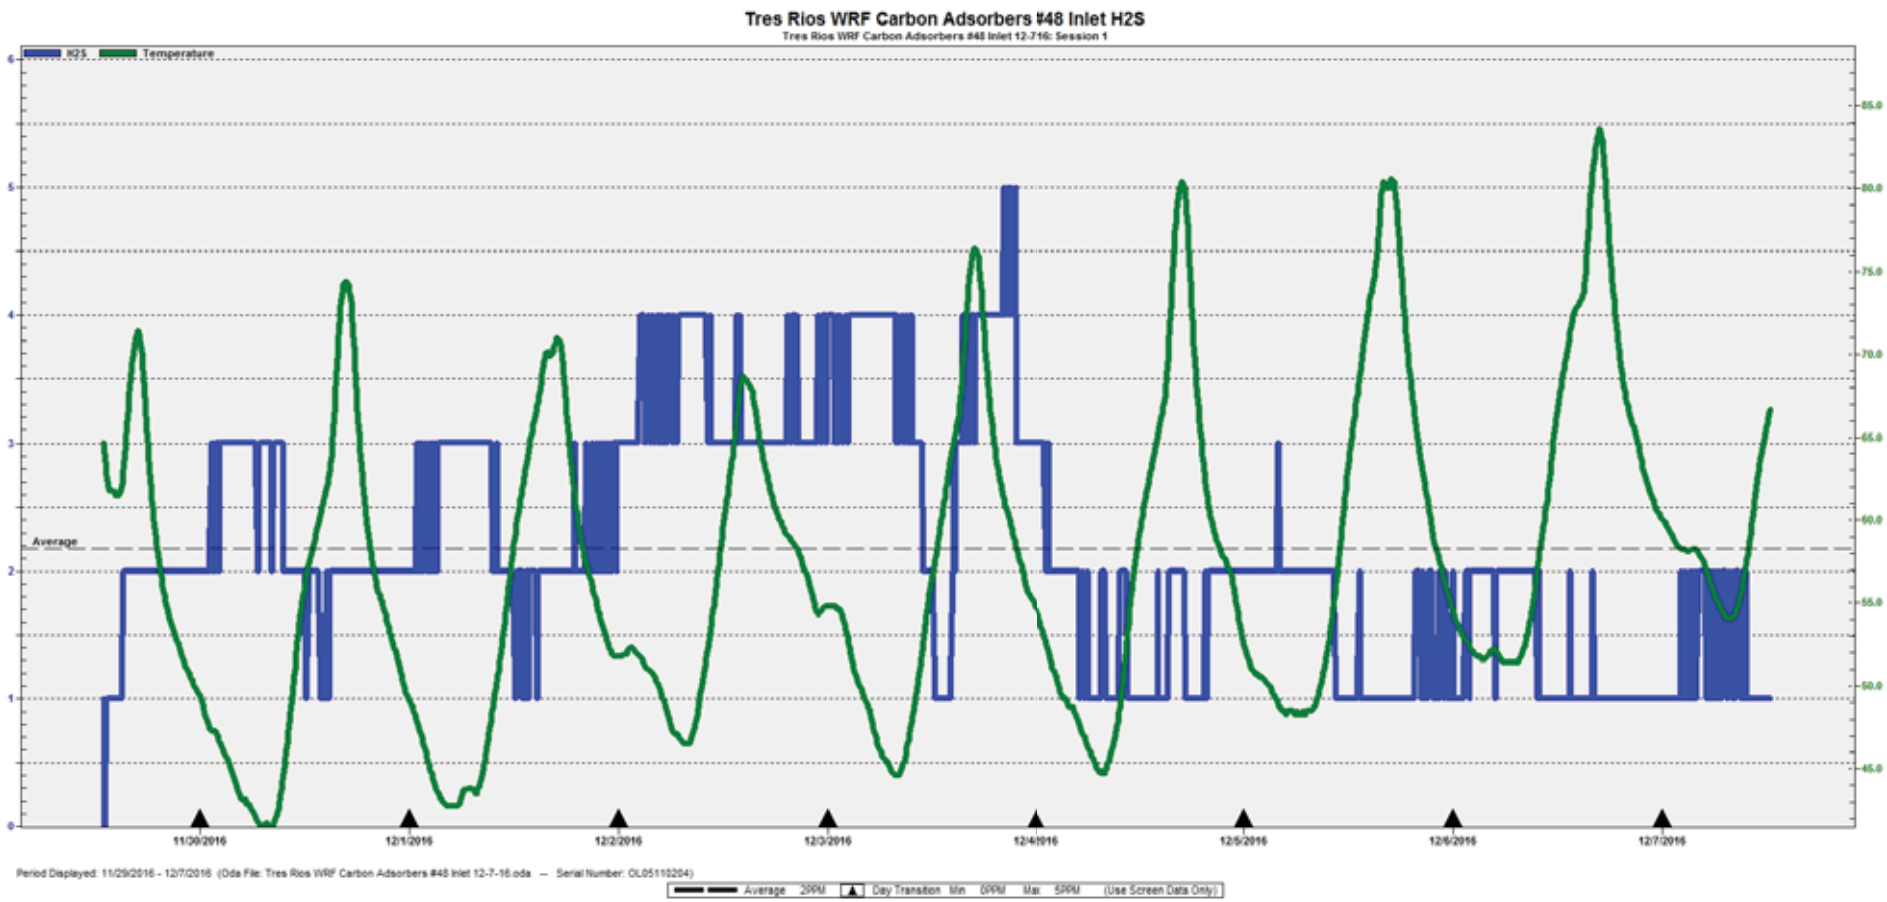
The odor scrubbers located at building 88 are in the central portion of the treatment plant and draw foul air from the biological reactors and primary clarifiers. Figures 15 through 17 demonstrate the operational removal efficiency of these devices for the period form 11/30/2016 through 12/7/2016. Throughout this period hydrogen sulfide concentrations at the outlet never exceeded 10 ppb.

Figure 15. This Chart reflects hydrogen sulfide concentrations measured at the carbon adsorber inlet for the period from 11/29/2016 through 12/7/2016. These adsorbers draw from the headspace of enclosed reactors and are not representative of ambient air.
