Re: **Marana Area Odor Complaints in the Vicinity of County Regional Wastewater Reclamation Facilities**

RE: Marana Area Odor Complaints

RE: Facility Inspection and Odor Assessment Report - Permit 1903

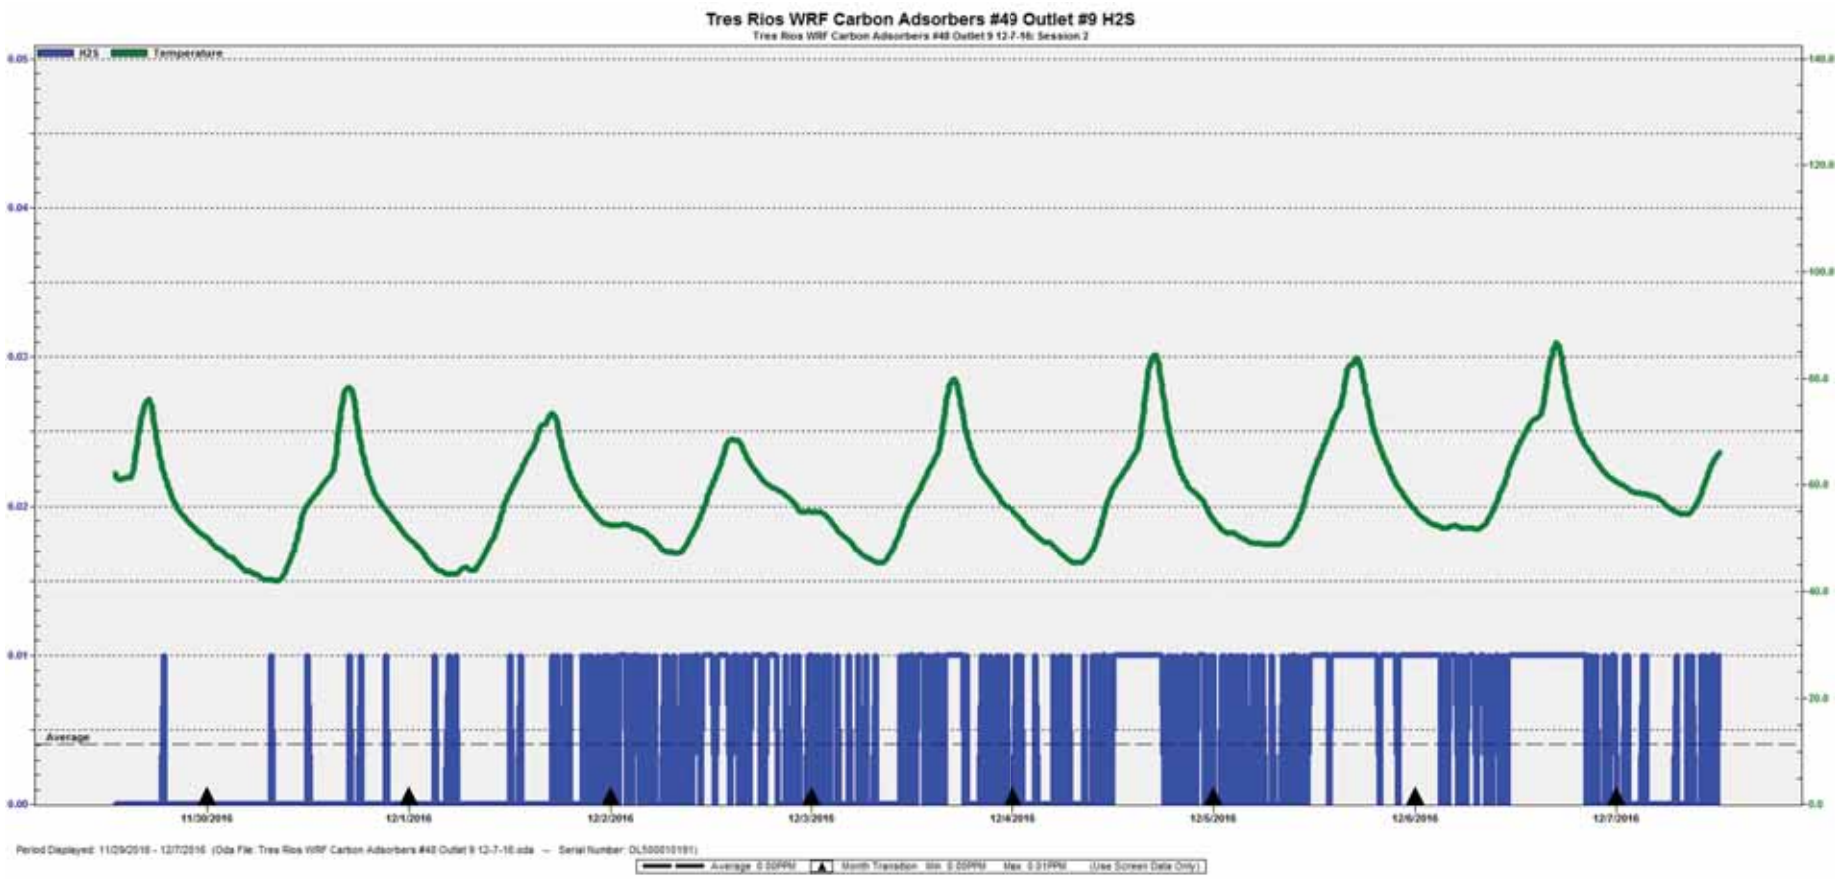
Figure 16. This figure depicts the overall hydrogen sulfide removal efficiency of the carbons adsorption scrubbers for the same period from 11/30/2016 through 12/7/2016. At no time did the hydrogen sulfide concentrations exceed 10 ppb and the exhaust is located in the center of the treatment facility and far removed from neighboring entities.

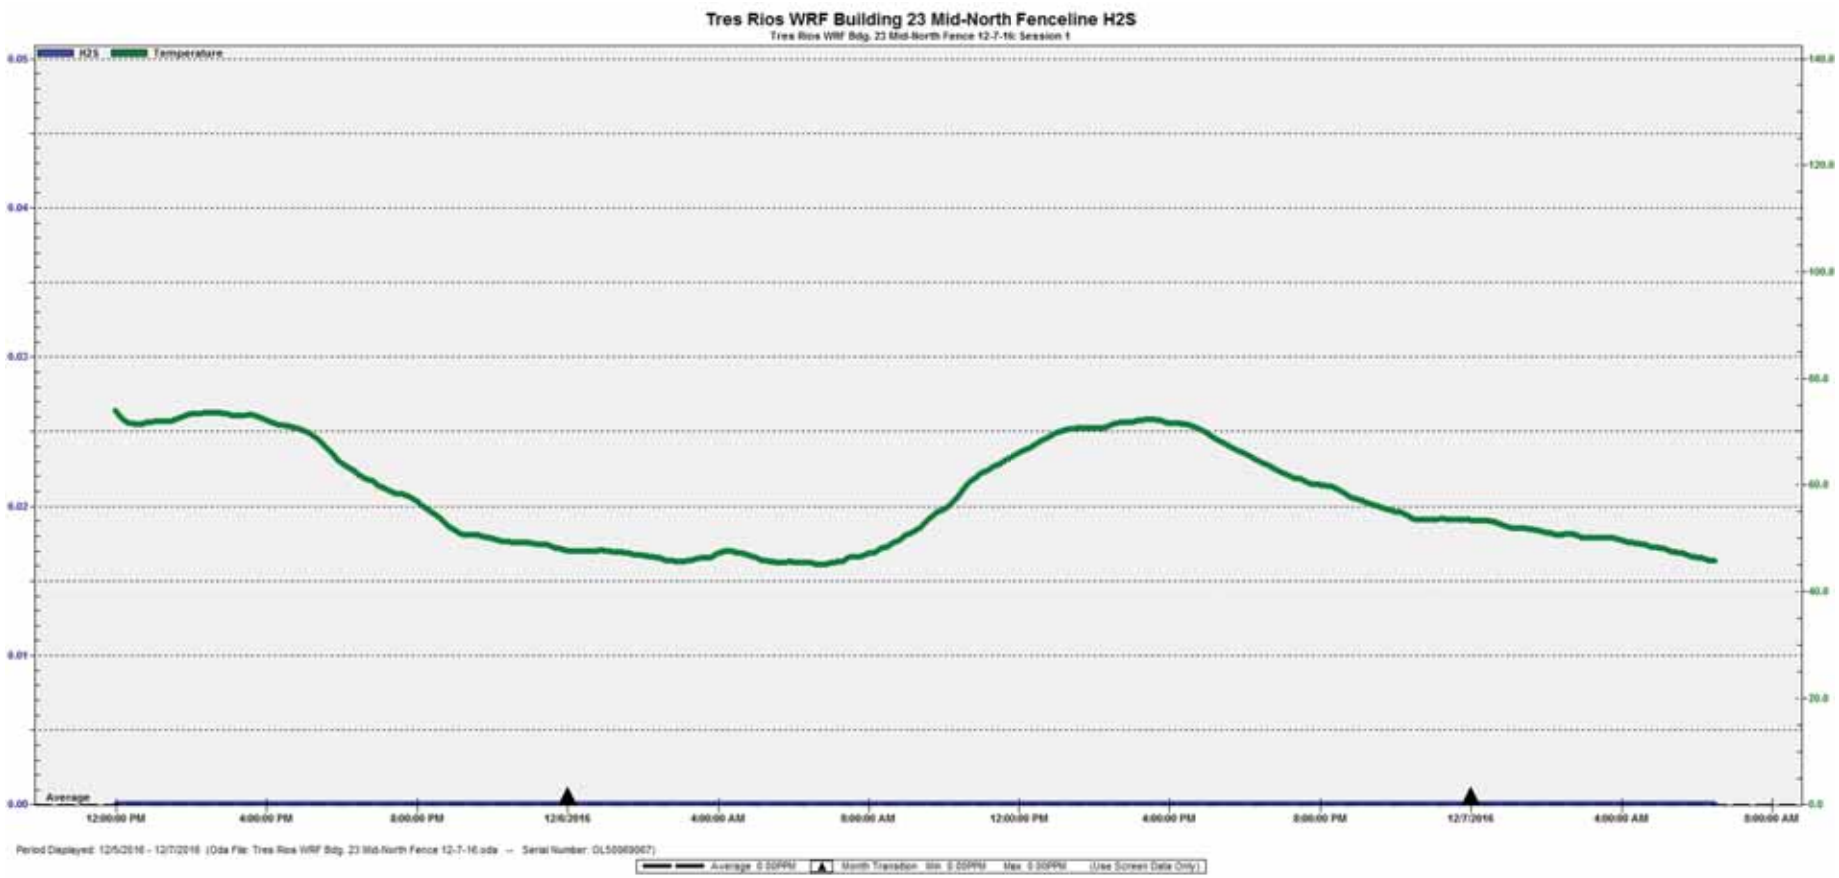
Figure 17. This chart depicts the facility fence line monitoring for the period from 12/5/2016 through 12/7/2016 showing no observable hydrogen sulfide odors at the facility boundary. The location of this sampling is midway between the northwest fence line monitoring near the digester complex/enclosed flare and Ina Road. Odors captured at this location would be indicative of odors originating from the carbon adsorption scrubbers, and centrifuge facility. No indications of observable hydrogen sulfide odors are indicated.
