PHOTOGRAPHIC LOG
Site Visit: January 2, 11 and 15, 2009

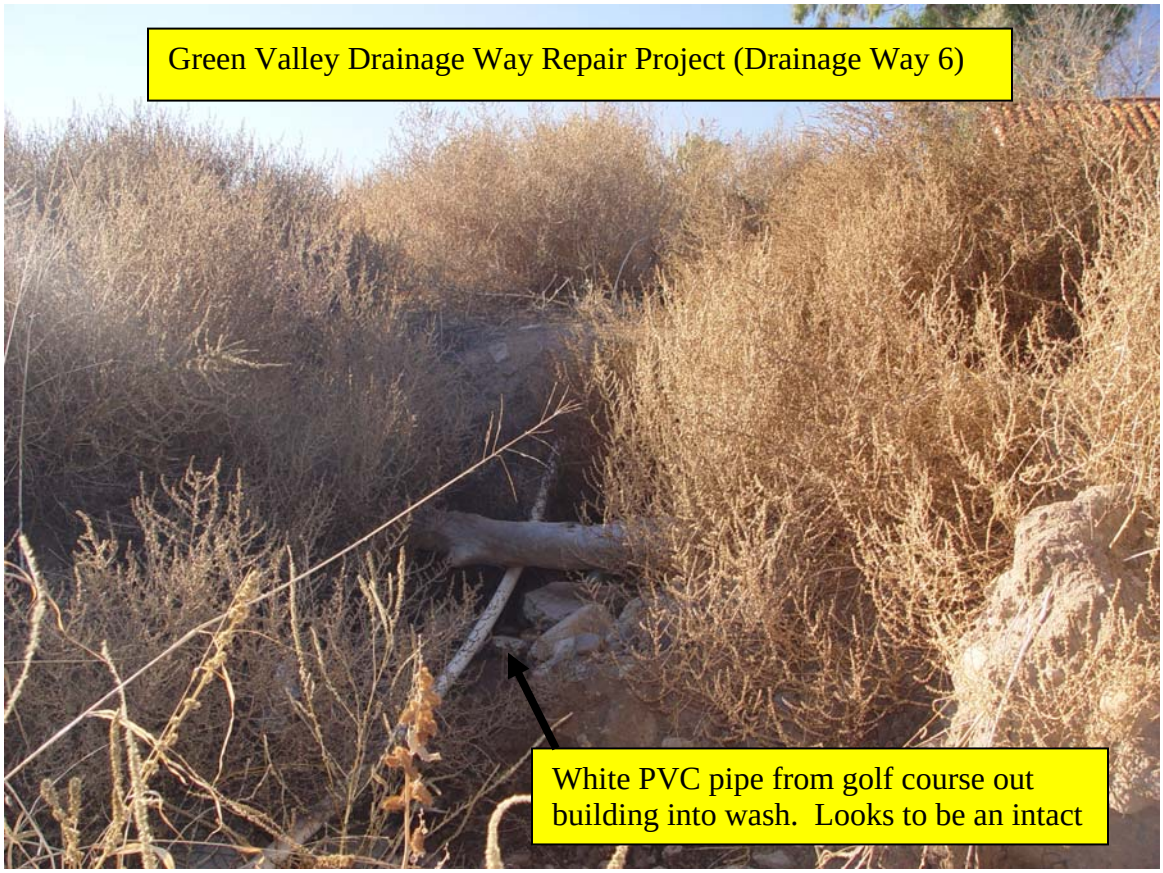
Green Valley Drainage Way Repair Project (Drainage Way 6)
White PVC pipe from golf course out building into wash. Looks to be an intact

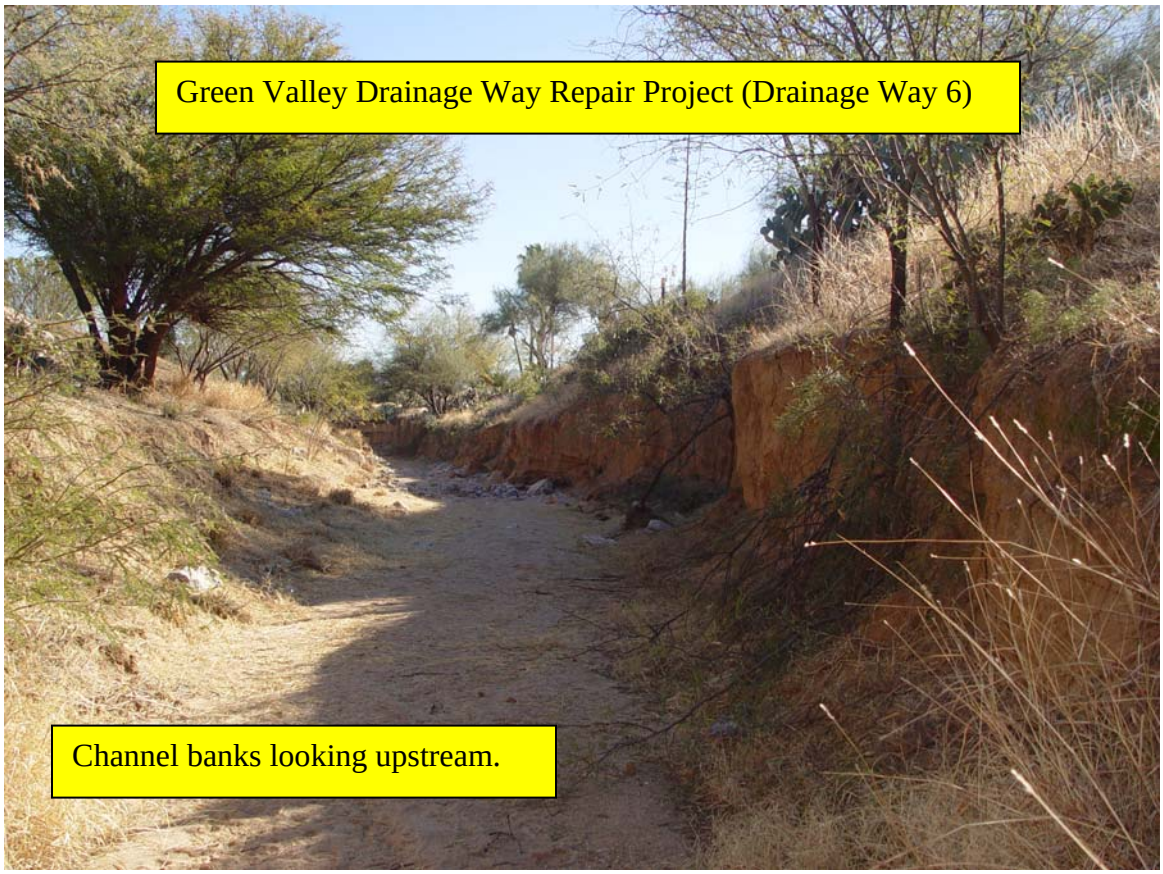
Green Valley Drainage Way Repair Project (Drainage Way 6)
Channel banks looking upstream.

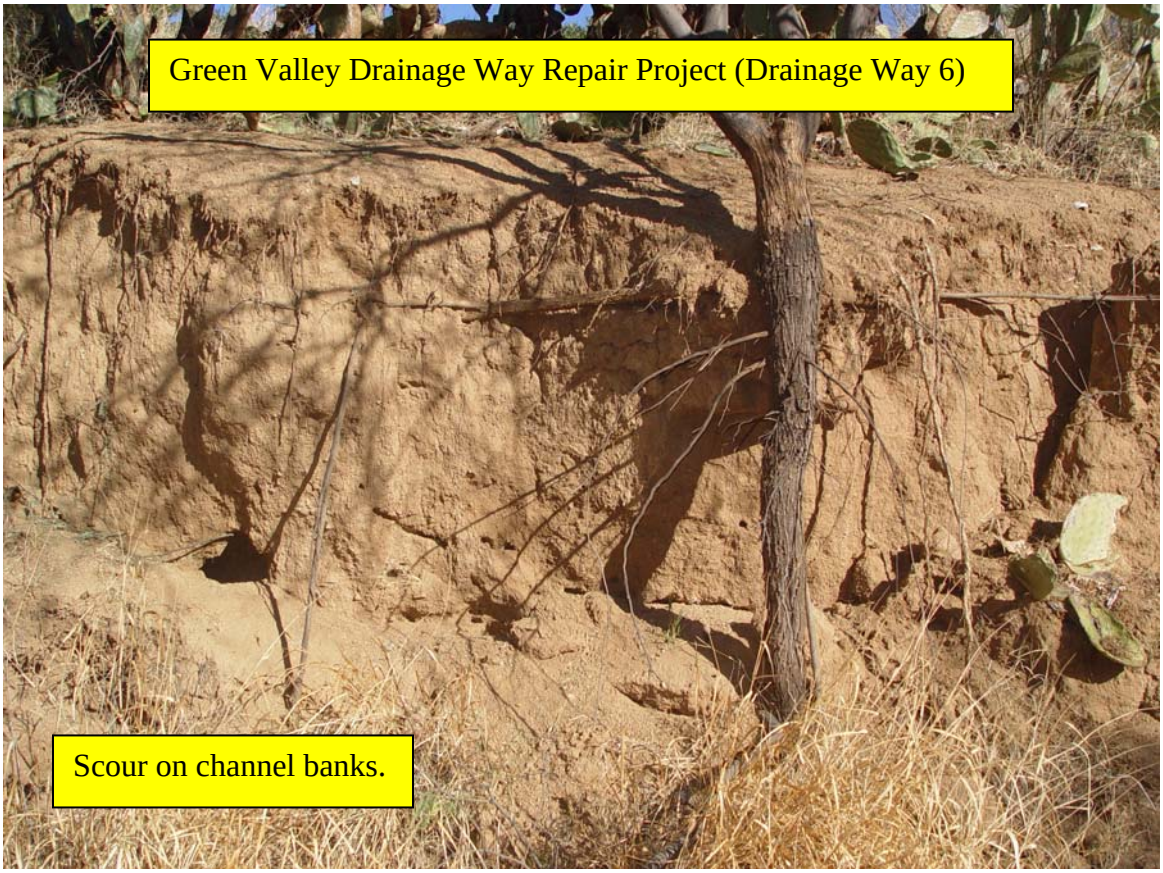
Green Valley Drainage Way Repair Project (Drainage Way 6)
Scour on channel banks.

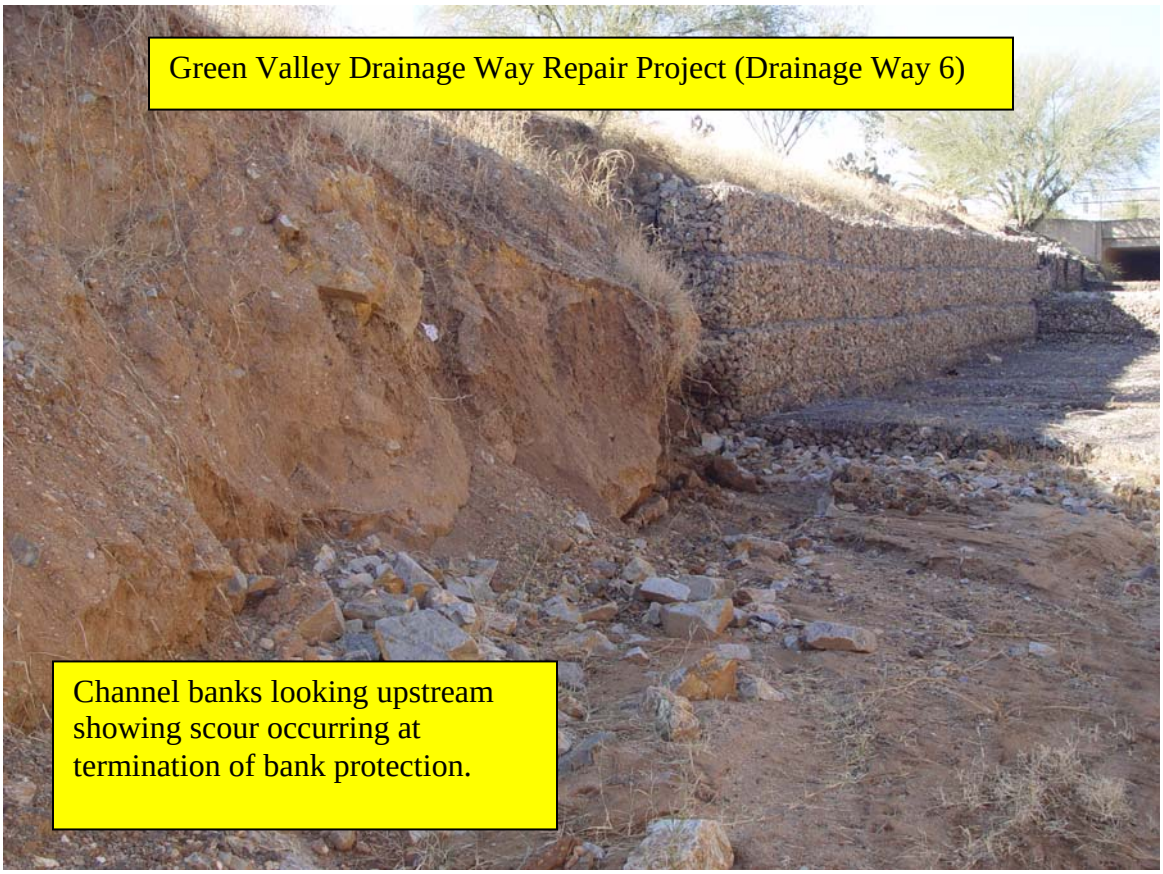
Green Valley Drainage Way Repair Project (Drainage Way 6)
Channel banks looking upstream showing scour occurring at termination of bank protection.

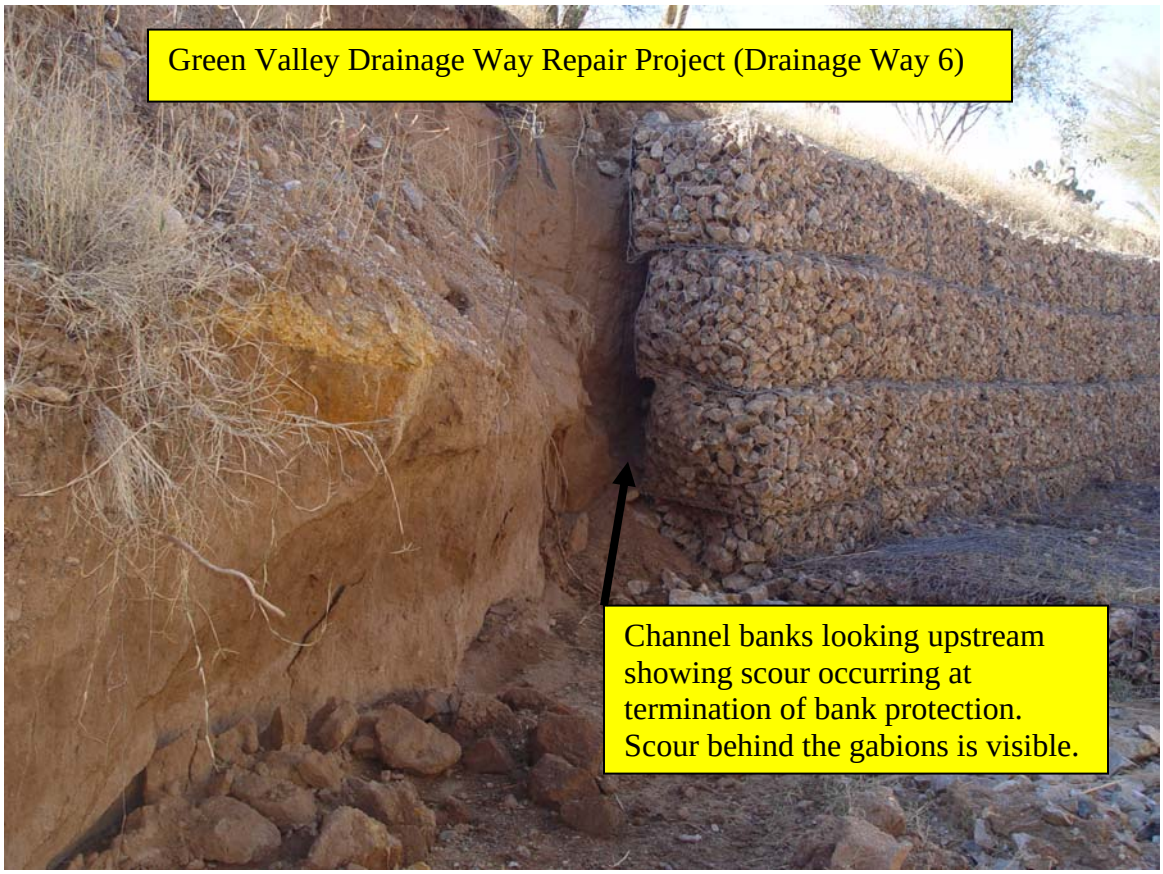
Green Valley Drainage Way Repair Project (Drainage Way 6)
Channel banks looking upstream showing scour occurring at termination of bank protection. Scour behind the gabions is visible.

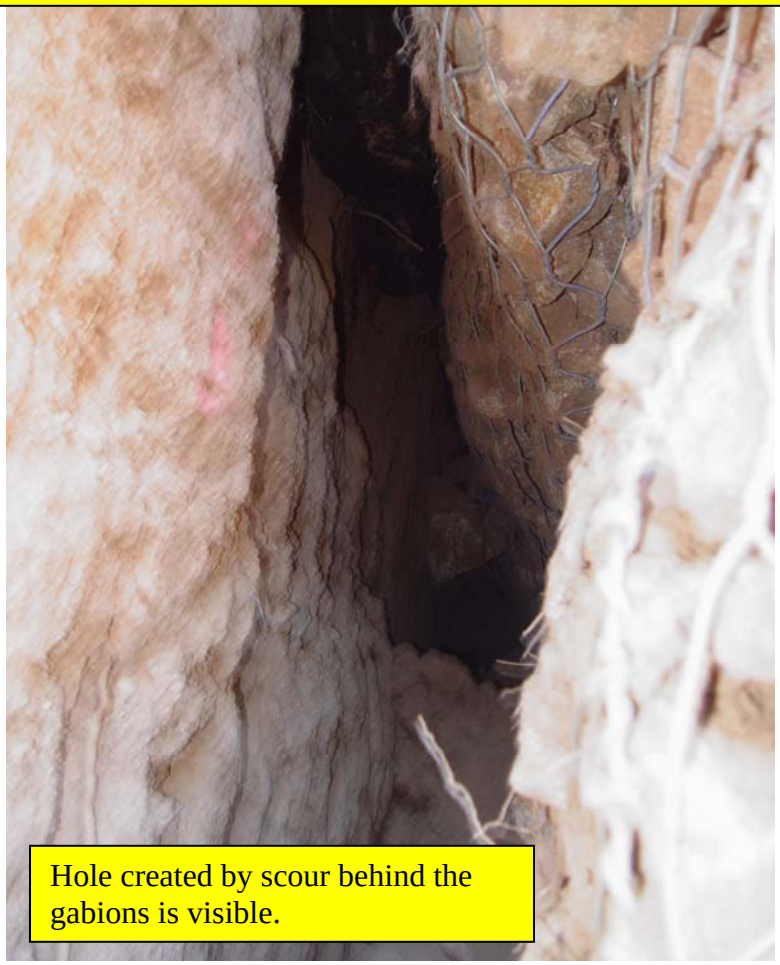
Hole created by scour behind the gabions is visible.

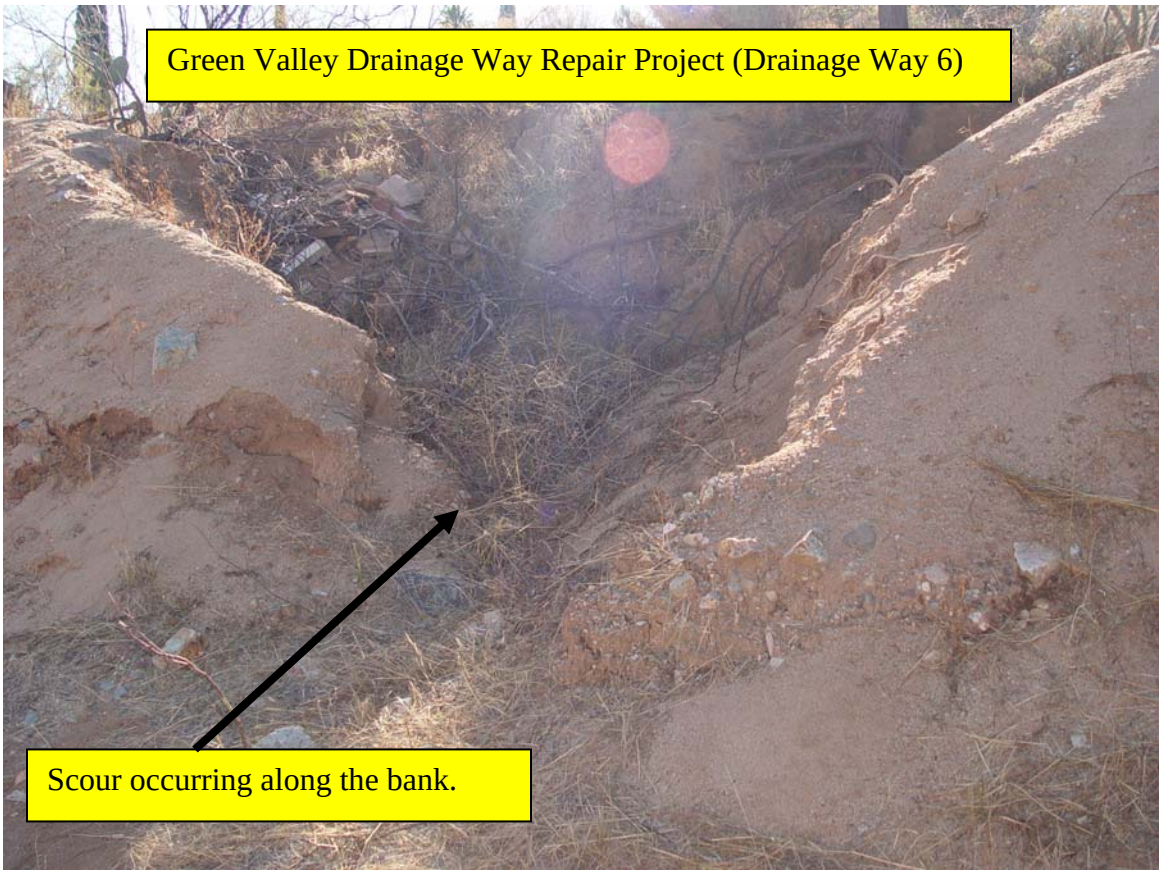
Green Valley Drainage Way Repair Project (Drainage Way 6)
Scour occurring along the bank.

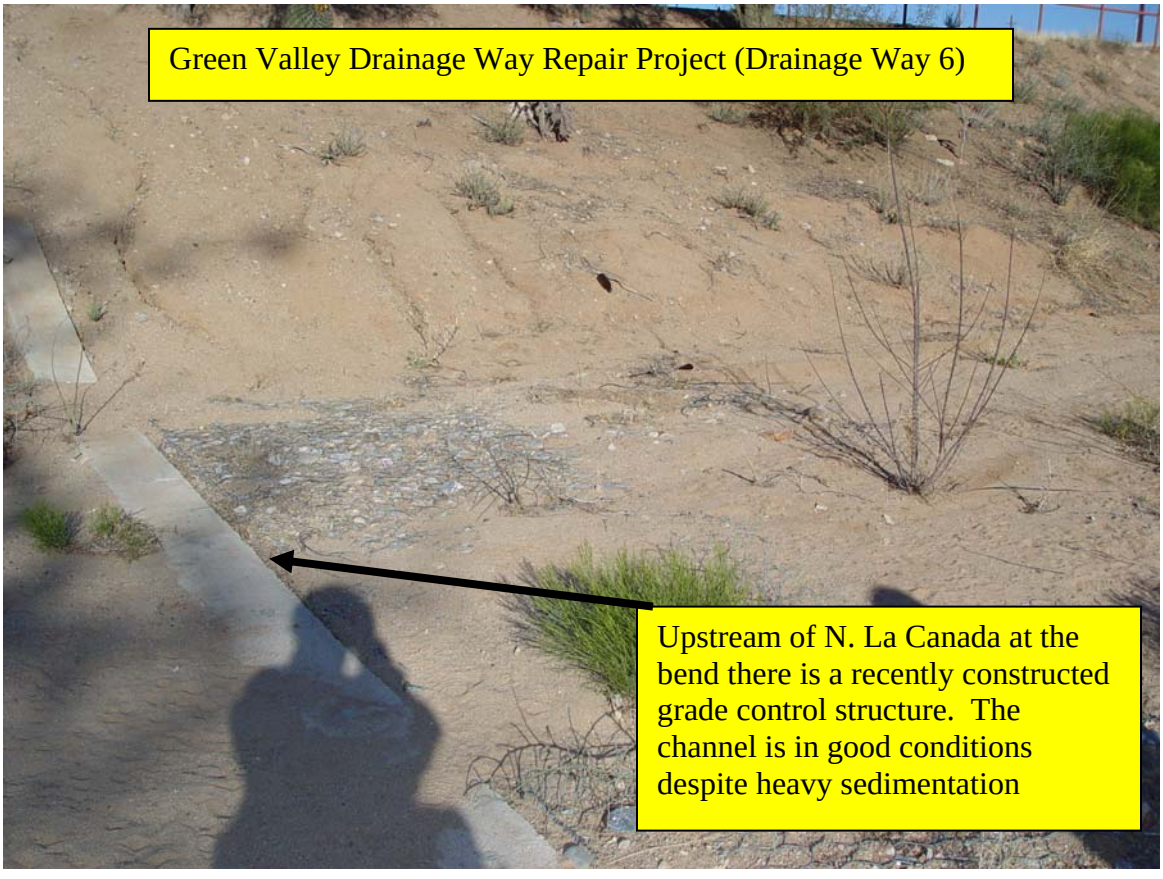
Green Valley Drainage Way Repair Project (Drainage Way 6)
Upstream of N. La Canada at the bend there is a recently constructed grade control structure. The channel is in good conditions despite heavy sedimentation
