# **‘GREEN AND HEALTHY’ ASSESSMENT OF PIMA COUNTY’S EMERGENCY SHELTERS AND TRANSITIONAL HOUSING**

*For Pima County Community Development and Neighborhood Conservation Department*  
FINAL DRAFT REVISED July 23, 2012

# Existing Conditions and Green/Health Assessment

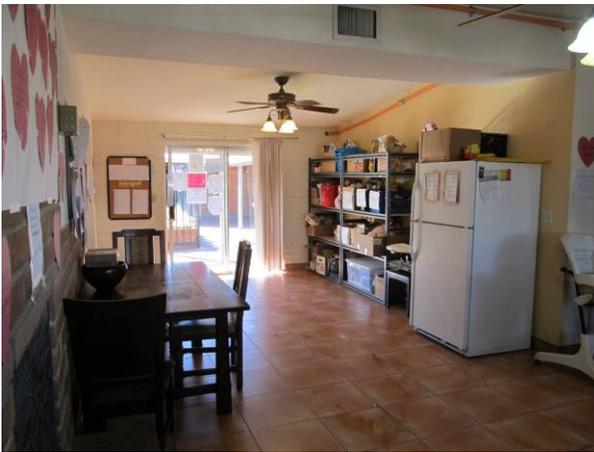
## Emerge! Renewal Center (50 beds)

Main Needs: Insulation furr-out, double-pane windows, low-flow fixtures, some electrical upgrade, water harvesting

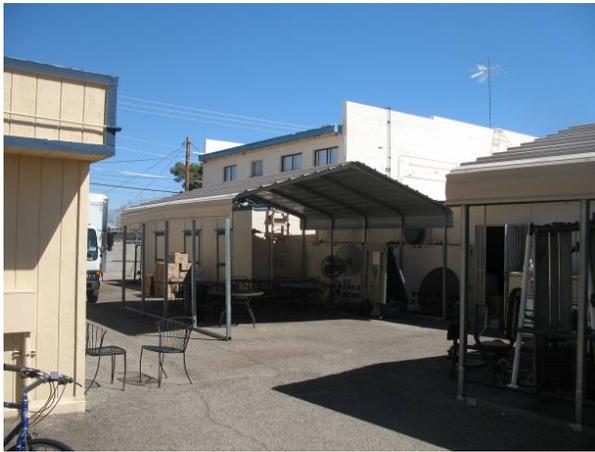
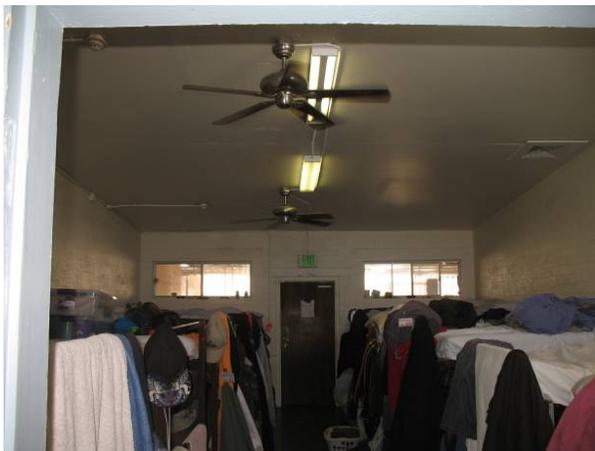
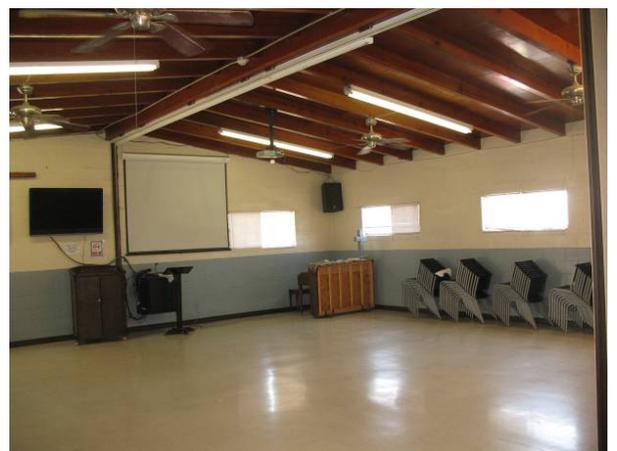
## Gospel Rescue Mission Men's Center (100 beds)

Main Needs: EIFS, new packaged AC, accessibility improvements, some remodel, double-pane windows, window shading, low-flow fixtures, energy-efficient lighting, electrical upgrade, water harvesting/landscaping, site planning & development

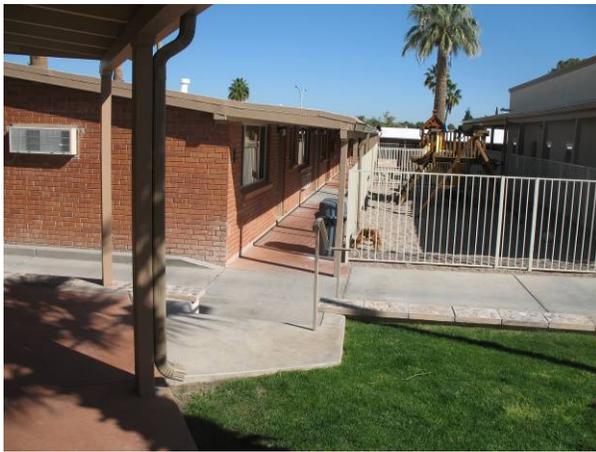
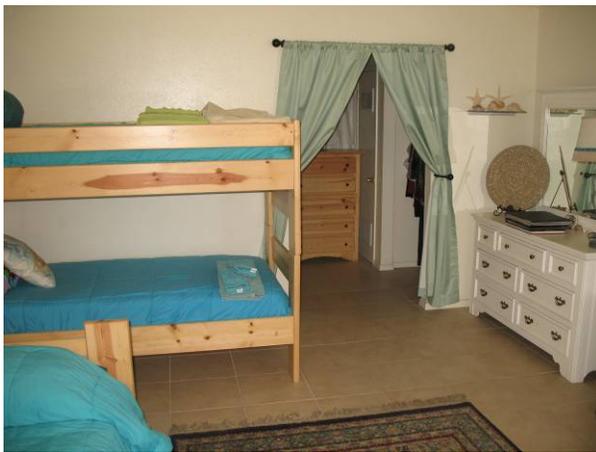
## Gospel Rescue Mission Women & Children's Center (32 units)

Main Needs: Insulation furr-out, some window shading, water harvesting, accessible unit

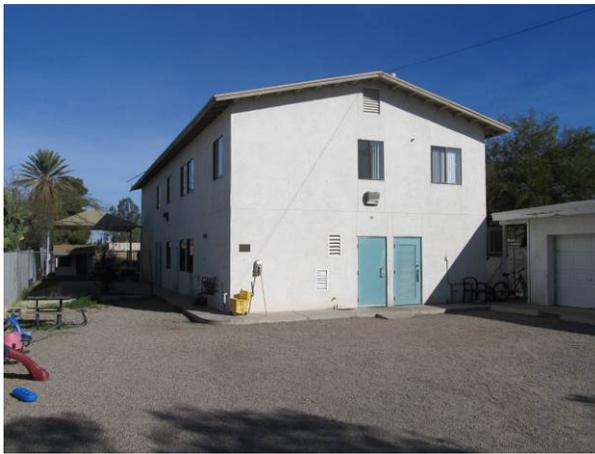
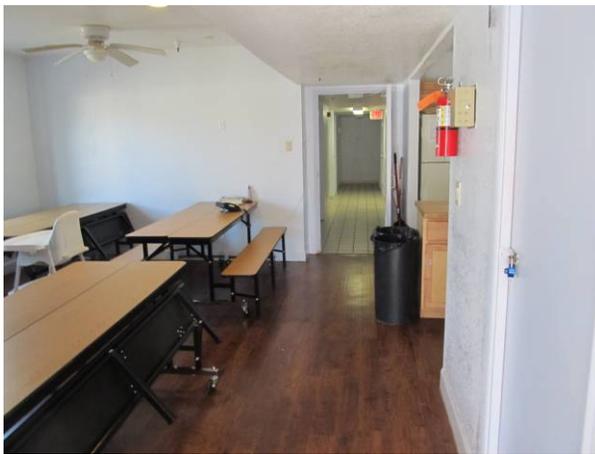
## New Beginnings for Women & Children Emergency Shelter (13 units)

Main Needs: Double-pane windows, window shading, low-flow fixtures, new packaged AC, electrical upgrade, water harvesting/landscaping, site planning & development

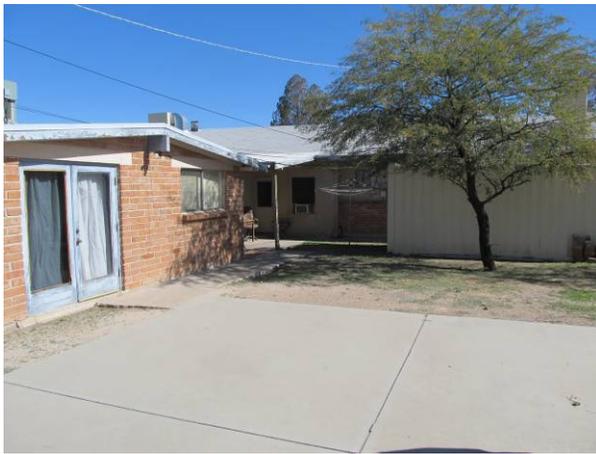
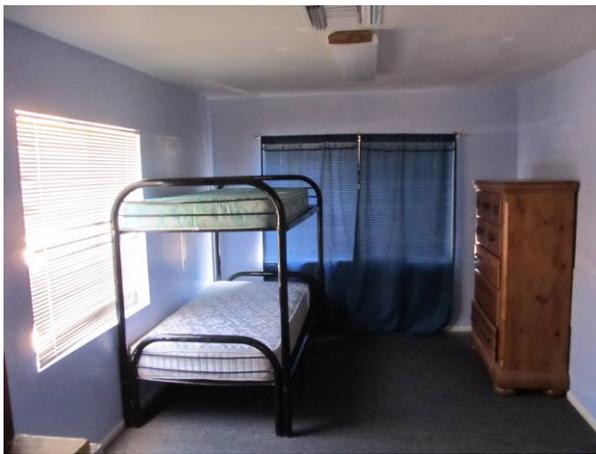
## Open Inn Louis Street Shelter (vacant)

Main Needs: Insulation and/or EIFS, double-pane windows, some window shading, low-flow fixtures, new packaged AC, water harvesting/landscaping, site planning & development

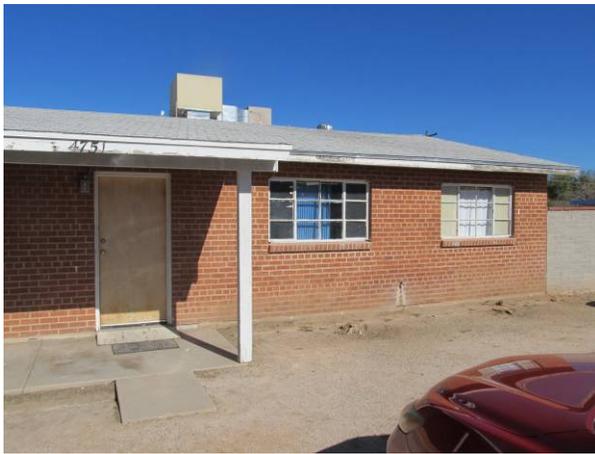
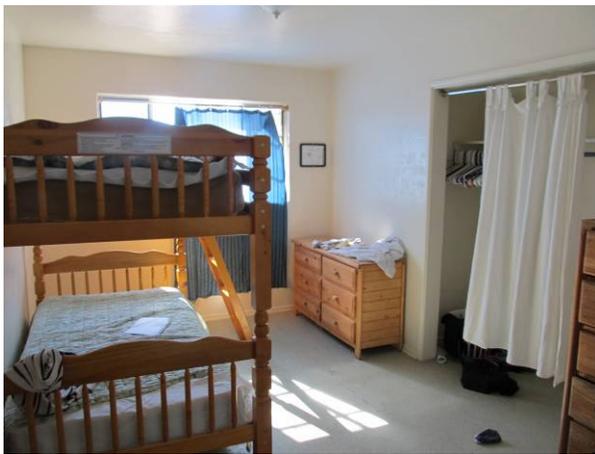
## Open Inn Linden Street Shelter (7 beds)

Main Needs: Insulation and/or EIFS, double-pane windows, window shading, low-flow fixtures, new packaged AC, water harvesting/landscaping, site planning & development

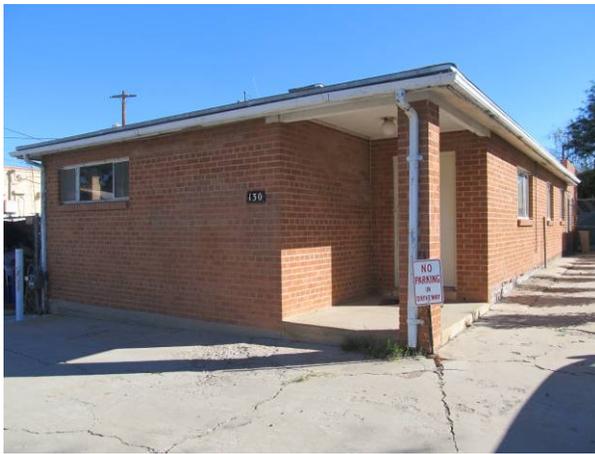
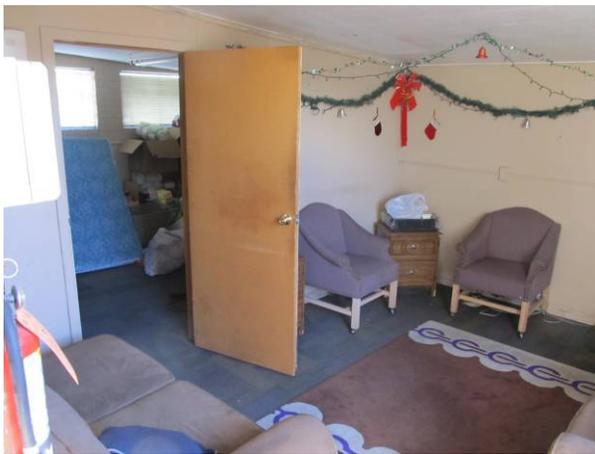
## Open Inn Ironhorse Shelter (temporary)

Main Needs: Insulation furr-out, double-pane windows, window shading, low-flow fixtures, electrical upgrade, water harvesting/landscaping, site planning & development

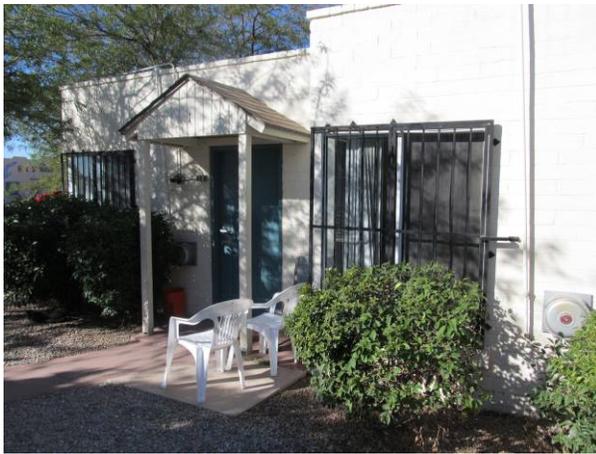
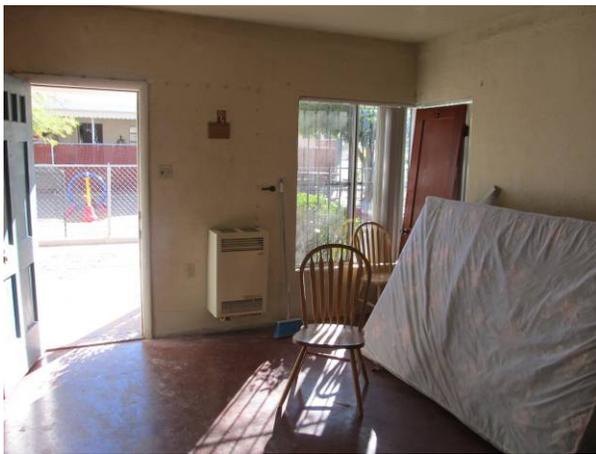
### Greyhound Family Shelter (17 units, 34 beds)

Main Needs: EIFS, window shading, ceiling fans

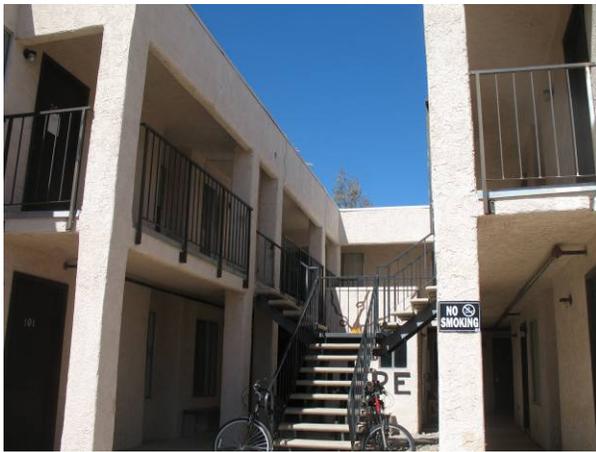
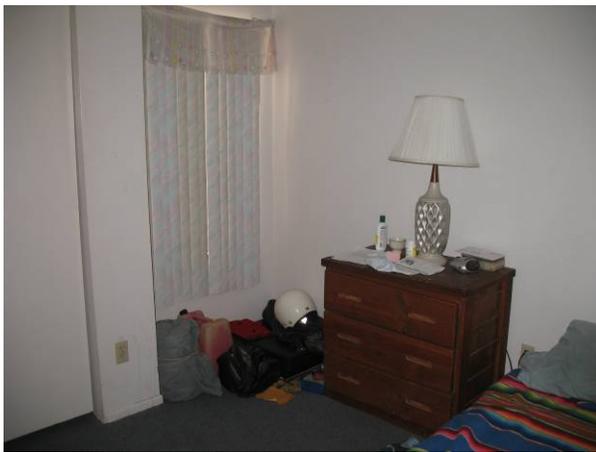
### Comin' Home – Apartments (15 units, 30 beds)

Main Needs: Double-pane windows, window shading, low-flow fixtures, water harvesting, accessibility improvements

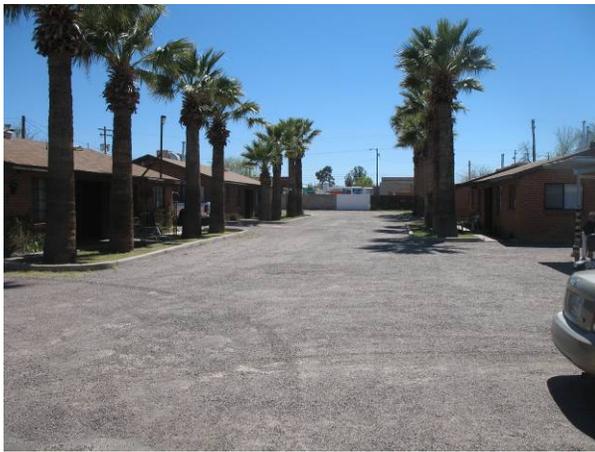
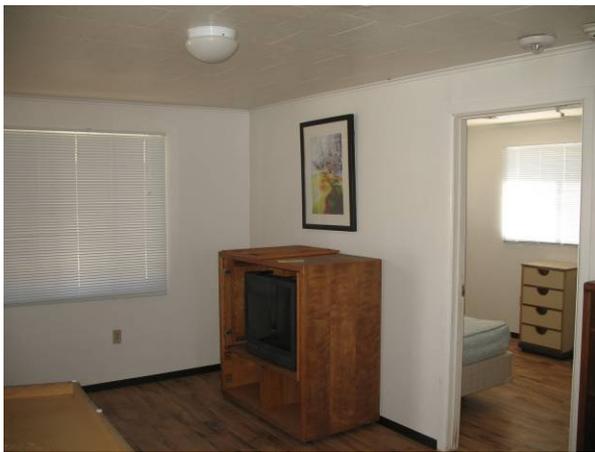
### Comin' Home – Duplexes (7 duplexes, 22 beds)

Main Needs: Insulation and/or EIFS, new packaged AC, accessibility improvements, double-pane windows, window shading, low-flow fixtures, electrical upgrade, water harvesting/landscaping, site planning & development

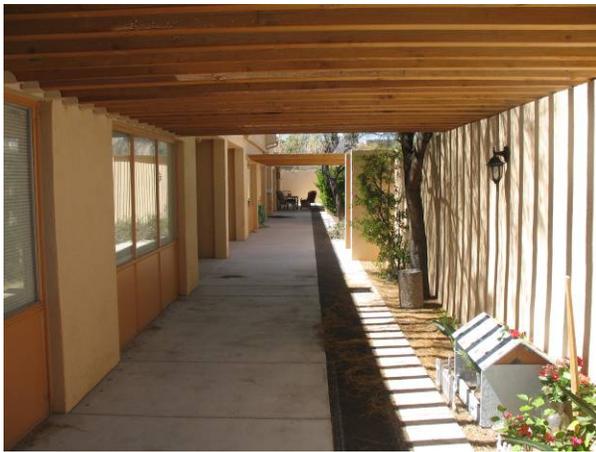
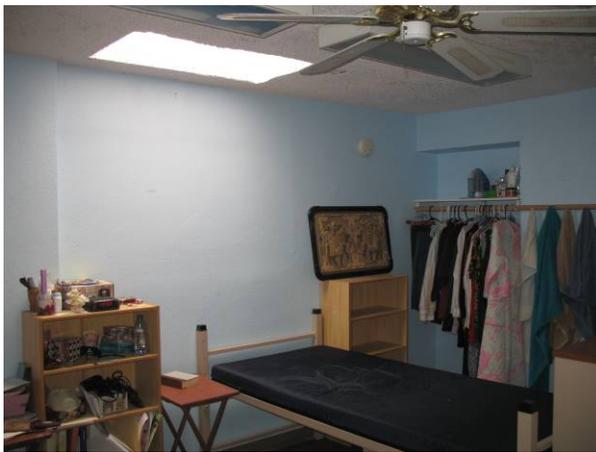
### Las Amigas (9 rooms, 21 beds)

Main Needs: Accessibility improvements, double-pane windows, some window shading, low-flow fixtures, energy-efficient lighting, water harvesting

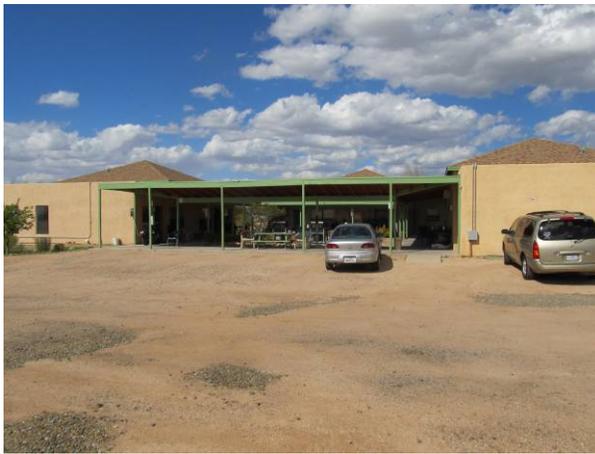
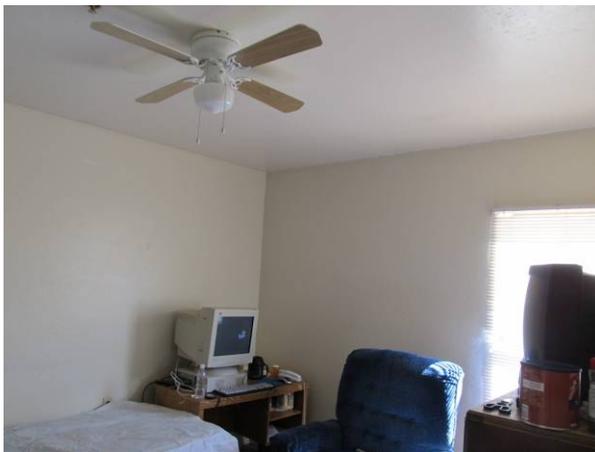
## Esperanza En Escalante Disabled Units (3 units, 15 beds)

Main Needs: New packaged AC, some window shading, may need low-flow fixtures, site planning & development

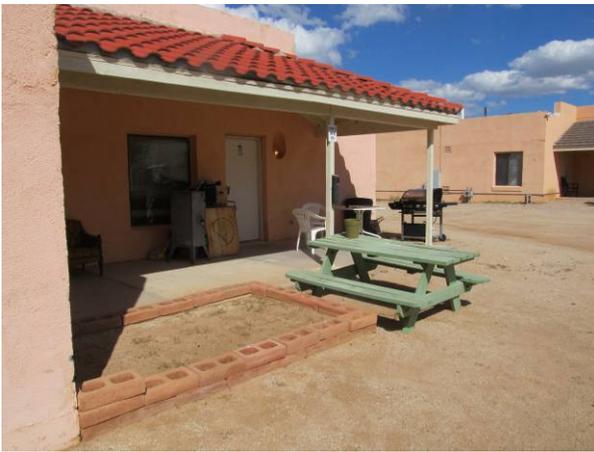
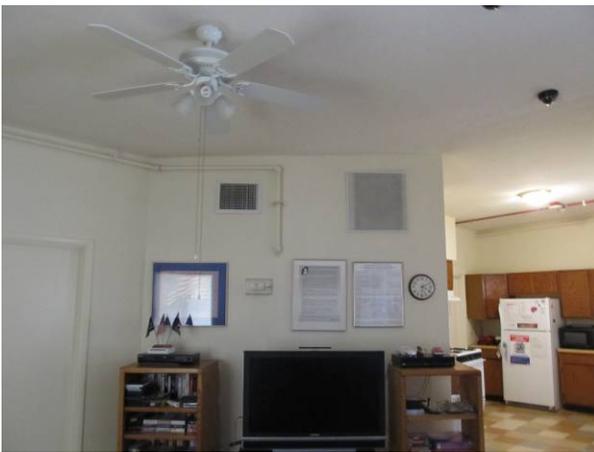
## Esperanza En Escalante Individual Units (5 units, 23 beds)

Main Needs: New packaged AC, some window shading, low-flow fixtures, water harvesting/landscaping, site planning & development

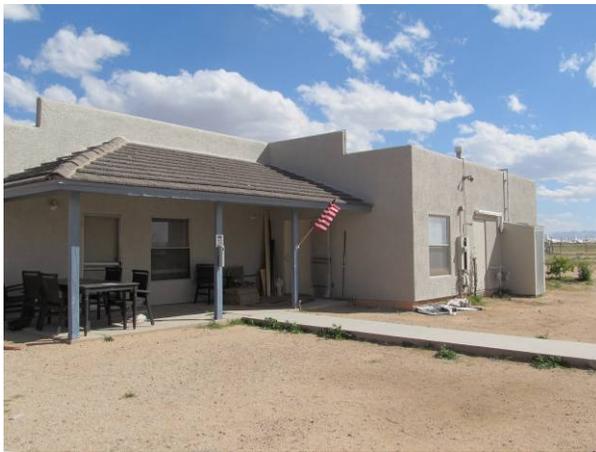
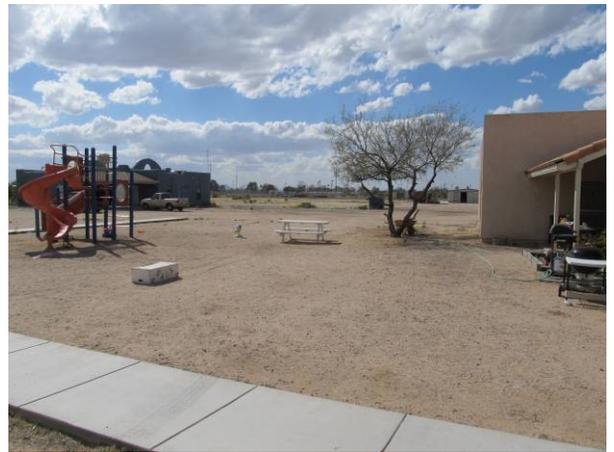
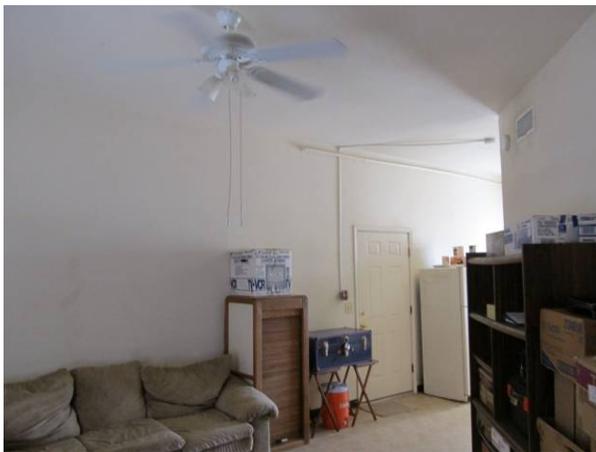
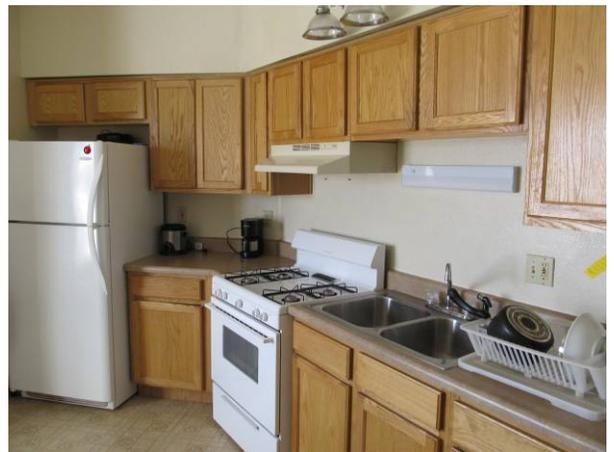
## Esperanza En Escalante Family Units (8 units)

Main Needs: New packaged AC, some window shading, low-flow fixtures, water harvesting/landscaping, site planning & development

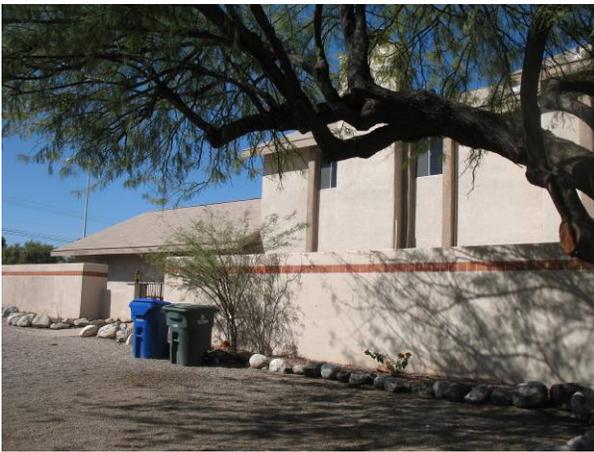
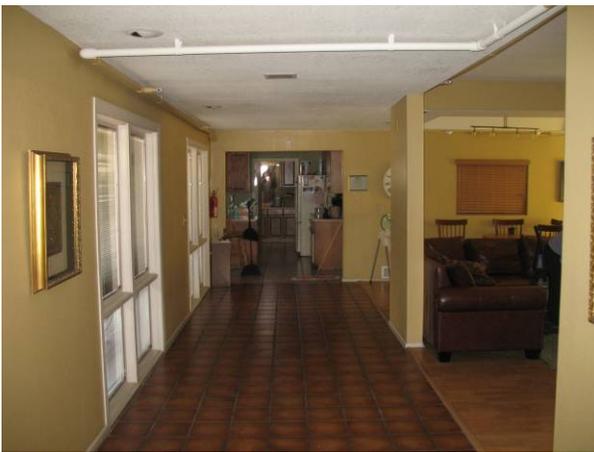
## Gospel Rescue Mission Women's Transitional (6 bedrooms)

Main Needs: Accessibility improvements, double-pane windows, some window shading, low-flow fixtures, water harvesting

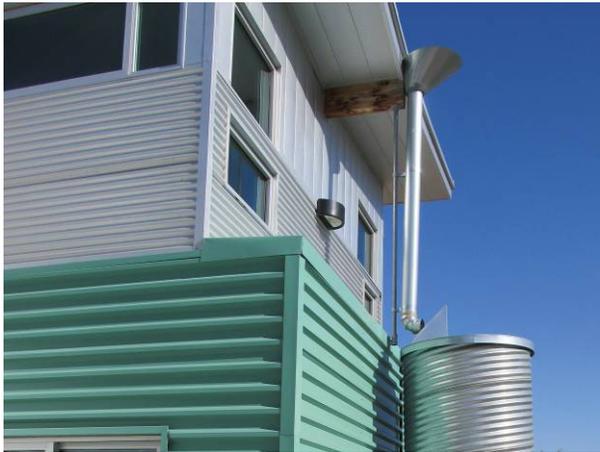
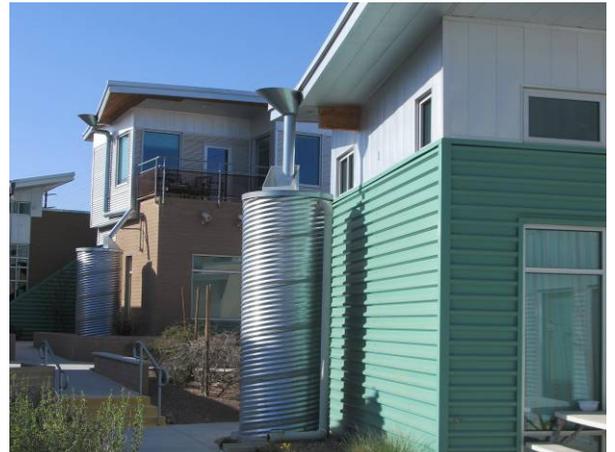
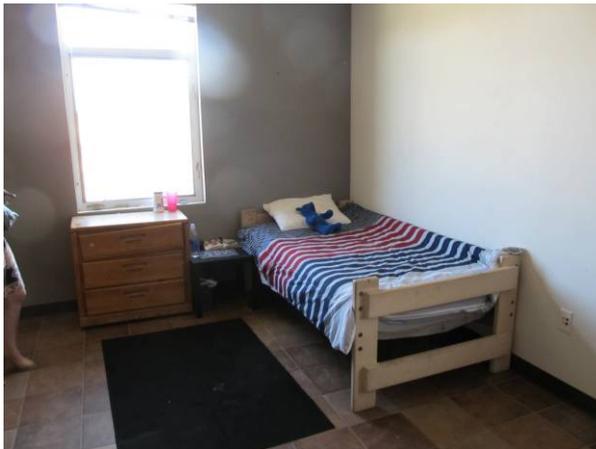
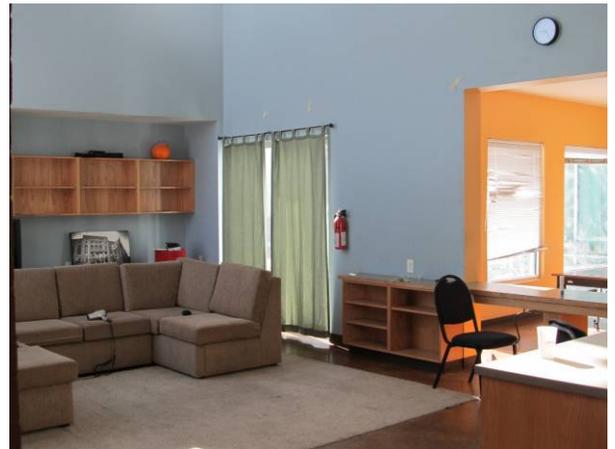
## La Paloma Family Services Fairview Group Home (10 beds)

Main Needs: Ceiling fans, may need low-flow, energy-efficient appliances

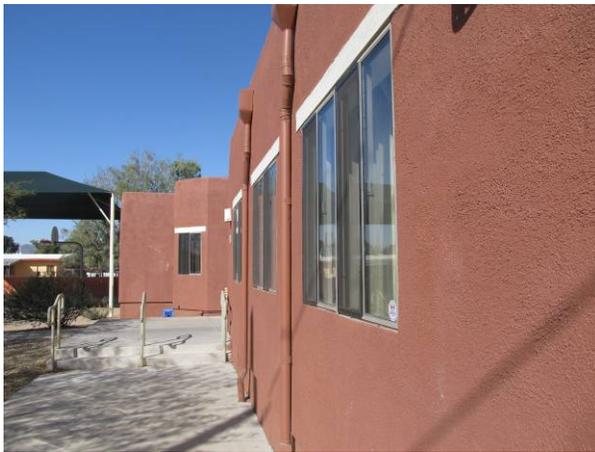
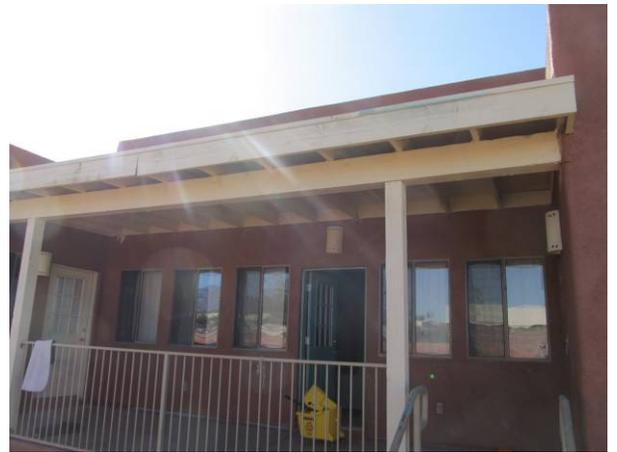
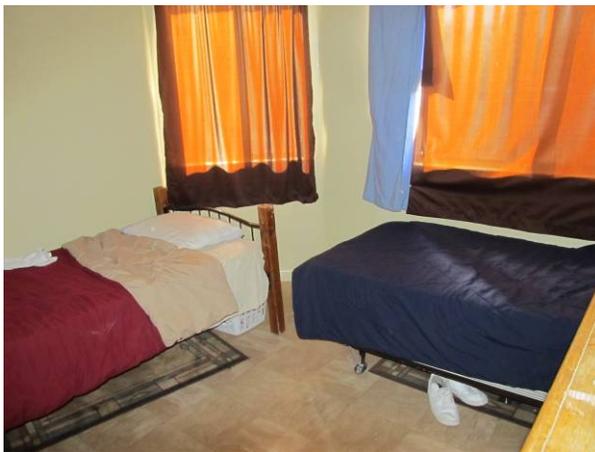
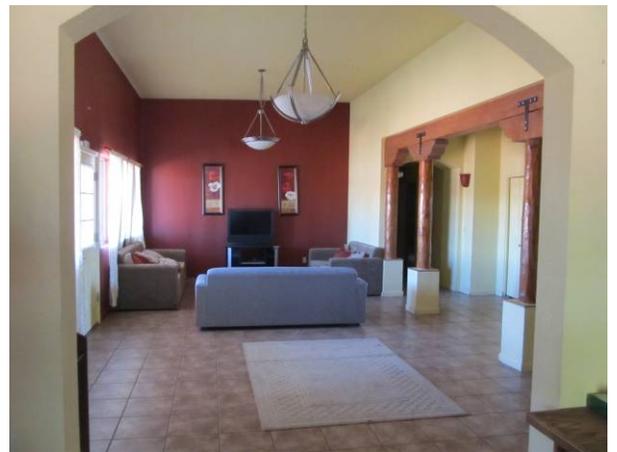
## La Paloma Family Services Menninger Group Home (10 beds)

Main Needs: Accessibility improvements, window shading, some electrical upgrade, water harvesting/landscaping

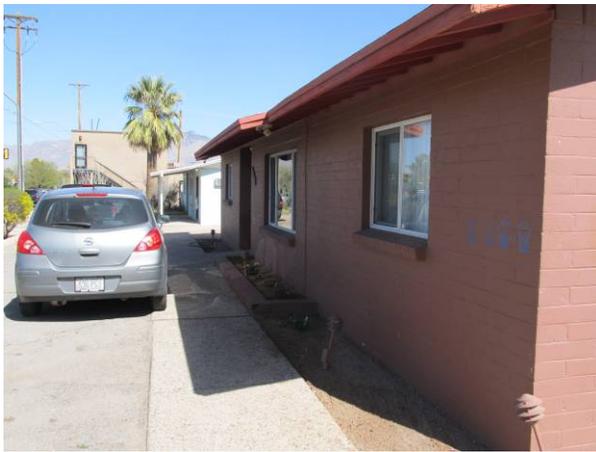
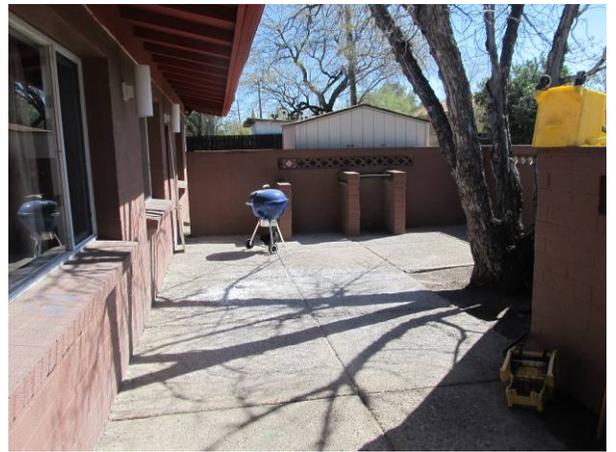
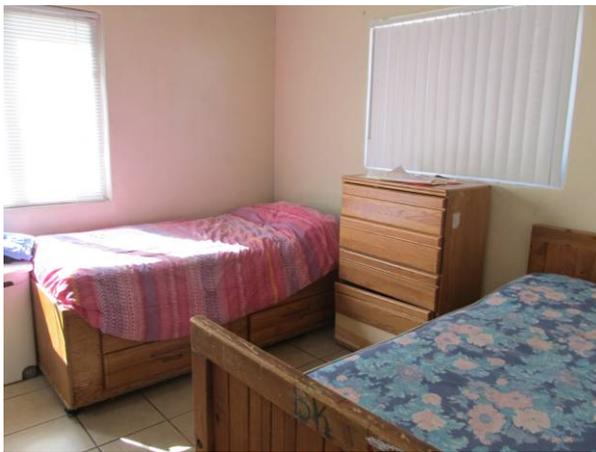
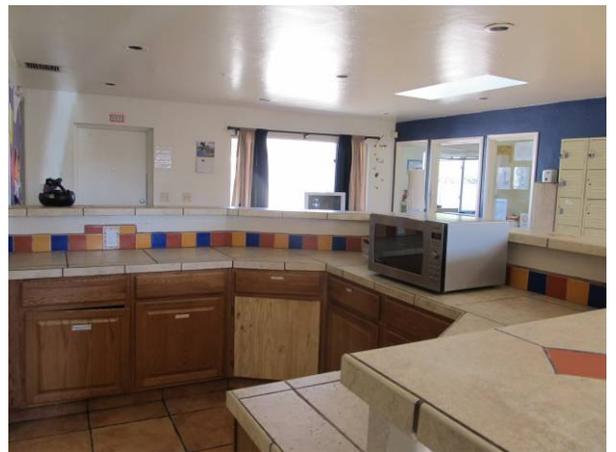
## La Paloma Family Services Diamondback Group Home (10 beds)

Main Needs: Accessibility improvements, some window shading, low-flow fixtures, water harvesting/landscaping

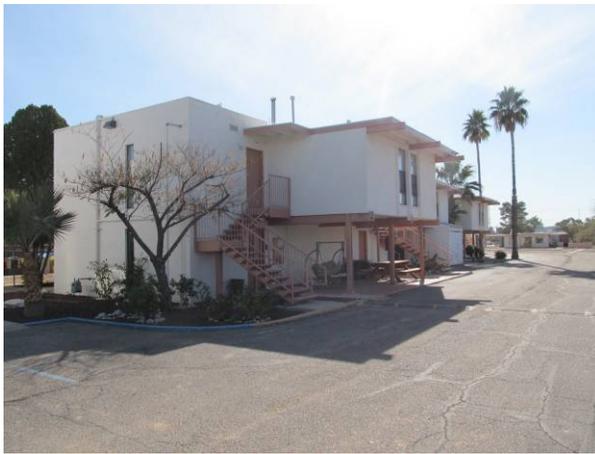
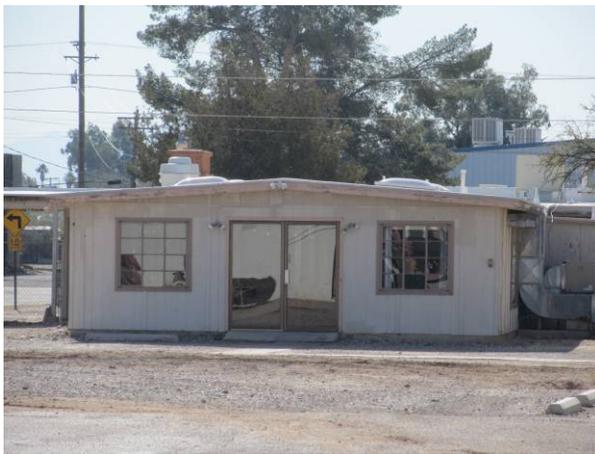
### Bridges: Mohave (15 units)

Main Needs: Insulation and/or EIFS, new packaged AC, accessibility improvements, window shading, low-flow fixtures, energy-efficient lighting, electrical upgrade, water harvesting/landscaping, site planning & development

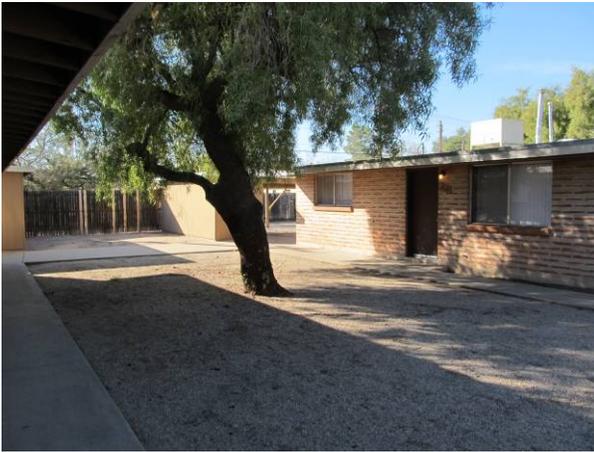
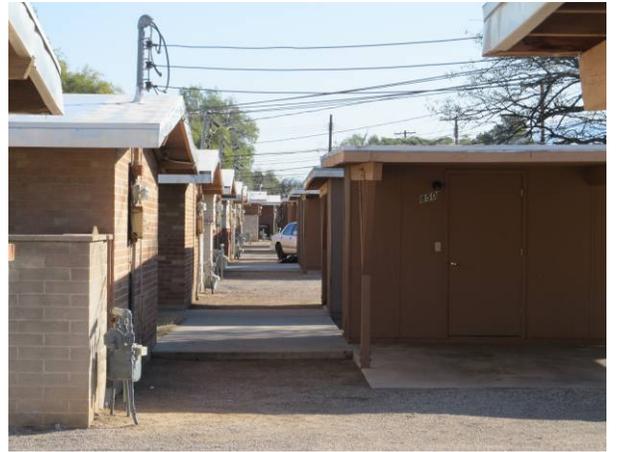
### Bridges: Holaway (4 units)

Main Needs: Insulation and/or EIFS, new packaged AC, accessibility improvements, double-pane windows, some window shading, low-flow fixtures, energy-efficient lighting, electrical upgrade, water harvesting/landscaping, site planning & development

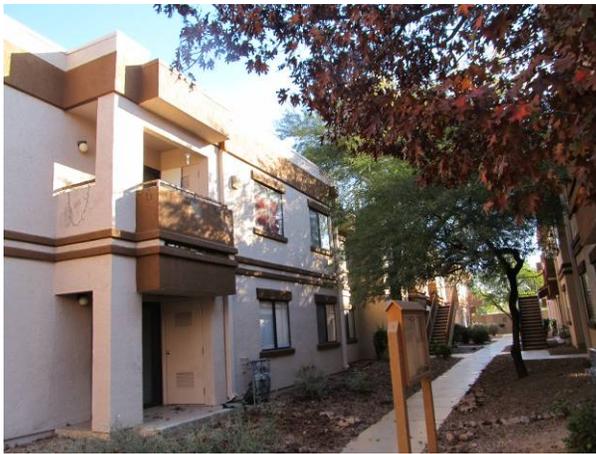
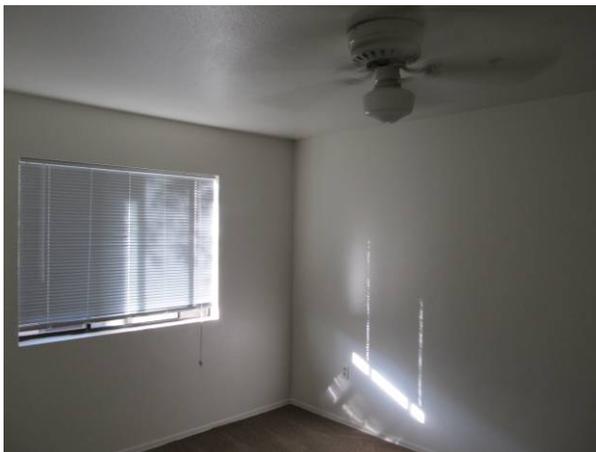
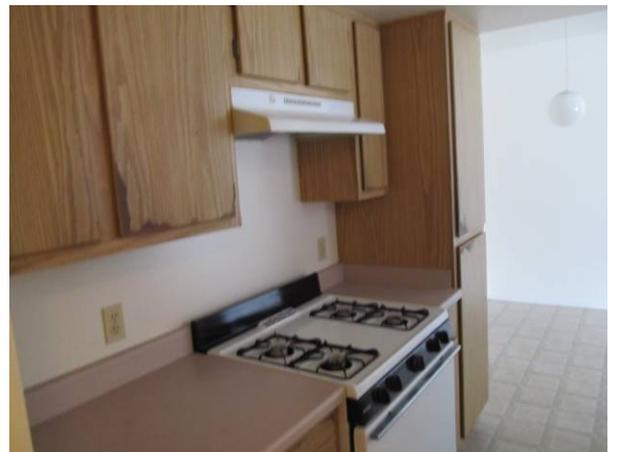
### La Promesa Apartments (23 units)

Main Needs: Accessibility improvements, window shading, low-flow fixtures, energy-efficient lighting, water harvesting

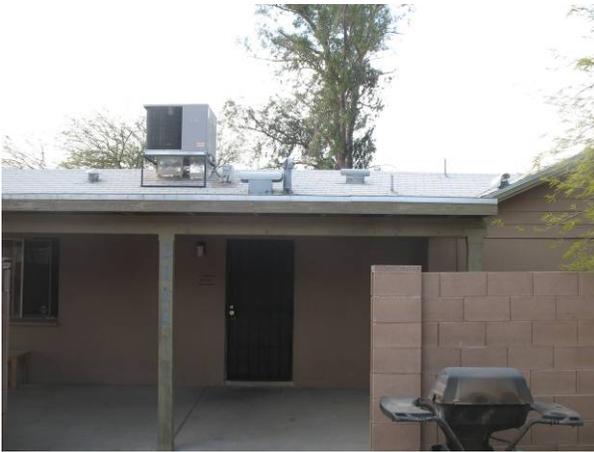
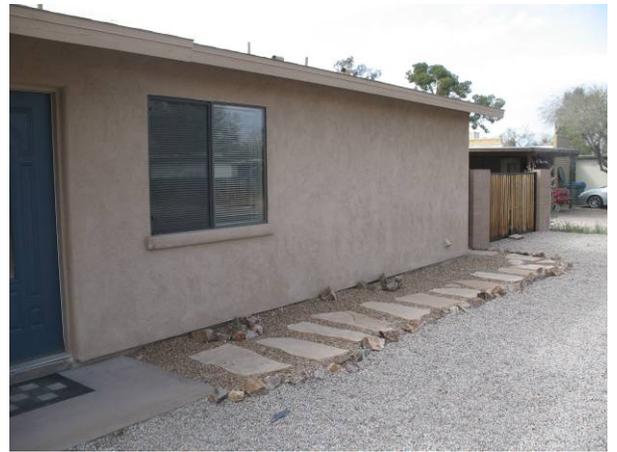
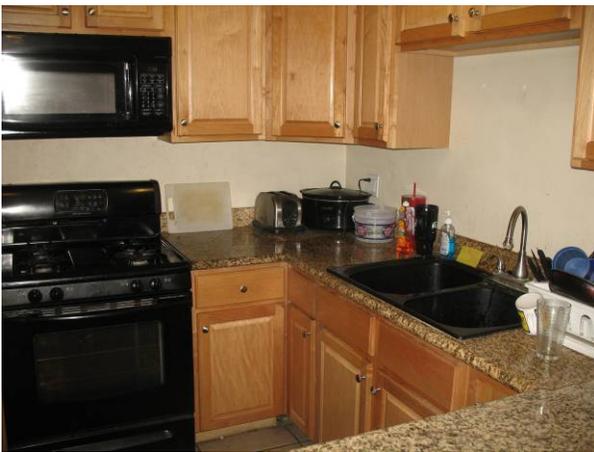
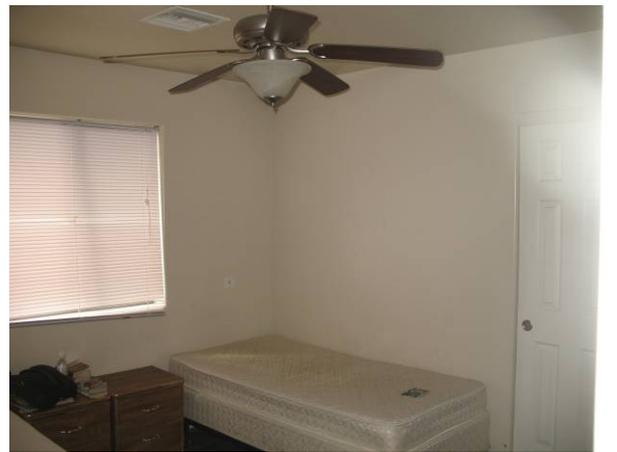
### Bell Seneca (12 beds)

Main Needs: Accessibility improvements, double-pane windows, some window shading, water harvesting/landscaping

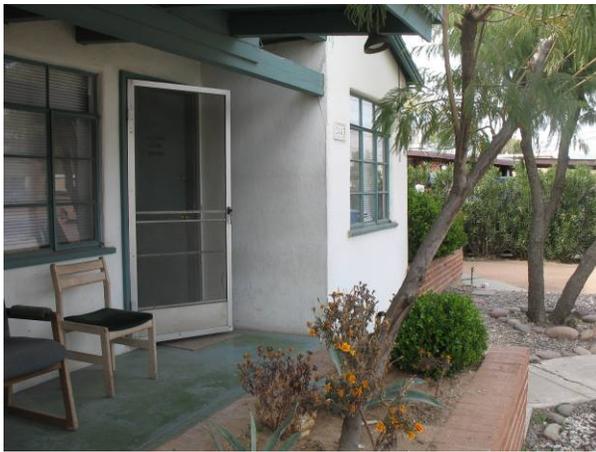
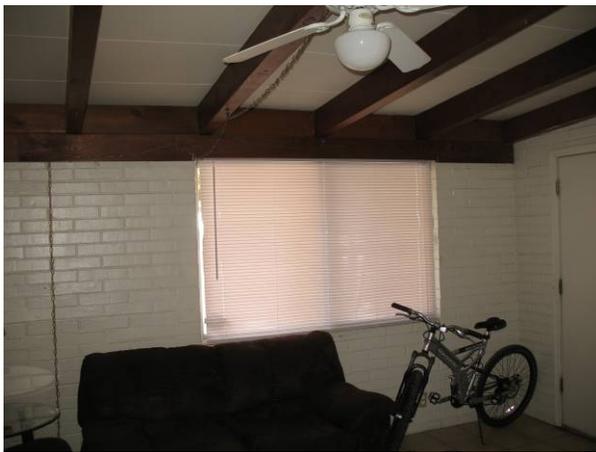
### Sparkman (11 beds)

Main Needs: New packaged AC, accessibility improvements, double-pane windows, some window shading, low-flow fixtures, electrical upgrade, some site development, water harvesting/ landscaping, site planning & development

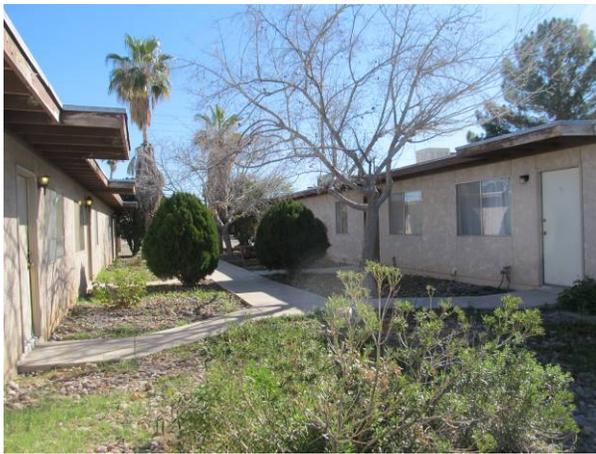
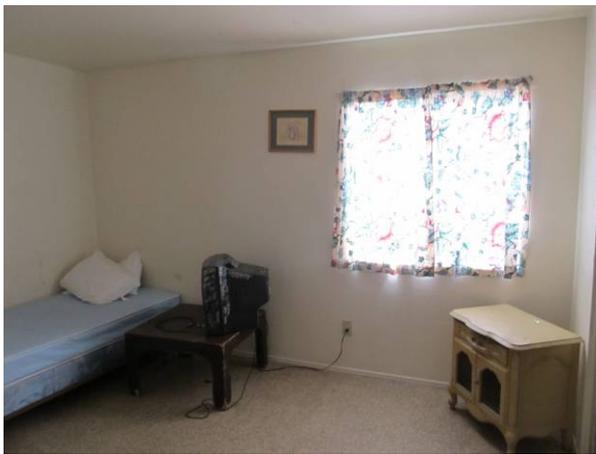
Open Inn  
TALP (8 beds, 4 units)  
Tucson, AZ

Main Needs: New packaged AC, accessibility improvements, double-pane windows, some window shading, low-flow fixtures, electrical upgrade, water harvesting/landscaping

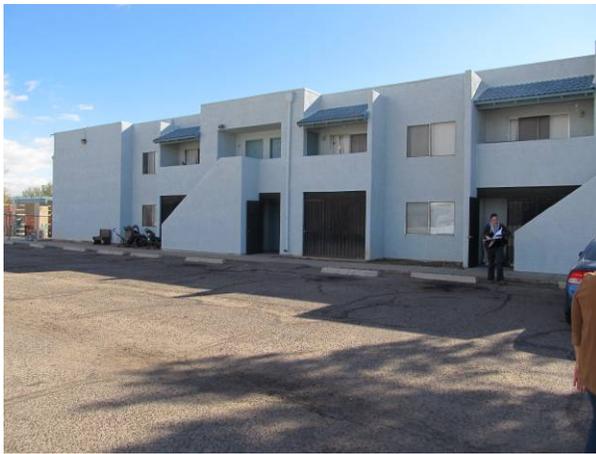
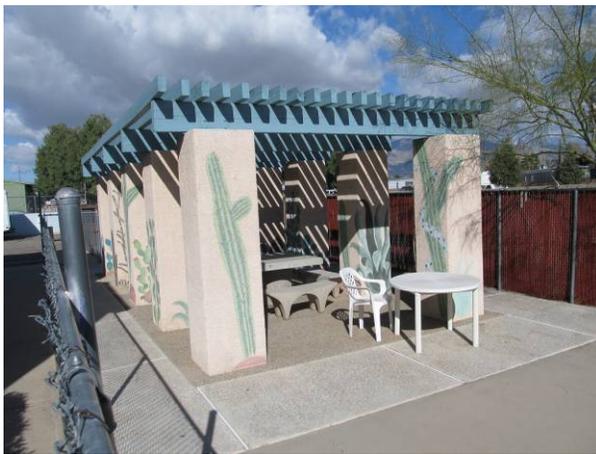
### Common Unity – Apartments (20 units)

Main Needs: Accessibility improvements, double-pane windows, some window shading, low-flow fixtures, energy-efficient lighting, water harvesting/landscaping

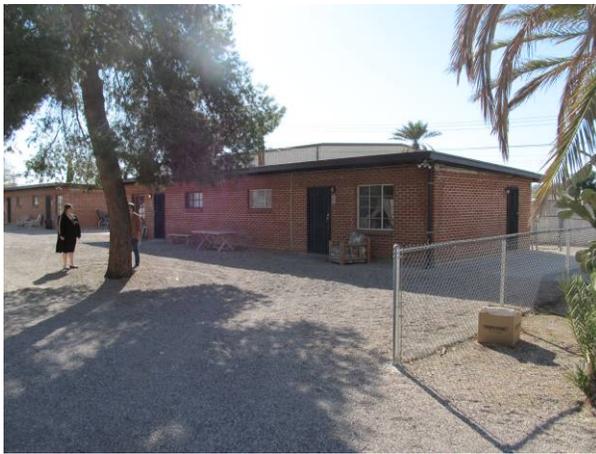
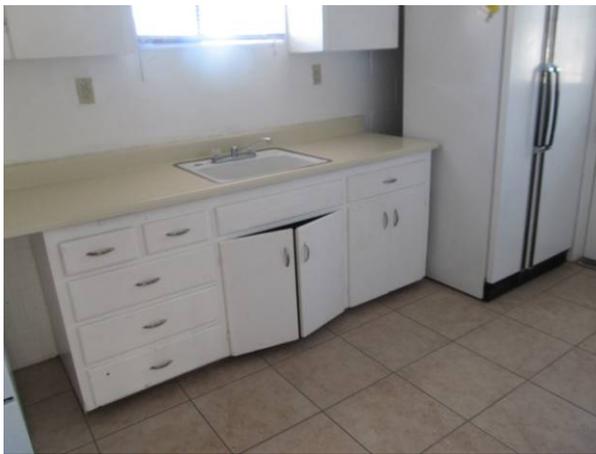
## Our Family Services The Hearth (6 units)

Main Needs: (Some units) insulation and/or EIFS, new packaged AC, accessibility improvements, double-pane windows, some window shading, low-flow fixtures, energy-efficient lighting, electrical upgrade, water harvesting/landscaping, site planning & development

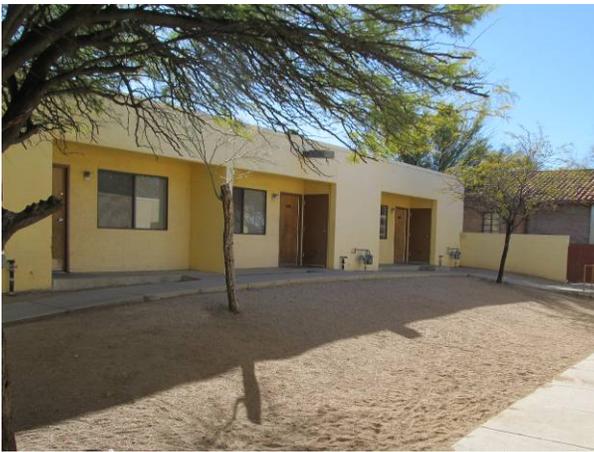
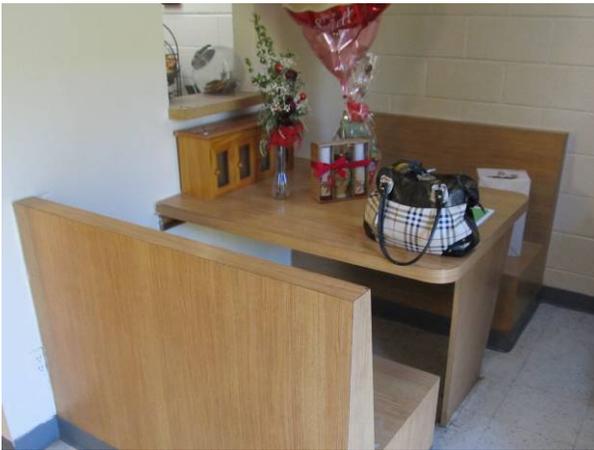
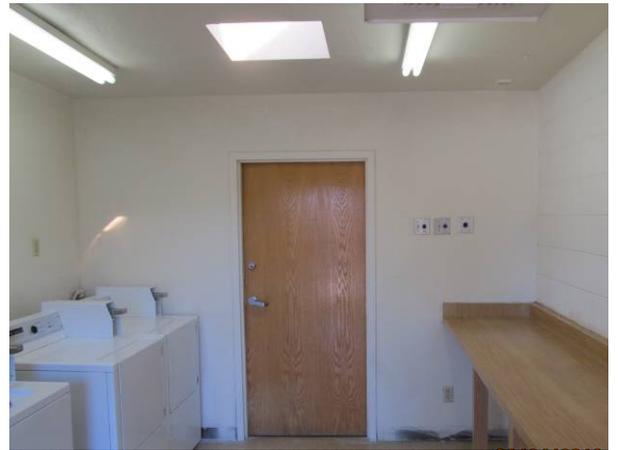
## Catholic Community Services Pio Decimo Center – Short Term (12 units)

**Main Needs:** Some plumbing & site grading work, insulation and/or EIFS, new packaged AC, accessibility improvements, low-flow fixtures, energy-efficient lighting, electrical upgrade, water harvesting/landscaping

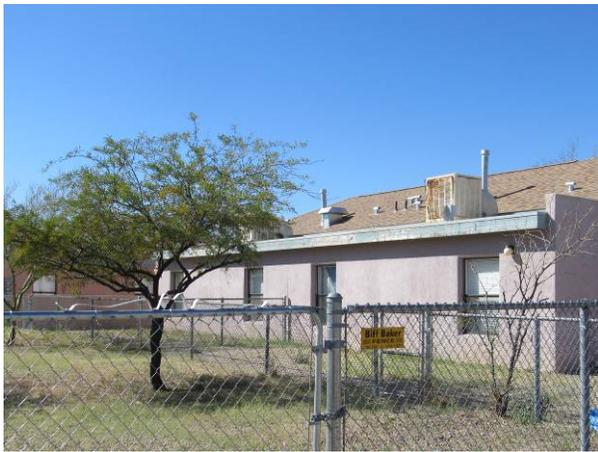
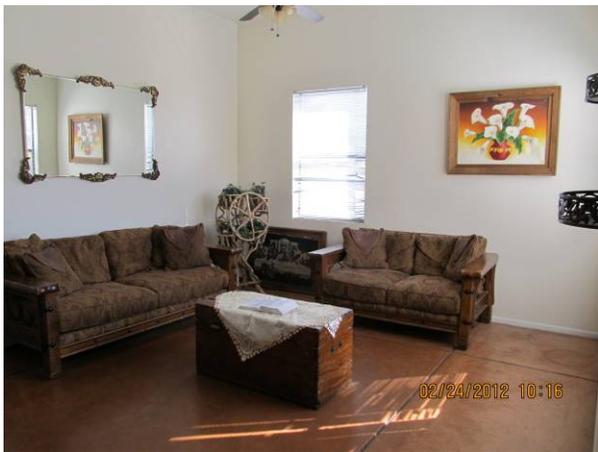
## Catholic Community Services Byas – Pio Decimo – Long Term (8 units)

Main Needs: New packaged AC, some window shading, water harvesting/landscaping, ceiling fans

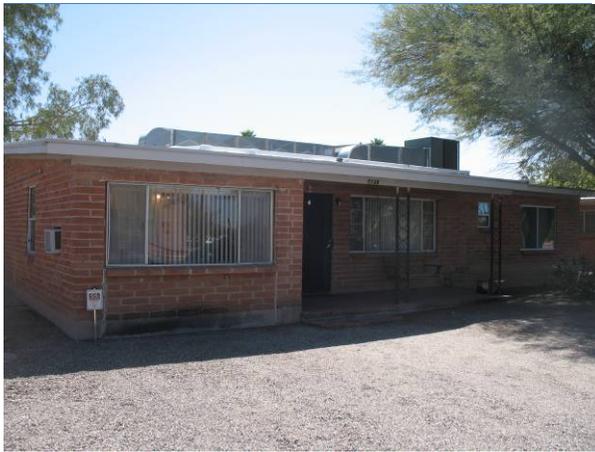
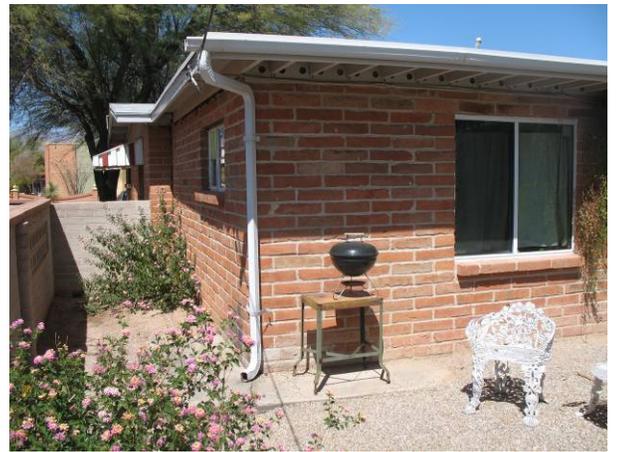
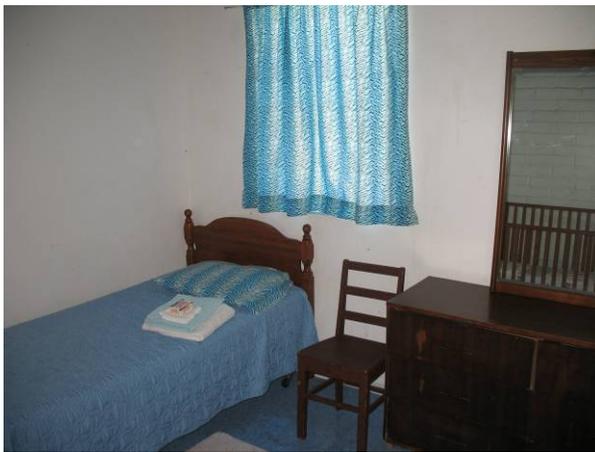
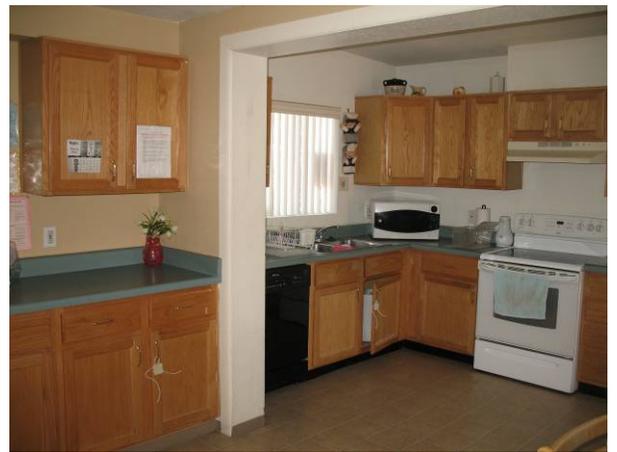
## Catholic Community Services Merilac Lodge (5 beds)

Main Needs: Insulation and/or EIFS, accessibility improvements, some double-pane windows, low-flow fixtures, water harvesting/landscaping

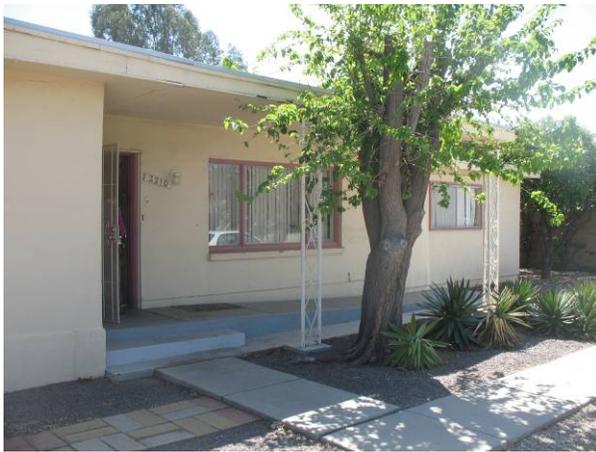
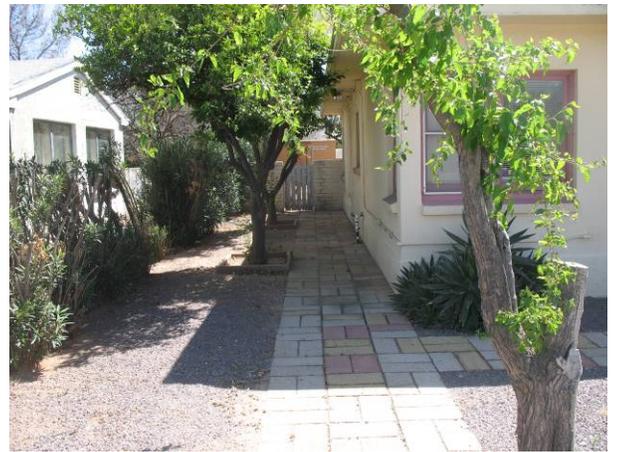
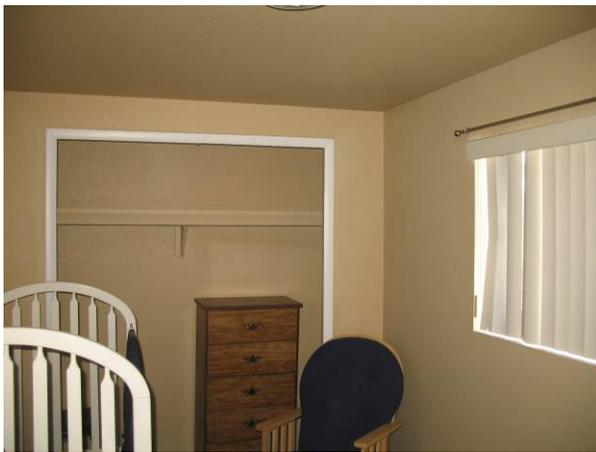
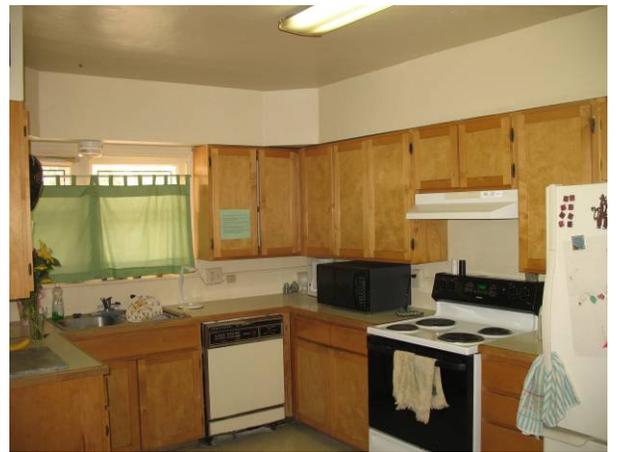
## Catholic Community Services Casa de Crianza (4 beds)

Main Needs: Insulation and/or EIFS, new packaged AC, accessibility improvements, double-pane windows, low-flow fixtures, electrical upgrade, water harvesting/landscaping

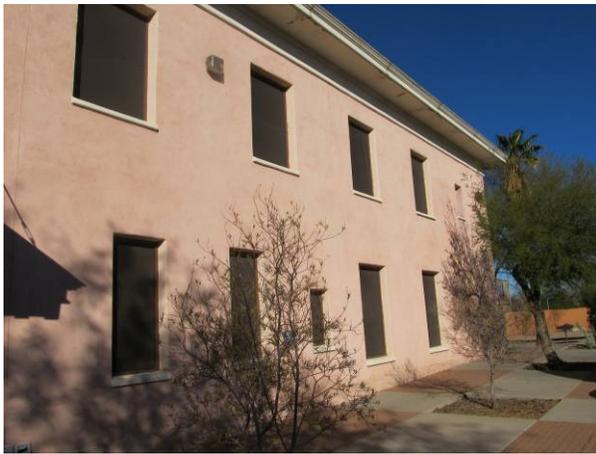
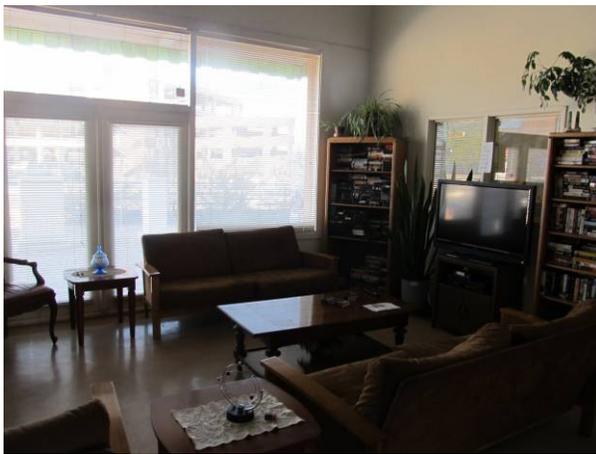
### Catalina House (20 bedrooms)

Main Needs: Double-pane windows, may need low-flow fixtures, water harvesting/landscaping
