# **‘GREEN AND HEALTHY’ ASSESSMENT OF PIMA COUNTY’S EMERGENCY SHELTERS AND TRANSITIONAL HOUSING**

*For Pima County Community Development and Neighborhood Conservation Department*  
FINAL DRAFT REVISED July 23, 2012

# Existing Conditions and Green/Health Assessment

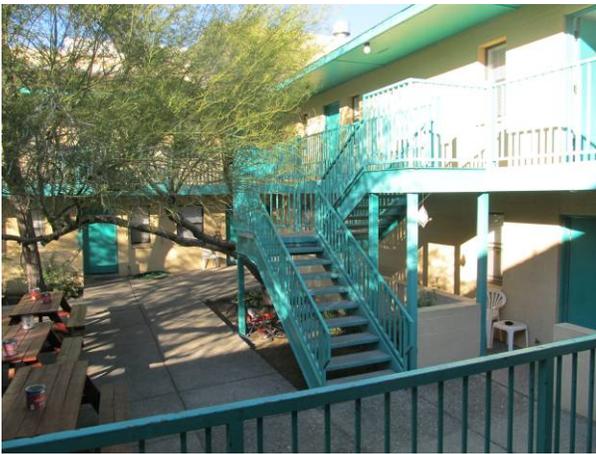
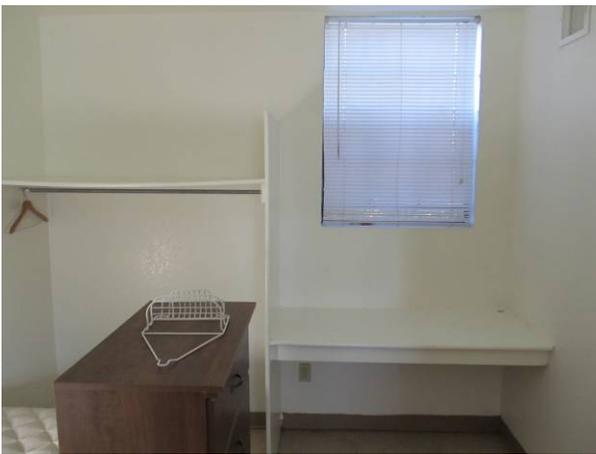
### 5 Points Transitional Housing (28 bedrooms)

Main Needs: New packaged AC, double-pane windows, may need low-flow fixtures, water harvesting

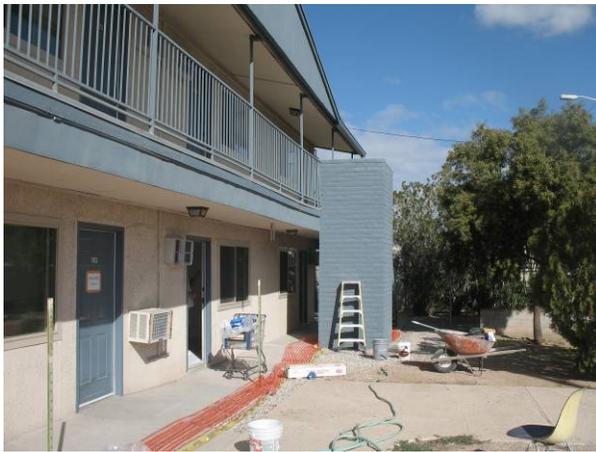
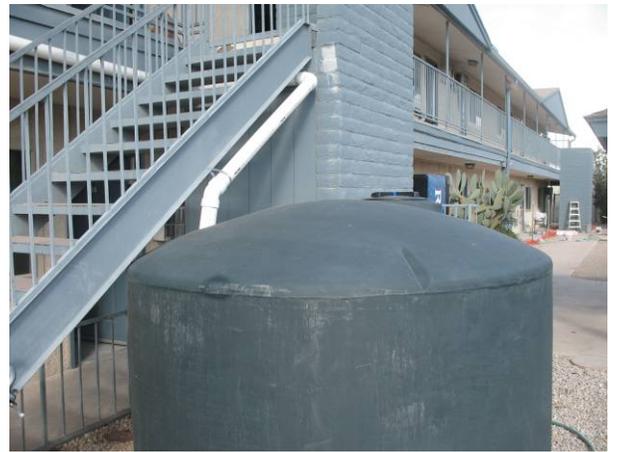
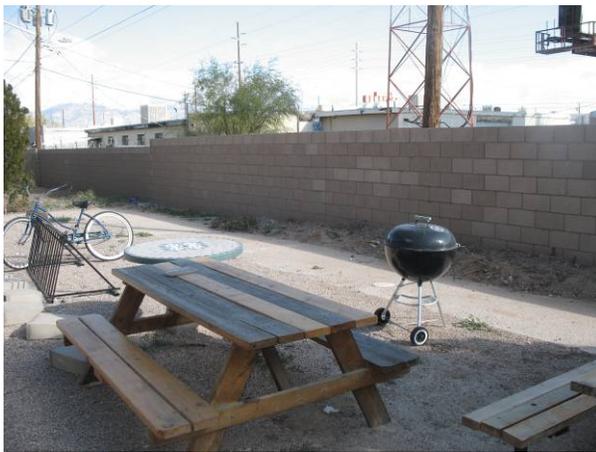
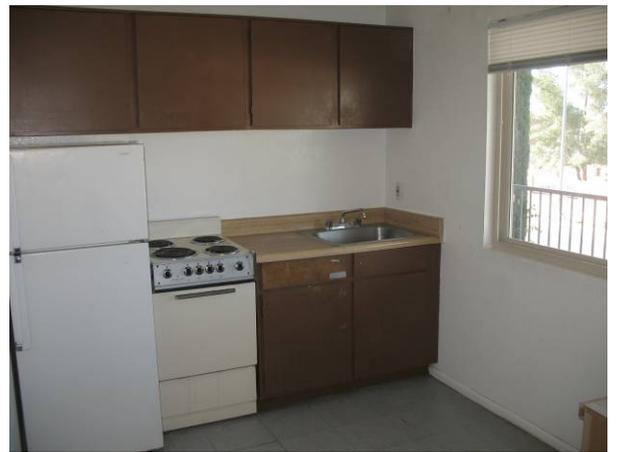
### Winstel Transitional Housing (28 units)

Main Needs: Enhance landscaping, ceiling fans, kitchen exhaust fans

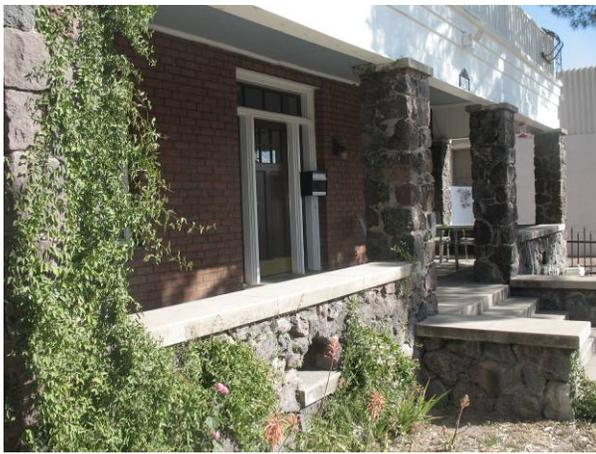
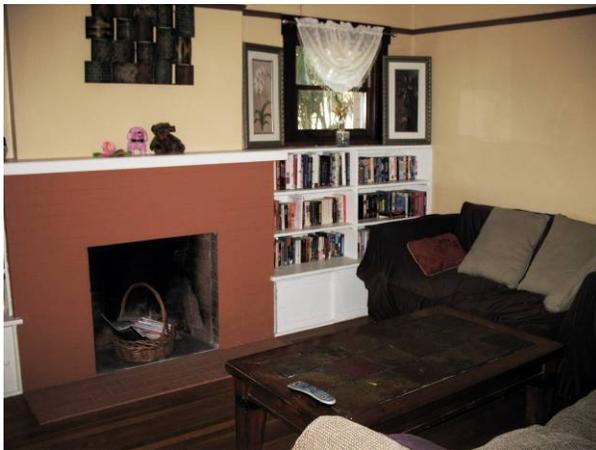
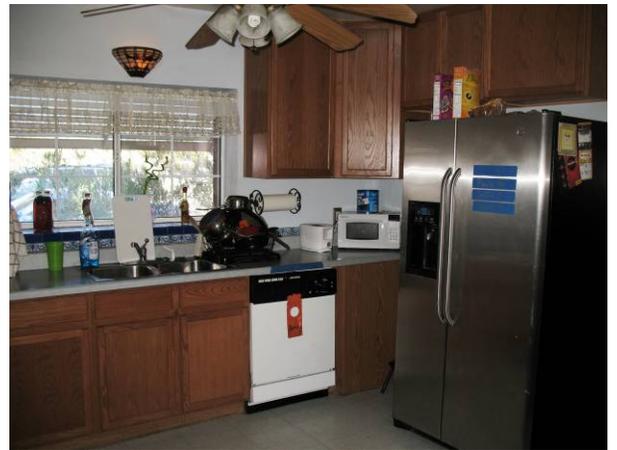
### Women in Transition – WIT (10 bedrooms)

Main Needs: Water harvesting/landscaping, more ceiling fans, hide garbage bins

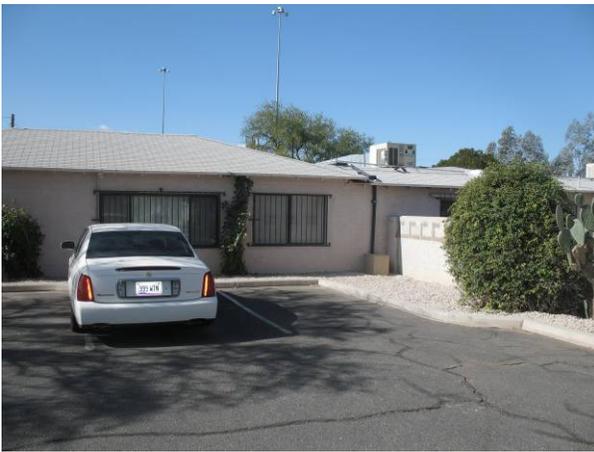
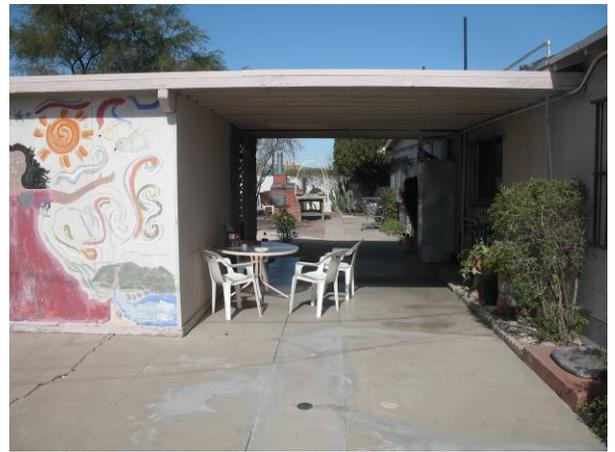
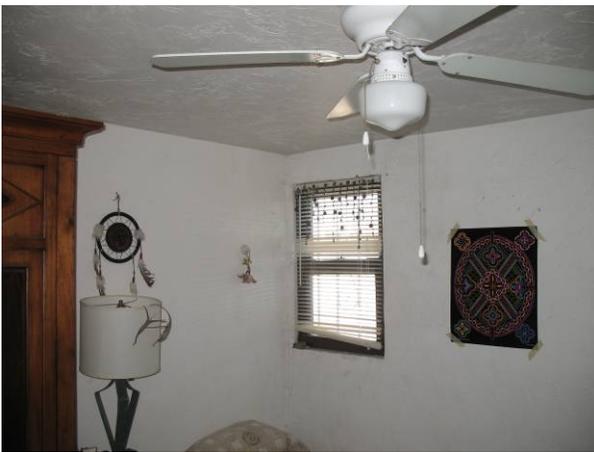
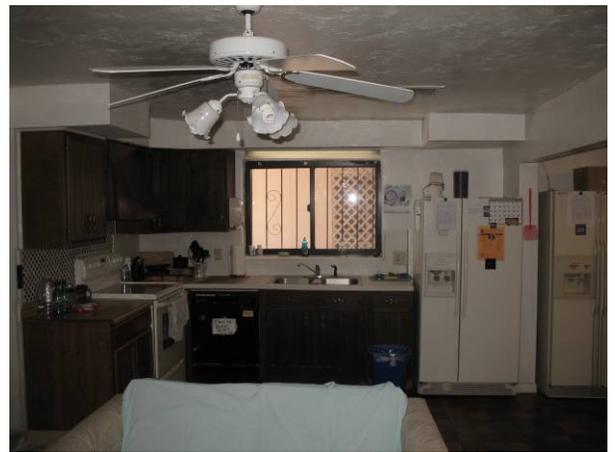
## Primavera Casa Paloma (9 beds)

Main Needs: Insulation and/or EIFS, new packaged AC, some double-pane windows, may need low-flow fixtures, water harvesting/landscaping

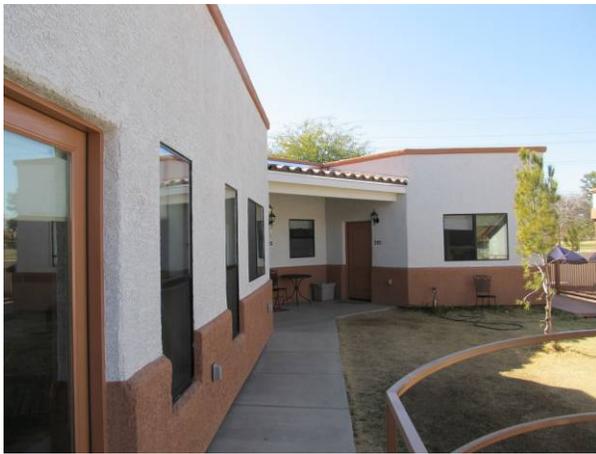
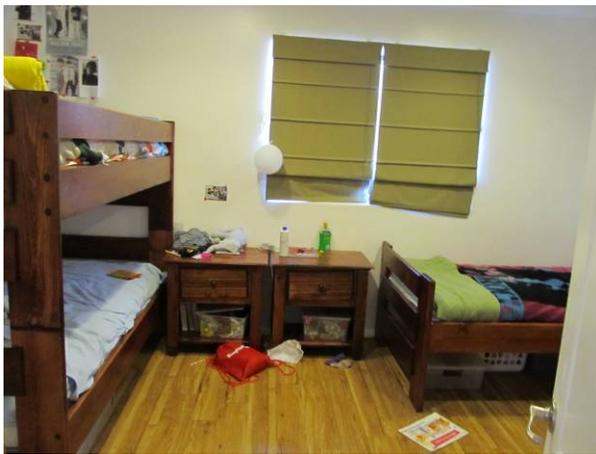
## TMM Family Services Children's Village (30 beds) 1550 N. Country Club Road Tucson, AZ 85716

Main Needs: Accessibility improvements, energy-efficient lighting, water harvesting/ landscaping

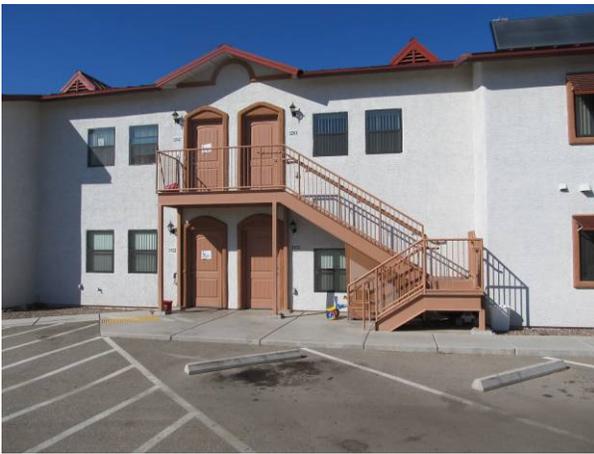
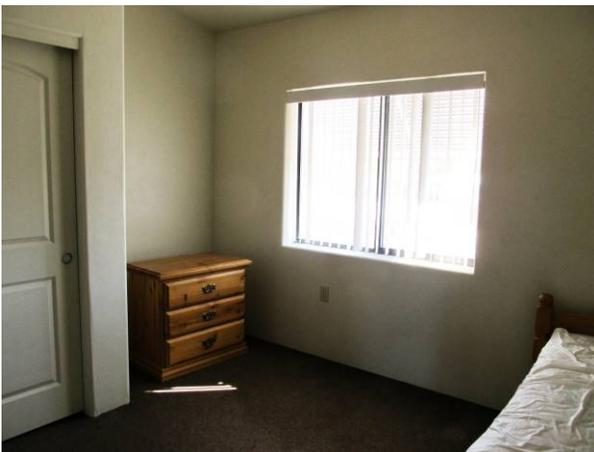
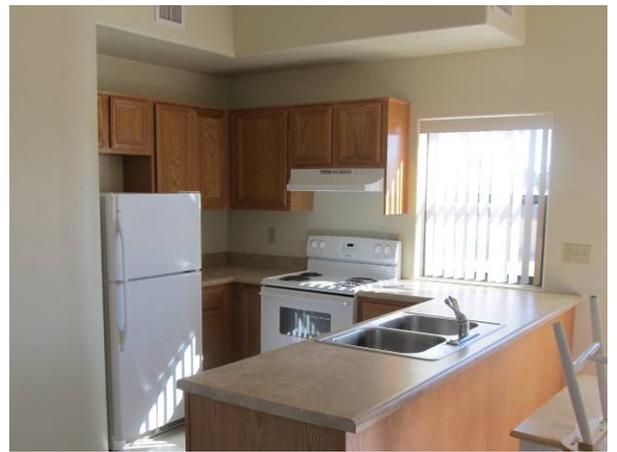
## TMM Family Services Fairhaven North (5 units)

Main Needs: Some window shading, energy-efficient lighting, continue water harvesting/  
landscaping

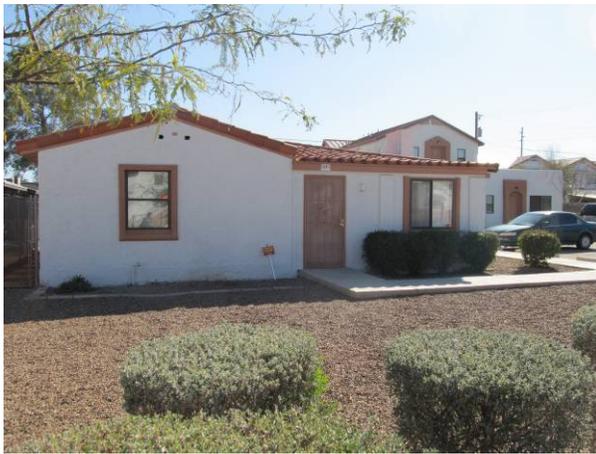
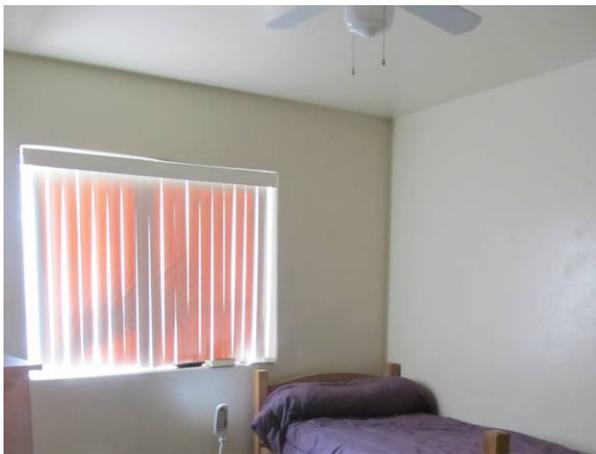
## TMM Family Services Fairhaven South (4 units)

Main Needs: May need some window shading, energy-efficient lighting, water harvesting/landscaping

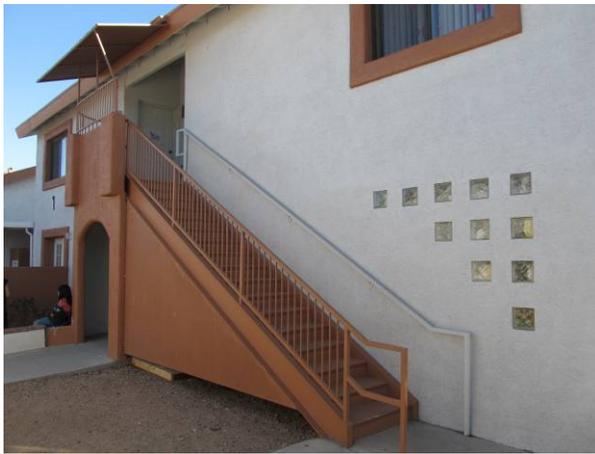
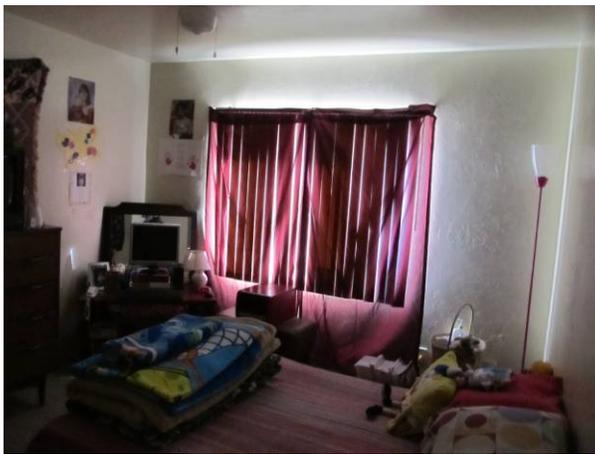
## TMM Family Services Older 2-Bed Units (11 units)

Main Needs: Accessibility improvements, some window shading, low-flow fixtures, energy-efficient lighting, water harvesting/landscaping, upgrade equipment
