OPPORTUNITY TO CORRECT - PC1602-106

Compliance Determination Report

Tracking ID: 6067-OR:29

Inspection Report

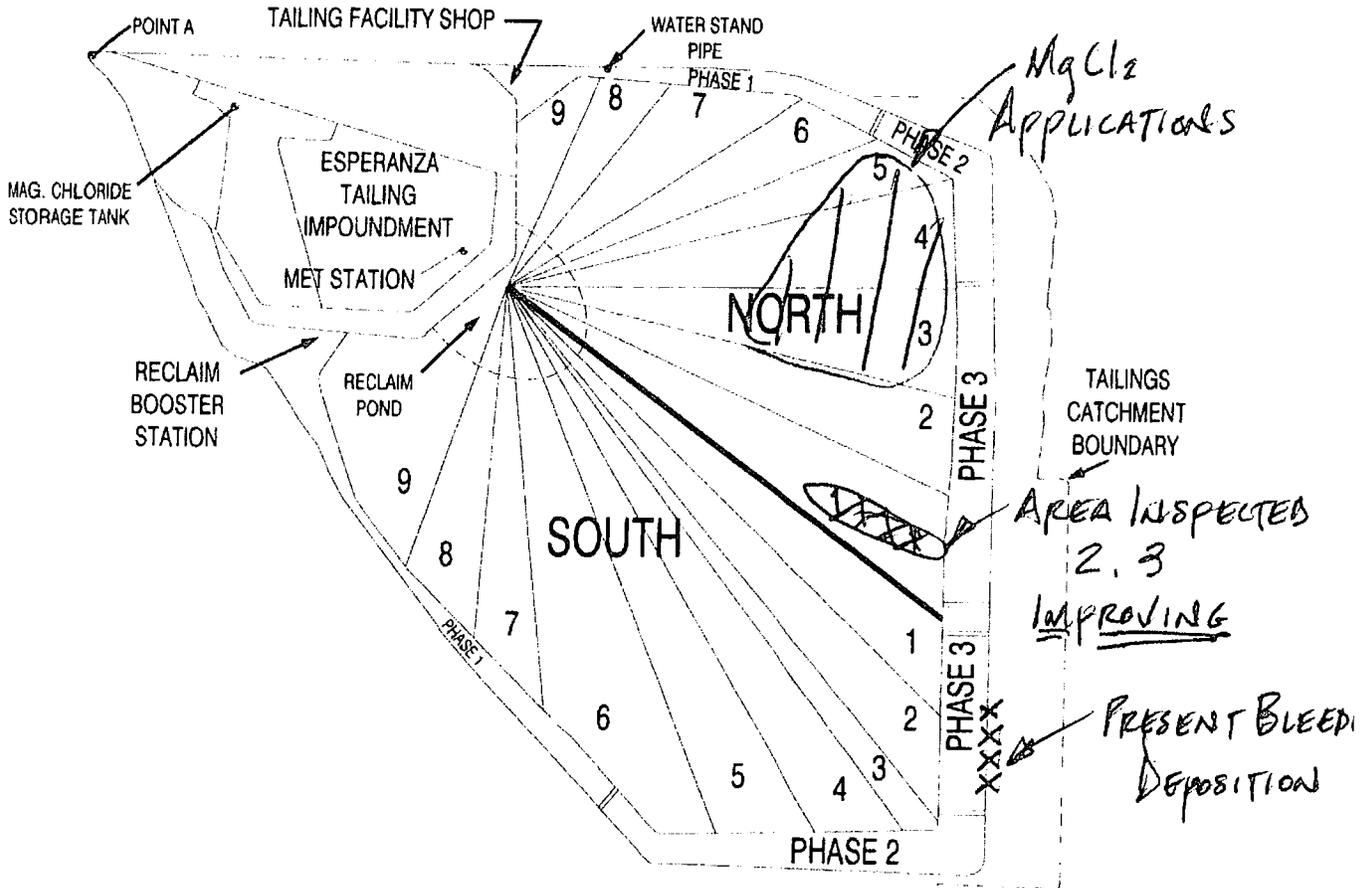
Date: 01/25/16
 Time: 1100
 Conditions: SUNNY, CALM
 Dam Inspected: NORTH Phase(s) 0
 GPS Coordinates: _____

Weather Conditions: Wind Speed _____ Gusts To _____ Temperature 60°F Precipitation Last 24 Hrs. Y (N)

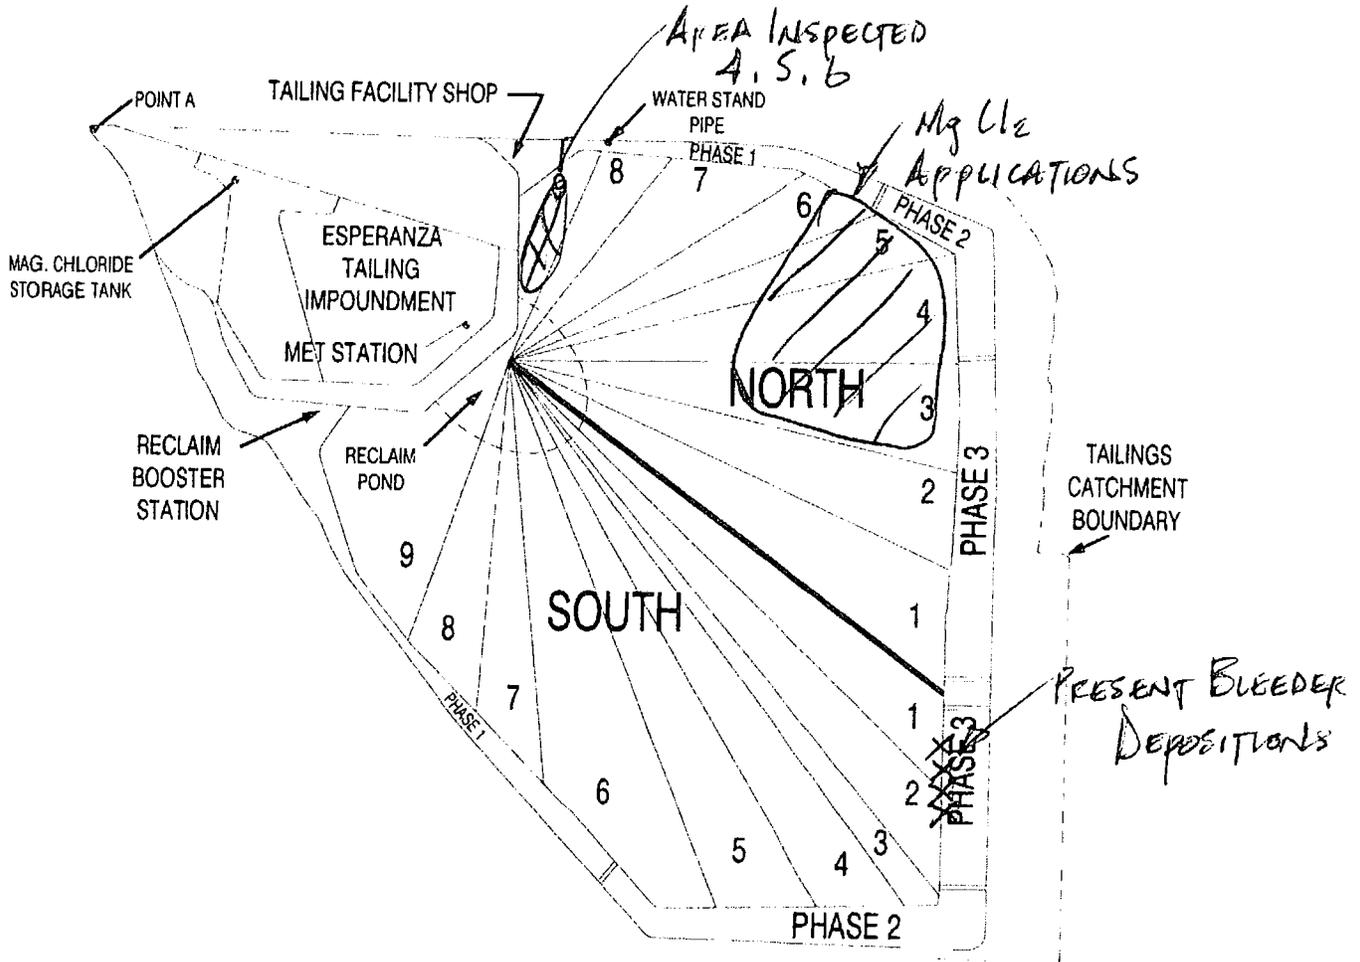
Date: 01/26/16
 Time: 1030
 Conditions: SUNNY
 Dam Inspected: NORTH Phase(s) 1
 GPS Coordinates: _____

Weather Conditions: Wind Speed _____ Gusts To _____ Temperature 65° Precipitation Last 24 Hrs. (N)

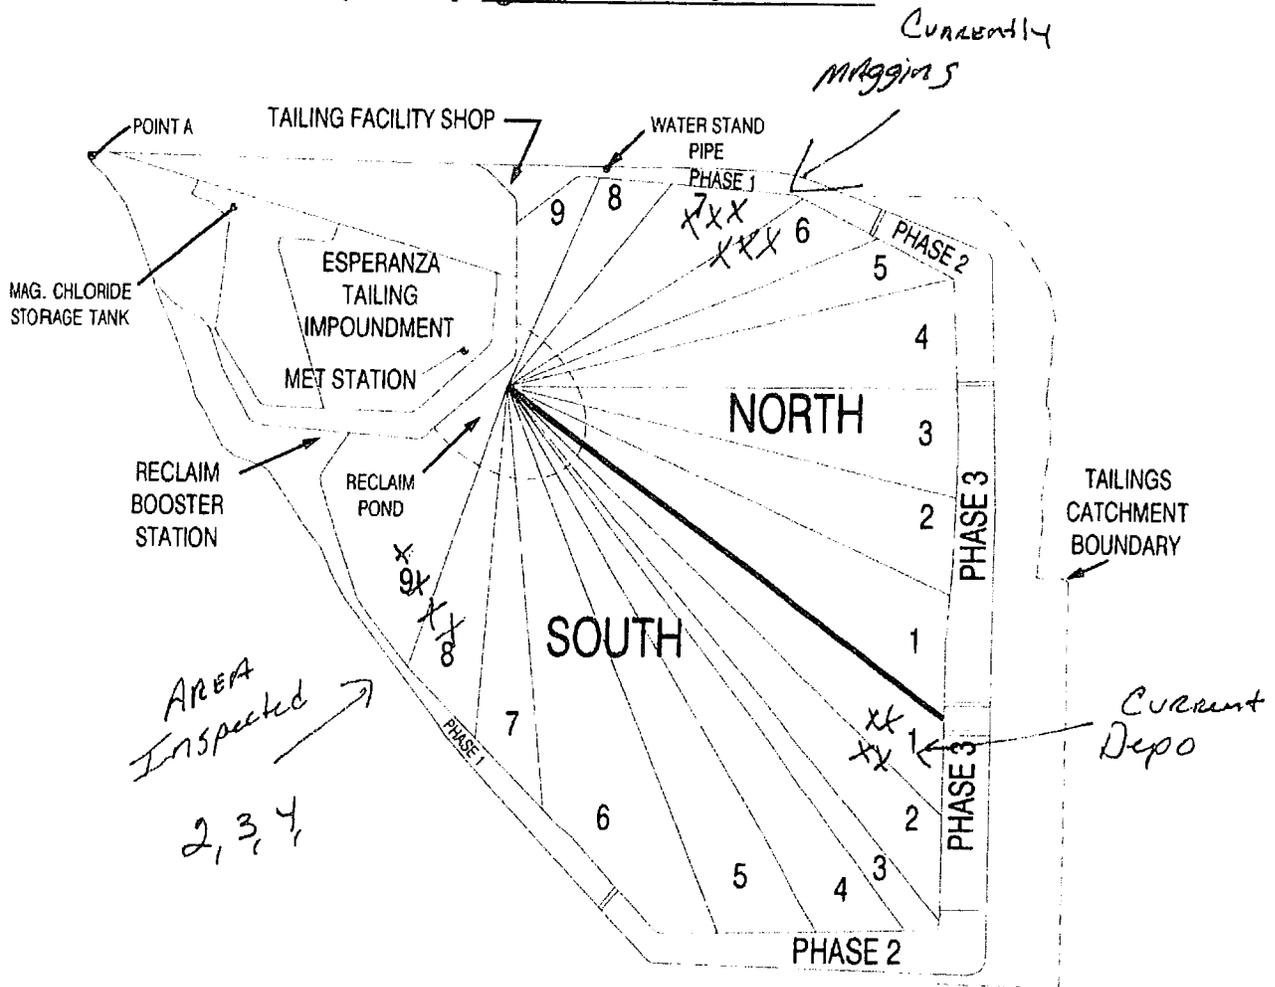
Date: 1-27-16
 Time: 9:45 AM
 Conditions: Clear & sunny
 Dam Inspected: South Phase(s): 1 WEST END
 GPS Coordinates: _____

Weather Conditions: Wind Speed 0 Gusts To 0 Temperature 61 Precipitation Last 24 Hrs. Y/N: _____

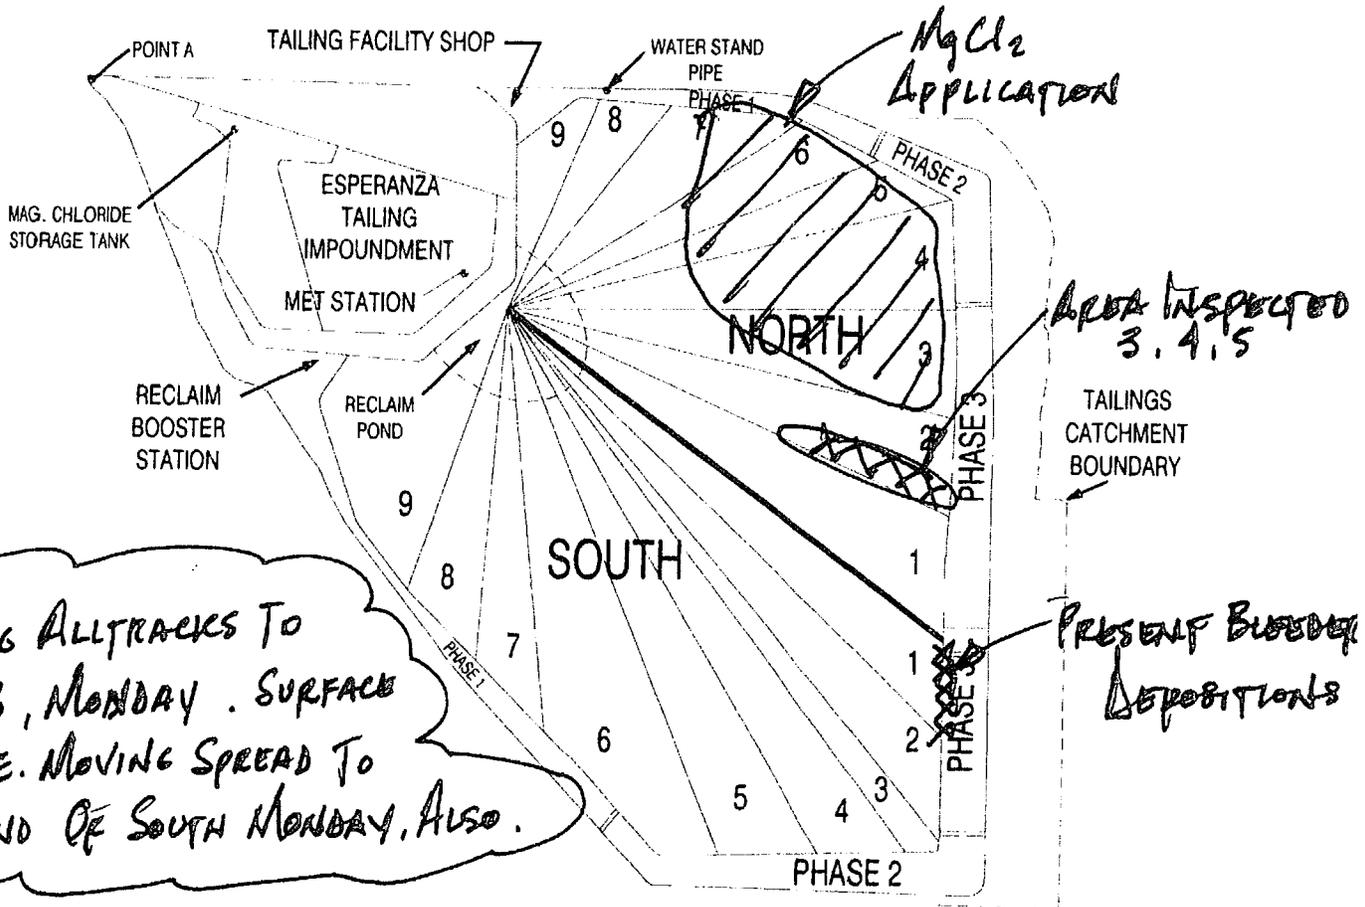
Date: 01/29/16
 Time: 1300
 Conditions: SUNNY, CALM
 Dam Inspected: NORTH Phase(s) 3
 GPS Coordinates: _____

MOVING ALL TRACKS TO PHASE 3, MONDAY. SURFACE PASSABLE. MOVING SPREAD TO WEST END OF SOUTH MONDAY, ALSO.

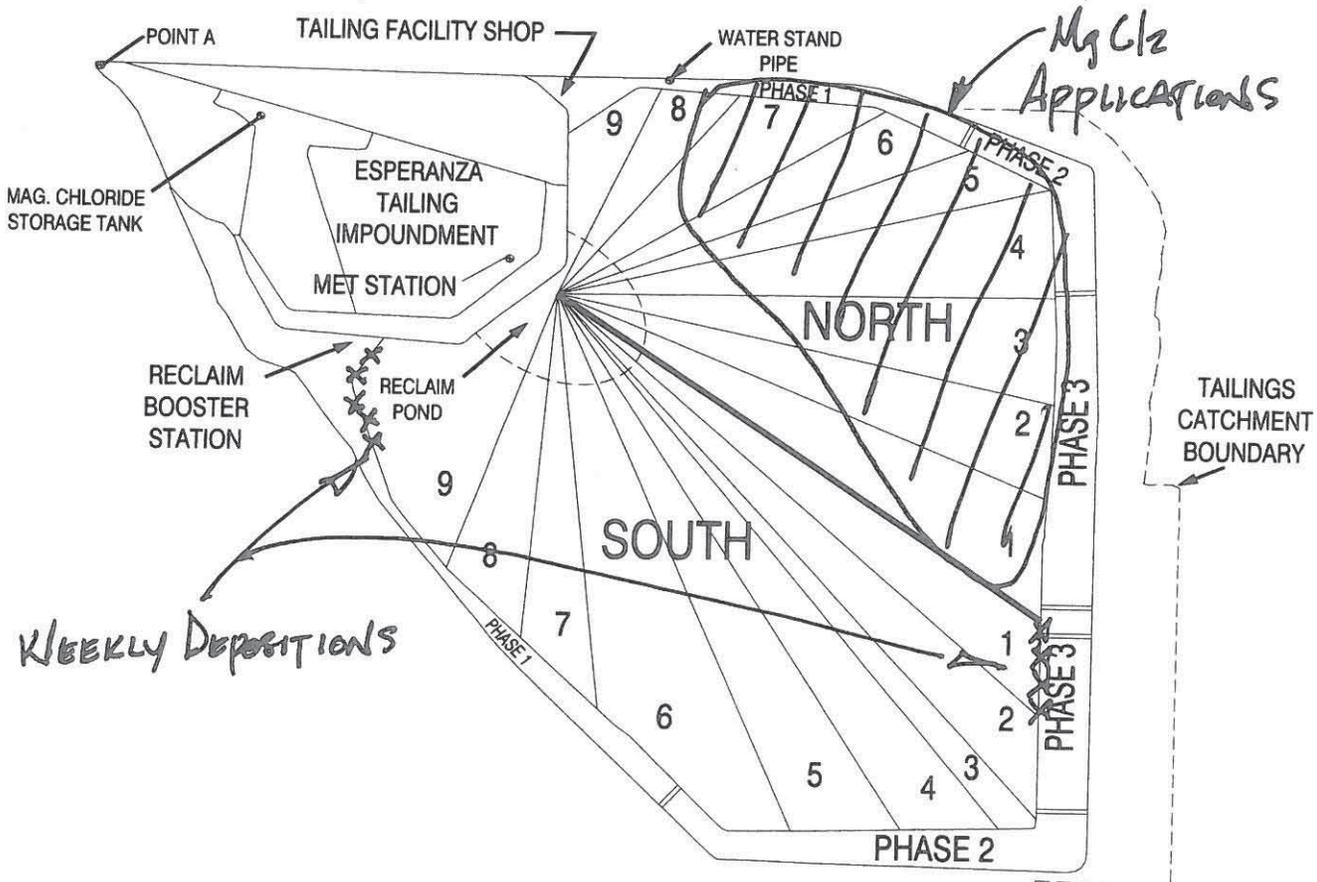
Comments MgCl₂, ENVIROtac II Applications, EXTREME WIND EVENT 01/31 - 02/01. DEPOSITION MOVED FROM P 3 TO P1 SOUTH DAM.

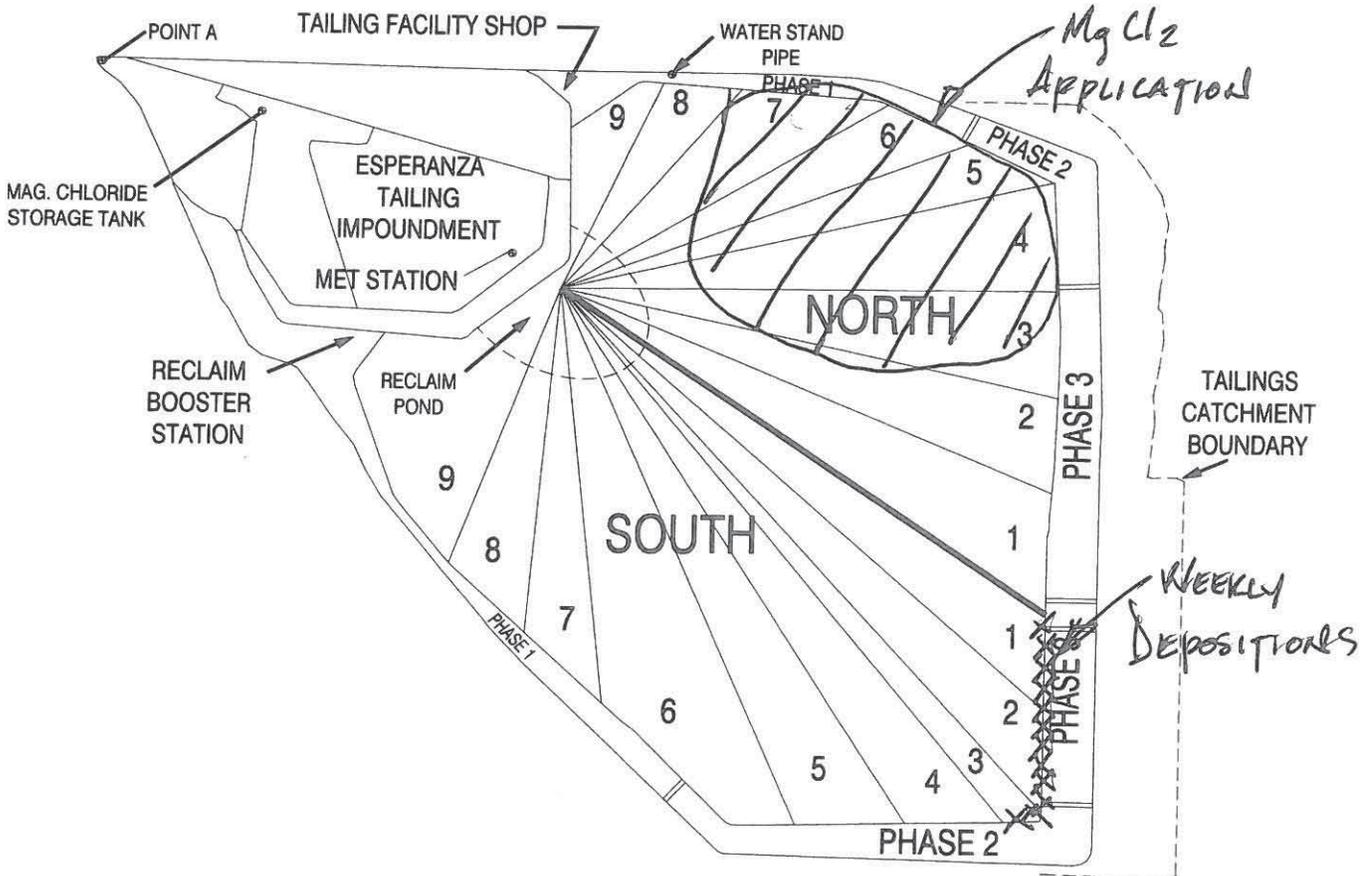
Comments MgCl₂ APPLICATIONS TO PHASE 1, NORTH DAM.
DEPOSITIONS SOUTH DAM.

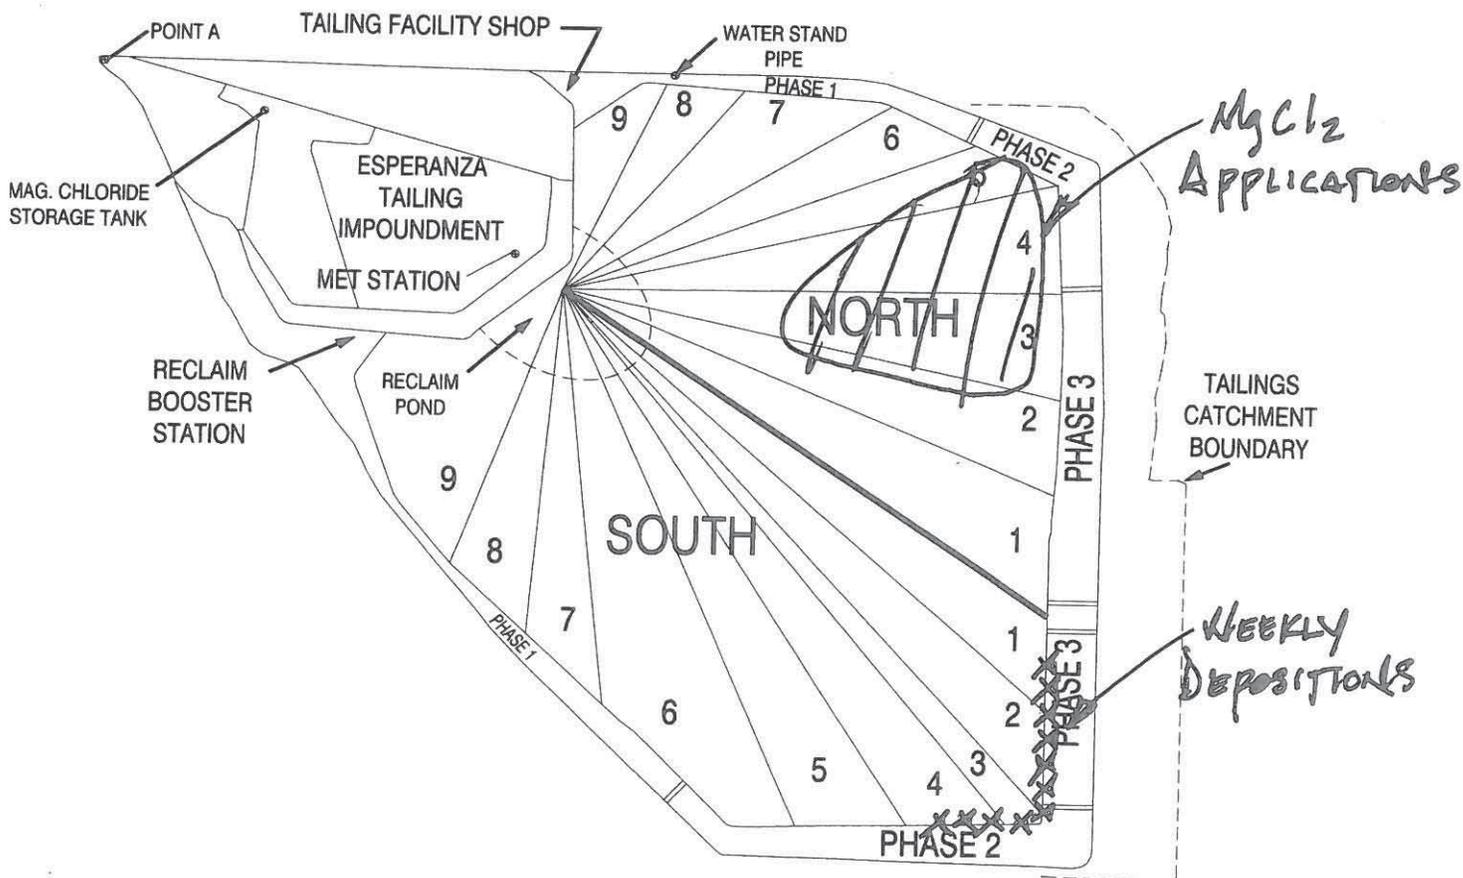
Comments MgCl₂ APPLICATIONS TO PH 1, 2 NORTH DAM.

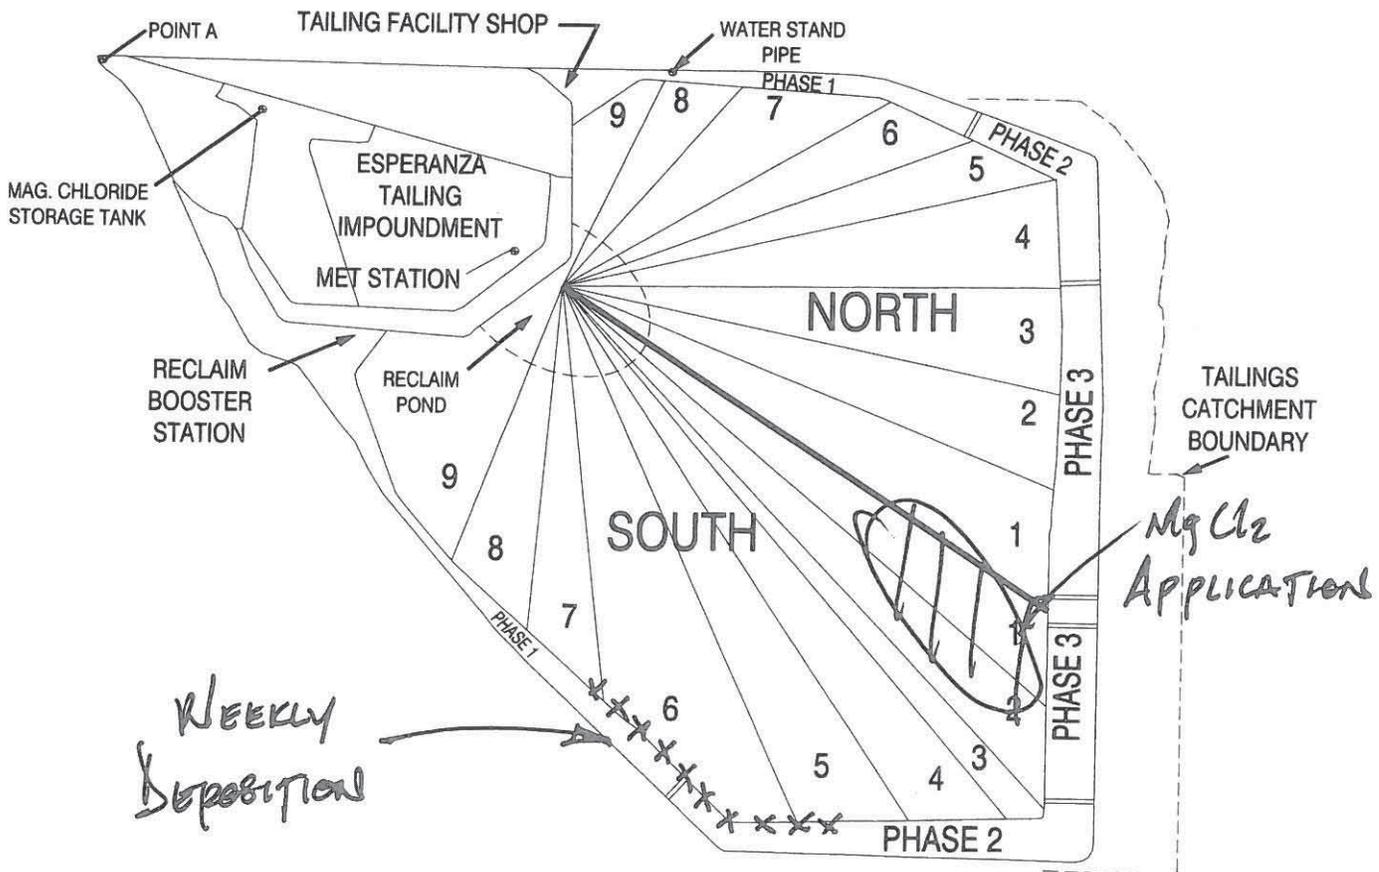
Comments DEPOSITION CONTINUES SOUTH DAM. MgCl₂ APPLICATION TO PHASE 3, SOUTH DAM

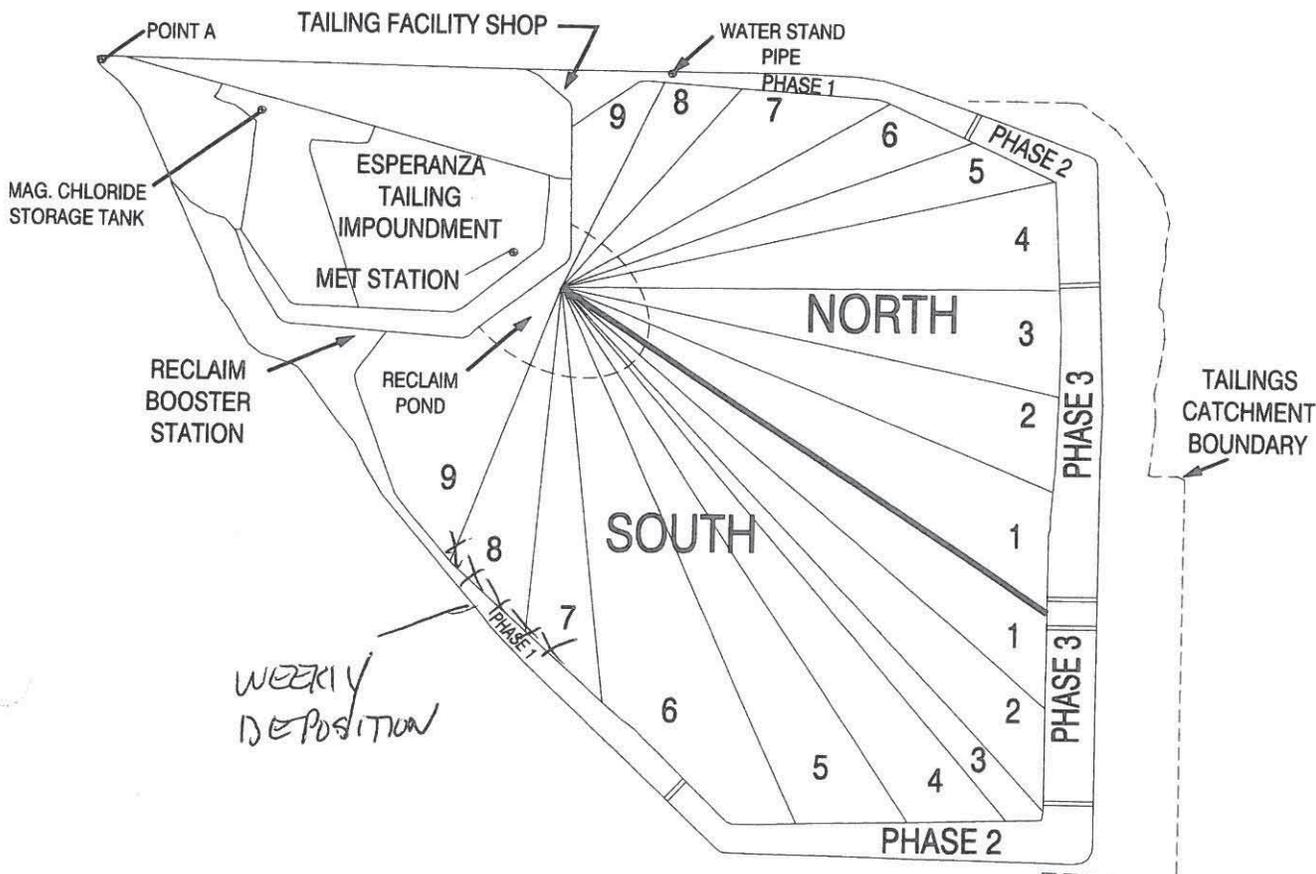
Comments RAIN
