**PIMA COUNTY DEPARTMENT OF ENVIRONMENTAL QUALITY  
AIR PROGRAM**

**Site Inspection Report**

**Tracking ID: PC 1307-099**

**Permit #:** 6067  
**Source:** Freeport-McMoRan Sierrita Inc.  
**Location:** 6200 W. Duval Mine Road, Green Valley, AZ  
**Date:** July 29, 2013  
**Arrival Time:** 1:00 pm  
**Departure Time:** 3:30 pm  
**Inspectors:** Anna Martin  
Elizabeth Quinley  
Janice Easley  
**Spoke With:** Kali Hoyak, Environmental Engineer II  
Eric Werner, Environmental Engineer I  
Procopio Gonzales, Senior Tailings Supervisor  
**Phone #:** 520-393-2603 (Hoyak)  
**Reason for Inspection:** Complaint  
**Compliance Status:** Noncompliant

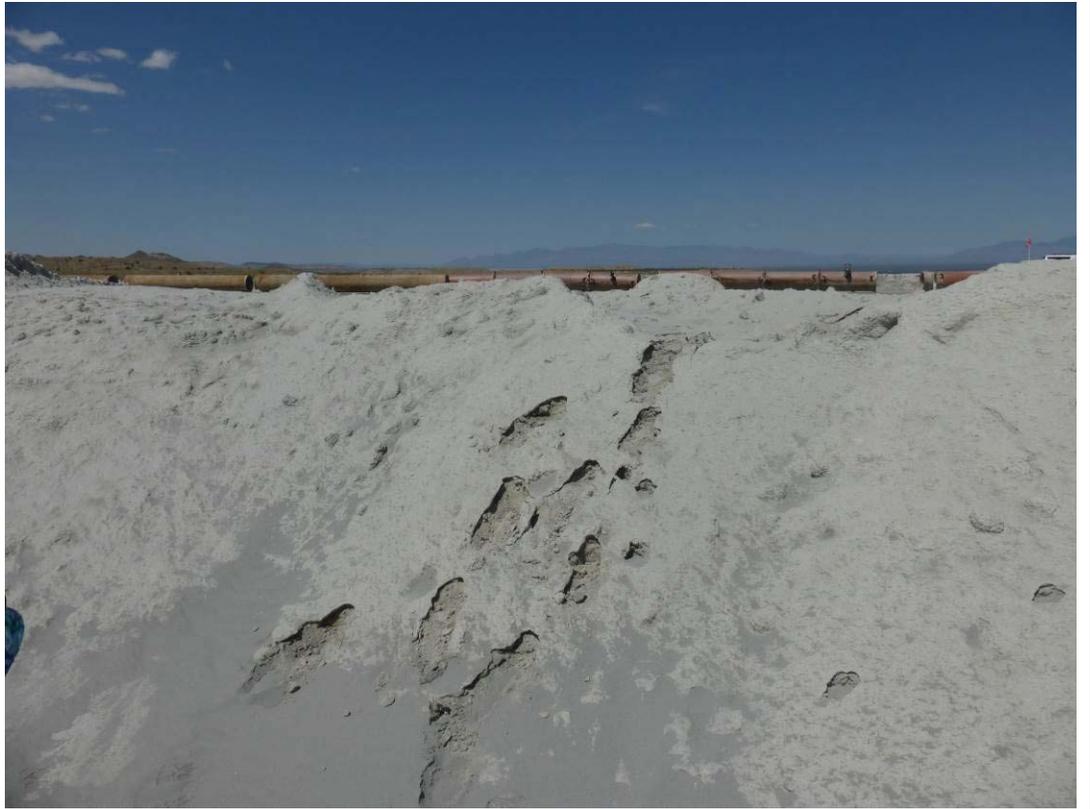
**Photo No. 5**

We entered FMSI, met with Ms. Kali Hoyak, Environmental Engineer II, and Eric Werner, Environmental Engineer I, and conducted inspection rights protocol (Attachment 2). We reviewed the content of the complaints with Ms. Hoyak and Mr. Werner and showed them photos of the fugitive particulate matter event on July 27, 2013 (Attachment 3). Ms. Hoyak stated that she was not aware of any July 27, 2013 fugitive emissions until PDEQ contacted her on July 29, 2013. We drove to the north side of the tailings impoundment and met with Mr. Procopio Gonzales, FMSI Senior Tailings Supervisor. We conducted inspection rights protocol with Mr. Gonzales (Attachment 2) and began discussions about recent and current activity on the tailings impoundment. We learned that FMSI is currently depositing tailings slurry on the southern half (south dam) of the tailings impoundment and that the north side (north dam) is undergoing road construction and pipeline lifts, to raise the dam walls which contain the tailings. We learned that the pipeline lift was underway on the north edge of the impoundment dam. This pipeline lift follows the near-completion of a new road around the tailings impoundment. Ms. Hoyak and Mr. Gonzales indicated that the road along the north edge of the impoundment dam was complete except for capping with native soil. They stated that magnesium chloride had been applied to the road at least twice since its construction. The road appeared stable (Attachment 1, Photo 3) and we observed traffic traveling at or below the speed limit of 25 mph generating little to no dust. Between the road and the tailings lay berms and stockpiles of soil from road construction. The road was bordered with piles and pushed berms of tailings soil material. We observed water trucks spraying the soil (Attachment 1, Photo 4) and found the piles to be well-crustured and stable (Attachment 1, Photo 5). Mr. Gonzales indicated the piles are sprayed by a water truck approximately every 2 hours.

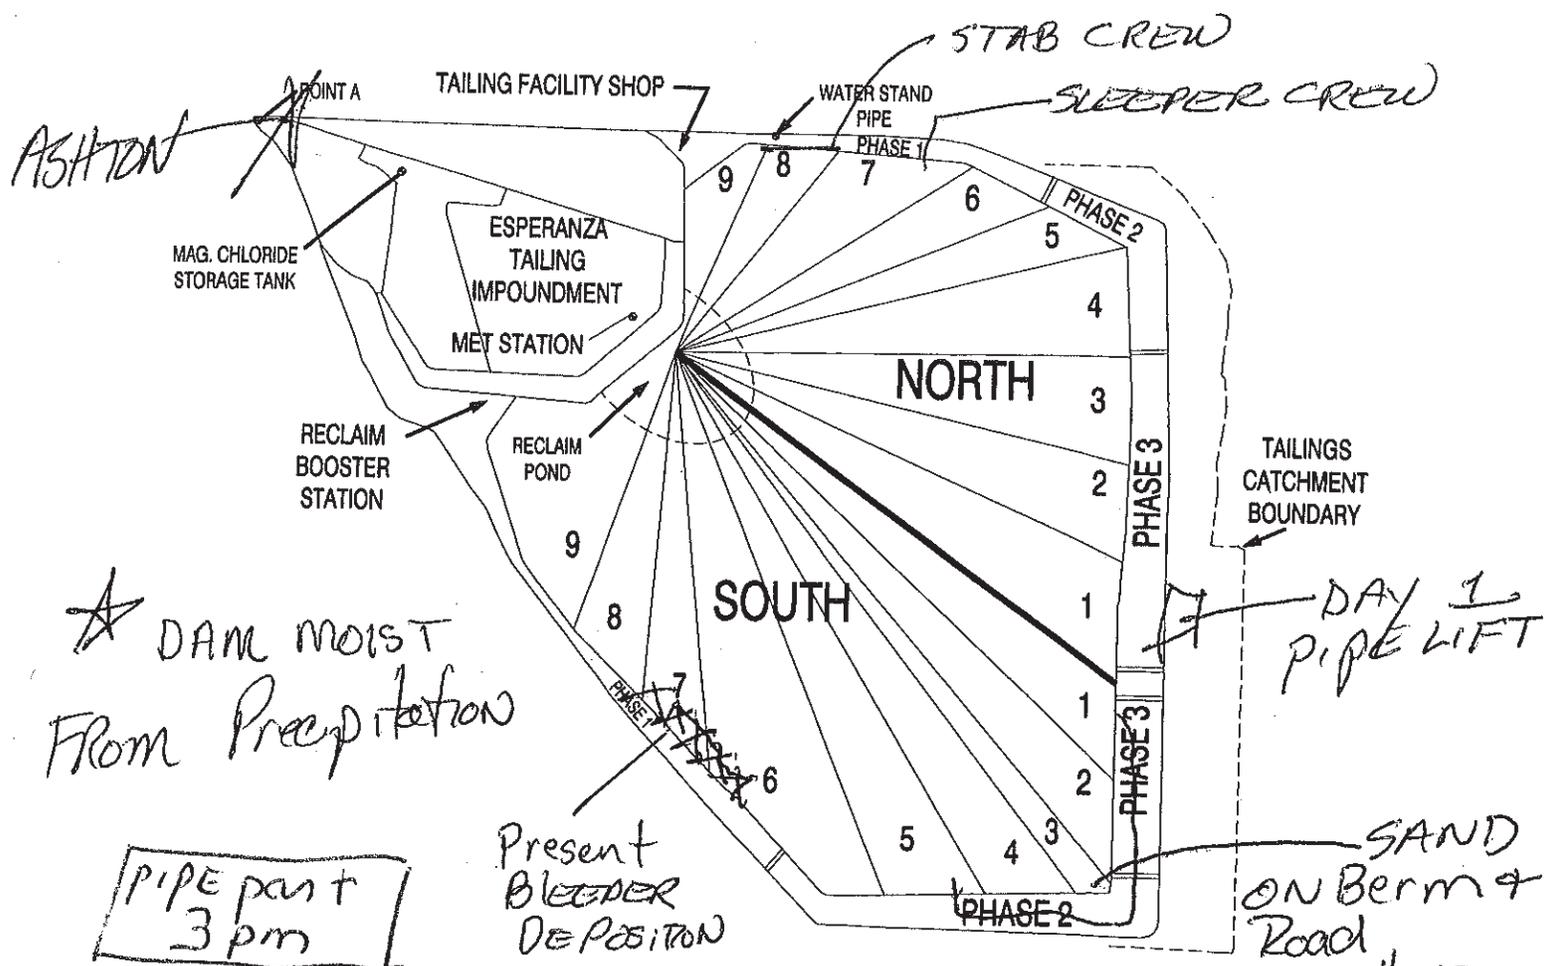
Date: July 8 2013  
 Time: 0700  
 Conditions: Hot  
 Dam Inspected: \_\_\_\_\_ Phase(s): \_\_\_\_\_  
 GPS Coordinates: \_\_\_\_\_

★ DAM MOIST FROM PRECIPITATION

PIPE part 3 pm

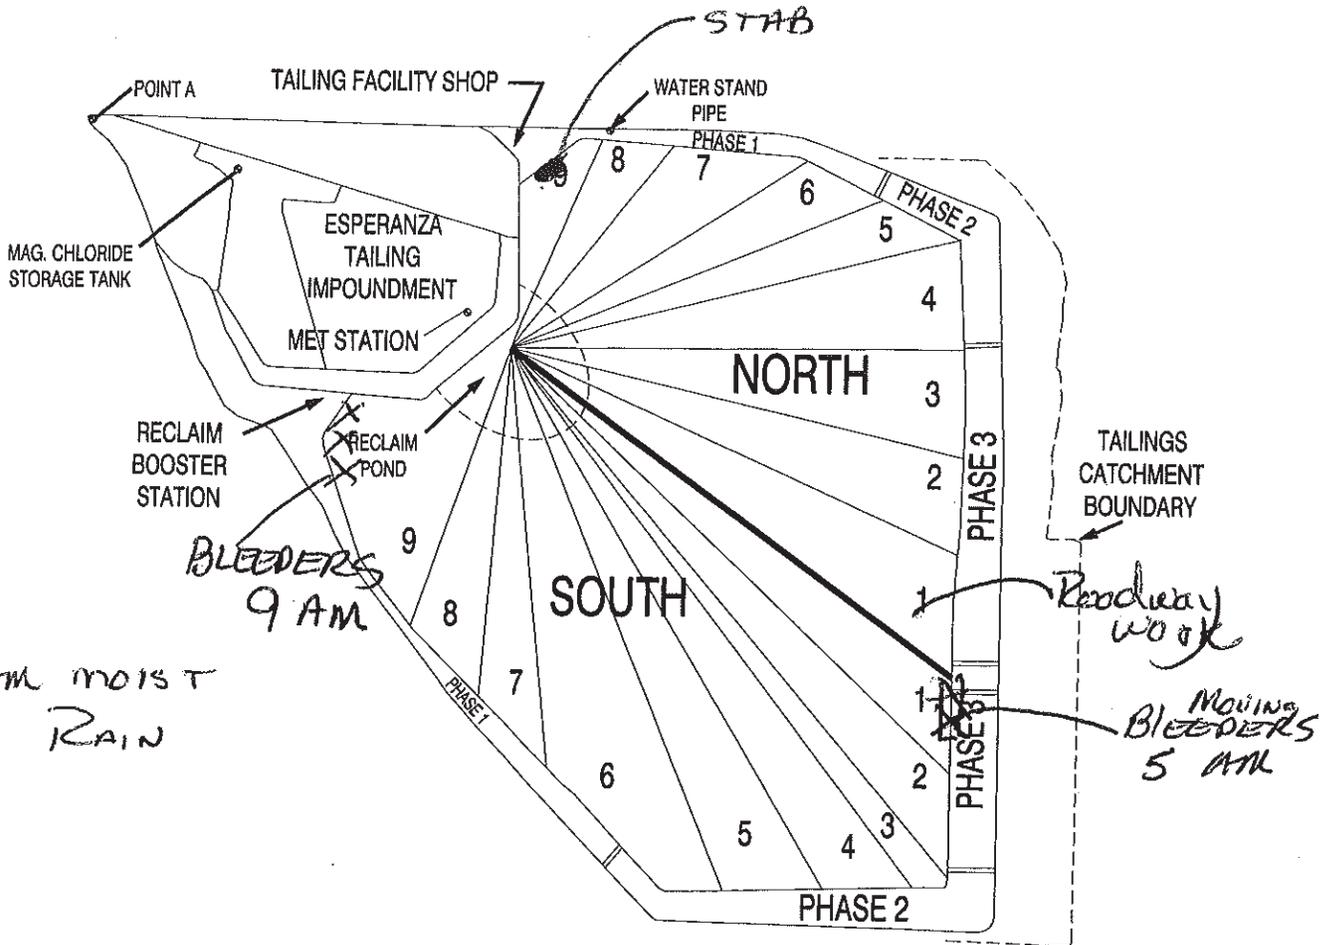
Date: 7-1-13  
 Time: 0700  
 Conditions: WARM CALM  
 Dam Inspected: ALL Phase(s): 1-3  
 GPS Coordinates: \_\_\_\_\_

DAM MOIST FROM RAIN

ROADWAY WORK  
MOVING BLEEDERS 5 AM
