Re: **Technical Reports and Analysis Completed by County Staff Regarding the Canoa Hills Golf Course Proposal**

DATE: March 15, 2018

SUBJECT: Canoa Hills Golf Course – Proposed Donation

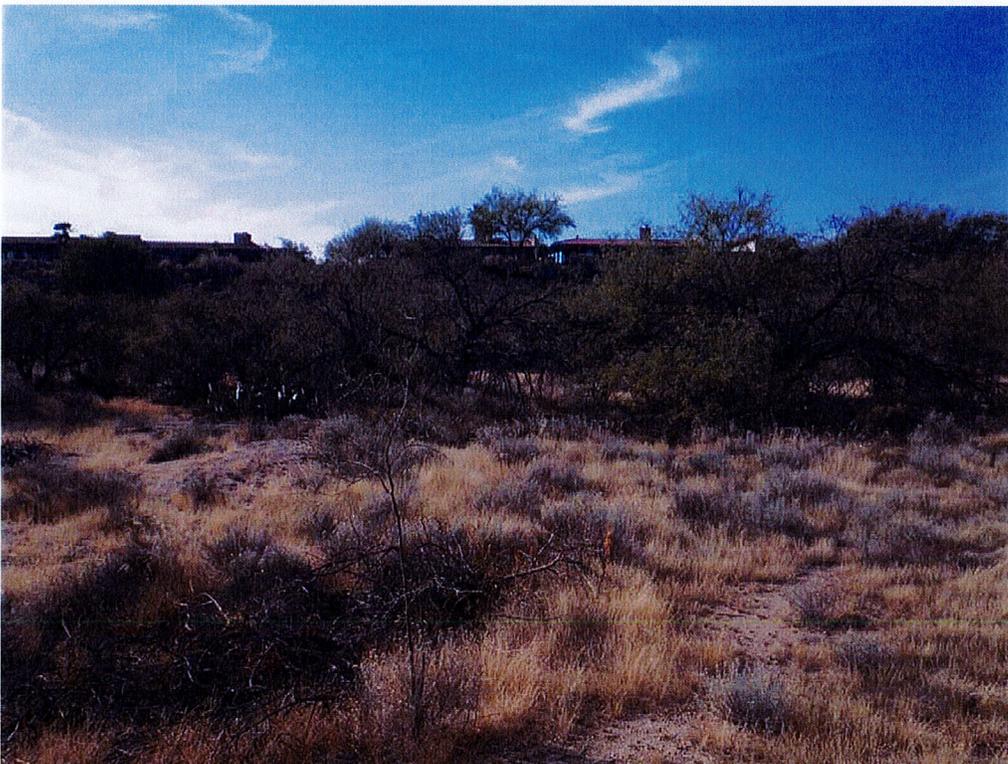
Vegetation communities outside of the constructed course were mostly preserved in place (see Photos 1 and 2) and contain large remnant patches of native vegetation that support a diverse array of species (Table 1 – Existing Plant List). Generally, these areas are topographically higher than the golf course and would provide a local source of native seed over time.

Photo 2. Semidesert Grassland plant community preserved in place.

Land cover Class 3, Native plant communities preserved in place. Varying topography throughout the site supports three separate plant communities including Sonoran Desertscrub, Semidesert grassland, and Xeroriparian habitat. The Sonoran Desertscrub is located on the hilltops and slopes (Photo 1), Semidesert grassland (Photo 2) is between the base of slopes and floodplain/riparian areas, and Xeroriparian habitat (Photo 9) is along the wash corridors and areas of ponding. These remnant habitat fragments provide resources for native animals, birds and insects. Native plant communities that have been preserved in place could provide a seed source for plant recruitment or for collection and growth at the Native Plant Nursery.

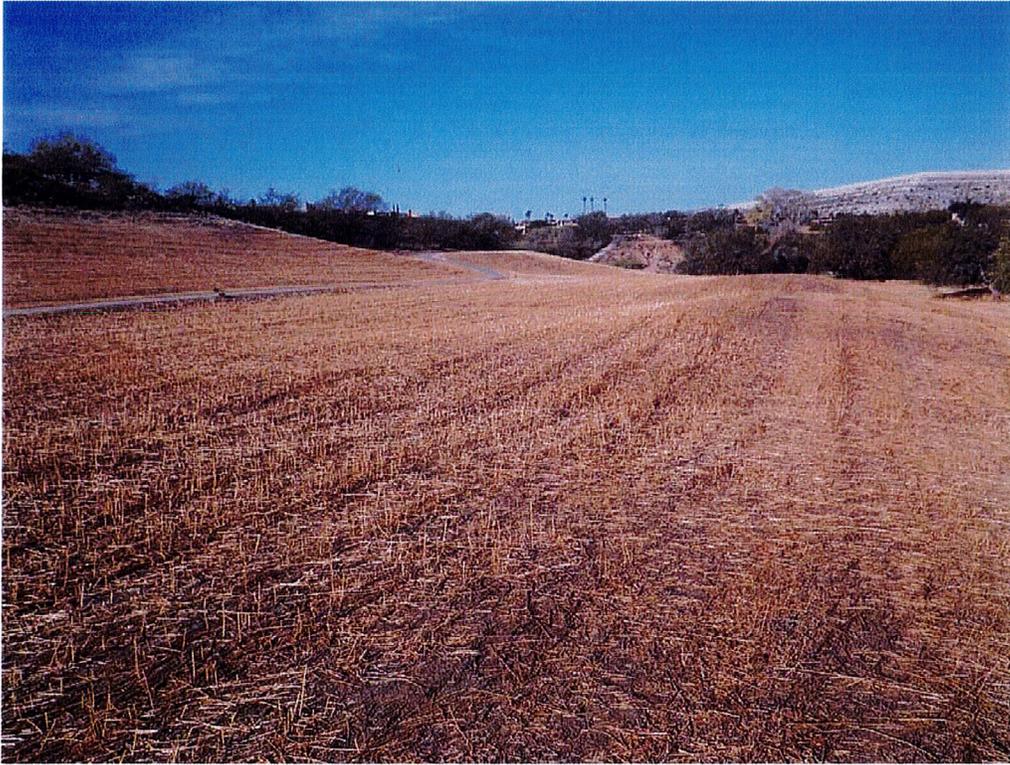
1. Retired golf course converting to an annual native plant community with low species richness (54 acres; see Photos 6 and 7).
2. Native trees preserved in place with understory converting to an annual native plant community (12.6 acres; see Photo 8).

Photo 7. Retired golf course converting to Palmer's Amaranth
