**PIMA DEPARTMENT OF ENVIRONMENTAL QUALITY
AIR PROGRAM**

OPPORTUNITY TO CORRECT - TRACKING # 0910-122

Complaint Investigation Report

Tracking ID: PC0910-086

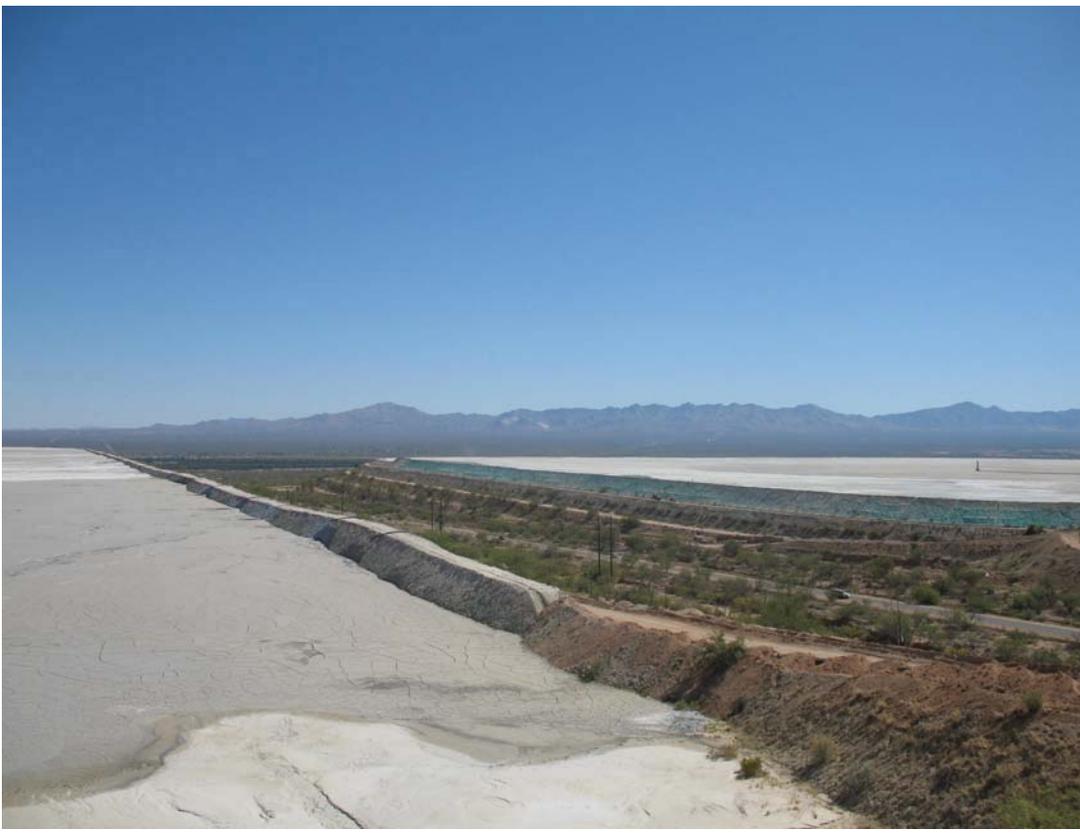
Photo No. 4

Date: 10/21/2009	
Photo Description: View of the tailings dam #8. A new berm has been built on the west and north faces. The outer sides of the slopes are colored blue from the polymer stabilizer applied to the surface.

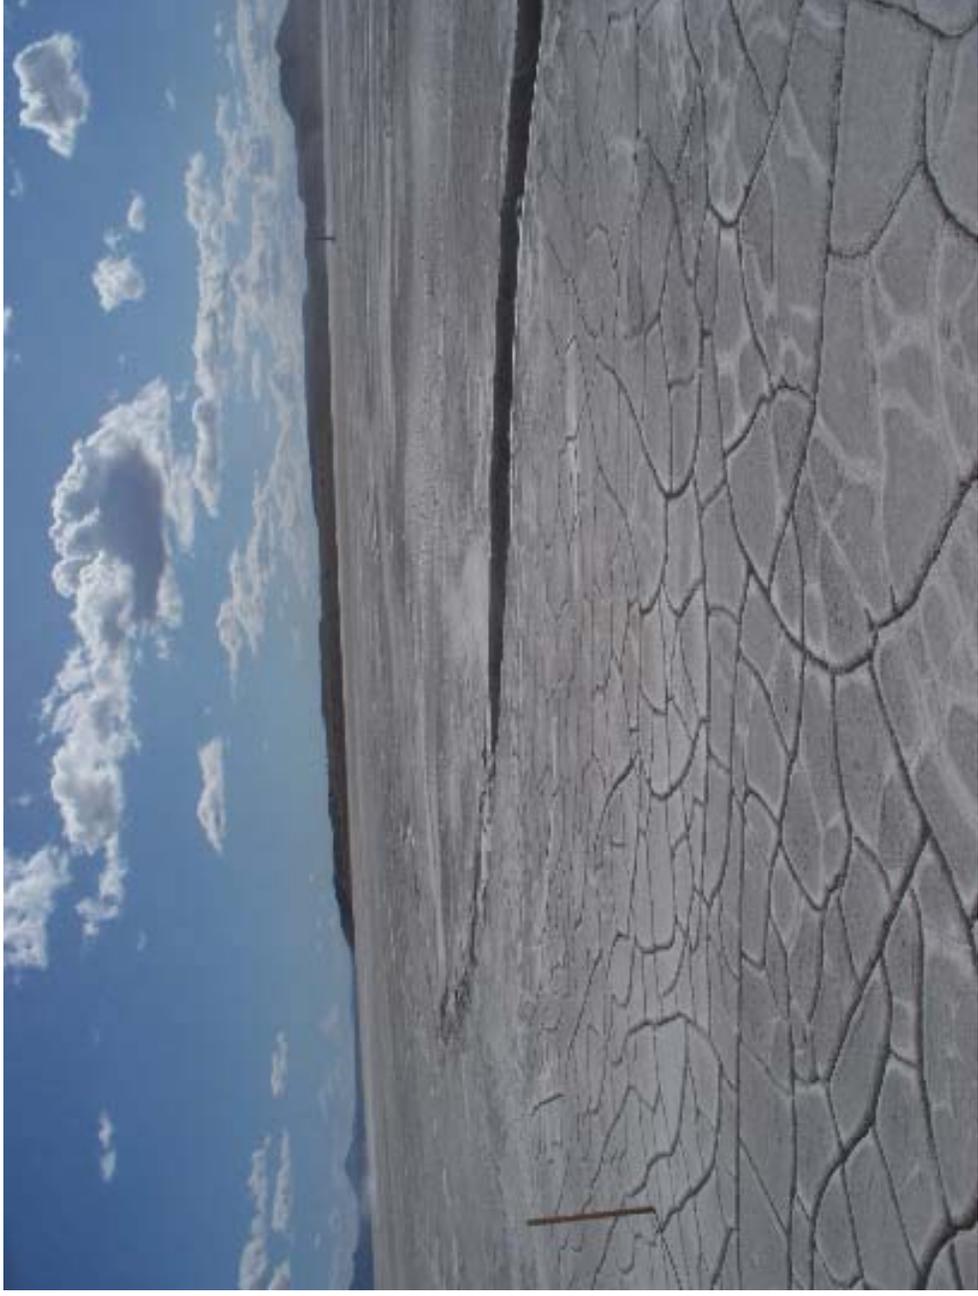
On top of Tailing # 8. Looking SW

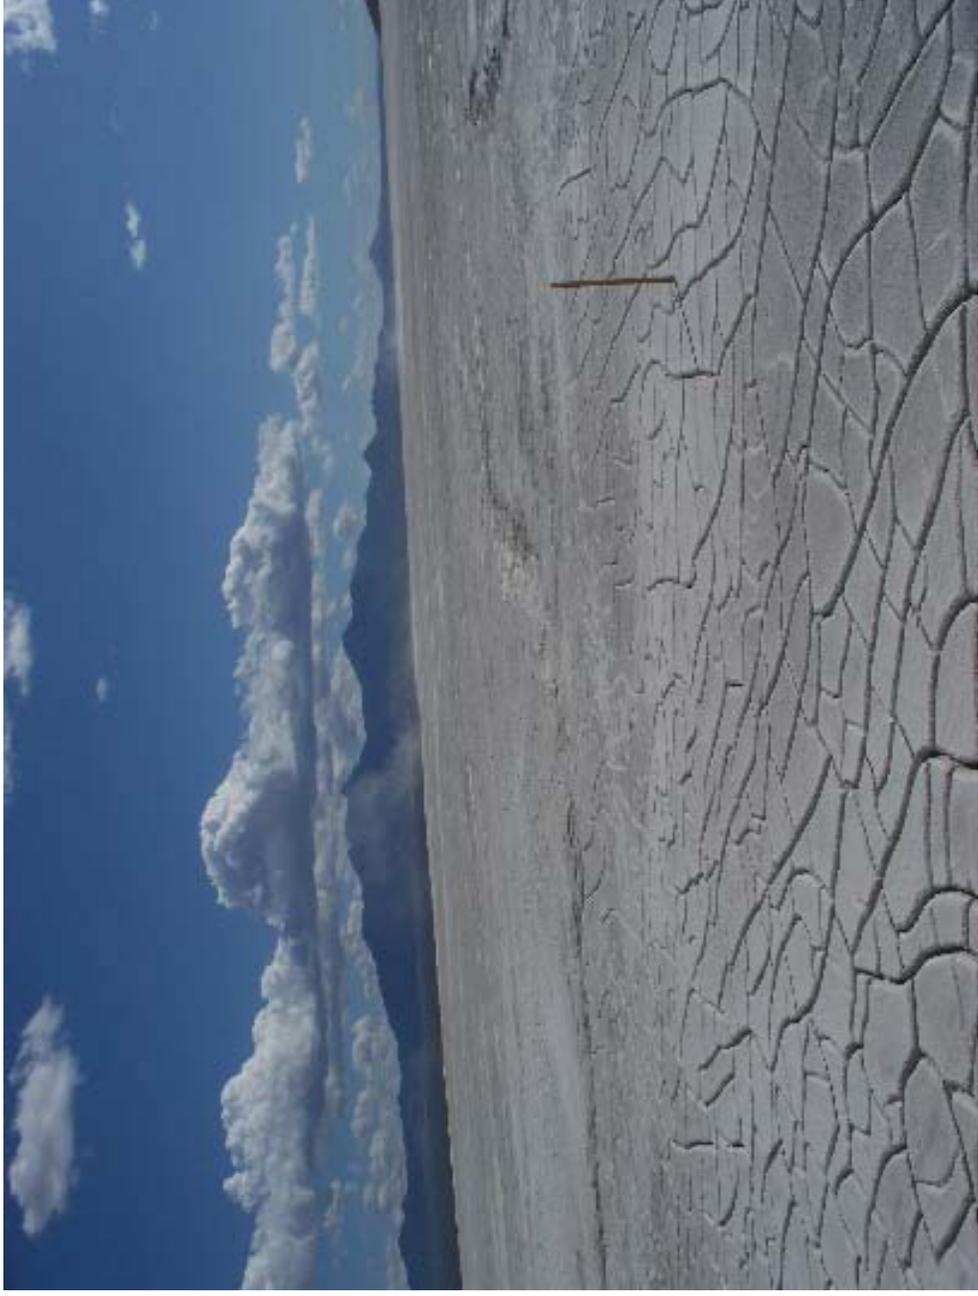
On top of Tailing # 8. Looking SW

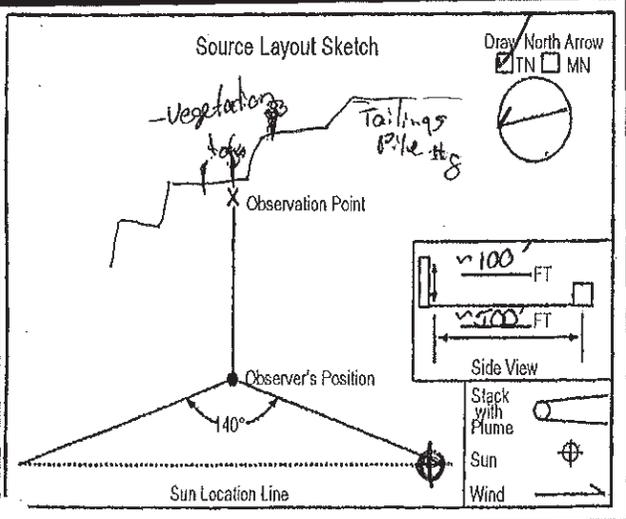
MIN	SEC				COMMENTS
	0	15	30	45	
1	0	10	0	0	
2	0	0	0	0	
3	0	0	0	5	
4	0	0	0	0	
5	0	0	0	0	
6	0	0	0	0	
7	0				Opacity = 0.6
8					AVG
9					Note:
10					See attached photos
11					taken before + after
12					
13					
14					
15					
16					
17					
18					
19					
20					
21					
22					
23					
24					
25					
26					
27					
28					
29					
30

ADDITIONAL INFORMATION
① Berm building mode - activity suspended due to forecast of high winds.

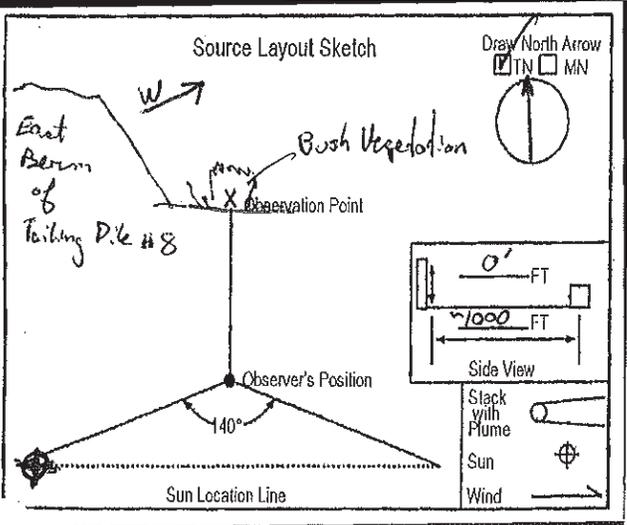
inner impoundment surface area were observed by the inspector as they crossed the east slope of the dam. The opacity was measured to be an average 29.8 % between 5:24 and 5:31 pm (Attachment 4).

MIN	SEC	0	15	30	45	COMMENTS
1	10	10	5	0		Readings taken
2	0	0	20	20		sitting close to wind pressure
3	40	30	20	10		
4	30	40	40	100		winds gusting
5	100	100	100	50		
6	20	0	0	0		
7	0					opacity
8						Avg = 29.8%
9						
10						
11						See Attached Photos.
12						taken before, during, & after VE evaluation
13						
14						
15						
16						
17						
18						
19						
20						
21						
22						
23						
24						
25						
26						
27						
28						
29						
30

ADDITIONAL INFORMATION
 ① Berm building made - activity suspended due to forecast of high winds.
