PIMA COUNTY
DEPARTMENT OF ENVIRONMENTAL QUALITY
33 N. Stone Avenue, Suite 700
Tucson, Arizona 85701-1429
www.deq.pima.gov

January 11, 2013

ASARCO LLC – Mission Complex
Attn: Thomas H. Phillips, General Manager
4201 W. Pima Mine Road
Sahuarita, AZ 85629

NOTICE OF VIOLATION # PC 1212-045

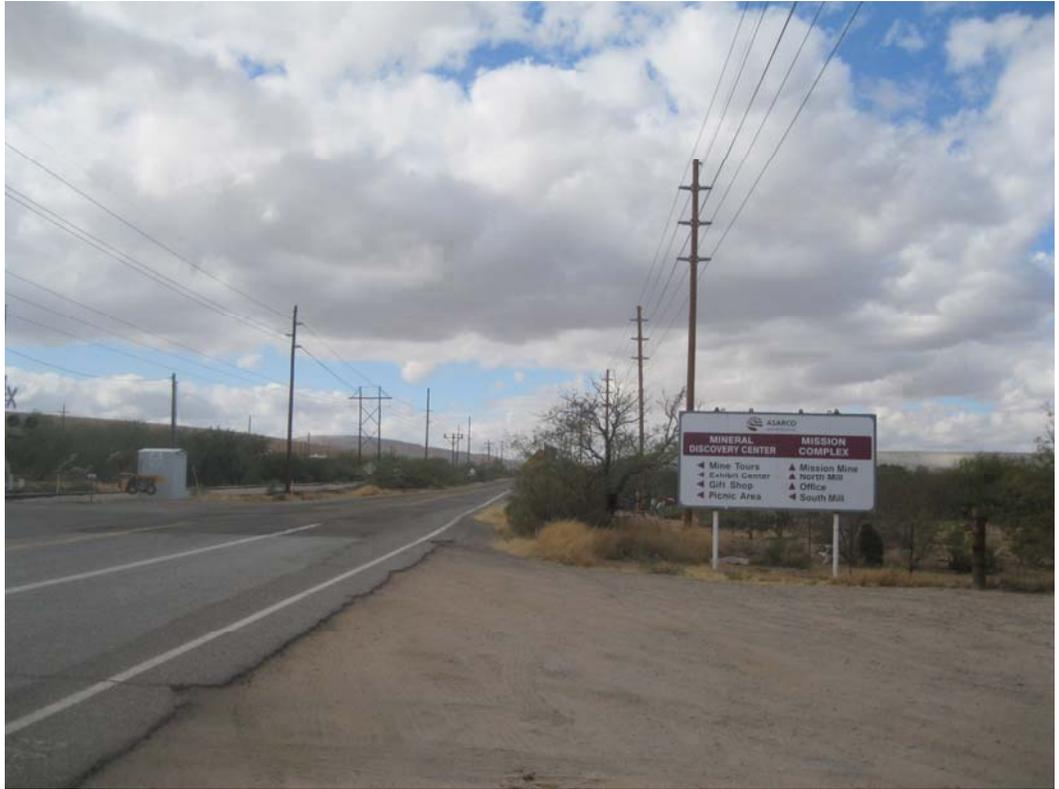
Photo No. 1
Date: 12/13/2012
Photo Description: View of the roadway and Tailings Impoundment #4 to the left at a pullout near the I-19/Pima Mine Road intersection.

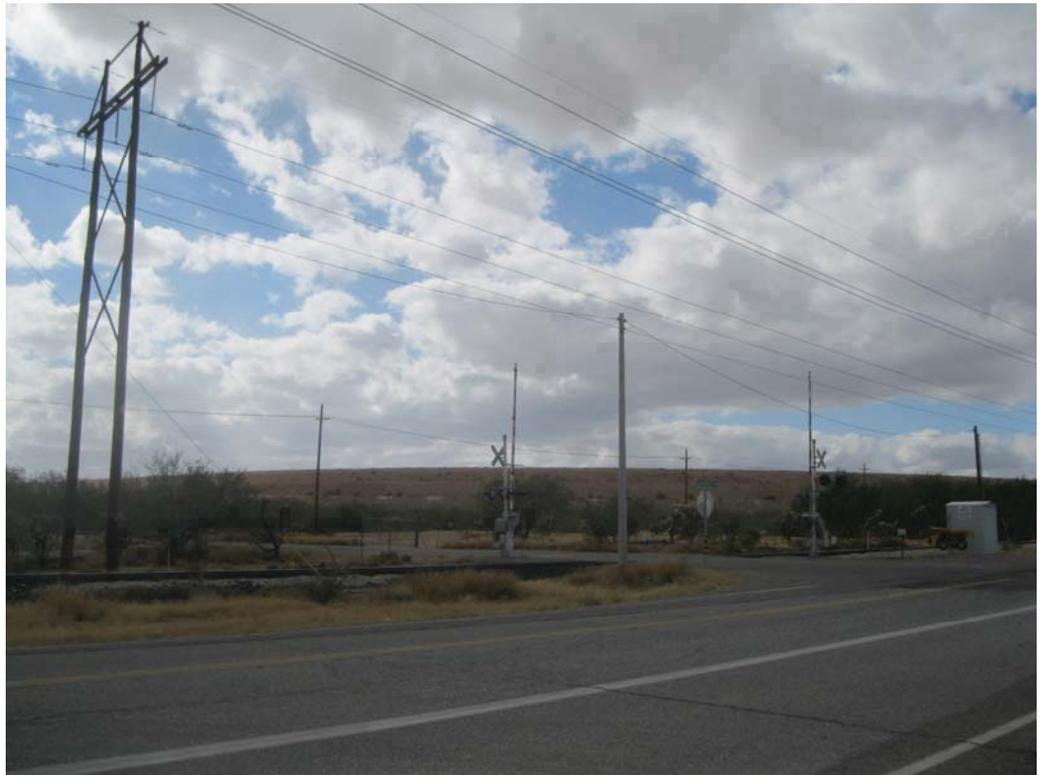
Photo No. 2
Date:
Photo Description: View of Tailings Impoundment #4 looking toward the southwest.

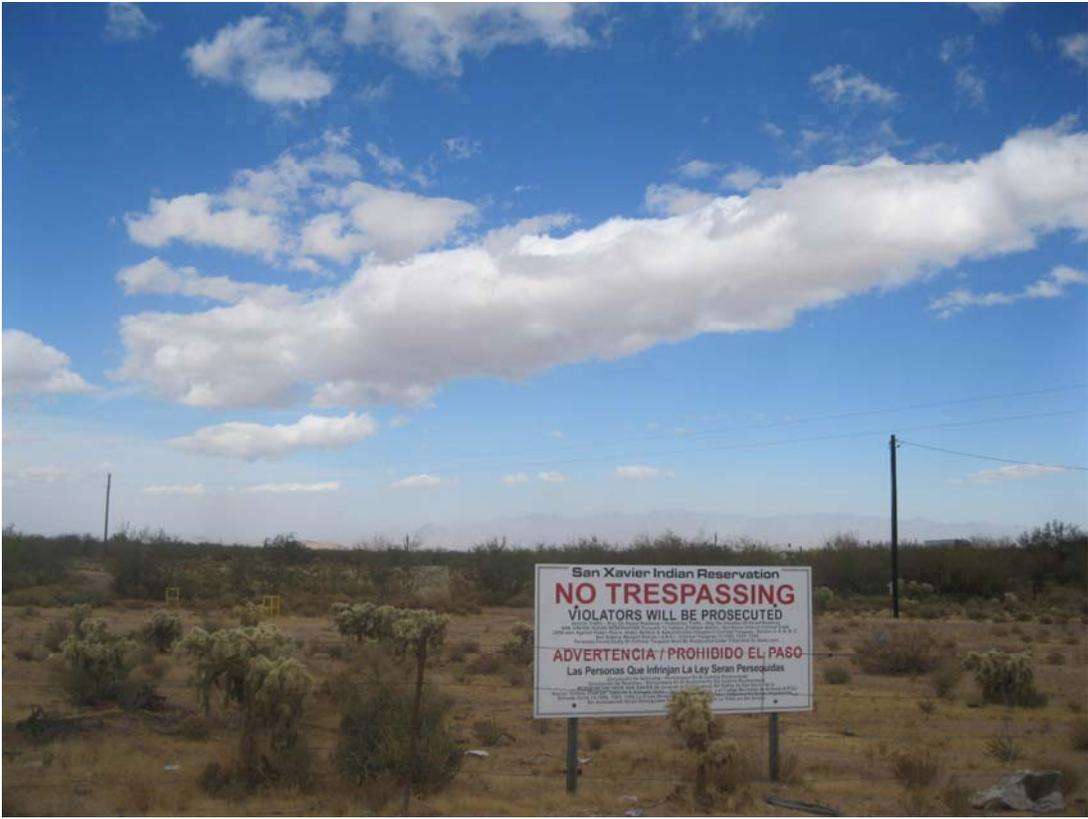
<p>Photo No. 3</p>

<p>Date: 12/13/2012</p>	
<p>Photo Description: View of background and horizon looking northeast toward Tucson.</p>

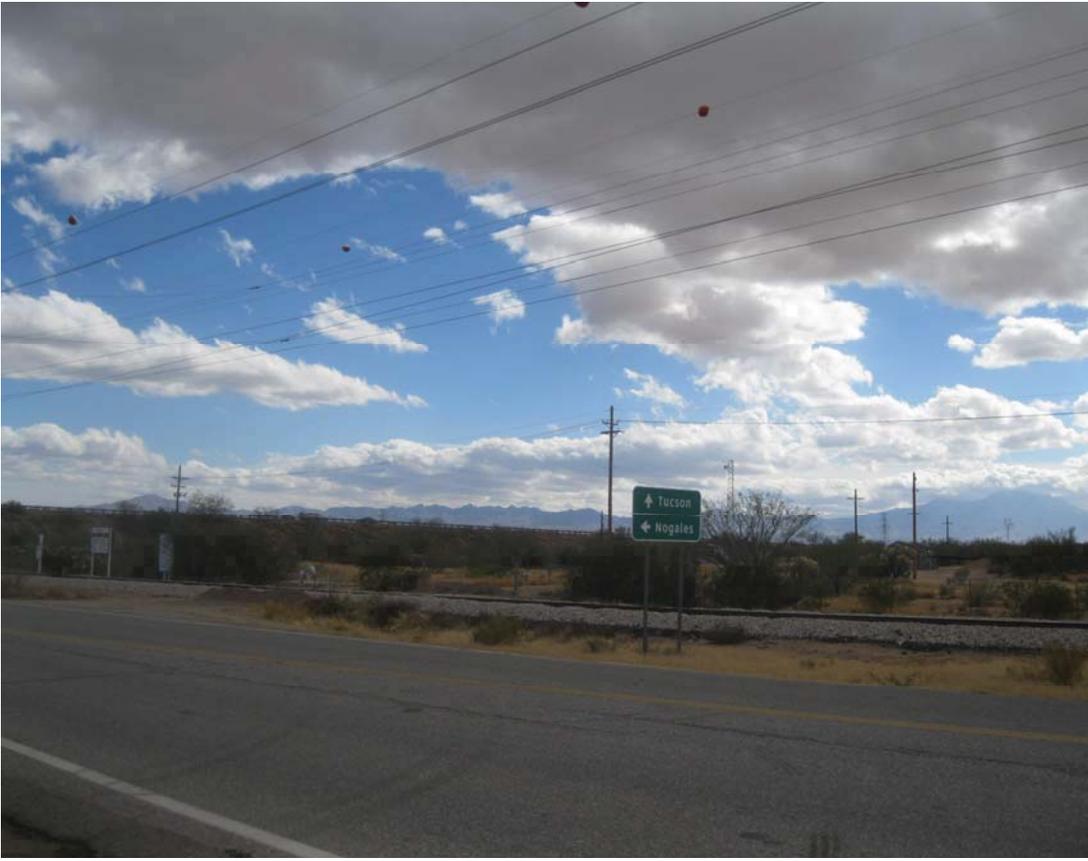
<p>Photo No. 4</p>

<p>Date: 12/13/2012</p>	
<p>Photo Description: View of background and horizon looking toward the southeast.</p>

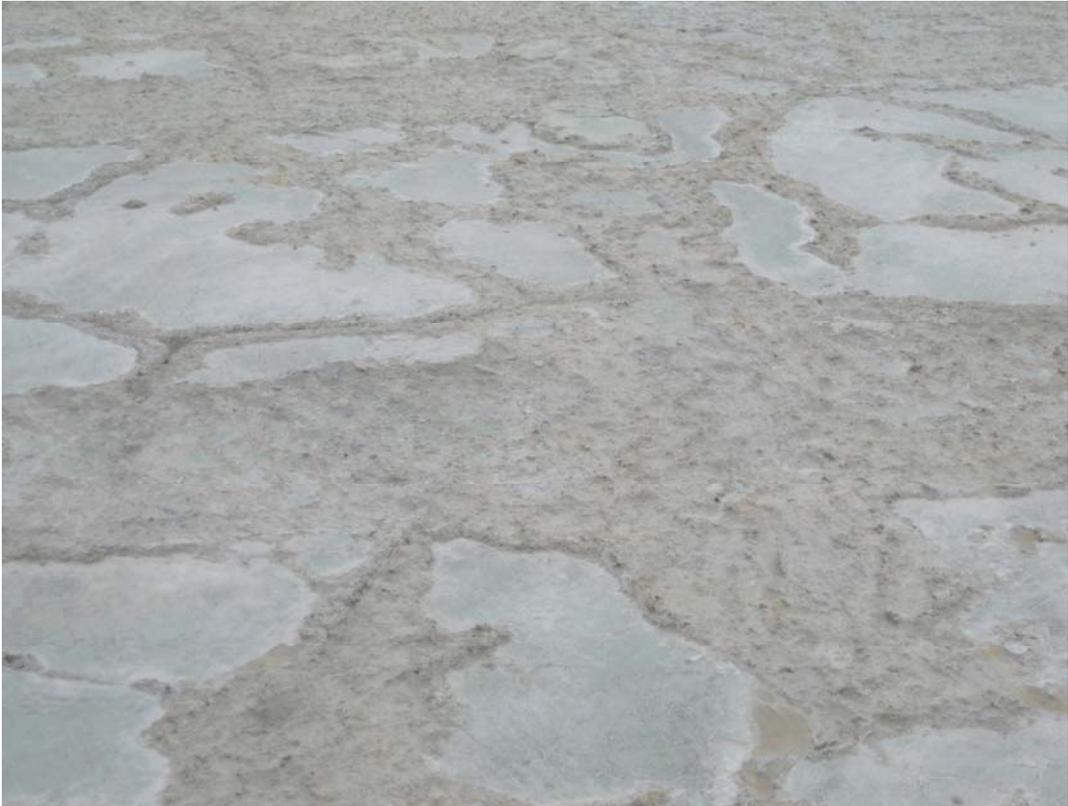
Photo No. 19

I walked out and examined the condition of the tailings surface in parts of the northeast area of the tailings impoundment where I had observed some of the plumes. I observed sizeable areas where the surface exhibited relatively low encrustation and appeared weathered. These areas were easily damaged under the weight of my footsteps. Blue green coloration was observed throughout the areas I walked indicating the areas had been treated with polymer in the past. The polymer was interspersed in non-uniform patterns in these areas. Prior to leaving the impoundment I measured a wind speed of 19 mph and the winds appeared to be diminishing (Attachment 1, Photo No.'s 13-22).

Date: 12/13/2012	
Photo Description: Close up view.

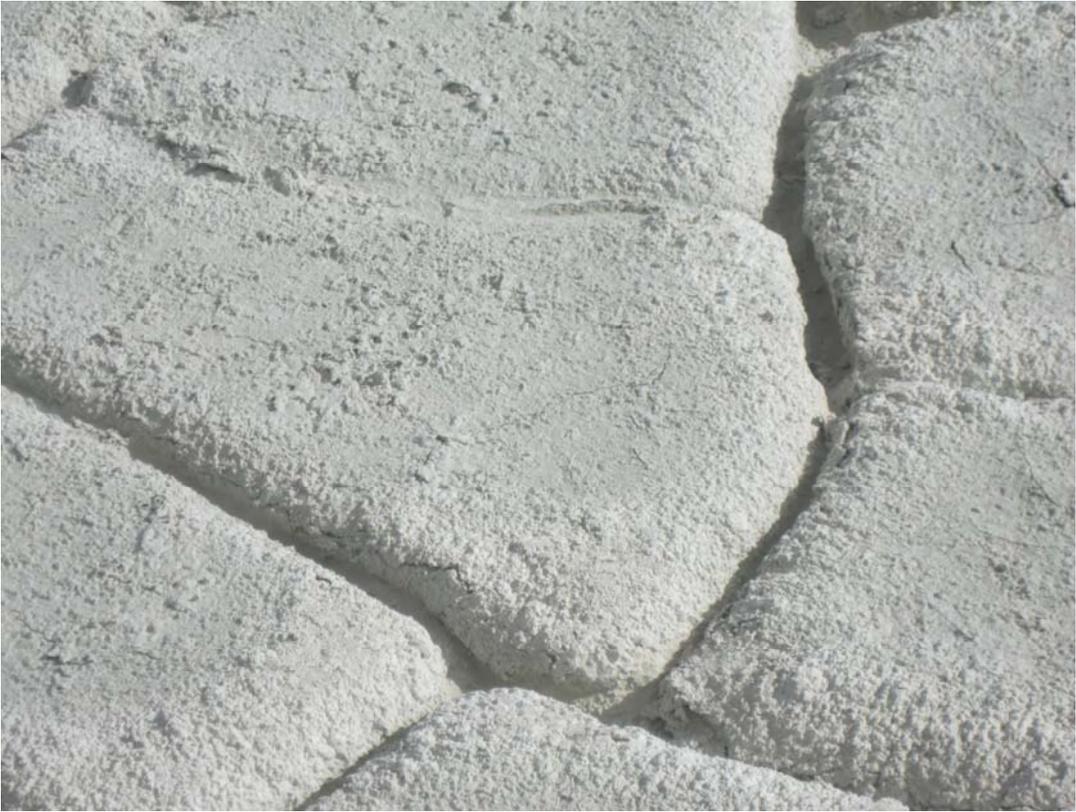
Photo No. 21

Date: 12/13/2012	
Photo Description: A Close up view.
