ASARCO LLC – Mission Complex
Attn: Thomas H. Phillips, General Manager
4201 W. Pima Mine Road
Sahuarita, AZ 85629

NOTICE OF VIOLATION # PC 1301-055

Site Location: ASARCO LLC – Mission Complex 4201 W. Pima Mine Road, Sahuarita, AZ	Photographer: J. M. Jones	Tracking #: PC 1301-055
--	-------------------------------------	-----------------------------------

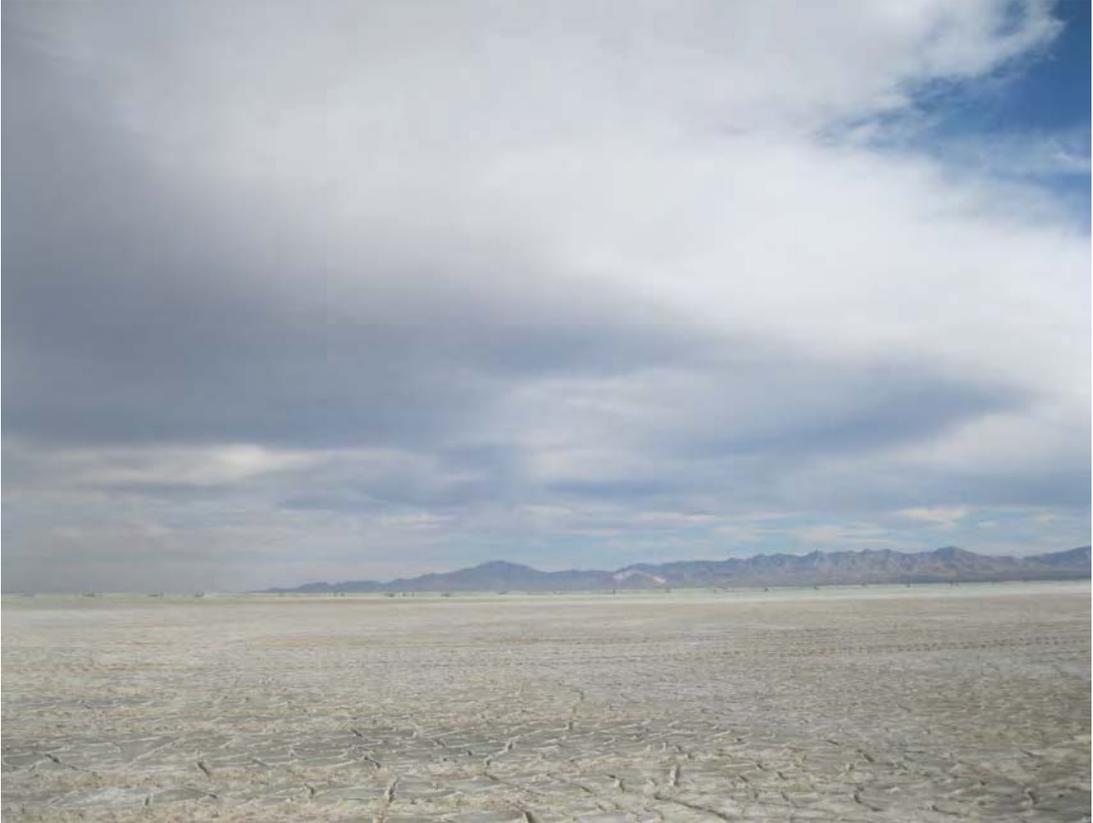
<p>Photo No. 18</p>

<p>Date: 1/10/2013</p>	
<p>Photo Description:</p> <p>View of the east dam looking east from the same location above.</p>

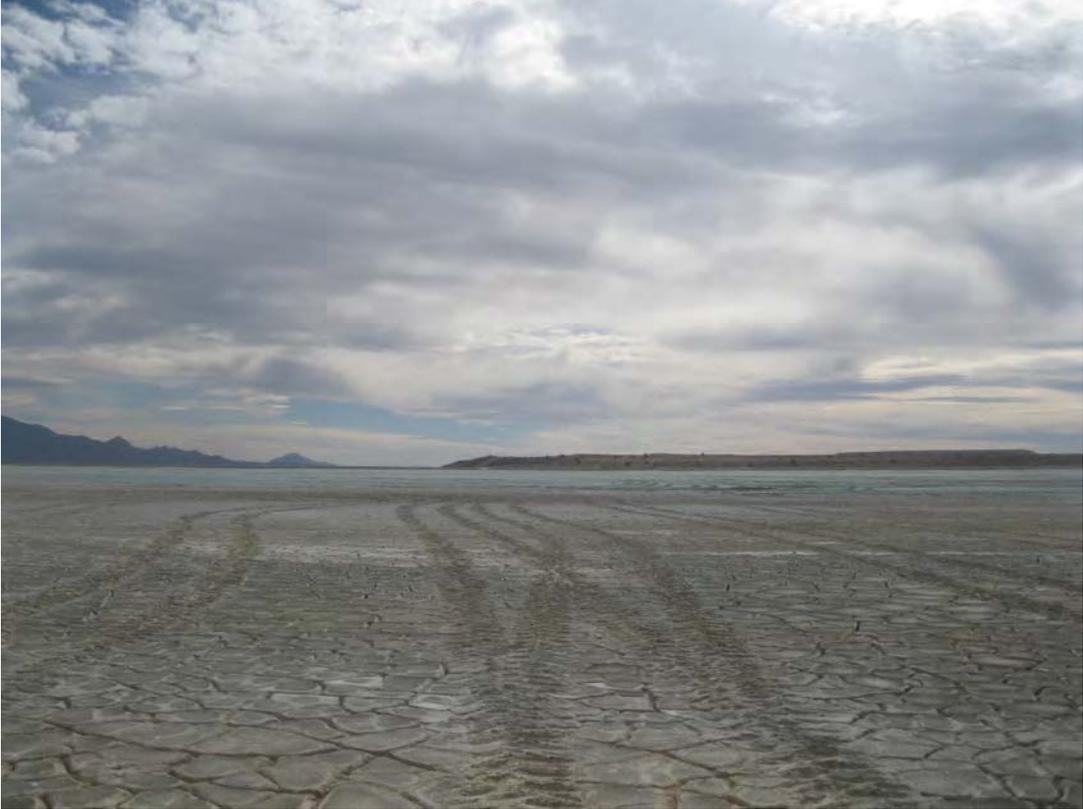
<p>Photo No. 20</p>

<p>Date: 1/10/2013</p>	
<p>Photo Description:</p> <p>View toward the south from the location above.</p>

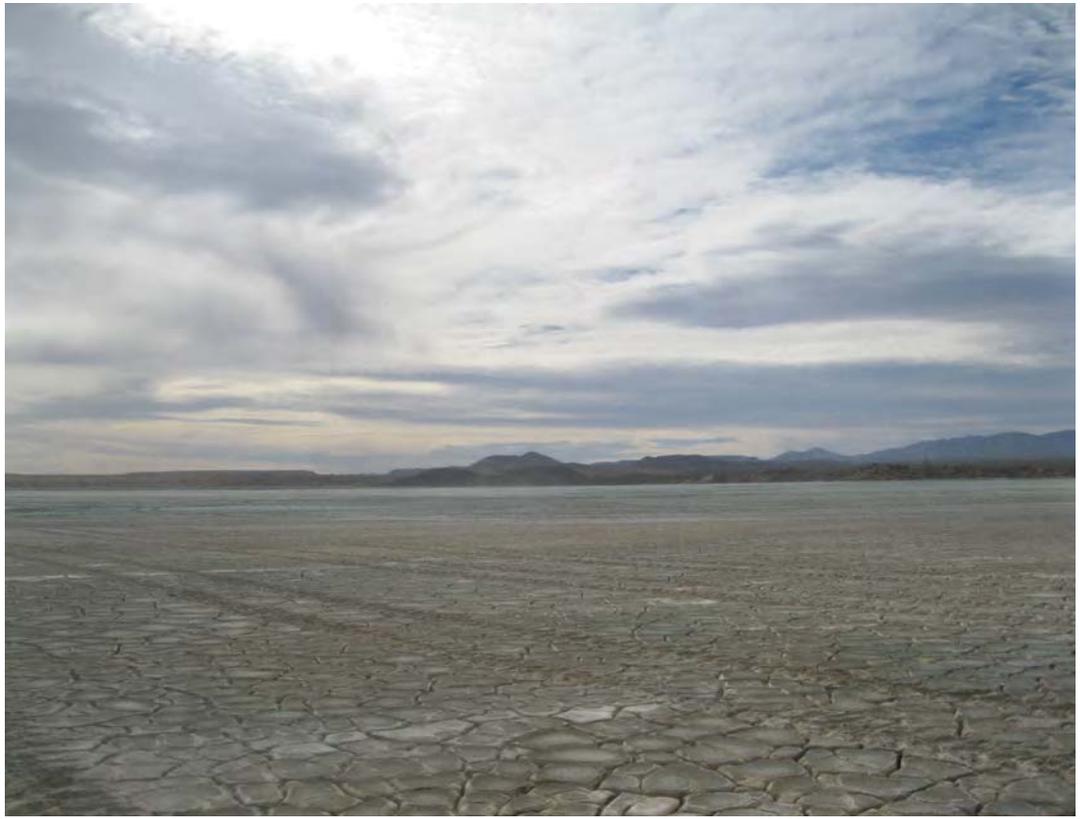
Photo No. 21

Date: 1/10/2013	
Photo Description: View toward the southwest from the location above.

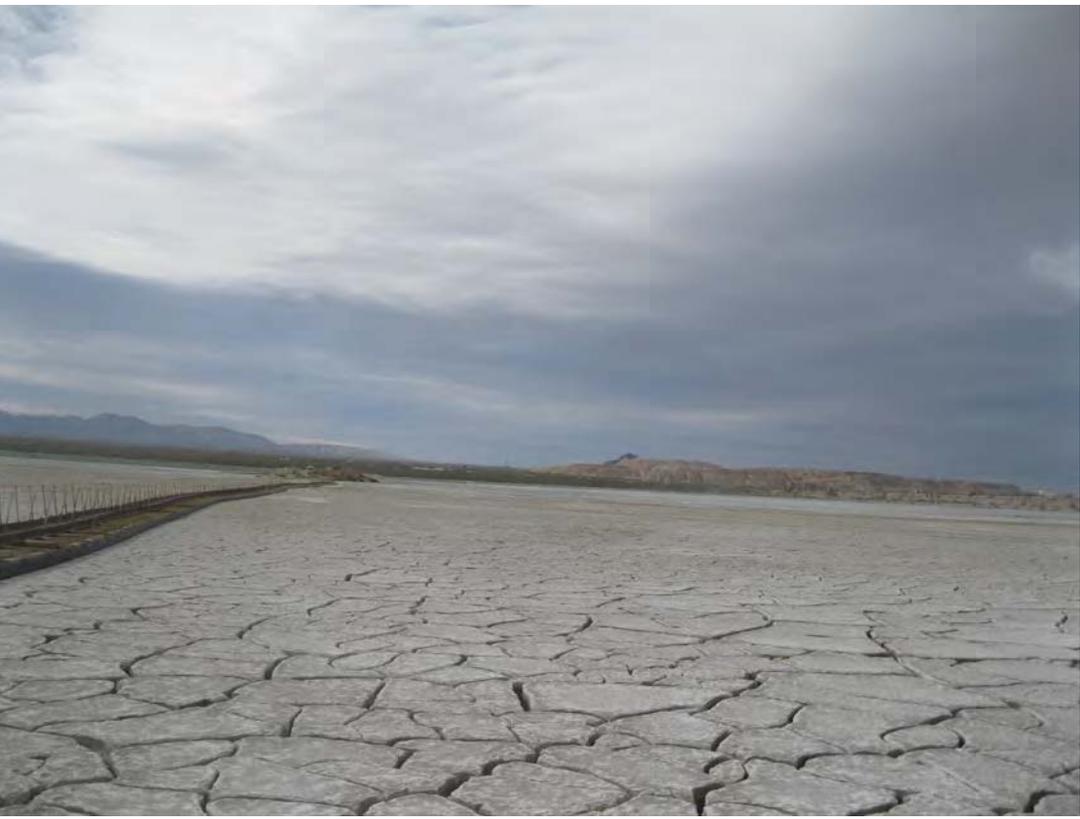
Photo No. 22

Date: 1/10/2013	
Photo Description: View looking toward the west from the decant tower area.

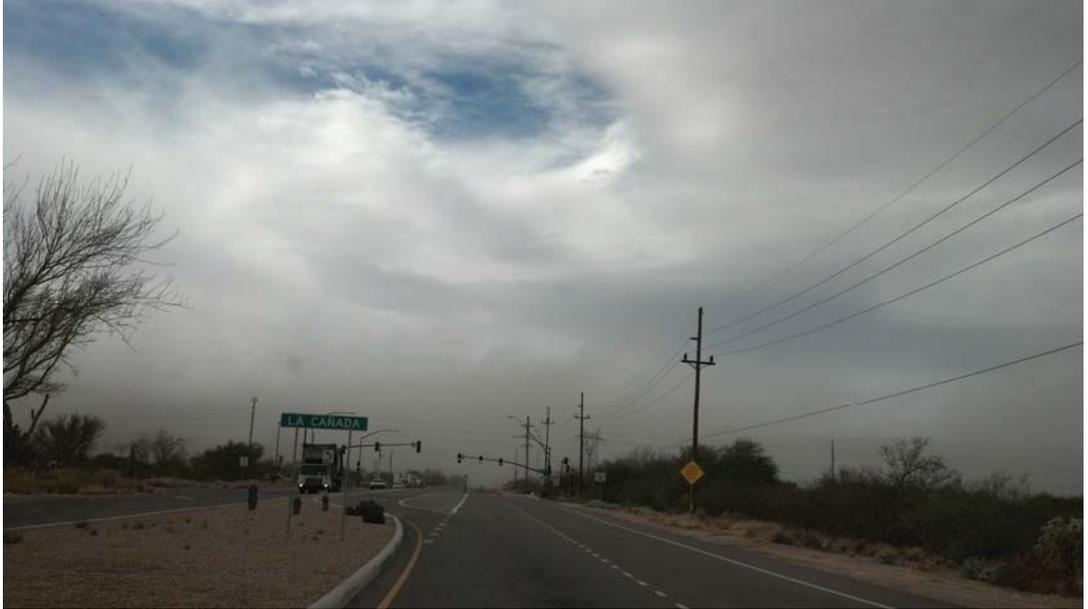
<p>Photo No. 4</p>

<p>Date: 1/10/2013</p>	
<p>Photo Description:</p> <p>Another view looking west towards the La Canada Drive / Sahuarita Road intersection.</p>
