**NOTICE OF VIOLATION # PC 0912-067**

**Complaint Investigation Report**

**Tracking ID: PC0912-067**

**Source:** ASARCO, LLC - Mission Complex

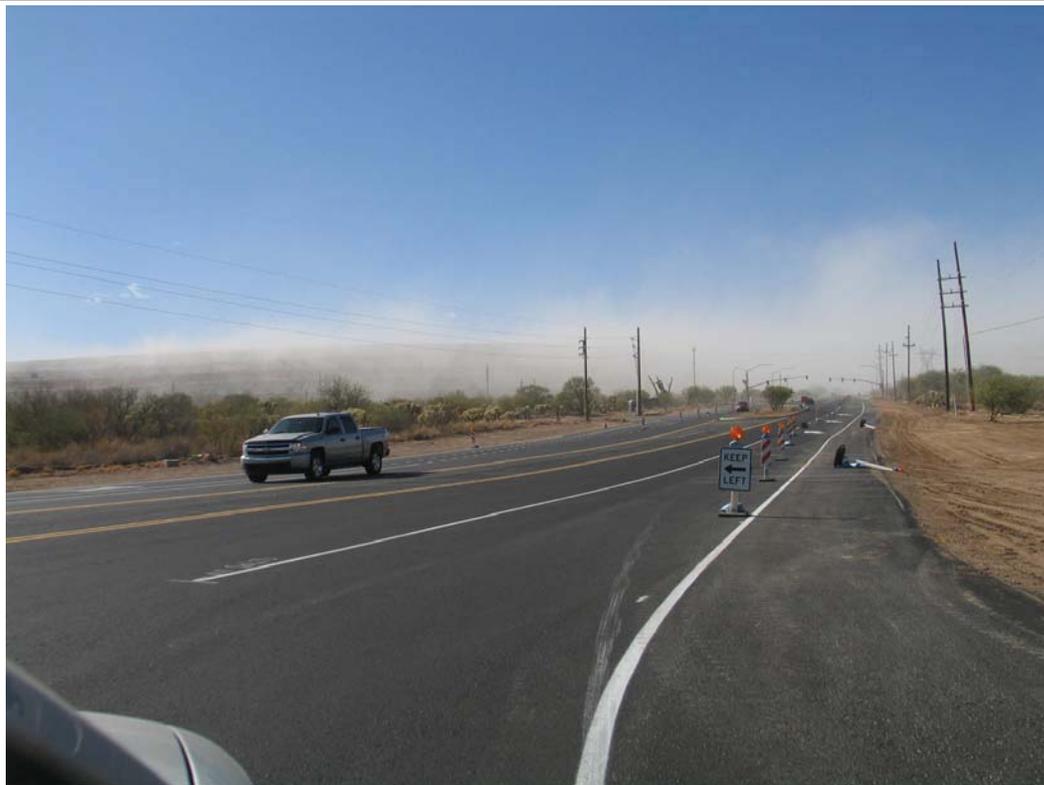
<p><b>Photo No. 3 a,b,c,d</b></p>

View of the light colored visible particulate emissions generating from tailings dam #8 at 1:05 pm as viewed from the side of Sahuarita Road west of I-19. The visible emissions can be observed blowing across Helmet Peak Road and obscuring visibility.

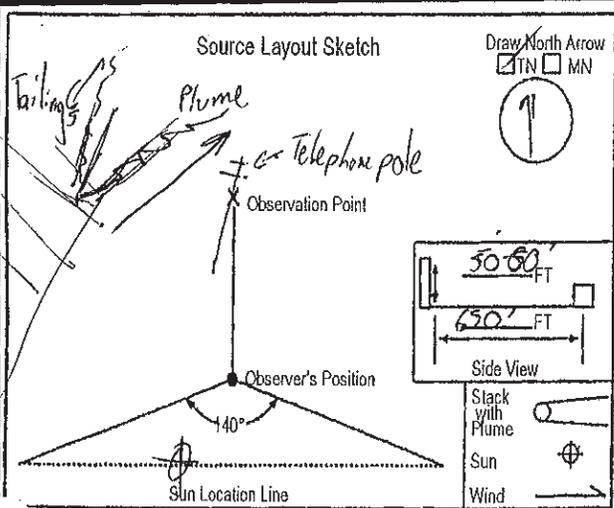
MIN	SEC	0	15	30	45	COMMENTS
1	0	5	10	5		
2	10	20	20	5		Observation point
3	5	5	40	40		only catching outer
4	20	15	30	40		fringe of plume
5	20	10	5	10		
6	40	80	40	50		Opacity Avg. 23.4%
7	40	15	10			
8						See attached Photos
9						
10						
11						
12						
13						
14						
15						
16						
17						
18						
19						
20						
21						
22						
23						
24						
25						
26						
27						
28						
29						
30

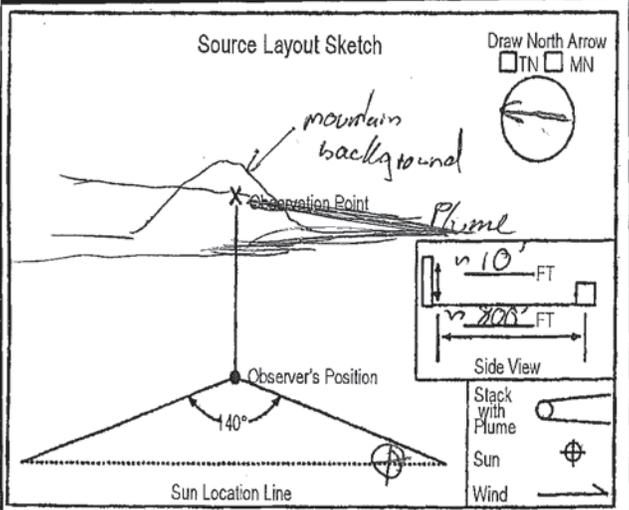
MIN	SEC				COMMENTS
	0	15	30	45	
1	100	100	100	40	
2	75	100	60	50	
3	100	100	100	100	
4	100	100	100	100	
5	100	100	40	40	
6	30	70	60	85	
7	60				Opacity Avg. 80.4%
8					
9					(see attached photo)
10					
11					
12					
13					
14					
15					
16					
17					
18					
19					
20					
21					
22					
23					
24					
25					
26					
27					
28					
29					
30
