PIMA COUNTY REGIONAL FLOOD CONTROL DISTRICT INFRASTRUCTURE MAINTENANCE DIVISION

Inspection Form

**19-MA-0004 - Santa Cruz River - Miracle Mile to Sweetwater Drive
Confluence of Flowing Wells Wash at Prince Road**

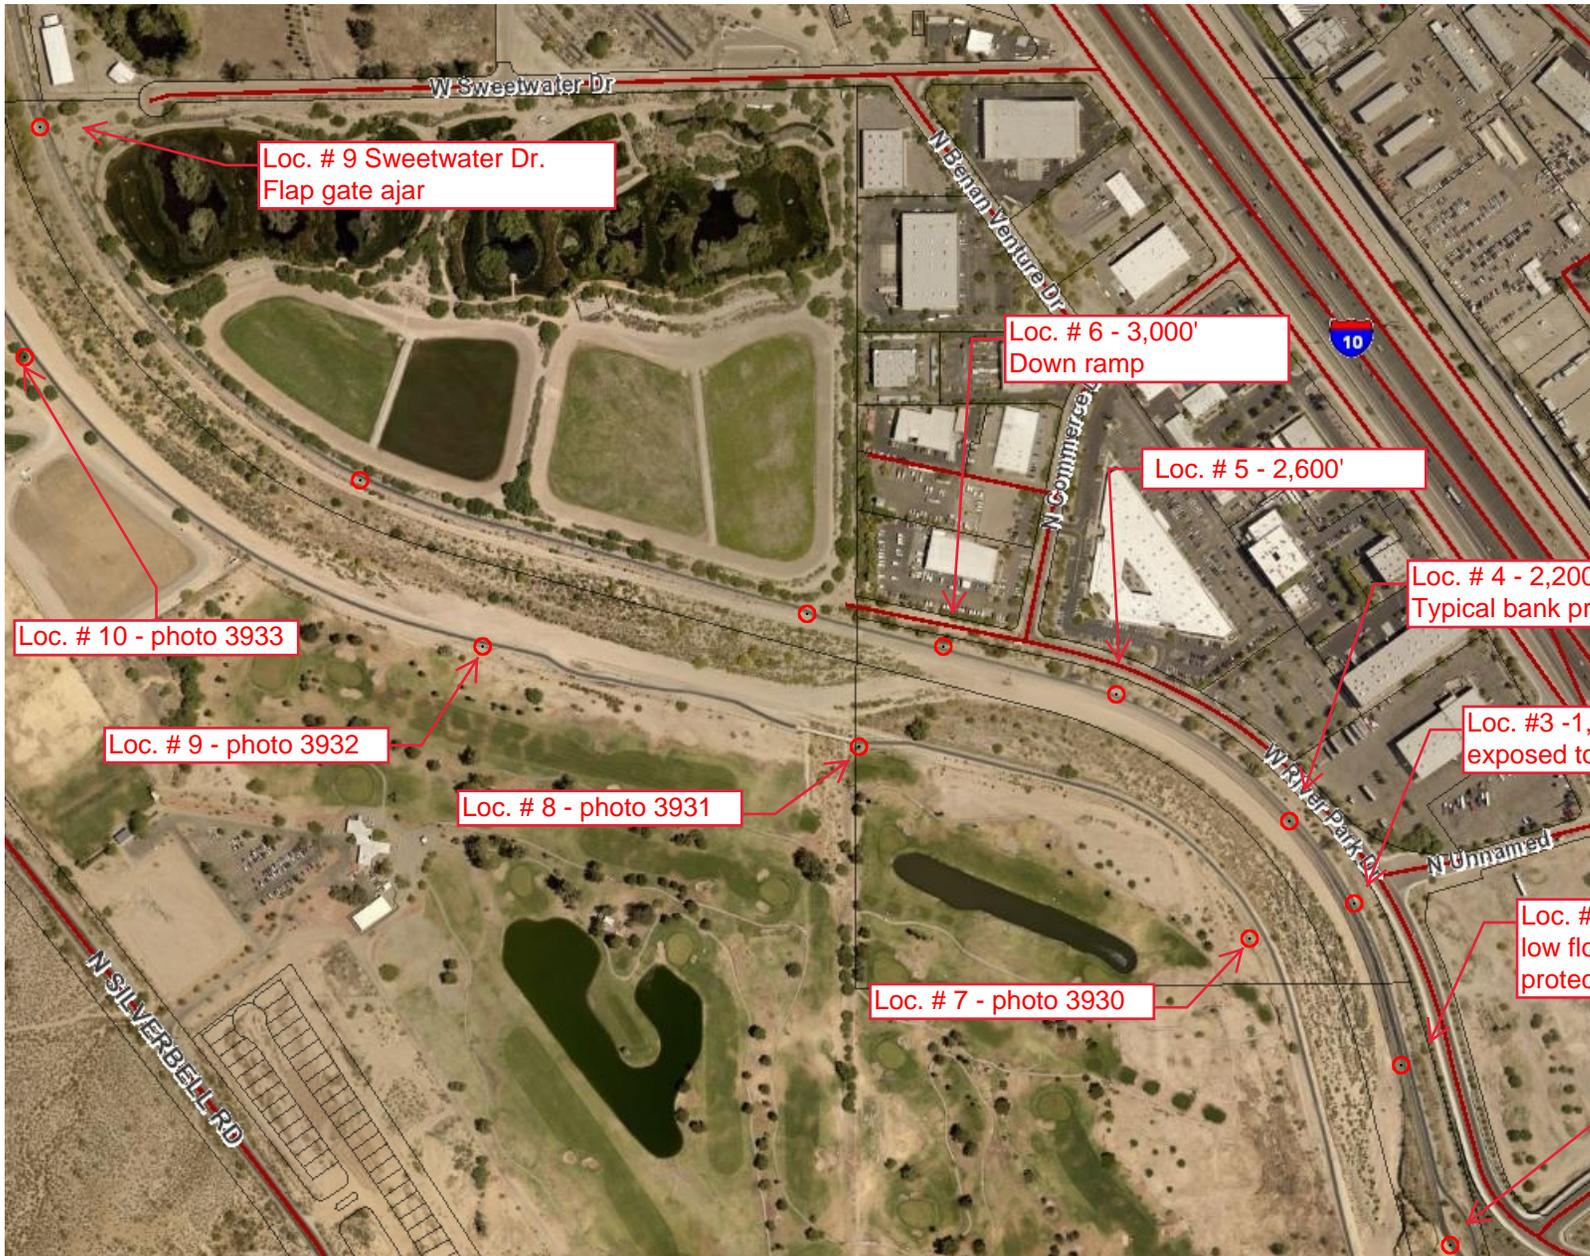
Loc. # 9 Sweetwater Dr.
Flap gate ajar

Loc. # 6 - 3,000'
Down ramp

Loc. # 5 - 2,600'

Loc. # 4 - 2,200'
Typical bank protection

Loc. #3 -1,500'
exposed toe down

Loc. # 2 - 600'
low flow meets bank
protection

Loc. #1 - Prince Rd.
Flowing Wells Wash

Loc. # 10 - photo 3933

Loc. # 9 - photo 3932

Loc. # 8 - photo 3931

Loc. # 7 - photo 3930

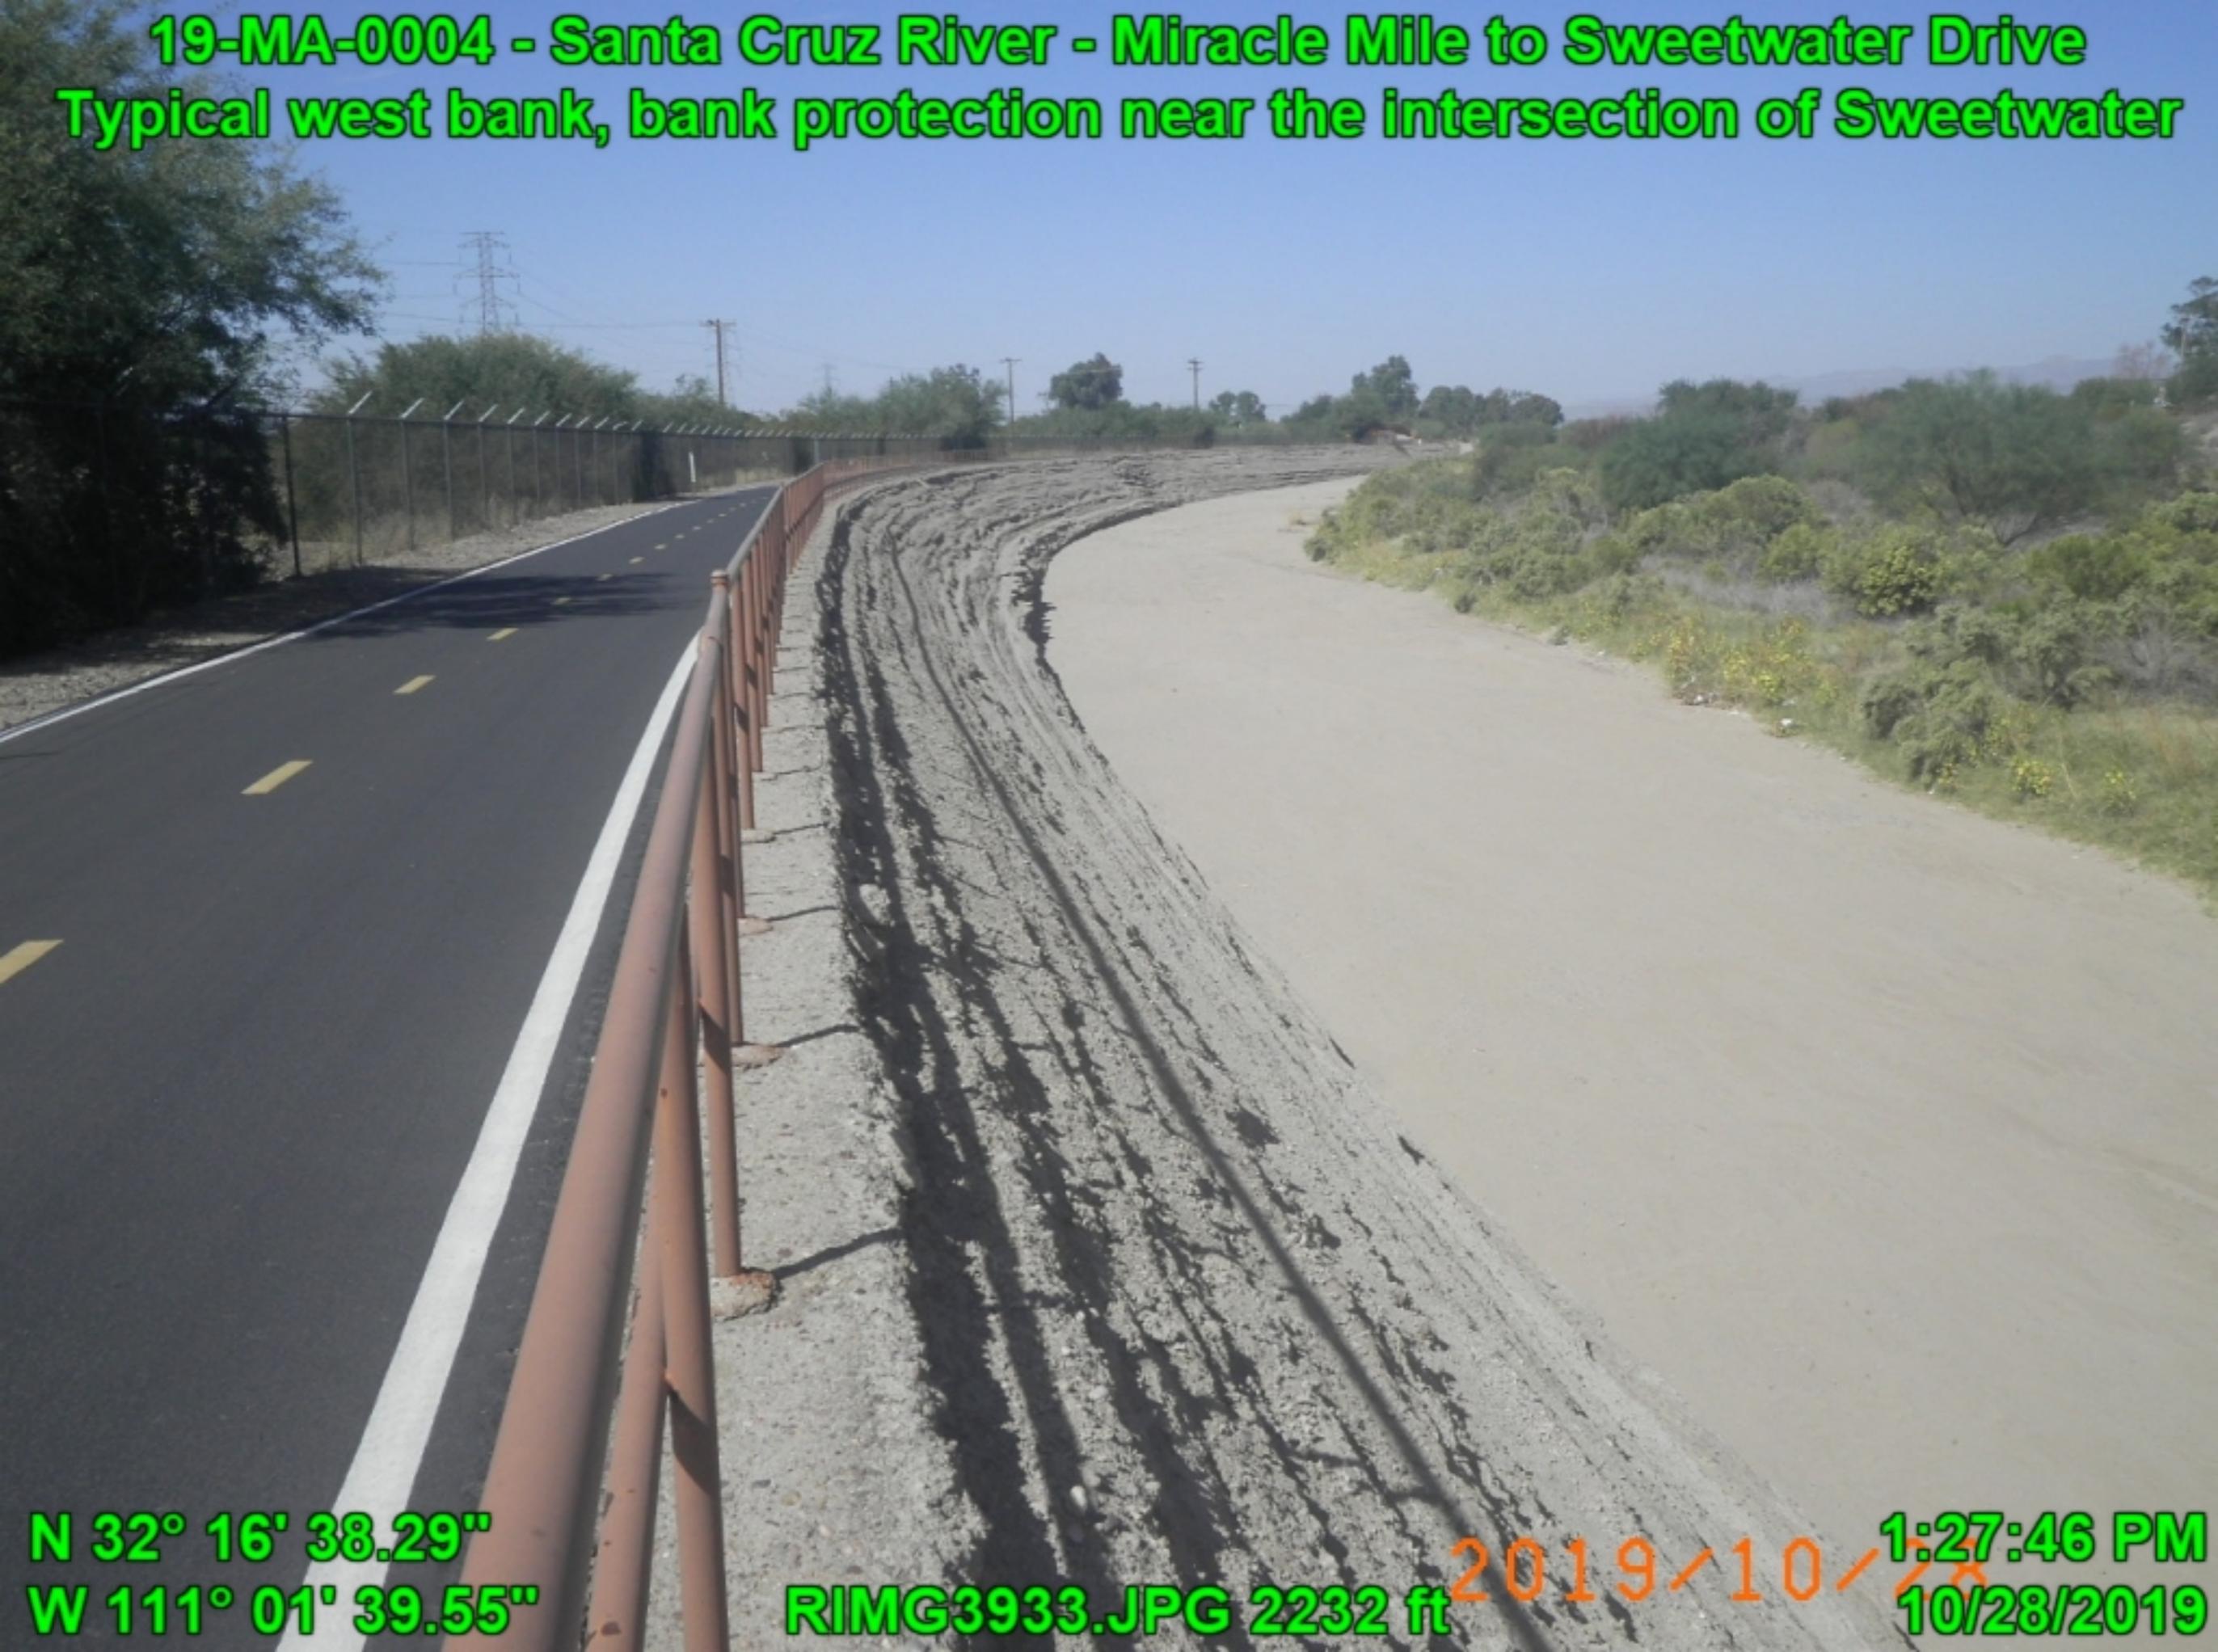
RIMG3933.JPG 2232 ft

19-MA-0004 - Santa Cruz River - Miracle Mile to Sweetwater Drive
Typical west bank, bank protection near the intersection of Sweetwater
