Canoa Ranch

Historic Rehabilitation Work by Pima County:
A sampling of before and after conditions between
2005 and 2014

Bond Funded Construction Phases I-IV 2006 - 2012

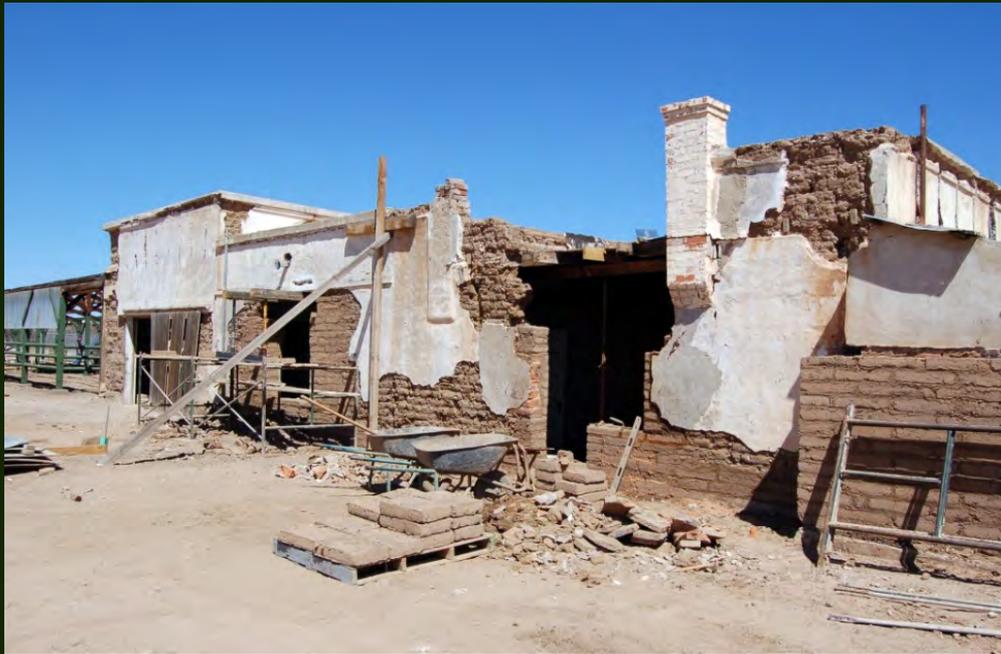
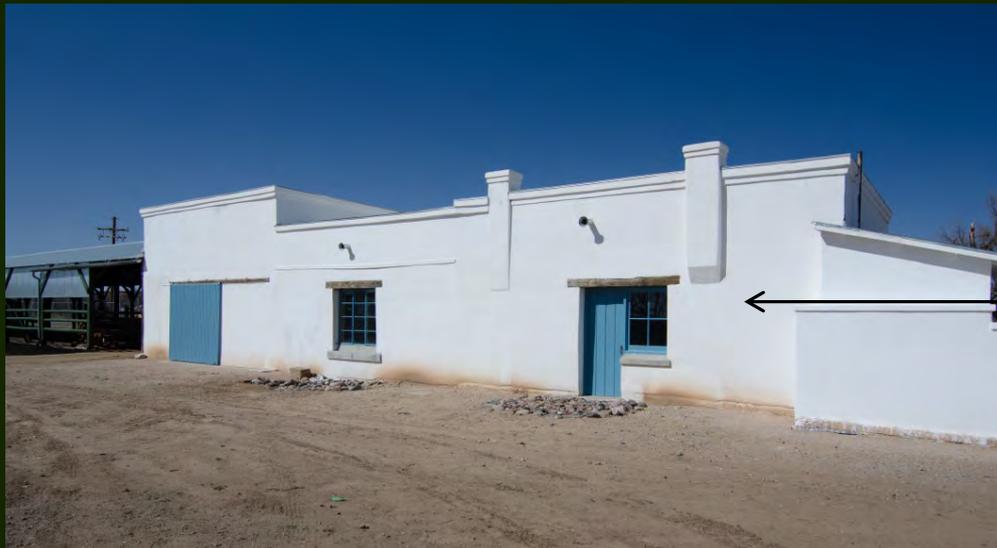
Utility Building
(south side) with
portion of
Employee's House

A portion of this building
(at right) was used by the
Grijalva family.
