Adkins Residence

Adkins Steel Parcel

Building Condition Assessment Report

February 25, 2008

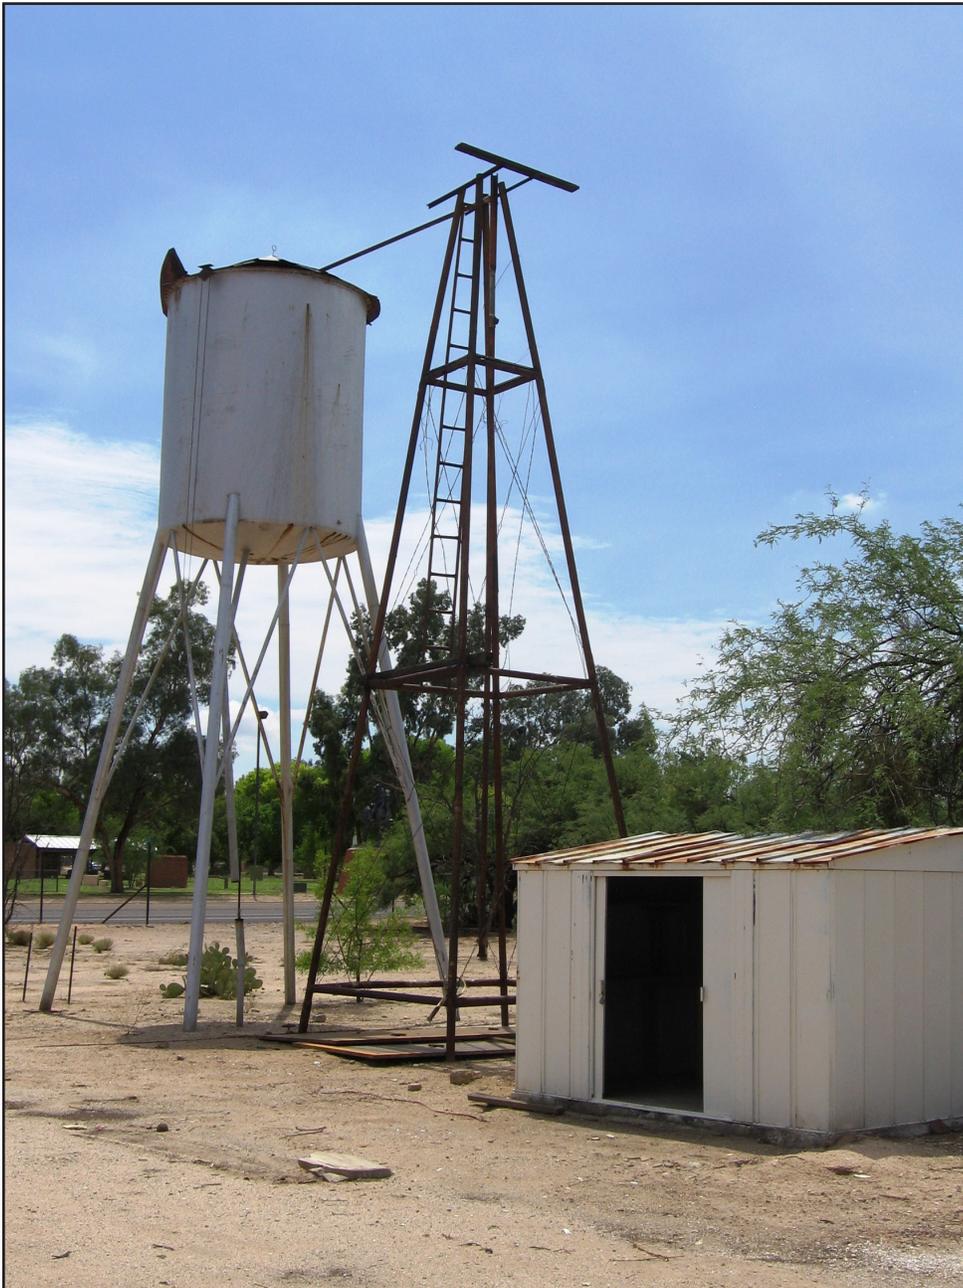
In the rear yard of the house there is the windmill and the water storage tower; beside these is a steel shed.

Figure No. 11 – Windmill base, water tank, and “tin” shed south of house

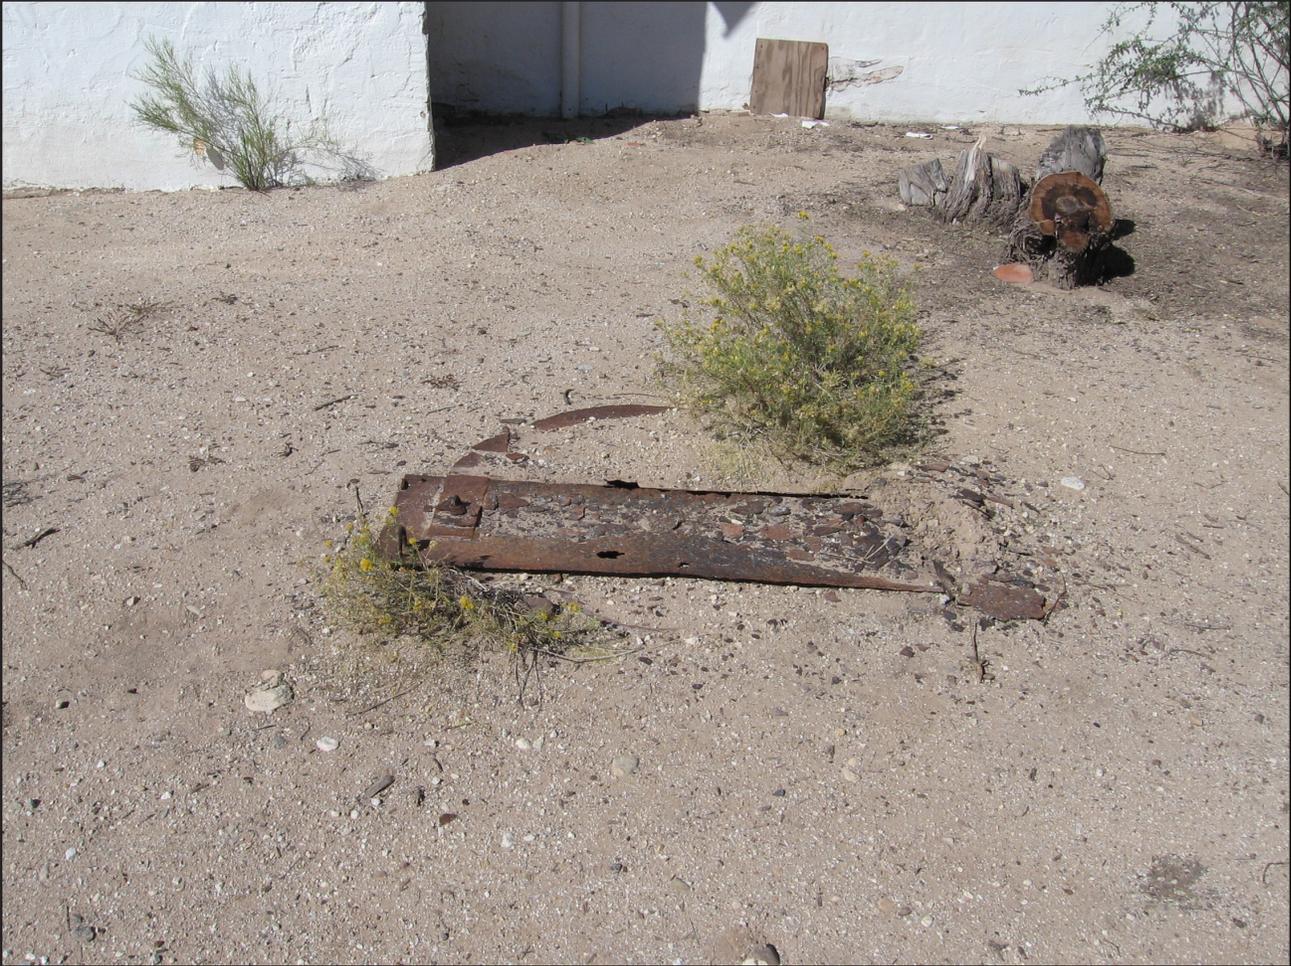
To the east there is a well casing or perhaps a monitor opening for a septic system (see Plumbing systems) that is covered with a steel plate.

Figure No. 12 – Monitor opening for septic with steel cover

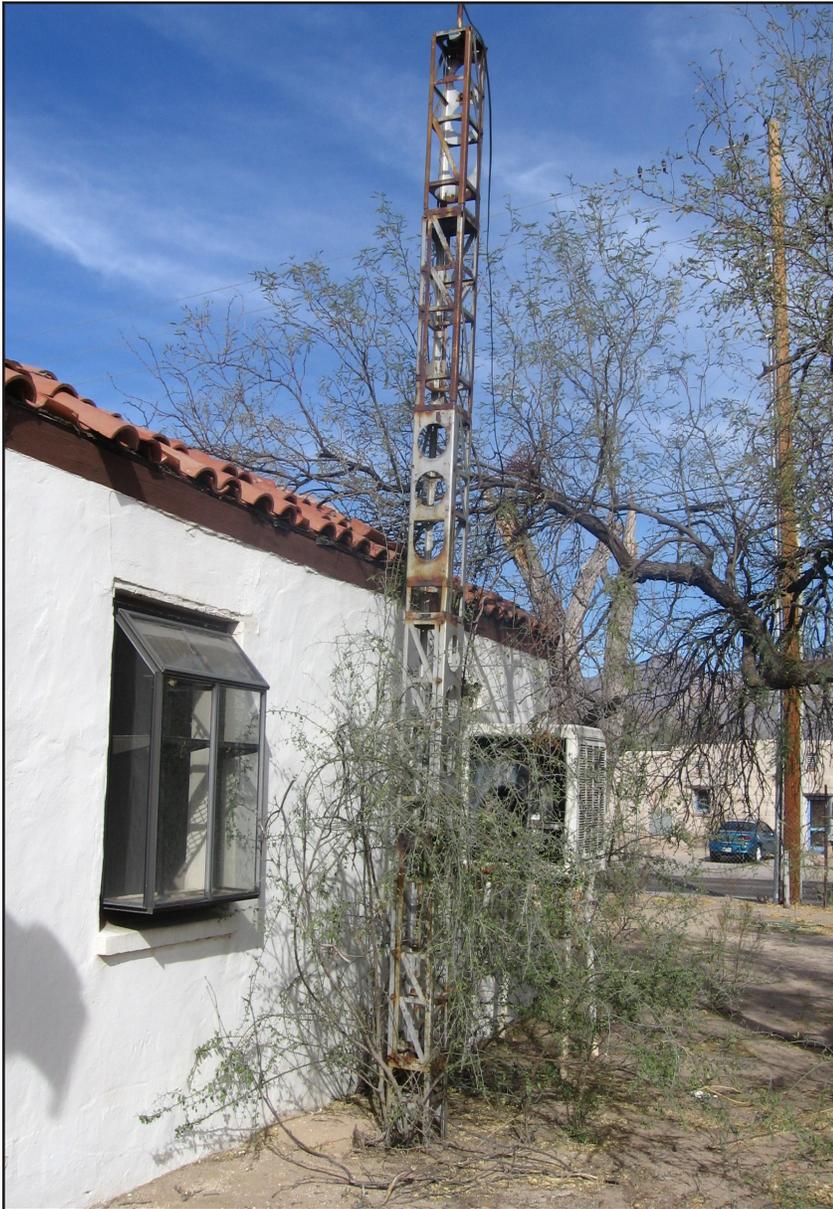
At the east side of the house, there is an antenna support tower fabricated from what appear to be shell casing racks, probably obtained from Davis Monthan Air Force Base. This is another example of the can-do attitude at work – constructing something useful and unique out of the objects at hand.

Figure No. 13 – Antenna tower fabricated from shell casing storage racks

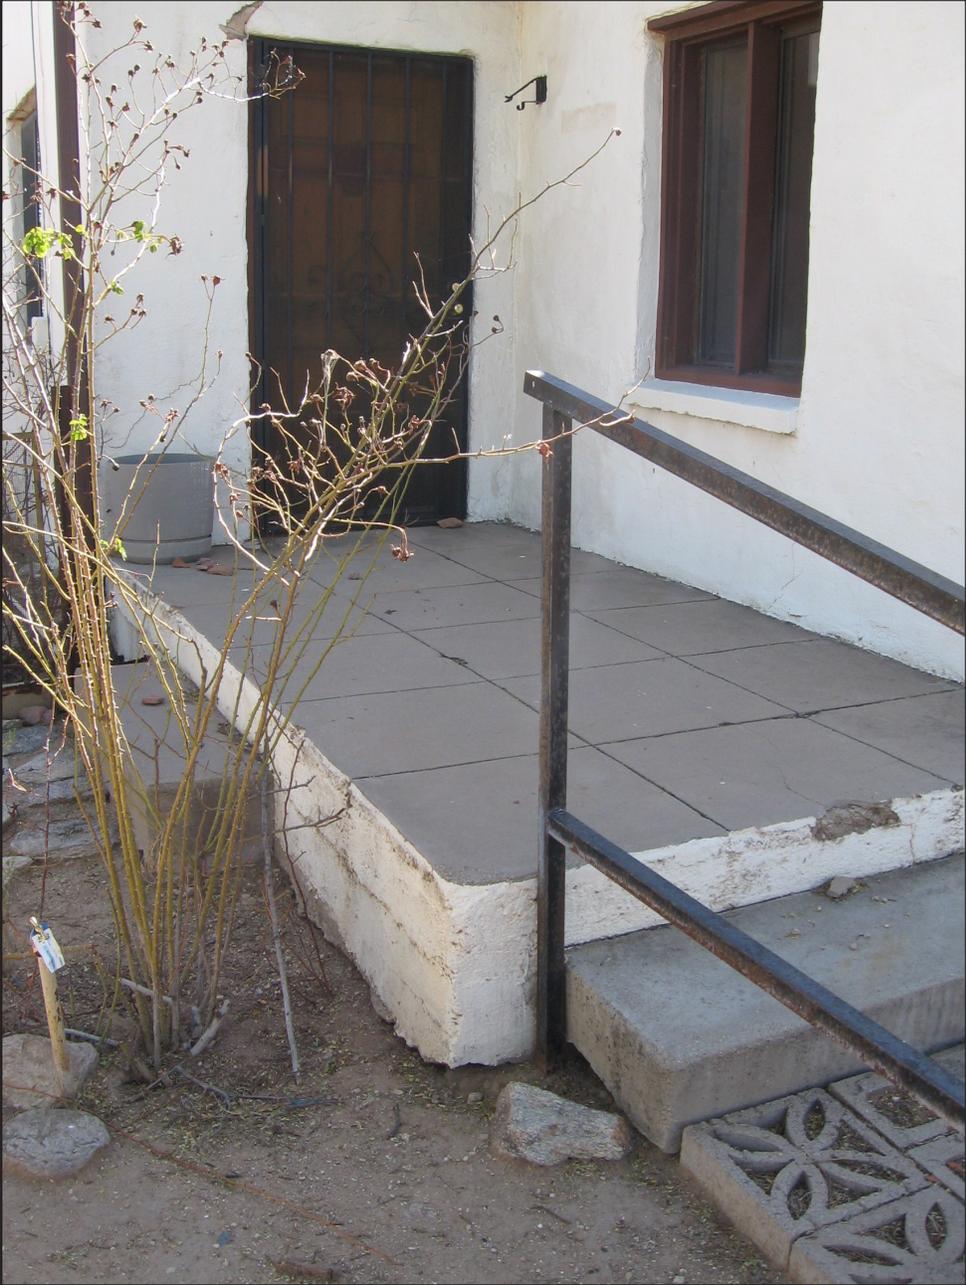
There is an entry porch with an ornamental steel railing. The porch is cast-in-place concrete accessed by a step on the west side and one on the north (Figure 18).

Figure No. 18 – Entry porch with railing

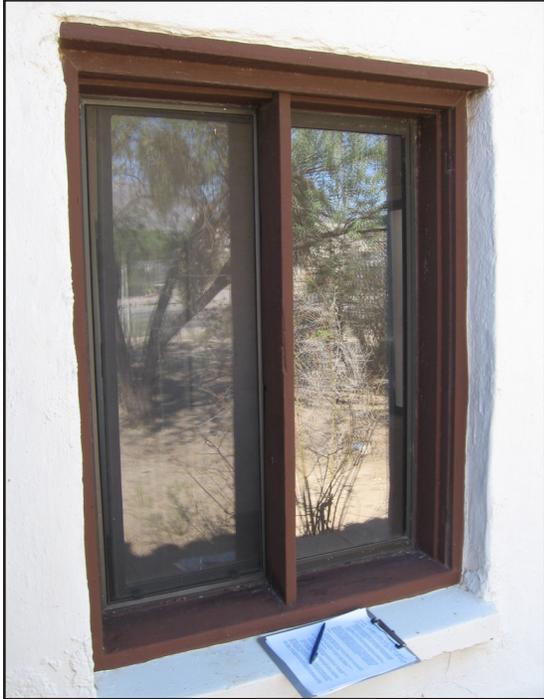
There appear to be no original windows left on the house. Most existing windows are residential-grade dark-bronze aluminum horizontal sliding installed behind the original wood frame. There is evidence of hinging for the original windows (perhaps wood out swinging casement) on the frames(Figure 23).

Figure No. 22 – Original wood casing with aluminum window mounted behind

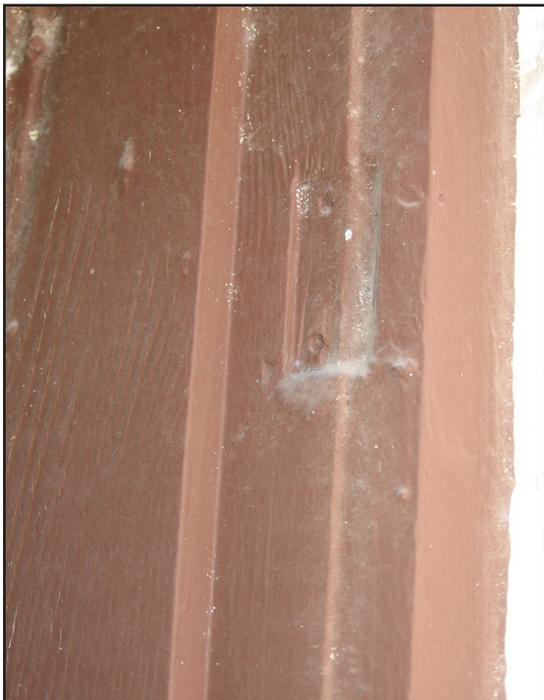
Figure No. 23 – Wood casing with painted-over indentation from removed hinges

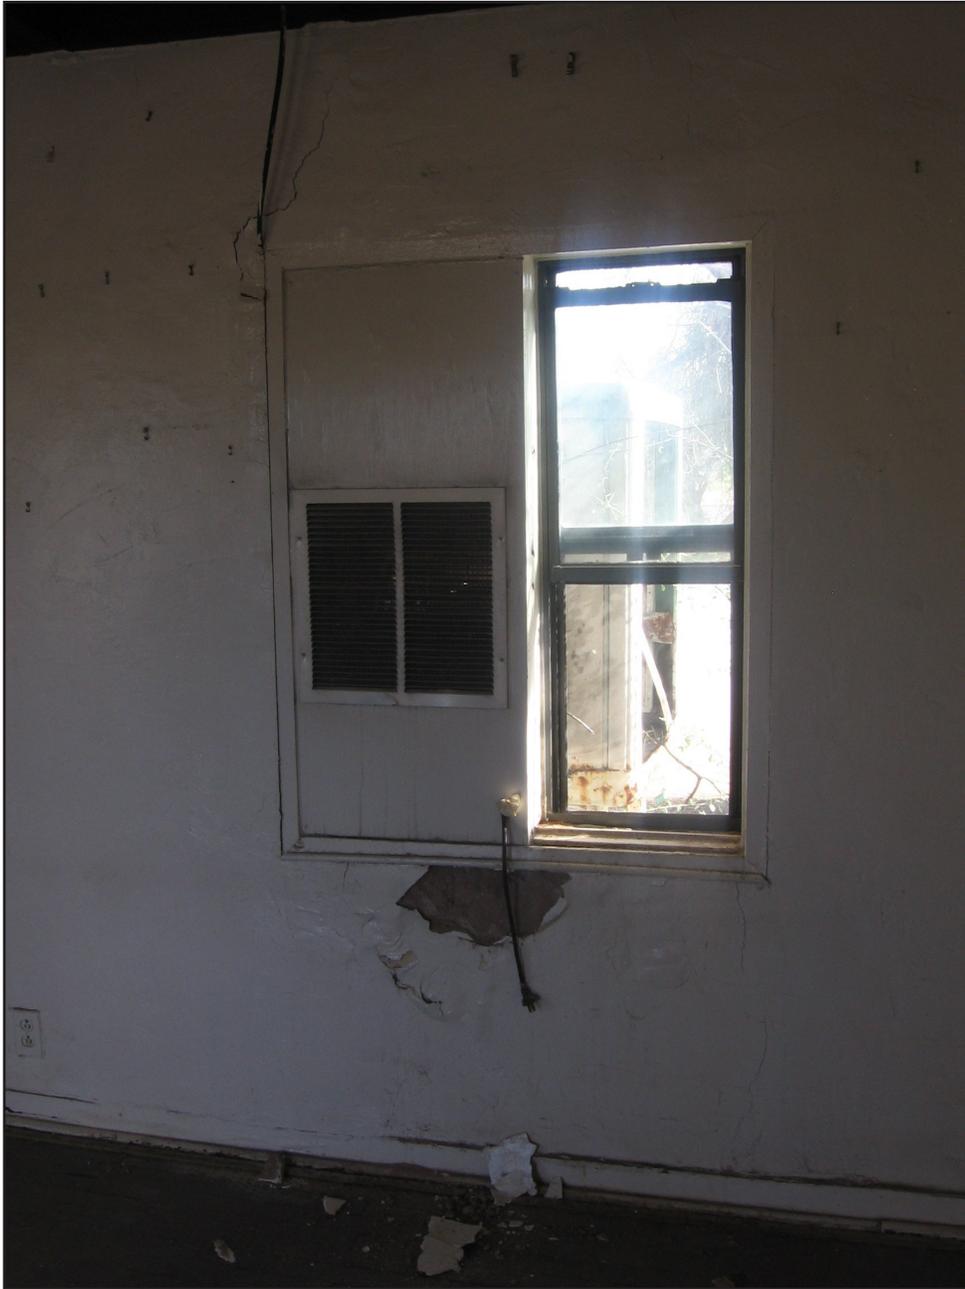
There is an aluminum bay window in the dining room. The east window in the living room has been framed in to accept a window evaporative cooler (Figure 24)

Figure No. 24 – East living room window, filled in for side-vent cooler

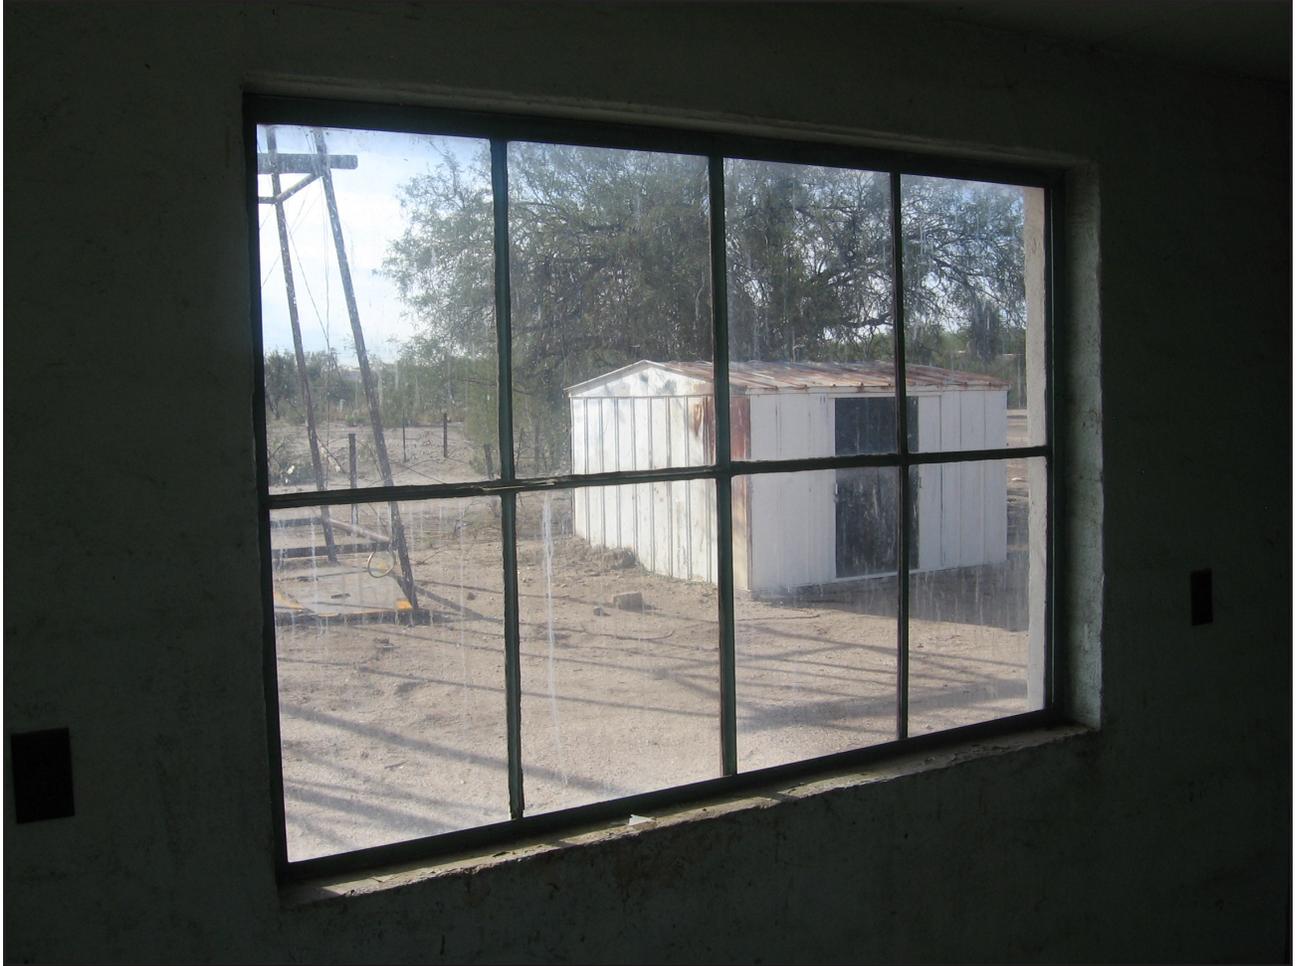
At the addition there are steel sash windows that have been modified by the Adkins to be horizontal sliding – they are mounted in steel tracks and steel handles have been welded to them, creating operable windows out of otherwise fixed window frames.

Figure No. 25 – Sliding steel sash with handle welded to it

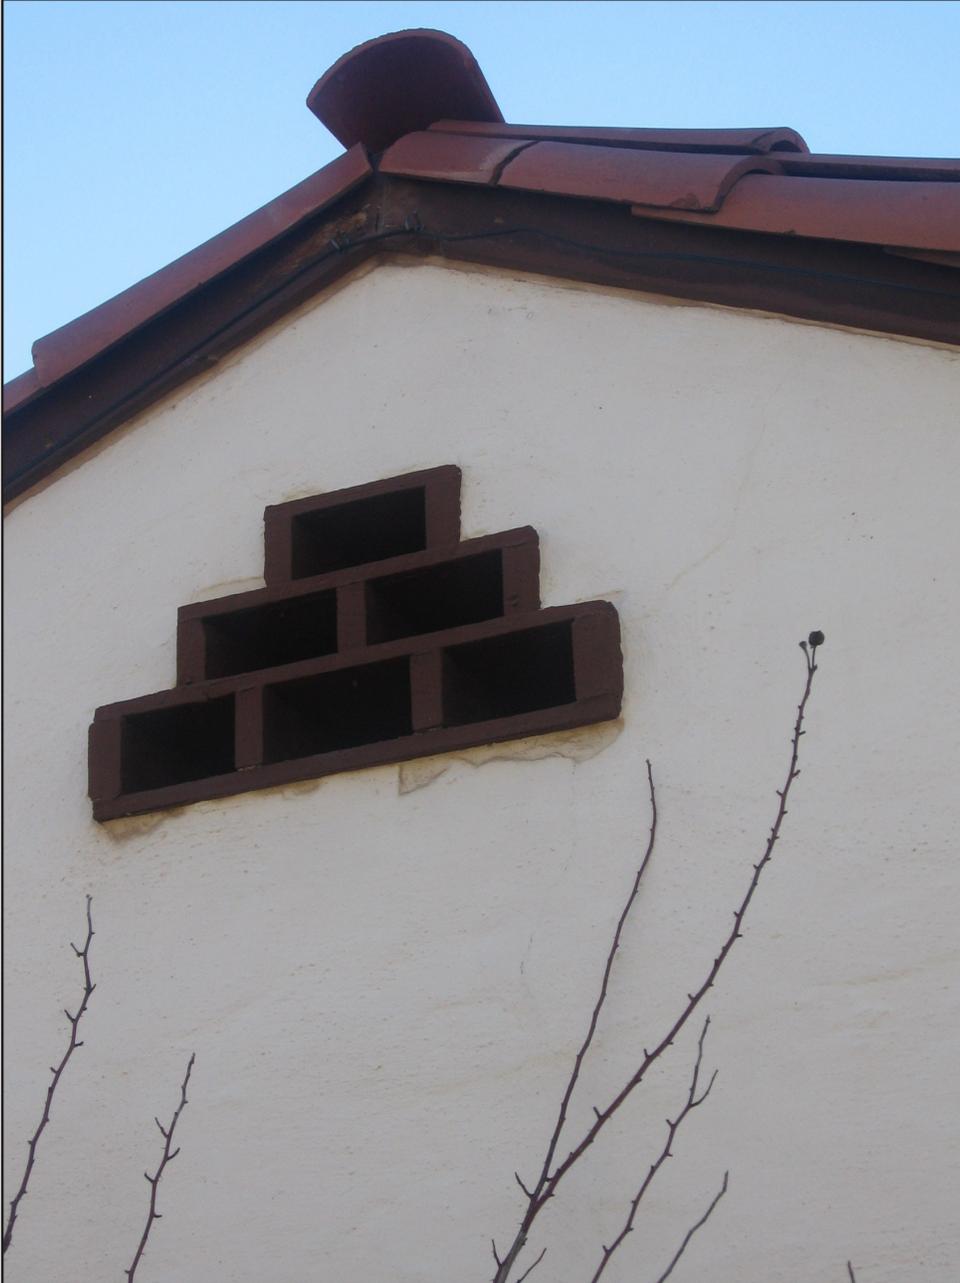
Roof/attic venting is accomplished by terra cotta pipe openings at the gable ends of the house that allow free air movement through the attic space.

Figure No. 29 - Rectangular terra cotta piping used to create vent opening, typical at gable ends of structure

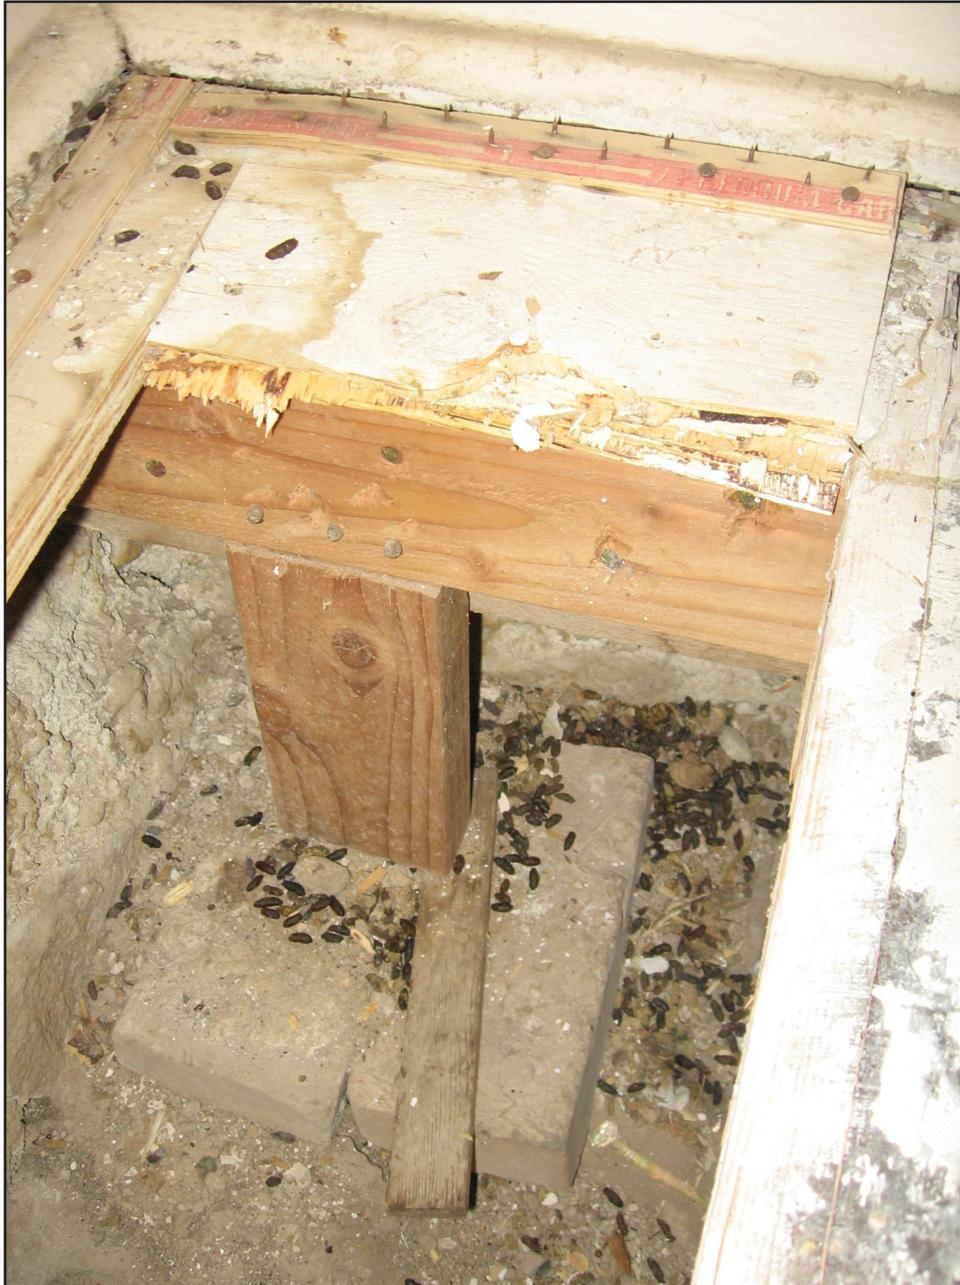
Interior walls are 2x4 wood studs with horizontal wood slats with mud plaster that is painted. The interior walls and the floor appear to be supported on a perimeter beam over the crawl space. The beam is supported off small wood stub columns sitting on bricks placed on the ground (Figure 34).

Figure No. 34 - Bricks on ground holding 2x4 wood column, supporting beam at edge of floor inside of exterior wall

There is settling of the floor at the wall line between the dining room and the kitchen on the east side of the house; it would appear that the wood stub column has rotted or given way causing the floor to buckle. A similar condition has probably occurred at the west wall of the dining room – where the wall stud is no longer solidly supported and the roof beam is bearing down on it, allowing the deflection of the ceiling beam supporting the roof ridge. Also, earlier noted conditions in front and back bedrooms.

2. Floor:
 - A. Cut open the floor where it is subsiding between the kitchen and the dining room to ascertain the cause. If the stub column is rotted or collapsed, reshore the floor. The work may be possible to execute from the dining room side; if not, some cabinetry in the kitchen may need to be removed to gain access.

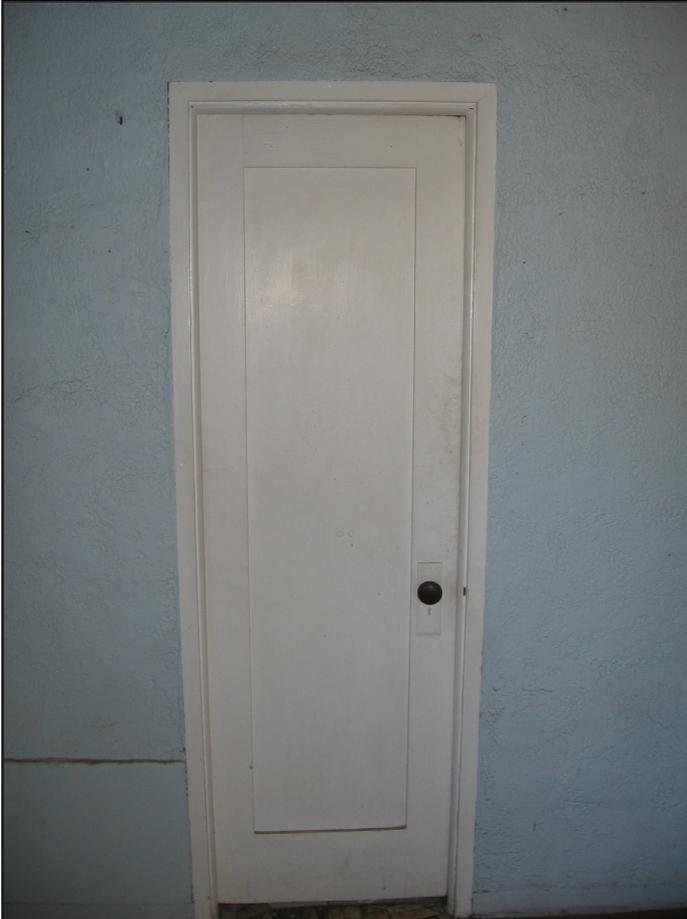
There are original doors between the bedrooms and the closet and bathroom (4 total) – 23-3/4" x 6'-3/12" single panel painted wood (Figure 37). Hinges are 5-kunckle plain bearing brass with rounded tips; lockset is a plain brass flat knob. The door to the back bedroom has been replaced with a single panel door 30" x 6'-2-1/2" that is short for the 6'-5-1/2" opening. There is no door to the front bedroom and the opening is cased with no evidence of hinges removed. There is a curtain rod on the bedroom side of the opening. The opening between the Dining Room and Kitchen is cased with no evidence of hinges removed.

Figure No. 37 - Original wood panel door to bathroom

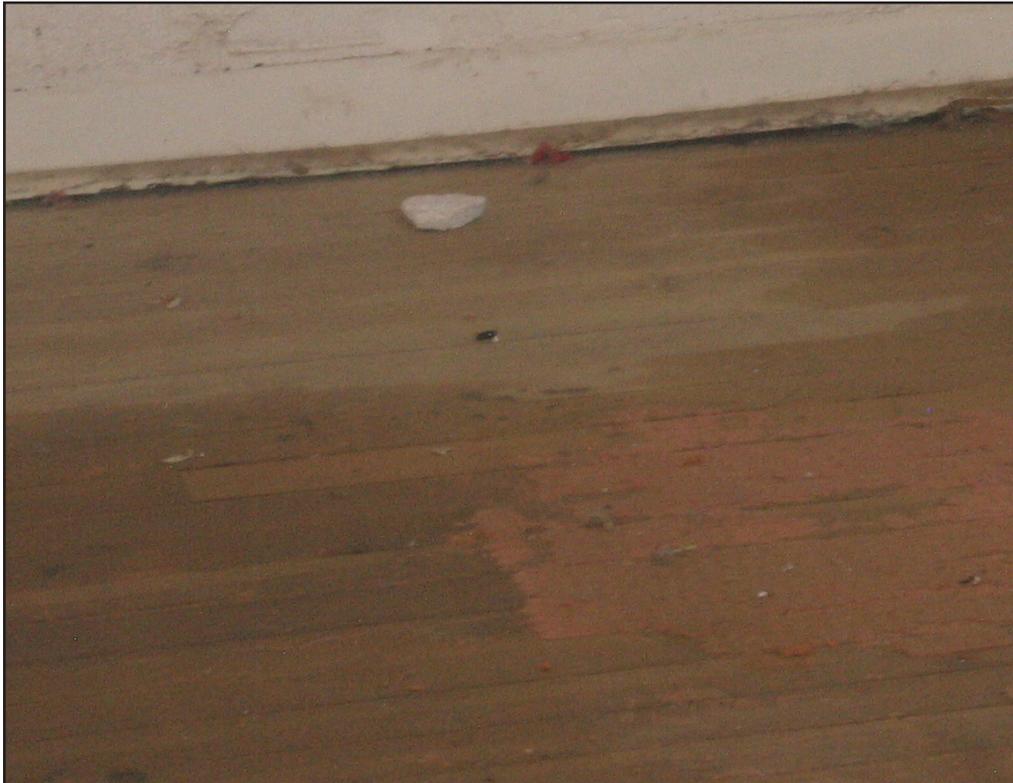
The original flooring is 2-3/4" x 3/4" x 4' square-sided plank (perhaps cedar – it is uniform with little graining or heartwood, unlike pine). Over the years it has been covered with a variety of materials: the living room and front bedroom had carpet over pad with perimeter nailers (removed by Pima County); there is linoleum in the rear bedroom – almost worn through to the wood beneath; sheet vinyl in the kitchen, dining and closet; and 12" x 12" vinyl tile in the bathroom. The addition has slab on grade with no finish, except for sheet vinyl at the entry stoop to the house back door.

Figure No. 38 -
Wood flooring

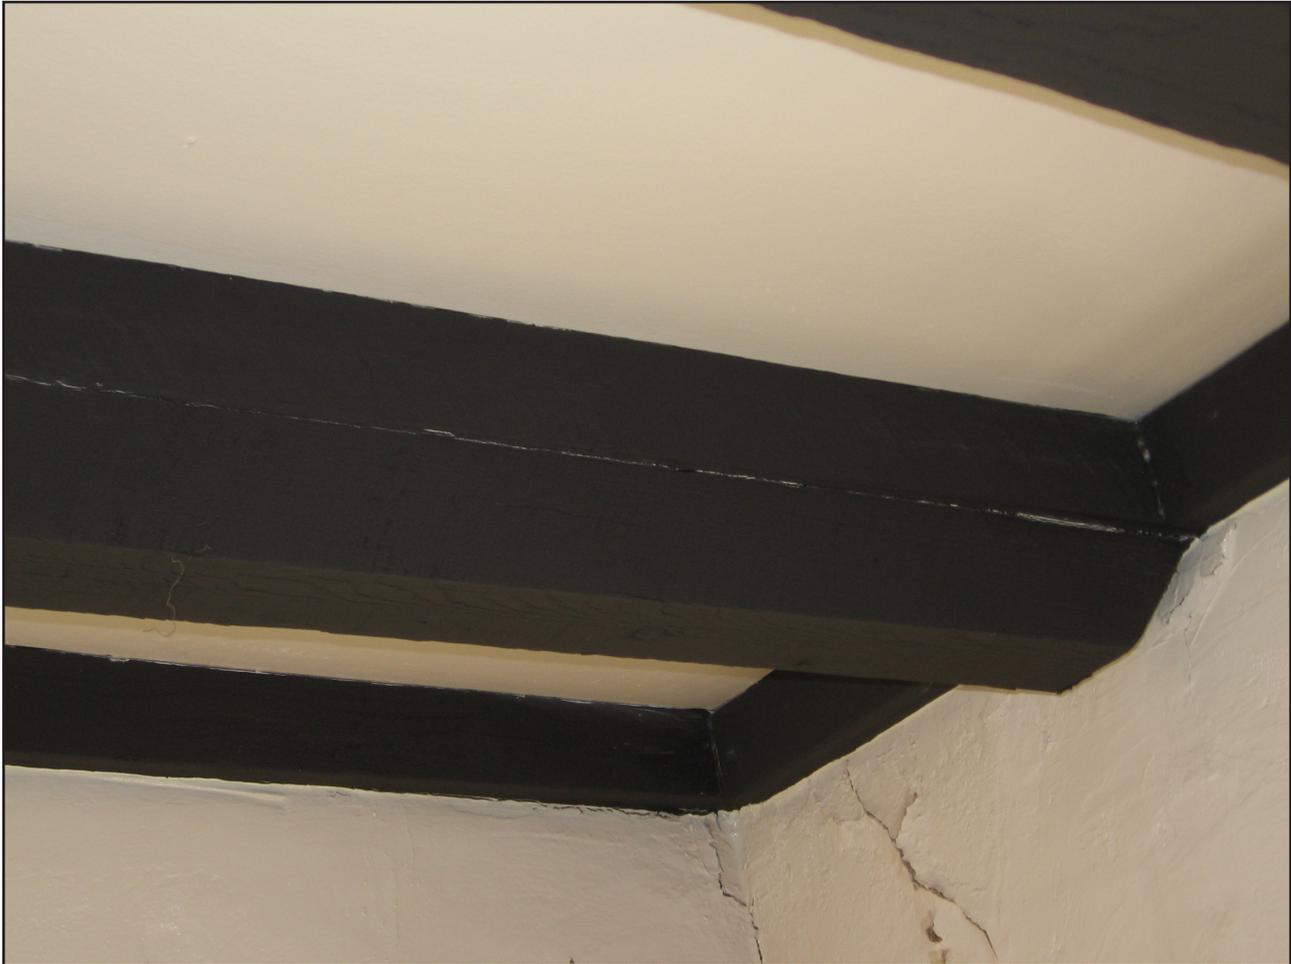
Interior ceilings appear to be framed with 2x6 lumber supporting cement plaster on wood lath. Ceilings are directly attached to the bottom of the ceiling framing, flat and painted, providing a ceiling height of approximately 8'-0" at the bedrooms, bath, closet, and kitchen (kitchen is almost 8'-1"). At the dining room and living room, the ceiling framing is expressed and the plaster ceiling is on top of the framing. An additional 4x4 has been fastened to the bottom of the exposed ceiling framing, beveled at the ends next to the walls, and all of it painted brown, as a decorative treatment. This provides a height of 8'-2" to the bottom of the perimeter beam and 8'-5-1/2" to the ceiling bottom surface.

Figure No. 39 - Decorative treatment at ceiling with perimeter beams and beveled decorative beams

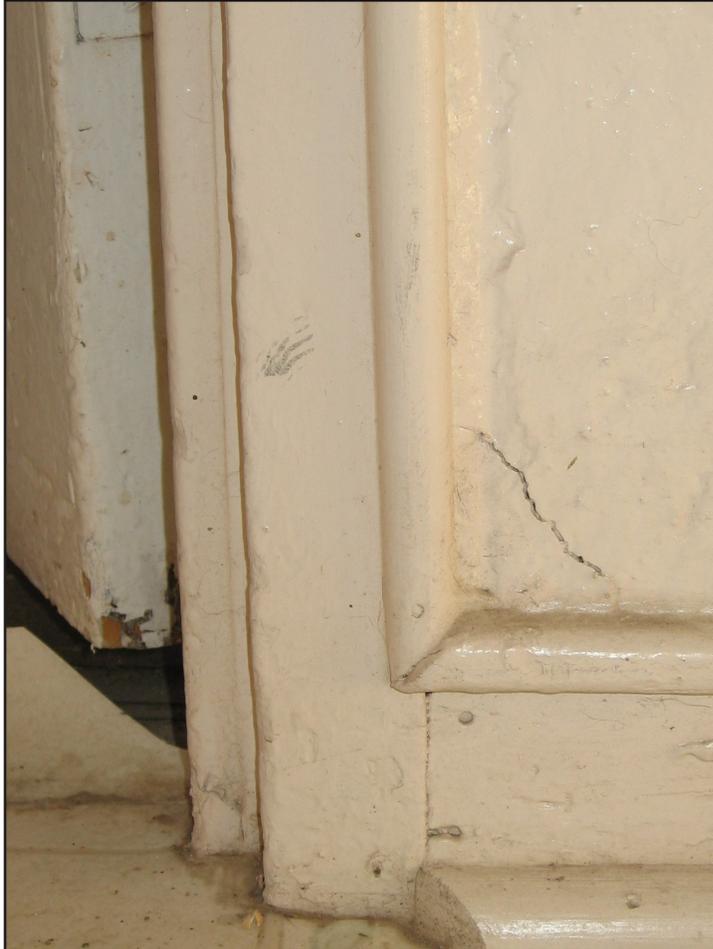
The living and dining rooms have a 4" wood base with a quarter-round at the bottom and a beaded (half-round) top; the whole piece turns up and becomes the door frame – the beading at the perimeter with 1-1/4" flat to the inside of the frame – this is typical of the openings out of these two rooms, including the exterior windows, and was part of the original construction.

Figure No. 40 - Quarter wood wall base; decorative half-round bead at top of base, turning up to become part of door casing trim

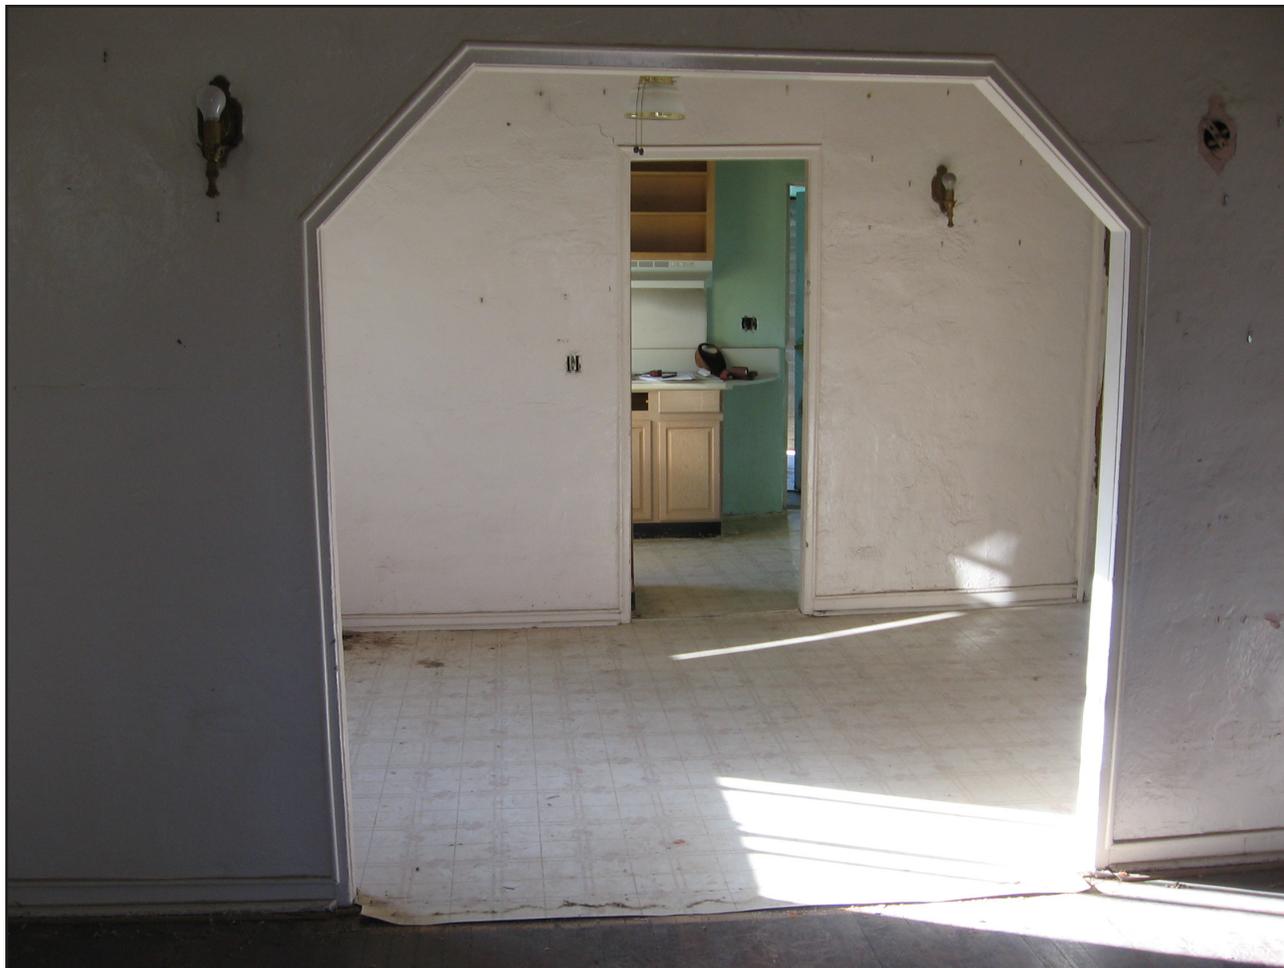
There is an arched opening between the dining room and living room with angled corners and the same casing detail both sides.

Figure No. 41 - Arched opening looking from living room to dining room

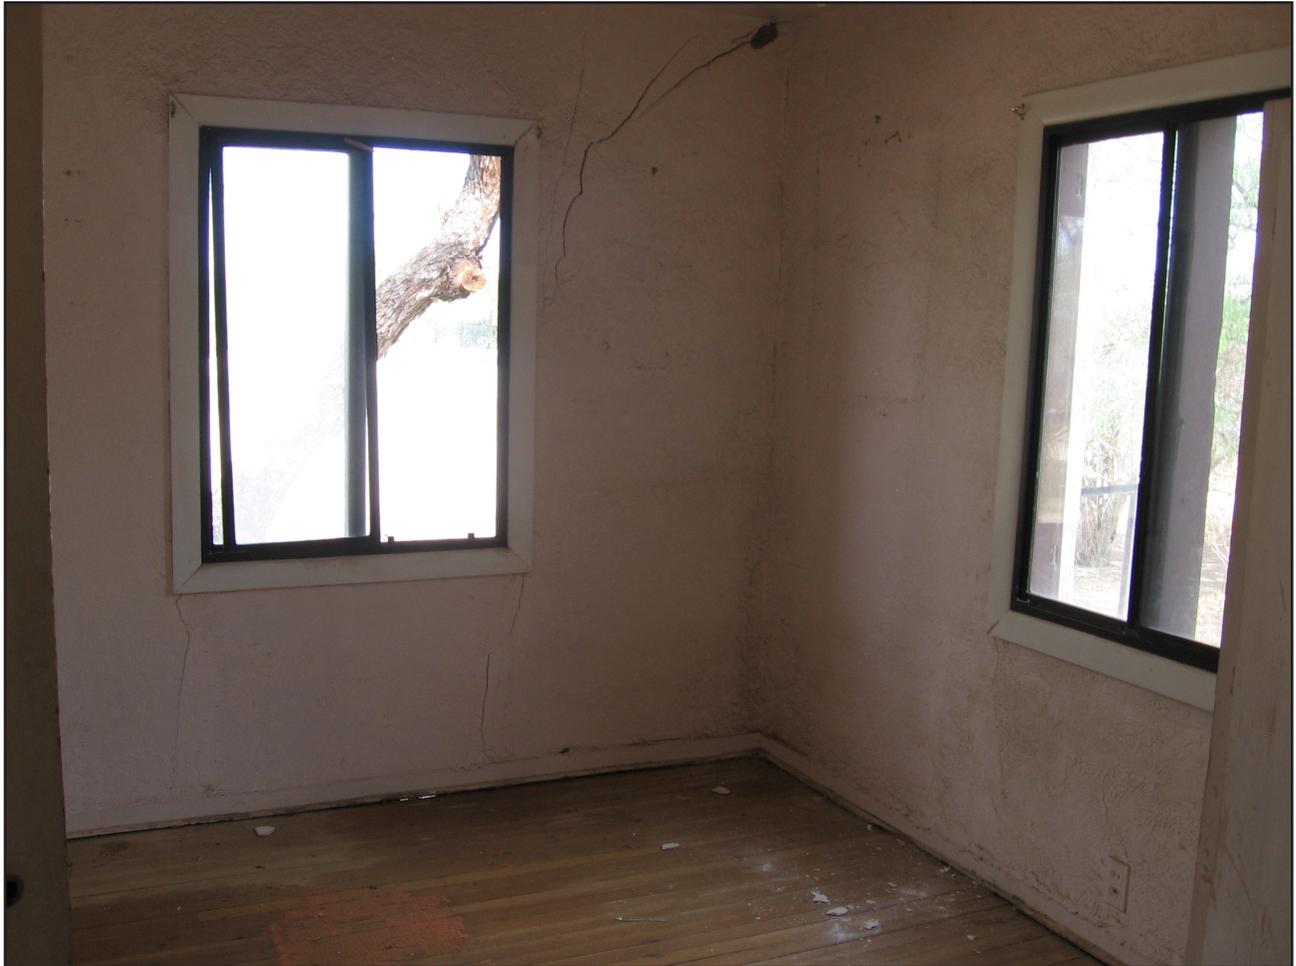
The bedrooms have 1-1/2" flat trim around the doors serving as a plaster stop. Windows in the bedroom have painted 3" beveled wood trim that was applied to hide the projecting edges of the aluminum windows mounted to the interior side of the original wood window frames.

Figure No. 42 - Beveled wood trim at interior side of aluminum window in bedroom

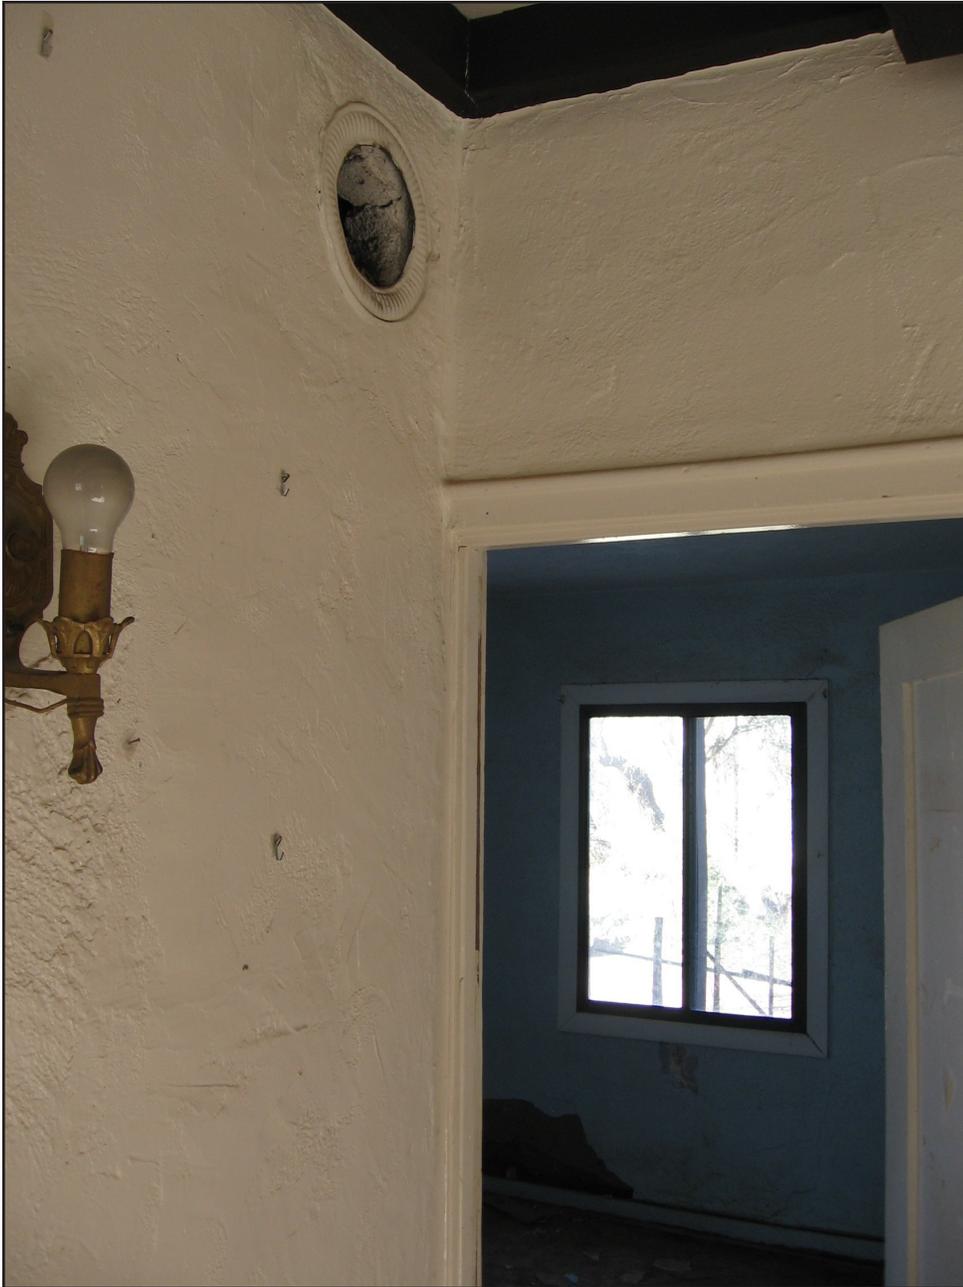
The door to the back bedroom from the dining room has a wall running into the south side of the door frame (Figure 43).

Figure No. 43 – Wall intersecting frame of bedroom; flue opening above for chimney pipe

It may be that this section of wall was built later or widened to accommodate a solid U-shaped wall to support the chimney above the recess immediately adjacent in the kitchen. The wall is of solid/dense construction possibly CMU, or perhaps adobe, but this cannot be determined without removing the existing plaster.

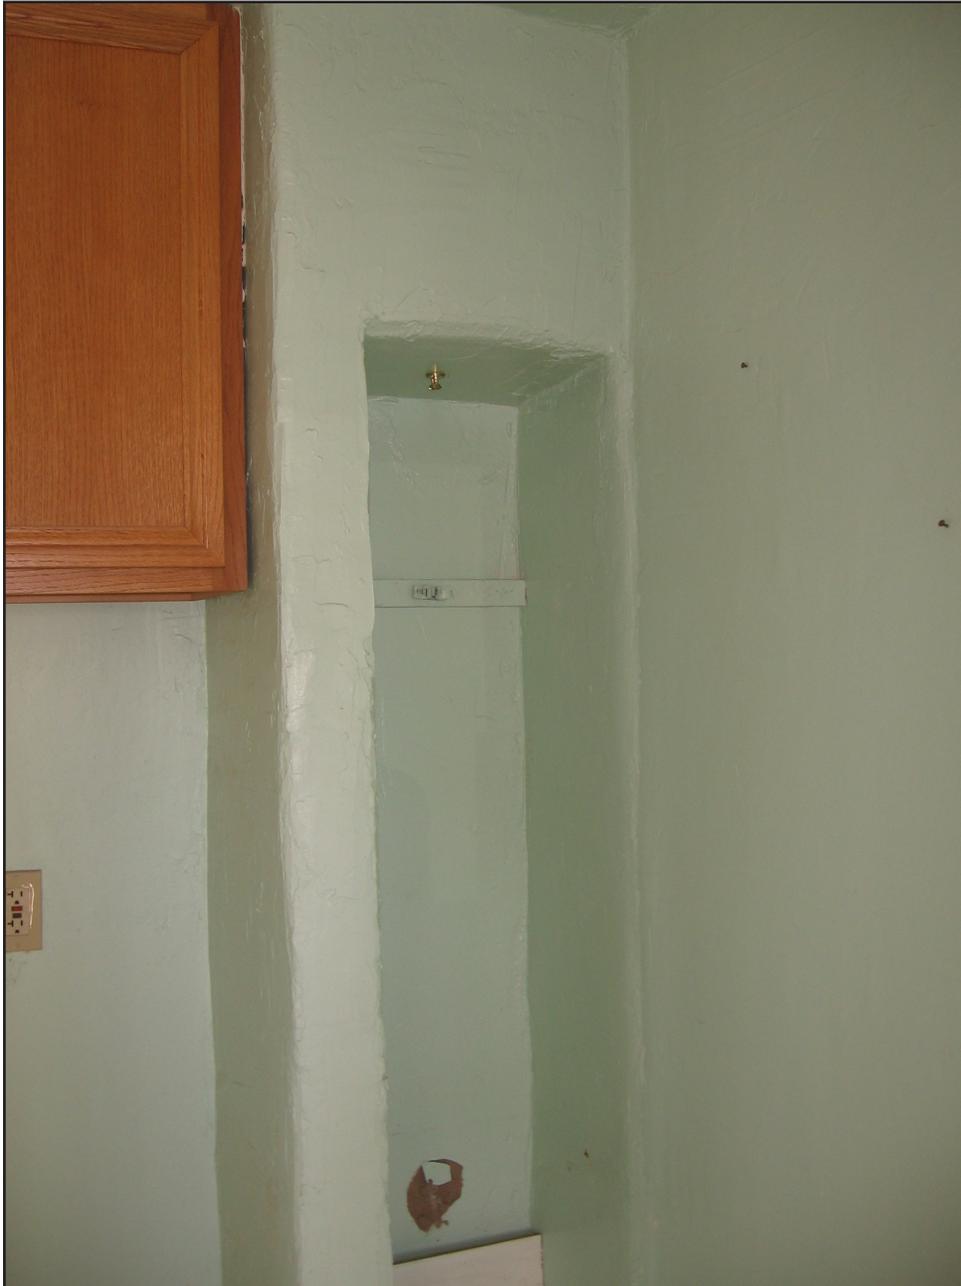
There is a brick chimney existing in the attic space at the west side of the kitchen. There is evidence that there was a gas stove in the living room with a chimney pipe passing over the bedroom door to the south and then up into the chimney and out through the roof. The chimney rises in the northwest corner of the kitchen and then is offset as it rises toward the roof to miss a structural member (Figure 33). It appears at the center of the south roof elevation just on the south side of the roof ridge (see Building Elevations). The chimney is supported in the kitchen by a u-shaped wall (see description under Interior Wood Trim, Figure 44).

Figure No. 44 -
U-shaped walls, producing a nook, supporting chimney above in attic

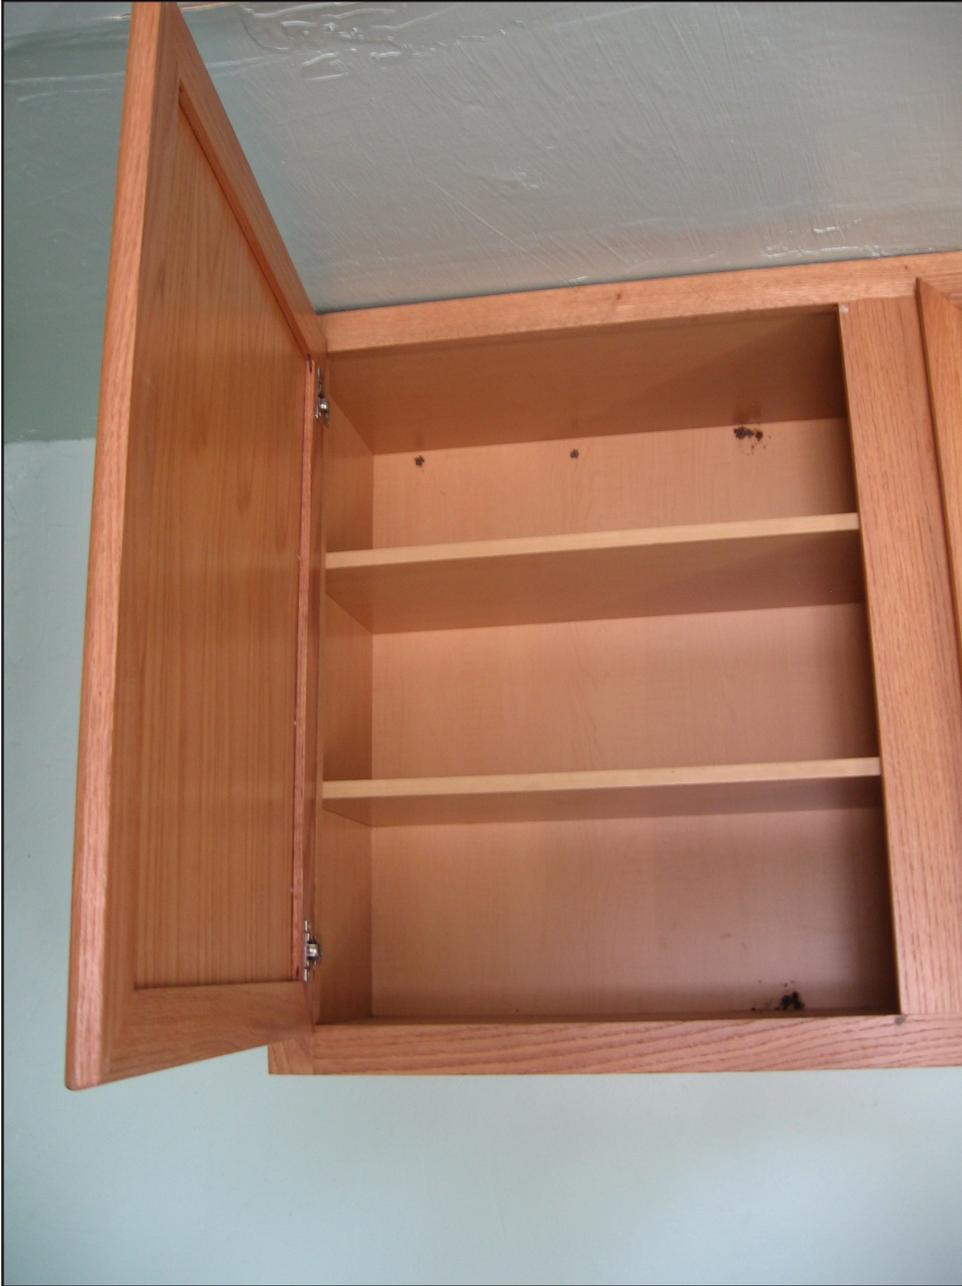
The kitchen has oak base and wall cabinets, a contemporary type probably manufactured within the last 10 years. They are veneer construction on medium density fiberboard, with melamine interiors, of the sort purchased at a home improvement center and installed by the home owner.

Figure no. 45 – contemporary wood cabinets
