Adkins Residence

Adkins Steel Parcel

Building Condition Assessment Report

February 25, 2008

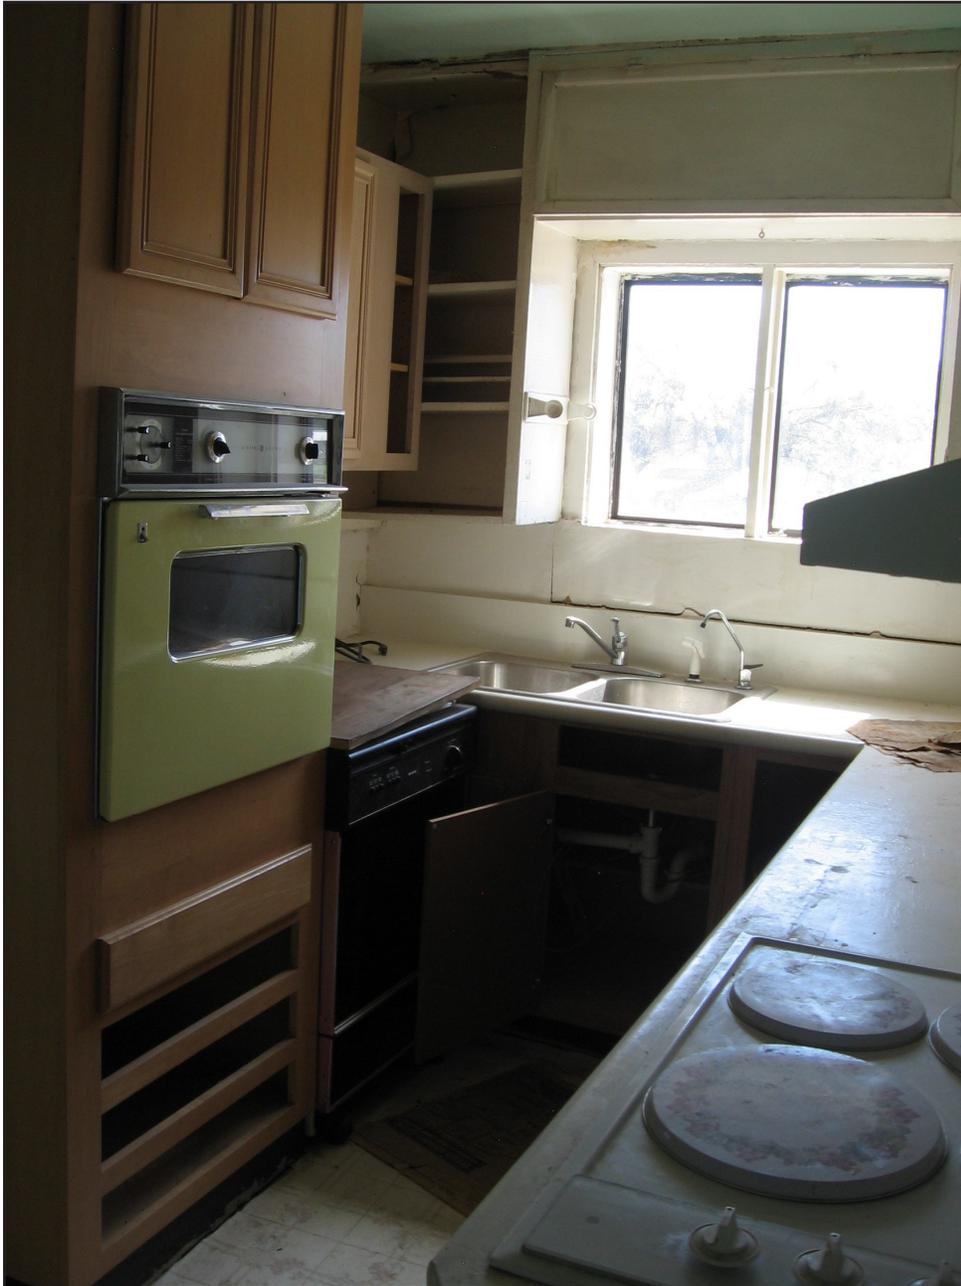
At the sink end the shelves and overhead cabinets are painted wood and were most likely built with the house.

Figure no. 46 – Painted wood cabinets at east end of kitchen, including overhead cabinet at sink

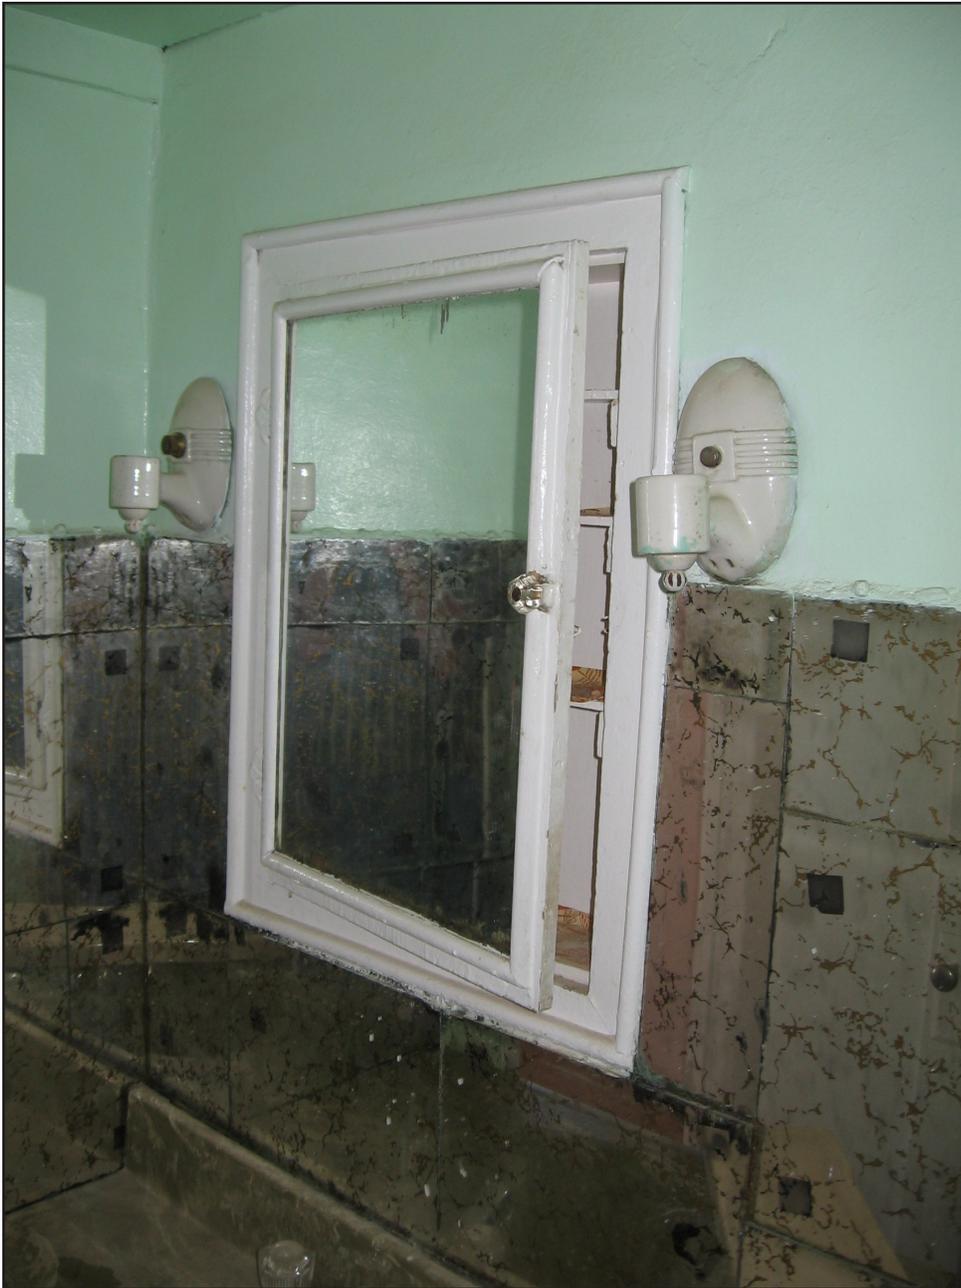
The painted medicine cabinet in the bathroom is original – its frame detail matches the base and door frame details – and is flanked with original porcelain wall sconces (Figure 47). There is also an overhead cabinet above the lavatory, of similar construction to the above kitchen, whose hinges appear quite old, and the cabinet is probably original.

Figure No. 47 - Medicine cabinet with original sconces (note marble-pattern mirror tiles)

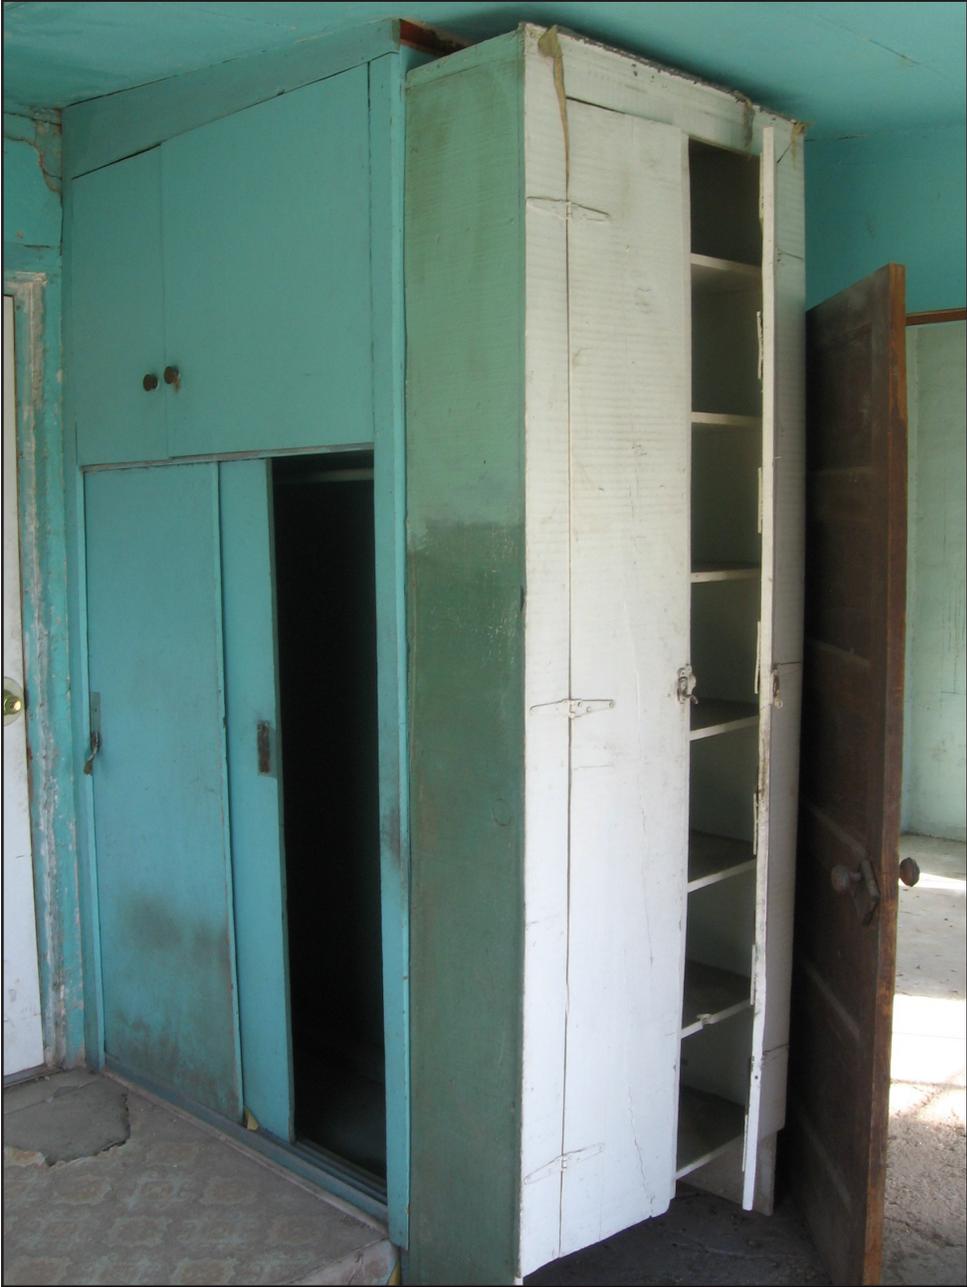
The addition has low quality plywood built-in storage cabinets.

Figure No. 48 - Built-in cabinets at addition

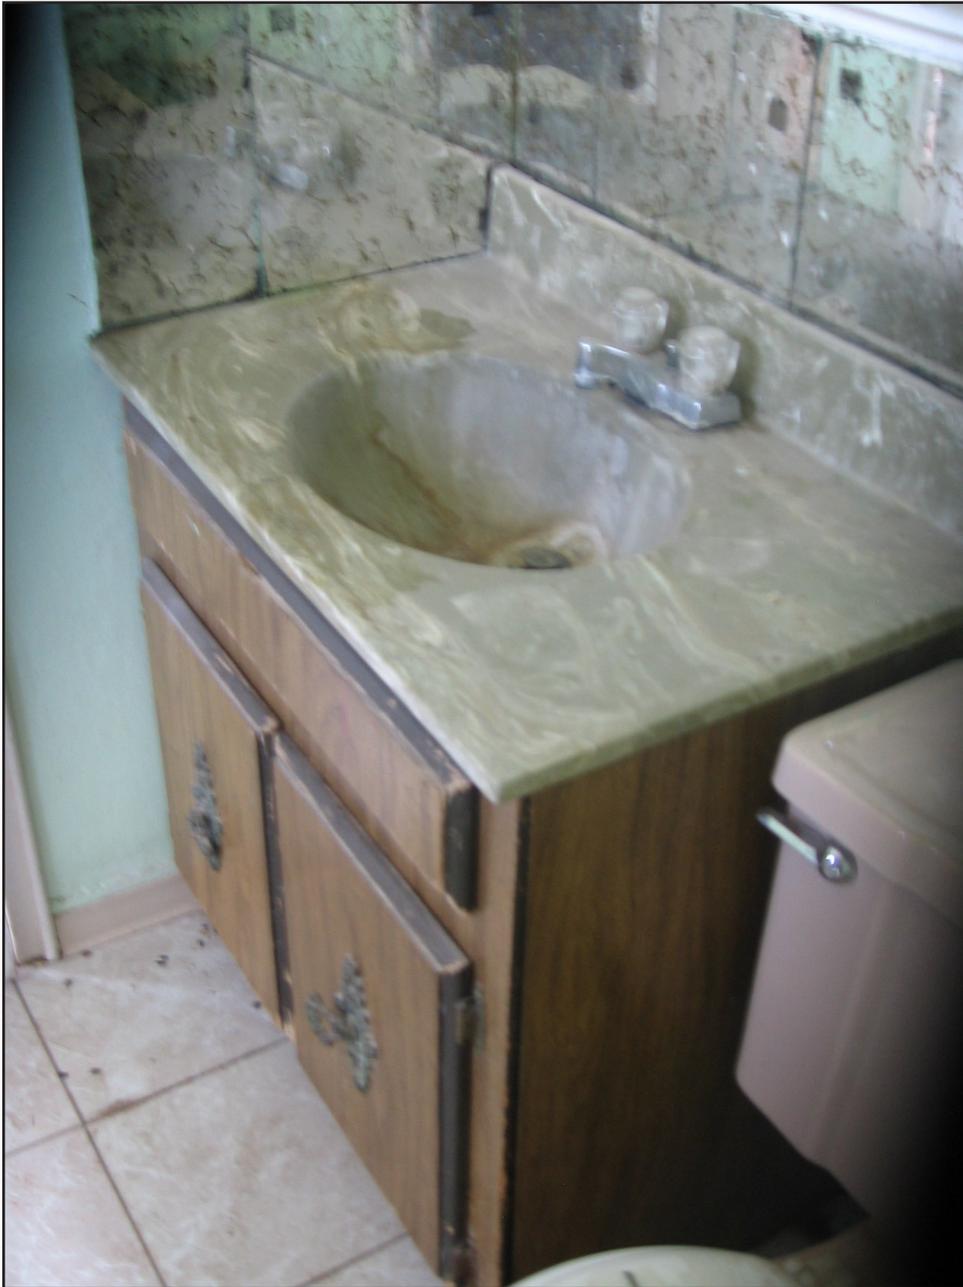
The bathroom has a “Spanish style” base cabinet with a cultured marble top and a contemporary faucet.

Figure No. 49 - Cabinet with lavatory

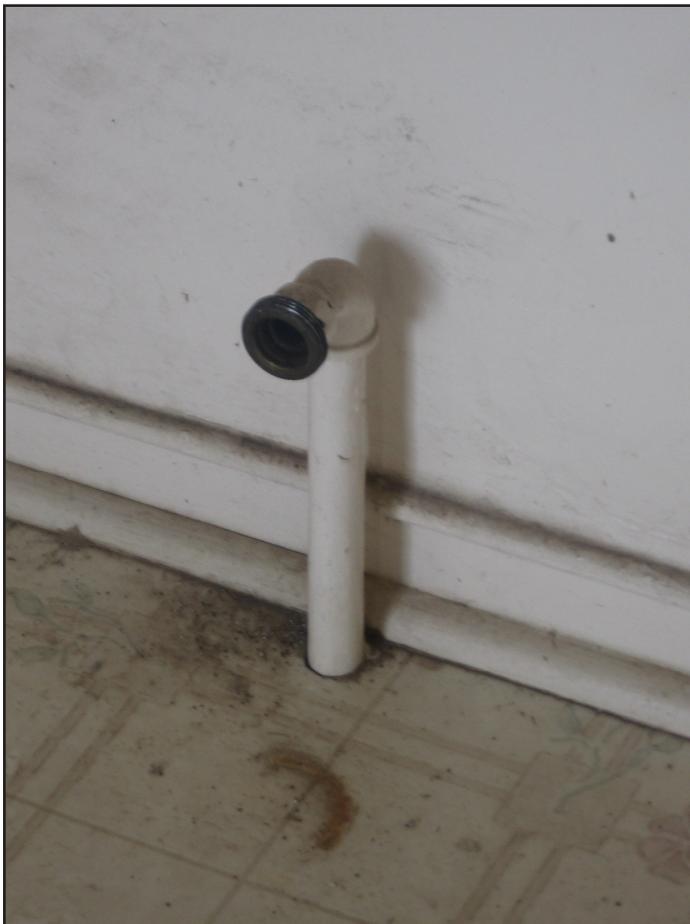
Gas piping rises from underground outside the west side of the building. This piping then penetrates the exterior wall and serves the water heater. Gas piping also rises up the interior dining room wall where it appears to have served a heater. The gas piping is either galvanized steel or black iron with threaded joints

Figure No. 50 - Gas pipe coming through dining room

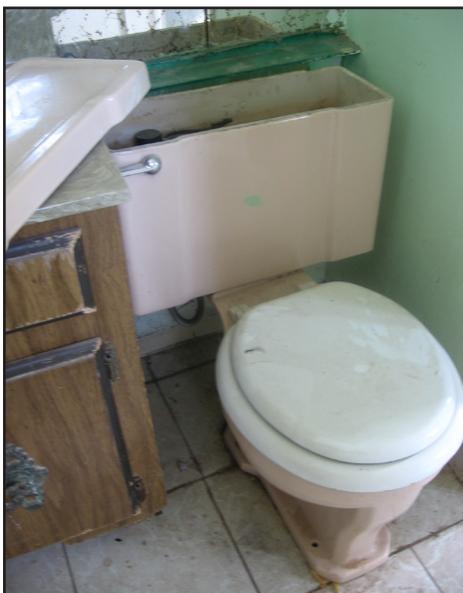
Figure No. 52 - 1950's floor-mount flush toilet; pink porcelain

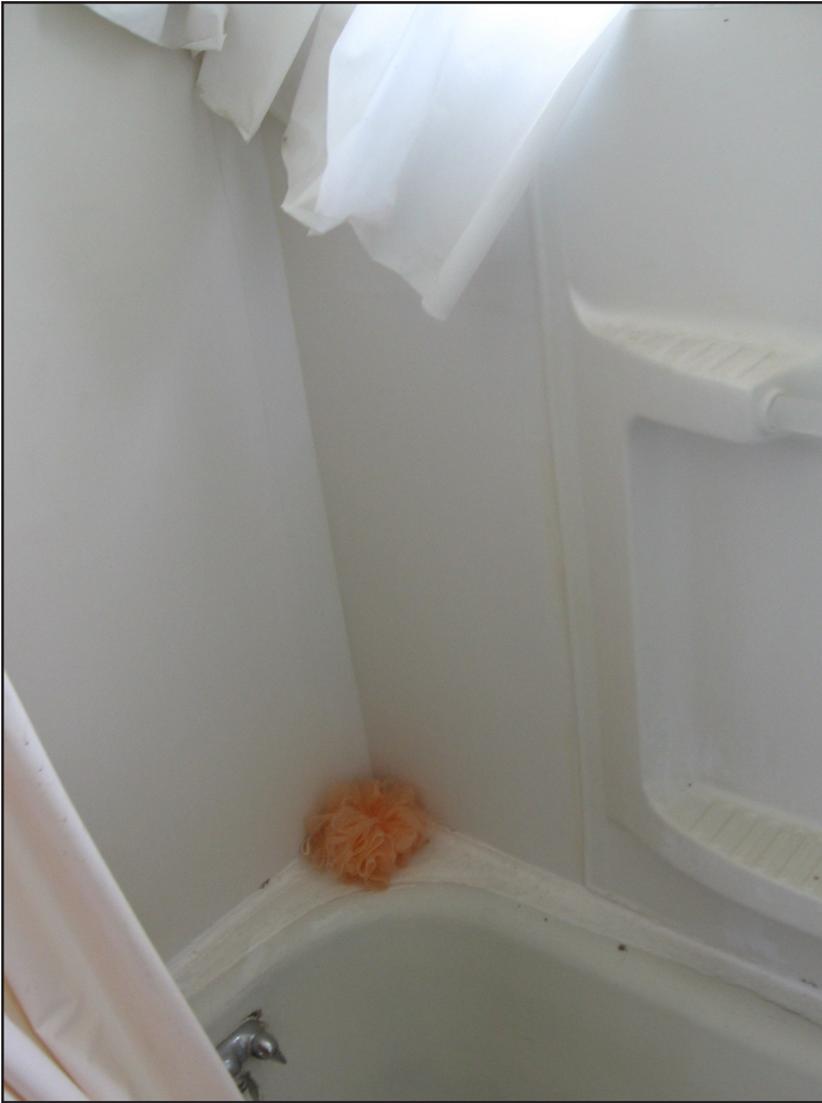
Figure No. 53 - Bathtub with full plastic liner

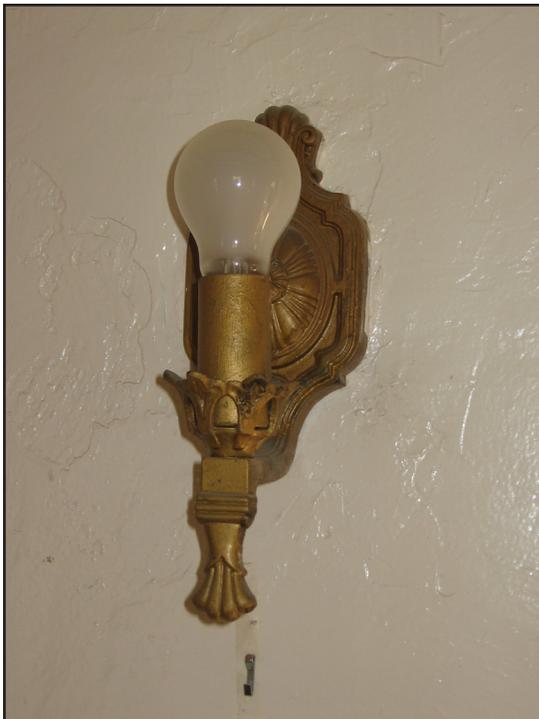
Most of the lights, switches and receptacles appear to be part of the original construction, except for the modernizing of the kitchen area.

Figure No. 54 - Original wall sconces in living and dining rooms

1. There are several lighting fixtures that have been removed, I recommend that the original fixtures be grouped in appropriate rooms and that replacement fixtures be installed on the existing outlets.
2. Wall covers are missing from several switches and receptacles throughout, replacement cover plates should be installed.
3. Replacement lighting fixtures and cover plates would be available from Rejuvenation Lamp & Fixture Company, Portland, OR.
4. Either remove the disconnect and receptacle adjacent to the water heater or repair the wiring between them with branch circuit in surface wireway.

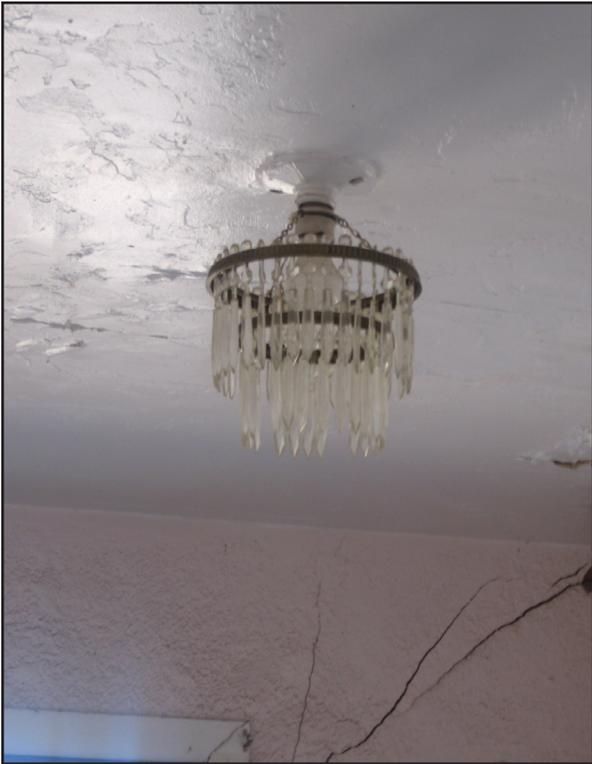
Figure No. 55 - Crystal on brass ring light fixture at front bedroom – from 1930's or 1940's

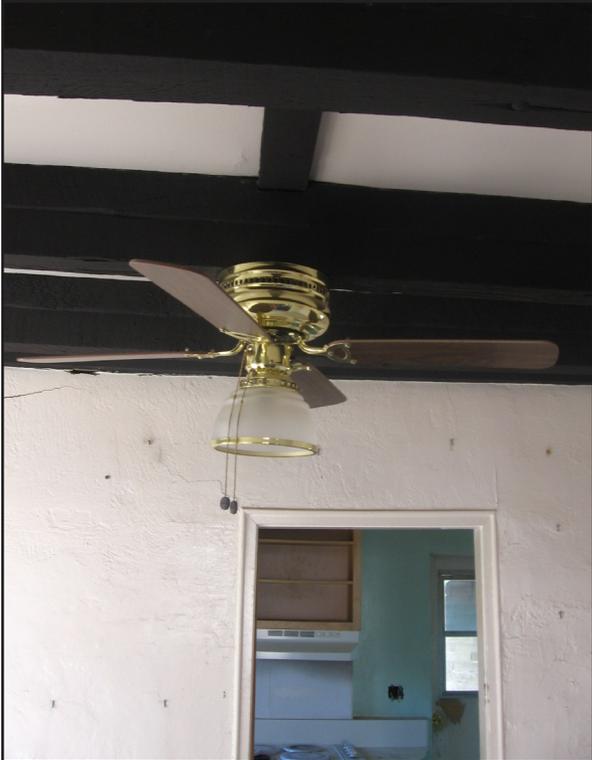
Figure No. 56 - Contemporary ceiling fan with light kit at dining room

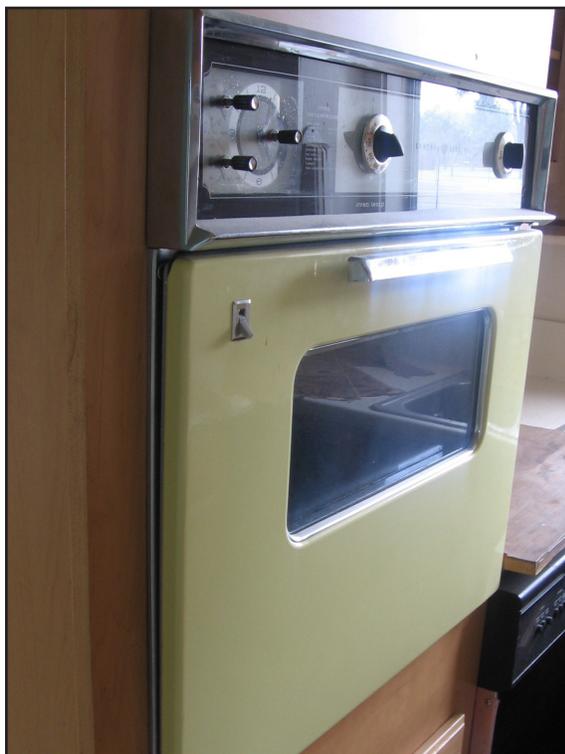
- a. A 1970's General Electric wall oven, lemon yellow, no nameplate.
- b. A 1990's General Electric electric counter-mount cook top with the notation "CRAIN 78.00 KNOBS ARE IN OFFICE" in black marker on bottom panel.
- c. A Broan Microtek System 1 exhaust hood with light over the cook top.
- d. A Frigidaire portable dishwasher with a cord and cap to plug into a wall receptacle above it.

Figure No. 57 - Wall oven and dishwasher
