Officer's Quarters No. 1, 2 & 3

Adkins Steel Parcel

Building Condition Assessment Report

February 25, 2008

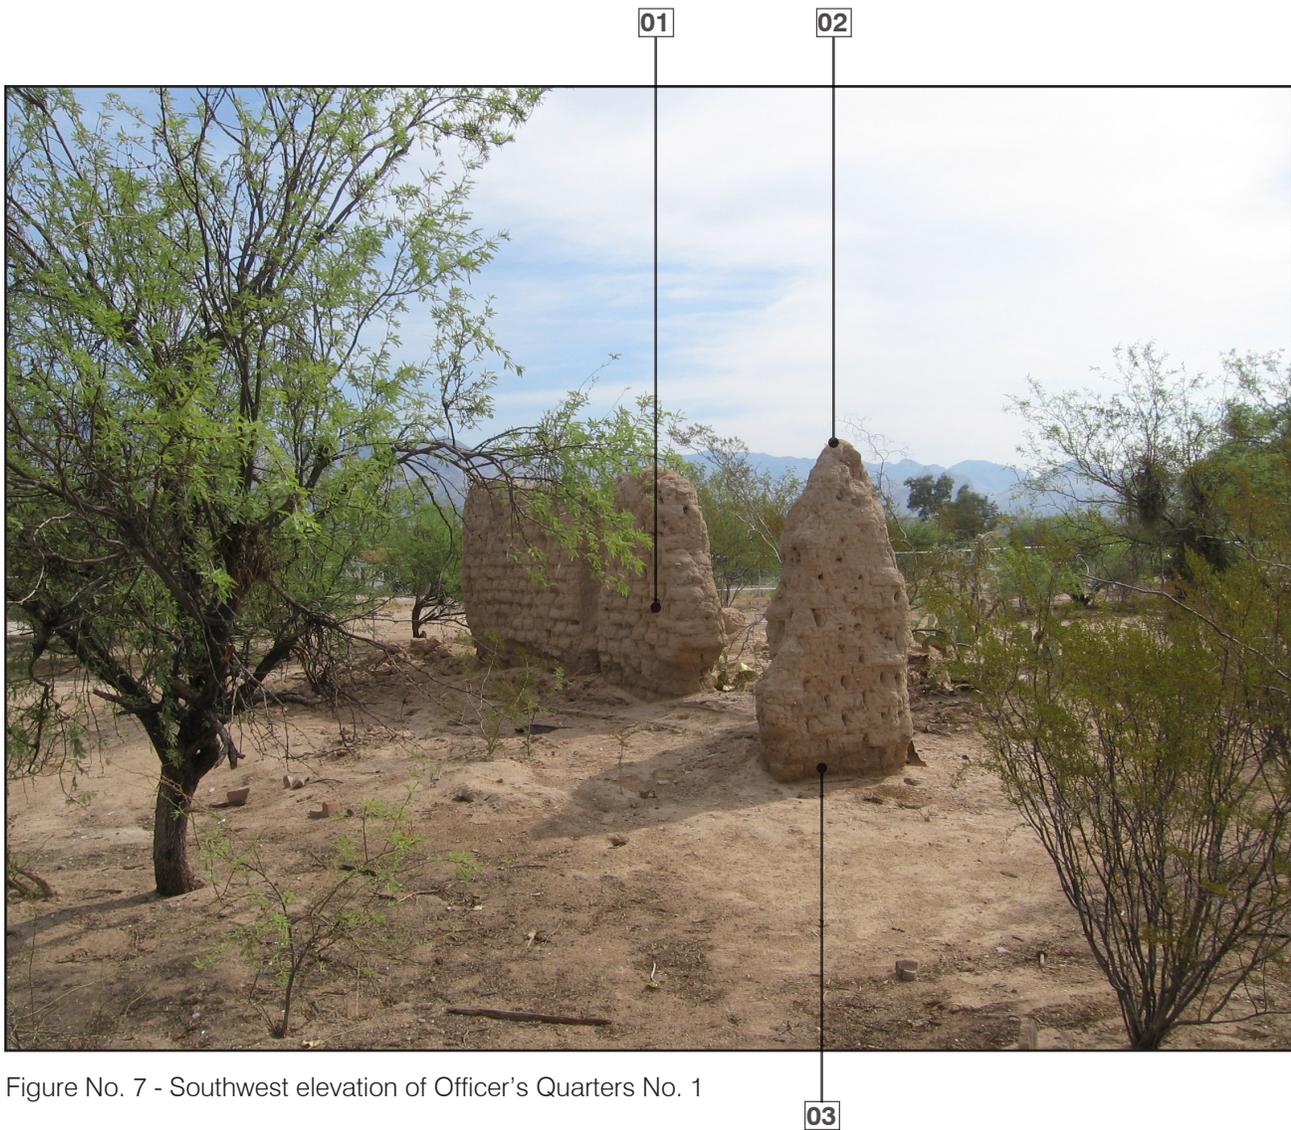
Figure No. 7 - Southwest elevation of Officer's Quarters No. 1

- 01. Adobe block wall
- 02. Erosion at top of wall
- 03. Coving at base of wall

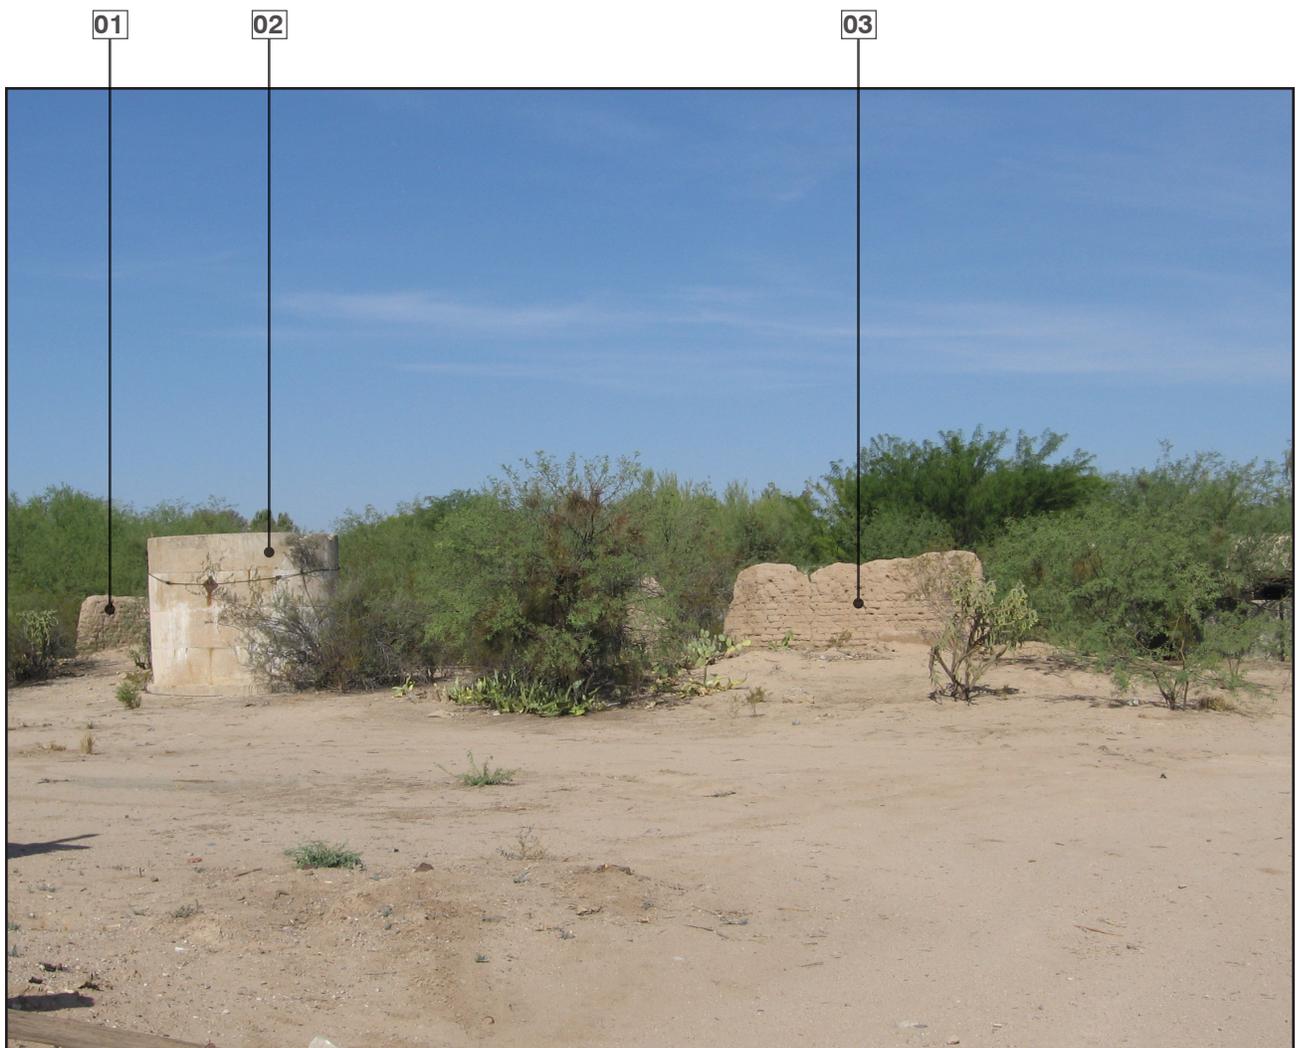
Figure No. 8 - East elevation of Officer's Quarters No. 1 and Kitchen No. 1

- 01. Adobe block wall
- 02. Concrete water tank
- 03. Coving at base of wall

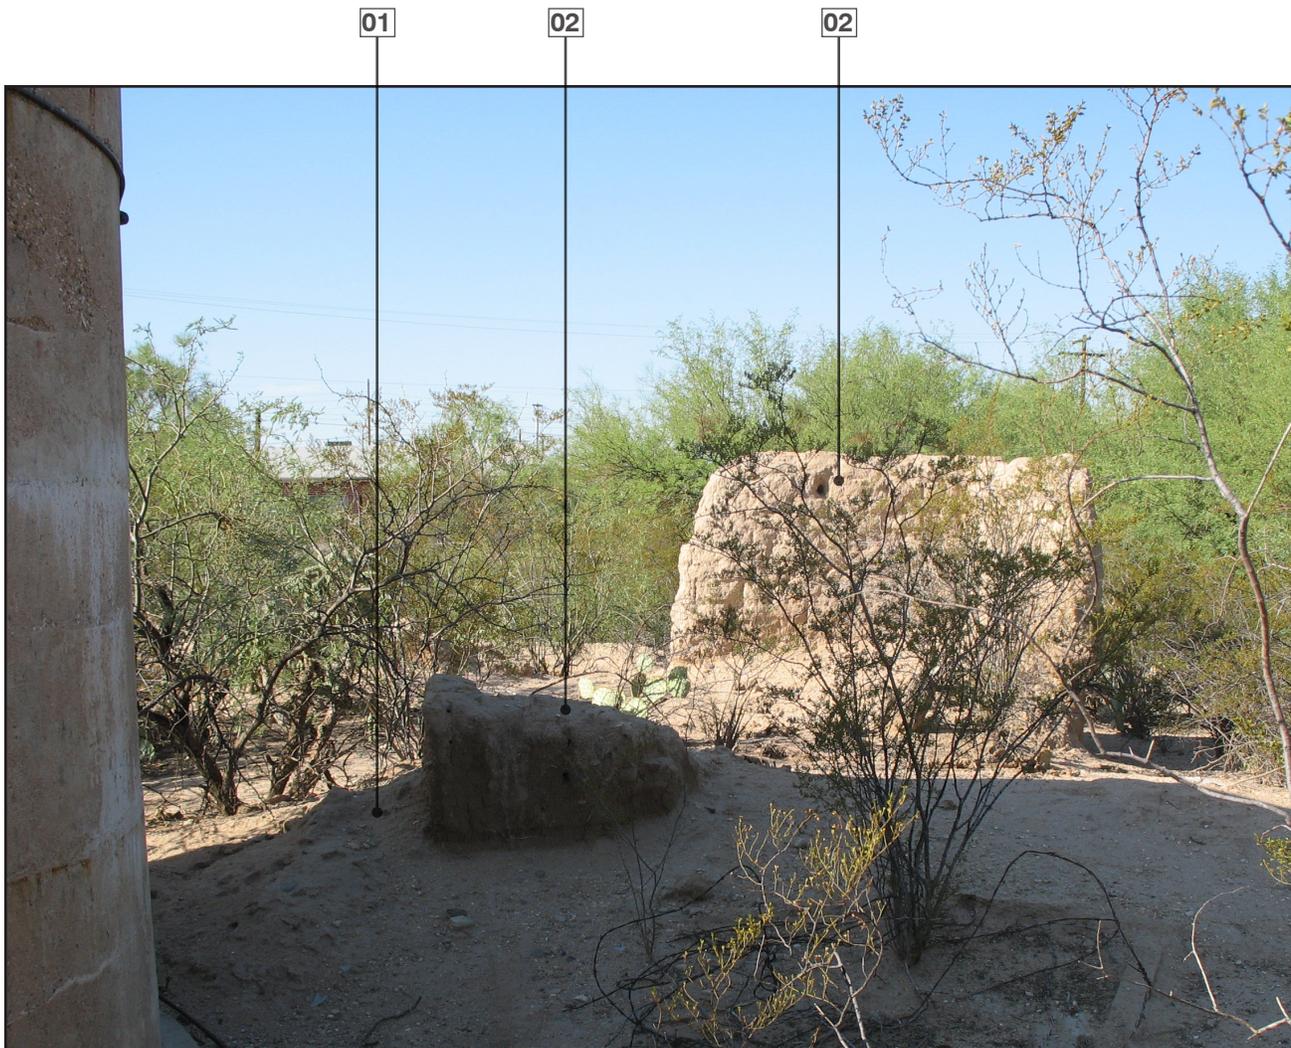
Figure No. 9 - North elevation of Kitchen No.1

- 01. Eroded adobe at base of wall
- 02. Erosion at top of wall
- 03. Adobe wall

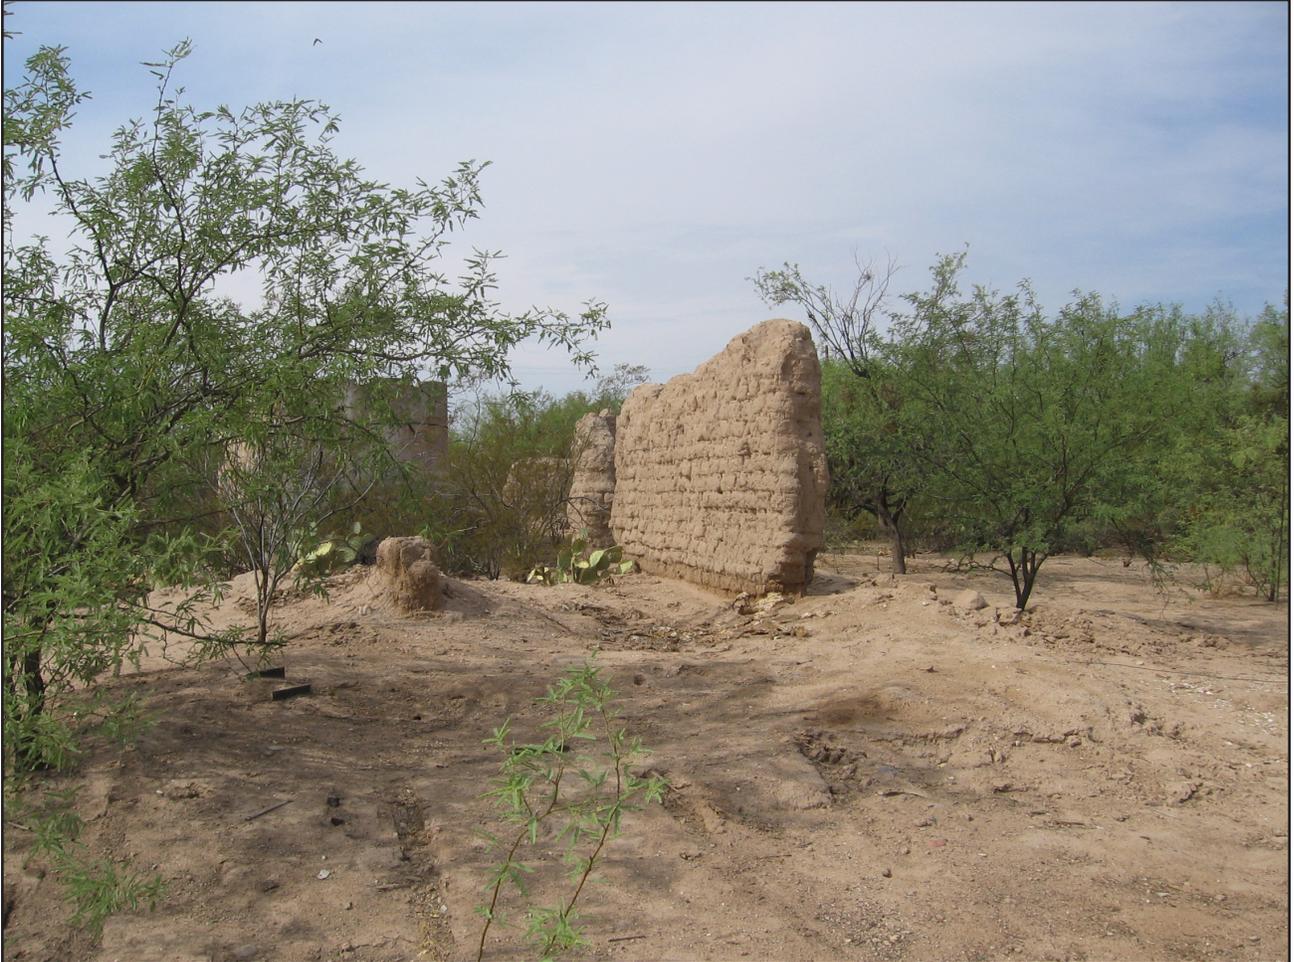
Figure No. 11 - Remaining wall segment

The remaining standing wall segments are surrounded by adobe melt and drainage is positive away from them.

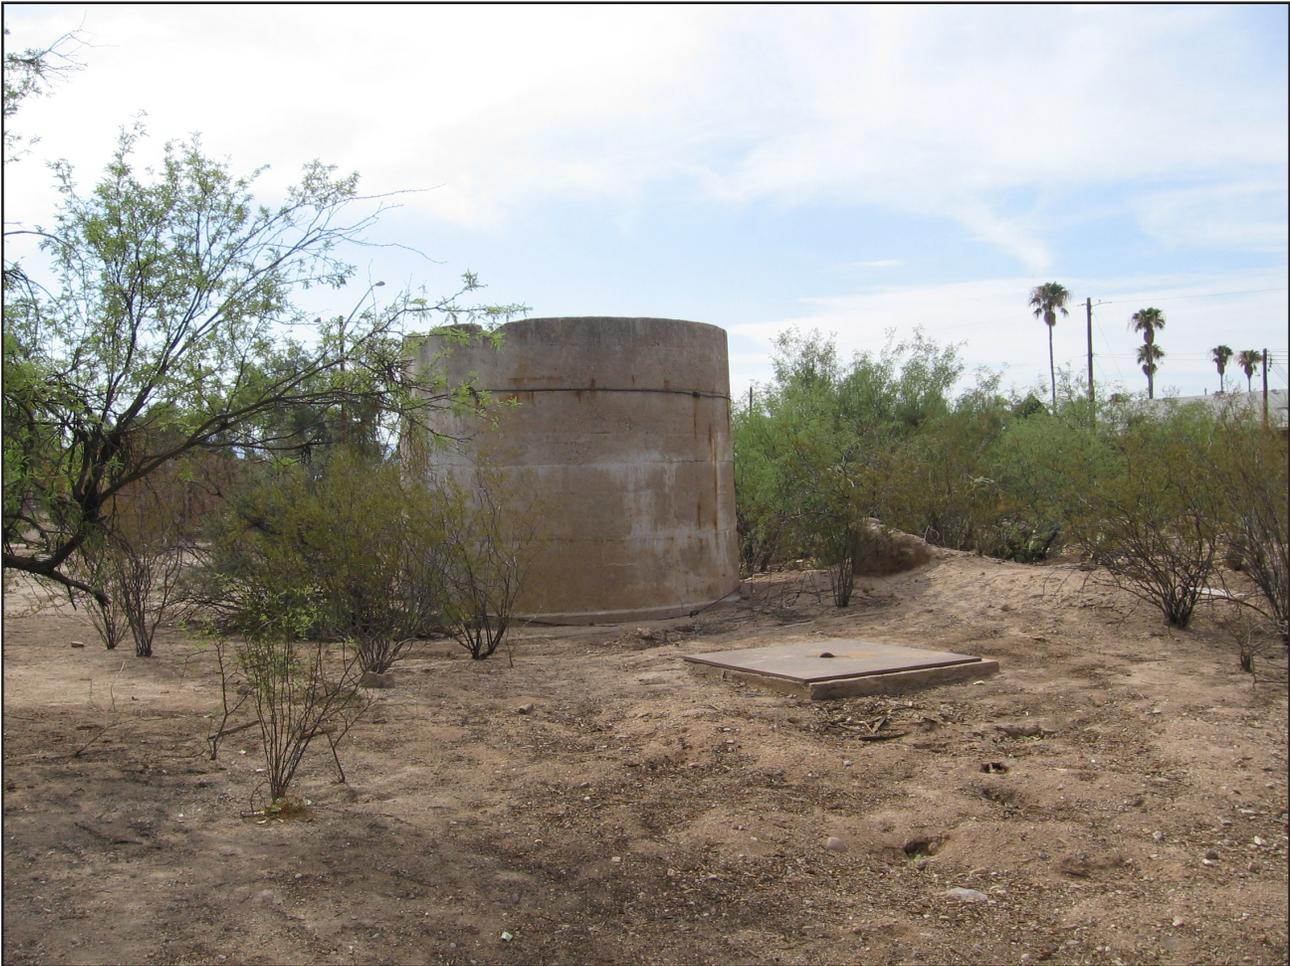
Figure No. 12 - Concrete water tower

The concrete water tower sits in the south end of the footprint of this Officer's Quarters. It is approximately 10' in diameter and 12' high with 5" thick cast-in-place concrete walls. To the west side of the tower is the concrete base of a windmill which is covered with a steel plate.

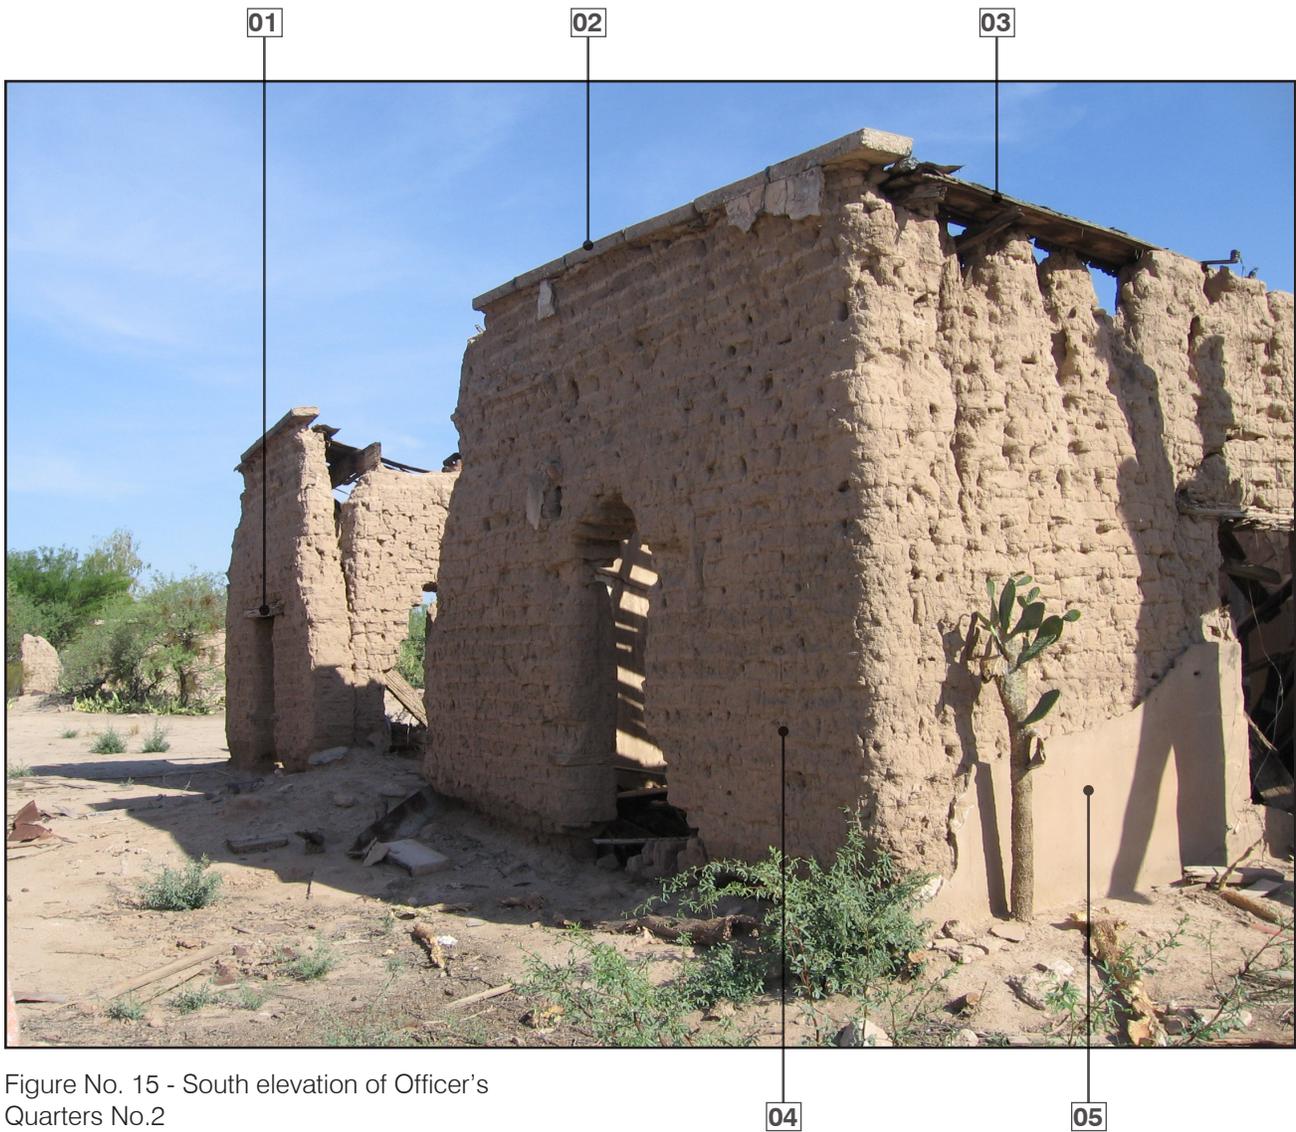
Figure No. 15 - South elevation of Officer's Quarters No.2

- 01. Wood lintel
- 02. Concrete parapet cap
- 03. Roof framing
- 04. Adobe block wall
- 05. Plaster on adobe block

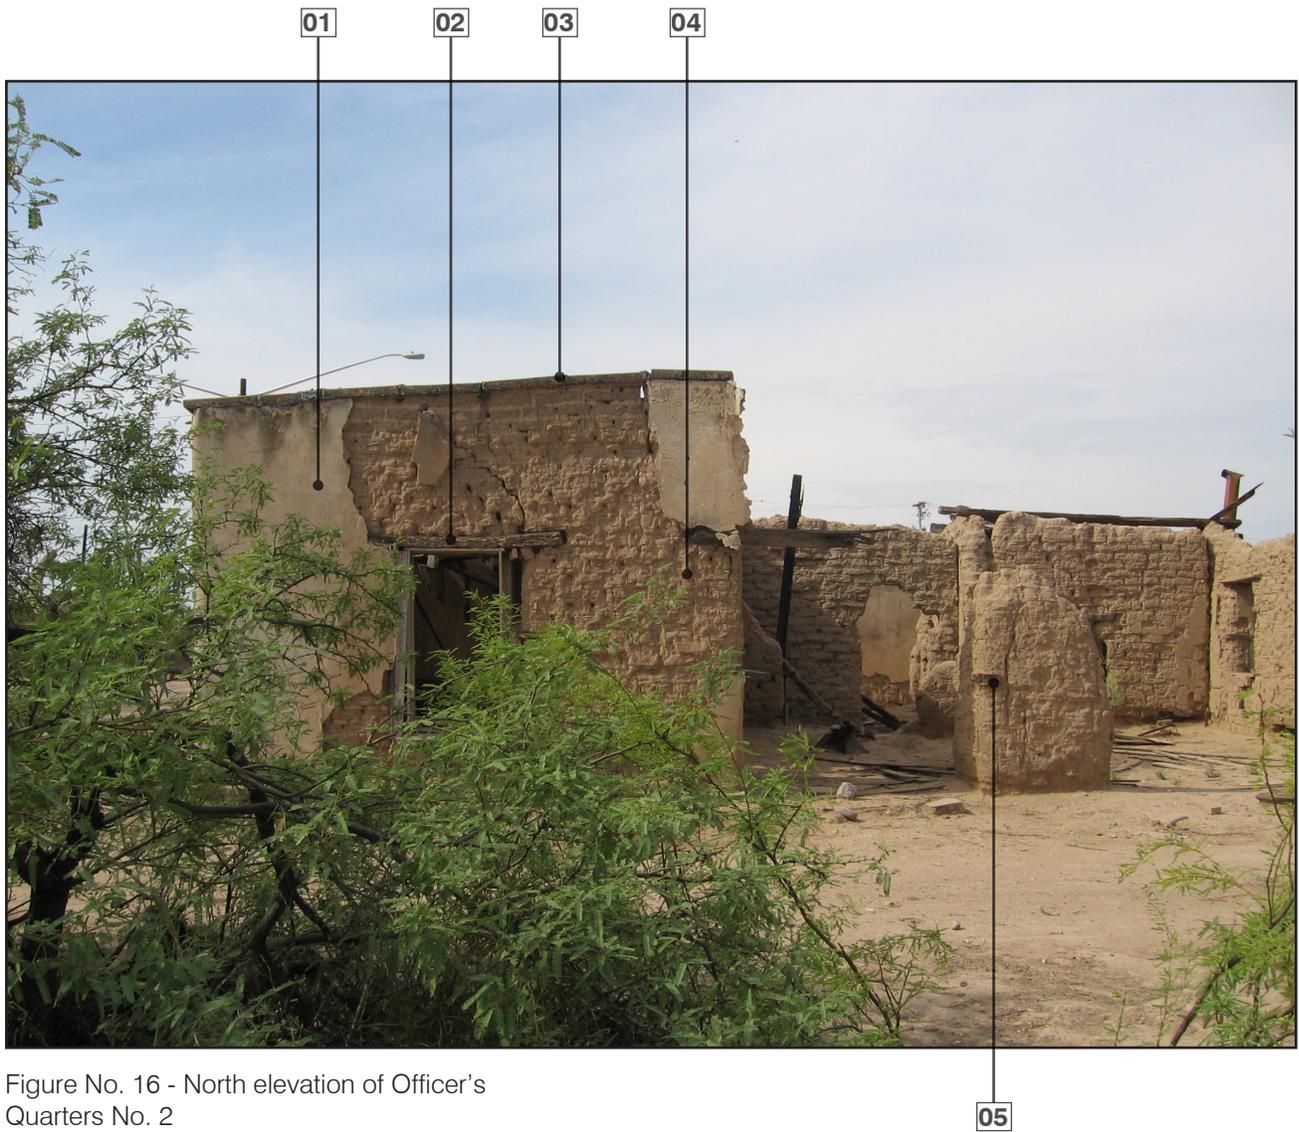
Figure No. 16 - North elevation of Officer's Quarters No. 2

- 01. Plaster on adobe block
- 02. Wood lintel and door frame
- 03. Concrete parapet cap
- 04. Adobe block wall
- 05. Eroded adobe wall

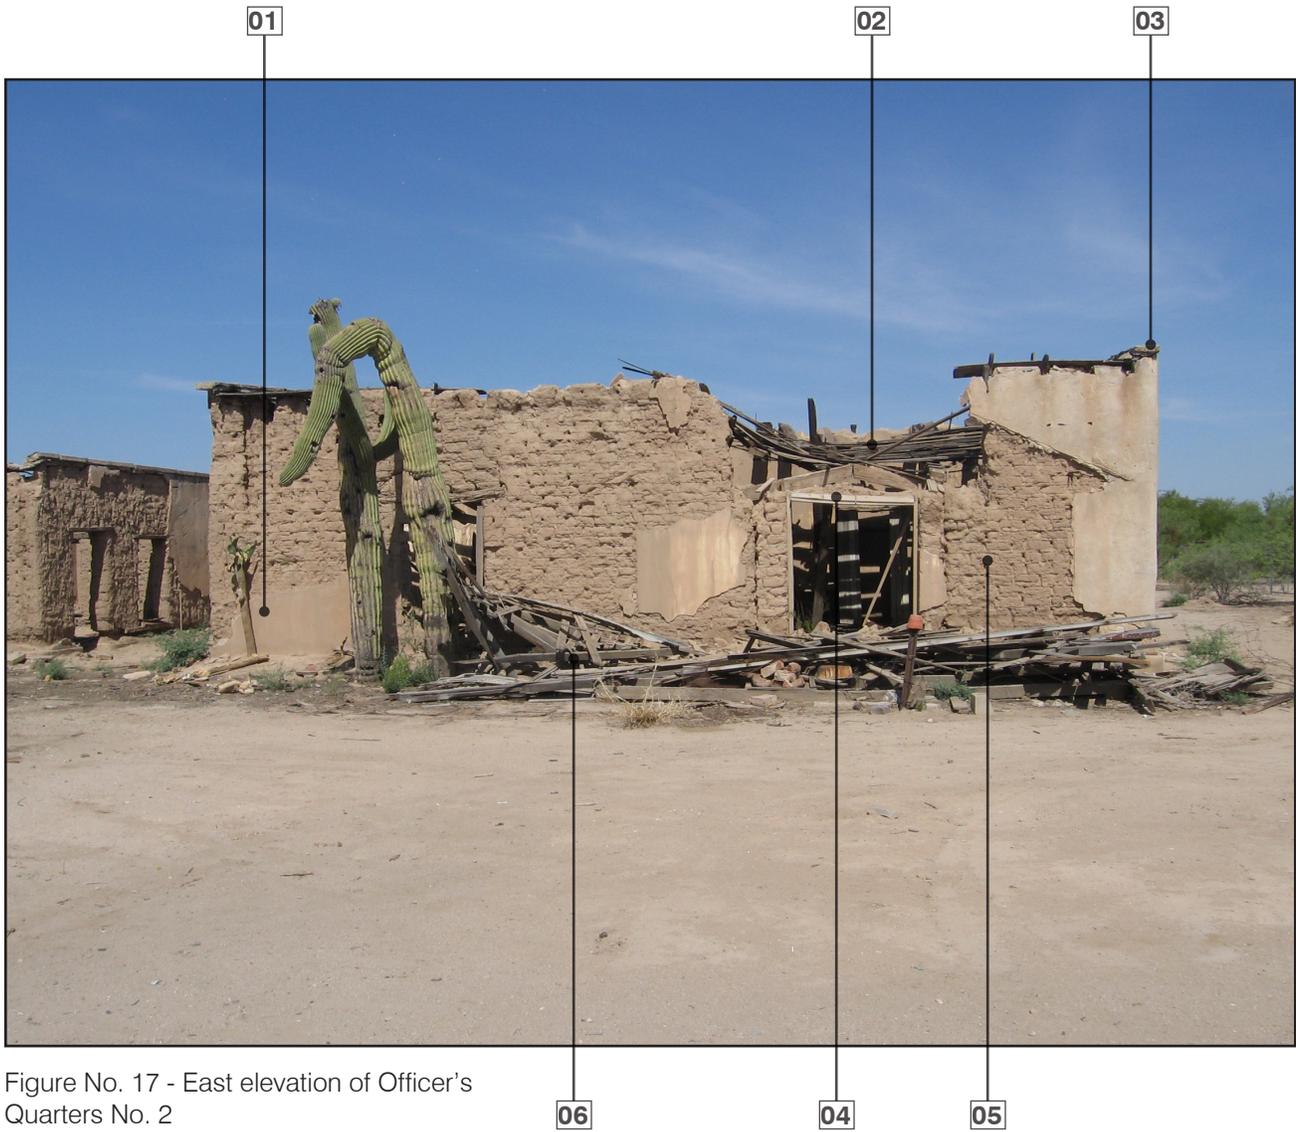
Figure No. 17 - East elevation of Officer's Quarters No. 2

- 01. Plaster on adobe block
- 02. Roof framing collapsing
- 03. Concrete parapet cap
- 04. Wood lintel and door frame at side porch
- 05. Adobe block wall
- 06. Remains of side porch and roof

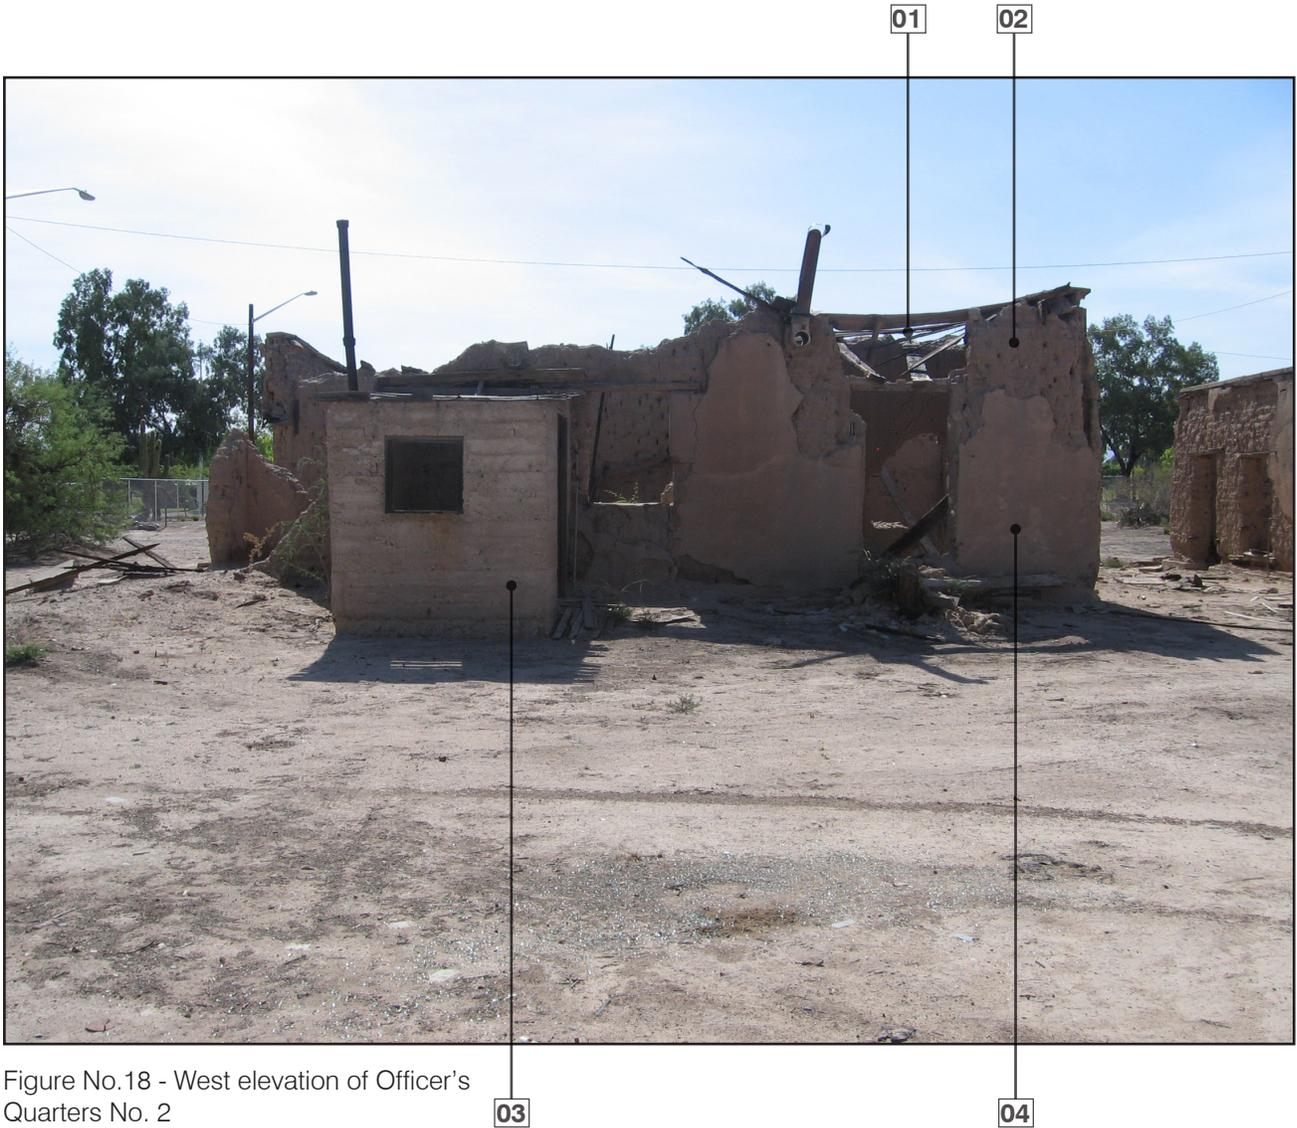
Figure No.18 - West elevation of Officer's Quarters No. 2

- 01. Roof framing collapsing
- 02. Adobe block wall
- 03. Cast in place concrete addition(bathroom)
- 04. Plaster on adobe block

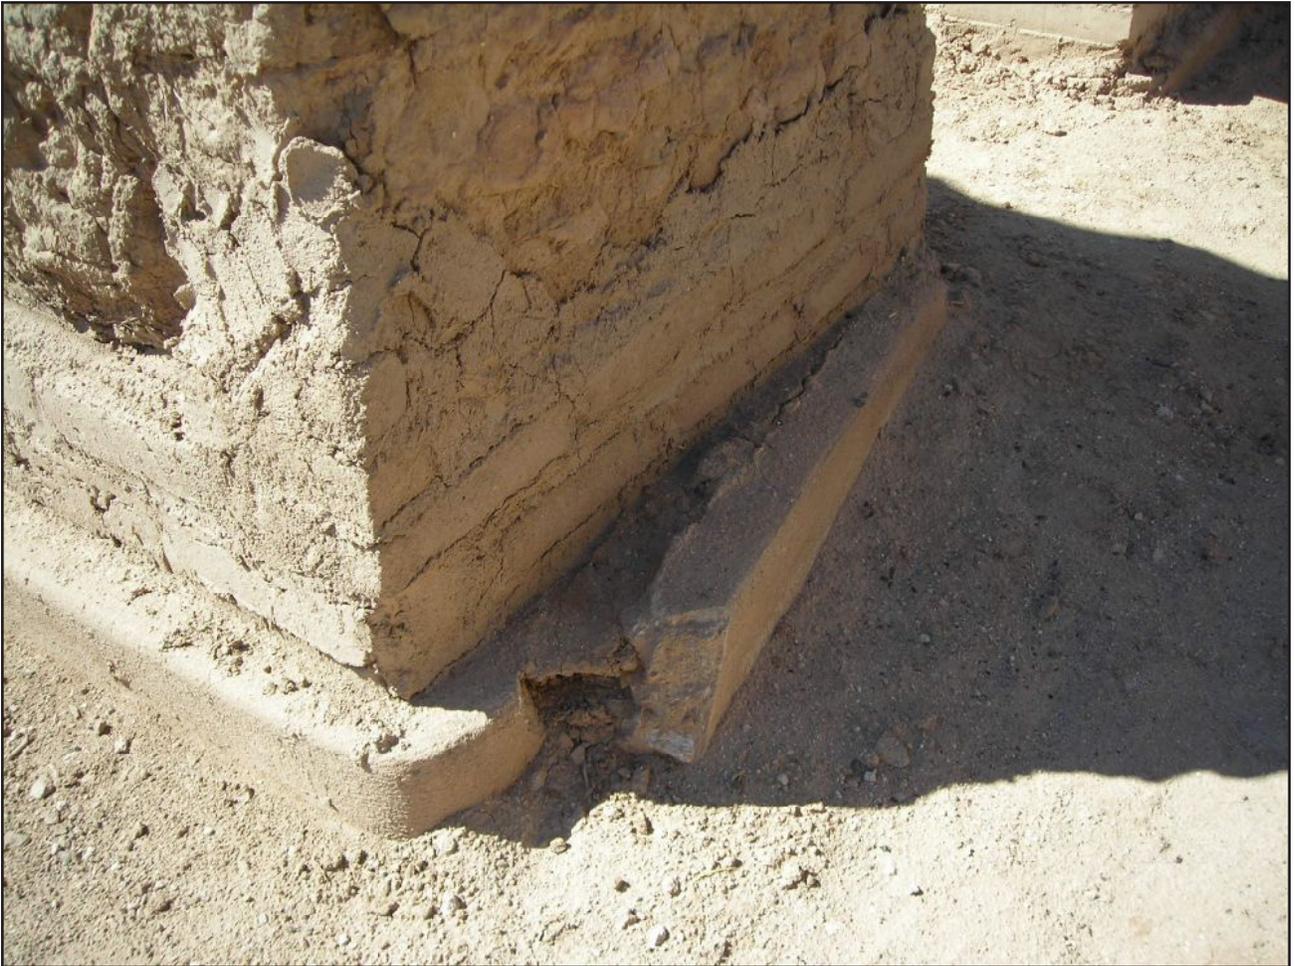
Figure No. 26 - Contra-pared at northeast corner of kitchen, typical of thin section on this structure; it can be pried away from the base of the wall

There are contra-pared, typically cast-in-place concrete curbs often fabricated at the bottom face of adobe walls at grade, and intended to moderate the effects of basal coving, but often aggravating the problem by holding more moisture behind them. These are contributing to the erosion at the wall base, all around the kitchen building, and along the east and north sides of the house. These are typically 4” deep thick and average 6” above finish grade (it is not determined how far they go below finish grade at this time). If further treatment is considered at this structure, all the contra-pared should be removed.

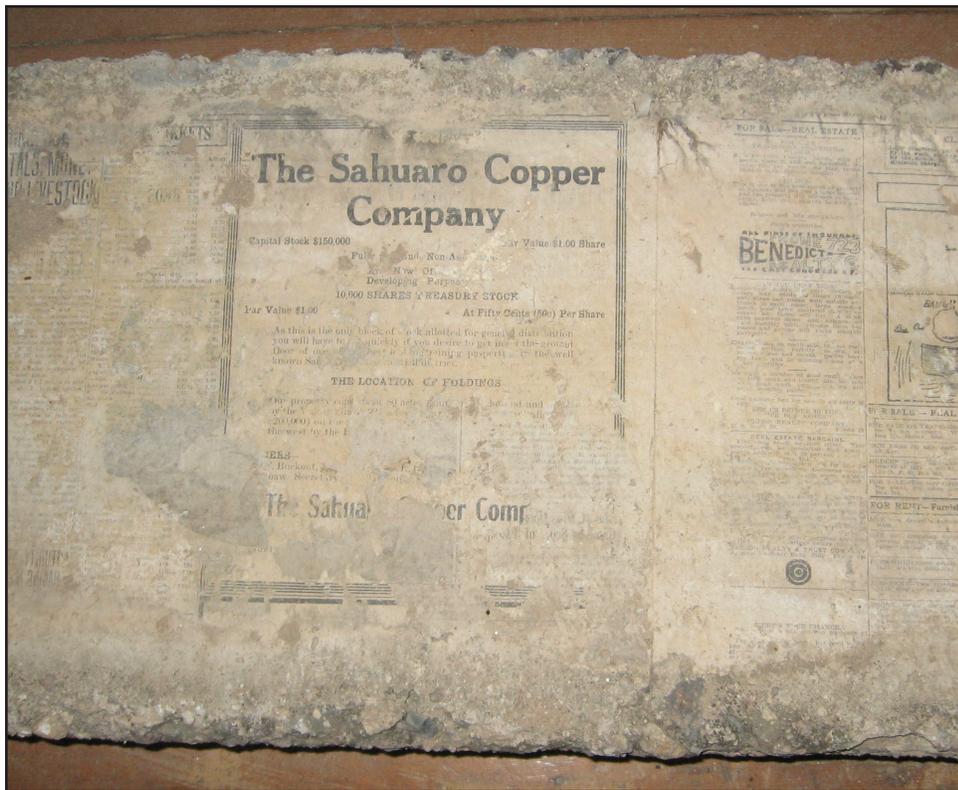
Figure No. 28 - Newspaper on bottom side of precast cap, ca 1920

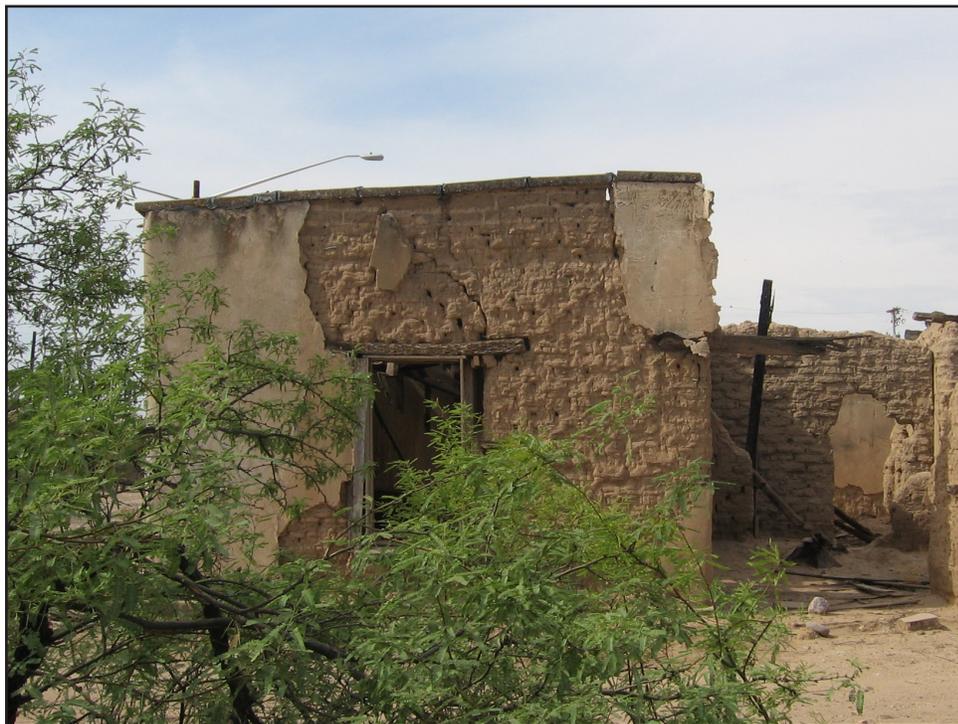
Figure No. 29 - Remaining cement plaster on north side of house and parapet caps

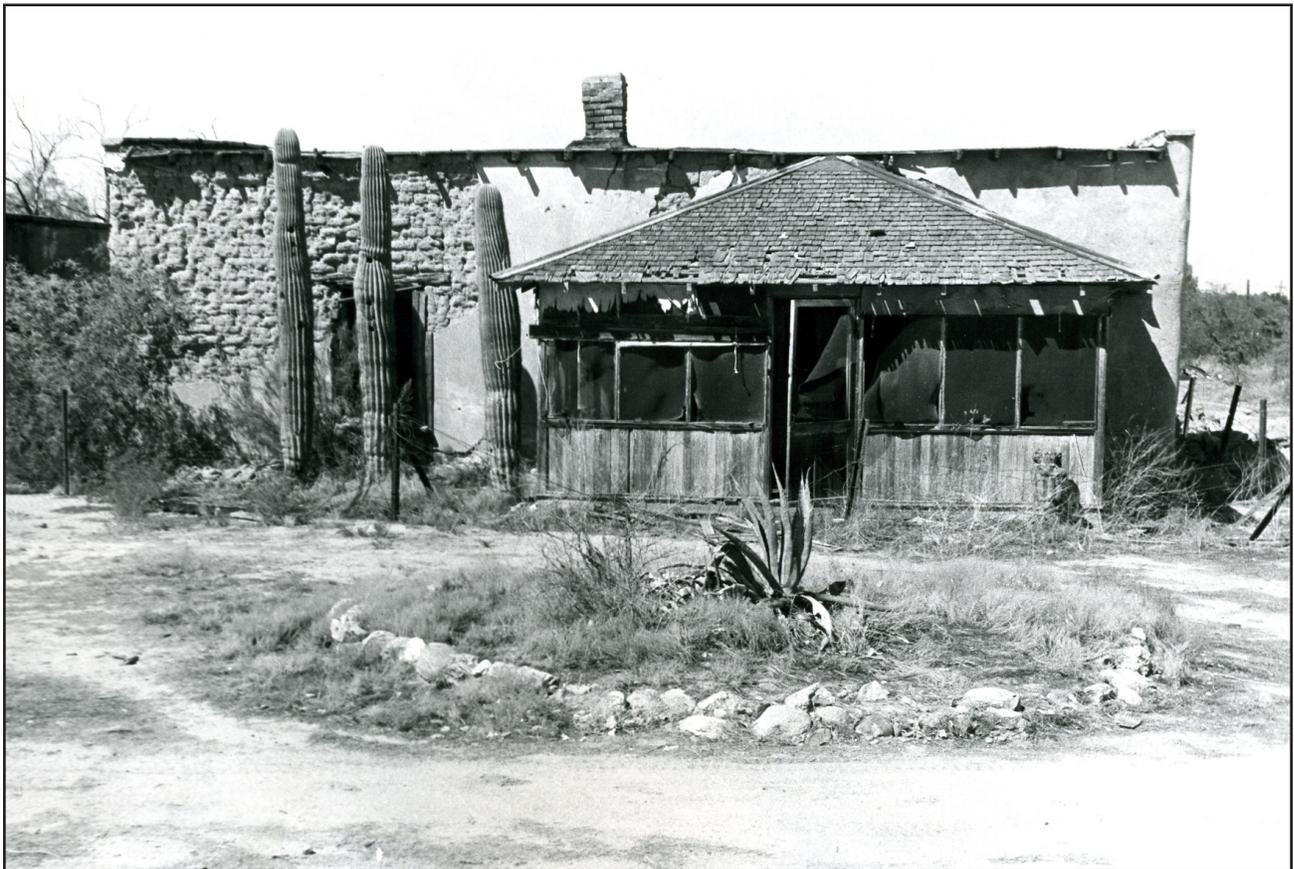
There was a porch that existed on the east side of Officer's Quarters No. 2 that does not show up in the 1940s aerial and was built prior to the structure burning in the 1970s, see Figure No. 31. The porch between the quarters and kitchen does not appear to be intact at this time also. By this time the structure has deteriorated and the vegetation is almost gone at east side of quarters.

Figure No. 31 - Porch at the east side of the house; edge of kitchen is visible;

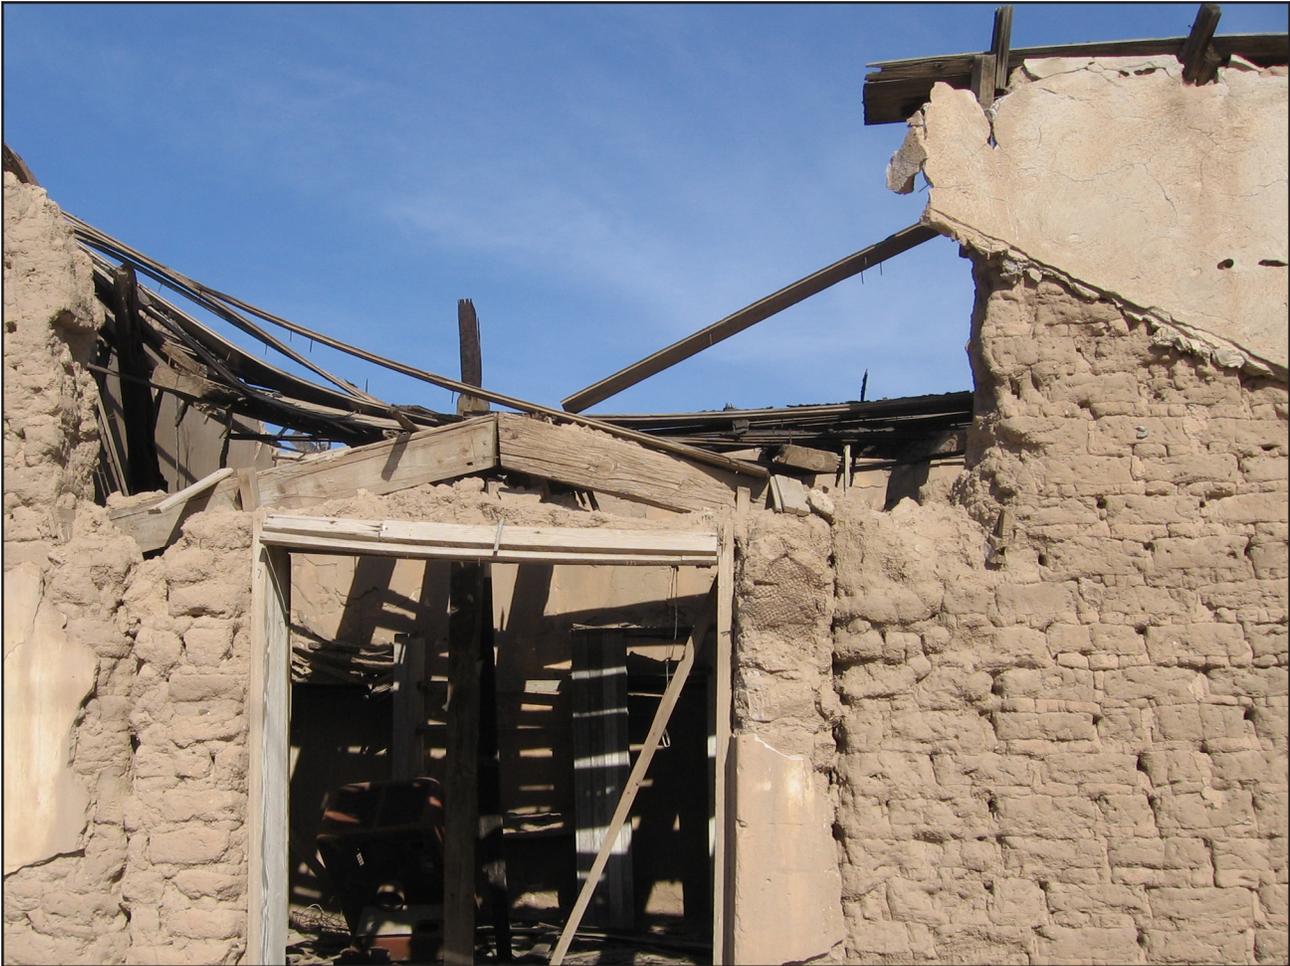
Figure No. 34 - Door frame and roof support at porch on east side of Officer's Quarters No. 2(see Figure No. 31); this porch, of similar construction to the porch on the south side of Officer's Quarters No. 3, is thought to have been added during the 1920's; it may have been a sleeping porch; note eave overhang to upper right

There are no extant doors. Some wood casements and lintels remain in openings, all in a very deteriorated condition. All openings should be braced.

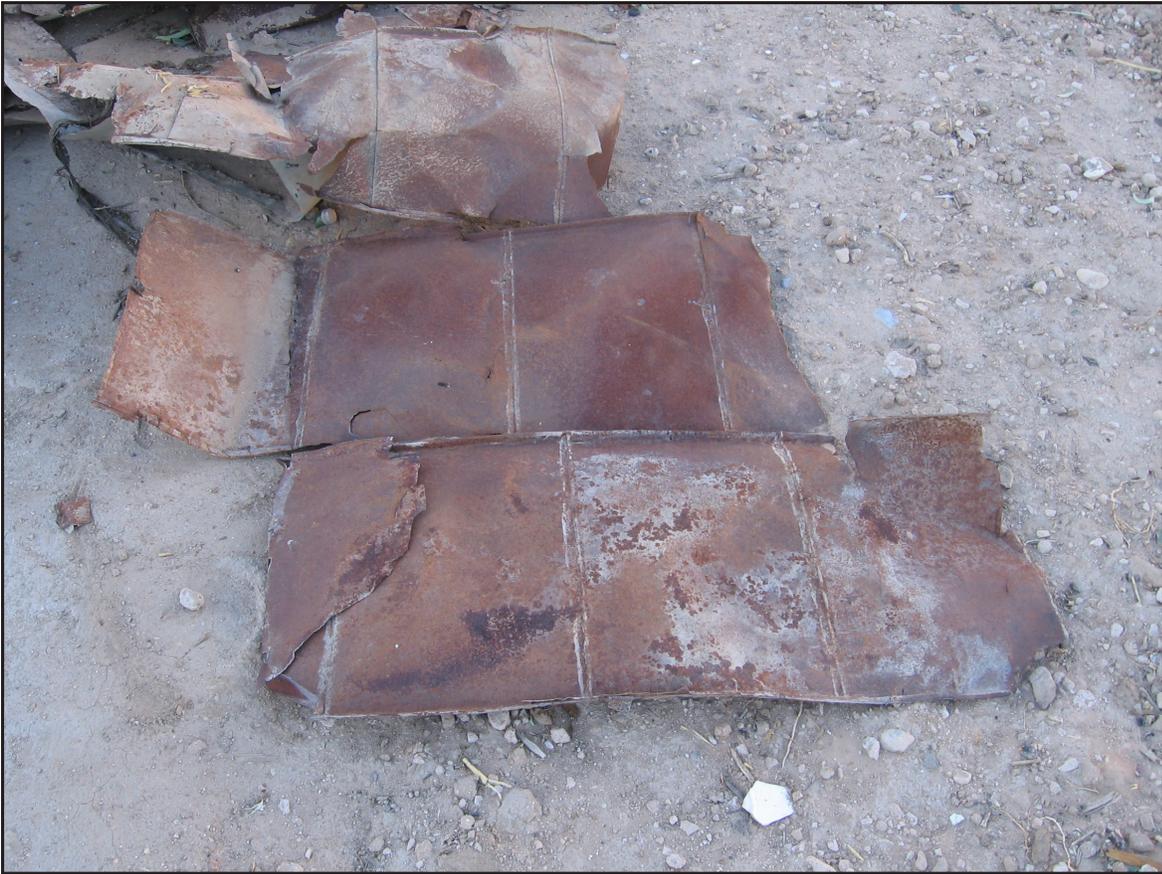
Figure No. 39 - Tin roof panels

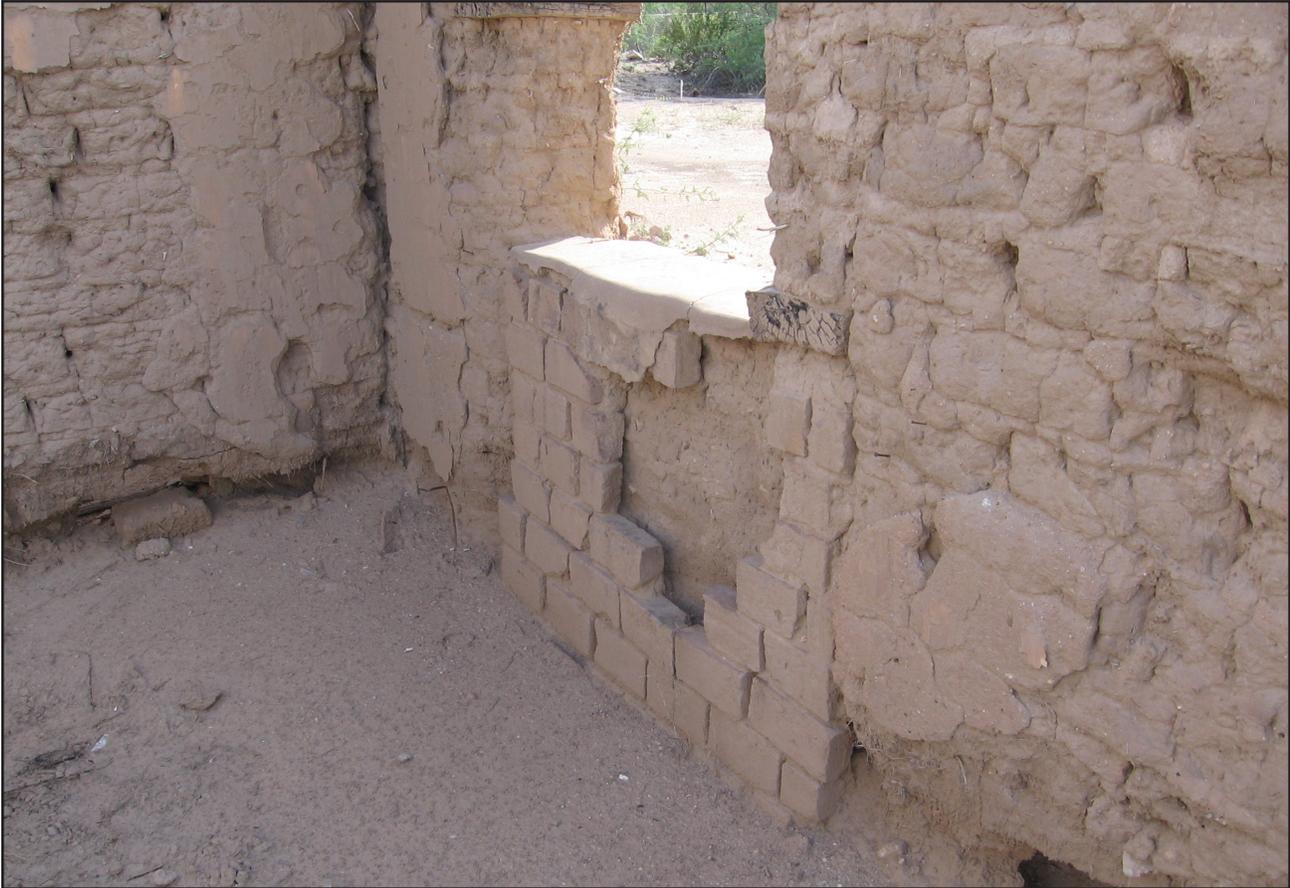
Figure No. 40 - Interior partition butting into west exterior wall; also undercutting through wall at bottom right, this location was filled in with adobes during the stabilization work; window modifications were made by Adkins family and include a cast-in-place concrete sill and brick overlaid on wall

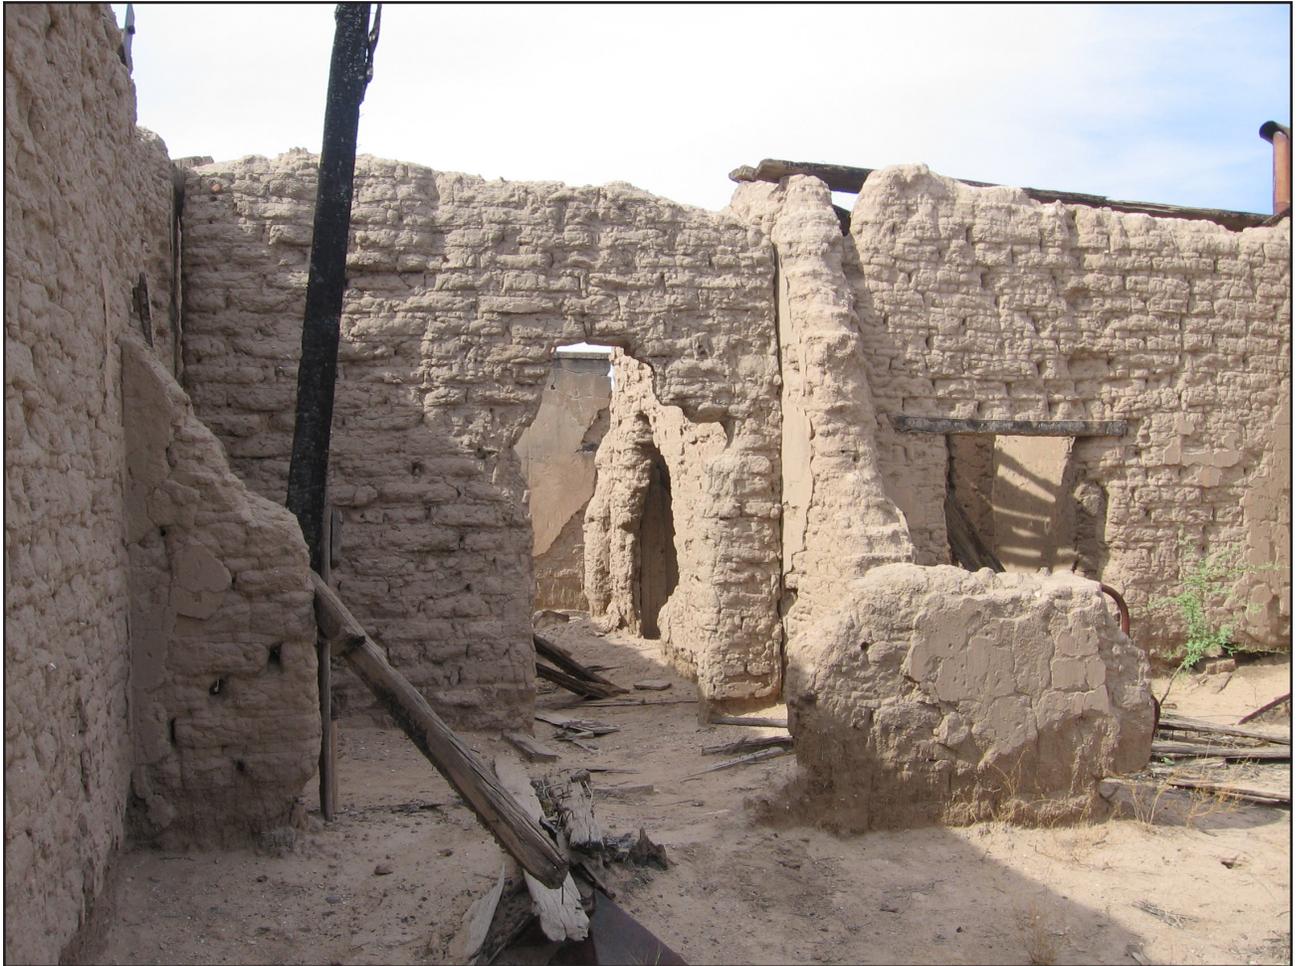
Figure No. 41 - Interior wall butting at both sides into other walls; this wall appears to have been installed some-time after original construction, though still of similar adobes; the plaster on the wall in the center of the picture runs beneath the intersecting wall; see also remaining plaster on upright wall at center and stub wall
