Officer's Quarters No. 1, 2 & 3

Adkins Steel Parcel

Building Condition Assessment Report

February 25, 2008

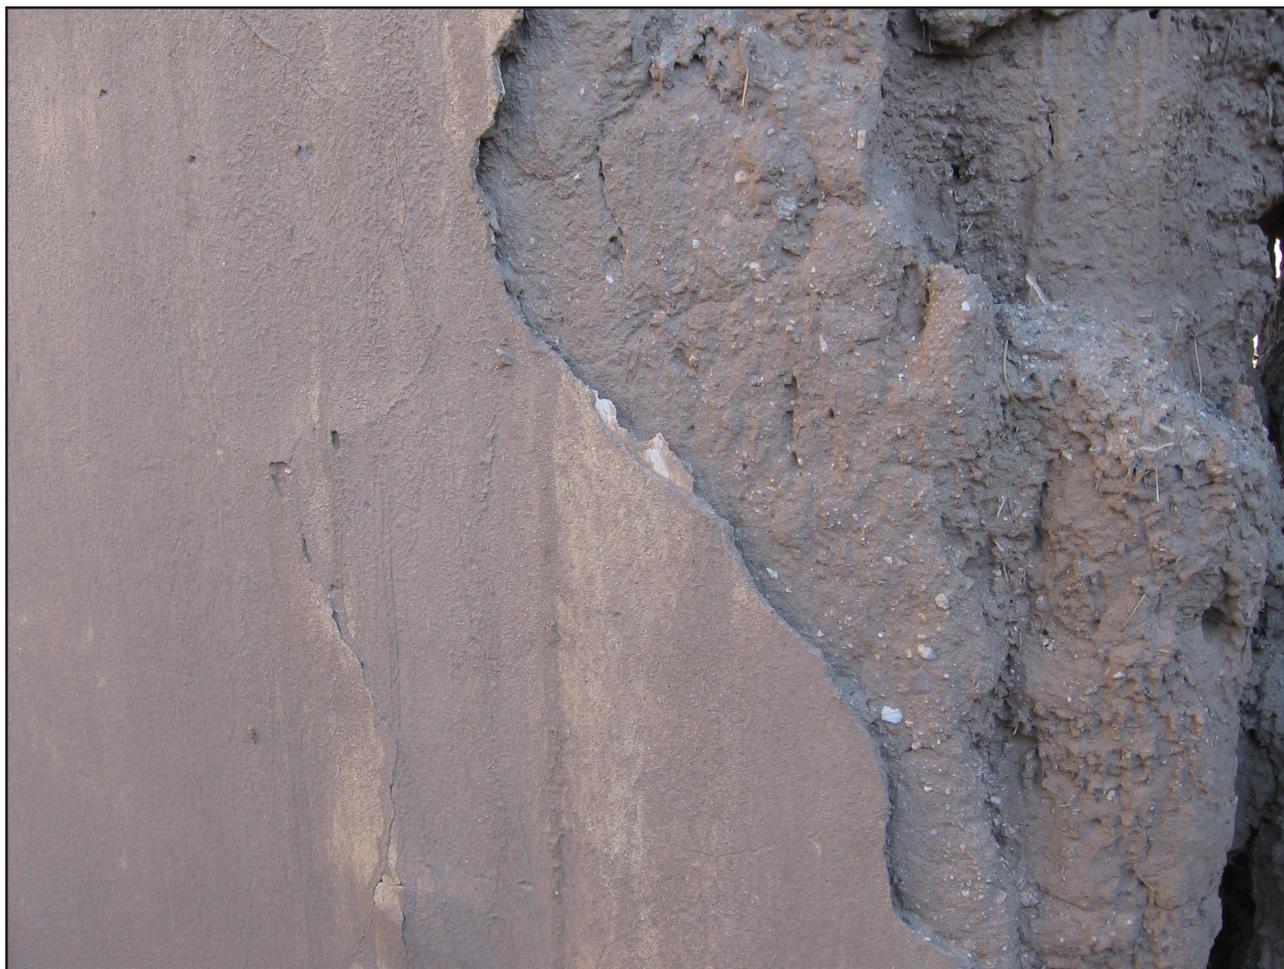
Figure No. 42 - Section of remaining smooth plaster at interior; note white lime at center.

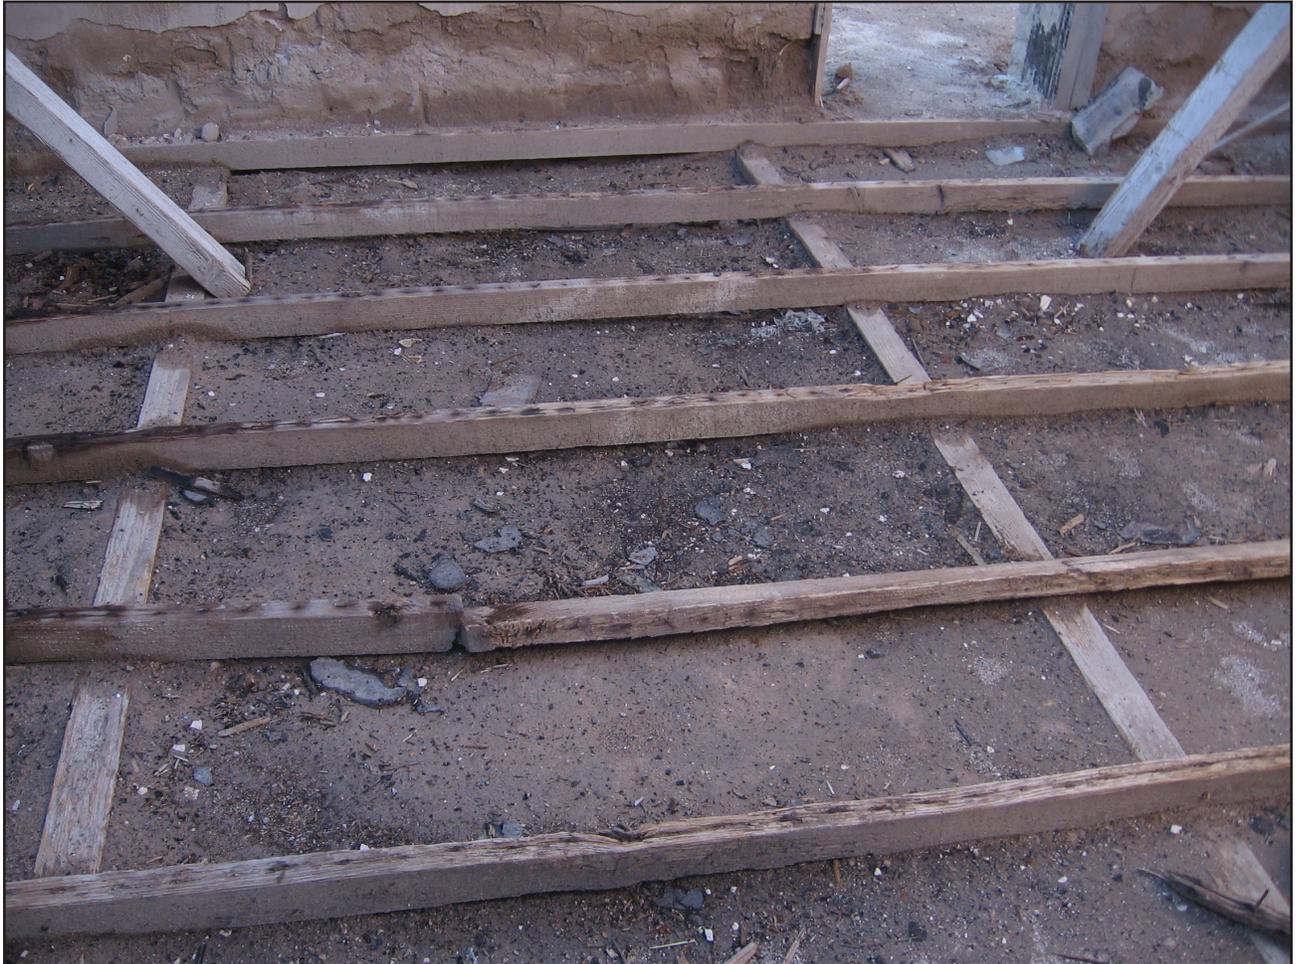
Figure No. 43 - Floor joists over sleepers at Bedroom 1

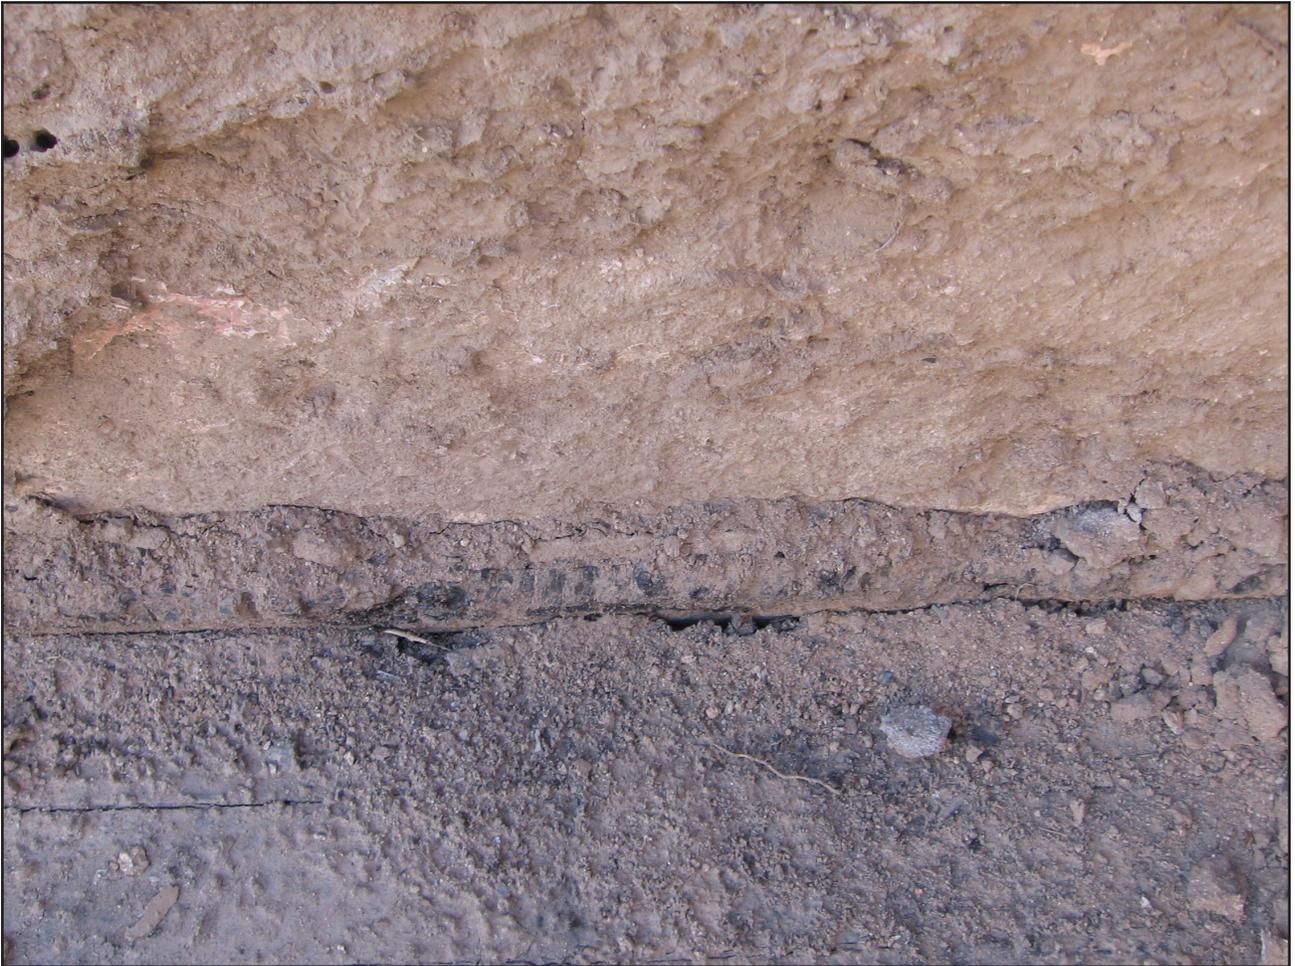
Figure No. 45 - Wall base at west side of east room at kitchen; wood floor pictured above is immediately adjacent but has been covered with dirt since the picture was taken

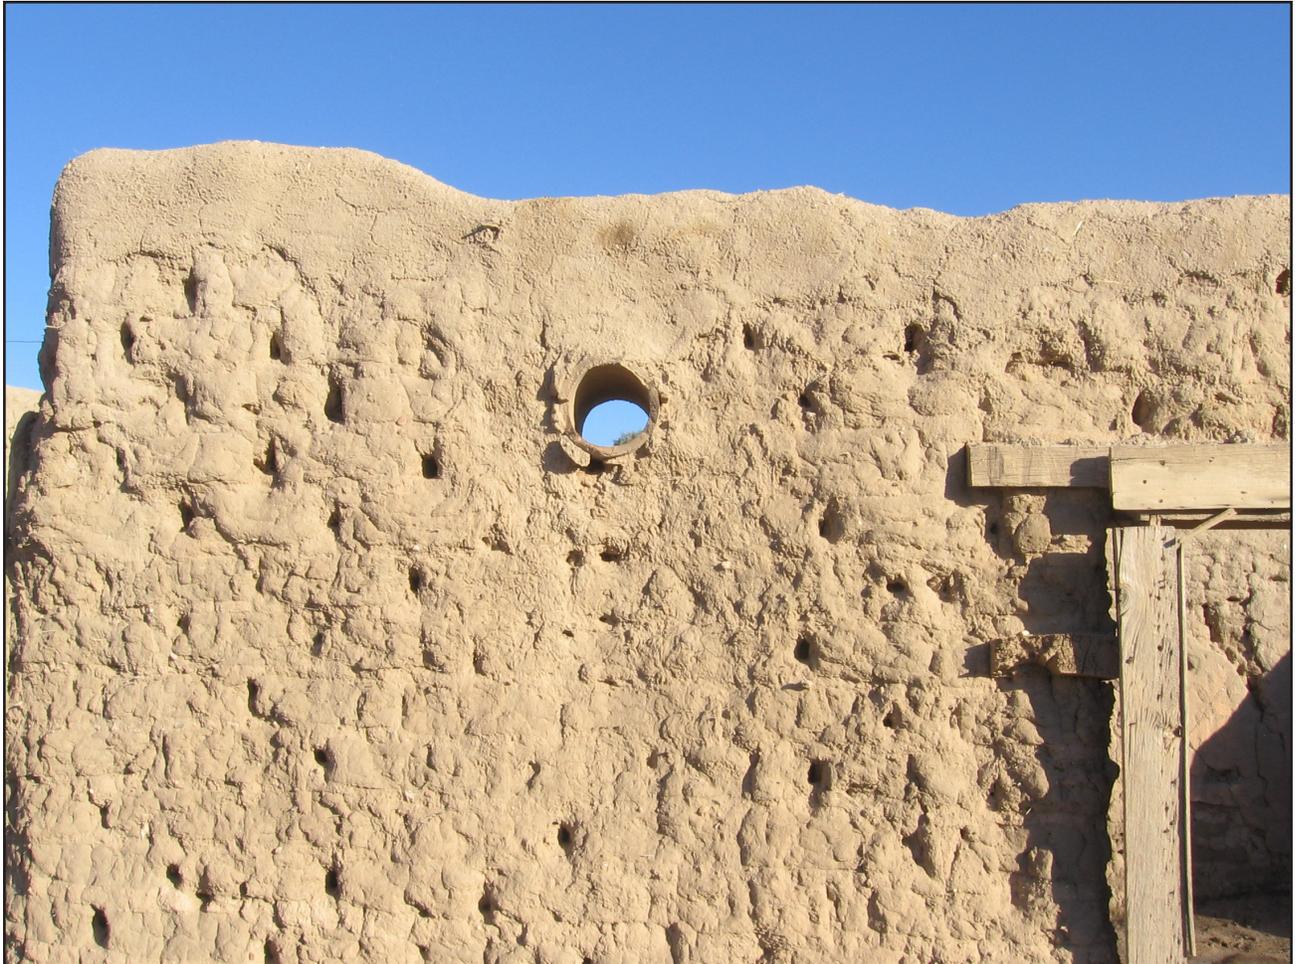
Figure No. 47 - Remains of flue at the Kitchen

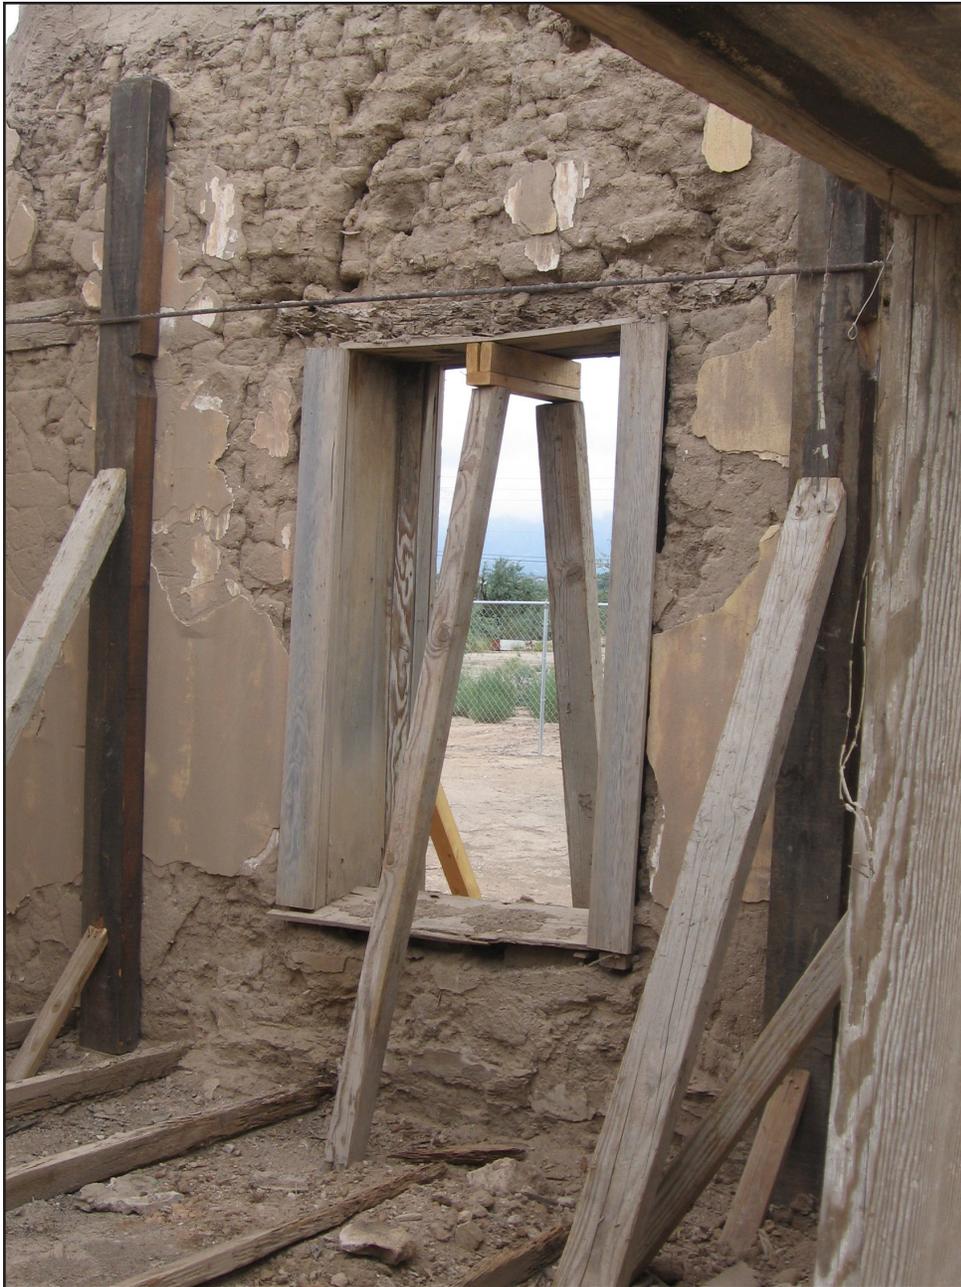
Figure No. 53 - Bracing at a window and against the walls in Bedroom No. 1 (the front bedroom); photograph taken 09/06/07

Note: All bracing should be monitored on a regular basis and adjusted as needed to provide positive support.

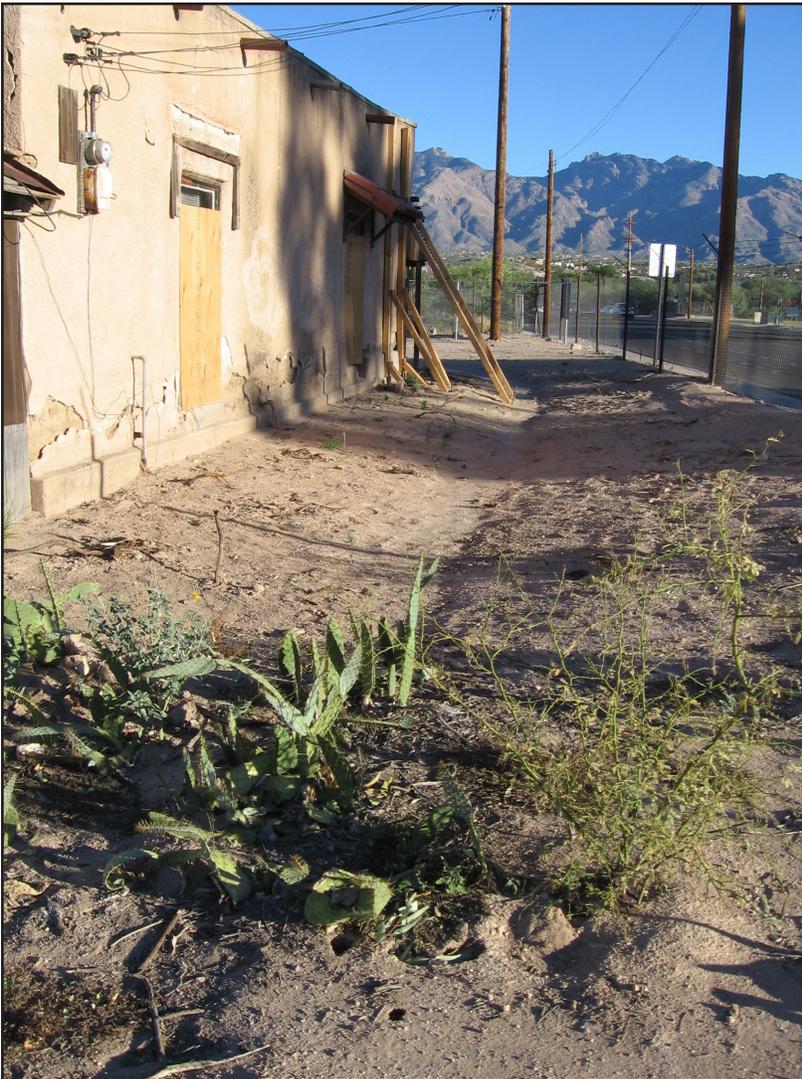
As part of the emergency stabilization, a shallow swale was formed stretching along the east side of the house, then turning and going along the south side of the house. The high point appears to be at the southeast corner and the swales drain water from here, around the house and away. The east side, along Craycroft Road, is all higher than the house, which has caused damage along this elevation over the years, and the new swale intercepts this flow. The swale is approximately 12" wide at the bottom and of varying depth. This should remain in place until further sitework and landscape is designed as part of the eventual building use.

Figure No. 58 - Swale looking north

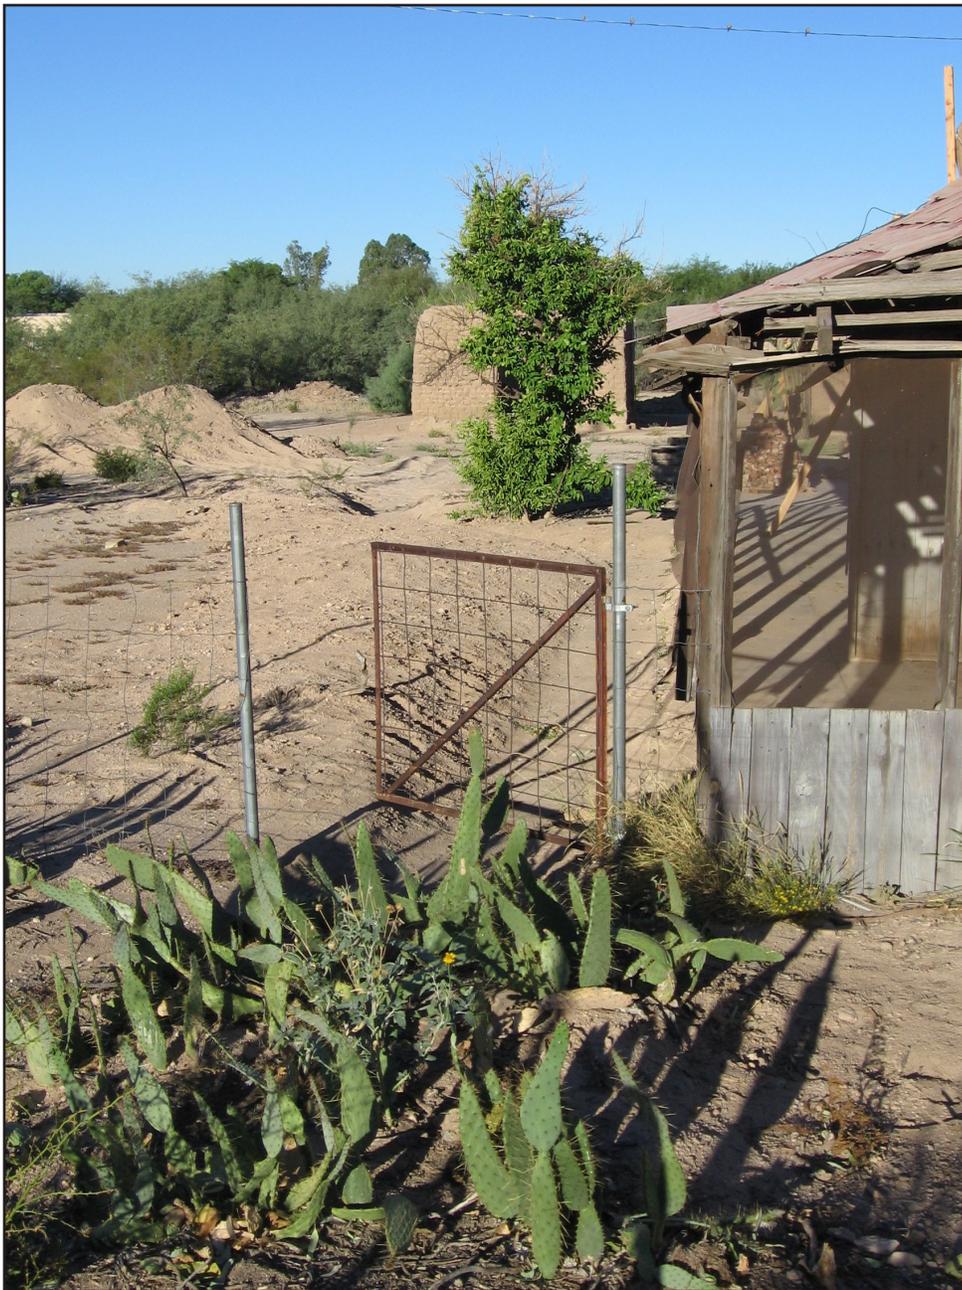
Figure No. 59 - Swale
looking west beyond gate

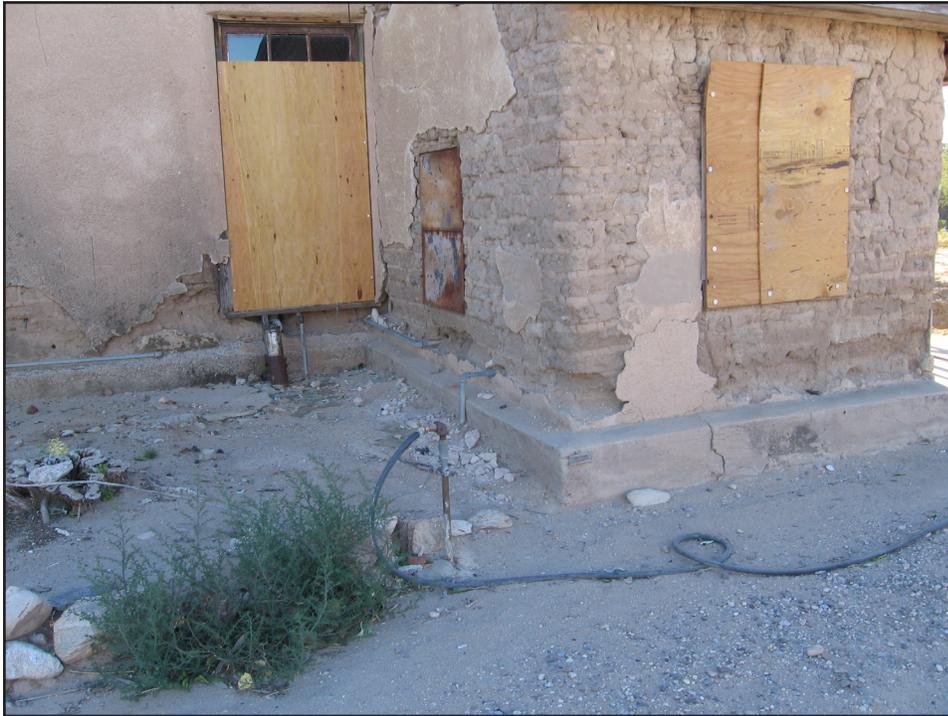
Contra-pared, cast-in-place concrete curbs often fabricated at the bottom face of adobe walls at grade, and intended to moderate the effects of basal coving, actually aggravate the problem by holding more moisture behind it, have been placed at the base of almost all exterior perimeter walls. They vary in height and in some cases have two applications, one atop the other. In some areas, rather than building the contra-pared, portland cement plaster patches have been applied to the coved areas. All of this material should be considered for removal in the Restoration Plan.

Figure No. 63 - Contrasted at bathroom addition; 11" high by 5"-6" wide(after stabilization)

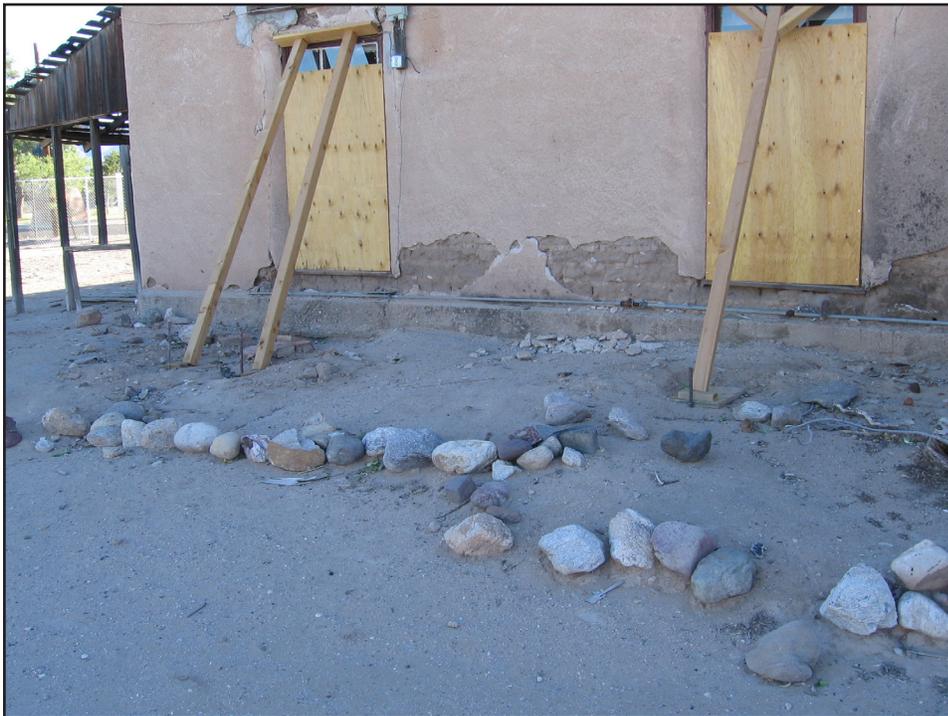
Figure No. 64 - Contrasted at west elevation; 12" high by 5"-6" wide; rougher concrete mix than that used at bathroom(larger aggregate) erosion visible(after stabilization)

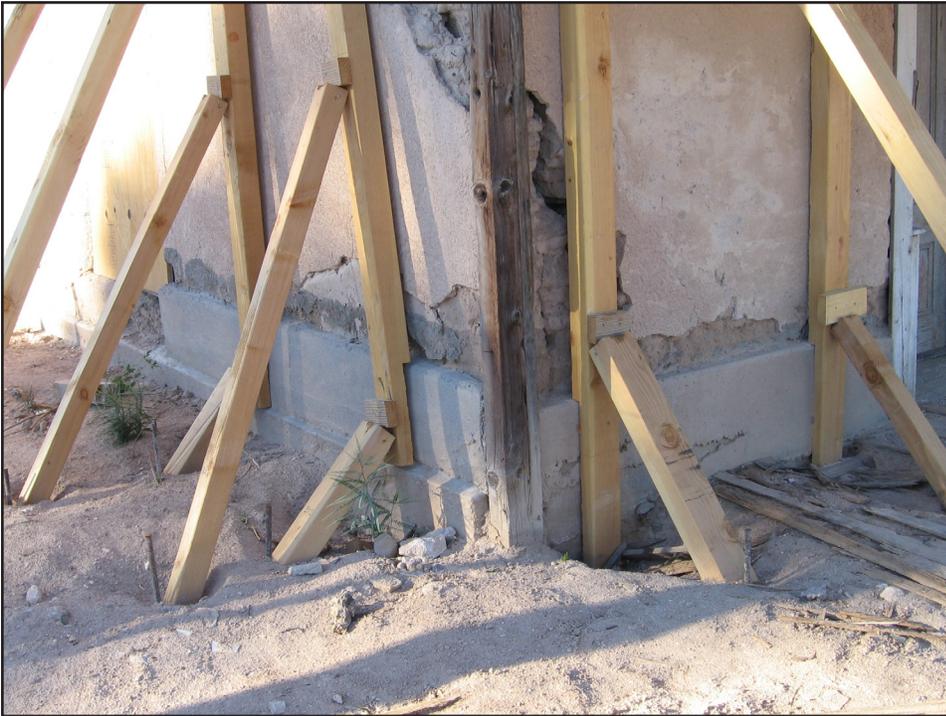
Figure No. 67 - Braced north corner with +/- 18" by 3"-3 1/2" contra-pared; two layer on east side, bottom 11" by 5" and top 14"-15" by 3" (after stabilization)

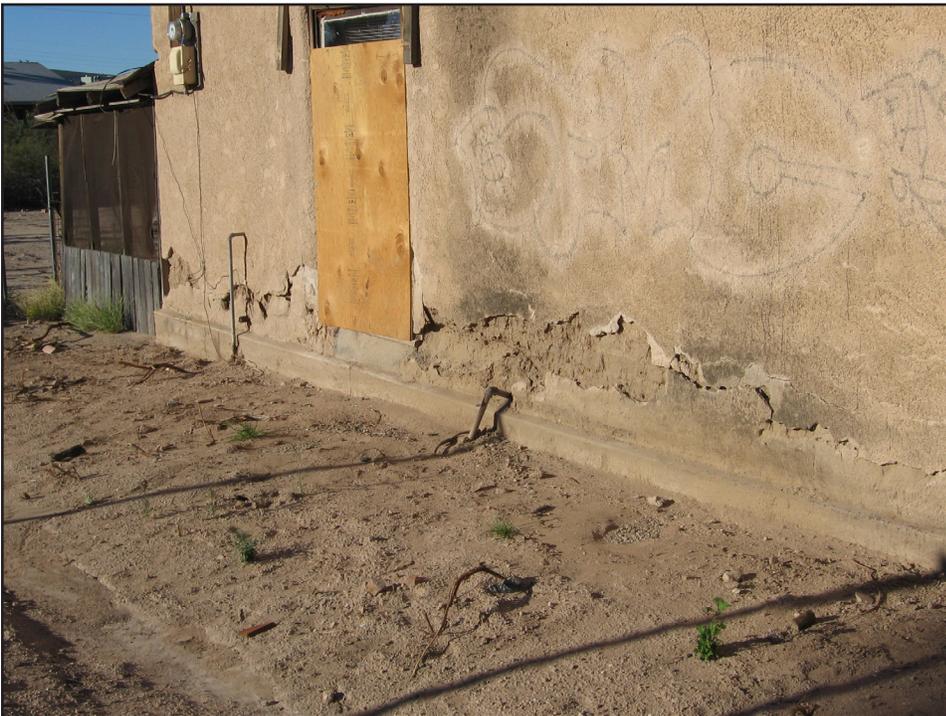
Figure No. 68 - Remaining section of east wall of house with a single layer contra-pared (after stabilization)

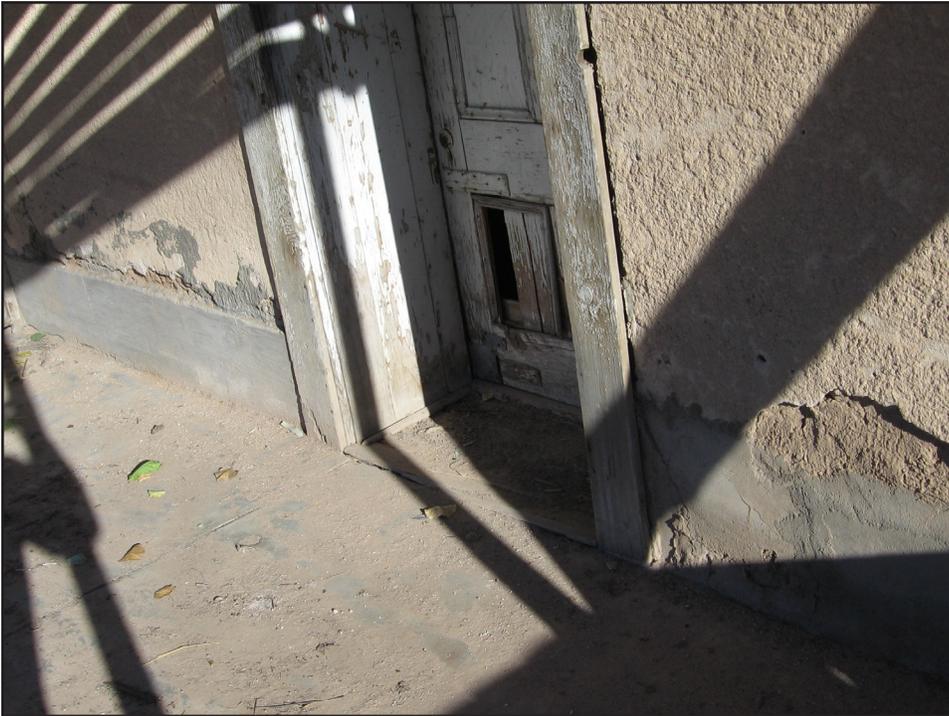
Figure No. 69 - Patching along south side and board form contra-pared 12" high

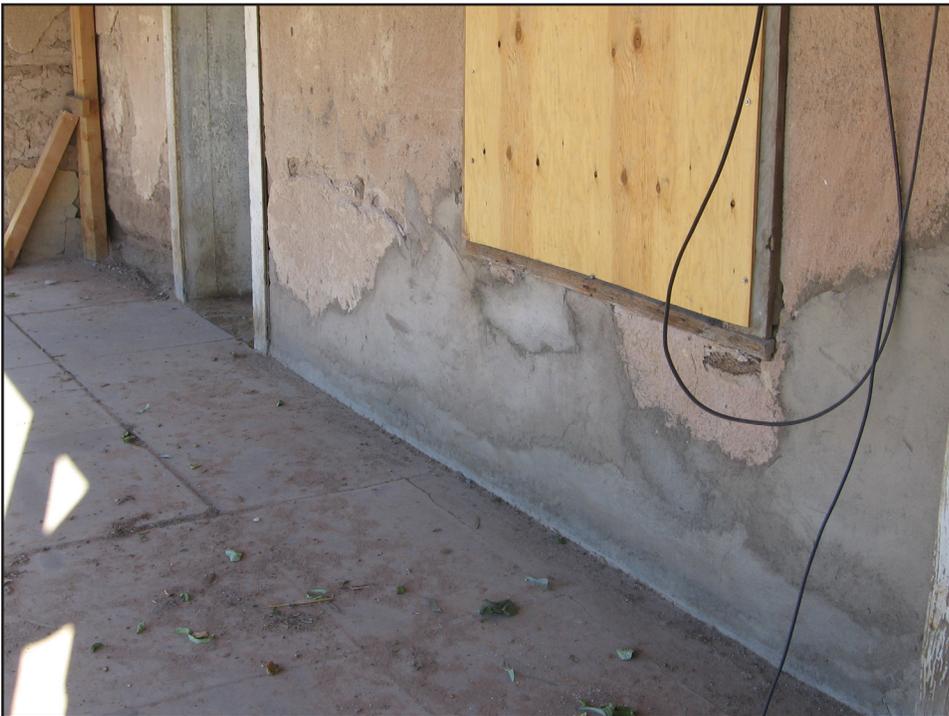
Figure No. 70 - Patching along remainder of south wall with covered area west of kitchen up to toilet addition (after stabilization)

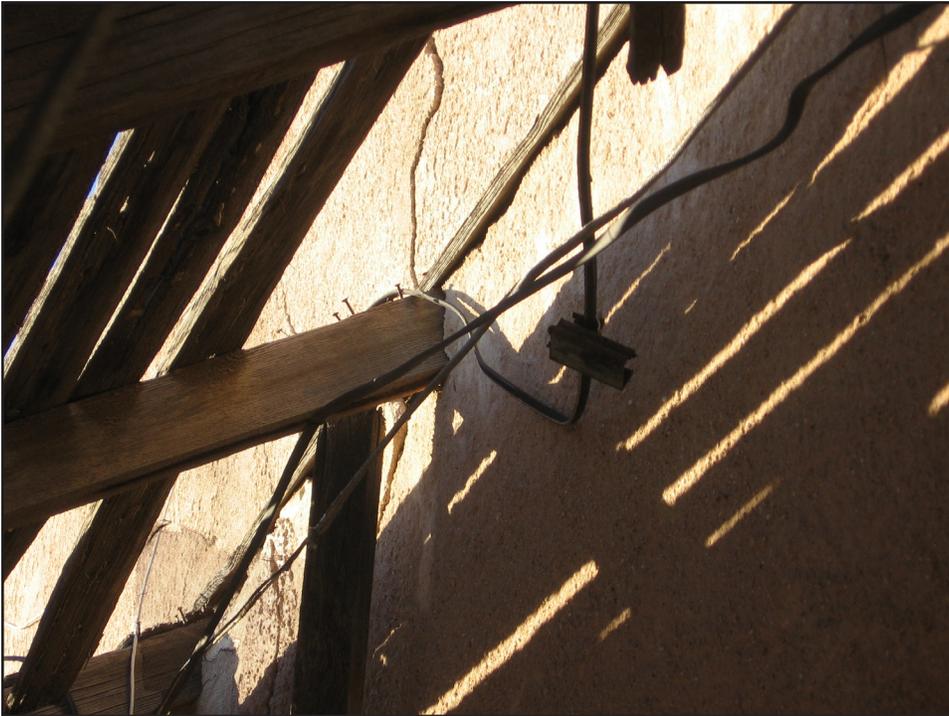
Wall Anomaly: It appears that the top of the porches on the north and south side are resting on a ledger of some sort, that is, a protruding section of wall that supports the framing. This occurs on the north and south elevations. The wall below the porch roof projects two-three inches beyond the face immediately above the roof. The houses were not plastered on the exterior until sometime in the Dolly Cate's period (early 1900's) and this anomaly may have been created at that time, though it seems that the top of the porch is integral with the projection and so built at the same time. This was not noticed when the Officer's Quarters building was reconstructed across the street and so is not reflected on that building. Nor does the condition appear on Officer's Quarters No. 2 – the north wall is too deteriorated to show it if it existed, and it does not appear on the south wall.

This is one explanation, but does not really take into account the fact that the projection follows the line of the porch roof, which is gabled at the west end of the south elevation. Any complete understanding of this condition will require further investigation of the wall structure.

Figure No. 71 - Projection at south elevation; with porch joists pocketed into plaster and a board across the top

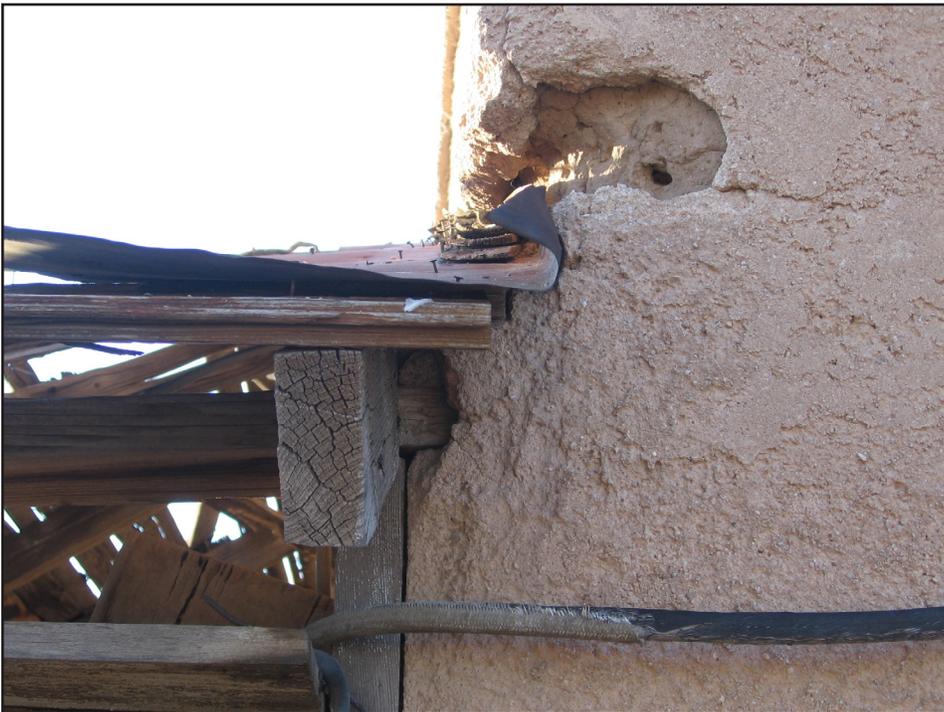
Figure No. 72 - End of porch at southwest corner, "stepping" in wall above porch line is clearly visible

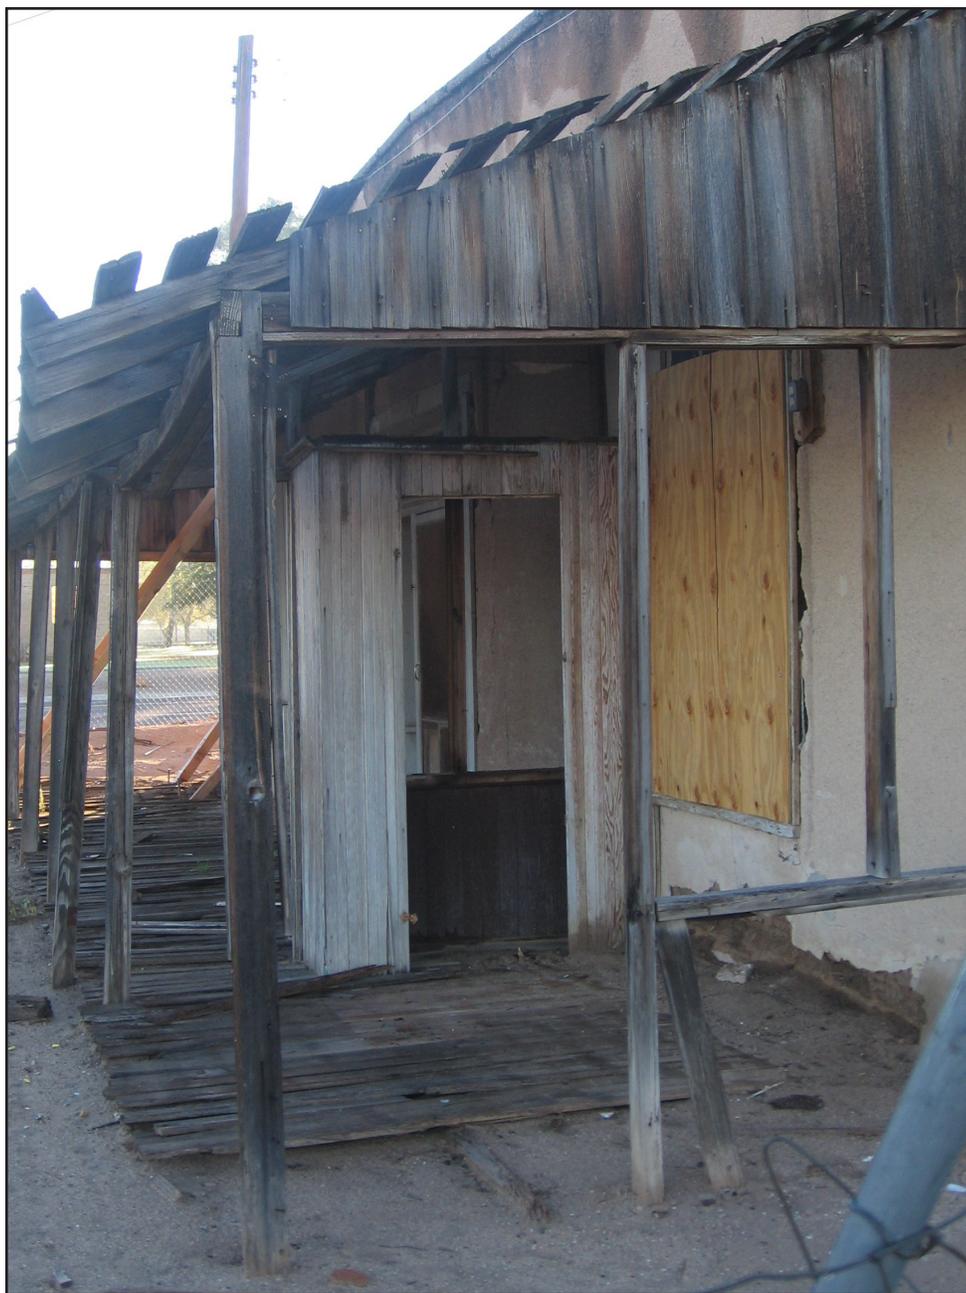
Figure No. 74 - Closet at sleeping porch on north

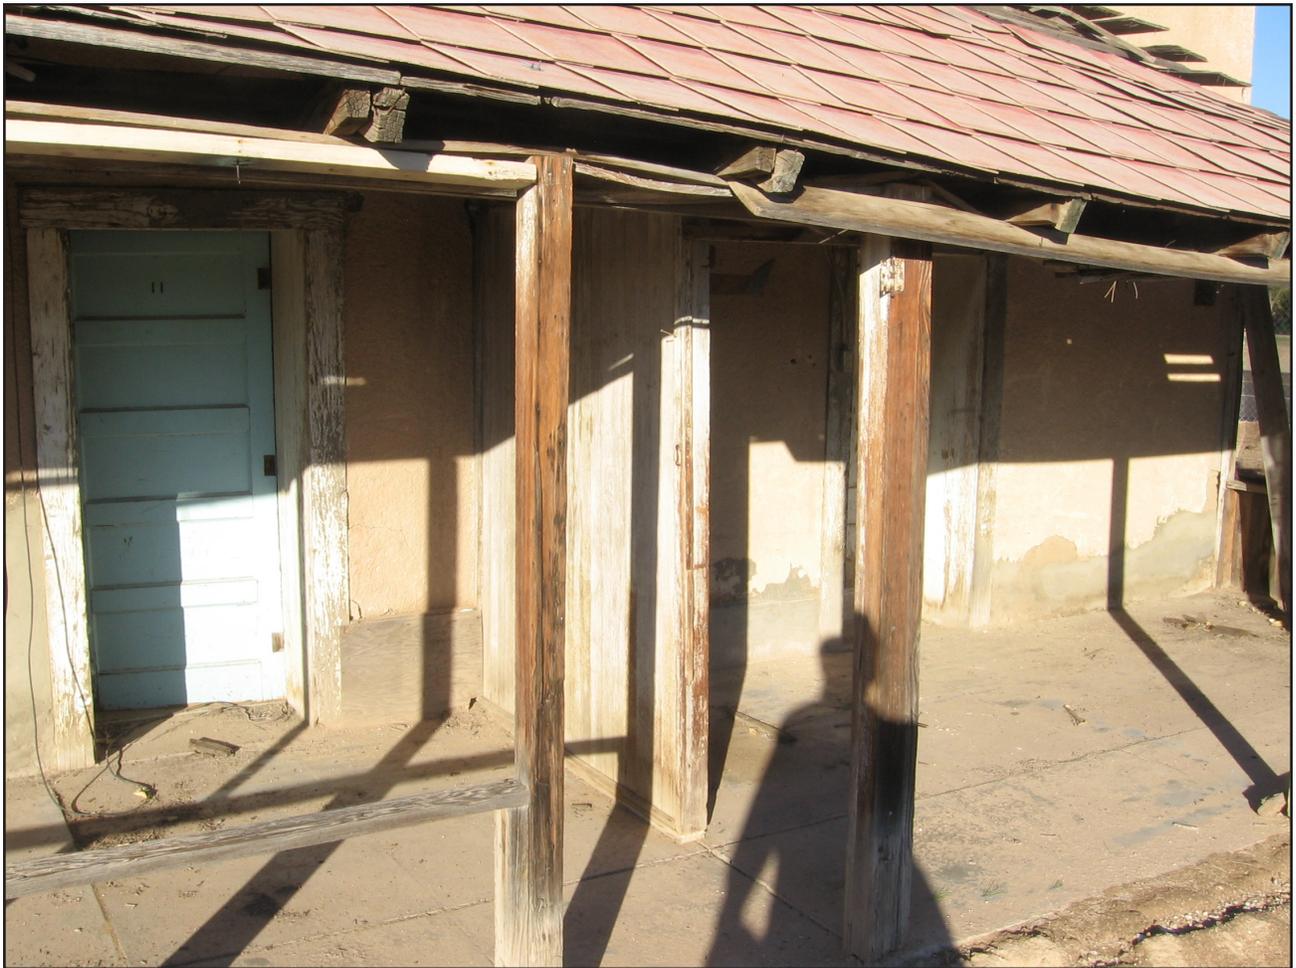
Figure No. 75 - Divider wall between Dining Room door and Bedroom 2 door at rear porch designating sleeping area; cement roof tiles are visible above

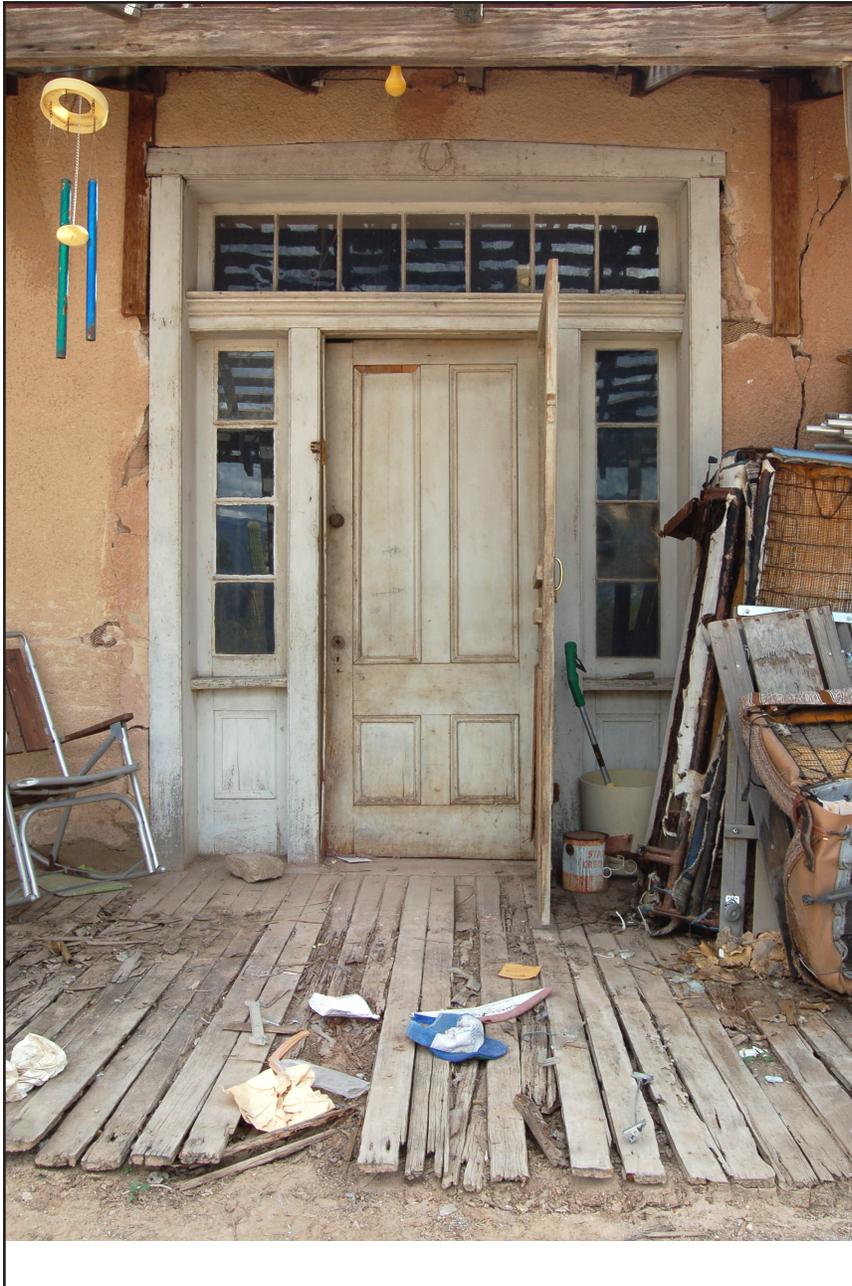
The main entry door is original, but has lost the remaining frosted glass noted on the HABS drawings; most of the original hardware is gone – there exists a deadbolt and a padlock hasp on the exterior; the lockset is contemporary and is mounted up high where a deadbolt would typically occur.

Figure No. 77 - Entry door, photo taken at the time the City took possession of property (fall 2006); windows on each side of door are operable to allow ventilation

Significance: High
Integrity: High
Condition: Fair
Comments: None

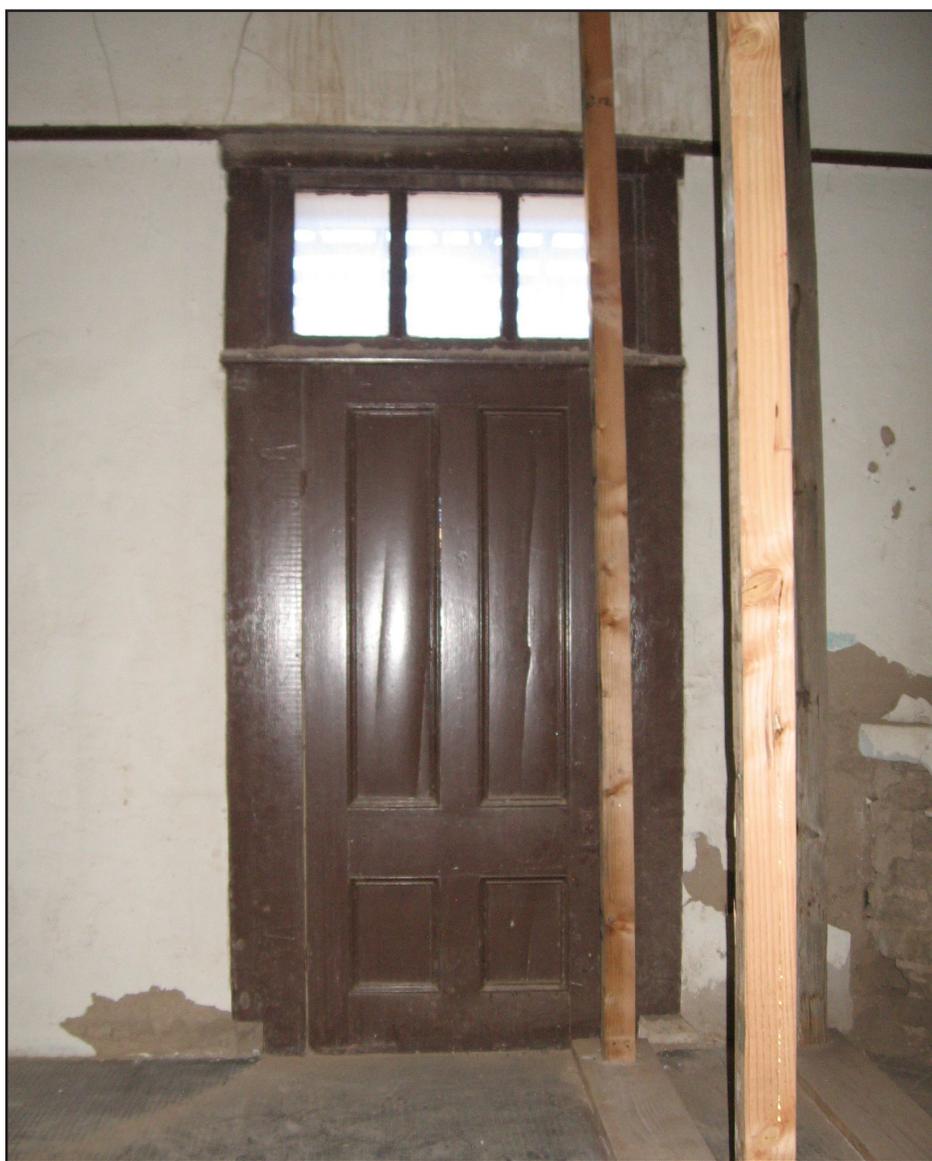
The exterior door from Bedroom 1 to the north appears to be original. This door appears to have been introduced in place of a window during the Cates time of use. The 1904 photo clearly shows the main entry on No. 3 with a window to each side. The exterior bead board detail could have been fabricated at the same time as the cabinets and the infill of the door between the dining and Bedroom No. 2. That would also account for the difference in the mullions between the main entry and this door – they are both as detailed on the HABS drawings, which would be correct because HABS would show all previous modifications. Johnson prepared rough floor plan sketches with his report of Officer's Quarters No. 4 and No. 5. No. 5 has the same floor plan as No. 3 – 3 doors along the south side and the one entry door at the north, with a window on each side of it. Further investigation will be required to determine if this opening originally contained a window. This door appears to have not been used recently and has no operating hardware, though hinges may be original. The panels on this door have dried out and cracked.

Figure No. 78 - Interior side of door at Bedroom 1

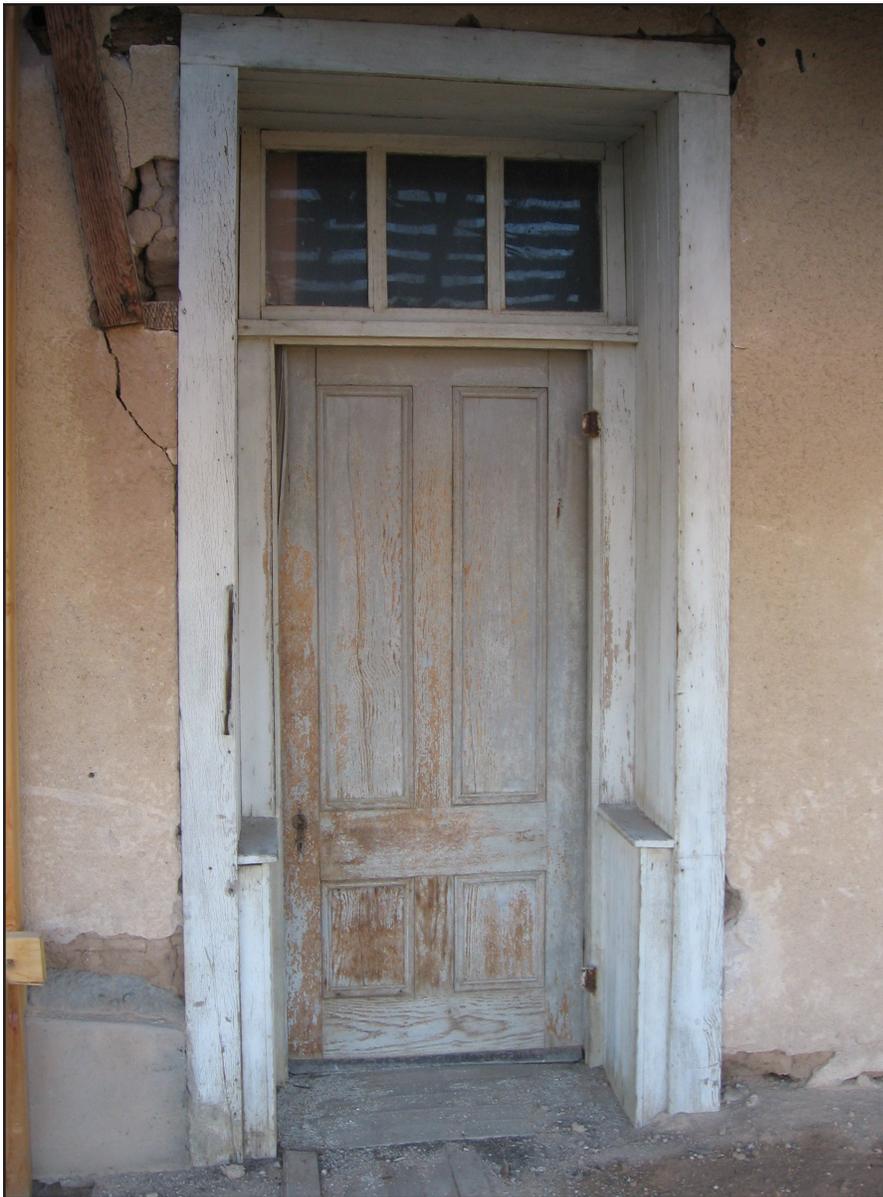
Figure No. 79 - Exterior entry door at Bedroom 1 with wainscot detail

Significance: High
Integrity: Low
Condition: Fair
Comments: None

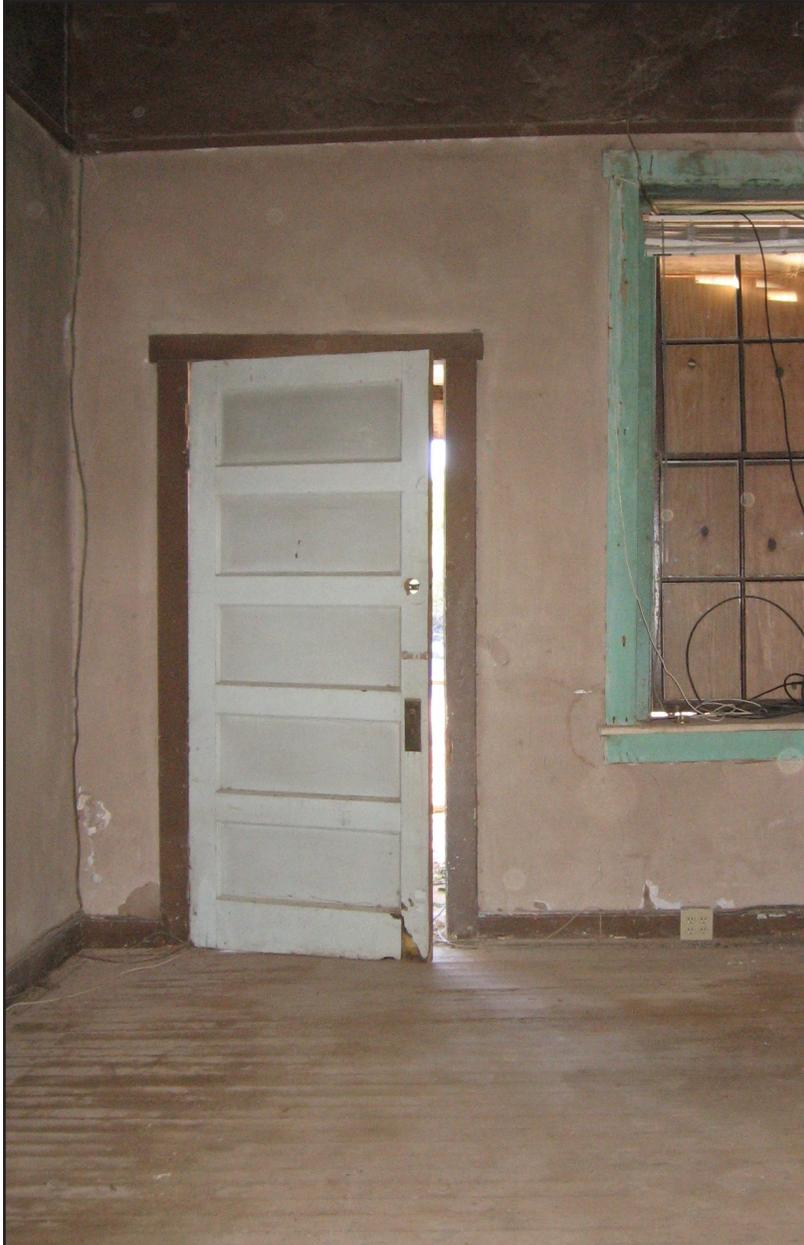
The door exiting the dining room is not original. It is a painted 5-panel, similar to that in kitchen.

Figure No. 81 - Door exiting Dining Room; the frame is original but the door is not

Condition: Fair

Comments: Replace with door to match original
