Officer's Quarters No. 1, 2 & 3

Adkins Steel Parcel

Building Condition Assessment Report

February 25, 2008

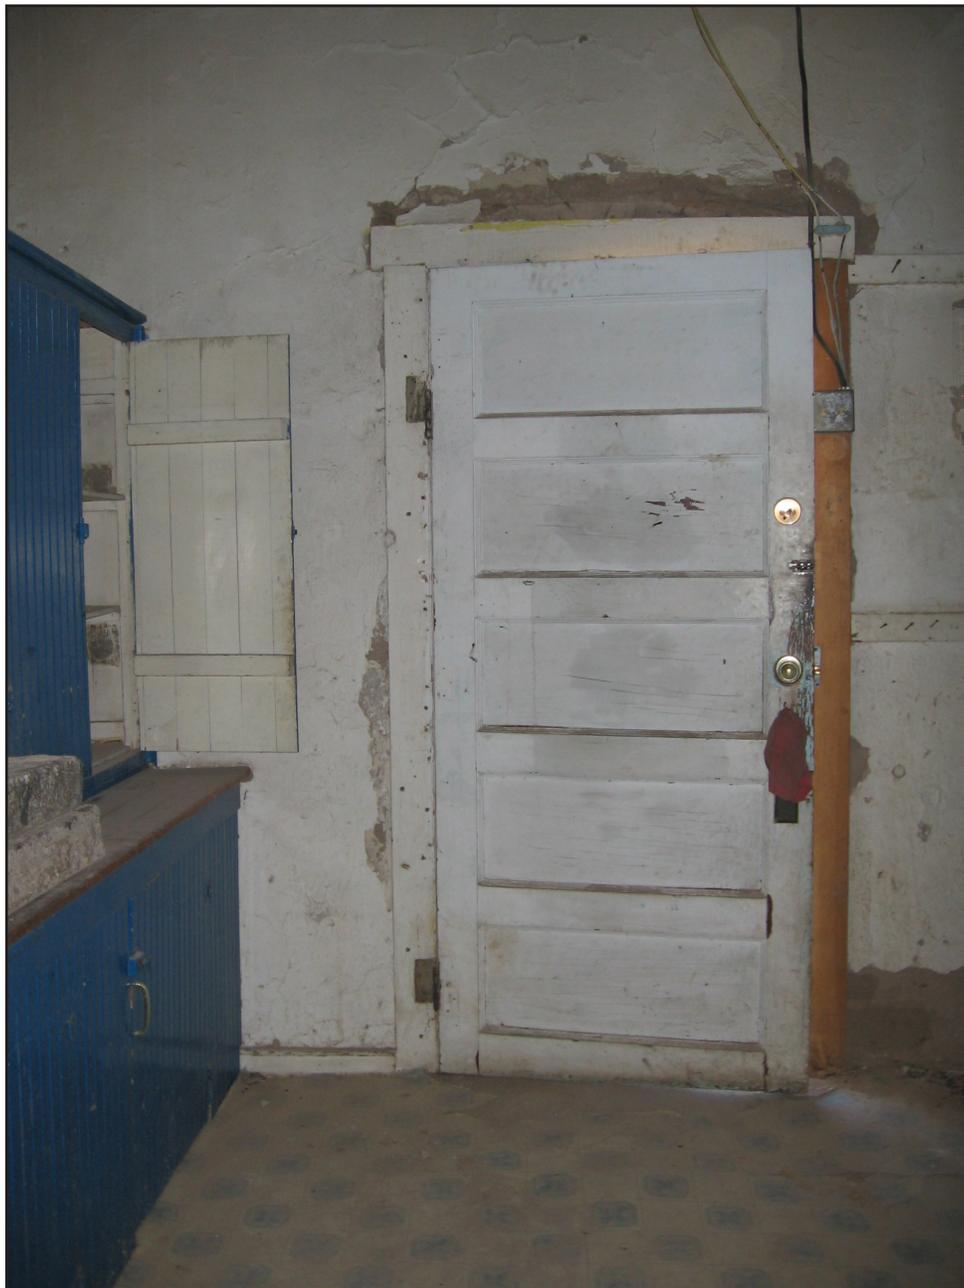
The door exiting the kitchen is similar to the one exiting the Dining Room, and does not appear original. It has been cut down from another opening and the original frame has been modified with raw lumber.

Figure No. 82 - Door exiting Kitchen; see lumber casing at right

Significance: High
Integrity: Low
Condition: Fair
Comments: Replace with door to match original

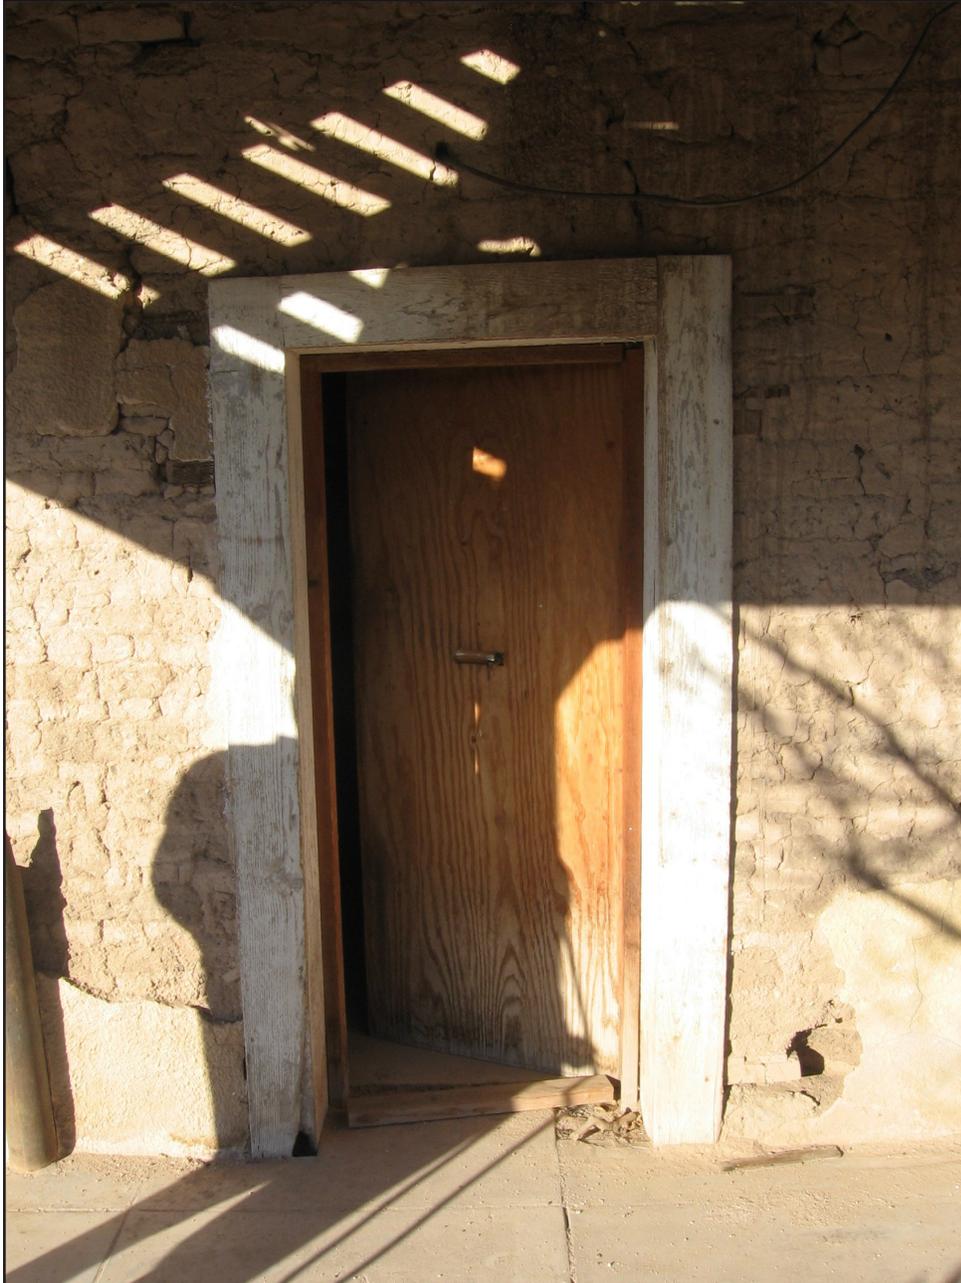
The door at the bathroom is made of plywood with a slide-handle bolt, fabricated by the Adkins family.

Figure No. 83 - Plywood bathroom door

Significance: Low
Integrity: Low
Condition: Fair
Comments: None

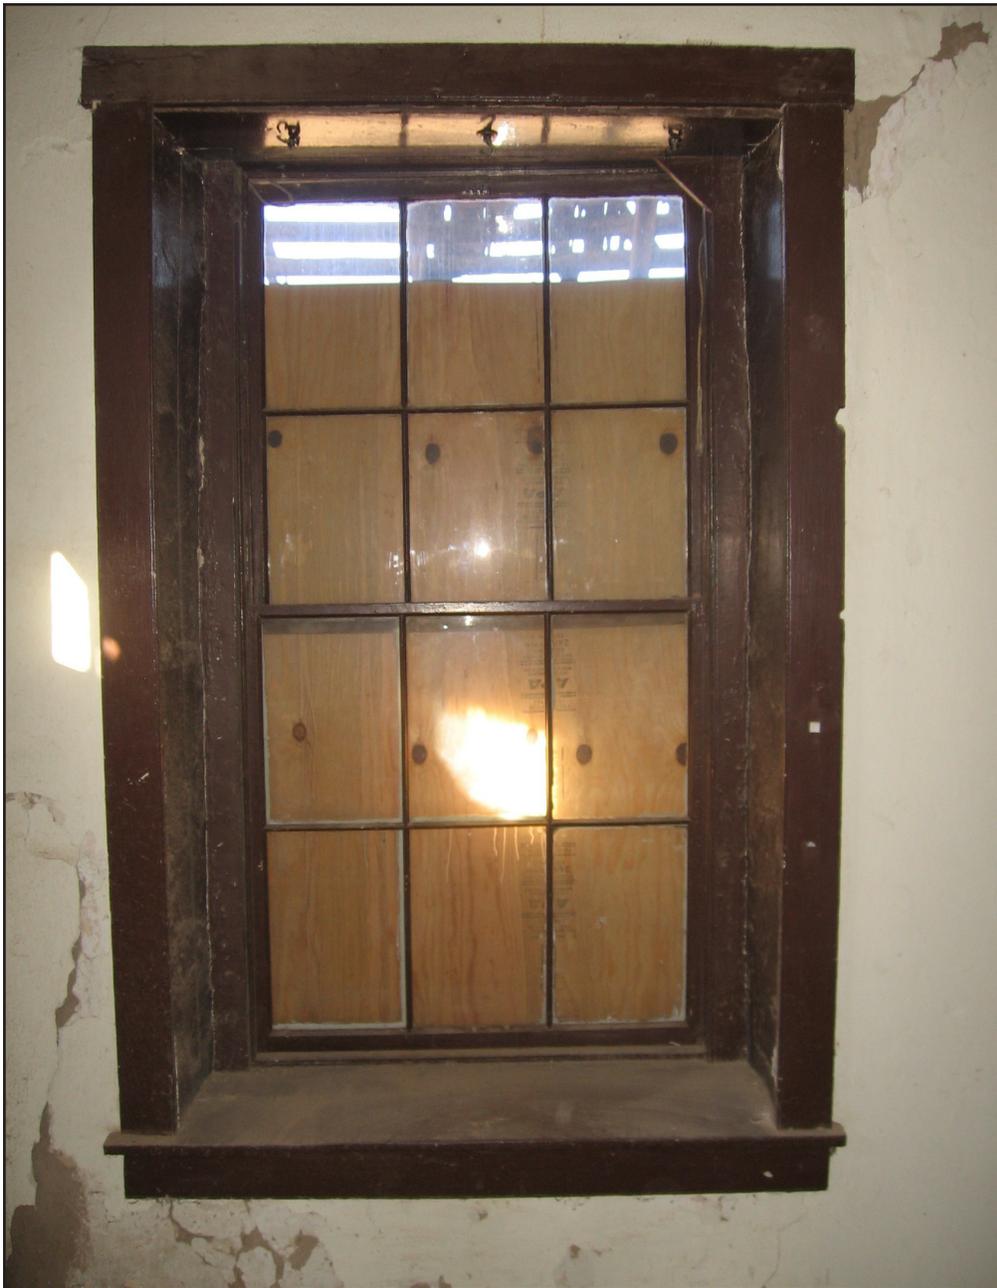
Figure No. 87 - Window looking north out of Living Room; of all the windows this one is the most historically complete

Significance: High
Integrity: High
Condition: Good
Comments: Minor repair needed

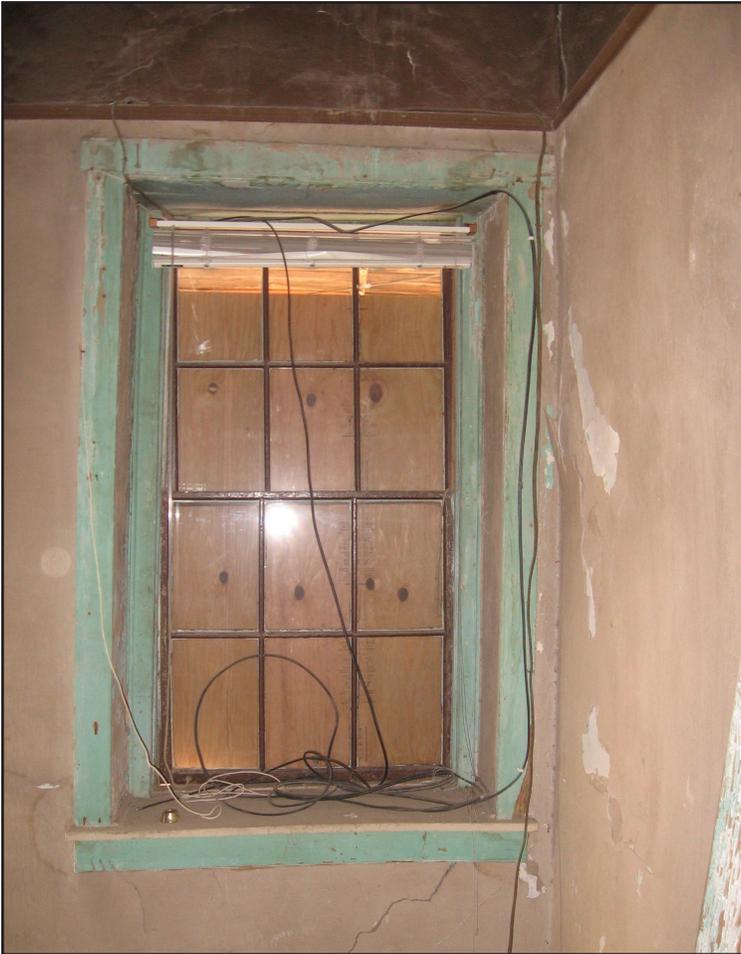
Figure No. 90 - Window at Dining Room looking south

Significance: High
Integrity: High
Condition: Good
Comments: Minor repair needed

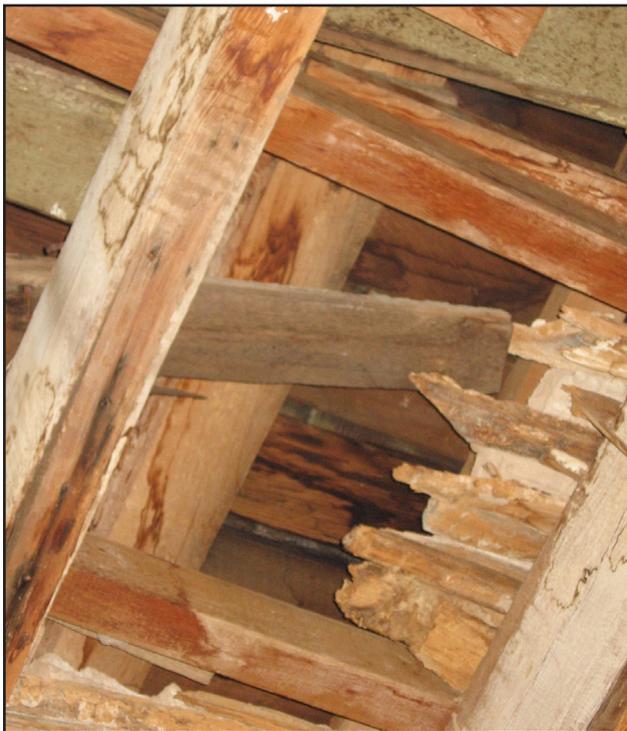
The main roof joists beams are supported by bearing on the adobe walls. The adobe walls are deteriorated and the bearing for some of the joists has given way. Several of the roof areas are currently being temporarily shored to prevent them from collapsing. None of the existing roof framing meets code requirements for example the framing is not tied to the top of the wall, inconsistent fastening of framing members and there is also additional loads that the roof framing and walls should not be supporting. The entire roof and roof framing should be removed and reconstructed.

Figure No. 91 - Beams with latillas and planks visible from below

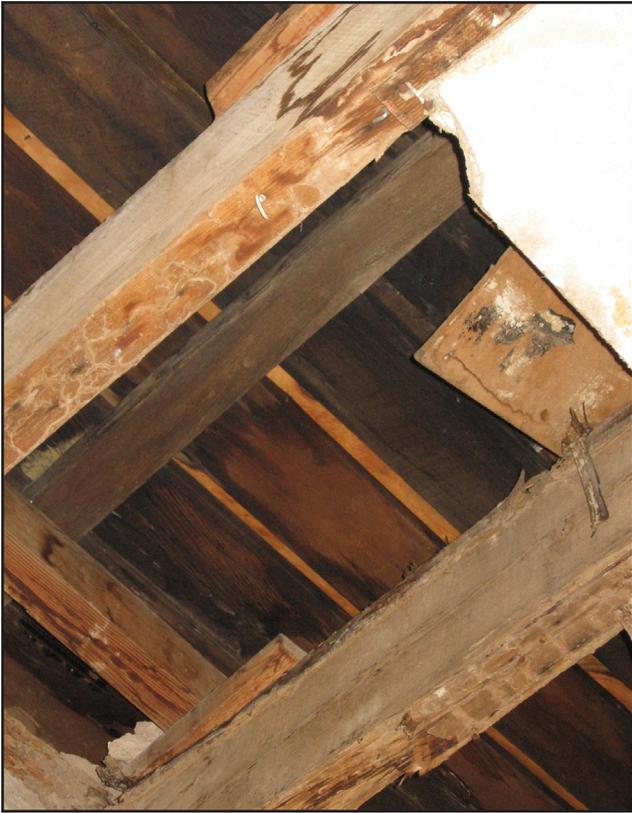
Figure No. 92 - Underside of top layer of decking supporting the final roof membrane

Significance: Medium
Integrity: Low
Condition: Poor
Comments: None

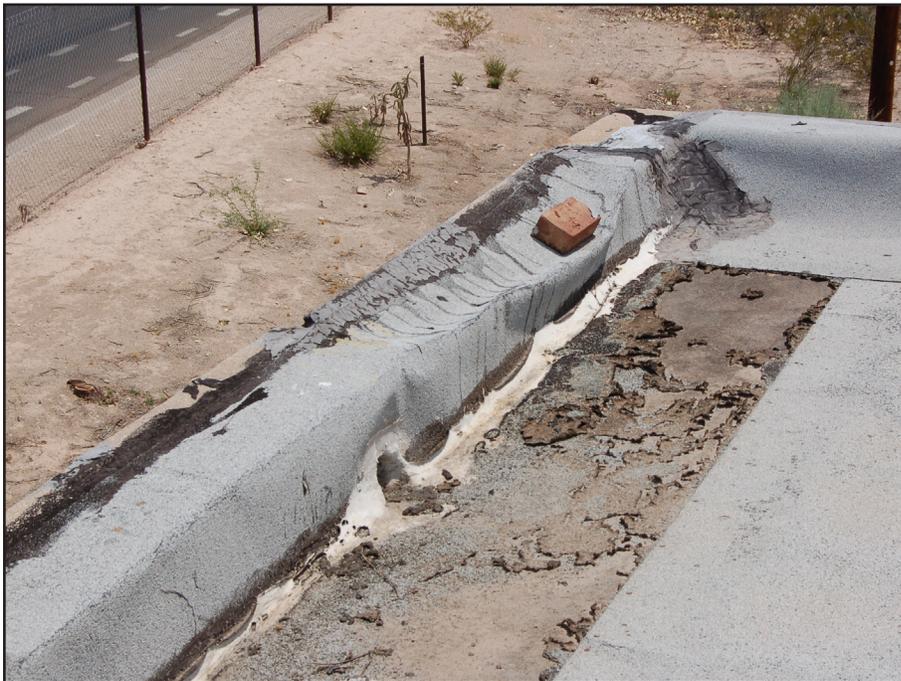
The tops of the walls had the cast concrete parapet caps as occurred on Officer’s Quarters No. 2. The flashing that they had held in place on No. 2 and had probably been removed previously from No. 3.

Figure No. 93 - Parapet with concrete caps removed

Condition: Temporarily stabilized

Comments: Replace roof after structure has been repaired/replaced

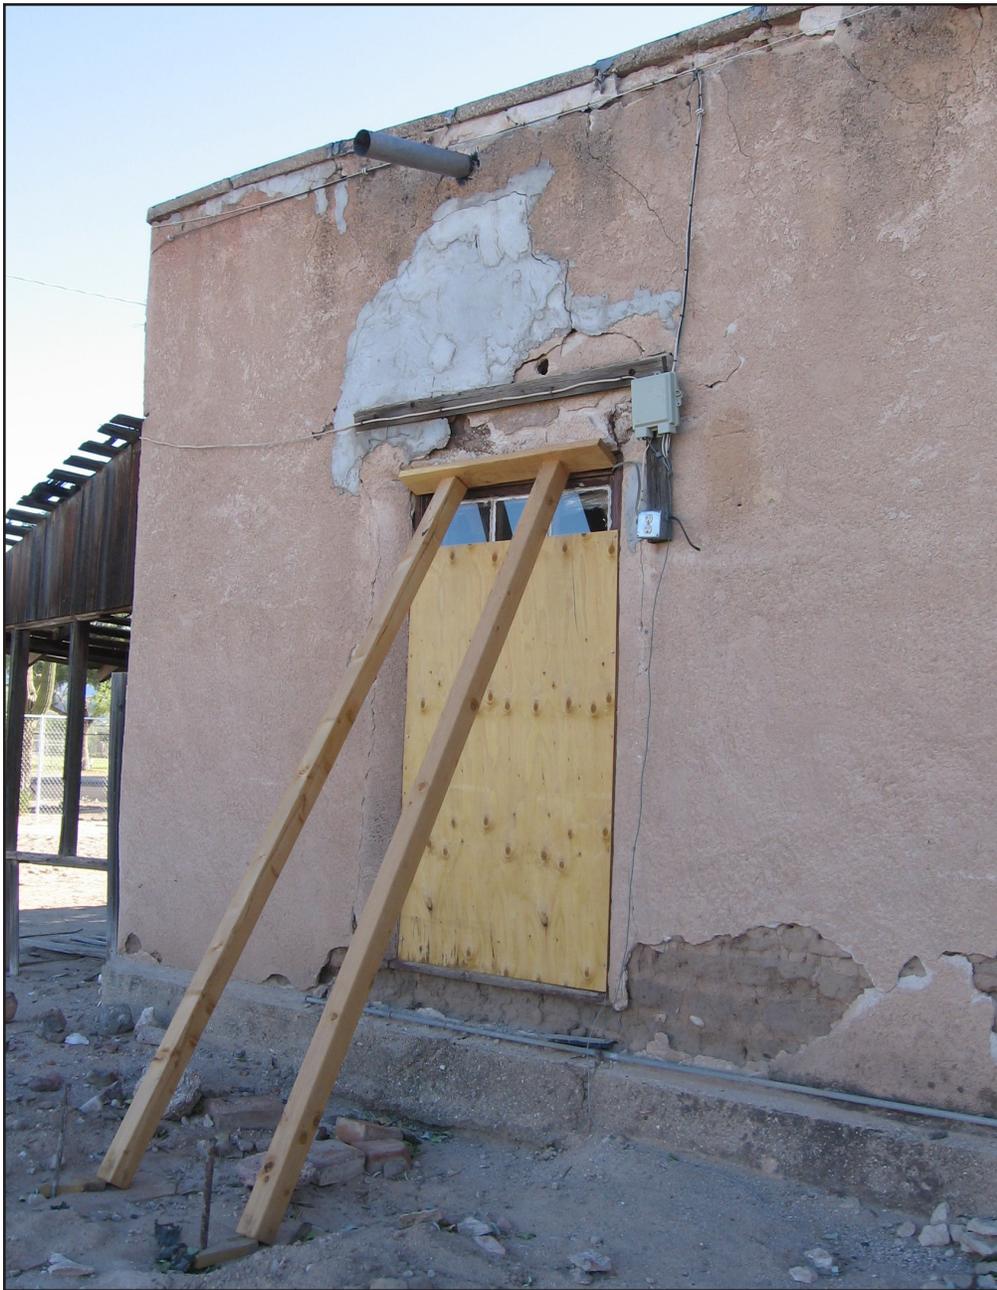
There are four pipe canales each on the west and east elevations, 4" diameter steel sheet metal or cast iron, projecting from wall 10" or more. The roof side of the canales is just at or above the roof surface and the emulsion coating runs into them. The one at the north-west corner of the house has been problematic for years – the wall is nearly eaten through on the interior above the window due to moisture intrusion, the lintel is collapsing, and there are cement patches over the window at the exterior.

Figure No. 95 - Exterior showing recently extended canale with concrete patch below and braces

Significance: High
Integrity: Low
Condition: Poor
Comments: None

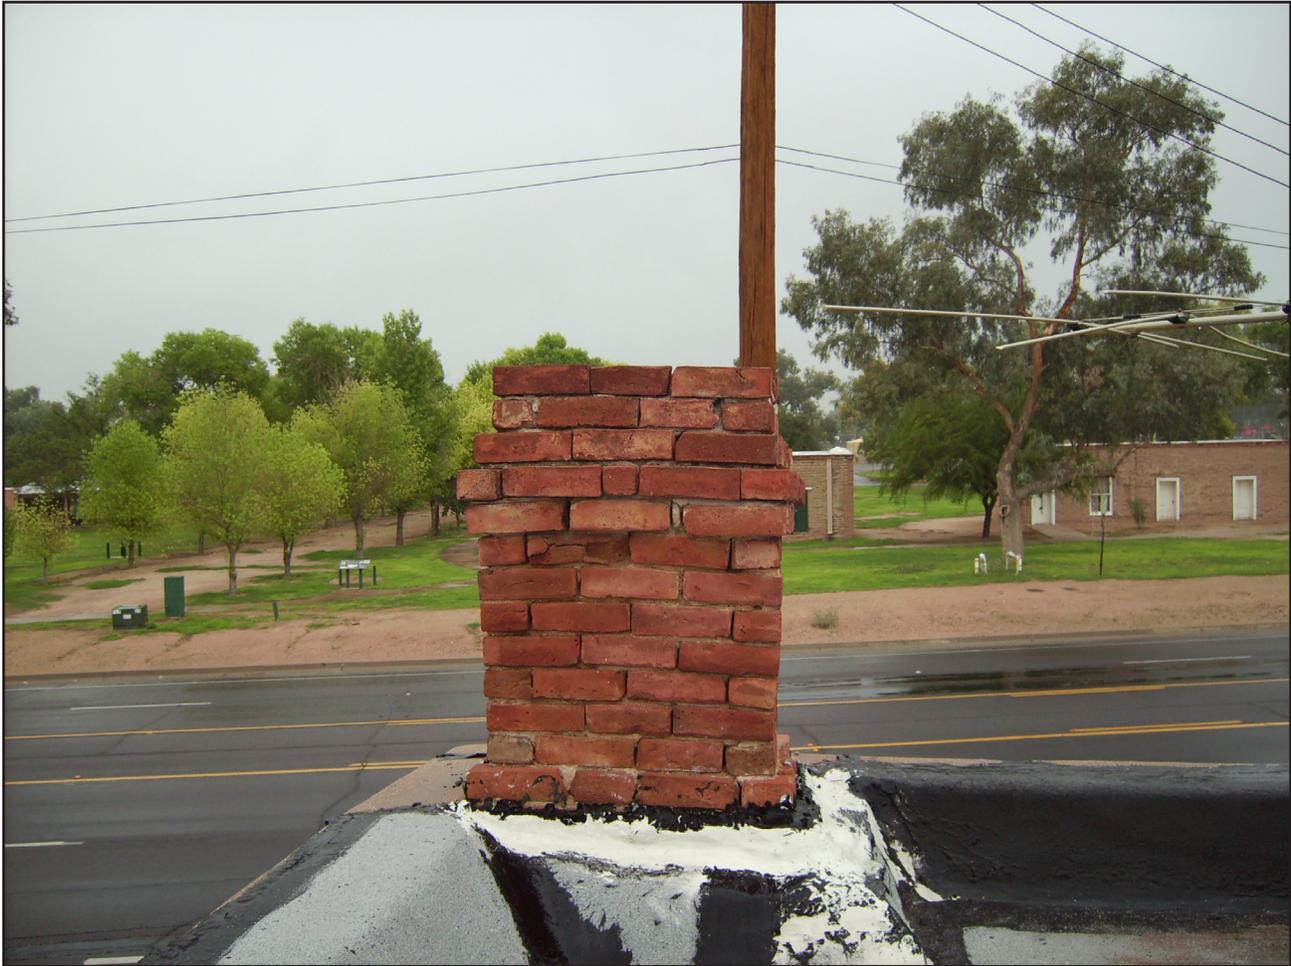
The existing chimneys have been removed and their constituent bricks stacked on a slab next to the building. The chimneys were fabricated from a local, smooth faced red brick 8-3/8" x 2-3/8" x 4 (Pictures – west elevation and – south elevation). See original locations on the roof plan.

Figure No. 96 - Chimney at northeast corner of house prior to removal

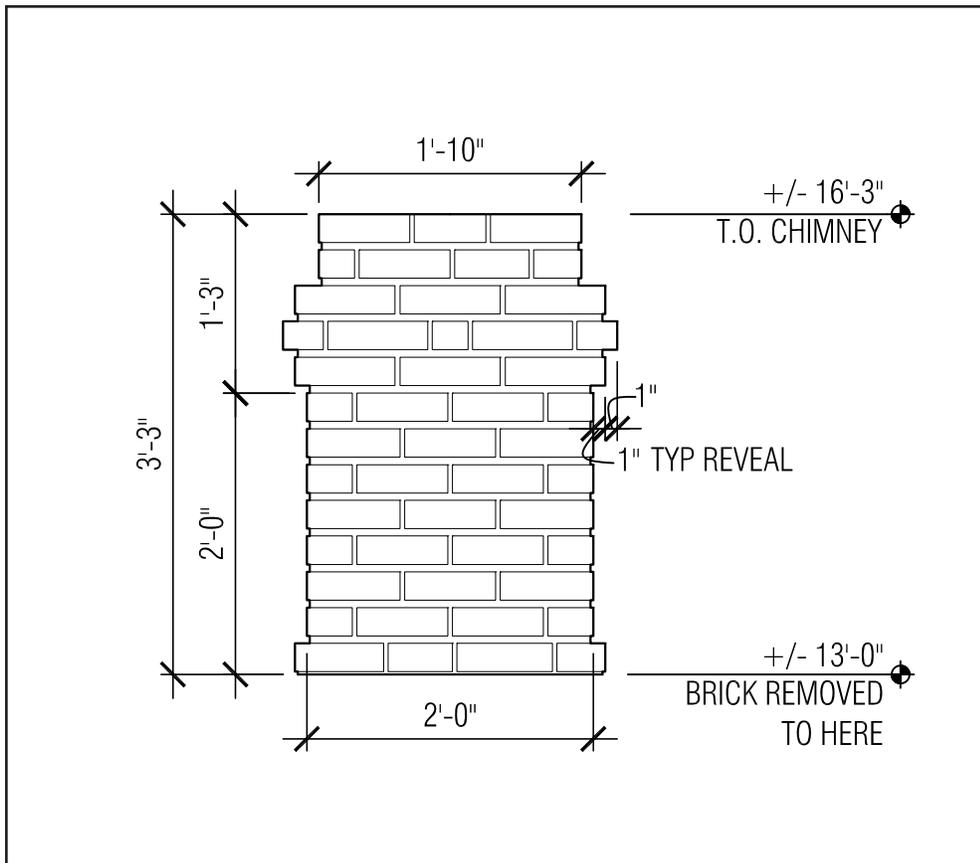
Figure No. 97 - Documentation of chimney for reconstruction

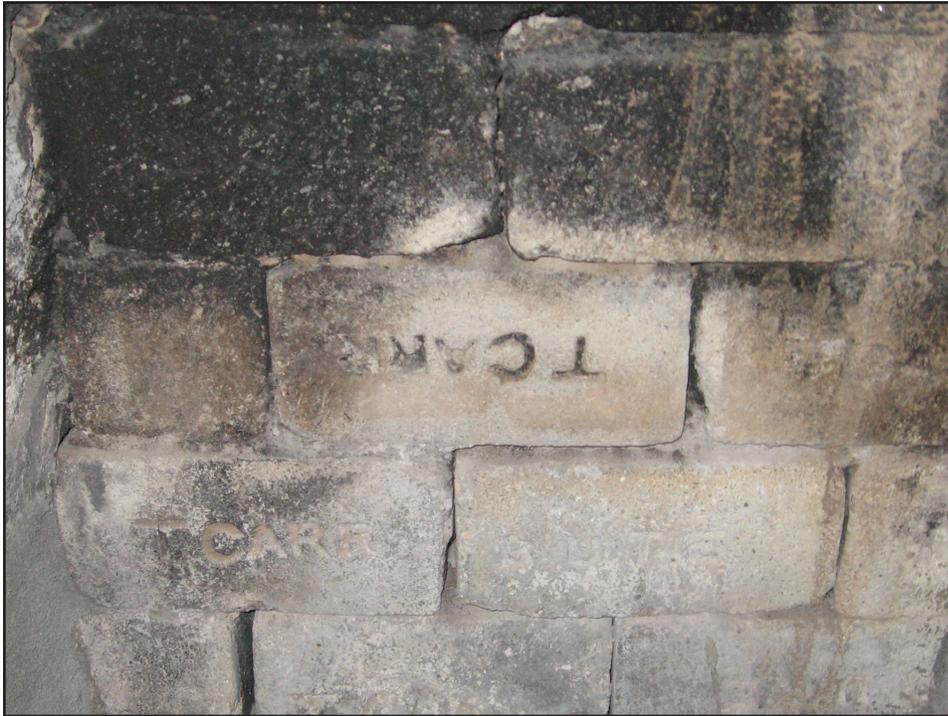
Figure No. 99 - Brick in rear of fireplace at Bedroom 2 with stamped mark "TCARR" - imported from England see Figure No. 100

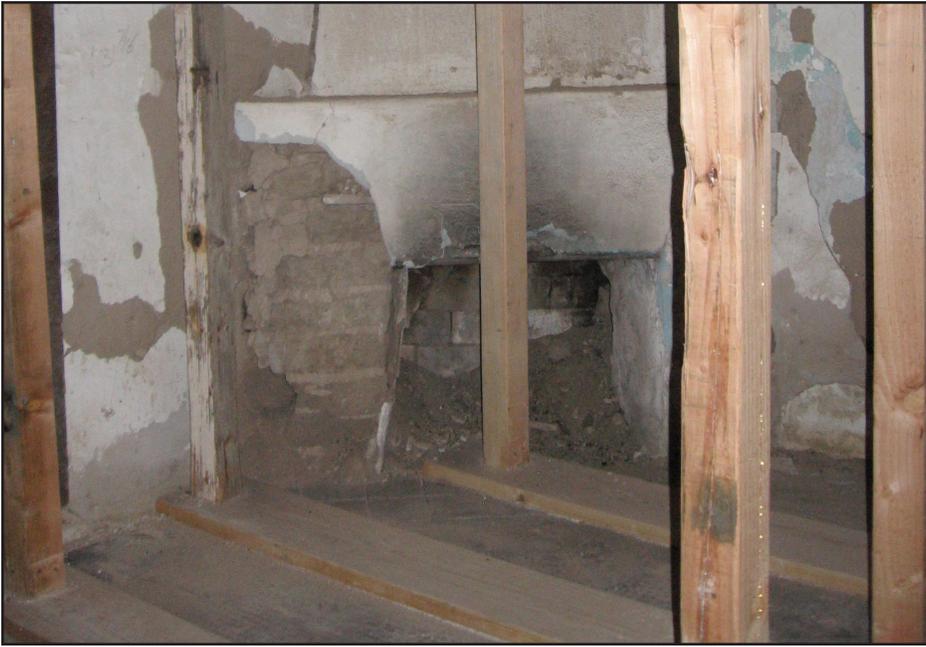
Figure No. 101 - Chimney at Bedroom 1 with exposed adobe and some patching; bracing was placed during stabilization to support ceiling

Significance: High
Integrity: Medium
Condition: Poor to fair
Comments: Fireplaces can be restored to original condition

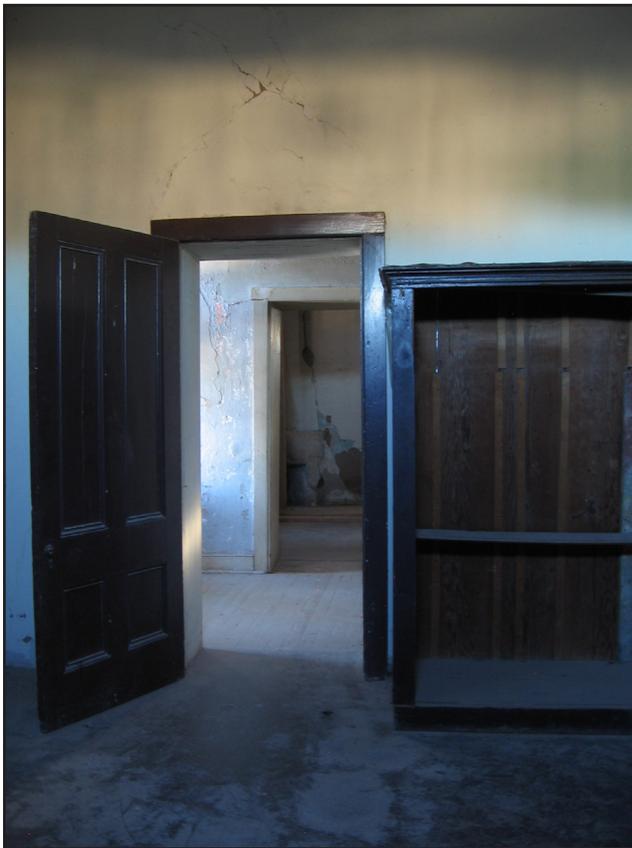
Between Living Room and Zaguan – stained, original hinges; lock altered

Figure No. 105 - Door between living room and zaguan

Condition: Fair to good

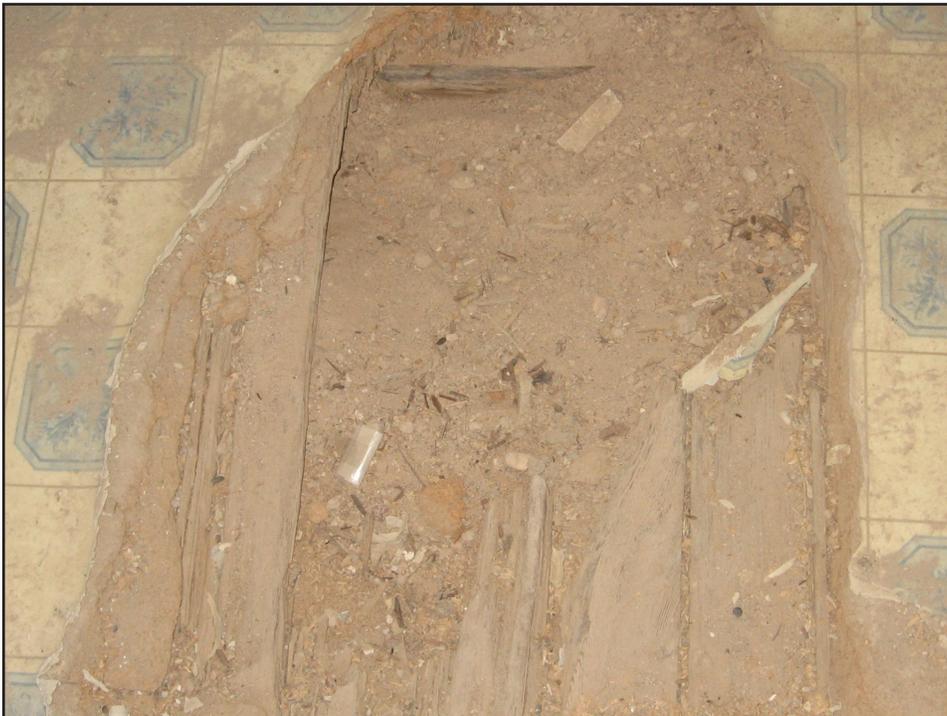
Kitchen and Pantry – particleboard laid over the wood flooring with sheet vinyl over that, all in poor condition.

Figure No. 106 - Sheet vinyl flooring in kitchen over particleboard with the original wood floor visible below, with sleeper on dirt running crosswise at top

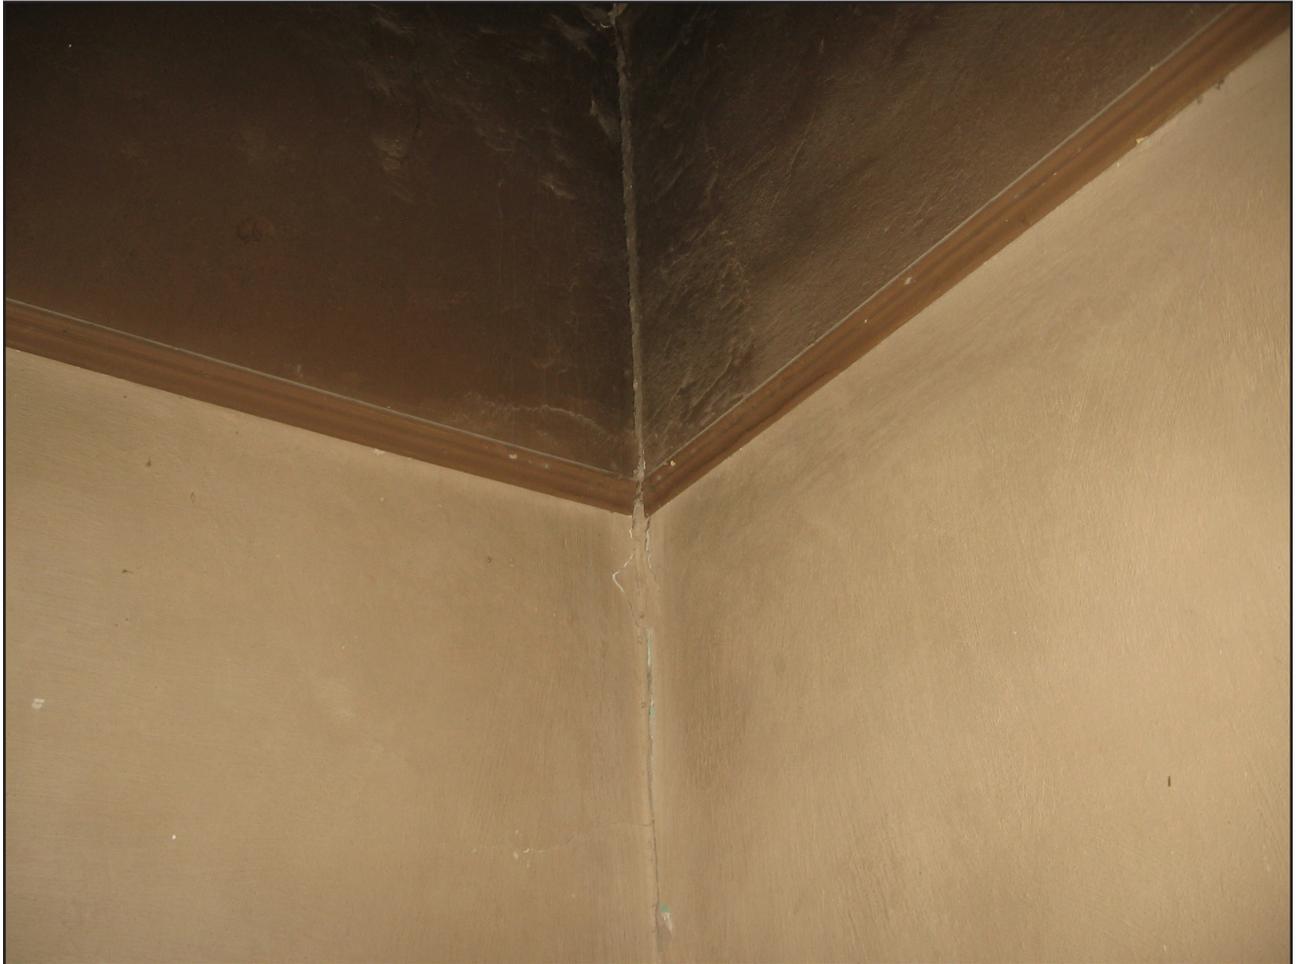
Figure No. 108 - Picture molding at Dining Room; below is the finish applied in the 1970s; date of rail installation unknown

Significance: High
Integrity: High
Condition: Good
Comments: None

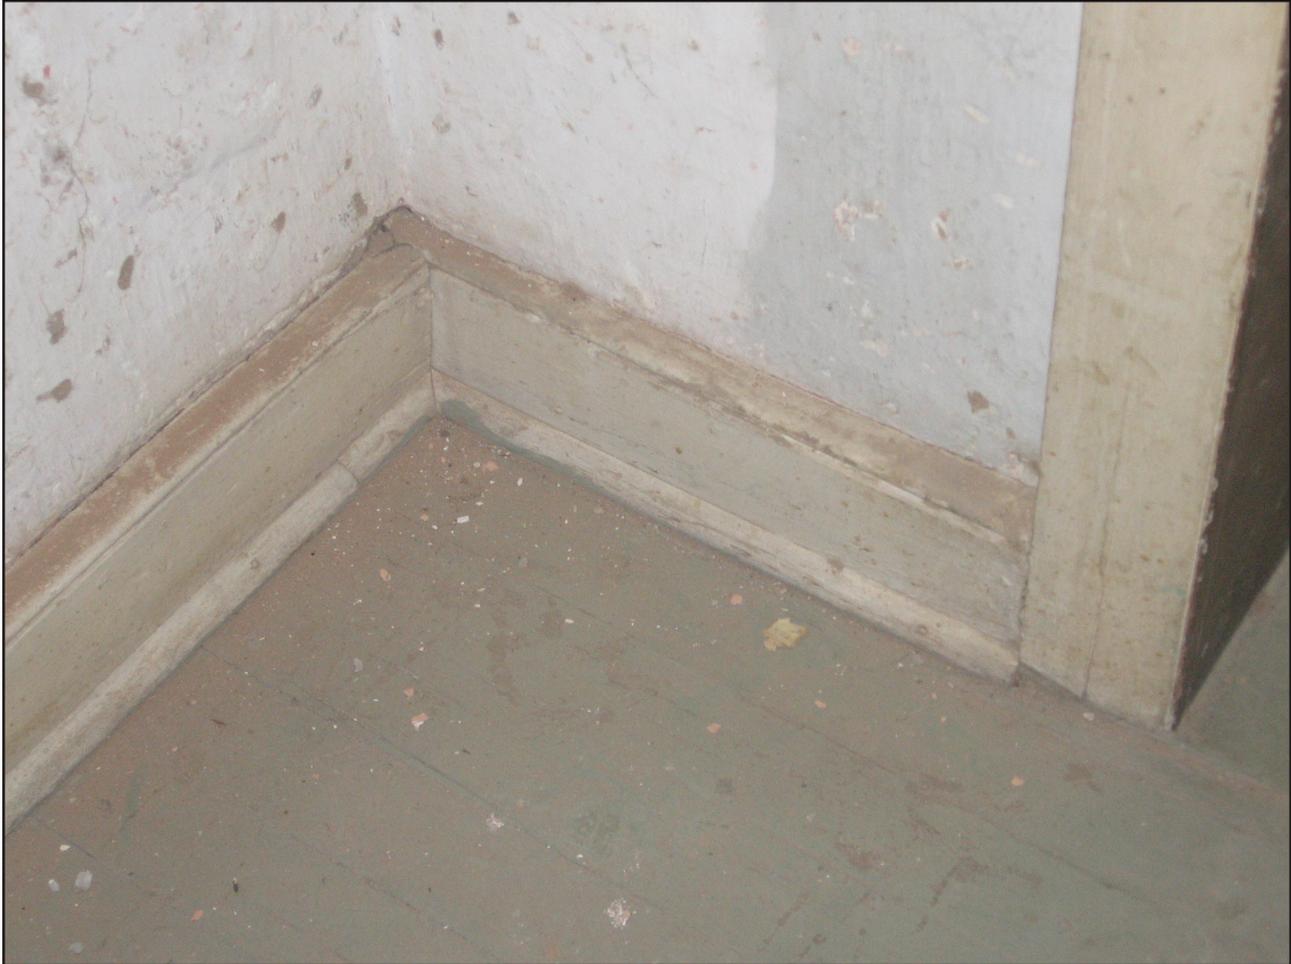
Wood base, 4-3/4" high with a beaded (rounded) top and a quarter round at the bottom, exists at the Dining Room, portions of Bedroom 2, the Zaguán, and partially covered by the addition of particleboard and vinyl flooring at Kitchen and Pantry, and is configured as detailed on the HABS drawings. There is no base in the Living Room or Bedroom 1.

Figure No. 109 - Wood base in Zaguán

Significance: High
Integrity: Low to high
Condition: Poor to good
Comments: None

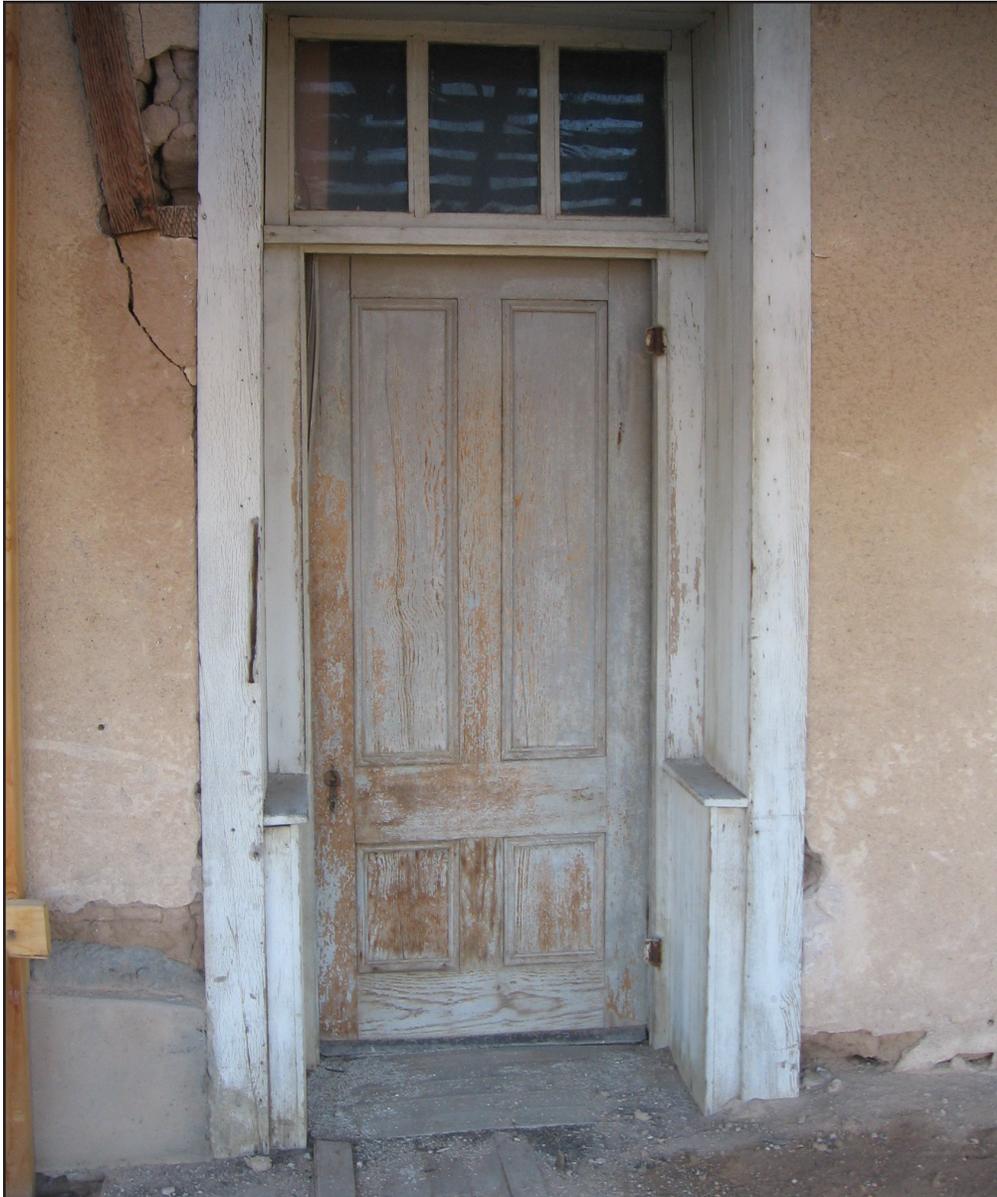
An interesting detail is the wainscot with beadboard that occurs at the exterior entry to Bedroom 1. This door opening is probably not from the Fort Lowell era and replaced a window. The beadboard could have been built with the remainder of the beadboard cabinetry inside the house. The door may have been relocated from either the Kitchen or Dining Room which know have non-original doors.

Figure No. 110 -
Beadboard wainscot
at exterior of entry
door to Bedroom 1

Condition: Good

Comments: Depending on era of significance to which the building is restored, this door may be replaced with a window

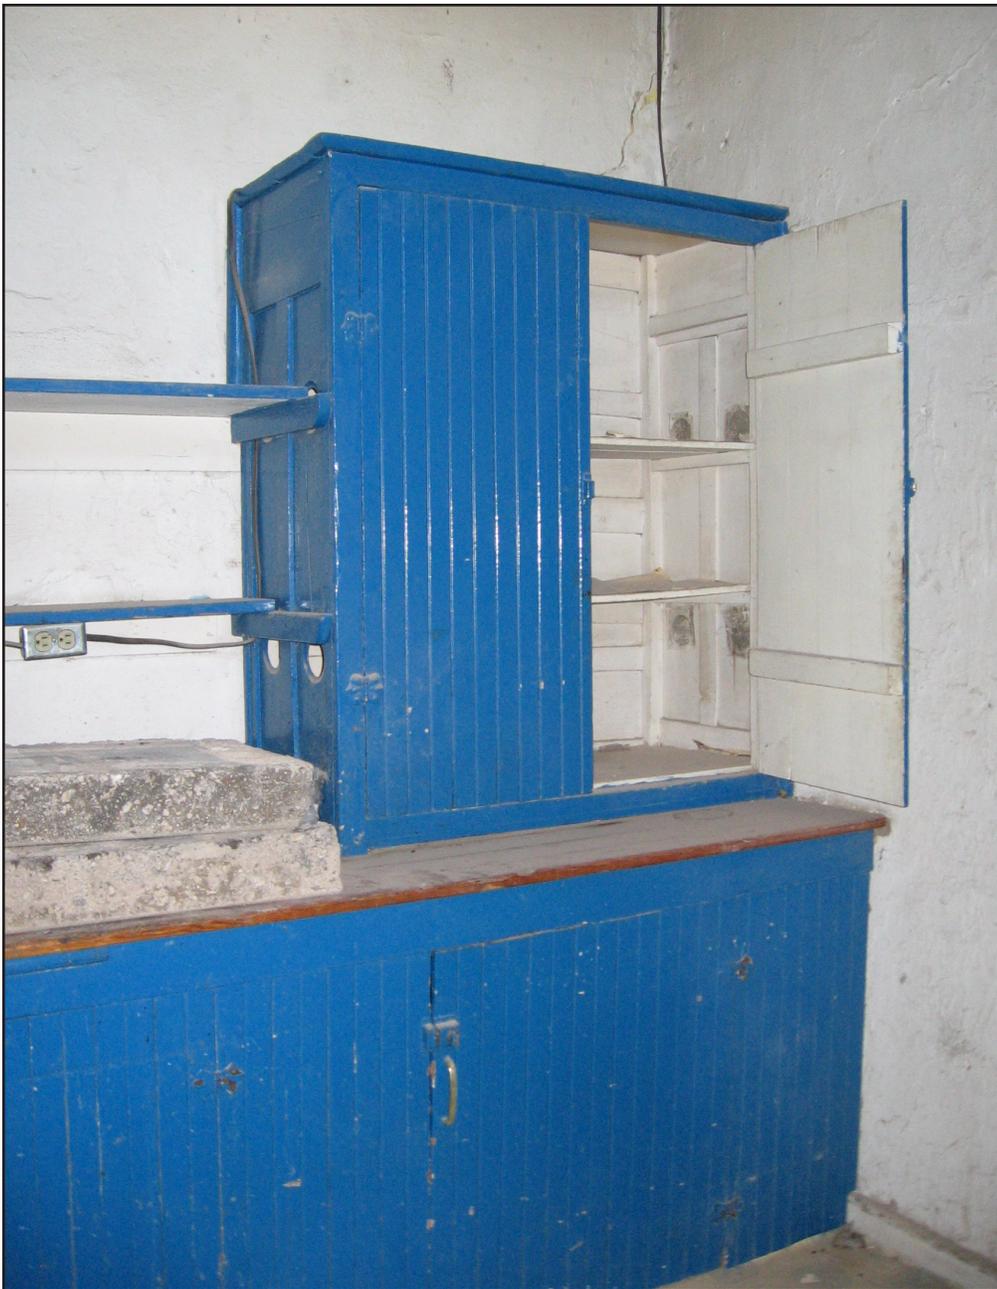
Figure No. 111 -
Typical cabinet at
Kitchen with wood
countertop

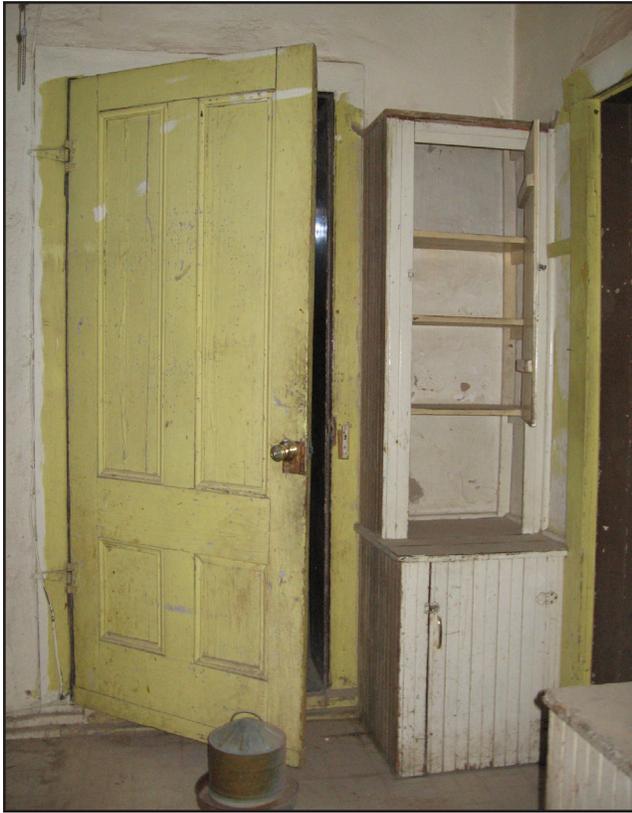
Figure No. 112 - Corner cabinet in Pantry; similar corner cabinet is visible at lower right

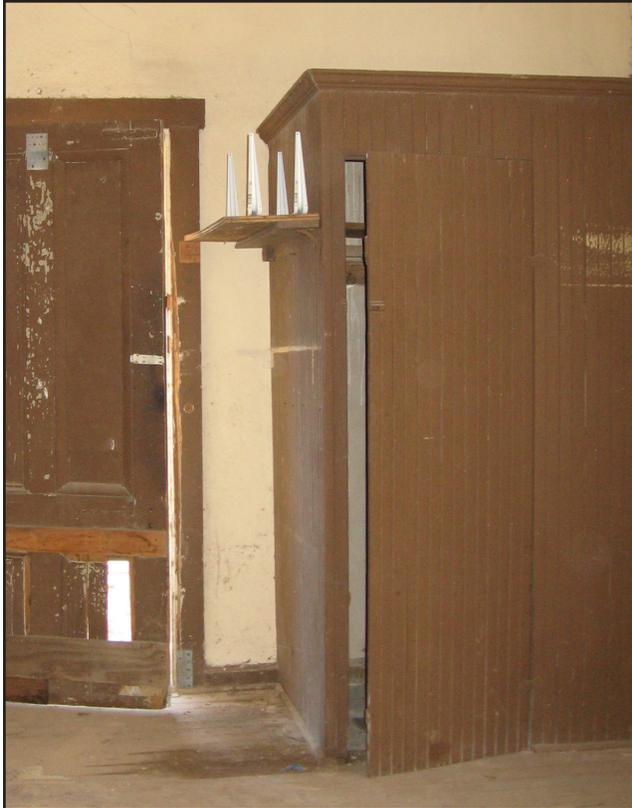
Figure No. 113 - Beadboard closet at Bedroom 2

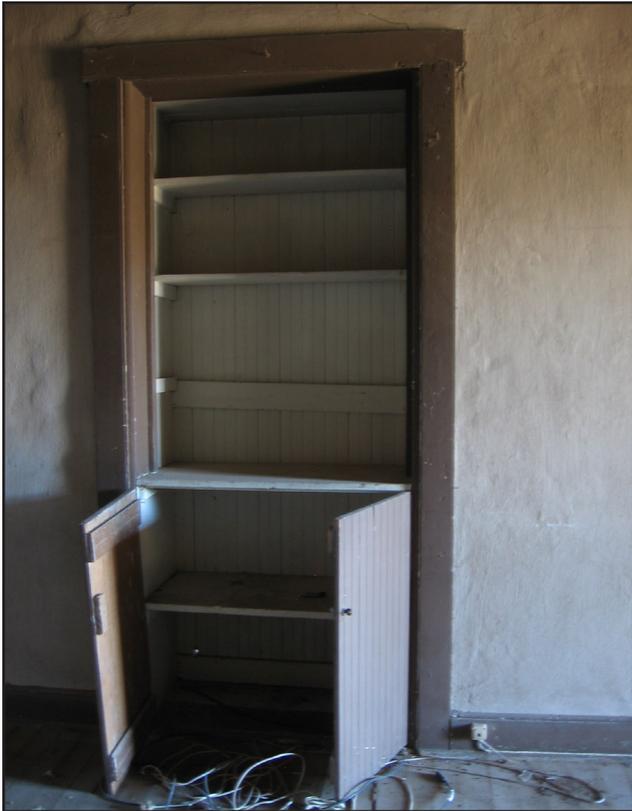
Figure No. 114 - “China Case” at dining room

It may be speculated, since the construction of all the beadboard cabinetry is very similar to the china case, that all the beadboard cabinetry, as well as the beadboard wainscot at the Bedroom 1 entry, may be attributed to the same time period, noted by the HABS drawings to be circa 1909 or 1910 (we do not know how this was determined). The HABS drawings do not show the other cabinetry, but that may be because it was not considered by them to be “built-in”. Architectural drawings will often only show “built-in” cabinets and omit things that could be put in place after construction has been completed.

Significance: Low
Integrity: Low
Condition: Good
Comments: None

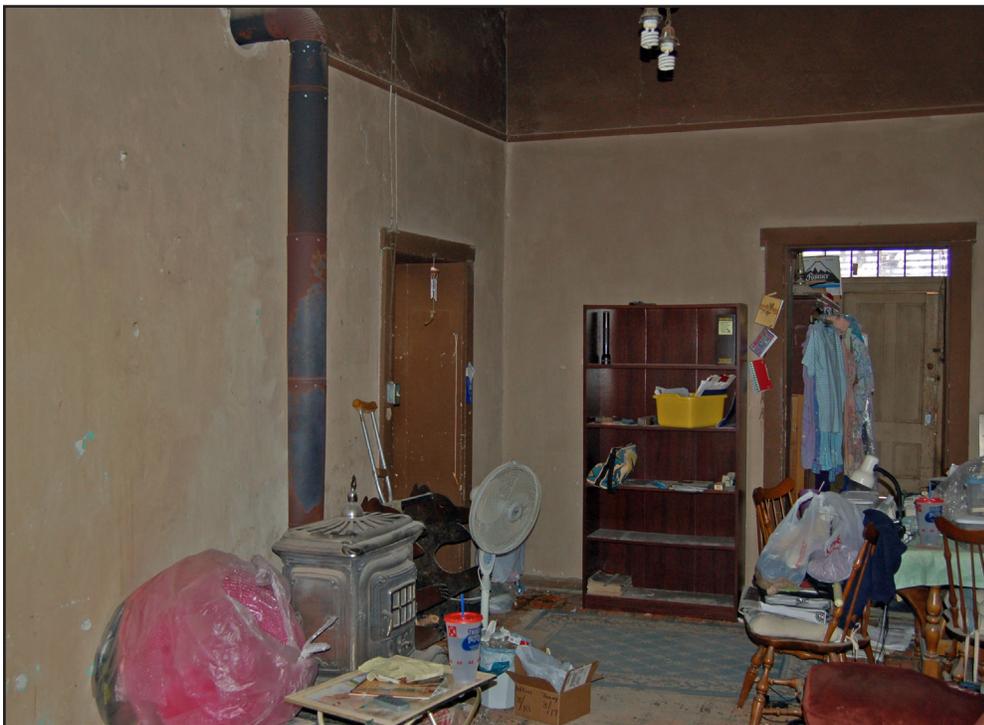
Figure No. 115 - Non-original stove in Dining Room

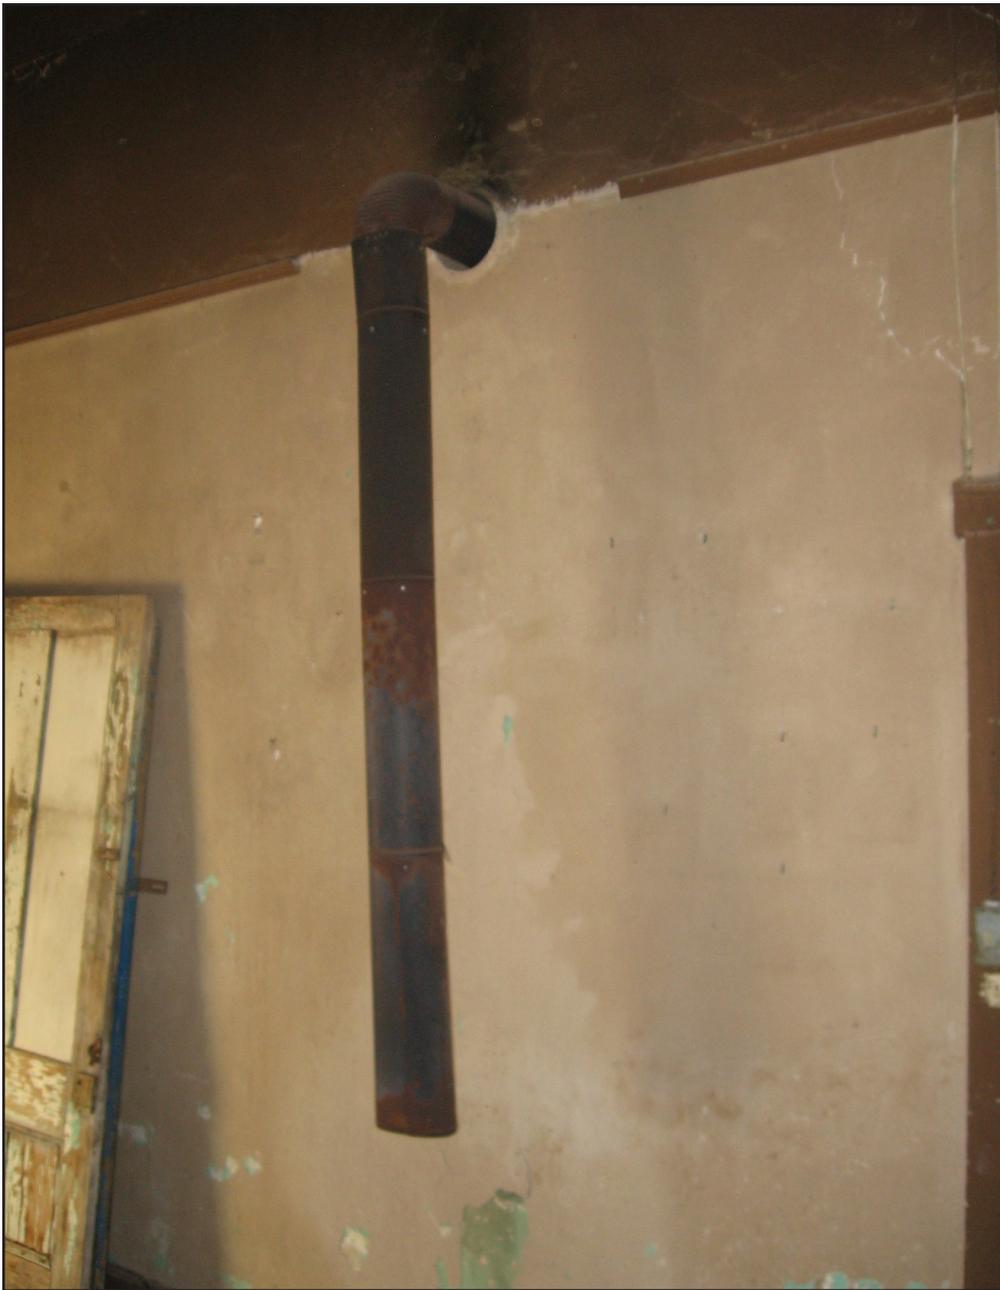
Figure No. 116 - Remaining flue from stove as it exists; also two interior doors are stacked at left
