Officer's Quarters No. 1, 2 & 3

Adkins Steel Parcel

Building Condition Assessment Report

February 25, 2008

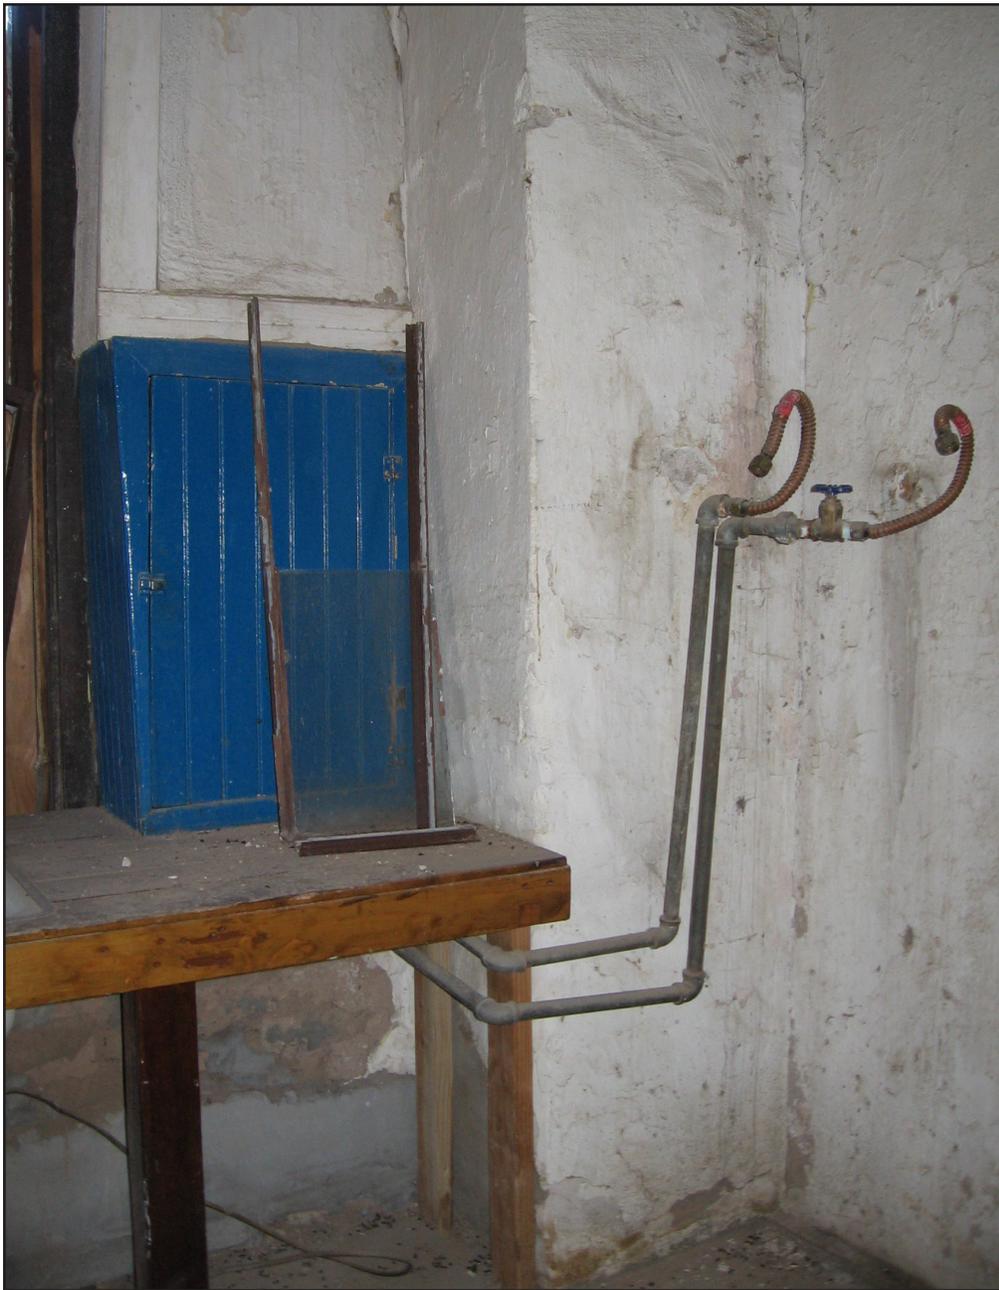
Figure No. 117-
Piping in northwest
corner of Kitchen
previously serving the
water heater

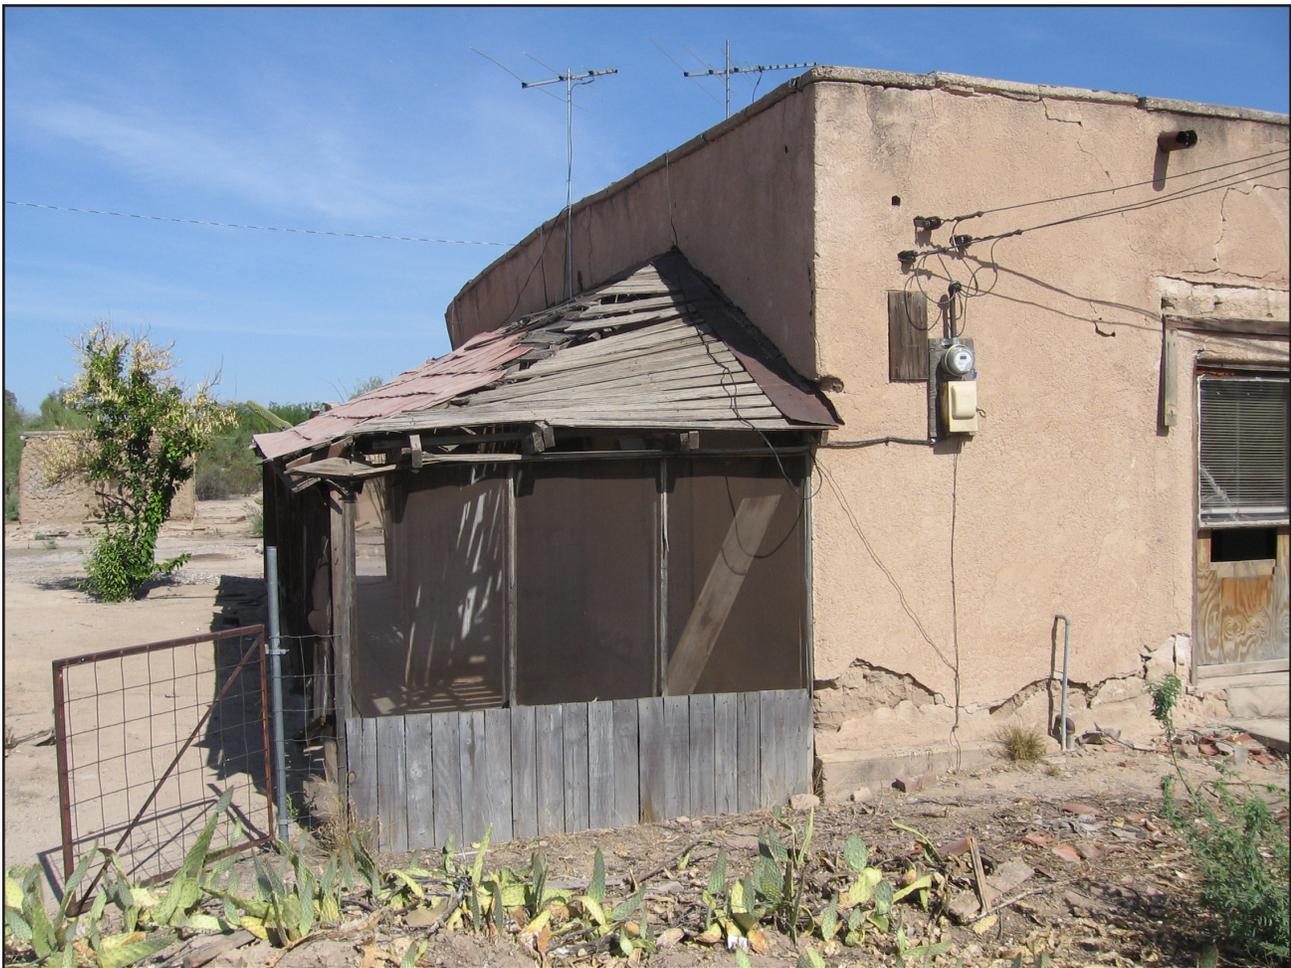
Power and Distribution: The electrical service to the building is an overhead drop, with the metal brackets to support the overhead drop secured to the wood frame work through the exterior finish. The service is 120/240 volt – 1 Ø and fused at 50 amps. The disconnect switch is locked off by T.E.P. It is located on the east side of the building at the south end and is located over 8 feet above the ground. It is not over 30 years old based on the style of the disconnect switch and the condition of the metal exterior surface. The service feeds a single 6 circuit, screw-in fuse panel that is located on the south wall at the east corner and the front cover is missing. It is located over 7 feet above the floor. It is hard to judge the age of this type of fuse panel and all of the wiring is non-metallic sheathed type, but varying in age from cloth to neoprene type jacketing.

Figure No. 118 - Electrical service connection; note remaining paneling on porch similar to that shown in photograph of side porch at Officer's Quarters No. 2 (no longer exists)

Comments: All services will have to be replaced with new if the building use requires power or communications

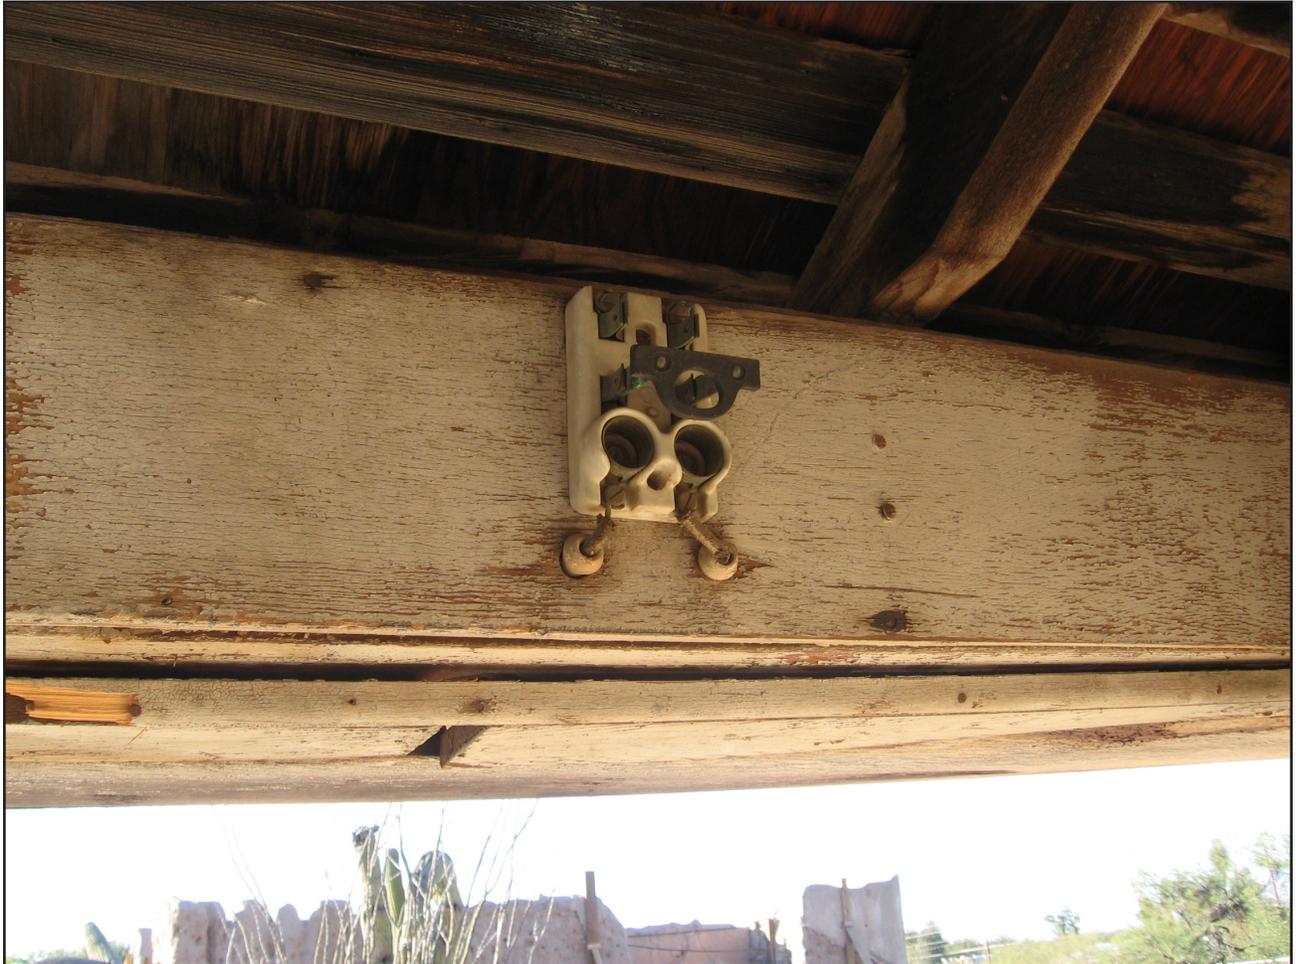
The wiring throughout the building and cover porch varies from different versions of knob and tube type (K&T) wiring, which probably dates back to Miss Cate's sanatorium, in the early 1900's, to different types of nonmetallic sheathed cable (NMC). In some instances the NMC wiring is connected to the older K&T to complete a circuit. It does not appear that any metal conduit or cabling was used for wiring the building.

Figure No. 119 - Knob and tube equipment on rear porch

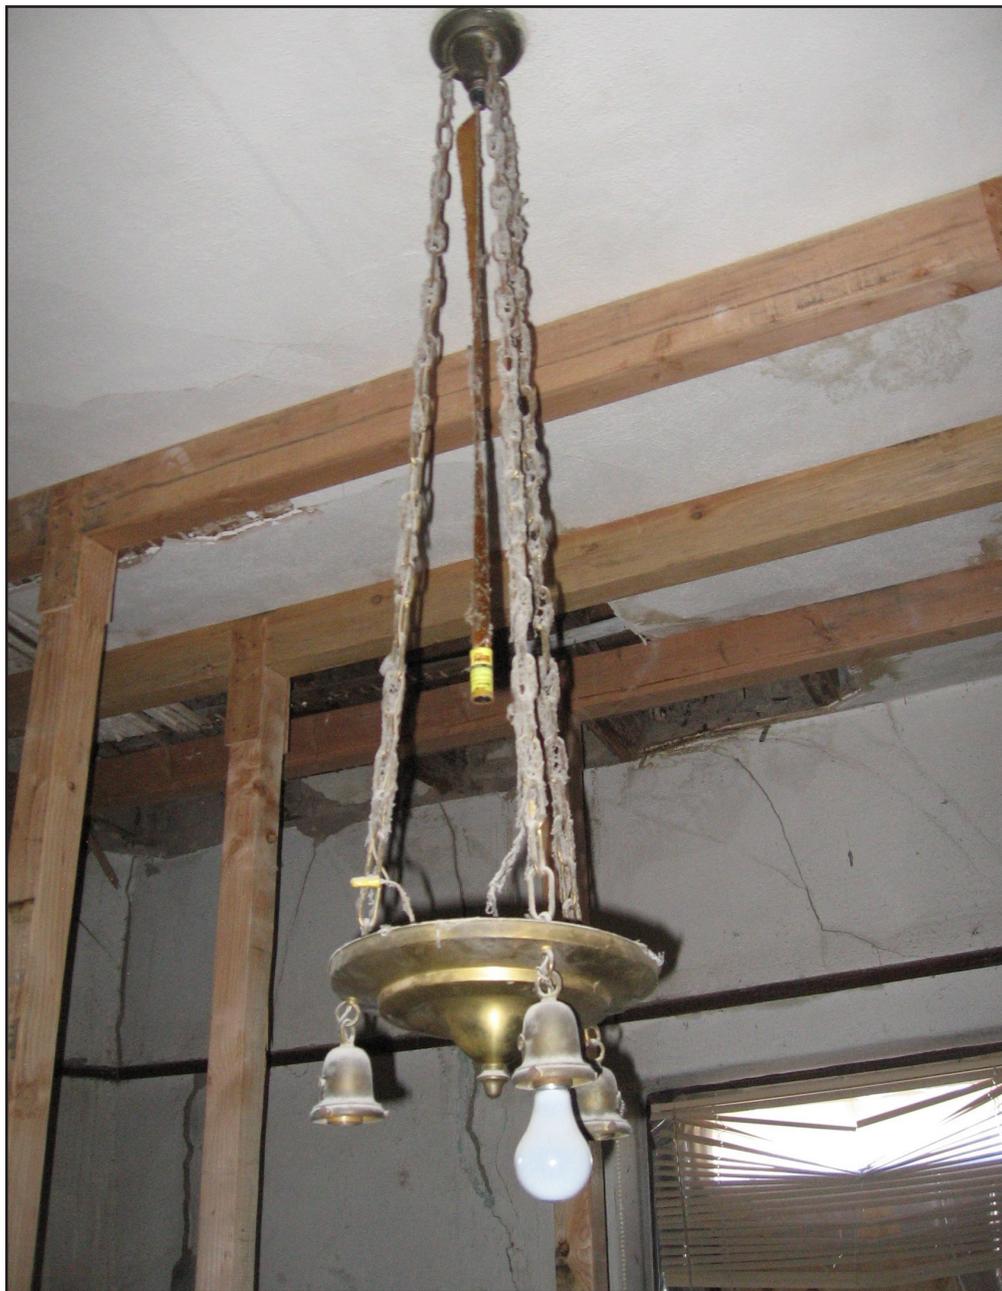
Figure No. 120 - Brass fixture in bathroom 1; probably 1930s or 1940s

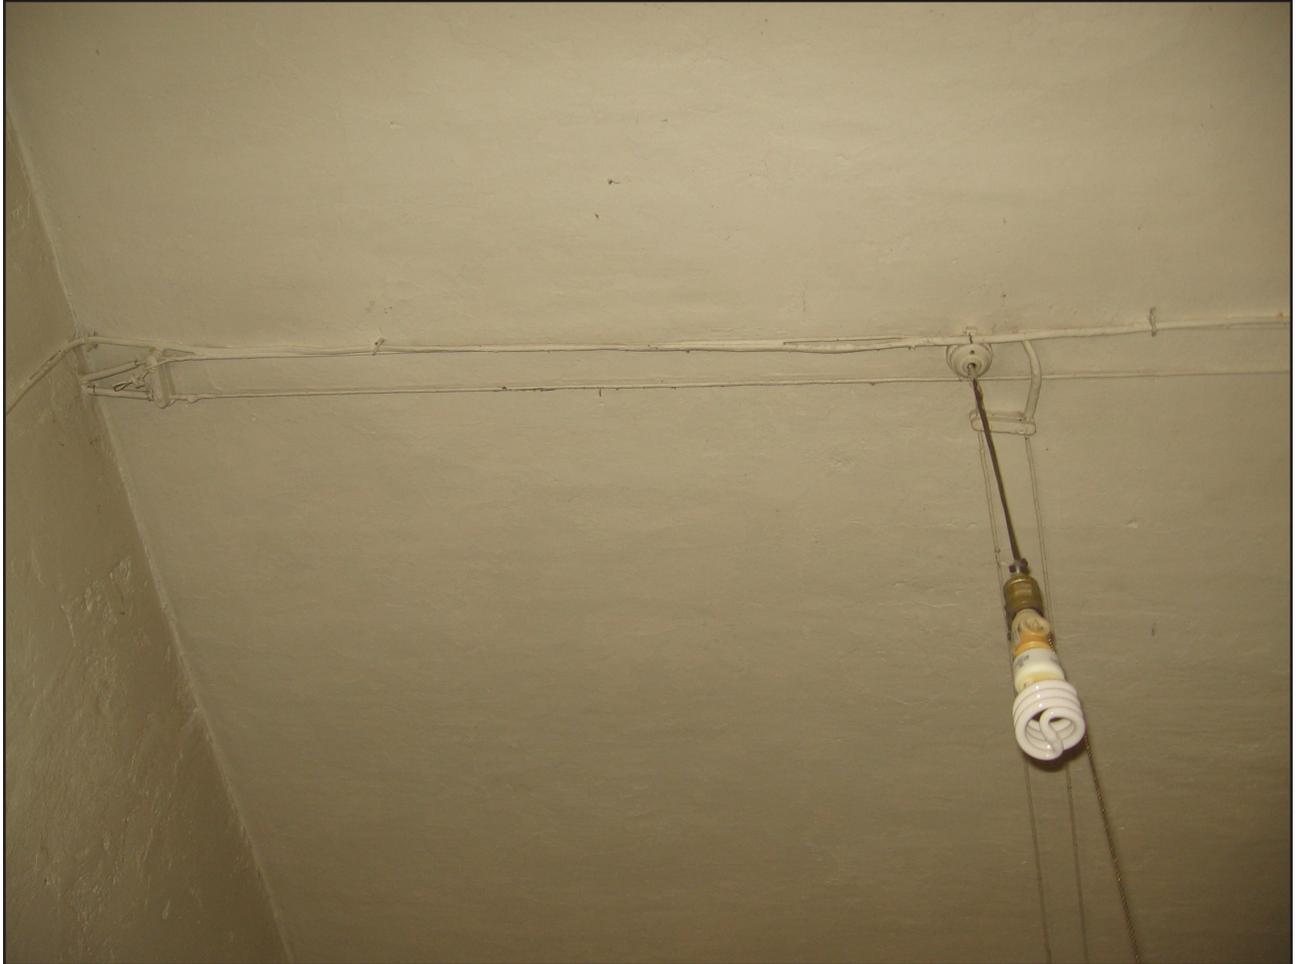
Figure No. 121 - Fixture in Zagan, bare suspended wire installed with knob and tube system; a similar fixture exists at Bedroom 2

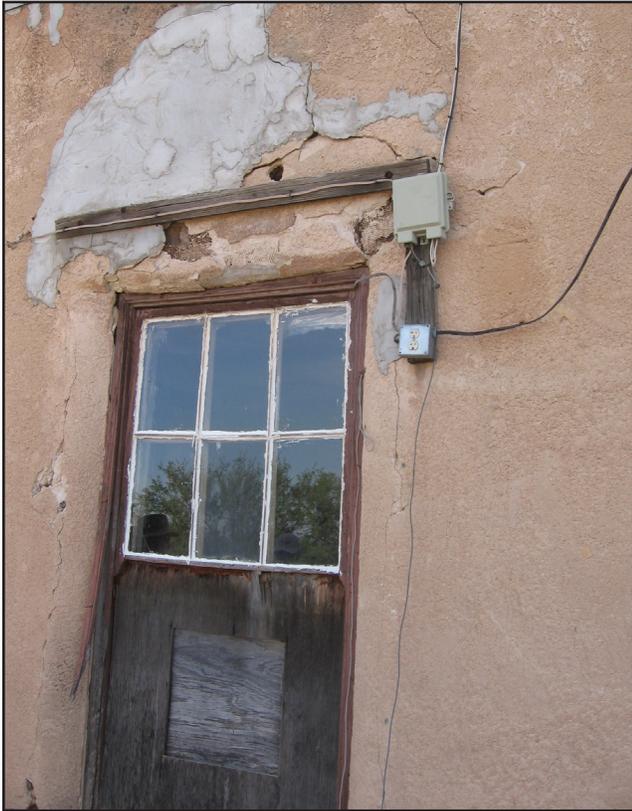
Telephone Service: Telephone is serviced overhead to the west wall near the north end; there is a surface receptacle at that same location that is exposed to the weather and not weatherproof construction.

Figure No. 122 - Telephone entry on west wall above Living Room window

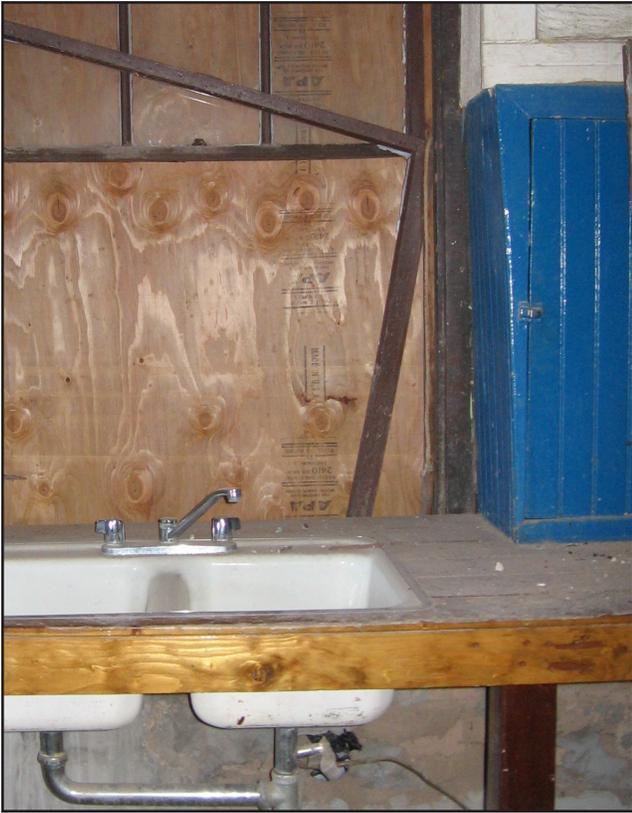
Figure No. 123 - Double sink at Kitchen; the drain went through the wall into a drain pipe

Comments: All plumbing systems will have to be replaced with new if the building use requires such services

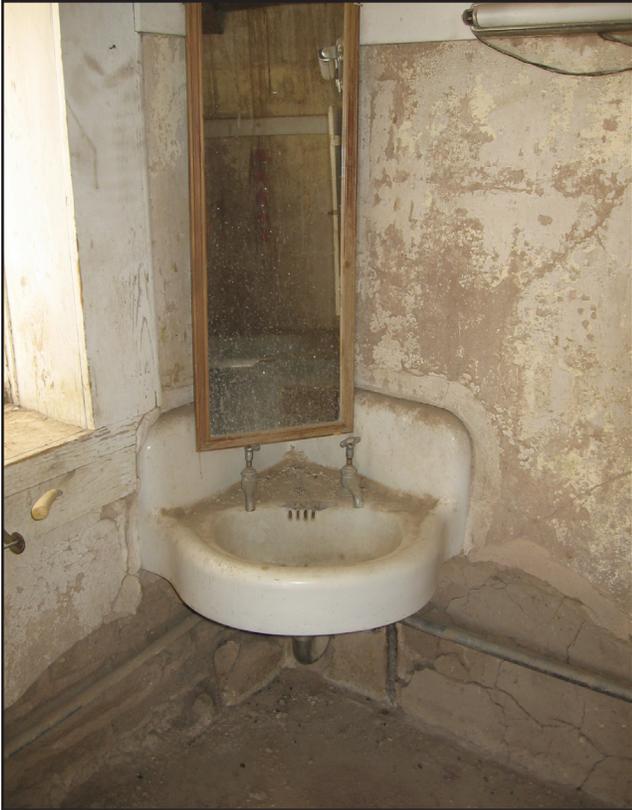
Figure No. 124 - Lavatory at Bathroom

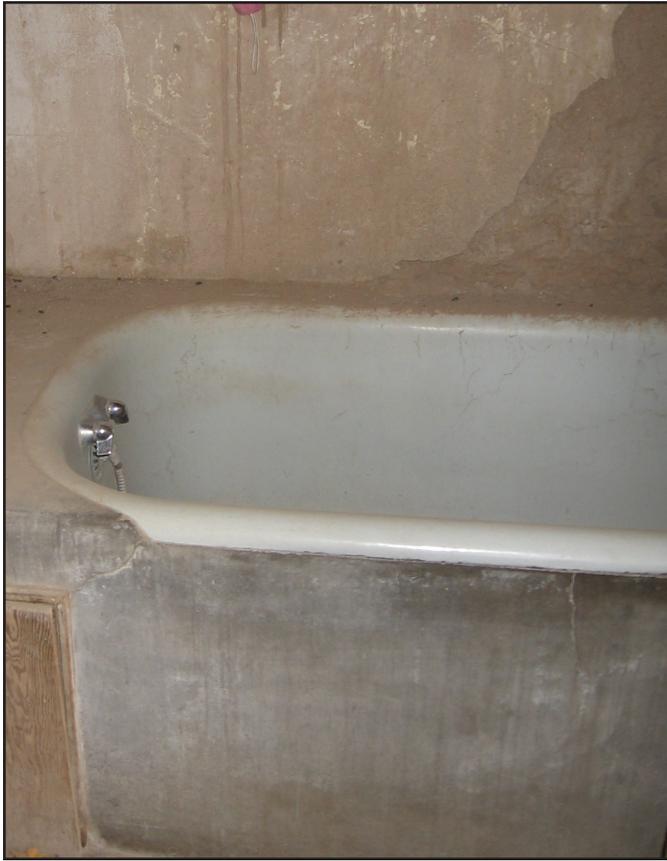
Figure No. 125 - Cast-iron tub set into a cast concrete base, note the plywood access panel cover to the plumbing

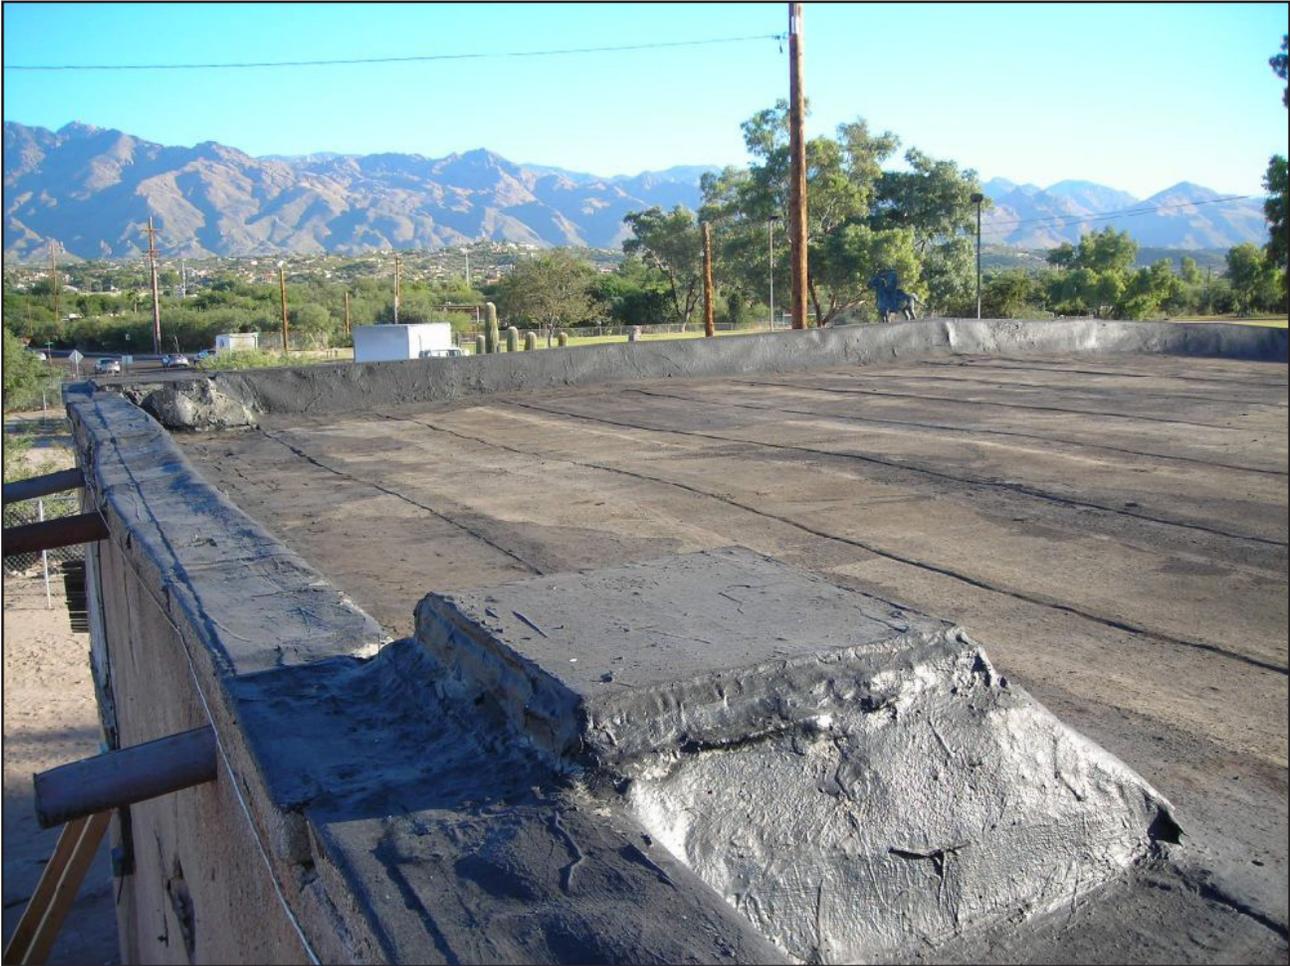
Figure No. 126 - Temporary roofing system , in foreground is chimney base with plywood cap and temporary roofing cap

- a. The building has been stabilized with the addition of a temporary roof consisting of an asphalt emulsion seal coat (Henry 107 Emulsion), a layer of yellow fiberglass fabric and another emulsion coat.

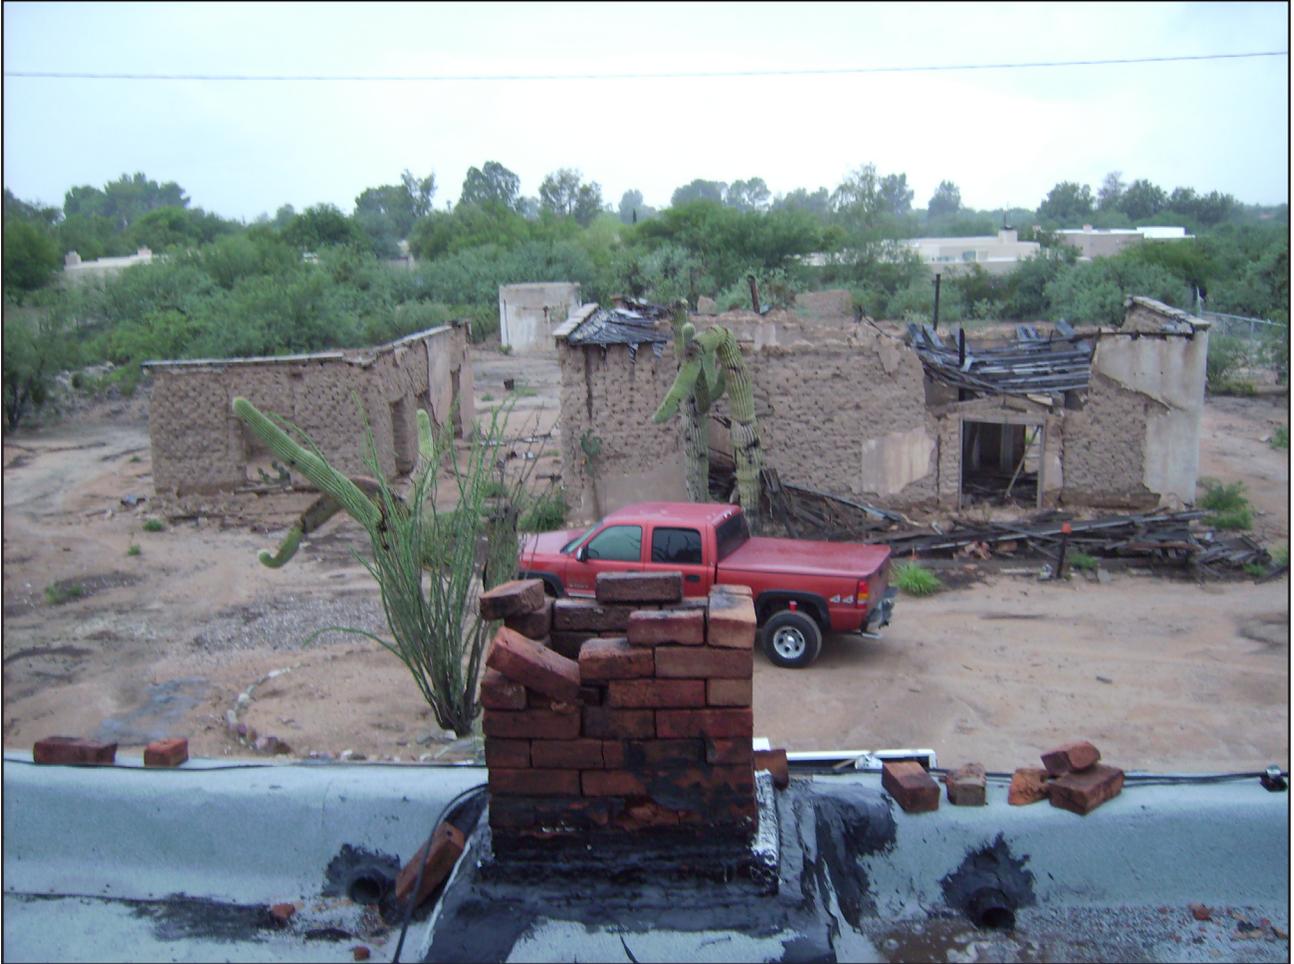
- b. The brick chimneys were falling down – they were documented photographically and have been accurately drawn so that they may be reconstructed.

Figure No. 127 - Falling down chimney on west side of roof, overlooking Officer's Quarters No. 2

- c. The chimneys were then disassembled and the bricks stacked on a concrete slab adjacent the house. The flue openings were covered with plywood and then the temporary roof system was applied over the plywood.

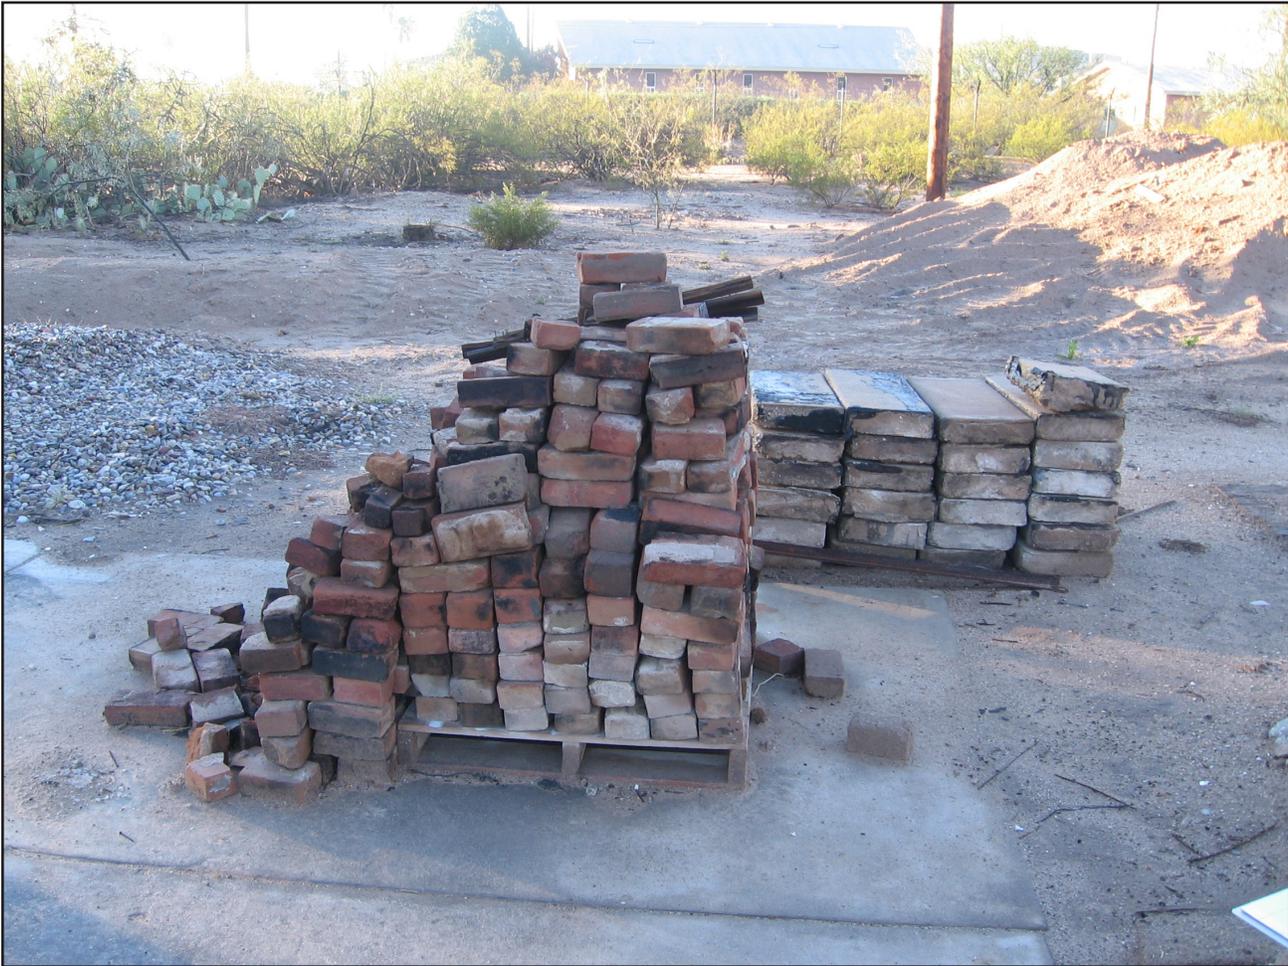
Figure No. 128 - Bricks from chimney stacked on the ground after removal from roof, behind are the cast concrete caps removed from both Officer's Quarters No. 2 and 3

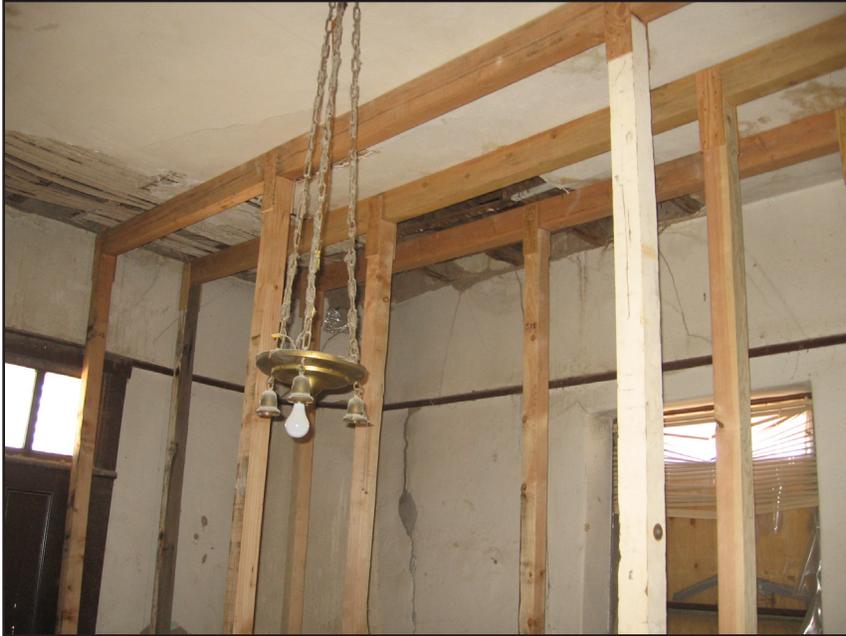
Figure No. 129 - Bracing at Bedroom 1 ceiling

- d. Bracing has been applied to interior collapsing ceilings at the Living Room and Bed room No. 1 and at the Living Room west window, and the northeast exterior corner of the building has been braced. The south side porch has been resupported and a portion of the parapet on that same side has been braced. Bracing has also been applied to the exterior of the building at the northeast corner

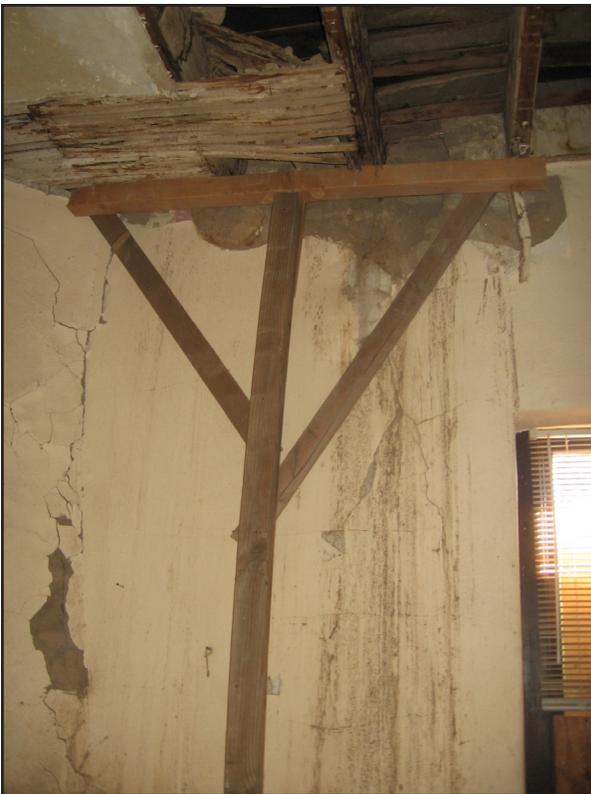
Figure No. 130 - Bracing at Bedroom 2 ceiling

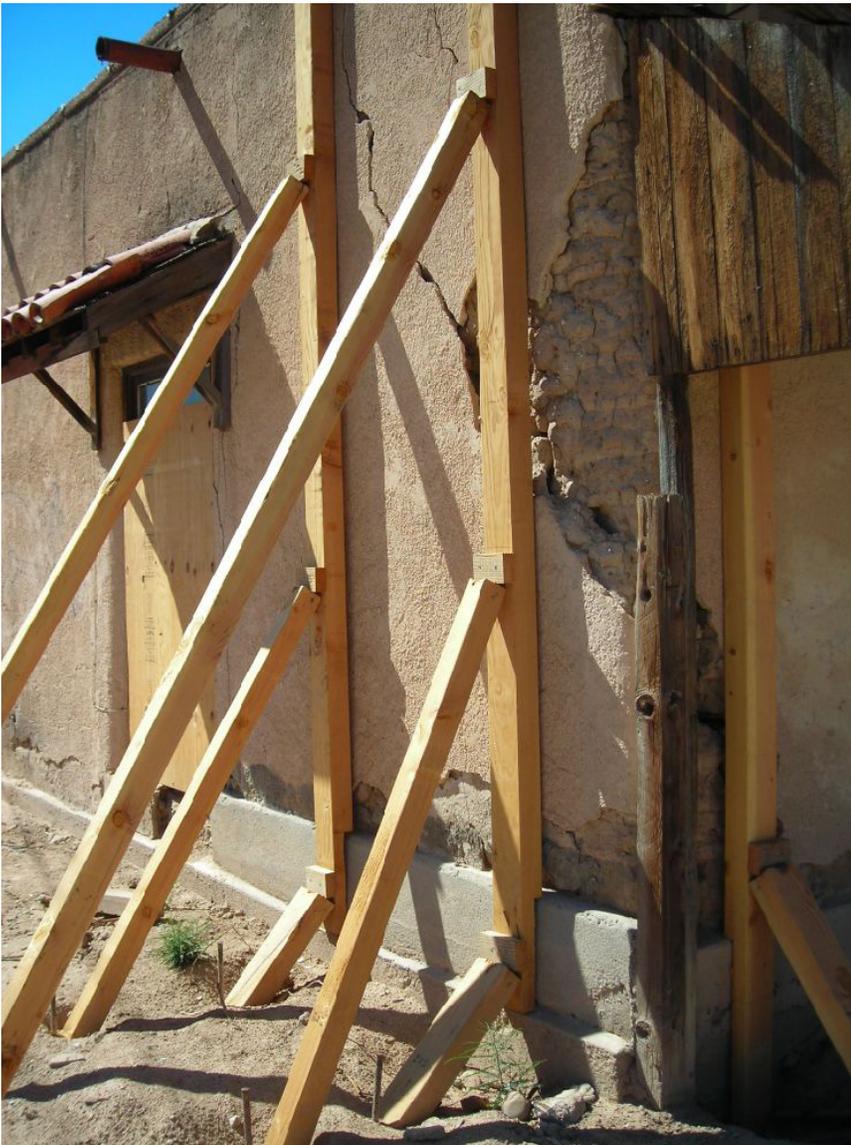
Figure No. 131 - Bracing at north-east corner of building

The mud adobe walls still have plaster remaining on most of the walls, but there are large cracks and separations in the plaster and in the adobe. The northeast corner is severely cracked and deteriorated and is temporarily shored to prevent the corner from collapsing.

Note: The recently installed shoring consists of wood bracing that is set in the exterior dirt grade. It appears that the recent rains have caused the wood bracing to settle. All of the temporary shoring that has recently been installed should be periodically observed and adjusted as needed to insure that it remains functional.
