Preservation Plan

*for the
Adkins Parcel at Fort Lowell Park*

November 2009

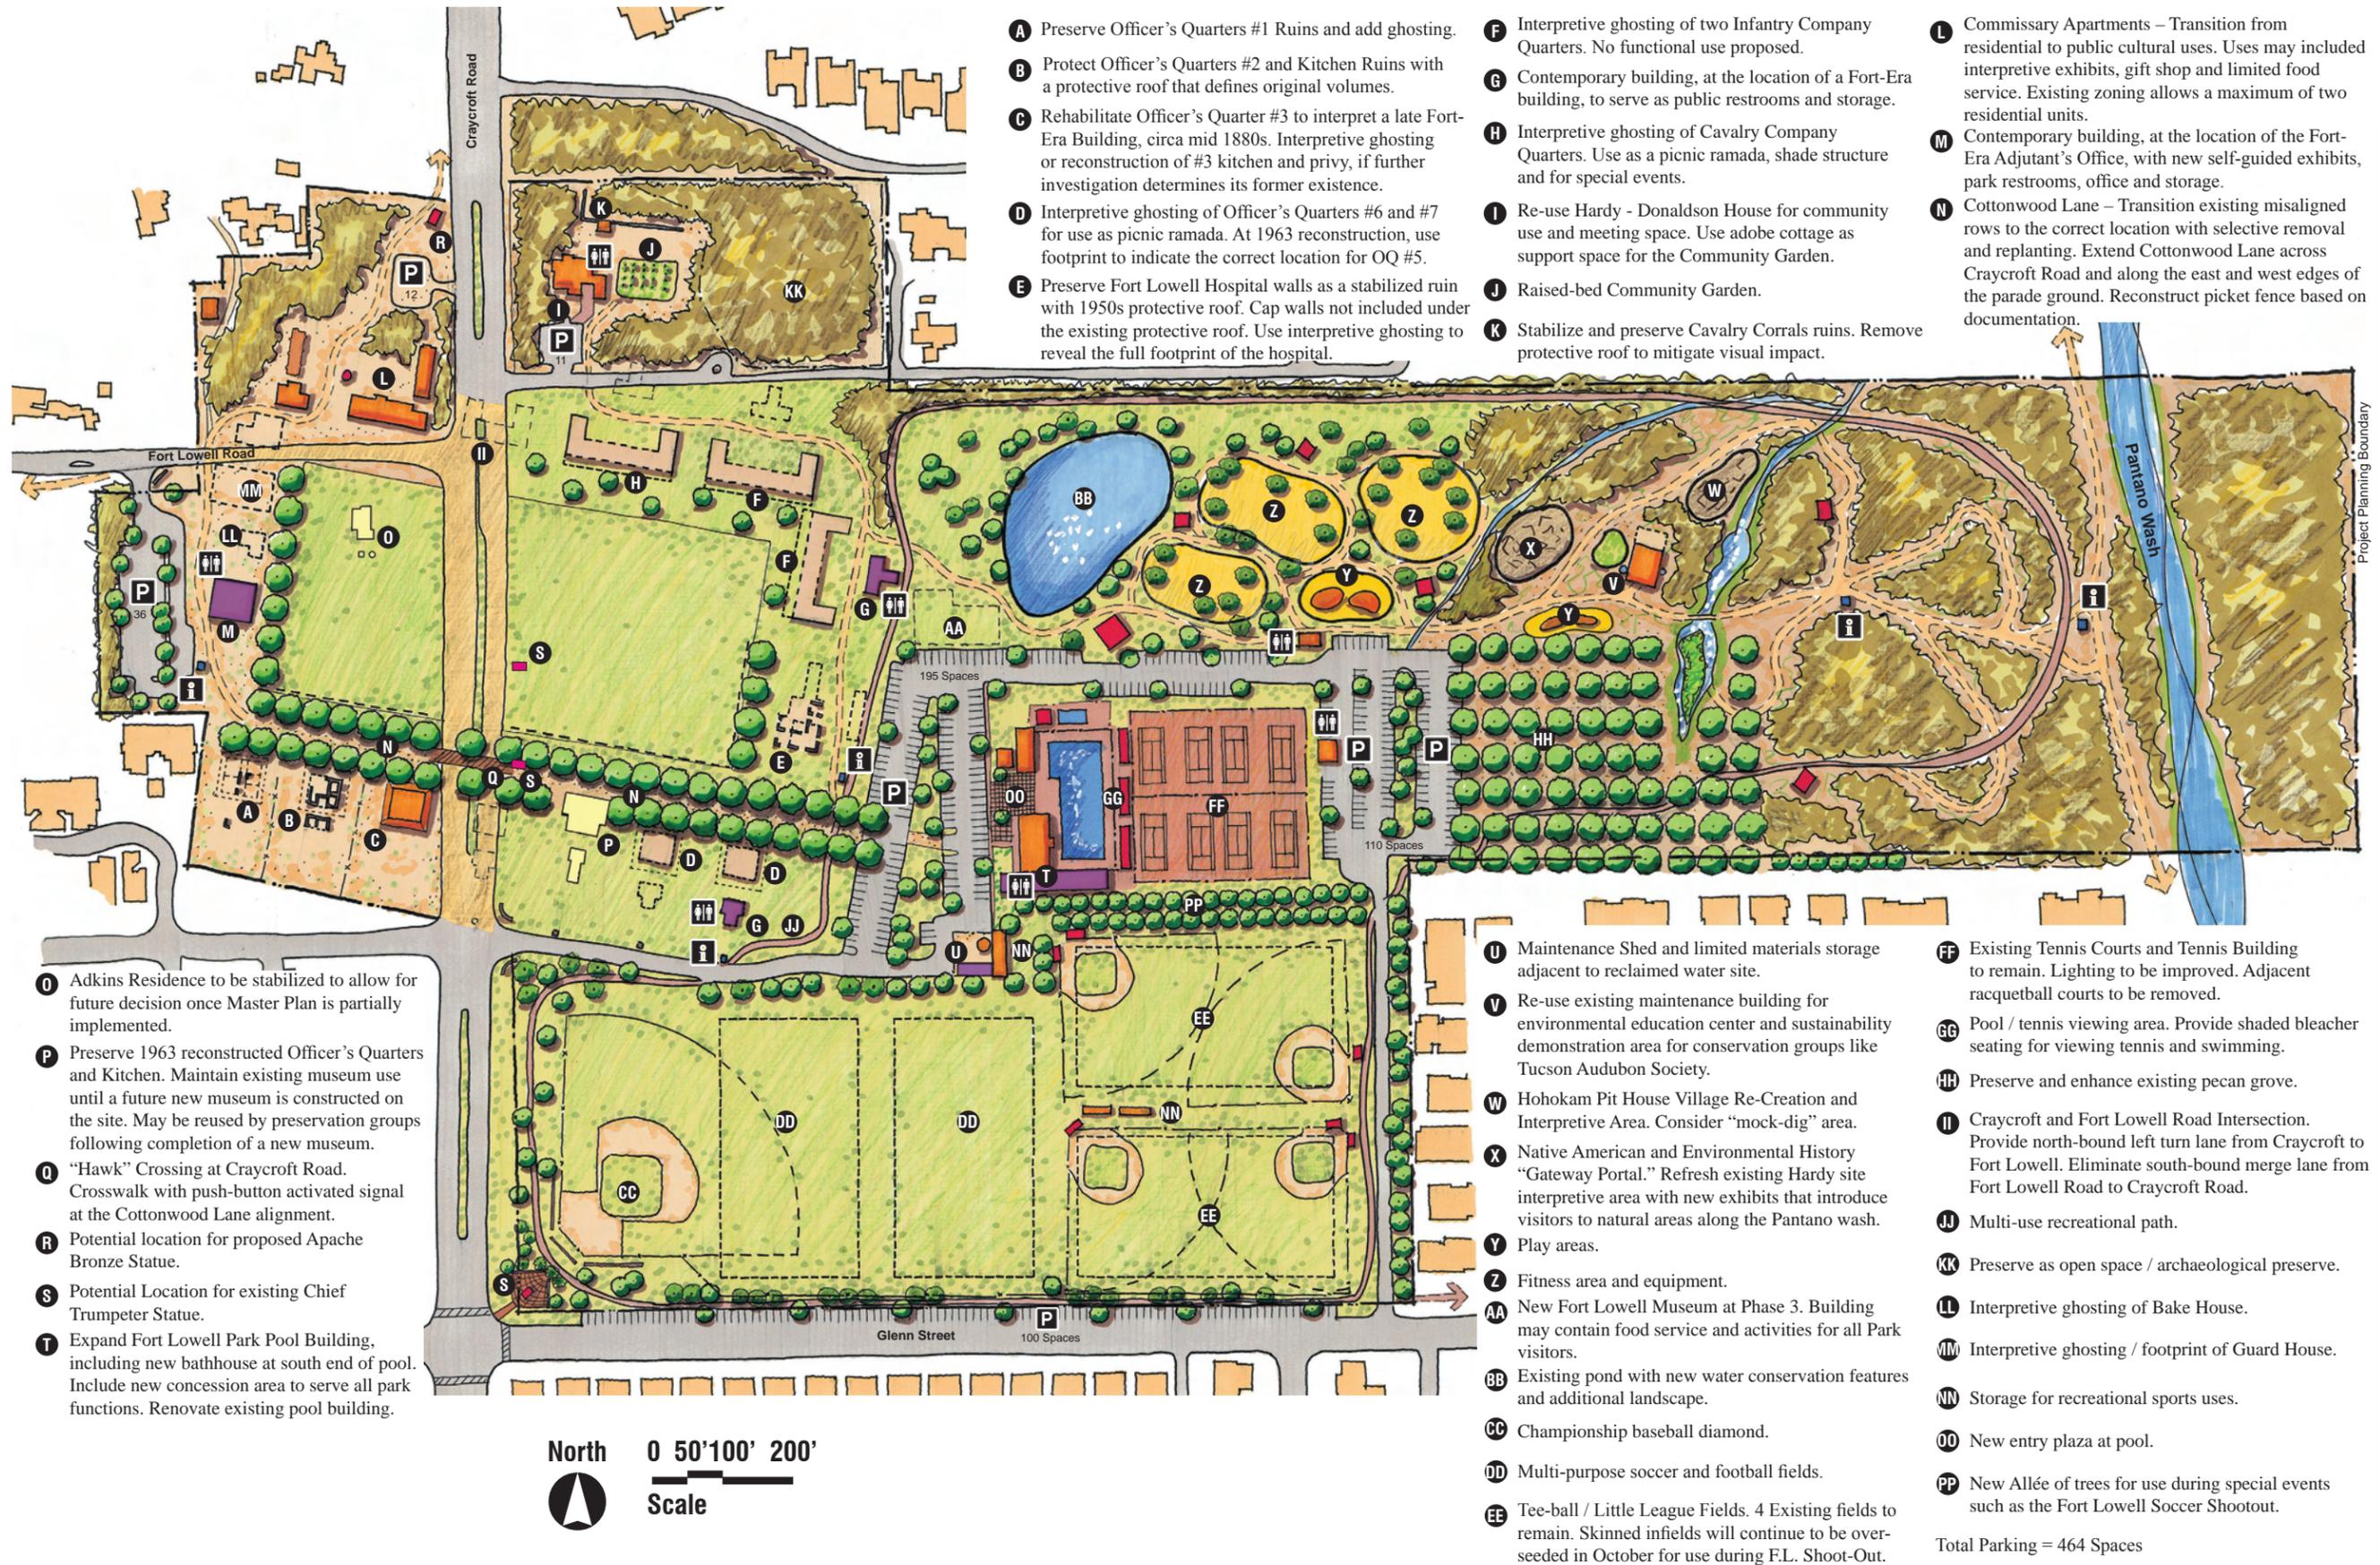
Figure 12: Fort Lowell Park Master Plan - Final Concept.

- A** Preserve Officer's Quarters #1 Ruins and add ghosting.
- B** Protect Officer's Quarters #2 and Kitchen Ruins with a protective roof that defines original volumes.

- C** Rehabilitate Officer's Quarter #3 to interpret a late Fort-Era Building, circa mid 1880s. Interpretive ghosting or reconstruction of #3 kitchen and privy, if further investigation determines its former existence.

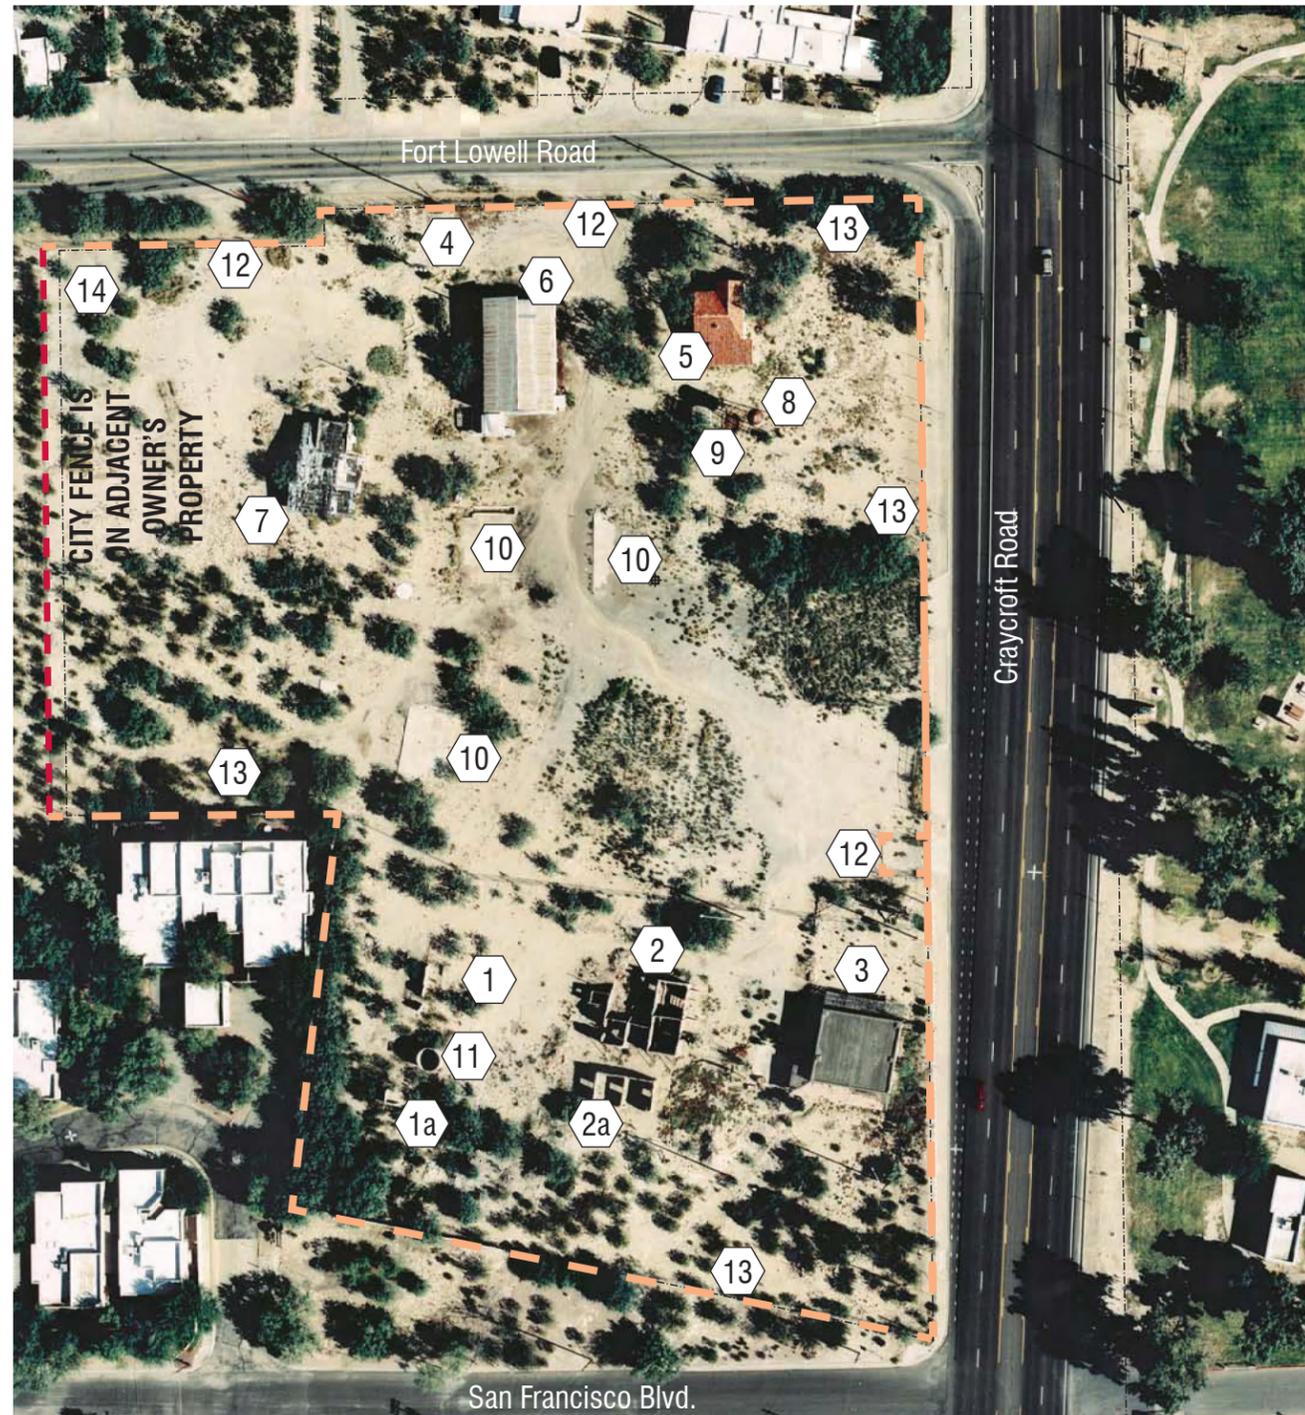
Figure 13: Adkins Parcel - Existing Conditions.

KEY	RESOURCE	TREATMENT
1	OFFICER'S QUARTERS #1 (RUINS)	PRESERVE / ADD GHOSTING
1a	OFFICER'S QUARTERS #1 KITCHEN (RUINS)	PRESERVE / NO GHOSTING
2	OFFICER'S QUARTERS #2 (PARTIAL RUINS)	PRESERVE / ADD GHOSTING
2a	OQ #2 KITCHEN (PARTIAL RUINS)	PRESERVE / ADD GHOSTING
3	OFFICER'S QUARTERS #3	REHABILITATE TO MID-1880s FORT PERIOD
4	FORT-ERA GUARD HOUSE (RUINS)	PRESERVE
5	ADKINS RESIDENCE	STABILIZE FOR FUTURE DECISION
6	ADKINS STEEL FABRICATION SHED	DOCUMENT AND REMOVE
7	RC MAGOR RESIDENCE (RUINS)	DOCUMENT AND REMOVE
8	ADKINS-ERA WATER TOWER	STABILIZE FOR FUTURE DECISION
9	ADKINS-ERA WINDMILL BASE	DOCUMENT AND REMOVE
10	ADKINS-ERA CONCRETE SLAB	DOCUMENT AND REMOVE
11	EARLY 20TH C. CONC. WATER TANK	DOCUMENT AND REMOVE
12	ENTRY GATE IN EXISTING FENCE	TO REMAIN IN USE INDEFINATELY
13	EXISTING PERIMETER FENCE	TO REMAIN IN USE INDEFINATELY
14	ASPHALT SLAB	REMOVE

Portions of the three western-most original Officer's Quarters remain on the Adkins Parcel. There are also two buildings and a number of site structures and objects from the Adkins Period. Underlying these later occupations are the prehistorical archaeological remains of the Hohokam.

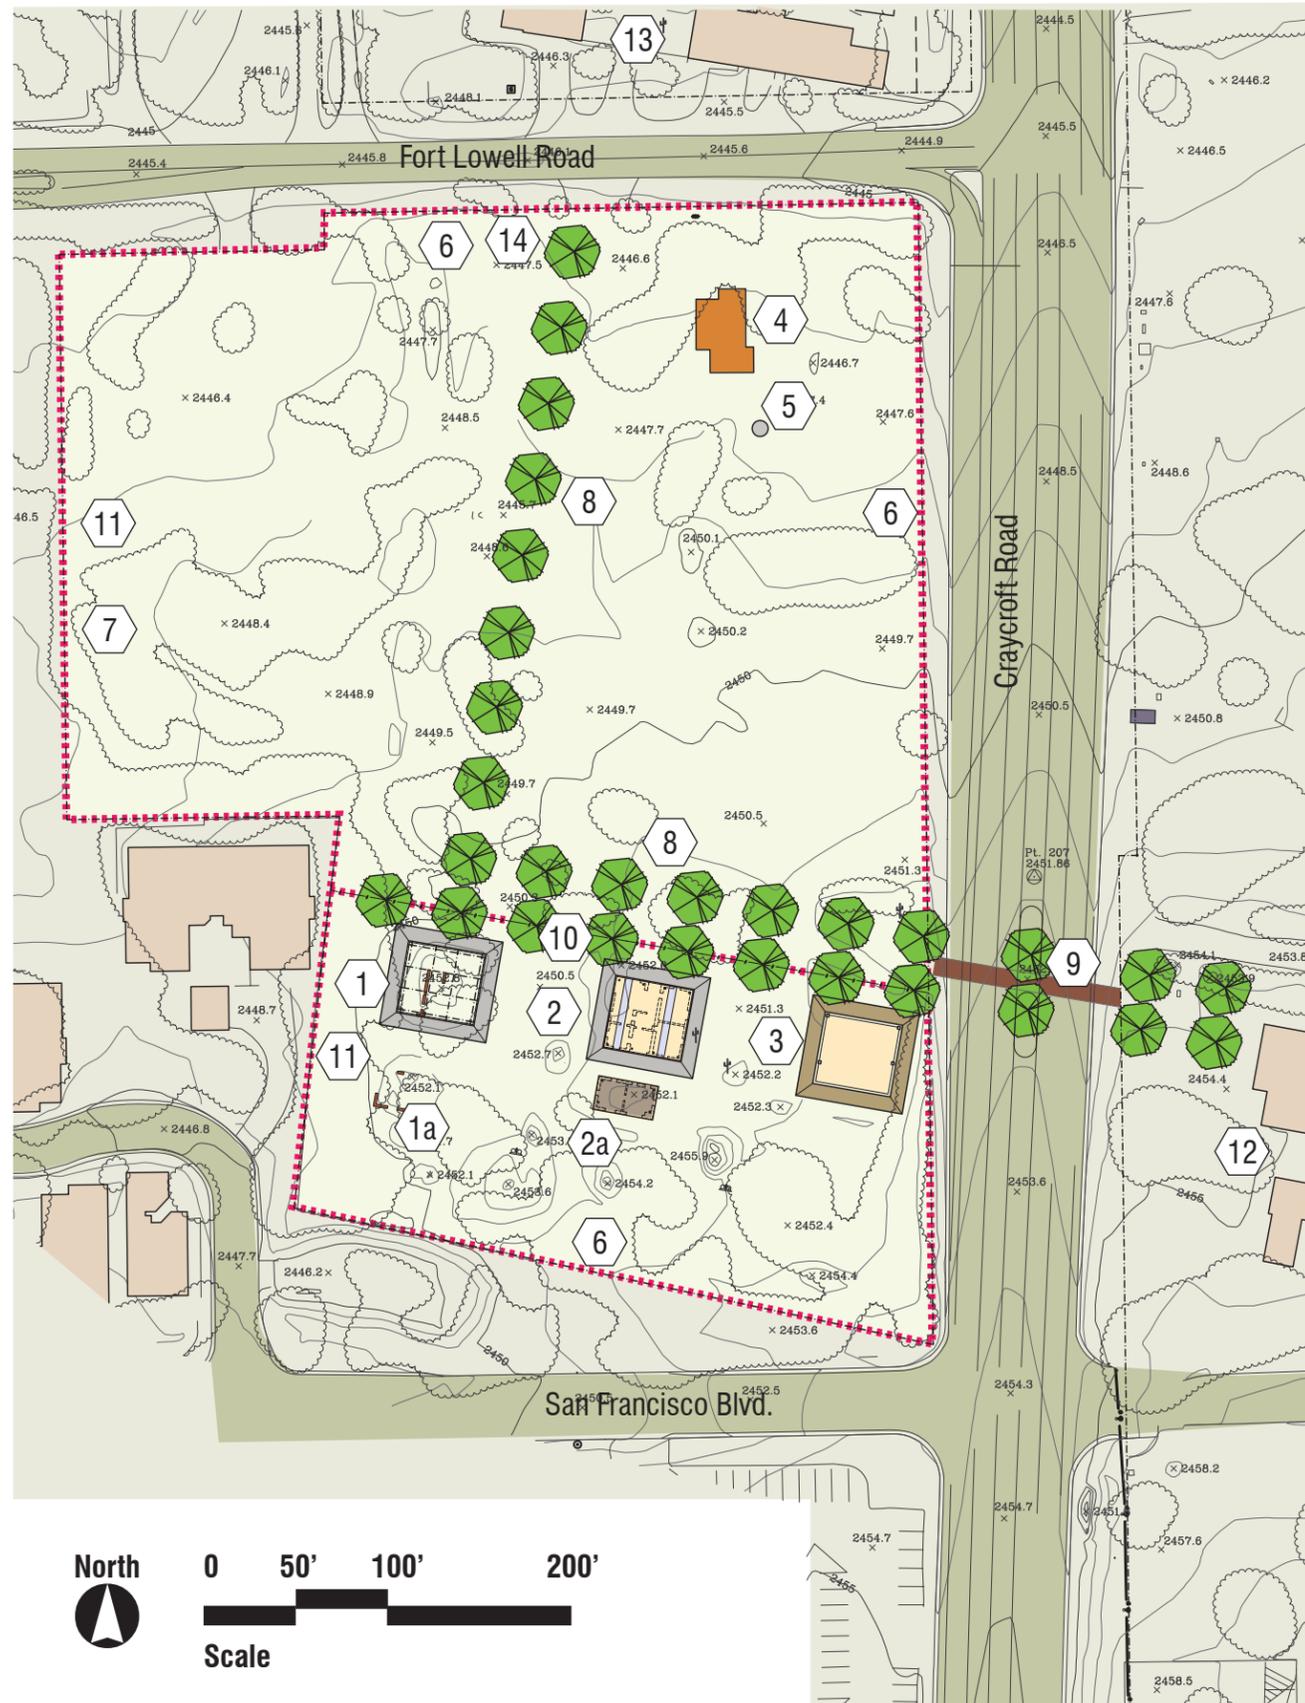
KEYNOTES

- 1 OFFICER'S QUARTERS #1 (RUINS) PROVIDE NEW GHOSTING TO DEFINE THE ORIGINAL FOOTPRINT AND VOLUME. STABILIZE EXISTING ADOBE WALLS AND PROVIDE SACRIFICIAL MUD CAP.

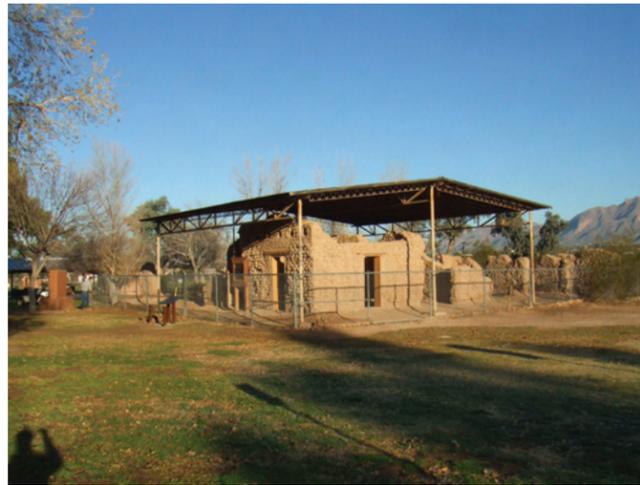
Figure 16: Fort Lowell Hospital, with its protective roof is an example of *preservation*.

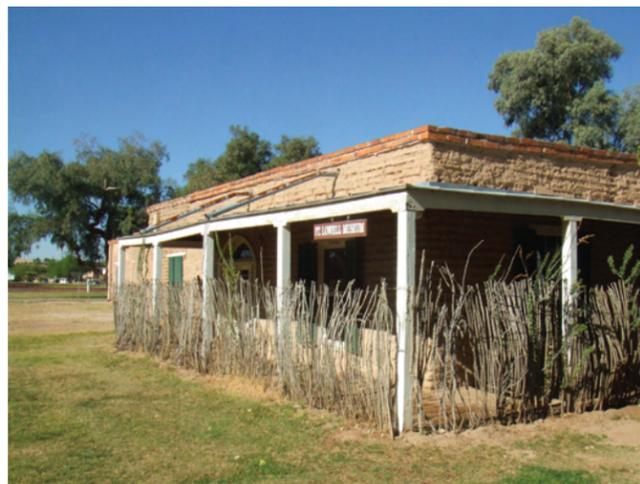
Figure 18: The Fort Lowell Museum, built in 1963, is an example of *reconstruction*.

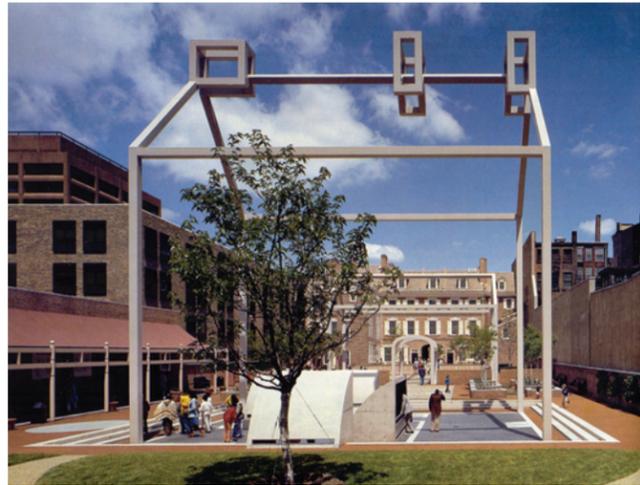
Figure 22: Interpretive "ghosting" at Franklin Court in Philadelphia.

A unique aspect of the Master Plan is the use of interpretive "ghosting" to delineate the outline of a missing or partially missing building. This technique has been used effectively at Franklin Court in Philadelphia to create a spatial experience for Ben Franklin's former residence. At Fort Lowell Park, there is currently little experiential understanding of how Fort Lowell was spatially organized; much of the historic fabric has been lost or has been heavily impacted by development and transportation corridors. The use of interpretive ghosting supports one of the primary goals of the Master Plan: *To tell all stories but give priority to the Fort era. Define the spatial character of the Fort.*

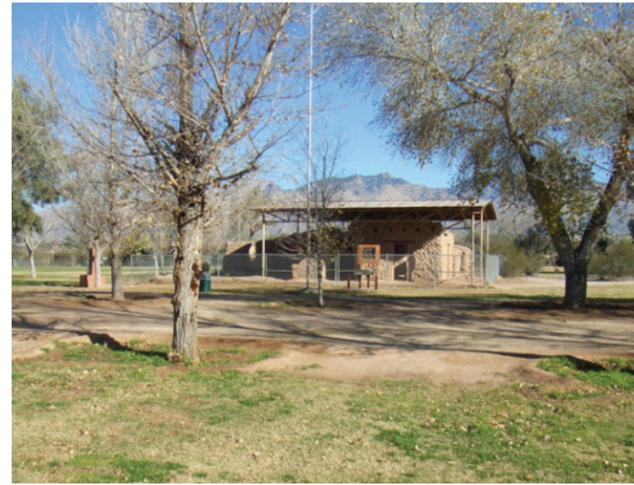
Figure 24: Protective roof over Fort Lowell Hospital ruins.

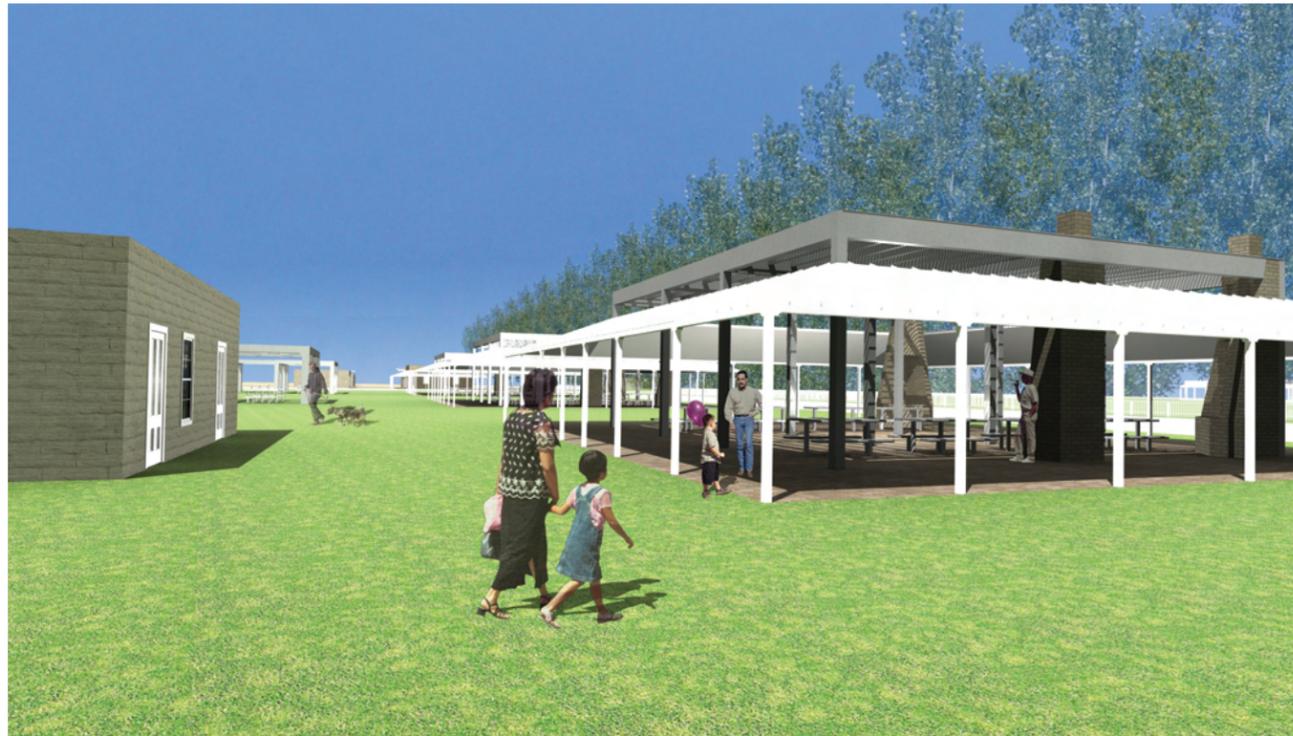
Figure 23: Fort Lowell Park Master Plan - Proposed Ghosting of Officer's Quarters #6 and 7 for Picnic Ramada.

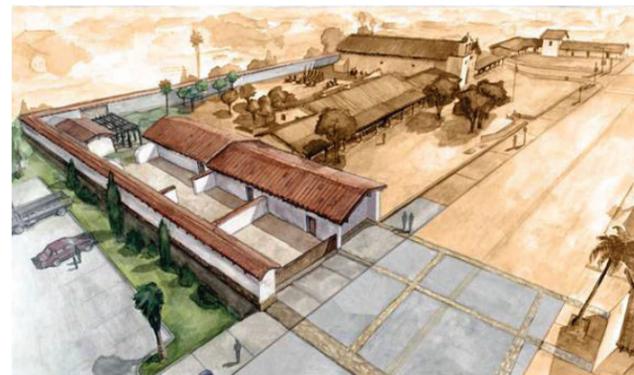
Figure 25: Santa Barbara Presidio showing footprint of building in pavement.

a three-dimensional outline of a building, such as for the location of Officer's Quarters #4 located in the middle of Craycroft Road, a "footprint" of the building's outline will be created. At Craycroft Road, the outline of Officer's Quarters #4 will be indicated through a change in the color and / or texture of the pavement. This technique was successfully used at the Santa Barbara Presidio. This technique could be used to create a more immediate predecessor to full "ghosting" at an earlier phase of implementation.

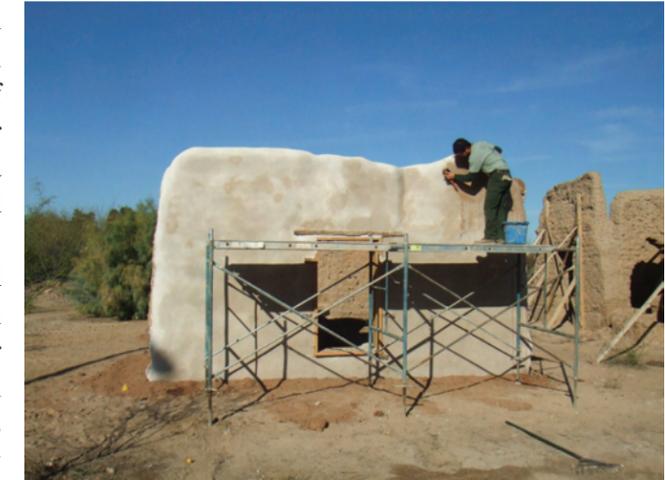
Figure 29: Applying mud-plaster rendering wash to Officer's Quarters #2, east wall, February 2009.

NOTE: THE EXTERIOR FINISH ON THE EXISTING ADOBE WALLS HAS NOT BEEN DETERMINED. THE FINISH WILL BE DETERMINED DURING THE DESIGN PHASE. AN EXPERIMENTAL MUD PLASTER COATING (SEE FIGURE 29) WAS INSTALLED ON THE EAST WALL OF THE KITCHEN BUILDING IN FEBRUARY 2009 AS AN EXAMPLE OF ONE POSSIBLE FINISH. A MUD PLASTER FINISH WOULD COMPLETELY COVER THE PROPOSED POLYESTER WEBBING. THE MUD PLASTER WOULD PROVIDE ADDITIONAL PROTECTION TO THE ADOBE WALLS, BUT REQUIRE PERIODIC MAINTENANCE APPROXIMATELY EVERY 5- 7 YEARS. THE MUD PLASTER CHANGES THE VISUAL APPEARANCE OF THE RUIN AND WOULD IMPACT THE VISITOR EXPERIENCE BY NOT ALLOWING THE CONSTRUCTION TECHNIQUES TO BE AS APPARENT.

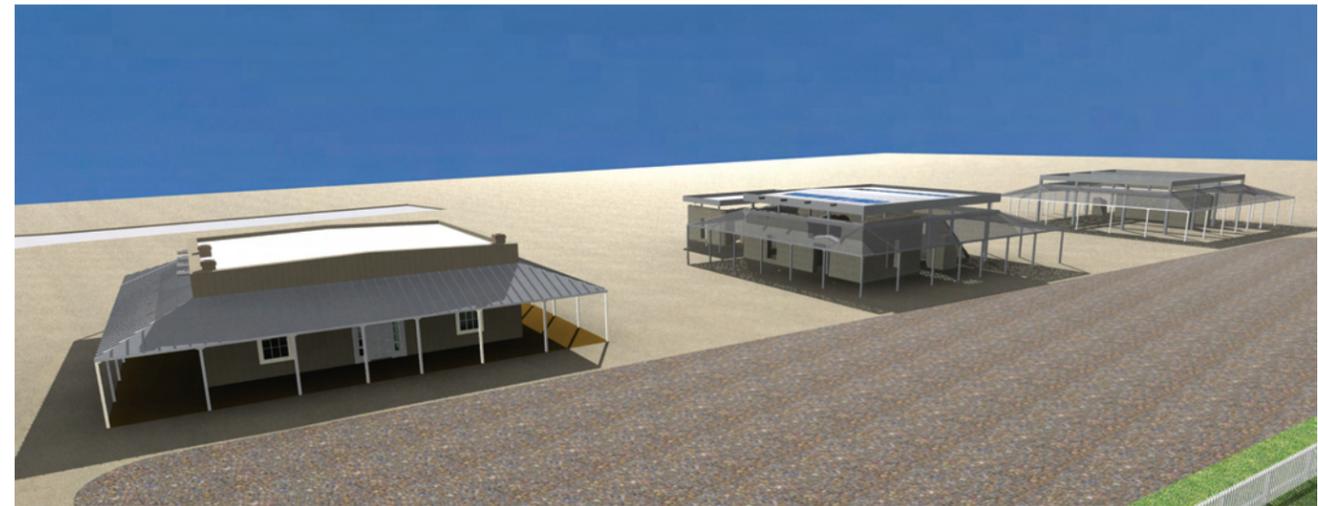
Figure 33: From left to right, OQ#3, #2, and #1 showing proposed treatments, including ghosting on #2 and #1.

As the western-most building, the placement of Officer's Quarters #1 anchors the southwest corner of the site. To give this location the "weight" it needs to anchor the corner, a steel ghosted structure will be placed over the remaining walls to illustrate the original footprint and volume of the building. The lower wrap-around porch will also be constructed. The ghosting on Officer's Quarters #1 will be visually consistent with the ghosting employed on Officer's Quarters #2. The major difference will be that Officer's Quarters #2 will have a solid roof and Officer's Quarters #1 will be open on top. The lower porches at both structures will be the same perforated metal.

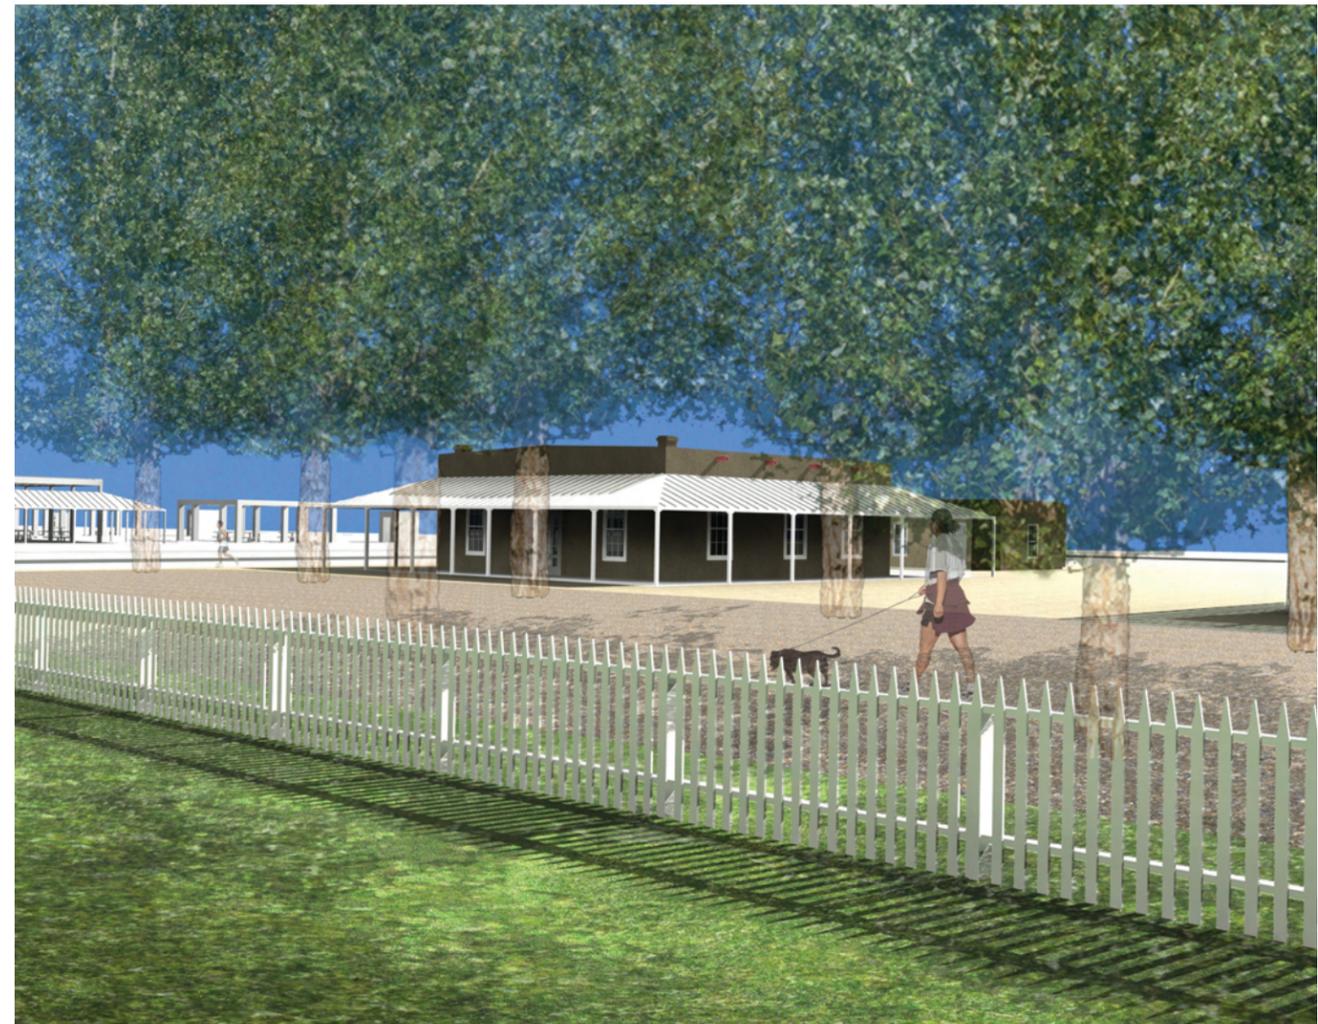
Figure 34: View from Parade Ground looking southeast across Cottonwood Lane towards Officer's Quarters #3. Picket fence will be reconstructed during implementation of the Master Plan. Note: Image was produced during the master planning process and does not accurately depict the final design for the area behind Officer's Quarters #2 or the area east of Craycroft Road.

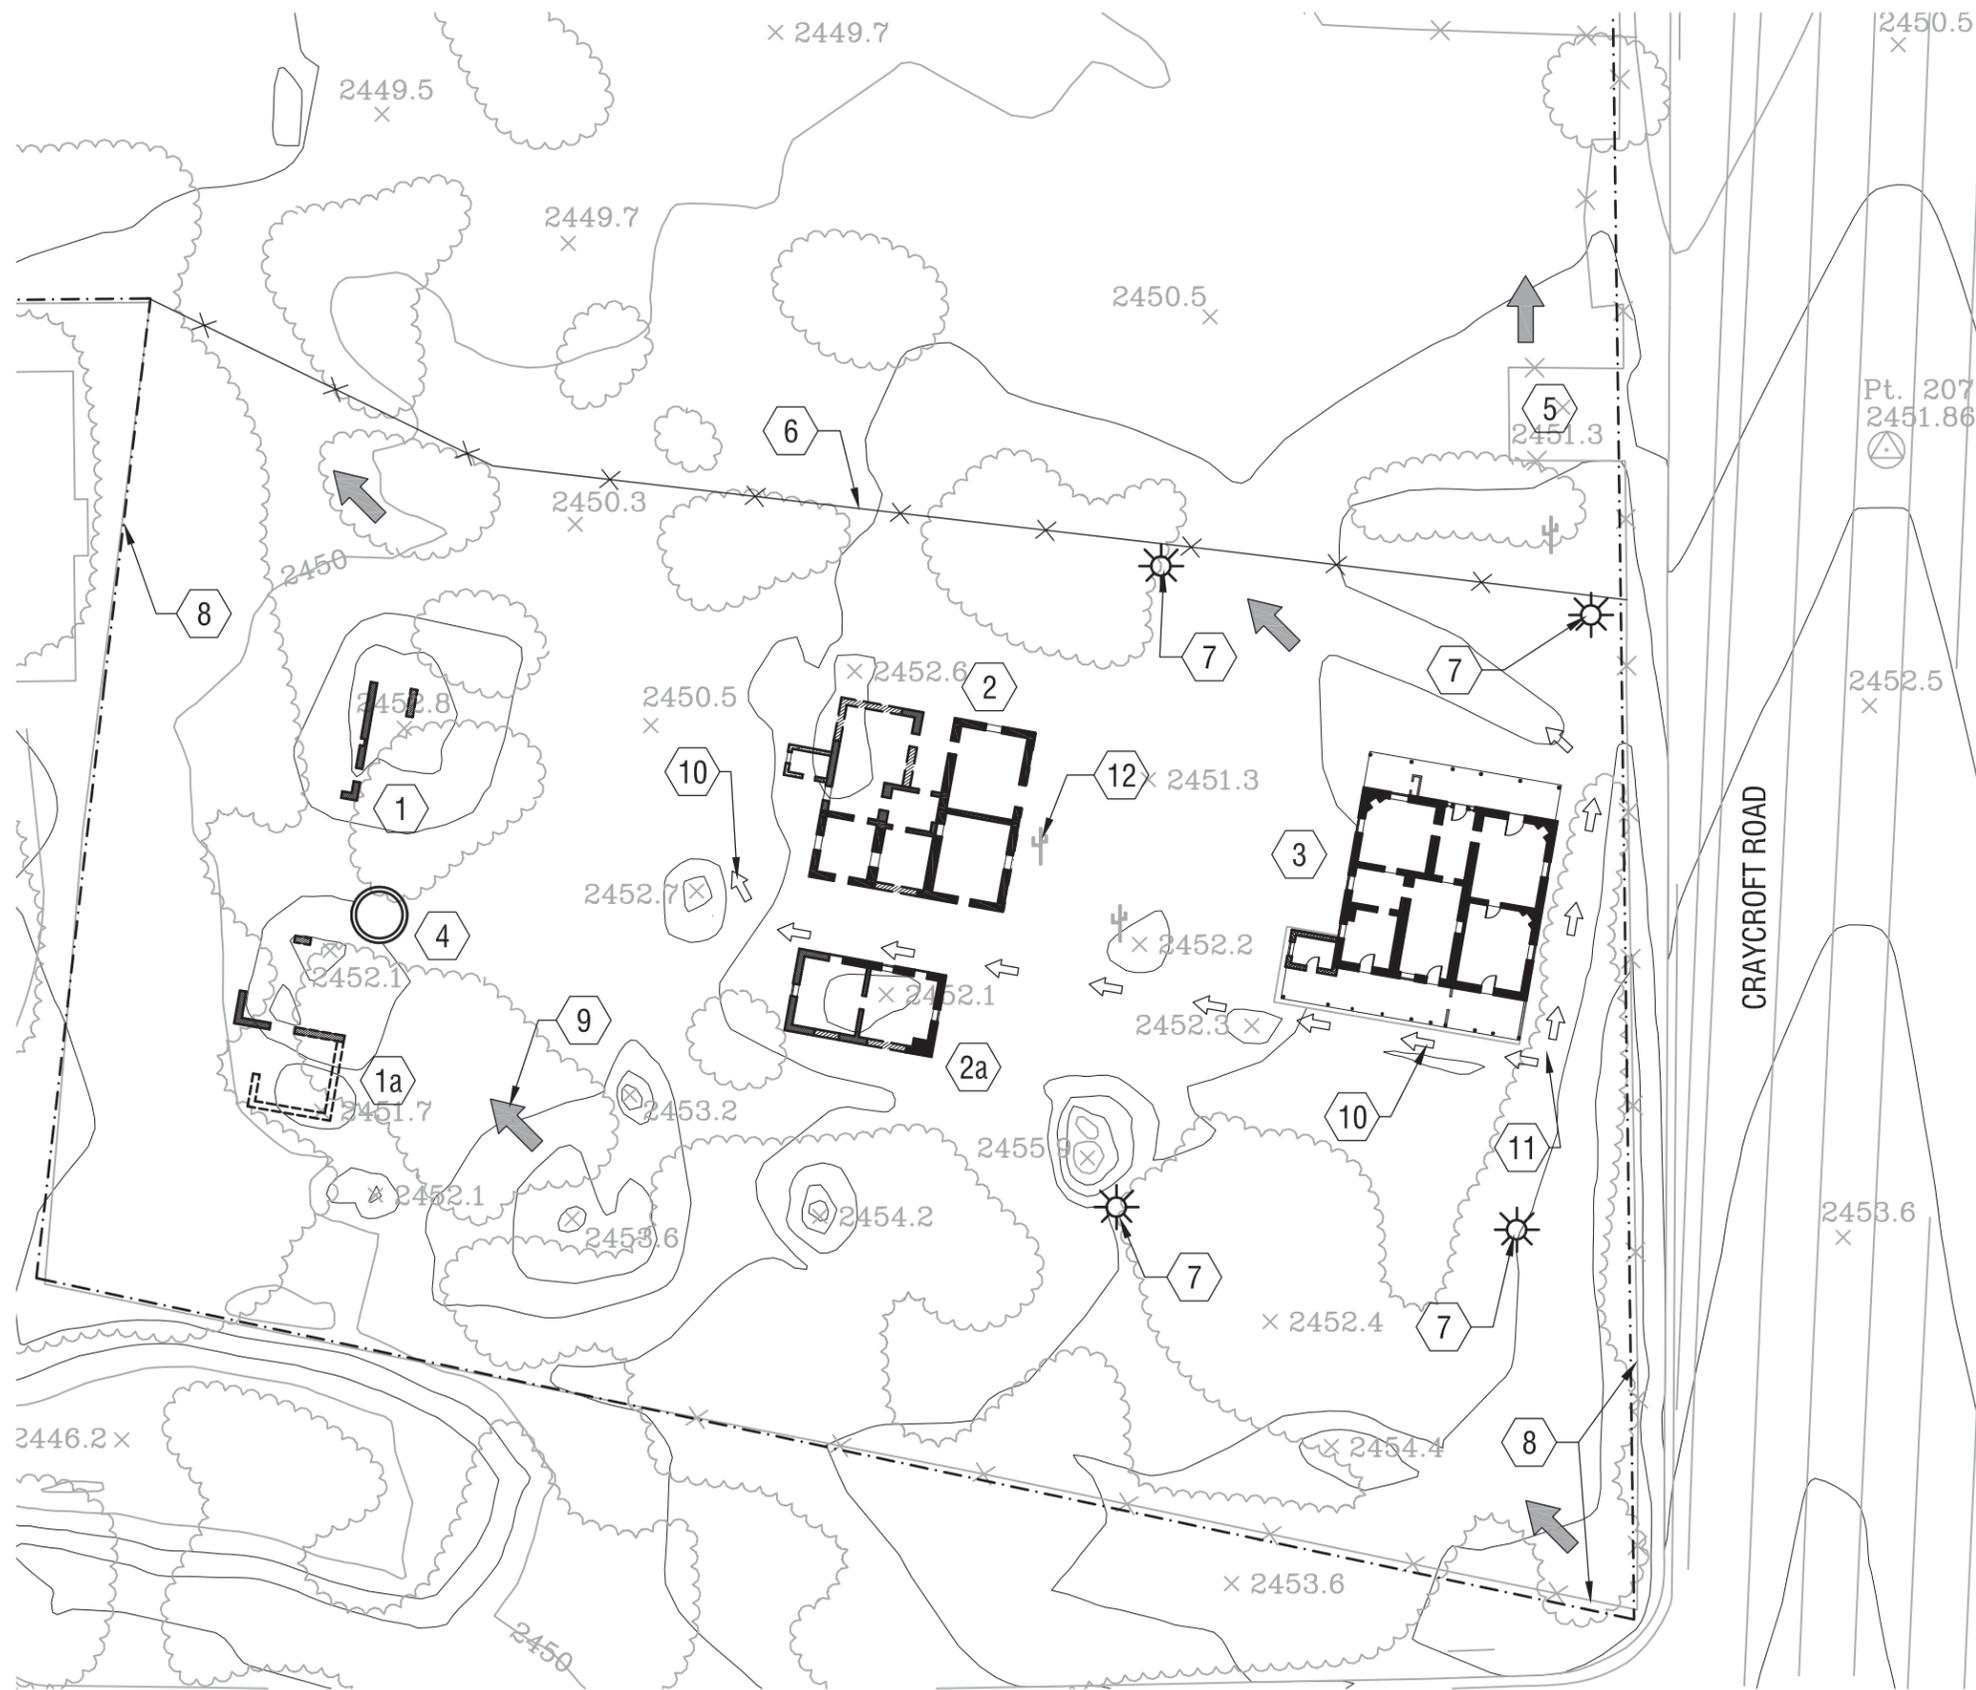
1 Partial Adkins Parcel Site Plan (Existing)
SCALE 1"=40'-0"

- ① OFFICER'S QUARTERS #1 (RUINS)
- ①a OFFICER'S QUARTERS #1 KITCHEN (RUINS)
- ② OFFICER'S QUARTERS #2 (PARTIAL RUINS)
- ②a OFFICER'S QUARTERS #2 KITCHEN (PARTIAL RUINS)
- ③ OFFICER'S QUARTERS #3
- ④ EARLY 20TH CENTURY CONCRETE WATER TANK
- ⑤ ENTRY GATE IN EXISTING FENCE
- ⑥ EXISTING SECURITY FENCE
- ⑦ EXISTING SECURITY LIGHT
- ⑧ EXISTING SITE FENCE AT PERIMETER OF PROPERTY
- ⑨ DIRECTION OF NATURAL FLOW
- ⑩ DRAINAGE SWALE CREATED TO MOVE WATER AWAY FROM ADOBE WALLS
- ⑪ HIGH POINT OF SWALES
- ⑫ EXISTING SAGUARO TO BE RELOCATED (ALT. IS TO LEAVE AND INCORPORATE INTO PORCH WITH INTERPRETATION.)

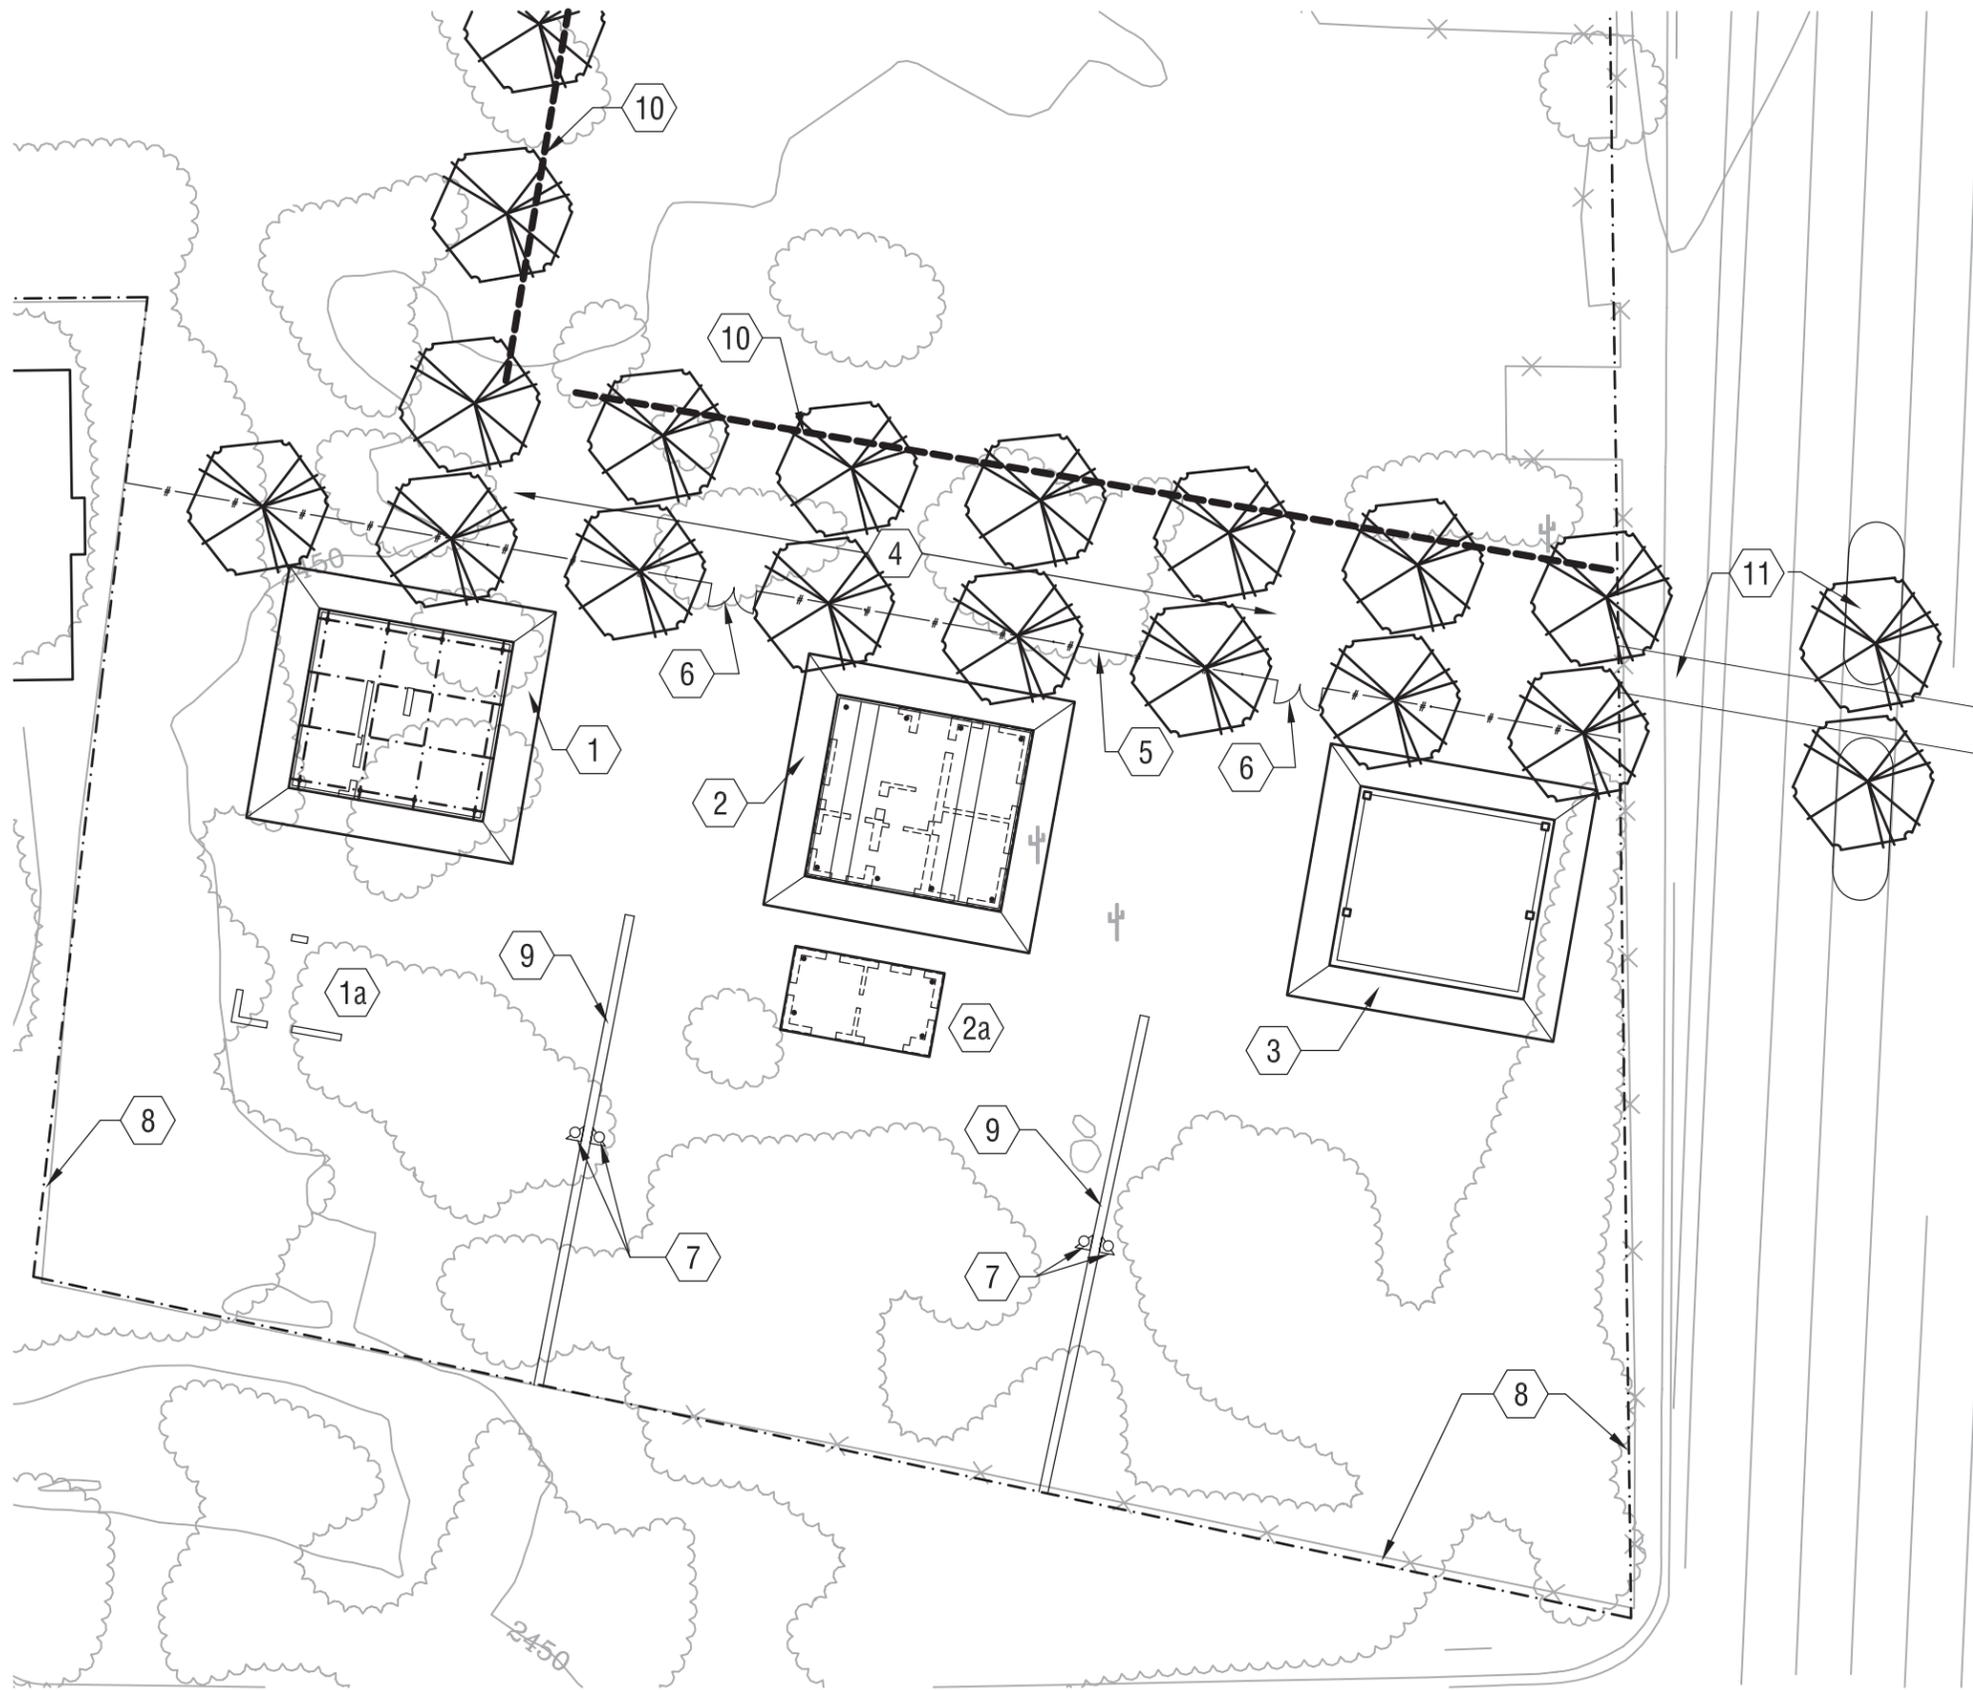
1 Partial Adkins Parcel Site Plan (Proposed)
SCALE 1"=40'-0"

- 1 OFFICER'S QUARTERS #1 (RUINS). PROVIDE NEW GHOSTING TO DEFINE THE ORIGINAL FOOTPRINT AND VOLUME. STABILIZE EXISTING ADOBE WALLS AND PROVIDE SACRIFICIAL MUD CAP.

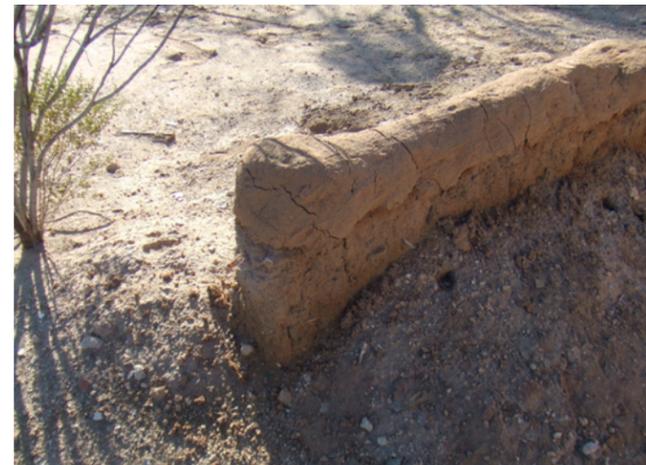
Figure 37: Sacrificial mud cap on historic adobe wall.
