Preservation Plan

*for the
Adkins Parcel at Fort Lowell Park*

November 2009

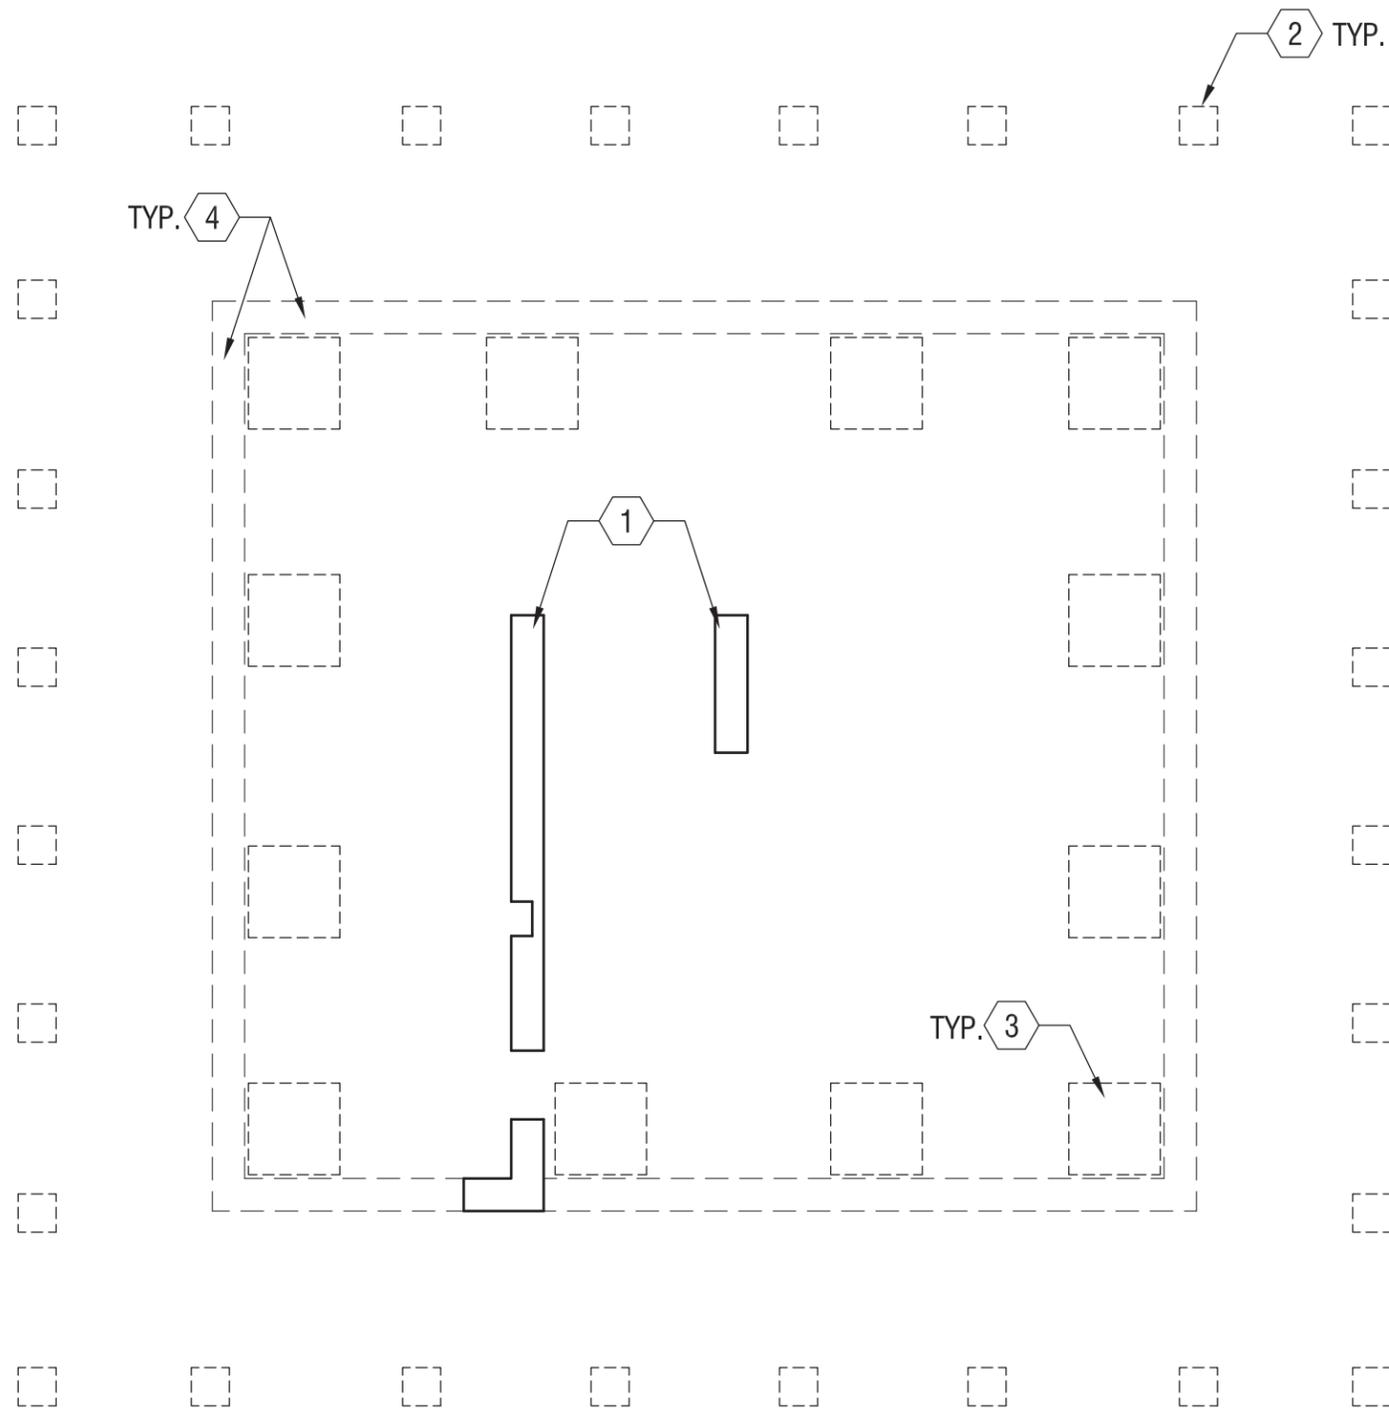
Officer's Quarters #1

KEYNOTES

- ① EXISTING ADOBE WALLS TO BE PRESERVED IN PLACE. PROTECT TOP OF WALL WITH SACRIFICIAL MUD CAP.
- ② CONCRETE WATER TANK TO BE REMOVED.
- ③ WELL TO BE FILLED DURING ENVIRONMENTAL CLEAN-UP PHASE.
- ④ LOW ADOBE WALL AND ADOBE "MELT".
- ⑤ BEAMS AT OPEN ROOF.
- ⑥ STEEL FRAMING WITH PERFORATED METAL ROOF AT FORMER PORCHES.

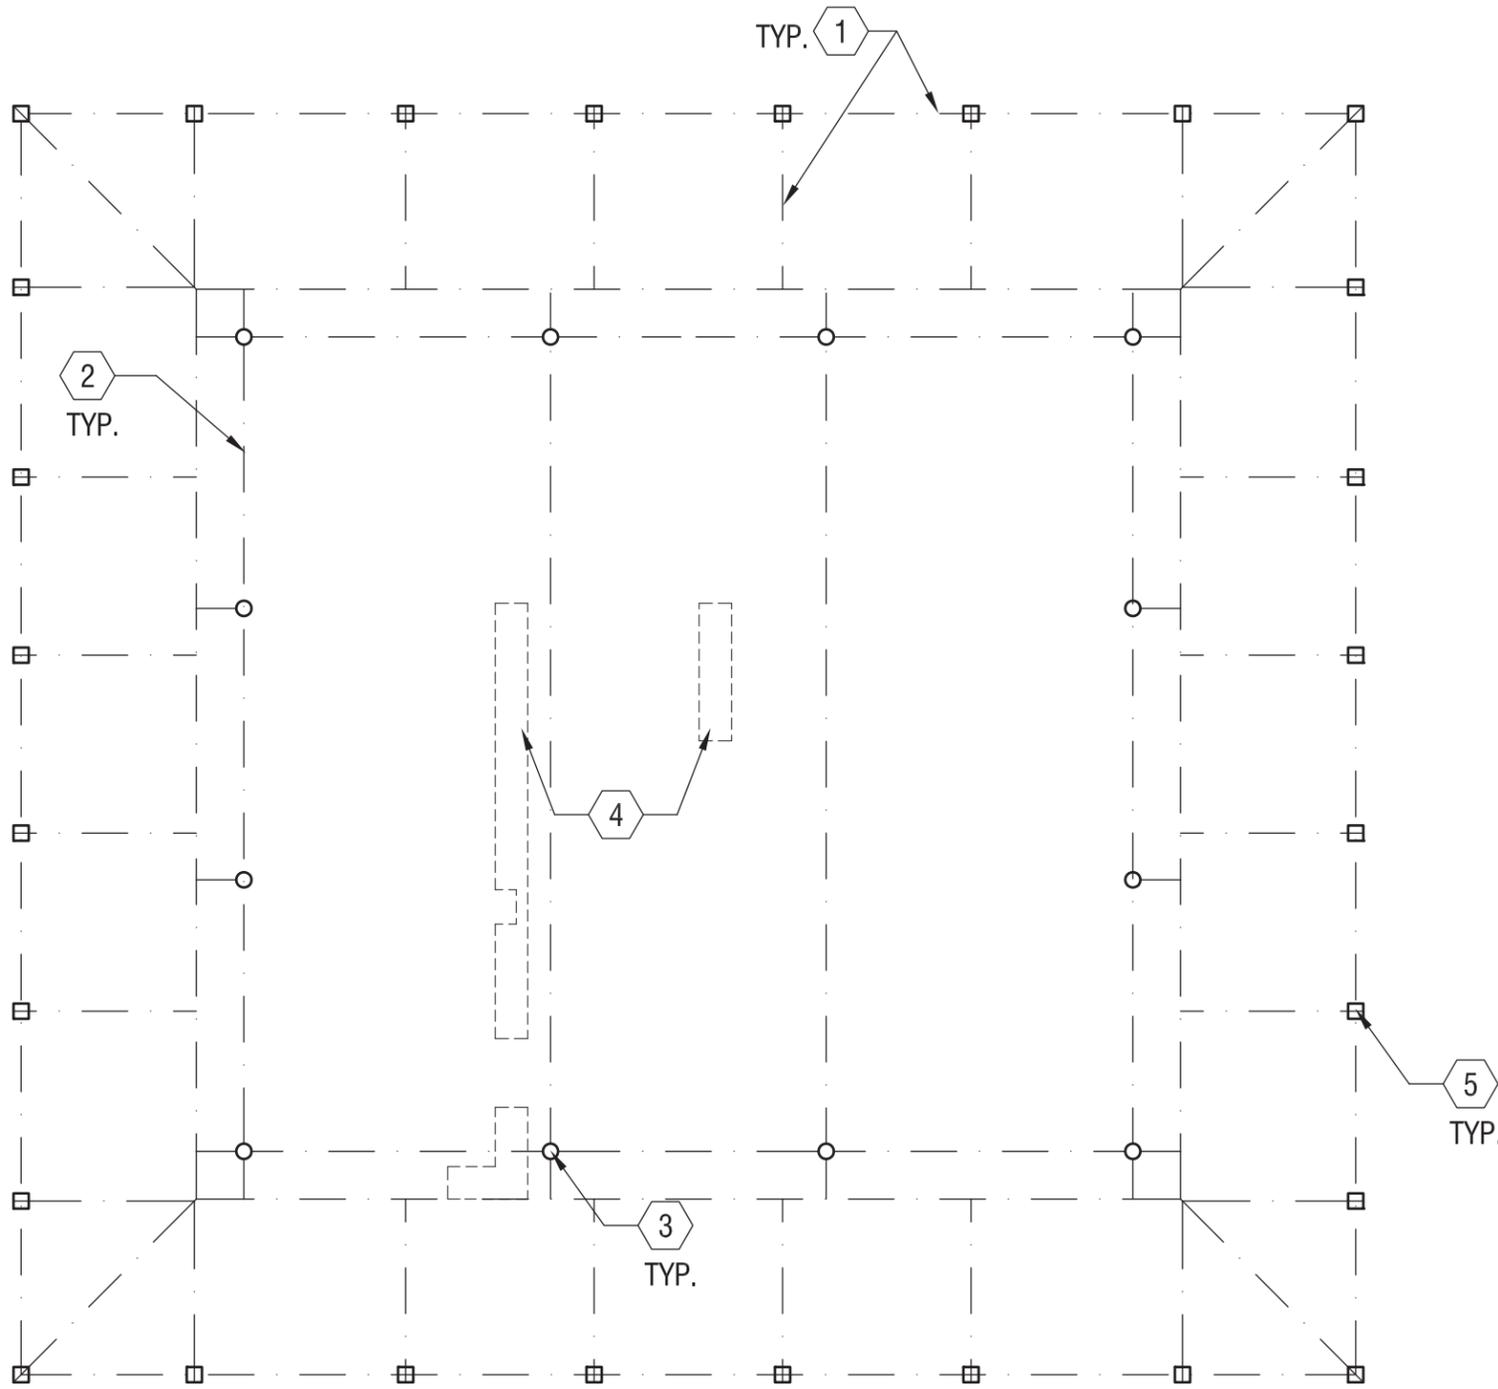
1 Foundation Plan
SCALE 1/8"=1'-0"

KEYNOTES

- ① EXISTING ADOBE WALL TO BE PRESERVED. REPAIR BASAL COVING.
- ② NEW FOOTING AT STEEL GHOST COLUMN.
- ③ NEW FOOTING AT STEEL SUPPORT COLUMN FOR PROTECTIVE ROOF.
- ④ SUB-SURFACE ADOBE WALLS POSSIBLE IN THIS LOCATION. PLACE NEW COLUMN FOOTING AWAY FROM ORIGINAL WALL ALIGNMENT.

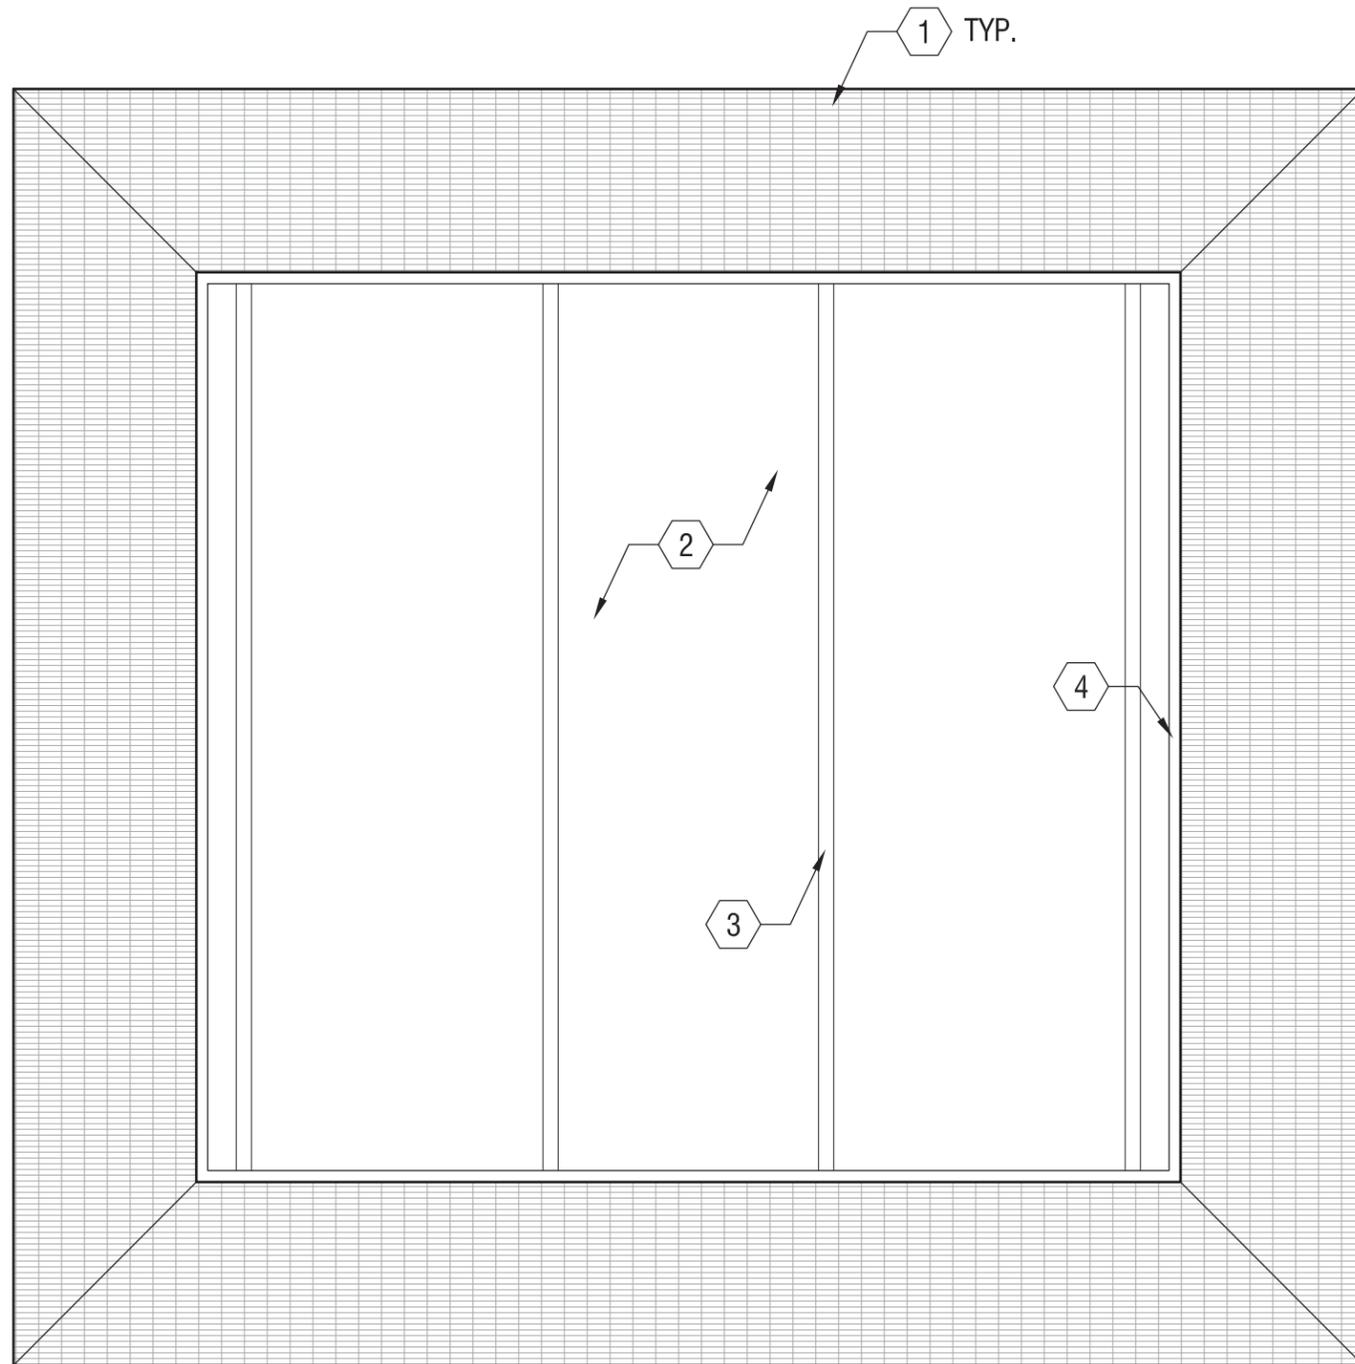
Officer's Quarters #1

KEYNOTES

- ① NEW STEEL FRAMING.
- ② NEW STEEL BEAMS AT COLUMNS. SET BEAMS TO RECEIVE NEW STEEL PORCH FRAMING.
- ③ NEW STEEL COLUMN TO SUPPORT UPPER GHOSTED FRAMING.
- ④ EXISTING ADOBE WALLS TO BE PRESERVED IN PLACE. PROTECT TOP OF WALL WITH SACRIFICIAL MUD CAP.
- ⑤ NEW STEEL COLUMN AT GHOSTED LOWER PORCH.

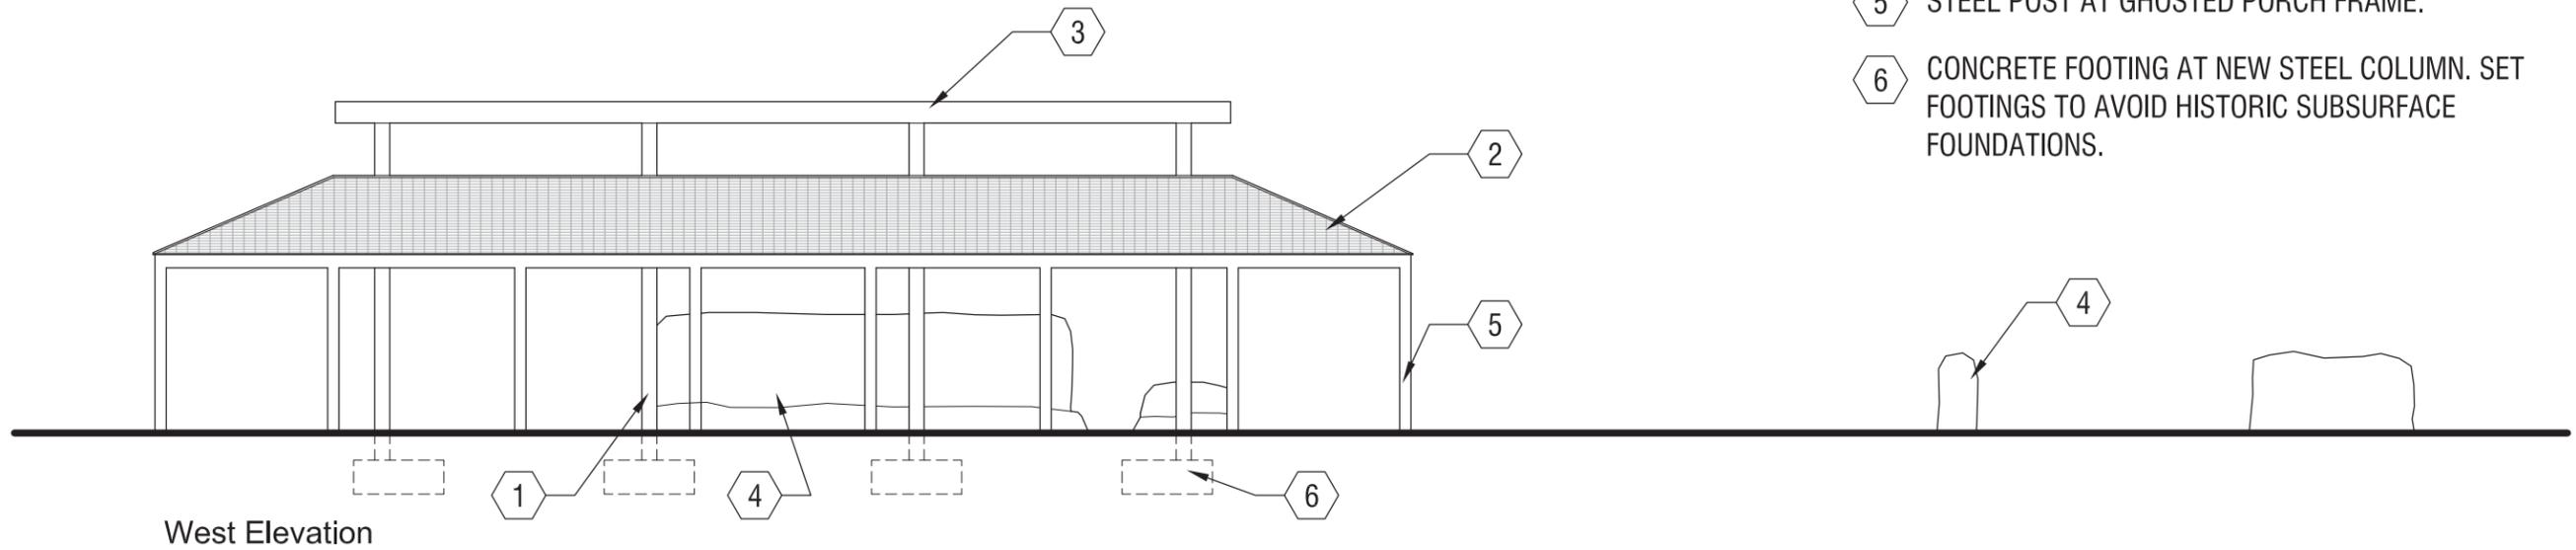
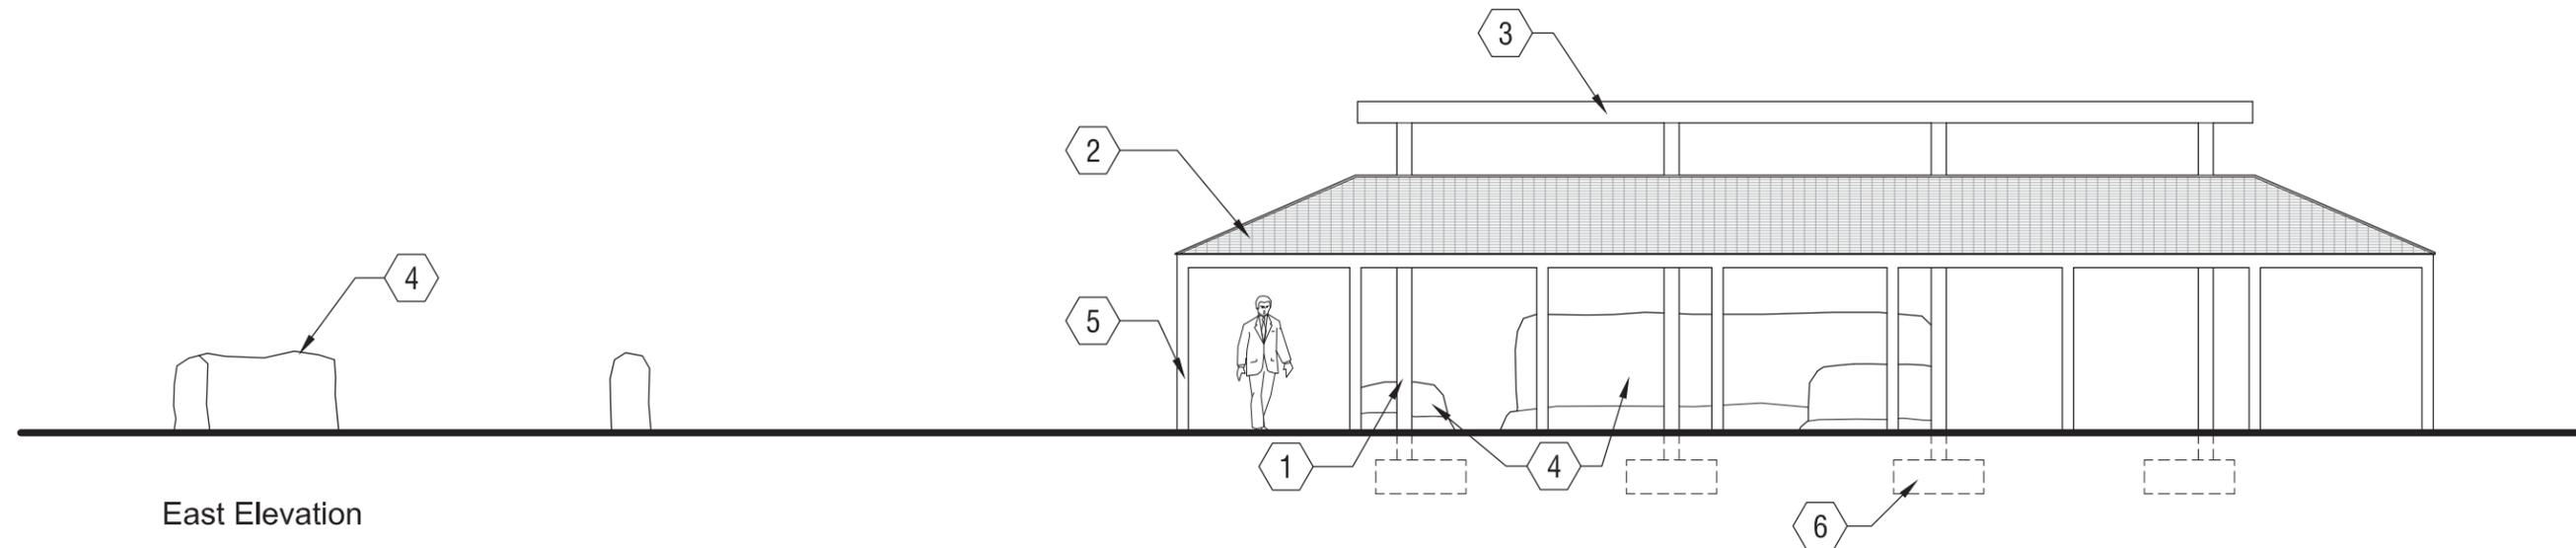
1 East and West Elevations
SCALE 1/8"=1'-0"

KEYNOTES

- ① NEW STEEL COLUMN TO SUPPORT GHOSTING.
- ② NEW STEEL FRAME WITH PERFORATED METAL ROOF AT PORCH GHOSTING.
- ③ UPPER GHOST FRAMING TO DEFINE EXTENT OF FORMER FORT-ERA BUILDING.
- ④ EXISTING ADOBE WALLS TO BE PRESERVED IN PLACE. PROTECT TOP OF WALL WITH SACRIFICIAL MUD CAP.
- ⑤ STEEL POST AT GHOSTED PORCH FRAME.
- ⑥ CONCRETE FOOTING AT NEW STEEL COLUMN. SET FOOTINGS TO AVOID HISTORIC SUBSURFACE FOUNDATIONS.

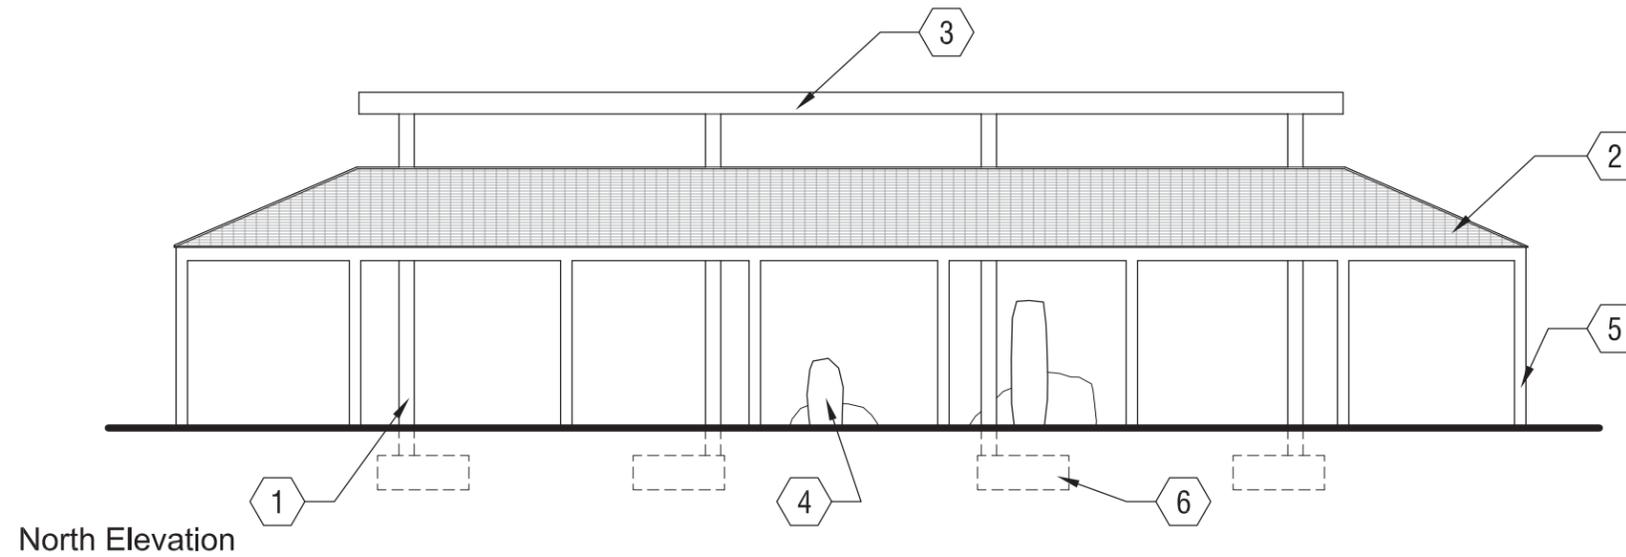
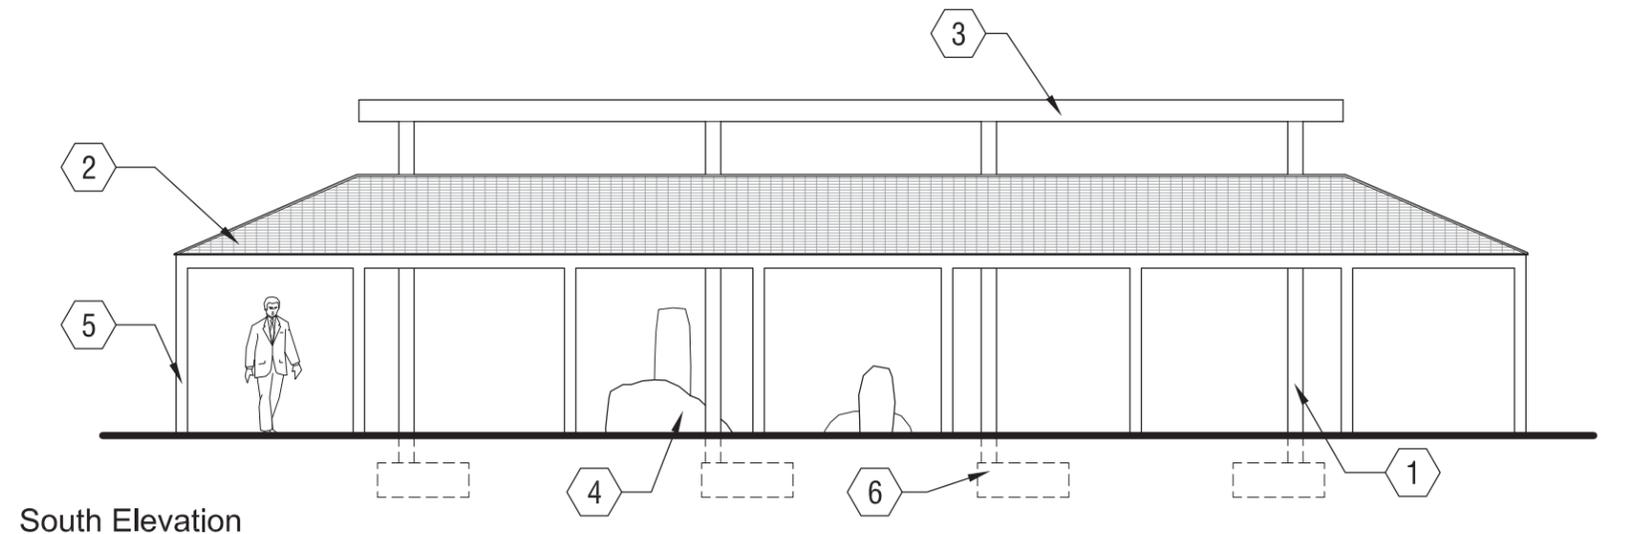
1 North and South Elevations
SCALE 1/8"=1'-0"

- ① NEW STEEL COLUMN TO SUPPORT GHOSTING.
- ② NEW STEEL FRAME WITH PERFORATED METAL ROOF AT PORCH GHOSTING.
- ③ UPPER GHOST FRAMING TO DEFINE EXTENT OF FORMER FORT-ERA BUILDING.
- ④ EXISTING ADOBE WALLS TO BE PRESERVED IN PLACE. PROTECT TOP OF WALL WITH SACRIFICIAL MUD CAP.
- ⑤ STEEL POST AT GHOSTED PORCH FRAME.
- ⑥ CONCRETE FOOTING AT NEW STEEL COLUMN. SET FOOTINGS TO AVOID HISTORIC SUBSURFACE FOUNDATIONS.

North Elevation

South Elevation

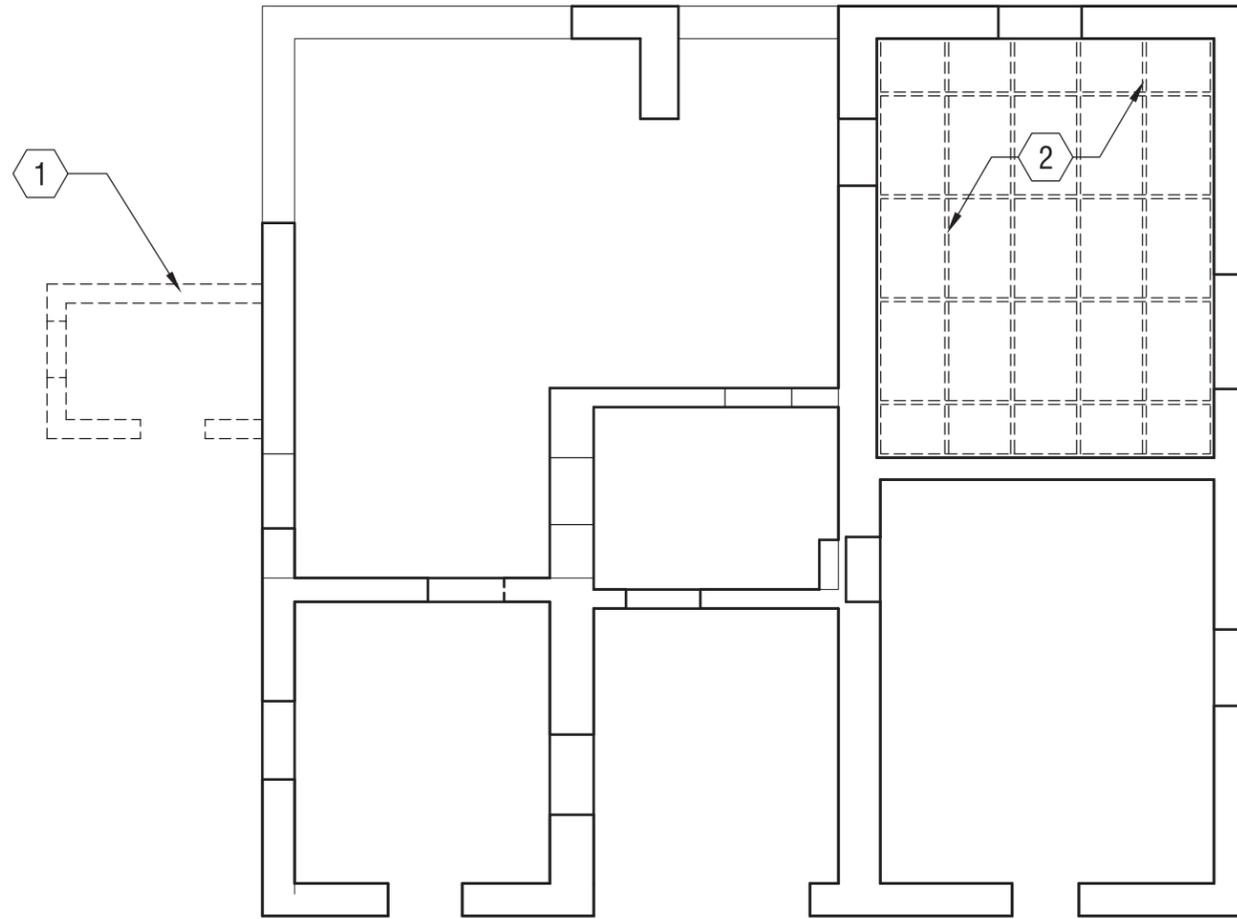
1 Officer's Quarters De-Construction Floor Plan
SCALE 1/8"=1'-0"

KEYNOTES

- 1** REMOVE POURED-IN-PLACE CONCRETE ROOM. STABILIZE ADOBE WALL PRIOR TO REMOVAL.
- 2** REMOVE REMAINING WOOD FLOOR SLEEPERS IN THIS ROOM. IF DRAINAGE AND TERMITES ARE NOT AN ISSUE ONCE THE PROTECTIVE ROOF IS INSTALLED, THE SLEEPERS COULD REMAIN FOR INTERPRETIVE PURPOSES.

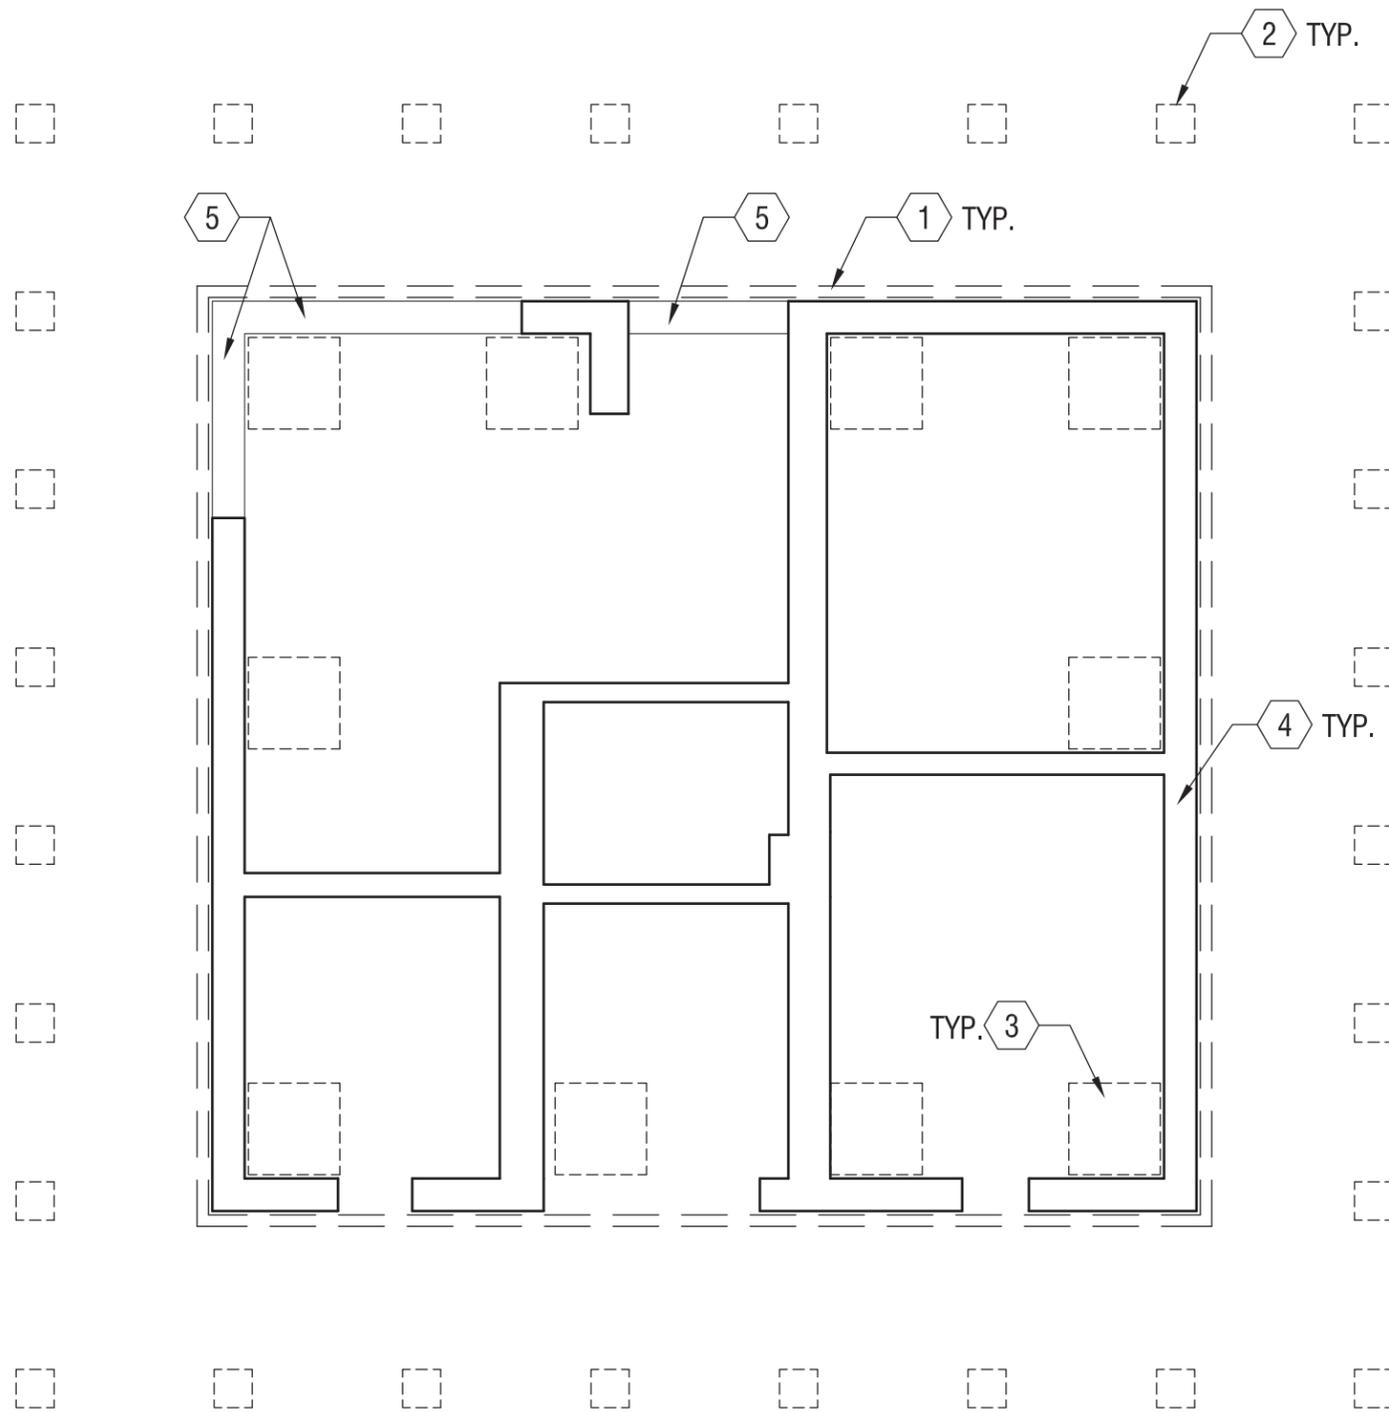
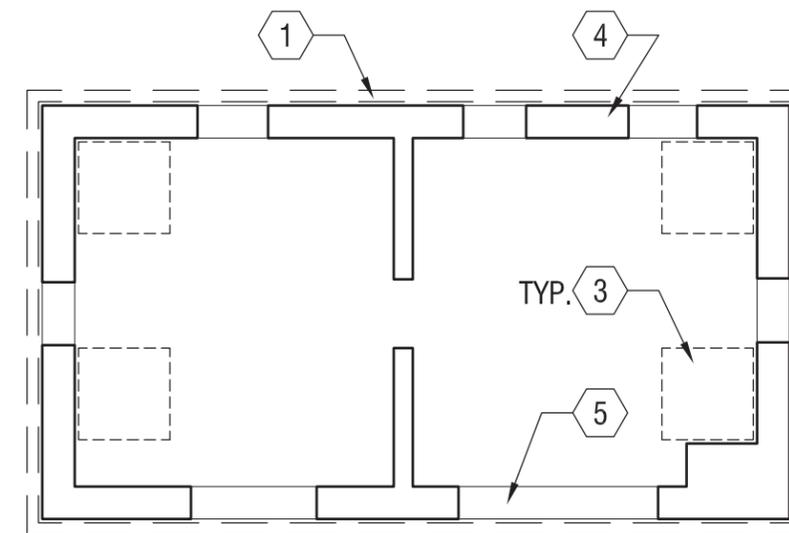
① Officer's Quarters Foundation Plan
SCALE 1/8"=1'-0"

KEYNOTES

- ① FOUNDATION DRAIN.
- ② NEW FOOTING AT STEEL GHOST COLUMN.
- ③ NEW FOOTING AT STEEL SUPPORT COLUMN FOR PROTECTIVE ROOF.
- ④ EXISTING ADOBE WALL. REPAIR AS REQUIRED
- ⑤ SUB-SURFACE ADOBE WALLS POSSIBLE IN THIS LOCATION. PLACE NEW COLUMN FOOTING AWAY FROM ORIGINAL WALL ALIGNMENT.

② Kitchen Foundation Plan
SCALE 1/8"=1'-0"

A comprehensive grading and drainage plan for the entire Adkins Parcel will be developed during project implementation. Water harvesting opportunities should be pursued to enhance the landscape. A foundation drainage system is proposed for the Officer's Quarters #2 and #3 to alleviate the moisture around the building.

Areas of the foundation walls that have settled will need to be repaired. Two options have been recommended: Option one is to stabilize the existing walls using low impact "adobe cages" per the design of architectural conservators, Crocker, Ltd. The other option is to over-excavate and compact the soil before rebuilding the walls. A foundation drain is proposed to be installed at the outside edge of the reconstructed wrap-around porch.

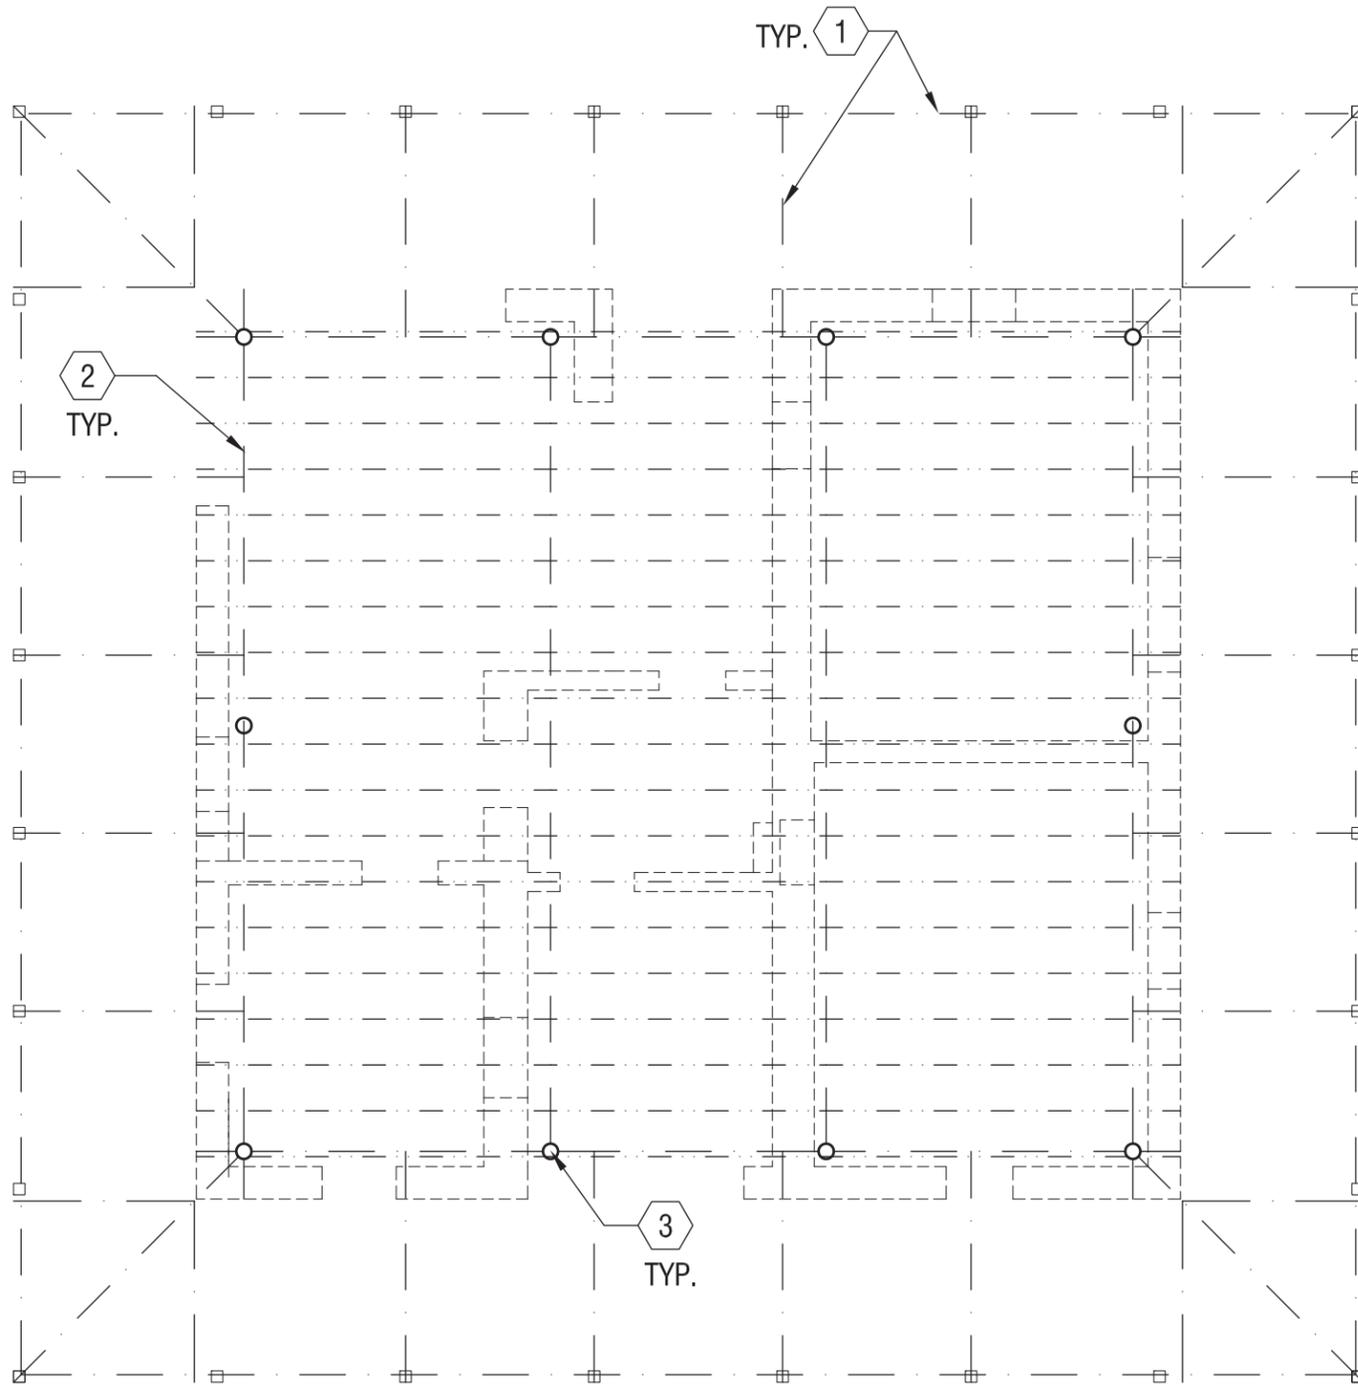
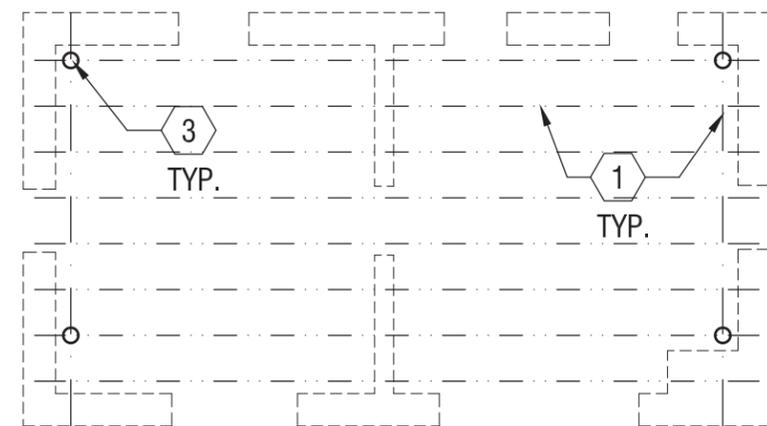
① Officer's Quarters Framing Plan
SCALE 1/8"=1'-0"

KEYNOTES

- ① NEW STEEL FRAMING.
- ② NEW STEEL BEAMS AT COLUMNS. SET BEAMS TO RECEIVE NEW STEEL PORCH FRAMING.
- ③ NEW STEEL COLUMN.

② Kitchen Framing Plan
SCALE 1/8"=1'-0"

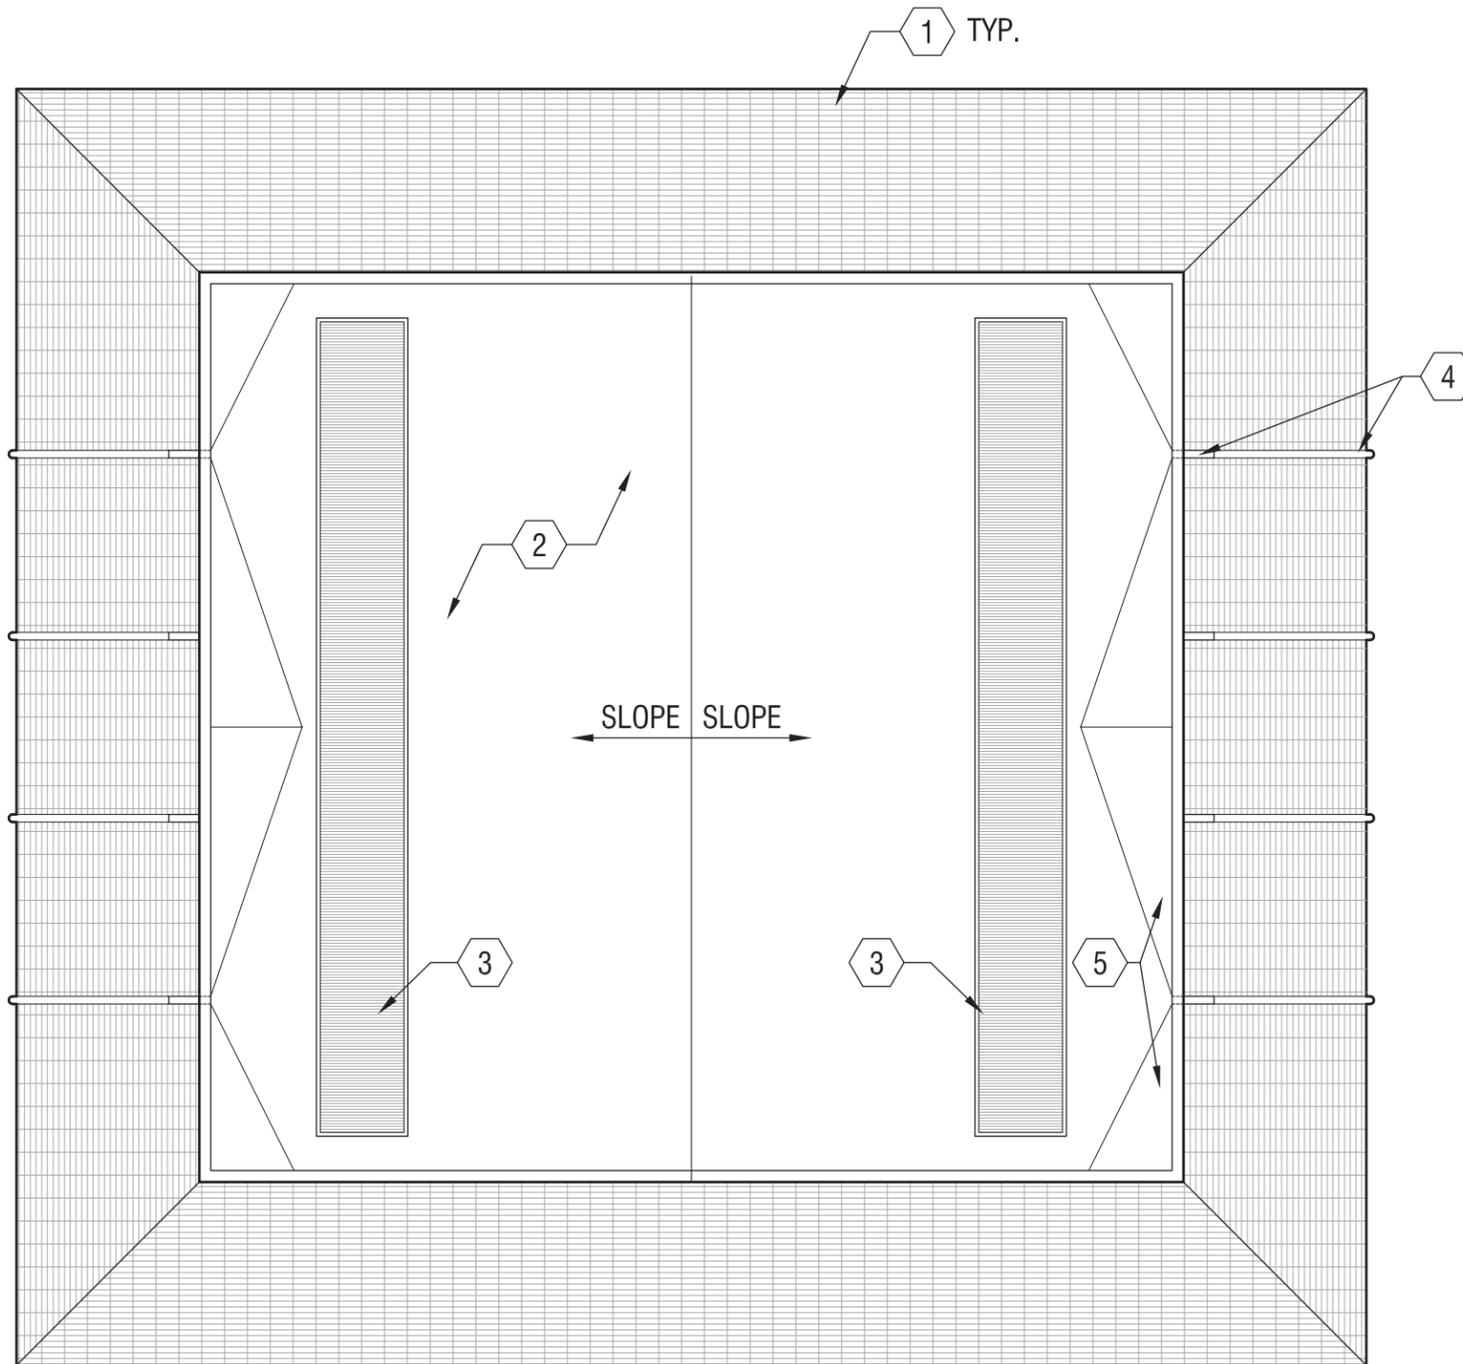
1 Officer's Quarters Roof Plan
SCALE 1/8"=1'-0"

KEYNOTES

- 1 NEW PERFORATED METAL OVER NEW STEEL FRAMING AT PORCH ROOF.
- 2 NEW SLOPED METAL ROOF.
- 3 NEW GLASS PANEL AT METAL ROOF.
- 4 CUSTOM FABRICATE HISTORICAL CANALES AND LEADERS (WHERE SHOWN) BASED ON DOCUMENTATION.
- 5 NEW ROOF CRICKET.

The upper roof drains to the east and west parapets where there are 4 canales near the top of each wall. The canales have been problematic, especially above the window at the northwest corner where the adobe and wood lintel above the window are severely deteriorated and supported with bracing. Although the 1904 shows one remaining canale on the west side of the building, the existing canales do not appear to be from the Fort Period. Fort-era photographs show extensions from the canales to the edge of the wrap-around porch.

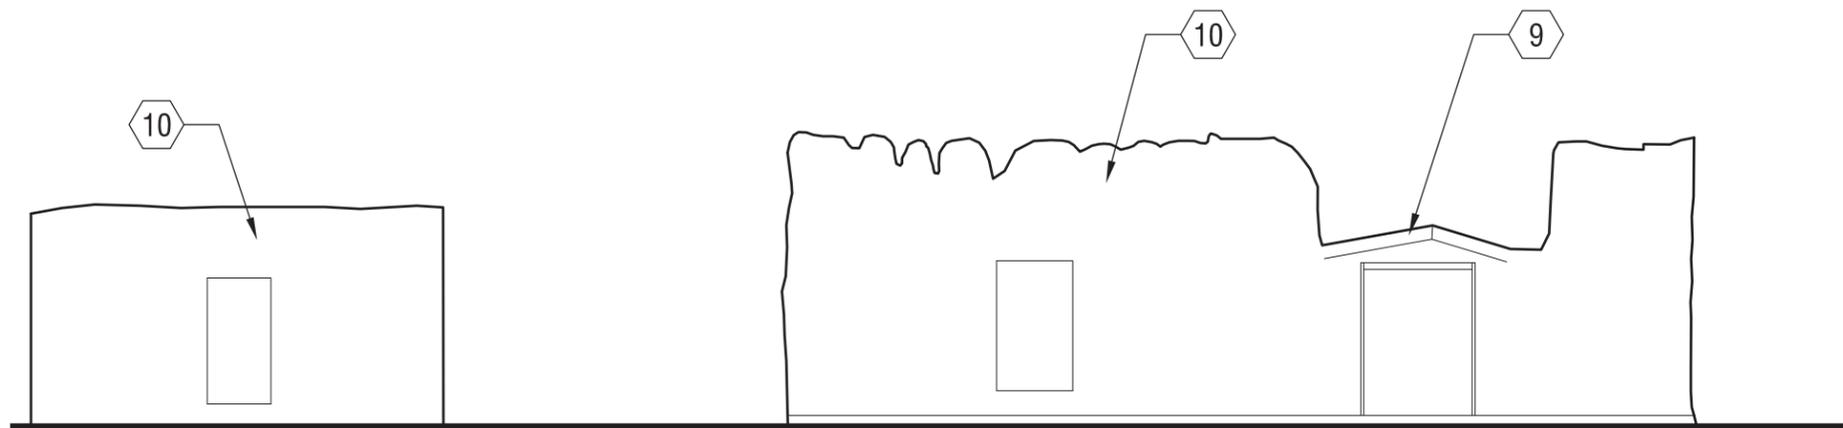
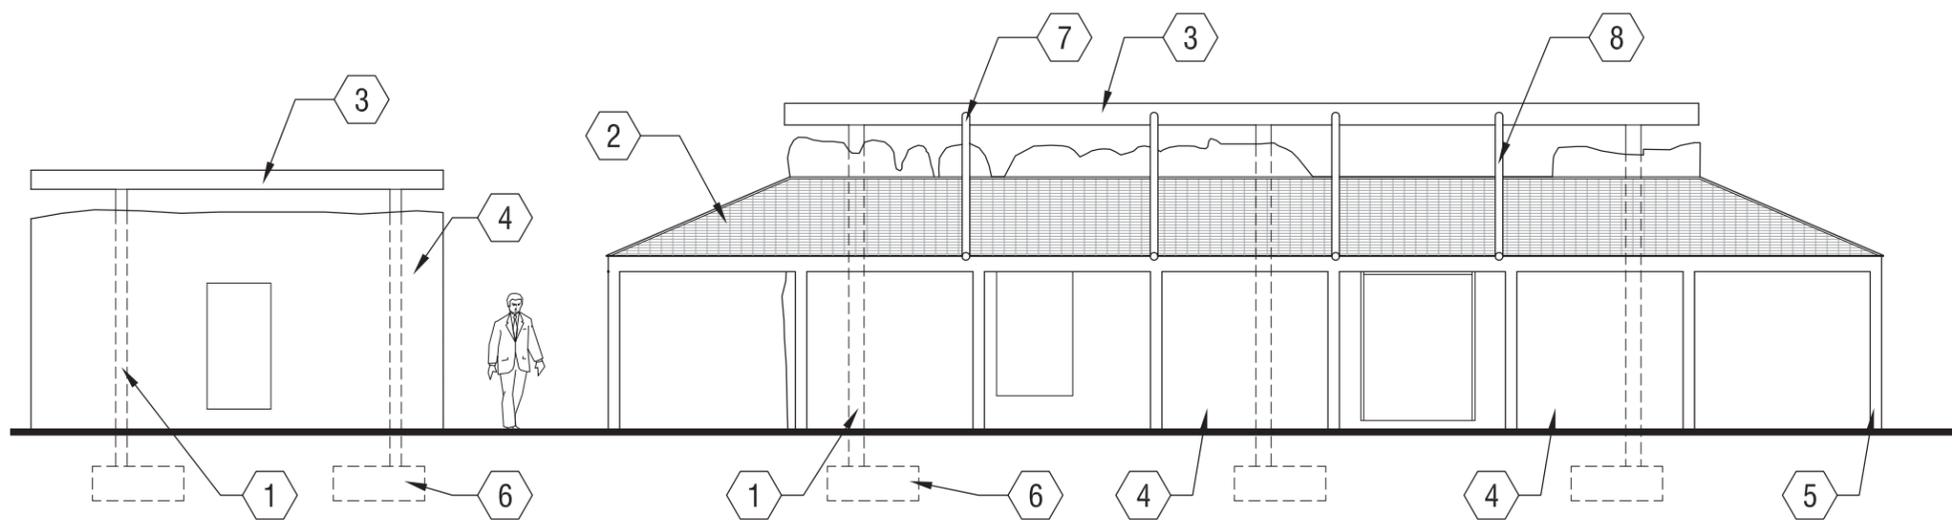
Kitchen
Existing East Elevation

Kitchen
Proposed East Elevation

- 1 NEW STEEL COLUMN TO SUPPORT GHOSTING.
- 2 NEW STEEL FRAME WITH PERFORATED METAL ROOF AT PORCH GHOSTING.
- 3 UPPER GHOST FRAMING TO DEFINE EXTENT OF FORMER FORT-ERA BUILDING.
- 4 EXISTING ADOBE WALLS TO BE PRESERVED IN PLACE. REPAIR UNSTABLE AREAS WITH LIKE MATERIALS. CONSIDER POLYESTER WEBBING ATTACHED TO NEW STEEL COLUMNS TO PROVIDE ADDITIONAL STABILITY.
- 5 STEEL POST AT GHOSTED PORCH FRAME.
- 6 CONCRETE FOOTING AT NEW STEEL COLUMN. SET FOOTINGS TO AVOID HISTORIC SUBSURFACE FOUNDATIONS.
- 7 STEEL CANALE TO DRAIN UPPER ROOF.
- 8 STEEL RAIN WATER LEADER FROM CANALE TO EDGE OF PORCH GHOSTING.
- 9 REPAIR DETERIORATED LINTEL IN THIS AREA. CONSIDER NEW ADOBE INFILL TO STABILIZE WALLS.
- 10 EXISTING ADOBE WALL.

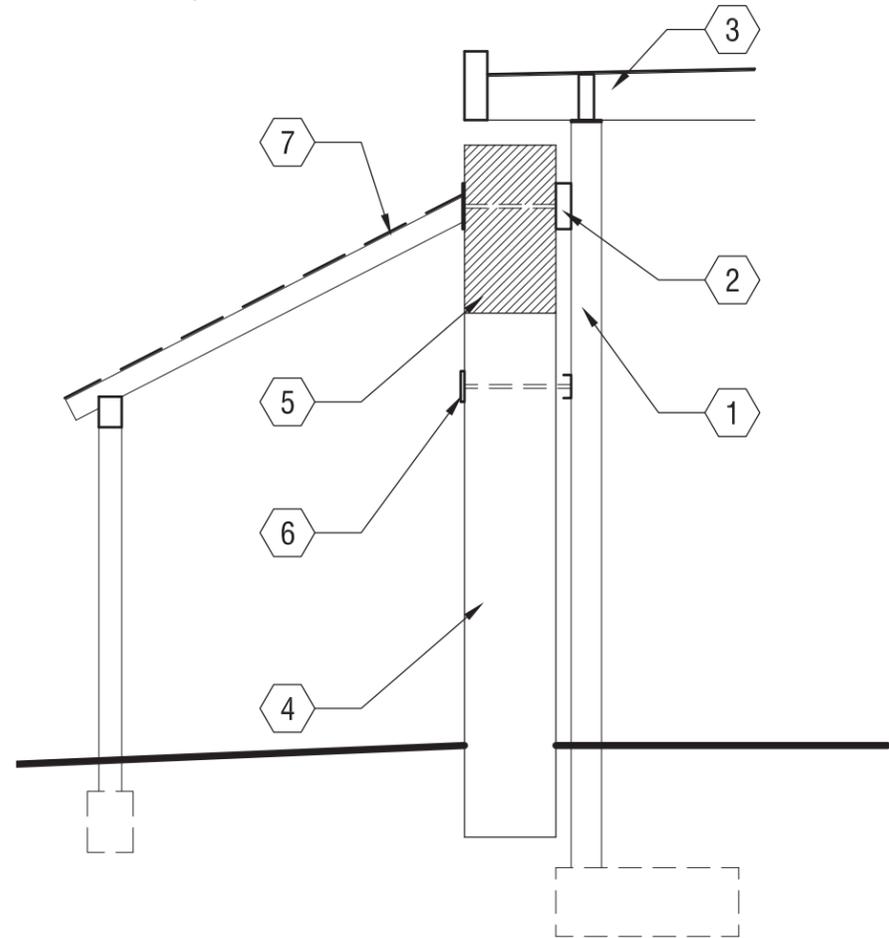
2 Optional Wall Section at New Porch Roof
SCALE 1/4"=1'-0"

KEYNOTES

- 1 NEW STEEL COLUMN AT INSIDE OF EXISTING ADOBE WALL.
- 2 NEW STEEL TUBE ATTACHED TO NEW STEEL COLUMN. WELD THREADED ROD TO STEEL TUBE AND CORE THROUGH ADOBE WALL. ATTACH STEEL PLATE THREADED ROD. WELD NEW STEEL PORCH JOIST TO STEEL PLATE.
- 3 NEW STEEL FRAME WITH METAL ROOF.
- 4 EXISTING ADOBE WALL. REPAIR AS REQUIRED.
- 5 EXISTING ADOBE OR NEW ADOBE INFILL, IF REQUIRED. CONSIDER DISTINGUISHING NEW ADOBE FROM OLD WITH MUD PLASTER OR DIFFERENT COLOR OF ADOBE.
- 6 12,000 LB. TEST POLYESTER WEBBING (IF REQUIRED) AT LINTEL HEIGHT. TIE TO WOOD LINTELS AND TO INTERIOR STEEL COLUMNS.
- 7 PERFORATED METAL ROOF.
- 8 STEEL STRUT TO CARRY GHOSTED PORCH FRAME.
- 9 (OPTIONAL) NEW ADOBE INFILL, AS REQUIRED TO STABILIZE WALL.
