Preservation Plan

*for the
Adkins Parcel at Fort Lowell Park*

November 2009

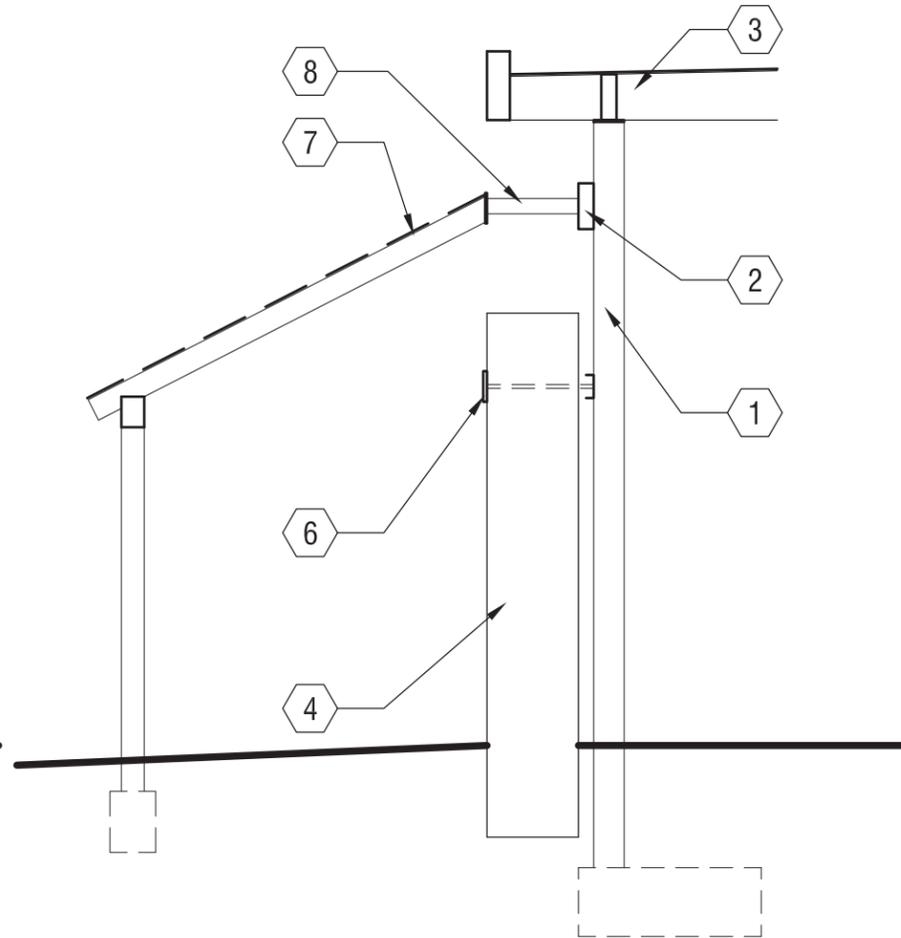
3 Wall Section at New Porch Roof
SCALE 1/4"=1'-0"

KEYNOTES

- 1 NEW STEEL COLUMN AT INSIDE OF EXISTING ADOBE WALL.
- 2 NEW STEEL TUBE ATTACHED TO NEW STEEL COLUMN. WELD THREADED ROD TO STEEL TUBE AND CORE THROUGH ADOBE WALL. ATTACH STEEL PLATE THREADED ROD. WELD NEW STEEL PORCH JOIST TO STEEL PLATE.
- 3 NEW STEEL FRAME WITH METAL ROOF.
- 4 EXISTING ADOBE WALL. REPAIR AS REQUIRED.
- 5 EXISTING ADOBE OR NEW ADOBE INFILL, IF REQUIRED. CONSIDER DISTINGUISHING NEW ADOBE FROM OLD WITH MUD PLASTER OR DIFFERENT COLOR OF ADOBE.
- 6 12,000 LB. TEST POLYESTER WEBBING (IF REQUIRED) AT LINTEL HEIGHT. TIE TO WOOD LINTELS AND TO INTERIOR STEEL COLUMNS.
- 7 PERFORATED METAL ROOF.
- 8 STEEL STRUT TO CARRY GHOSTED PORCH FRAME.
- 9 (OPTIONAL) NEW ADOBE INFILL, AS REQUIRED TO STABILIZE WALL.

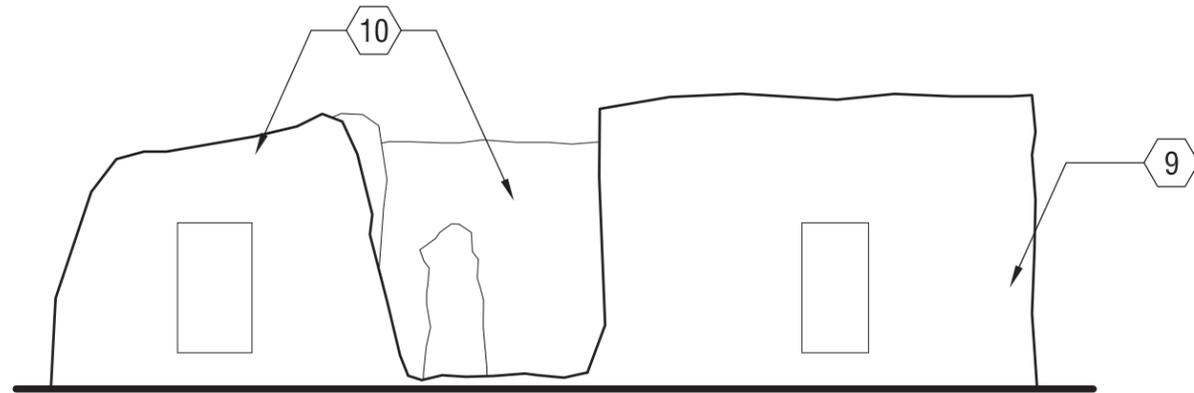
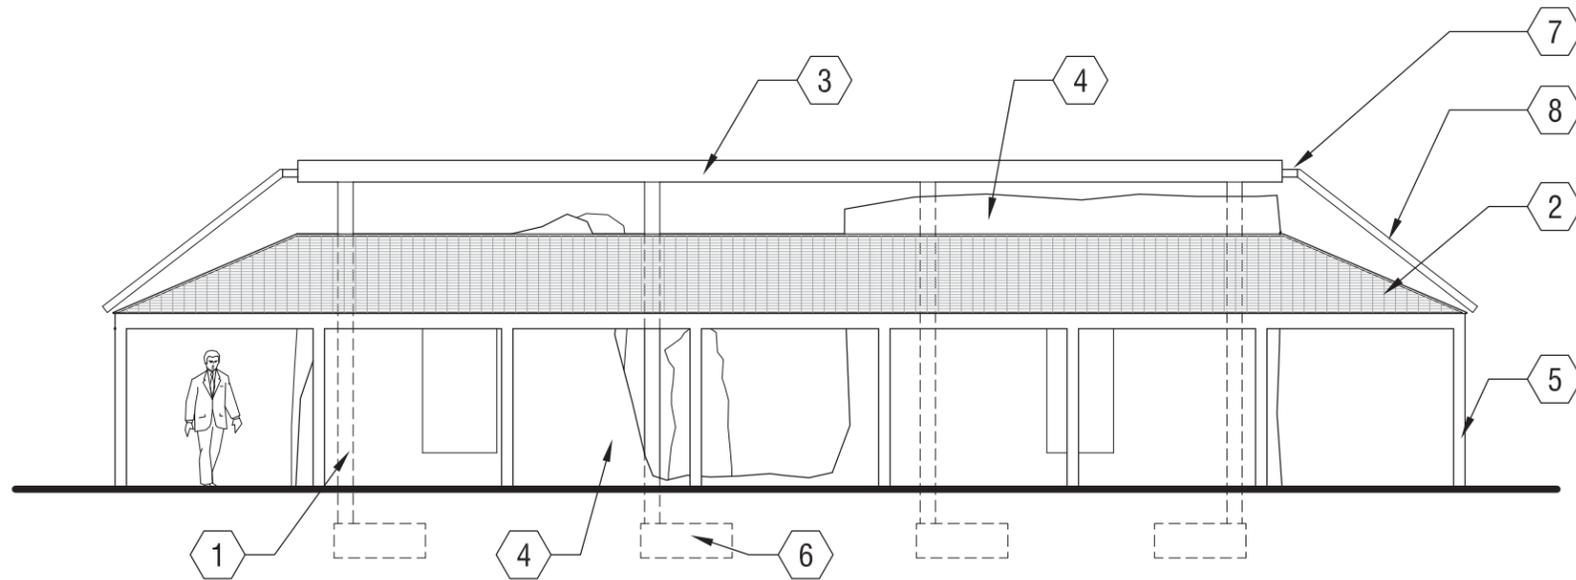
Existing South Elevation

Proposed South Elevation

KEYNOTES

- 1 NEW STEEL COLUMN TO SUPPORT GHOSTING.
- 2 NEW STEEL FRAME WITH PERFORATED METAL ROOF AT PORCH GHOSTING.
- 3 UPPER GHOST FRAMING TO DEFINE EXTENT OF FORMER FORT-ERA BUILDING.
- 4 EXISTING ADOBE WALLS TO BE PRESERVED IN PLACE. REPAIR UNSTABLE AREAS WITH LIKE MATERIALS. CONSIDER POLYESTER WEBBING ATTACHED TO NEW STEEL COLUMNS TO PROVIDE ADDITIONAL STABILITY.
- 5 STEEL POST AT GHOSTED PORCH FRAME.
- 6 CONCRETE FOOTING AT NEW STEEL COLUMN. SET FOOTINGS TO AVOID HISTORIC SUBSURFACE FOUNDATIONS.
- 7 STEEL CANALE TO DRAIN UPPER ROOF.
- 8 STEEL RAIN WATER LEADER FROM CANALE TO EDGE OF PORCH GHOSTING.
- 9 POST FORT-ERA POURED-IN-PLACE CONCRETE ROOM TO BE REMOVED.
- 10 EXISTING ADOBE WALL.

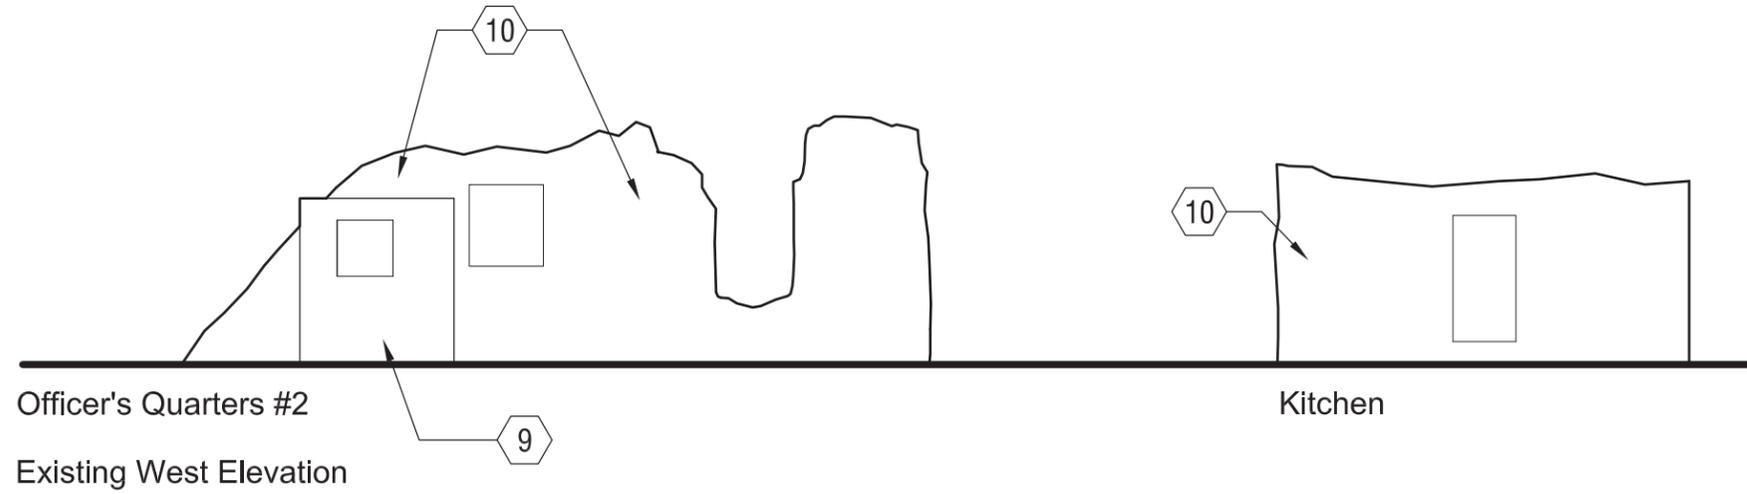
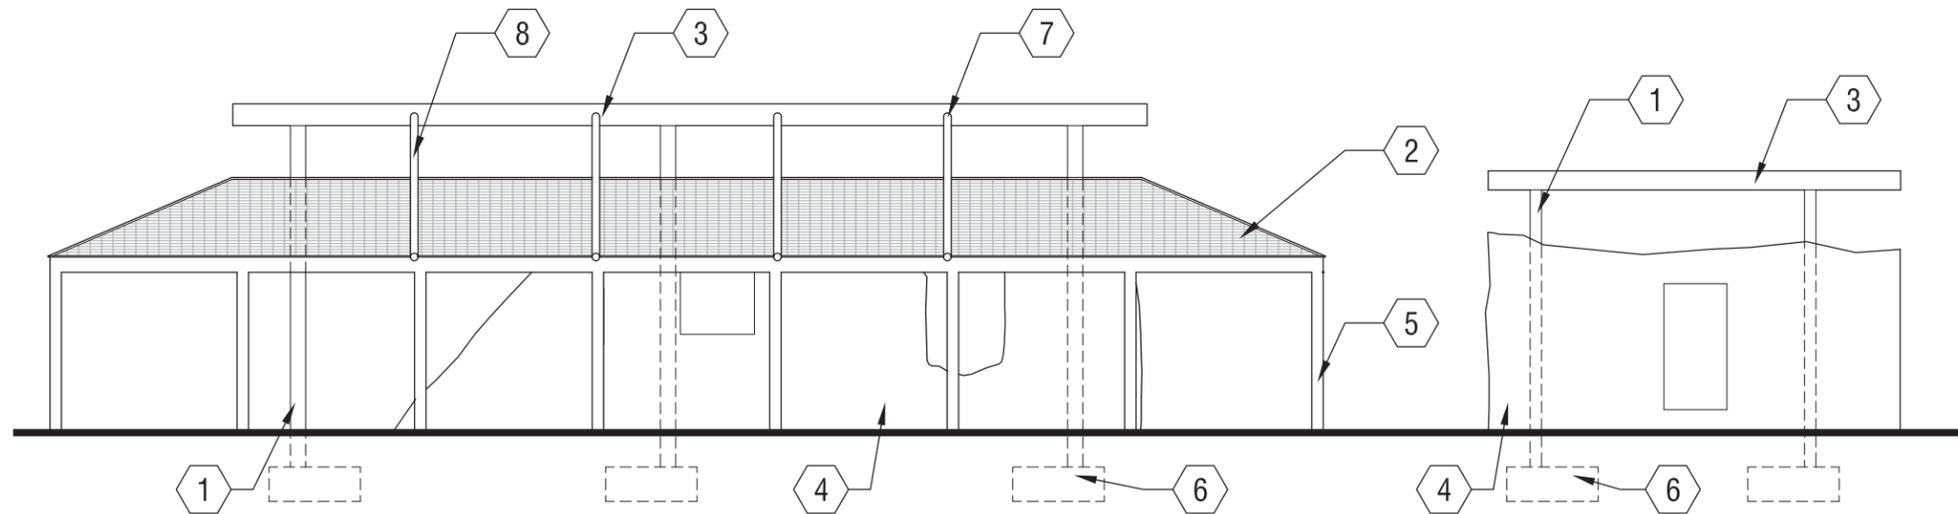
Officer's Quarters #2
Existing West Elevation

Officer's Quarters #2
Proposed West Elevation

- 1 NEW STEEL COLUMN TO SUPPORT GHOSTING.
- 2 NEW STEEL FRAME WITH PERFORATED METAL ROOF AT PORCH GHOSTING.
- 3 UPPER GHOST FRAMING TO DEFINE EXTENT OF FORMER FORT-ERA BUILDING.
- 4 EXISTING ADOBE WALLS TO BE PRESERVED IN PLACE. REPAIR UNSTABLE AREAS WITH LIKE MATERIALS. CONSIDER POLYESTER WEBBING ATTACHED TO NEW STEEL COLUMNS TO PROVIDE ADDITIONAL STABILITY.
- 5 STEEL POST AT GHOSTED PORCH FRAME.
- 6 CONCRETE FOOTING AT NEW STEEL COLUMN. SET FOOTINGS TO AVOID HISTORIC SUBSURFACE FOUNDATIONS.
- 7 STEEL CANALE TO DRAIN UPPER ROOF.
- 8 STEEL RAIN WATER LEADER FROM CANALE TO EDGE OF PORCH GHOSTING.
- 9 POST FORT-ERA POURED-IN-PLACE CONCRETE ROOM TO BE REMOVED.
- 10 EXISTING ADOBE WALL.

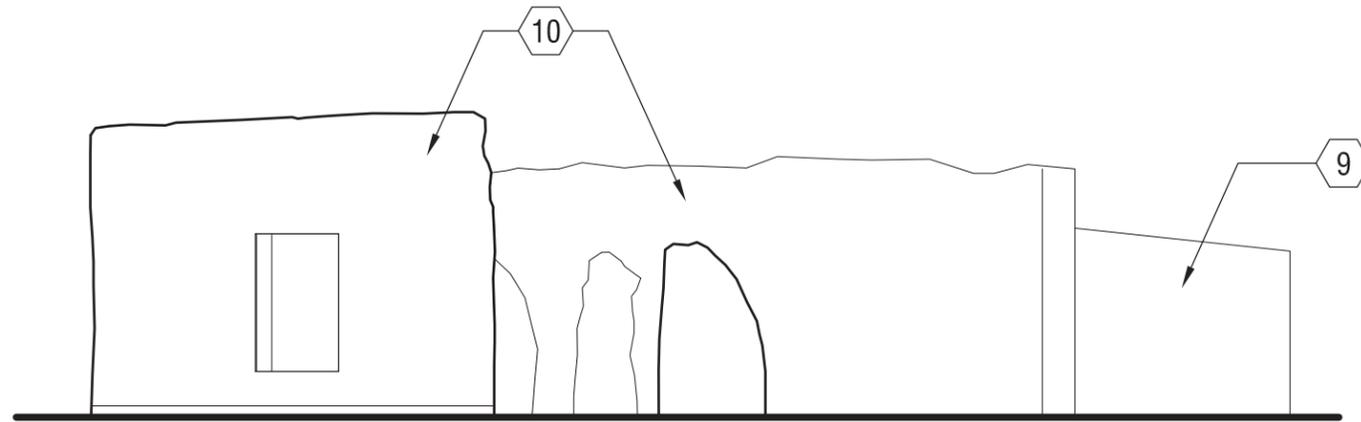
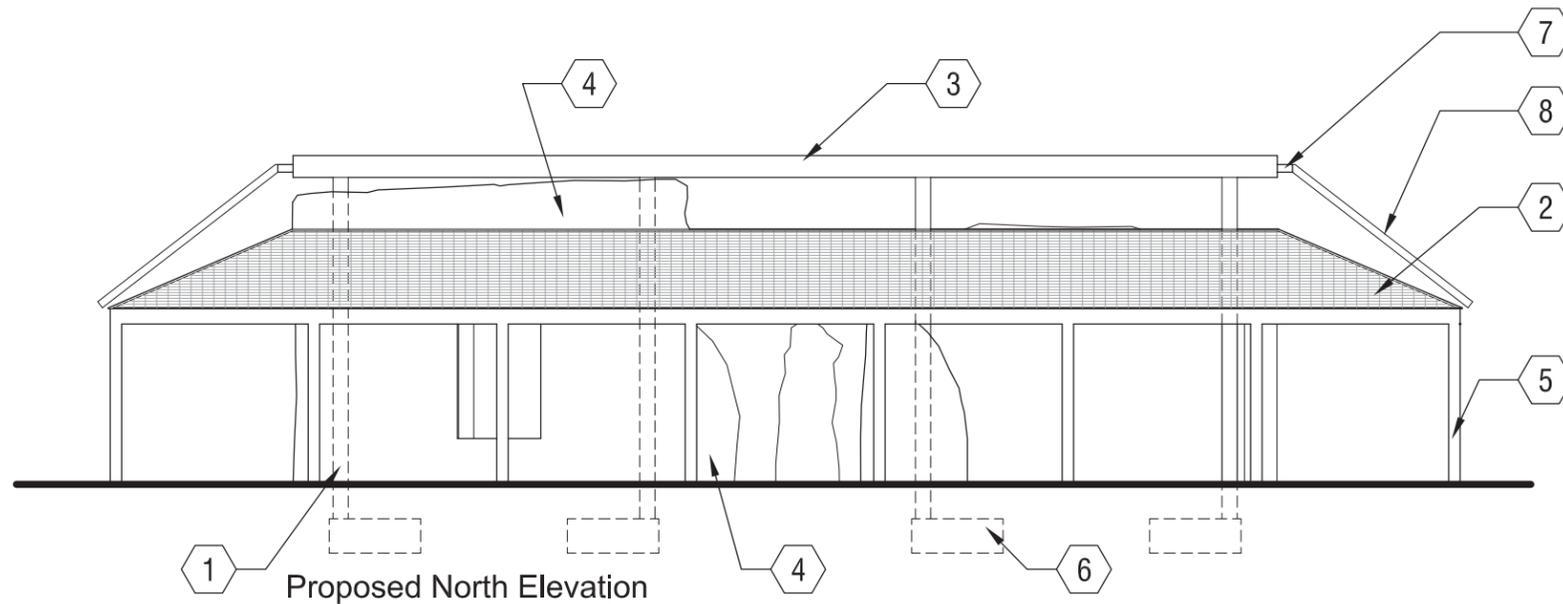
Existing North Elevation

Proposed North Elevation

KEYNOTES

- 1 NEW STEEL COLUMN TO SUPPORT GHOSTING.
- 2 NEW STEEL FRAME WITH PERFORATED METAL ROOF AT PORCH GHOSTING.
- 3 UPPER GHOST FRAMING TO DEFINE EXTENT OF FORMER FORT-ERA BUILDING.
- 4 EXISTING ADOBE WALLS TO BE PRESERVED IN PLACE. REPAIR UNSTABLE AREAS WITH LIKE MATERIALS. CONSIDER POLYESTER WEBBING ATTACHED TO NEW STEEL COLUMNS TO PROVIDE ADDITIONAL STABILITY.
- 5 STEEL POST AT GHOSTED PORCH FRAME.
- 6 CONCRETE FOOTING AT NEW STEEL COLUMN. SET FOOTINGS TO AVOID HISTORIC SUBSURFACE FOUNDATIONS.
- 7 STEEL CANALE TO DRAIN UPPER ROOF.
- 8 STEEL RAIN WATER LEADER FROM CANALE TO EDGE OF PORCH GHOSTING.
- 9 POST FORT-ERA POURED-IN-PLACE CONCRETE ROOM TO BE REMOVED.
- 10 EXISTING ADOBE WALL.

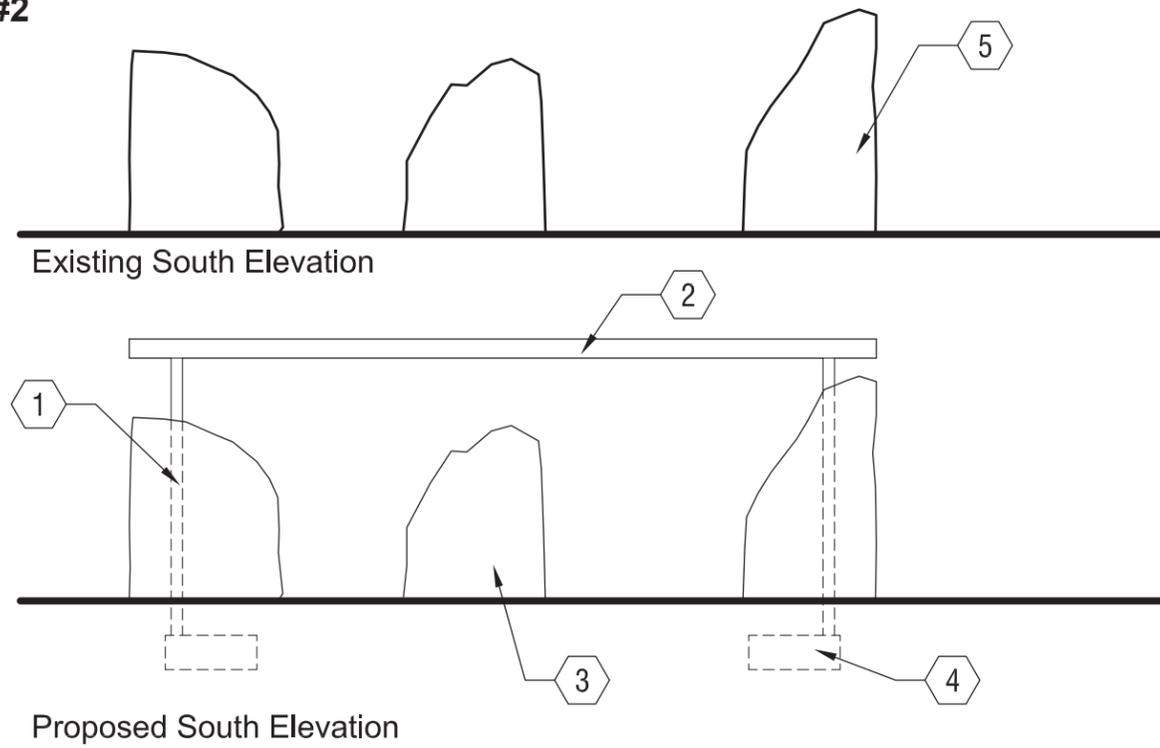
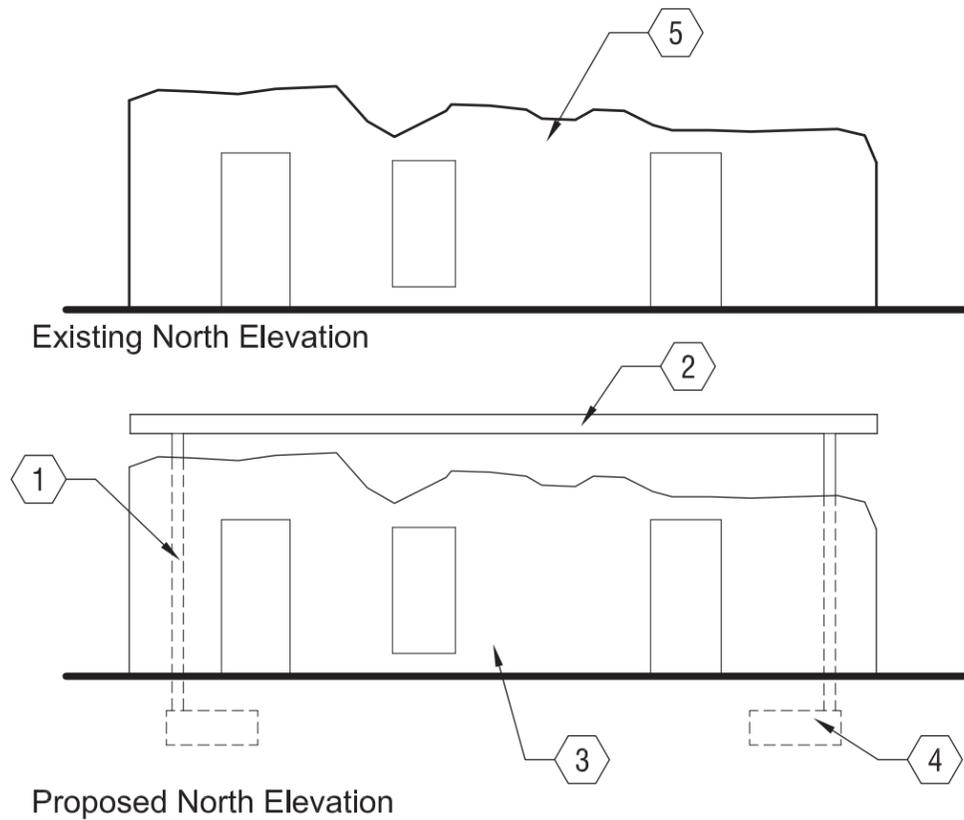
1 North and South Kitchen Elevations
SCALE 1/8"=1'-0"

KEYNOTES

- 1 NEW STEEL COLUMN TO SUPPORT GHOSTING.
- 2 UPPER GHOST FRAMING TO DEFINE EXTENT OF FORMER FORT-ERA BUILDING.
- 3 EXISTING ADOBE WALLS TO BE PRESERVED IN PLACE. REPAIR UNSTABLE AREAS WITH LIKE MATERIALS. CONSIDER POLYESTER WEBBING ATTACHED TO NEW STEEL COLUMNS TO PROVIDE ADDITIONAL STABILITY.
- 4 CONCRETE FOOTING AT NEW STEEL COLUMN. SET FOOTINGS TO AVOID HISTORIC SUBSURFACE FOUNDATIONS.
- 5 EXISTING ADOBE WALL.

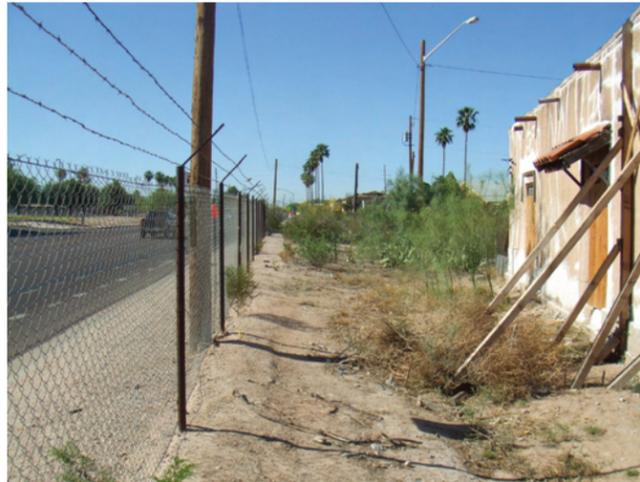
Figure 49: Drainage swale to the east of the building.

A comprehensive grading and drainage plan for the entire Adkins Parcel will be developed during project implementation. Water harvesting opportunities should be pursued to enhance the landscape. A foundation drainage system is proposed for the Officer's Quarters #2 and #3 to alleviate the moisture around the building.

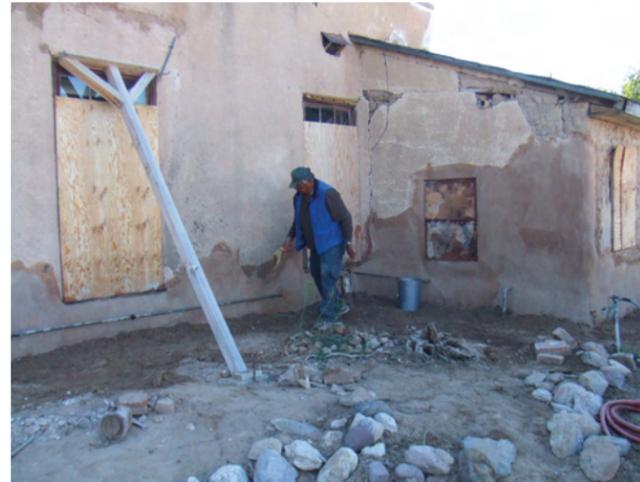
Figure 50: West wall after removal of the *contrapared*.

The buildings at Fort Lowell were constructed without foundations. According to an archaeological report prepared by Johnson in 1960, 4 to 5 courses of adobe, the same thickness of the wall above, were laid in shallow trenches on top of the local caliche subsurface. In the 20th century, concrete contra-pared and cement-based parging was applied to the walls at the ground level to presumably stop deterioration. These non-pervious treatments have contributed to basal erosion. The condition of subsurface adobes has not been evaluated. The most notable area of subsidence is at the northeast corner of the building where moisture has caused the wall to settle.

Areas of the foundation walls that have settled will need to be repaired. Two options have been recommended: Option one is to stabilize the existing walls using low impact "adobe cages" per the design of architectural conservators, Crocker, Ltd. The other option is to over-excavate and compact the soil before rebuilding the walls. A foundation drain is proposed to be installed at the outside edge of the reconstructed wrap-around porch.

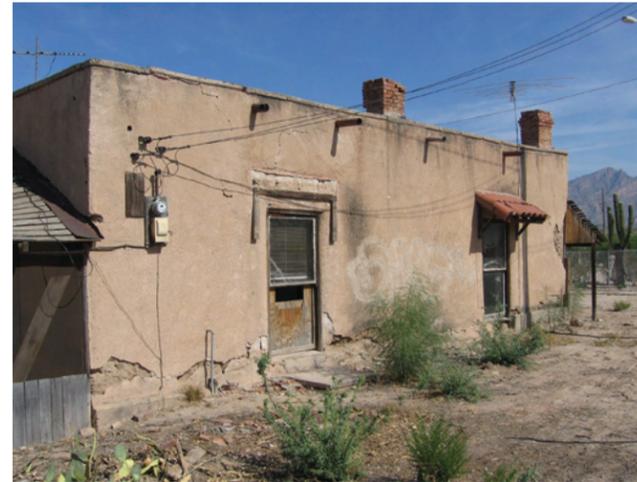
Figure 51: East Elevation

Exterior walls are constructed of unfired adobe brick with a dimension of 20" x 12" x 4". Adobe bricks were laid crosswise at exterior walls to give the walls a 20" thickness. Exterior walls do not appear to have been plastered during the Fort Period. Plaster was likely added in the early decades of the 20th Century during the Sanatorium Period. Exterior adobe walls are in fair condition. The northeast corner has separated and subsided presumably due to moisture being held in the soil on the east side of the building. As a whole, the east wall suffers from basal coving as a result of moisture that has wicked into the adobe and is trapped by the impervious cement stucco. Deterioration is also present around window openings and below scuppers on both the east and west walls. Large cracks are visible on the north wall, possibly as a result of the movement in the northeast corner.

The removal of the existing plaster will be necessary to completely evaluate the condition of the adobe walls. A combination of mud leveling coats and partial and full adobe blocks will be required, depending upon the depth of the adobe to be repaired. Although no exterior plaster was present on the building during the Fort Period, it is desirable from a maintenance and security standpoint. New mud plaster leveling and finish coats, tested for adhesion and resistance to cracking, will be used.

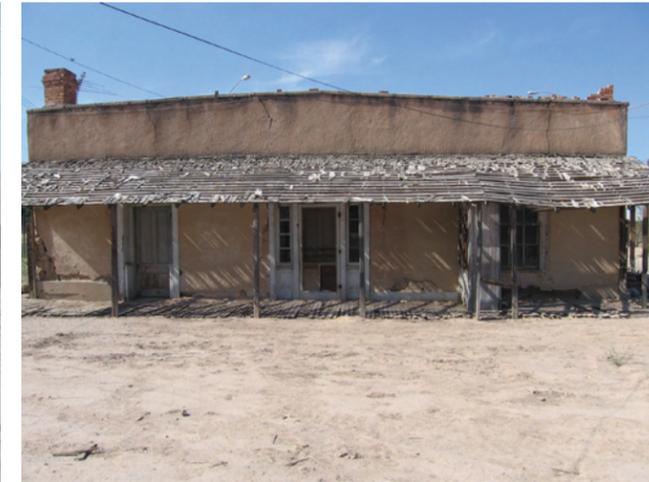
Figure 52: North wall showing Fort-era door at center.

It is probable that main entry door on north side of building dates to the Fort Period as it appears in the 1904 photo of Officer's Row. This door is also well documented in the HABS drawings. Doors are 4-panel, wood. The door opening leading into Bedroom 1 at the northeast corner was added during the early 20th Century. It appears to have been a window during Fort Period. The door in this 20th century opening does appear to date to the Fort-era, however. The exterior door at Bedroom 2 is also original, but in very poor condition. The exterior doors at the Dining Room and Kitchen are 5-panel doors that appear to have been added during the early 20th Century.

Restore remaining Fort-era doors. Reconstruct new doors to replace non Fort-era doors, based on extant material and HABS documentation. Frosted glass detail shown on HABS drawings should be restored on the north door. Salvage any existing historic hardware and reuse, if possible. New hardware should be customized to match Fort-era hardware.

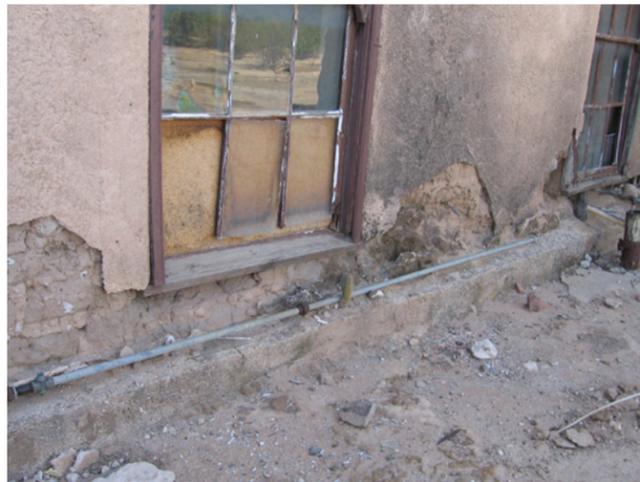
Figure 53: Original window to be restored.

By all appearances, many of the existing windows date to the Fort-era. The windows are well documented in the HABS drawings and are in good to fair condition. The windows are double-hung, 6 over 6 with wood sashes and frames. Counterbalances within the jamb are on braided cords. The glass is clear. Window condition varies, with a window in the Living Room nearly intact. Other windows have broken and replacement sashes and muntins that will need to be repaired. The two windows on the east wall have a slightly different frame profile. These two windows appear to have been replaced at an unknown date.

Repair the existing wood windows to working condition. Historic material should be preserved whenever possible. Where window frames have to be removed to repair adjacent adobe walls or lintels, the frames should be documented, removed and reinstalled. The two window frames and sashes for the windows on the east wall will need to be replicated to match an original Fort-era window.

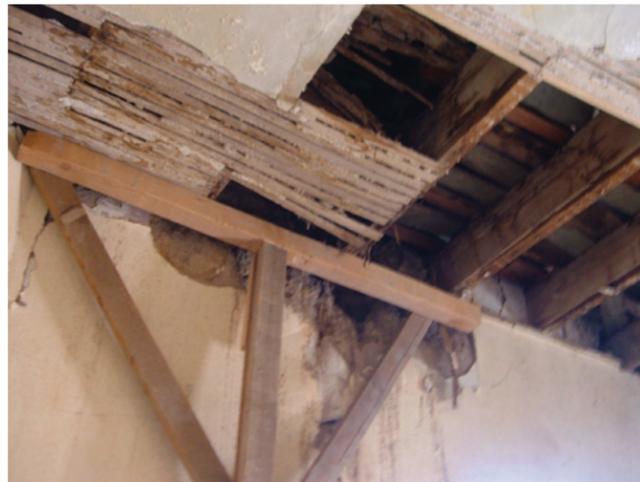
Figure 54: View of the ceiling showing wood beams.

Existing roof framing consists of several layers of framing members over original Fort-era framing. The original framing system consisted of 3" x 9" rough sawn beams at 16" O.C. These beams run from east to west and appear to bear on the interior walls at the Dining Room and Zaquan. Some of the 3" x 9" framing members are visible at exposed areas of ceiling. At the exterior bearing walls, where much of the ceiling has come loose, the beams are badly damaged and will need to be repaired. Furthermore, There is no connection between the beams and adobe walls. During the first decade of existence, the roof was dirt supported by saguaro ribs. Below the ceiling was mantas (cloth) to collect any dirt that came loose.

The existing roofing material will need to be removed to access the roof framing below. Where beam ends are decayed, new wood sections will be spliced to the solid ends of existing beams using new glass fiber rods. Wood that is structurally non-threatened may be repaired with epoxy. Beams will be attached to the exterior adobe walls. Polyester webbing is one approach being considered.

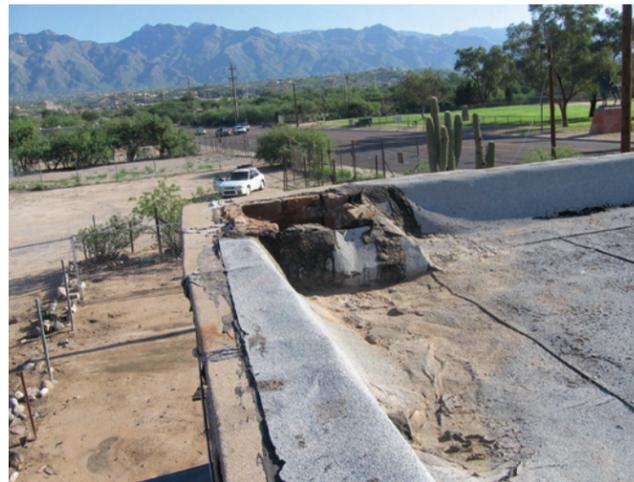
Figure 55: Roof prior to installation of temporary roof.

The early Fort-era roof consisted of dirt on saguaro ribs. After problems with leaking, tin was installed over the dirt roofs. Later layers of framing and roofing were added throughout the 20th Century. In 2007, a temporary roof was placed over the entire building that consists of an asphalt emulsion seal coat, a layer of yellow fiberglass fabric and another emulsion coat.

The entire roof is proposed to be rebuilt, starting from the original framing. Since the new roof will be hidden from view, insulation may be added on top of the existing roof. A new built-up or membrane roof will be installed over the entire building.

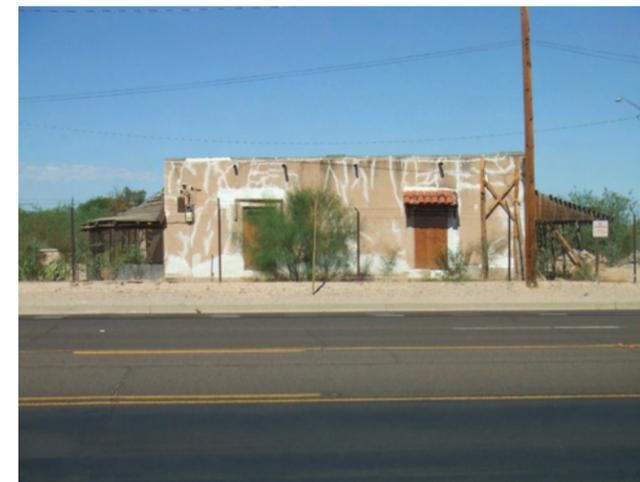
Figure 56: Existing canales at east wall.

The upper roof drains to the east and west parapets where there are 4 canales near the top of each wall. The canales have been problematic, especially above the window at the northwest corner where the adobe and wood lintel above the window are severely deteriorated and supported with bracing. Although the 1904 shows one remaining canale on the west side of the building, the existing canales do not appear to be from the Fort Period. Fort-era photographs show extensions from the canales to the edge of the wrap-around porch.

New canales and leaders from the canales to the edge of the lower roof will be reconstructed based on historic documentation. The discharge of water will be coordinated with new drains placed at the edge of the porch. Passive water harvesting strategies should be utilized to direct rainwater towards planting areas and away from foundations.

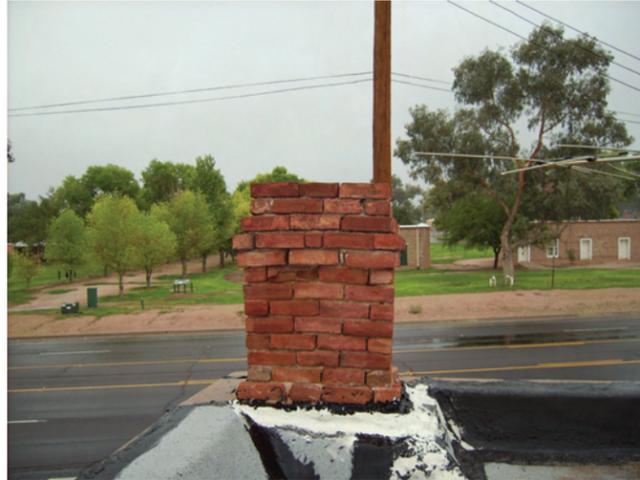
Figure 57: Northeast chimney prior to de-construction.

Due to their fragile condition, four chimneys were documented then de-constructed in 2007. Chimneys were constructed of local, smooth-faced red brick measuring 8-3/8" x 2-3/8" x 4". Three chimneys, including the chimney in the Kitchen, appear on the 1904 photograph. The chimney in Bedroom 2 is not visible in the photograph.

The chimneys will be reconstructed with the bricks salvaged during the deconstruction. Additional bricks will be needed to reconstruct the four chimneys. The new bricks should match the historic bricks in size, color and texture. A modern flue liner should be utilized at fireplaces that will be operational.

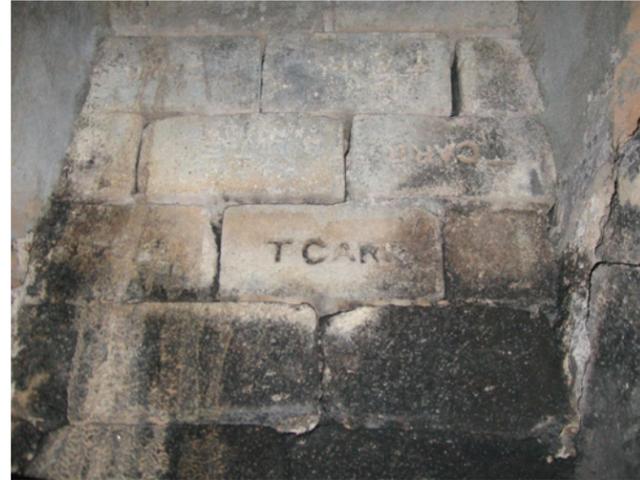
Figure 58: Original Firebrick.

The three fireplaces are in fair to poor condition. None of the fireplaces have been tested to determine if they are functional. The fireplace at the northeast corner is part of the exterior wall that has separated from the building. This fireplace will likely need to be completely rebuilt. The other two fireplaces, depending upon how adjacent walls are repaired, can be preserved and repaired. A modern flue should be installed for any fireplaces that will be operational. The firebrick is stamped TCARR, a product that was imported from England between 1827-1918.

The three fireplaces will be preserved and restored based on physical evidence and HABS documentation. It is desirable to make at least one fireplace fully functional for use in interpretation and for special events. Fireplaces that have to be reconstructed, should be completely documented during the de-construction process, with materials salvaged and reused whenever possible.

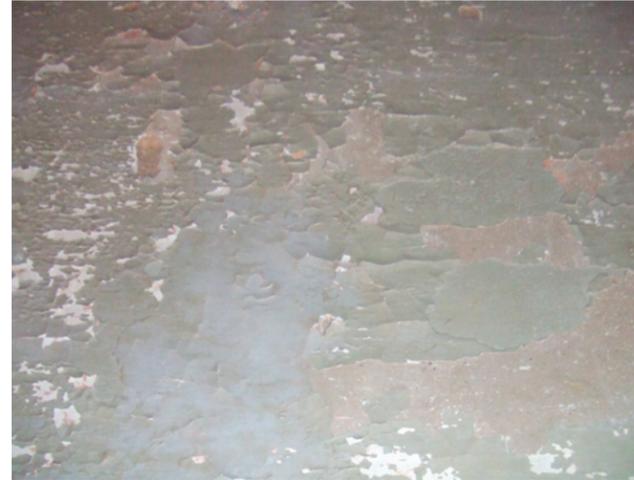
Figure 59: Fort-era plaster with later paint finish.

Interior walls do not appear connected to the exterior walls allowing differential movement between the interior and exterior walls to occur. This movement has caused some cracking of the interior plaster.

The goal is to preserve the existing plaster wherever possible. Preserving the plaster helps to maintain the building's high level of integrity. Plaster that is firmly attached to the adobe walls should be preserved. Loose plaster should be removed and replaced with a new base coat of mud plaster and a finish coat of lime plaster. Loose paint should be removed without damaging the lime plaster below. Additional research and design is required to determine the age of the paint and if it should be removed in its entirety.

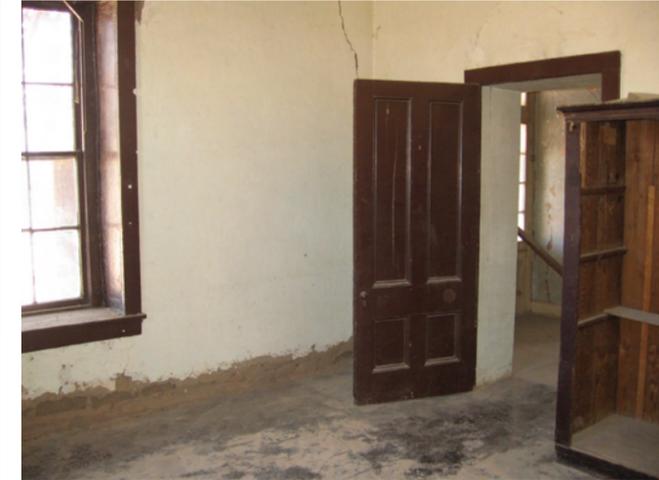
Figure 60: Historic interior door at northwest room.

Interior doors are stile and rail wood doors. The doors appear to date to the Fort-era. Not all opening currently have doors; it's possible that doors being stored in the Dining Room are original doors that can be re-hung. Most of the hardware on the doors has been replaced, although several sets of original hinges remain.

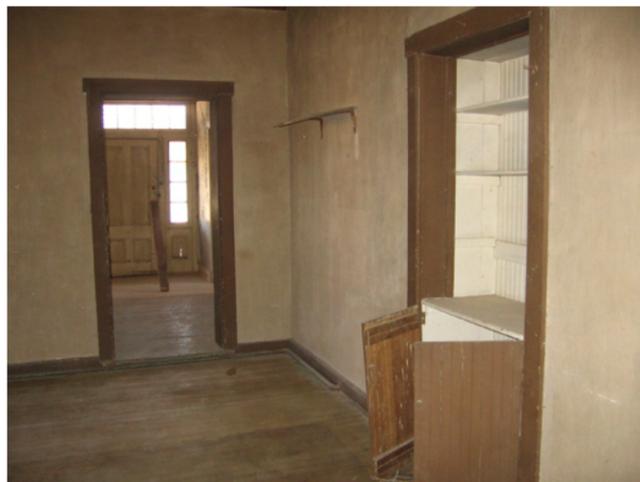
Figure 61: Original wood floor.

The wood floors in the northeast and northwest rooms were replaced with colored concrete slabs. This change appears to have occurred around the same time as the HABS documentation.

Concrete floors will be removed and replaced with new wood floors. Where wood floors are severely damaged, they will be replaced. Floors that are minimally damaged should be preserved and a wood restoration system will be applied to protect the floors. If an accessible path through the building is desired, the floors will need to have transitions from the northern room to the southern rooms. The is currently a 2-3 inch change in elevation. Since the rooms are accessible from the exterior, the need to create interior accessibility may not be required.

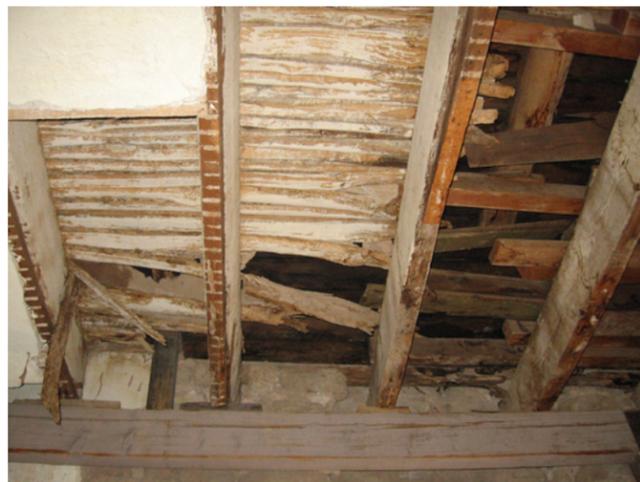
Figure 62: Exposed saguaro ribs above plaster ceiling.

The ceilings of buildings constructed at Fort Lowell were originally manta cloth hung below the structural wood beams. The manta cloth was designed to catch any material that fell through the saguaro ribs that created a "ceiling" between the wood beams and the earth placed on the roof. Plastered ceilings were added, along with tin roofs, because the original earthen roofs proved to be problematic. Ceiling heights vary. The date of the ceilings appears to have been the mid to late 1880s; additional research will be completed during the design phase to confirm. Ceiling are in fair condition with the ceilings adjacent to the exterior walls more severely damaged due to excessive water damage.

Wherever possible, existing plaster ceilings should remain. Damaged ceilings should be repaired with new lath and plaster. Because the roof cavity will be de-constructed from above, it may be possible to make the necessary structural repairs without disturbing the existing ceilings....

A "truth window" should be installed to be used during interpretation of the building. The "truth window" will allow the visitor to understand the construction system used in the building by displaying the saguaro ribs and wood beams.

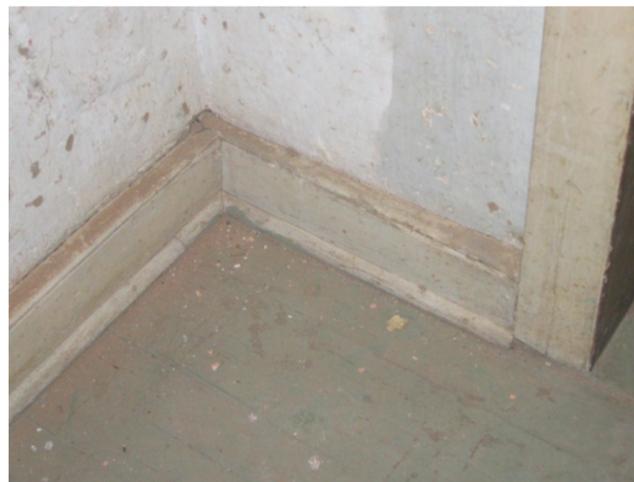
Figure 63: Original wood base.

Flat pine and redwood trim measuring 4-1/4" typical is installed around all windows and doors. There is also a picture rail at the Dining Room and Bedroom #1. The date of the trim is unknown, but presumably dates to the Fort-era. The trim is in fair to good condition.

The existing wood trim will be preserved. Any severely damaged areas will be replaced with in-kind material. Wood trim that is minimally damaged will be restored using a wood restoration system. Any wood trim that has to be removed to complete other repairs should be labeled and reinstalled. Existing finishes will be analyzed to determine the finish during the Fort-era.

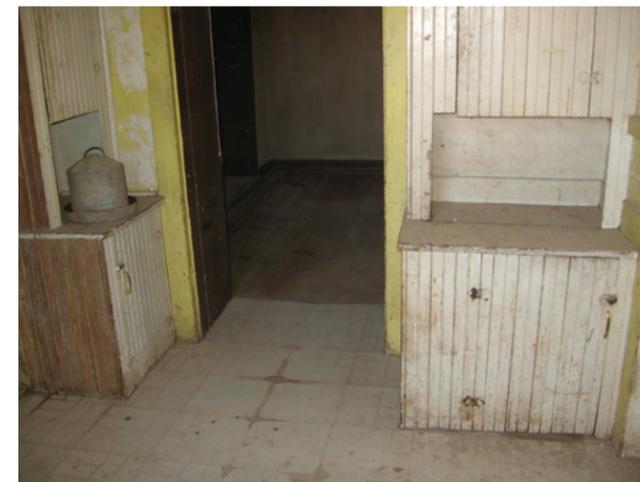
Figure 64: 20th Century bead board cabinets.

Features added following the abandonment of the Fort, including any built-in features from the early 20th Century, will be removed. This includes all built-in beadboard cabinets.

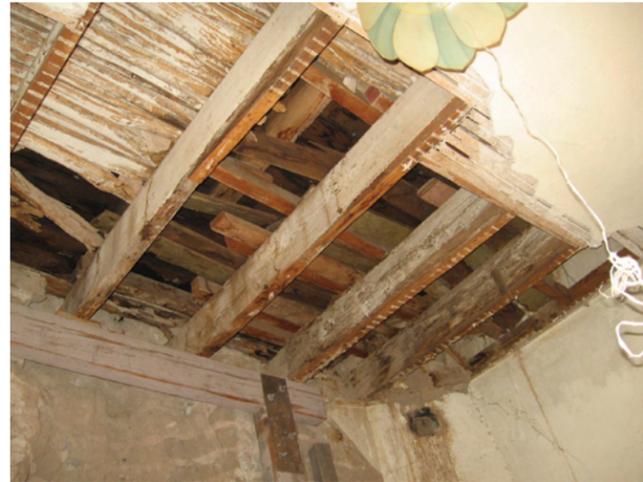
Figure 65: Existing ceiling cavity without insulation.

No insulation currently exists in the roof cavity. When originally constructed, the earthen roof helped to temper the inside environment. The high ceilings also helped to moderate indoor temperatures. It is not clear if any of the original earthen material has been retained above the saguaro ribs. De-construction of the existing roof and loose beams placed on top will allow a more thorough evaluation of the composition of the existing roof cavity.

Tapered roof insulation should be added to create a thermal barrier at the roof. Since the building will likely not be mechanically conditioned, circulation will be done passively. Small gaps in the exterior envelope will help alleviate the build-up of heat on this interior.

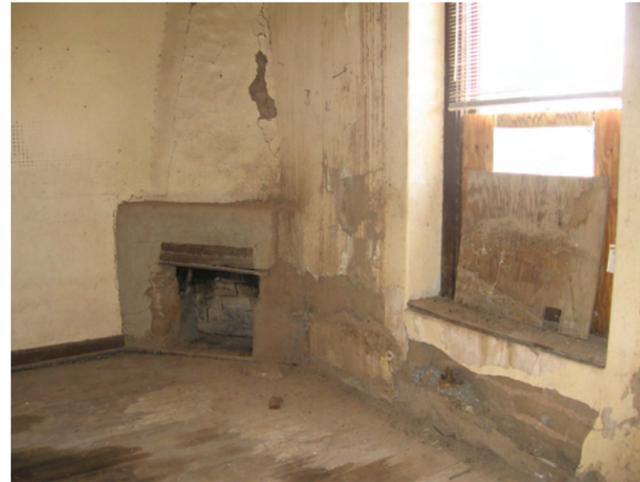
Figure 66: Historic fireplace.

The building most recently contained through-the-wall swamp coolers and wood-burning fireplaces and stoves. These features, with the exception of the original fireplaces, have been removed.

No modern heating, ventilation and air conditioning (HVAC) system is proposed for the building. Visitors will be able to experience how early settlers used climatically appropriate design strategies for mitigating the harsh conditions. Thick walls with good thermal mass, high ceilings, fireplaces, and porches are examples of the techniques used before the advent of mechanical heating and cooling.

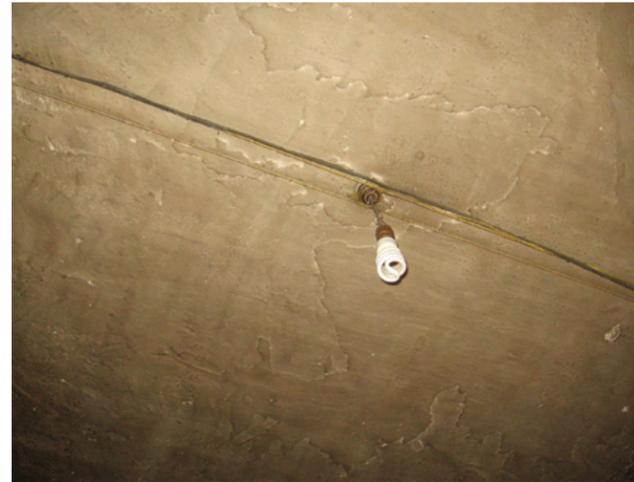
Figure 67: Knob & tube wiring.

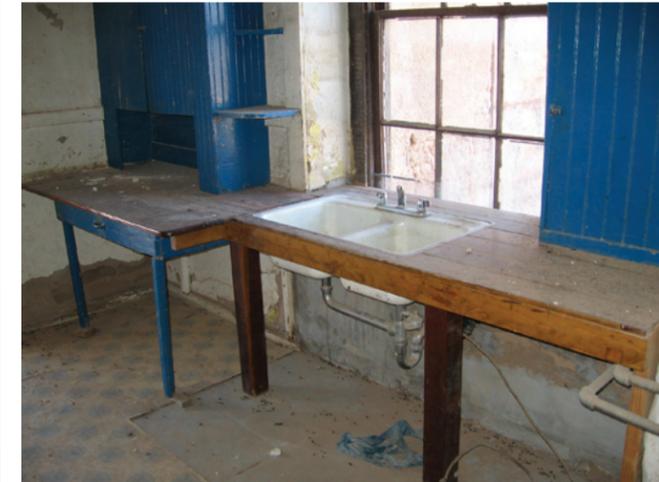
Figure 68: Sink in southwest corner.

Since the plumbing was added following the Fort-era, all plumbing fixtures and piping will be removed from the building. Removing all water from the building will alleviate a major threat to the building, the opportunity for a water pipe to rupture and saturate the adobe walls.

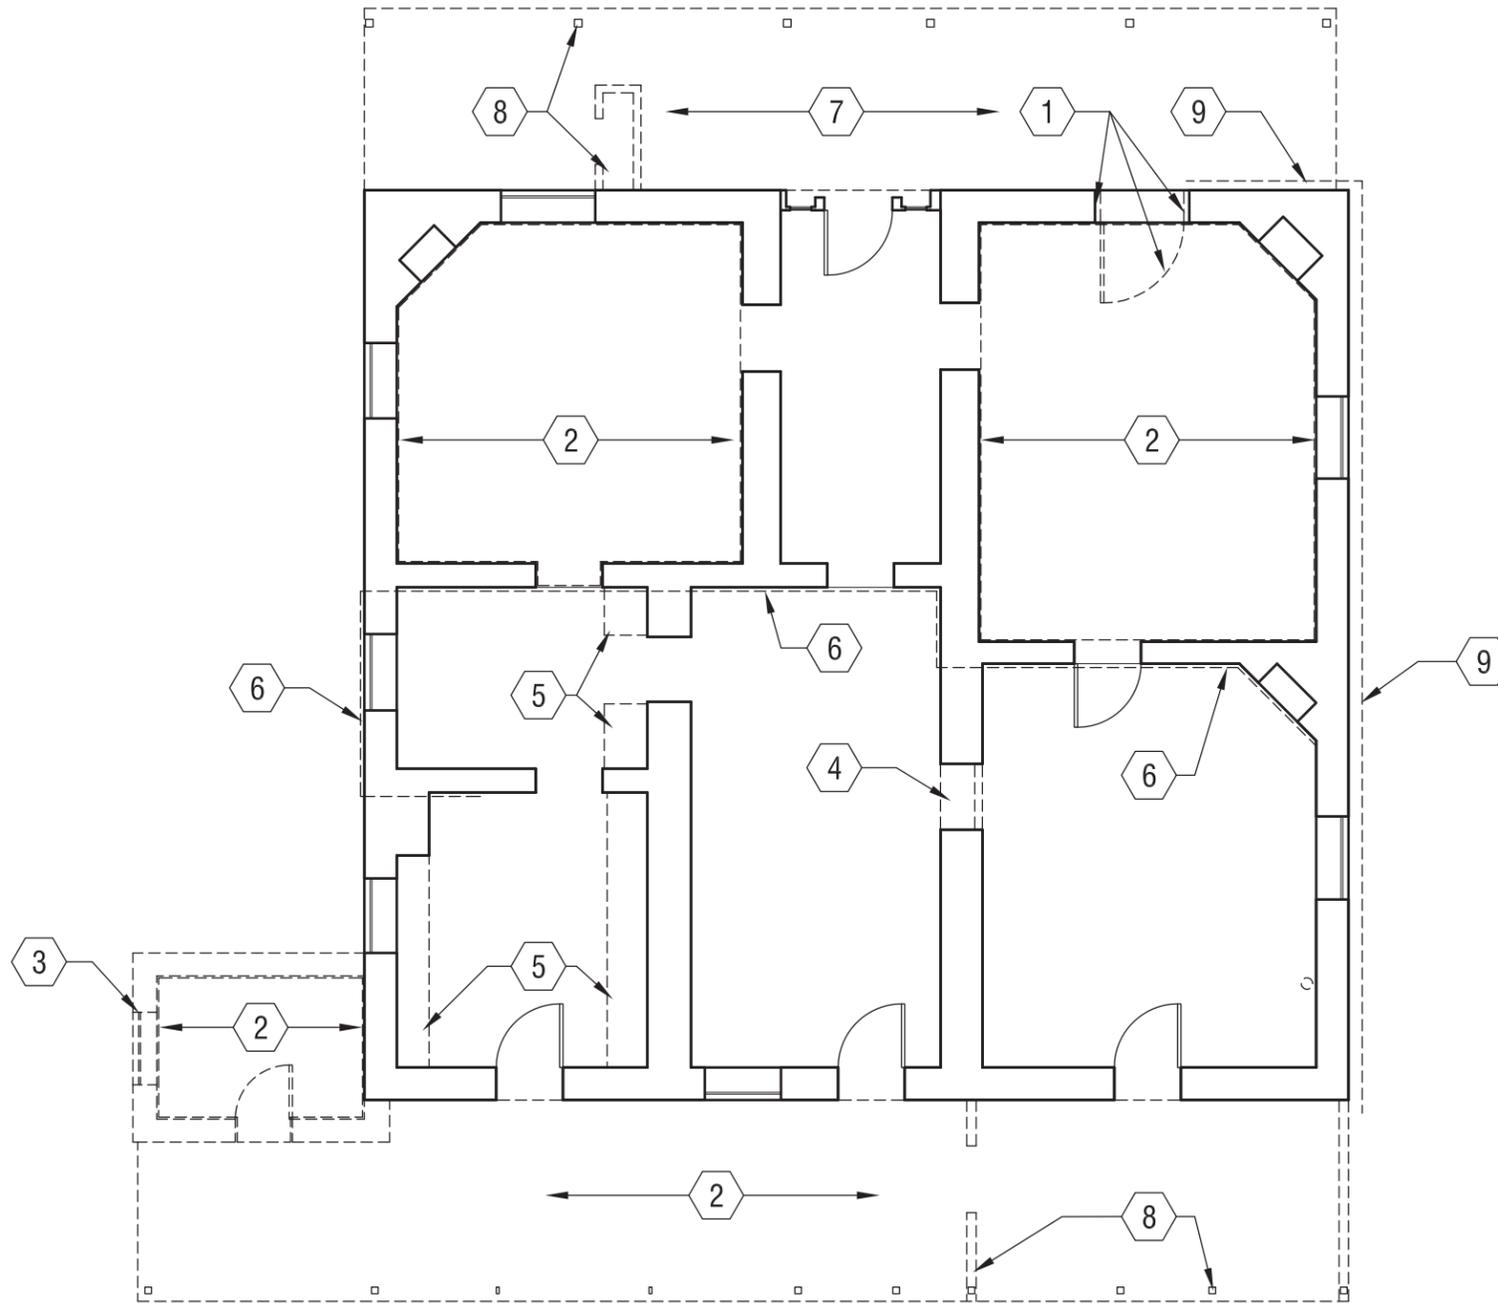
① De-Construction Floor Plan
SCALE 1/8"=1'-0"

- ① REMOVE POST FORT-ERA DOOR AND BEADBOARD WAINSCOT.
- ② REMOVE ADKINS-ERA CONCRETE SLAB.
- ③ REMOVE ADOBE BATHROOM ADDITION.
- ④ REMOVE 20TH CENTURY CABINET PLACED IN ORIGINAL DOOR OPENING.
- ⑤ REMOVE 20TH CENTURY BEADBOARD CABINETS.
- ⑥ REMOVE EXISTING GAS LINE.
- ⑦ REMOVE WOOD FLOOR, INCLUDING SLEEPERS AT NORTH PORCH.
- ⑧ REMOVE WOOD FRAMING AND POSTS AT PORCHES.
- ⑨ REMOVE CONCRETE *CONTRAPARED*.
