Preservation Plan

*for the
Adkins Parcel at Fort Lowell Park*

November 2009

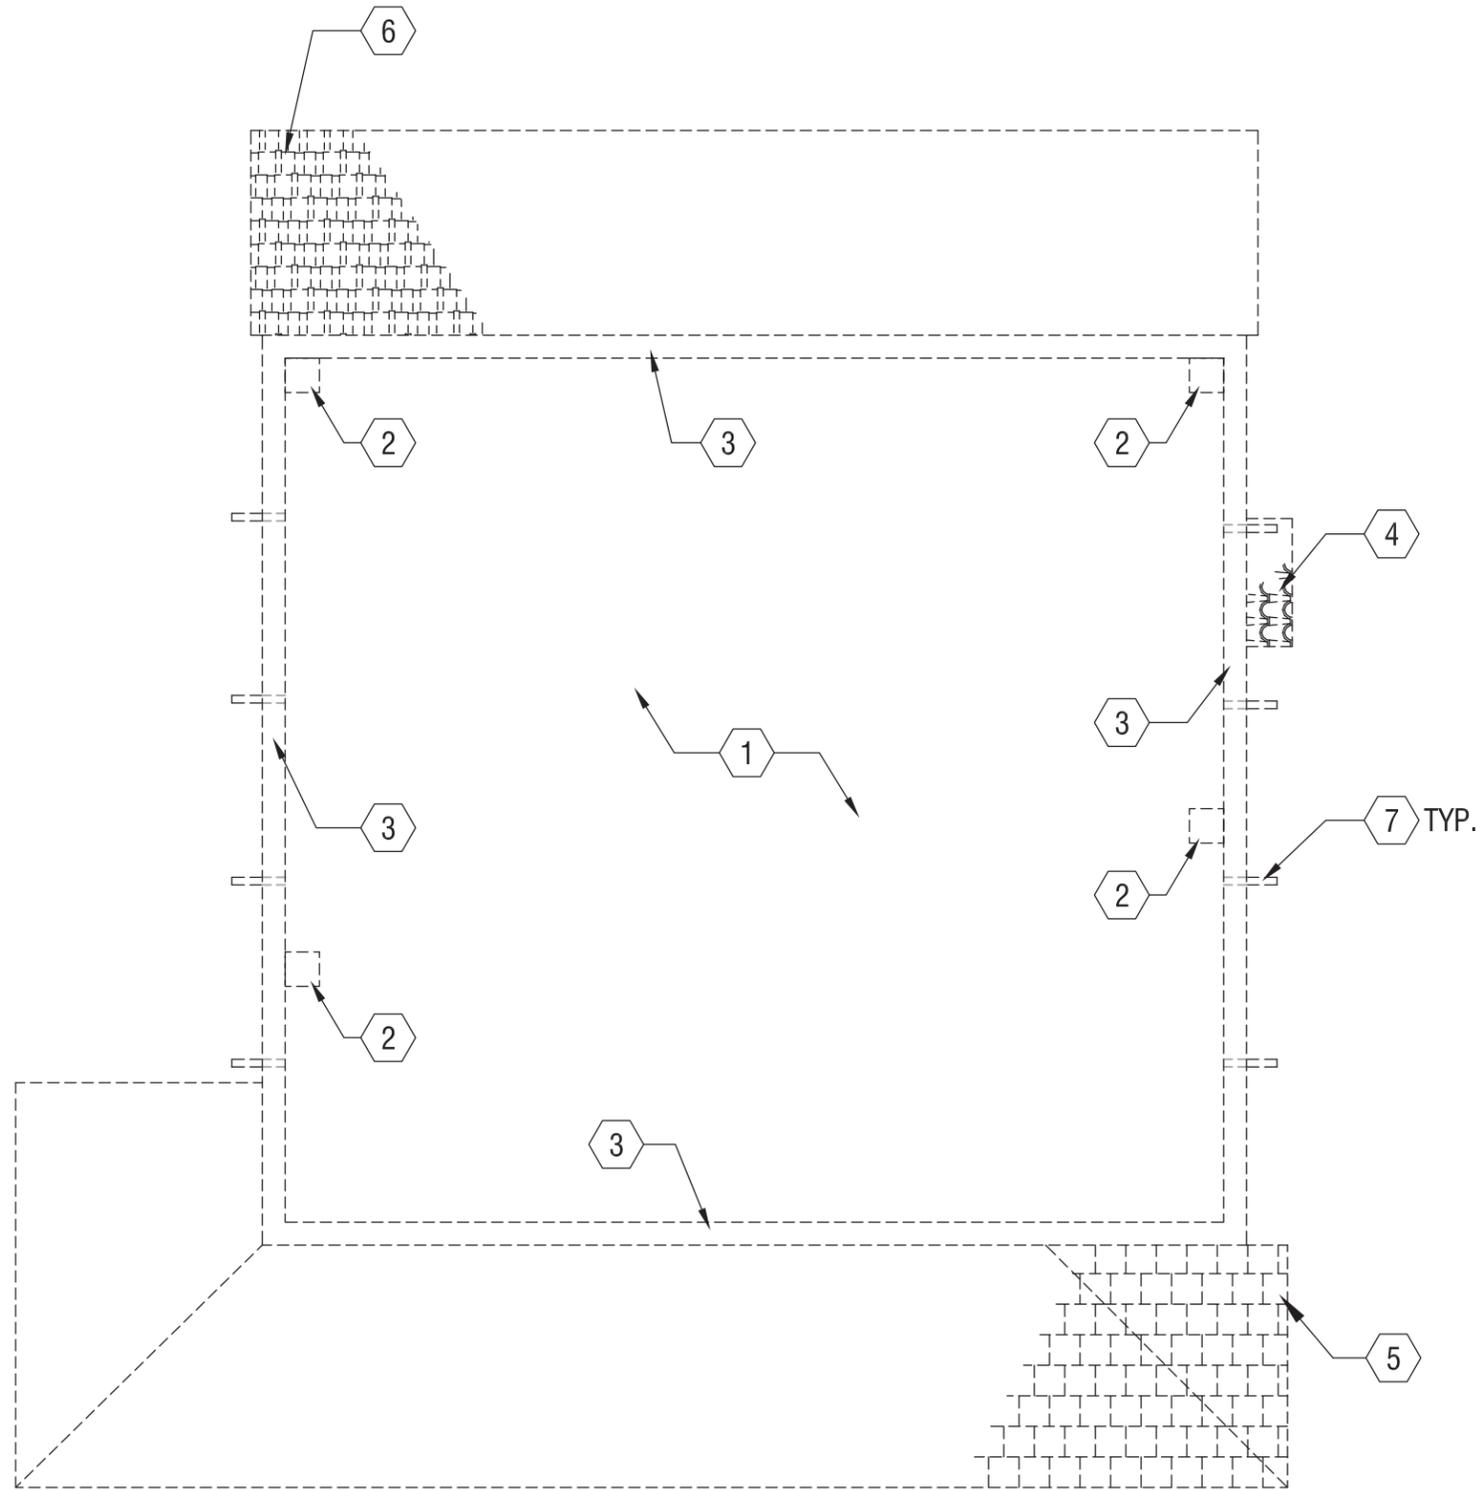
- ① REMOVE BUILT-UP ROOF AND DECKING TO EXPOSE WOOD FRAMING BELOW. REMOVE ALL LOOSE BOARDS AND FRAMING PLACED ABOVE ORIGINAL ROOF FRAMING. ORIGINAL ROOF FRAMING CONSISTS OF 2-3/4" X 9" BEAMS WITH SAGUARO RIBS AND EARTH ABOVE.
- ② REMOVE TEMPORARY ROOF PATCH AT ROOF IN PREPARATION OF CHIMNEY RESTORATION. BRICK SALVAGED FROM ORIGINAL CHIMNEYS IN 2007 IS TO BE USED IN THE NEW CHIMNEYS.
- ③ REMOVE CONCRETE CAP FROM TOP OF ADOBE PARAPET WALL.
- ④ REMOVAL CLAY TILE WINDOW AWNING AND ALL ASSOCIATED FRAMING.
- ⑤ REMOVE FIBER CEMENT SHINGLE ROOF AND ALL FRAMING AT SOUTH PORCH.
- ⑥ REMOVE WOOD SHINGLE ROOF AND ALL FRAMING AT NORTH PORCH.
- ⑦ REMOVE EXISTING CANALE.

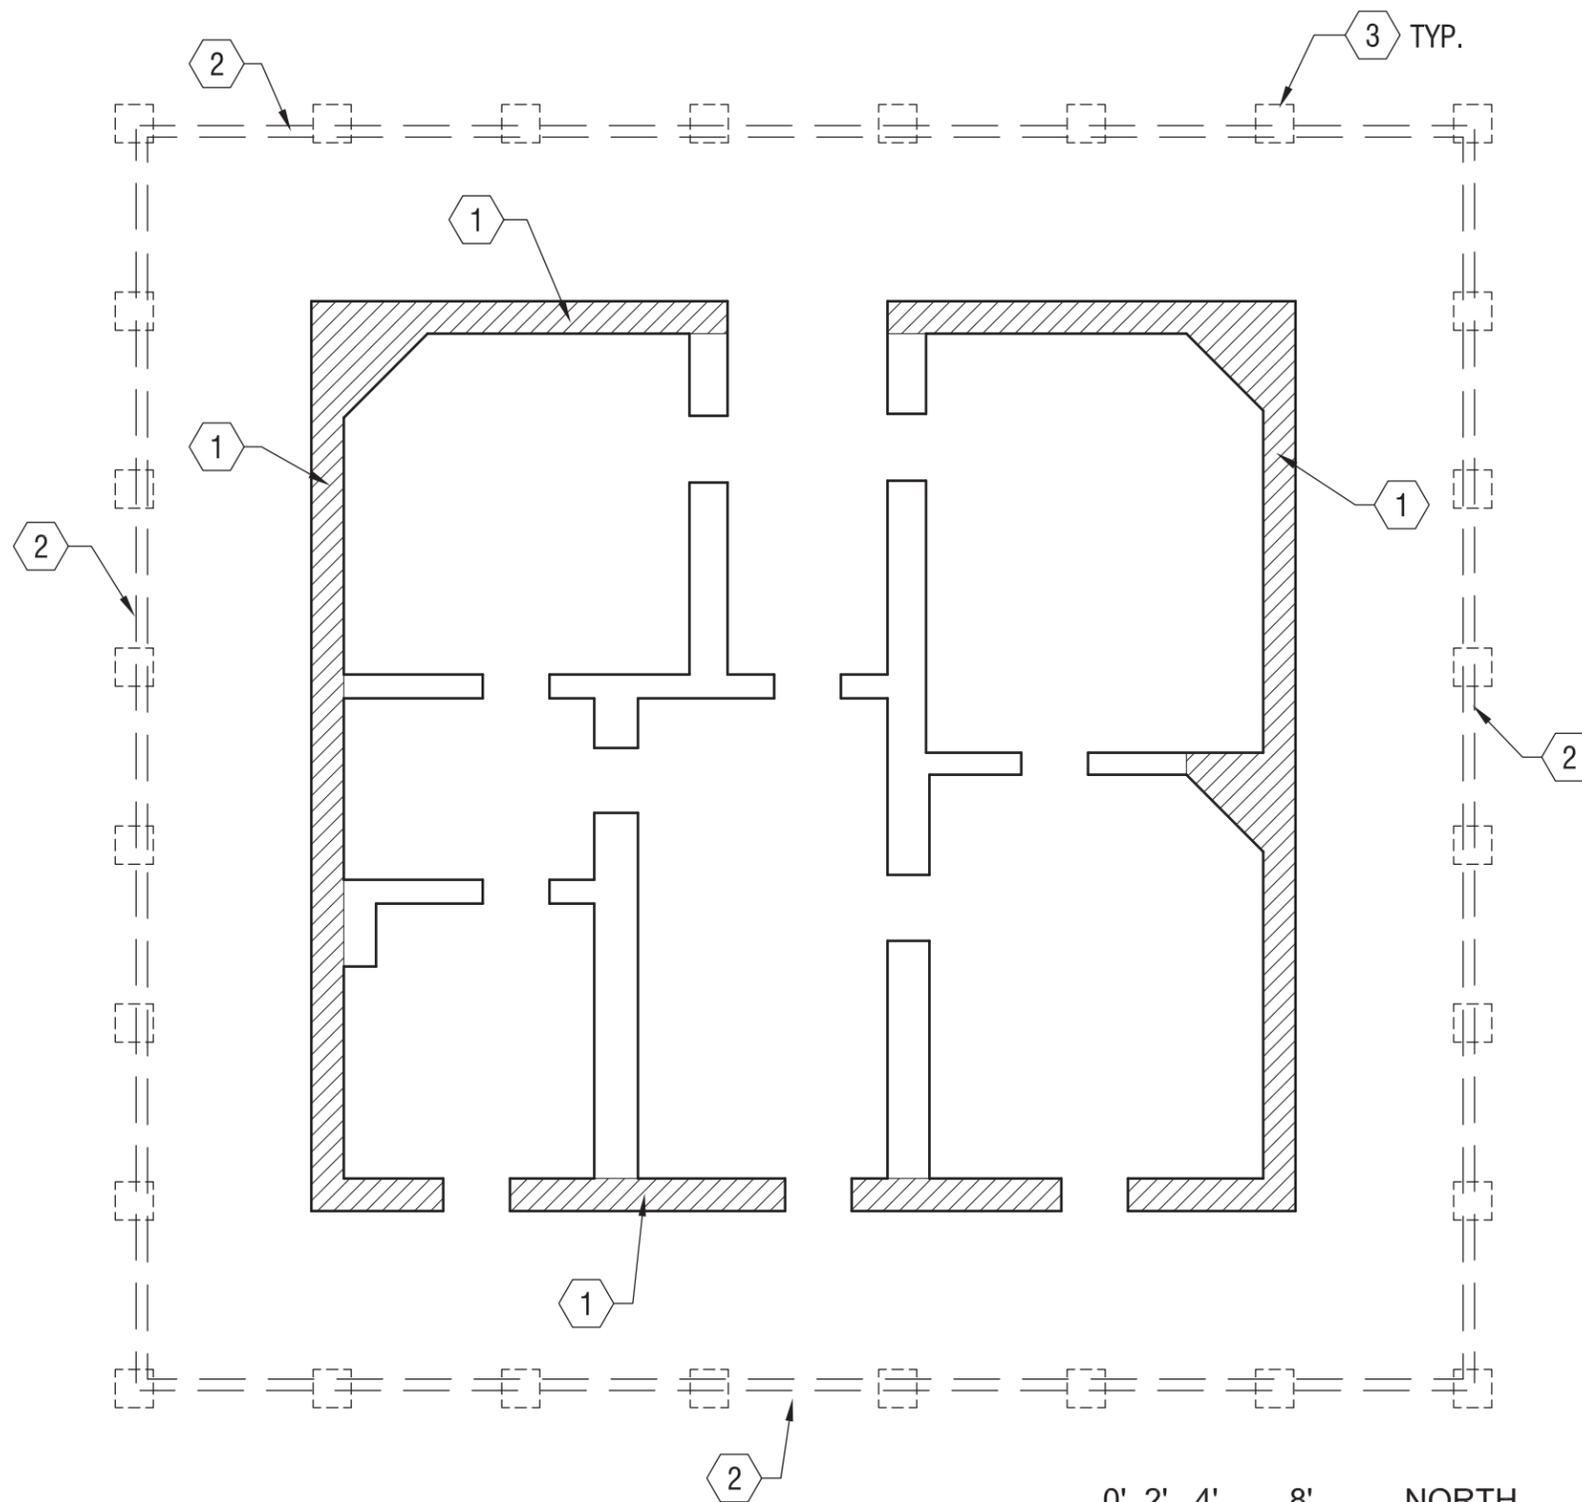
① Foundation Plan
SCALE 1/8"=1'-0"

- ① REPAIR ADOBE WALL AS REQUIRED. CONSIDER OVEREXCAVATING AND UNDERPINNING WITH NEW ADOBE BLOCKS OR STABILIZE THE WALLS USING "ADOBE CAGES" DEVELOPED BY ED CROCKER.
- ② FOUNDATION DRAIN AT THE INSIDE EDGE OF NEW PORCH.
- ③ NEW FOOTING AT RECONSTRUCTED PORCH COLUMN.

According to the Alfred E. Johnson Report, based on subsurface investigation at Officer's Quarters No. 5, "Foundations were not present, and the walls were placed on what was apparently the surface of the ground at the time of construction." At Officer's Quarters No. 4 (the Commanding Officer's Quarters that was demolished with construction of Craycroft Road) "The walls of Officer's Quarters No. 4 were underlaid by foundations of four to five courses of adobe bricks. The foundations were placed in trenches dug through a layer of fine, brown sand, the top of which was probably the surface of the ground at the time of construction, to the top of the underlying caliche layer. The foundations were the same thickness as the wall." Source- Building Condition Assessment, 2008.

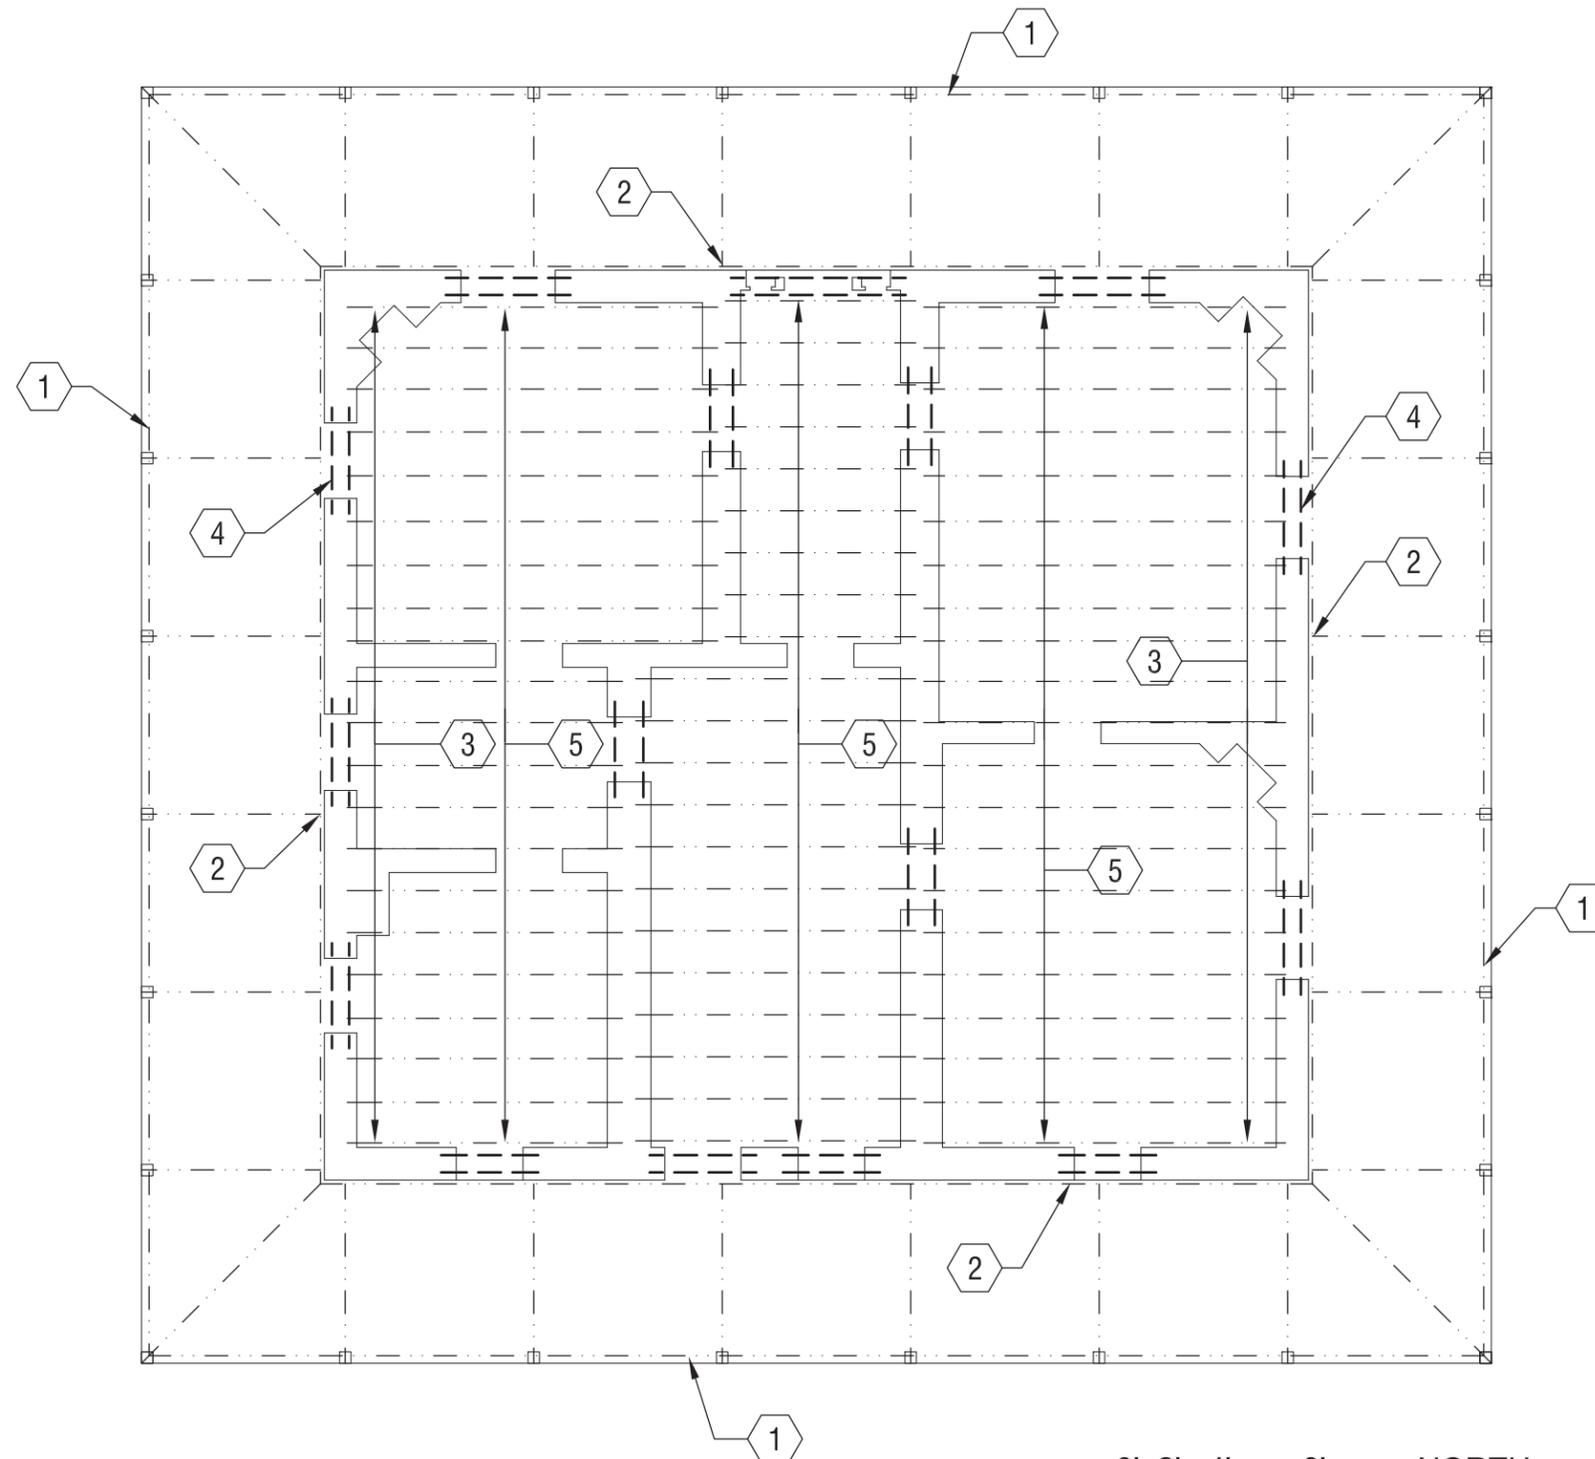
① Framing Plan
SCALE 1/8"=1'-0"

- ① NEW ROUGH-SAWN WOOD FRAME PORCH BASED ON ORIGINAL DESIGN AND CONSTRUCTION. TYPICAL AT ALL FOUR ELEVATIONS.
- ② NEW LEDGER AT EXISTING ADOBE WALL TO SUPPORT PORCH BEAMS? OR, POCKET BEAMS IN ADOBE WALL. DETERMINATION BASED ON FIELD EVIDENCE AFTER EXISTING PLASTER IS REMOVED FROM THE EXTERIOR OF THE BUILDING.
- ③ REPAIR EXISTING BEAM ENDS BY EPOXY DOWELING NEW BEAM ENDS. ACTUAL NUMBER OF BEAM ENDS NEEDING REPAIR TO BE DETERMINED IN THE FIELD AFTER THE EXISTING ROOF IS REMOVED FROM THE BUILDING. PROVIDE UNIT COST.
- ④ NEW WOOD LINTEL AT ADOBE WALL REPAIR.
- ⑤ EXISTING ORIGINAL WOOD BEAMS TO REMAIN. ACTUAL SPACING AND CONDITION TO BE DETERMINED AFTER THE EXISTING ROOF AND DECKING IS REMOVED FROM THE BUILDING. CONSTRUCT NEW ROOF, INCLUDING INSULATION AND FRAMING, ABOVE EXISTING BEAMS.

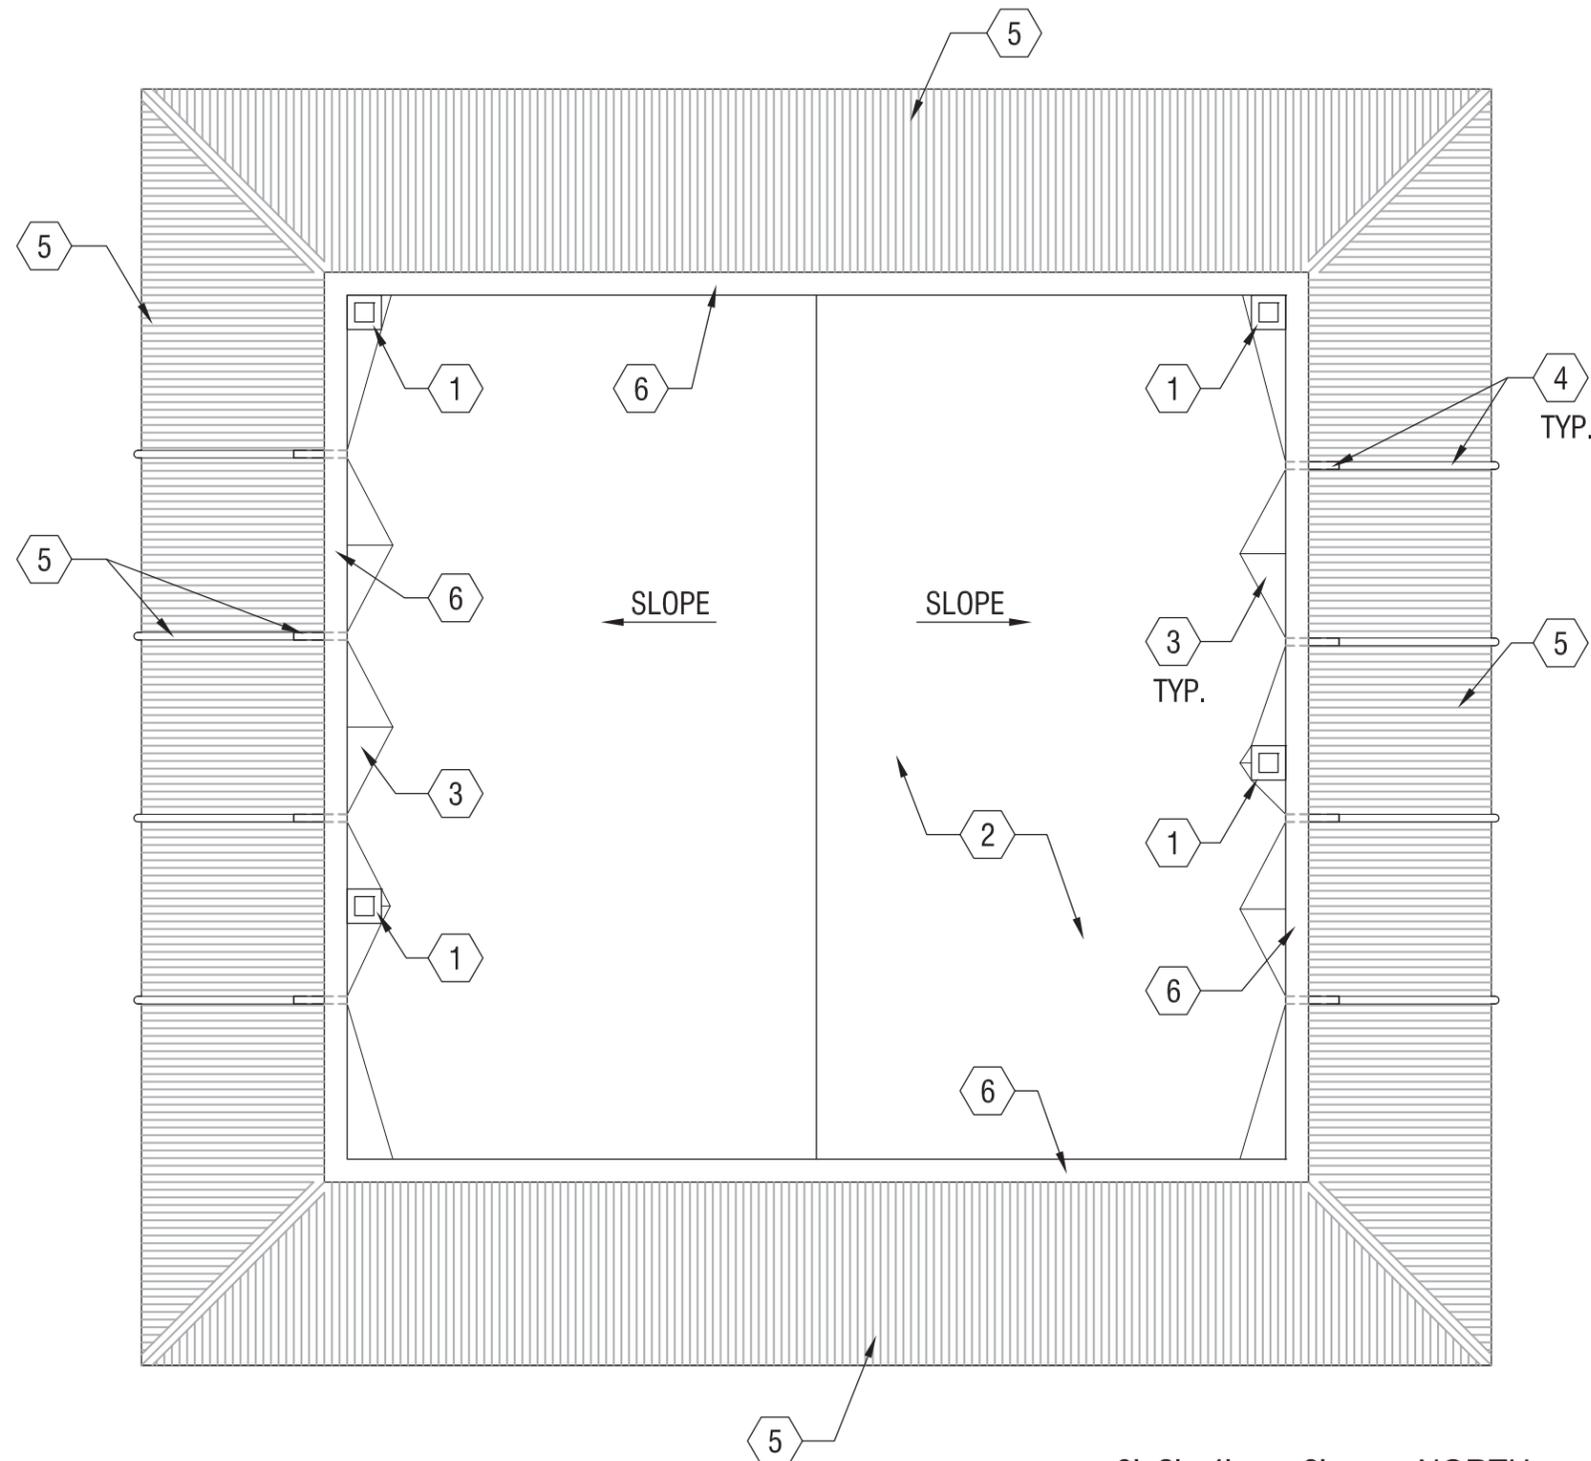
① Roof Plan
SCALE 1/8"=1'-0"

- ① RECONSTRUCT CHIMNEY BASED ON DRAWINGS AND DOCUMENTATION. BRICK SALVAGED FROM ORIGINAL CHIMNEYS IN 2007 IS TO BE USED IN THE NEW CHIMNEYS. ANY ADDITIONAL BRICKS REQUIRED TO COMPLETE THE RESTORATION SHOULD MATCH THE HISTORIC BRICKS.
- ② NEW FLAT ROOF (WITH NEW FRAMING?) OVER ORIGINAL FORT-ERA ROOF CAVITY. NEW ROOF CAVITY TO BE INSULATED WITH A WOOD DECK.
- ③ NEW ROOF CRICKETS.
- ④ CUSTOM FABRICATE HISTORICAL CANALES AND LEADERS BASED ON DOCUMENTATION.
- ⑤ RECONSTRUCT FORT-ERA WOOD PORCH BASED ON DOCUMENTATION. PORCH TO BE ROUGH-SAWN BEAMS WITH WOOD DECKING AND STANDING-SEAM METAL ROOF.
- ⑥ NEW PARAPET CAP. MATERIAL TO BE METAL OR TILE.

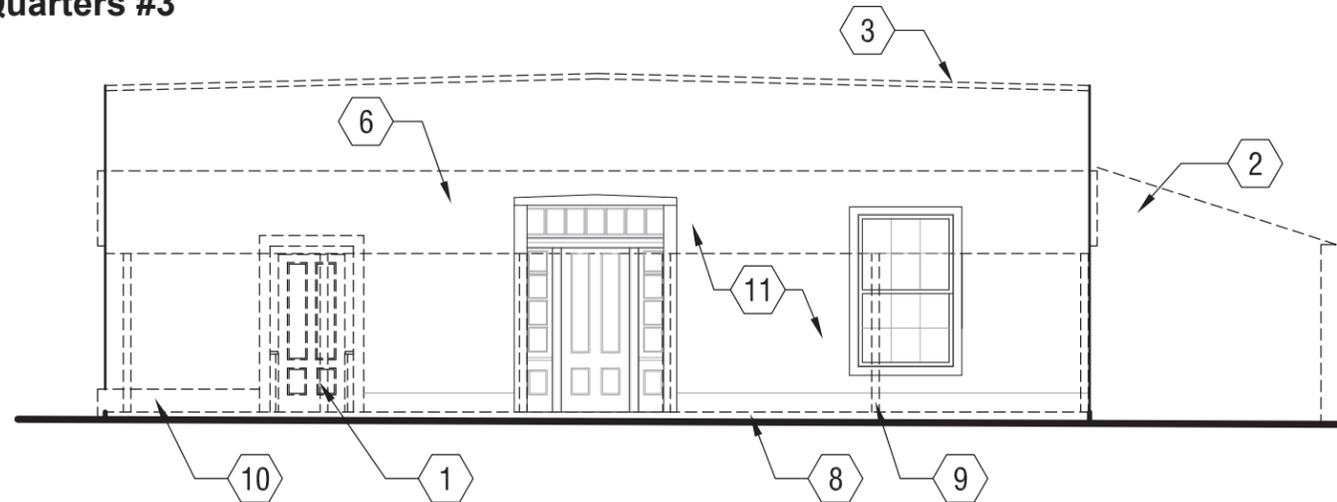
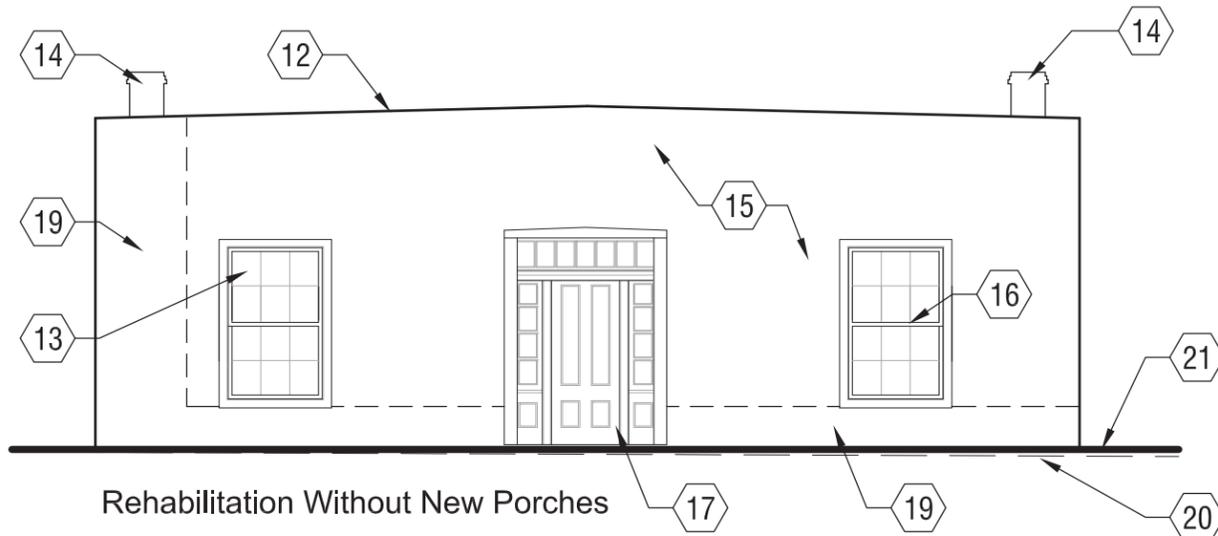
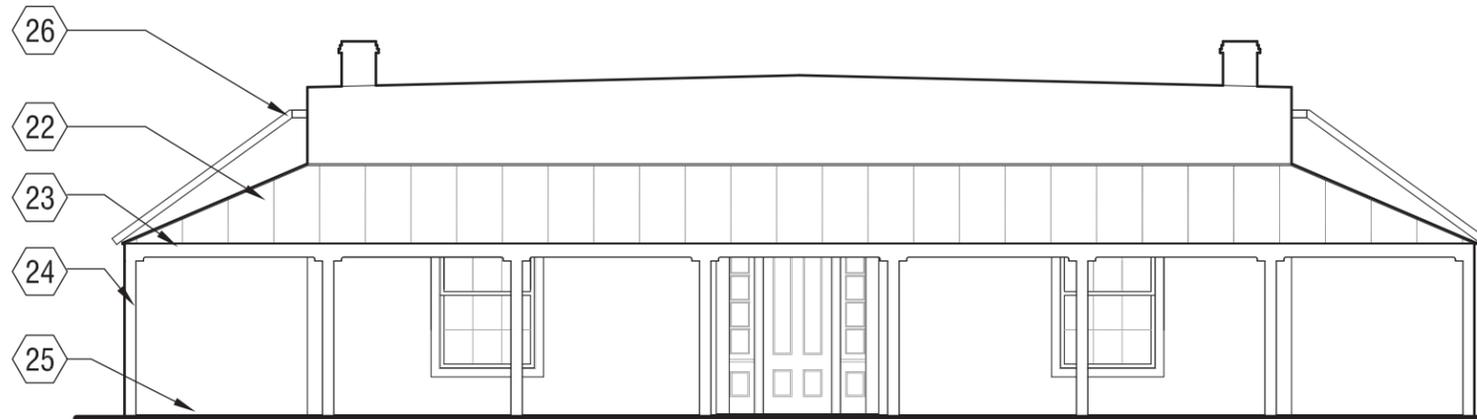
Existing Showing De-Construction

Rehabilitation Without New Porches

Rehabilitation With New Porches

- 1 REMOVE POST FORT-ERA DOOR AND BEADBOARD WAINSCOT.
- 2 REMOVE ADOBE BATHROOM ADDITION.
- 3 REMOVE CONCRETE CAP FROM TOP OF ADOBE PARAPET WALL.
- 4 NOT USED.

- 15 NEW MUD / LIME PLASTER FINISH.
- 16 RESTORE EXISTING WOOD WINDOW.
- 17 RESTORE EXISTING WOOD DOOR, SIDELIGHTS AND TRANSOM WINDOWS.
- 18 NOT USED.
- 19 ADOBE REPAIR. FURTHER INVESTIGATION REQUIRED TO DETERMINE EXTENT.

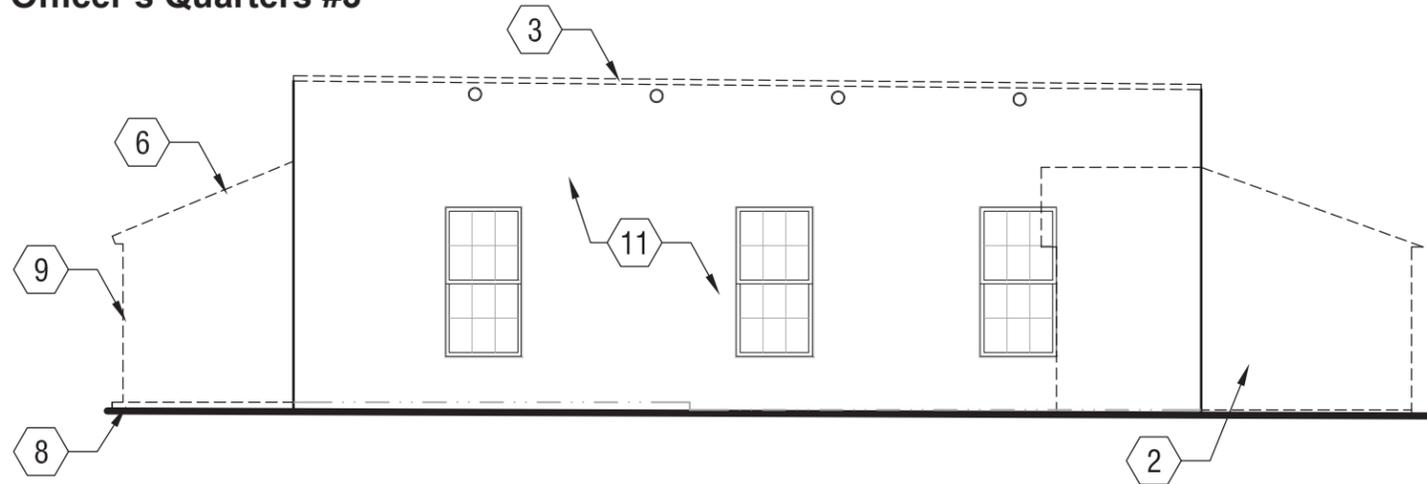
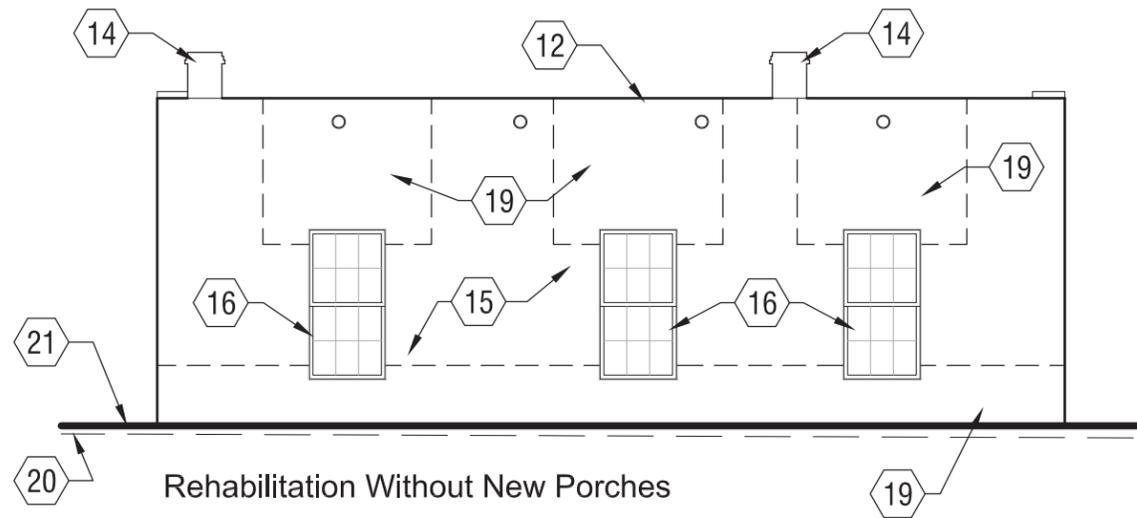
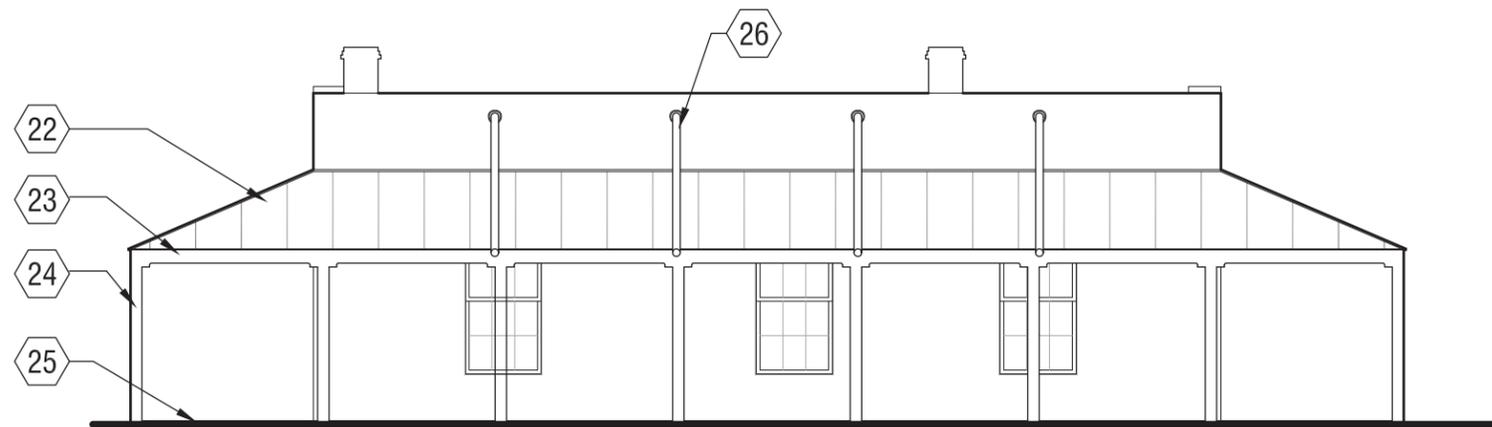
Existing Showing De-Construction

Rehabilitation Without New Porches

Rehabilitation With New Porches

- 1 NOT USED.
- 2 REMOVE ADOBE BATHROOM ADDITION.
- 3 REMOVE CONCRETE CAP FROM TOP OF ADOBE PARAPET WALL.
- 4 NOT USED.
- 5 NOT USED.
- 6 REMOVE WOOD SHINGLE ROOF AND ALL FRAMING.

- 15 NEW MUD / LIME PLASTER FINISH.
- 16 RESTORE EXISTING WOOD WINDOW.
- 17 NOT USED.
- 18 NOTUSED.
- 19 ADOBE REPAIR. FURTHER INVESTIGATION REQUIRED TO DETERMINE EXTENT.

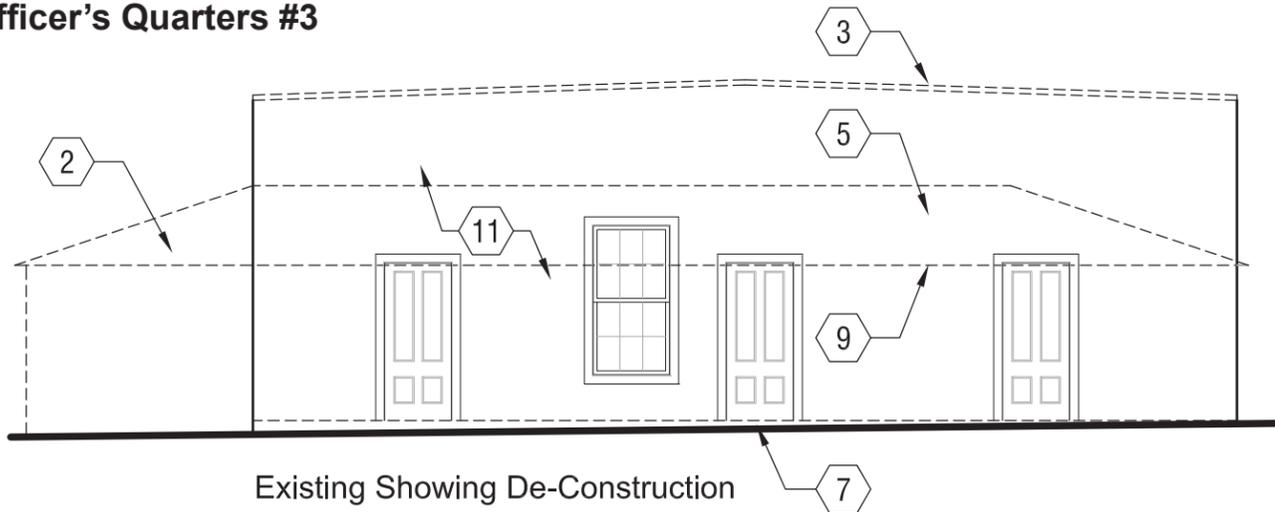
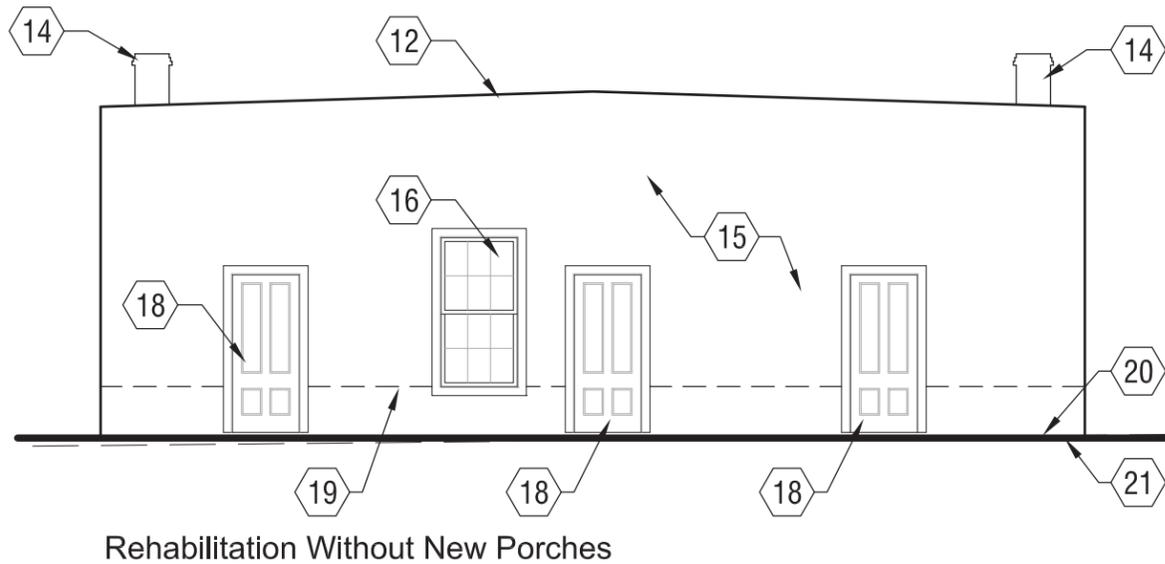
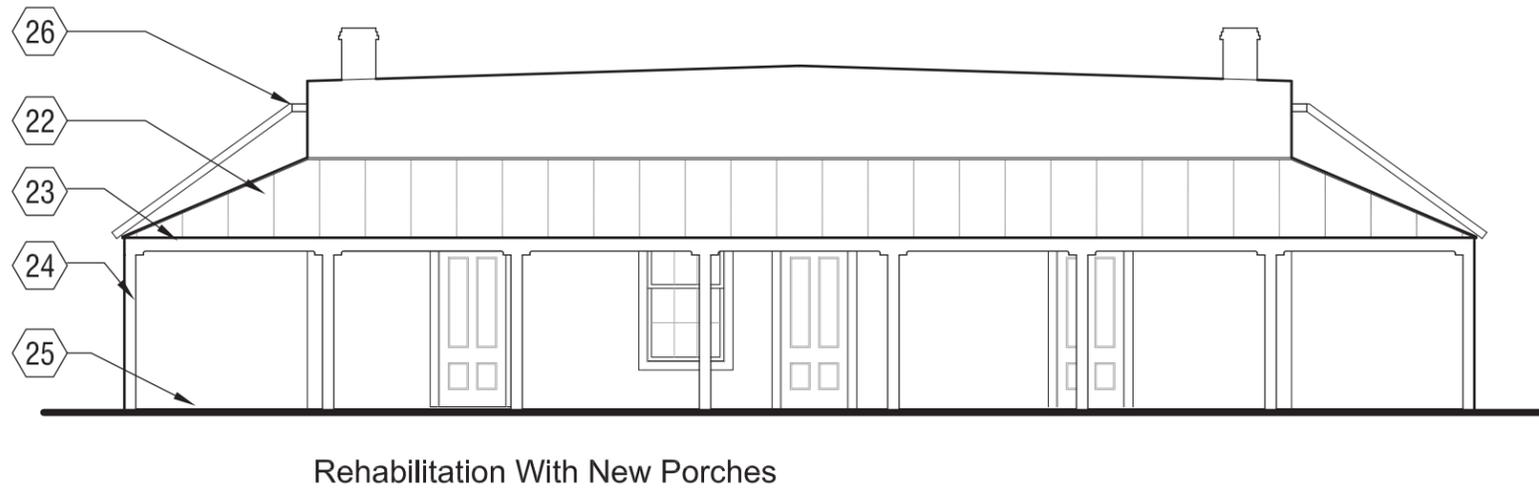
- 1 NOT USED.
- 2 REMOVE ADOBE BATHROOM ADDITION.
- 3 REMOVE CONCRETE CAP FROM TOP OF ADOBE PARAPET WALL.
- 4 NOT USED.
- 5 REMOVE FIBER CEMENT SHINGLE ROOF AND ALL FRAMING.

- 6 NOT USED.
- 7 REMOVE CONCRETE SLAB AT PORCH.
- 8 NOT USED.
- 9 REMOVE WOOD FRAMING AND POSTS AT PORCHES.
- 10 NOT USED.
- 11 REMOVE EXTERIOR PLASTER AT ALL EXTERIOR WALLS TO REVEAL ORIGINAL ADOBE CONSTRUCTION. EXISTING SURFACE LAYER IS CEMENT PLASTER. EARLIER LAYERS MAY BE MUD/ LIME PLASTER.

- 15 NEW MUD / LIME PLASTER FINISH.
- 16 RESTORE EXISTING WOOD WINDOW.
- 17 RESTORE EXISTING WOOD DOOR, SIDELIGHTS AND TRANSOM WINDOWS.
- 18 REPAIR / REUSE EXISTING DOORS AS FEASIBLE.

- 19 ADOBE REPAIR. FURTHER INVESTIGATION REQUIRED TO DETERMINE EXTENT.
- 20 EXISTING GRADE (APPROXIMATE).
- 21 NEW GRADE. SLOPE TO ACCOMMODATE NEW PORCH AND TO DRAIN AWAY FROM THE BUILDING.

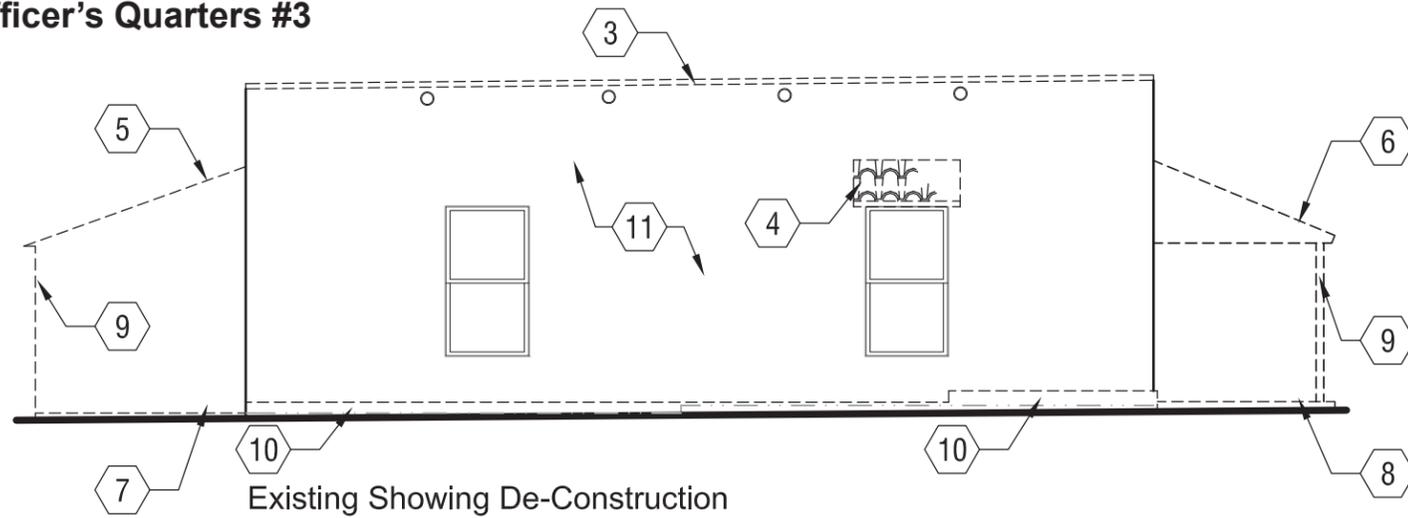
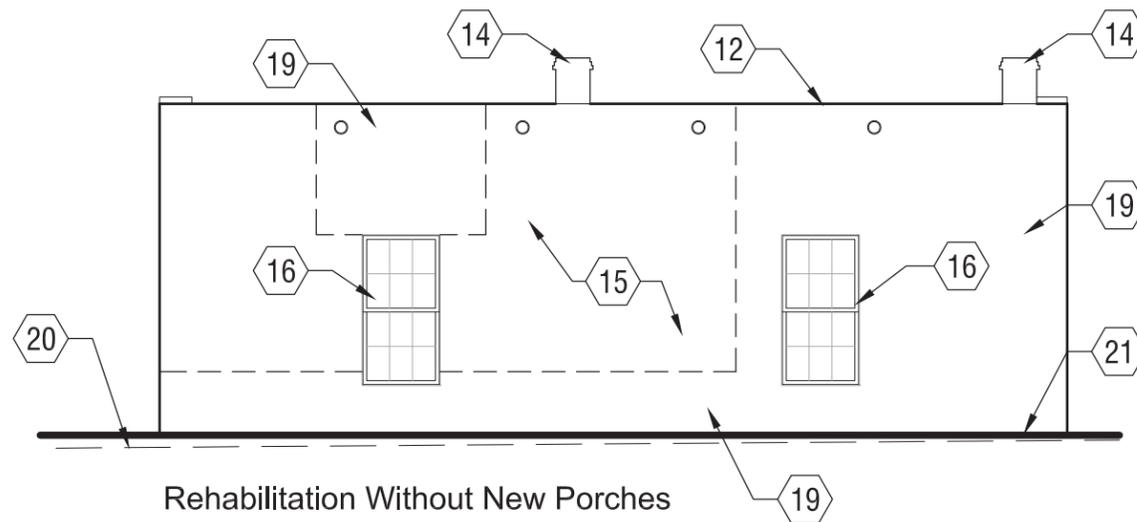
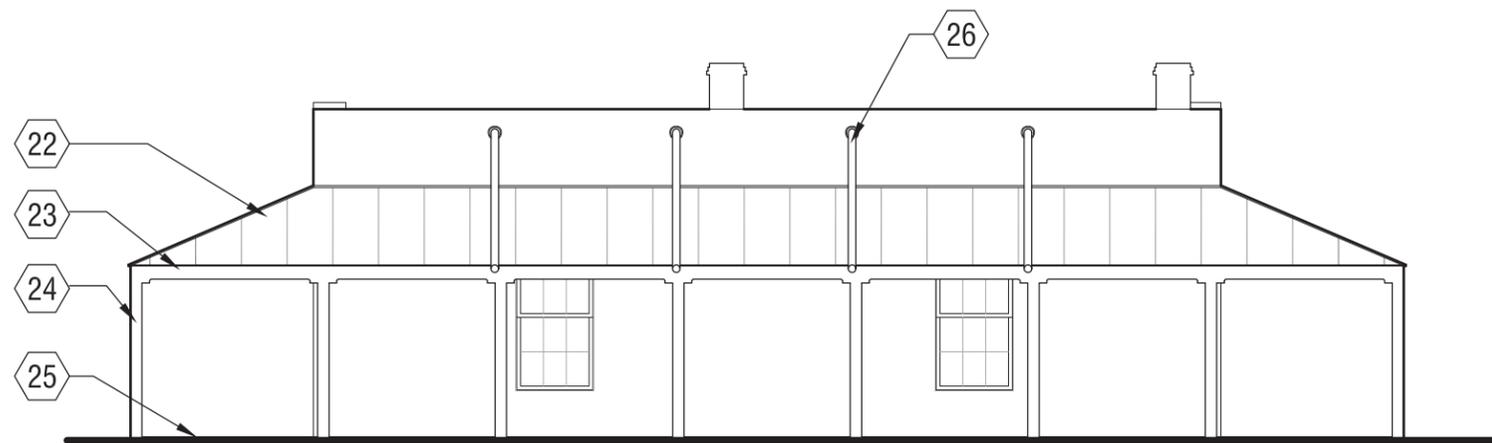
Existing Showing De-Construction

Rehabilitation Without New Porches

Rehabilitation With New Porches

- 1 NOT USED.
- 2 NOT USED.
- 3 REMOVE CONCRETE CAP FROM TOP OF ADOBE PARAPET WALL.
- 4 REMOVAL CLAY TILE WINDOW AWNING AND ALL ASSOCIATED FRAMING.
- 5 REMOVE FIBER CEMENT SHINGLE ROOF AND ALL FRAMING.

- 15 NEW MUD / LIME PLASTER FINISH.
- 16 NEW WOOD WINDOW AND FRAME TO MATCH HISTORIC PROFILE.
- 17 NOT USED.
- 18 NOT USED.
- 19 ADOBE REPAIR. FURTHER INVESTIGATION REQUIRED TO DETERMINE EXTENT.

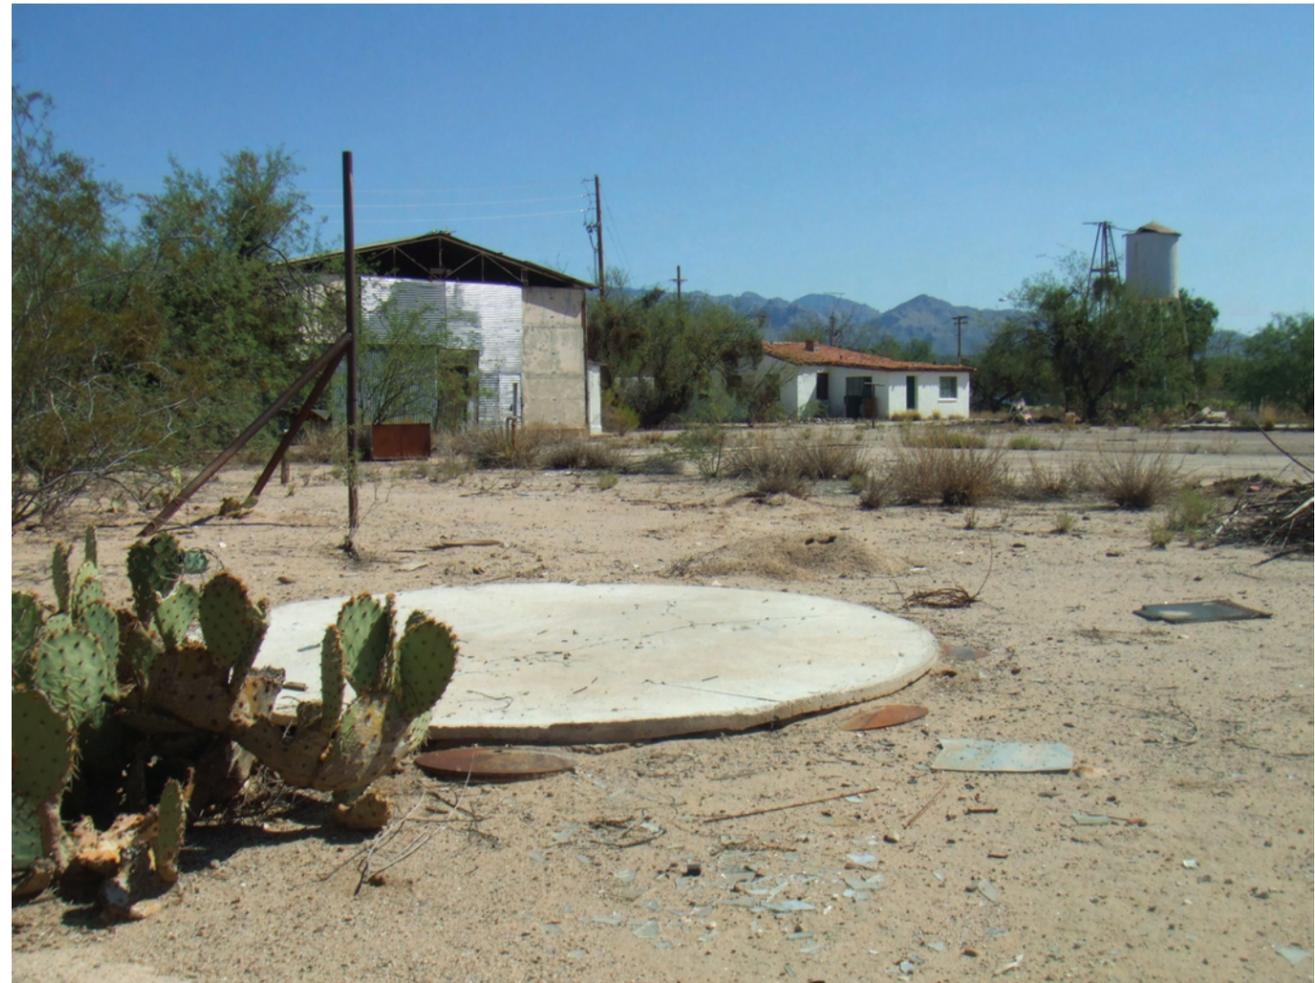
Figure 69: Adkins-era resources looking northeast.

The desire to represent the Fort-era site layout in an unambiguous and clear manner requires the removal of Adkins-era resources, especially where they are in conflict with the interpretation of Fort-era resources. The Steel Fabrication Shed, for example, is located at the edge of the Parade Ground and possibly above the location of the Fort Lowell Bake House. The location and scale of the shed would cause some difficulty in properly understanding the relationship of the Parade Ground to its surrounding buildings. The Steel Fabrication Shed was determined to need costly structural repairs to make it safe for public use. If possible, elements of the Steel Fabrication Shed should be salvaged for possible reuse on site or in the construction of interpretive exhibits.

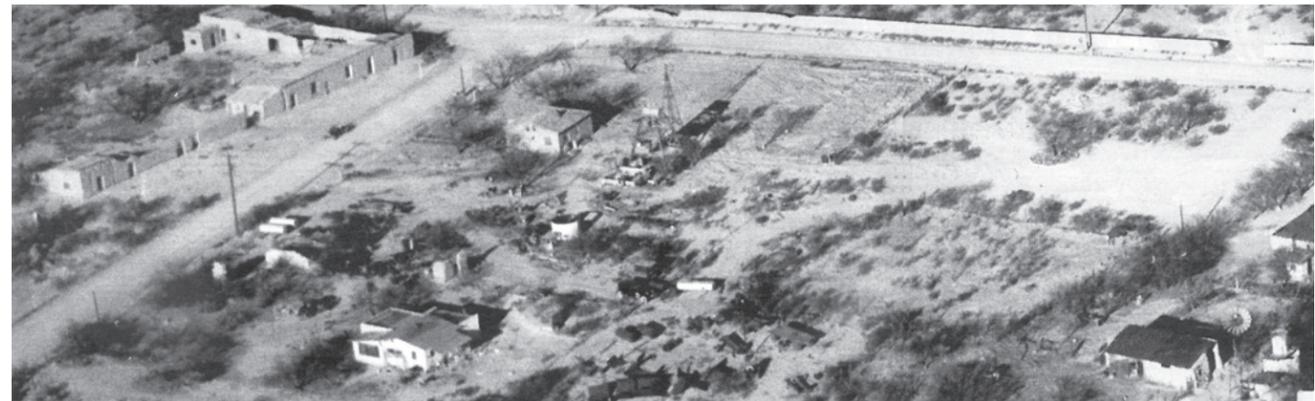
Figure 70: 1940s aerial photo of Adkins Buildings from the Magee Collection held at the Arizona Historic Society. RC Magor residence is located at lower left portion of image. Adkins Residence, prior to circa 1950 addition, is visible in the center of the photograph. Officer's Quarters #1 visible at lower right. The reconstructed commissary buildings are located in the upper left portion of the image.

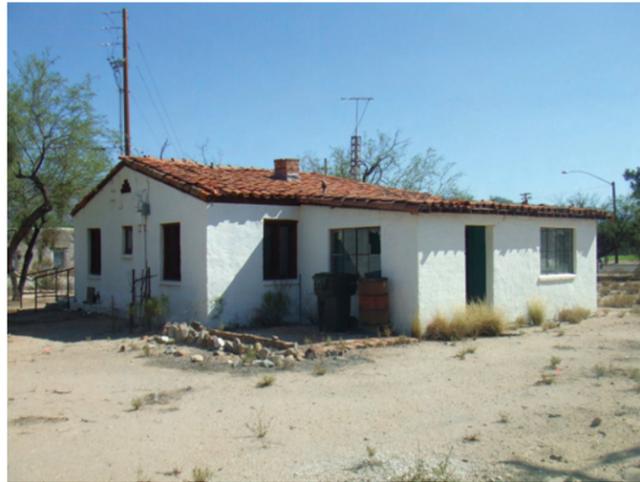
Figure 71: Adkins Residence looking northeast.

The Adkins Residence will be stabilized to allow for a future decision concerning its long term viability. Several critical deficiencies exist that need to be addressed to prevent additional damage. At the eaves, metal flashing should be installed under the existing roofing tile to prevent water from entering the walls. Moisture entering the wall is responsible for much of the coving that has occurred at the base of walls.

The severe deterioration at the west wall should be repaired to prevent the wall from collapsing. All openings in the building should be sealed to prevent vermin and wildlife from entering the building. Site stewardship should include periodic assessment of the Adkins Residence to ensure that the condition of the building does not decline any further.

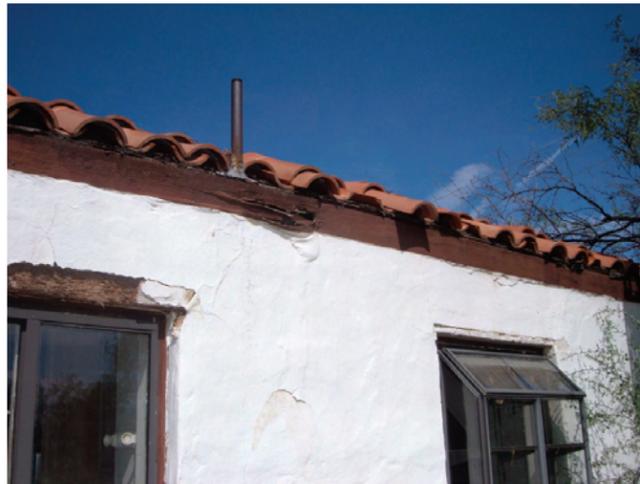
Figure 72: Water damage at roof eave.

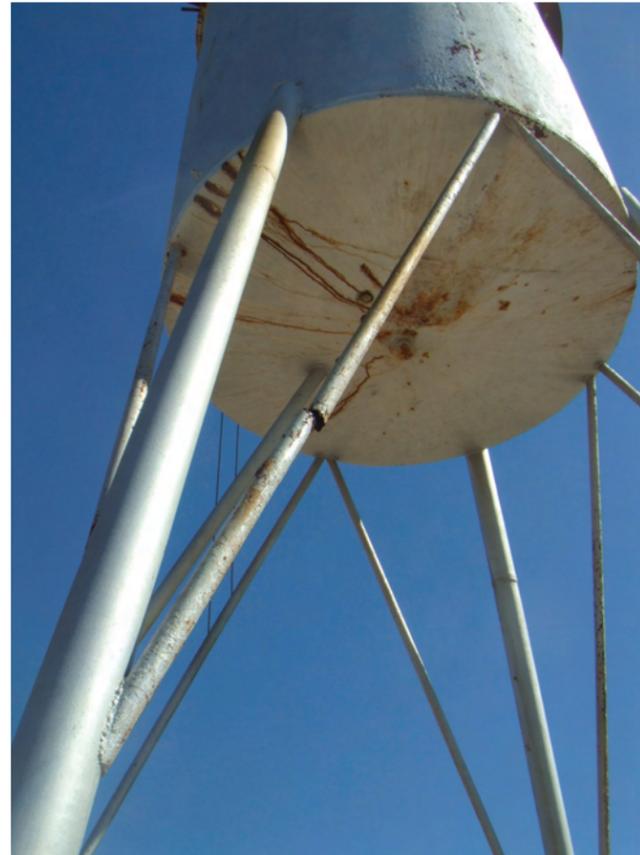
Figure 73: Water Tower with damaged steel brace.

The Adkins Water Tower will be stabilized, in-place, to allow for a future decision following partial implementation of the Master Plan. While no structural analysis has been performed on the Water Tower, it appears to be in good condition. The major deficiencies are a broken support strut at the southwest corner of the base and the peeling away of the roof allowing birds to access the interior. The broken support strut should be braced by attaching a temporary “splint” the full length of the broken strut. Openings at the top of the Water Tower should be sealed to prevent birds from inhabiting the interior of the Water Tower.

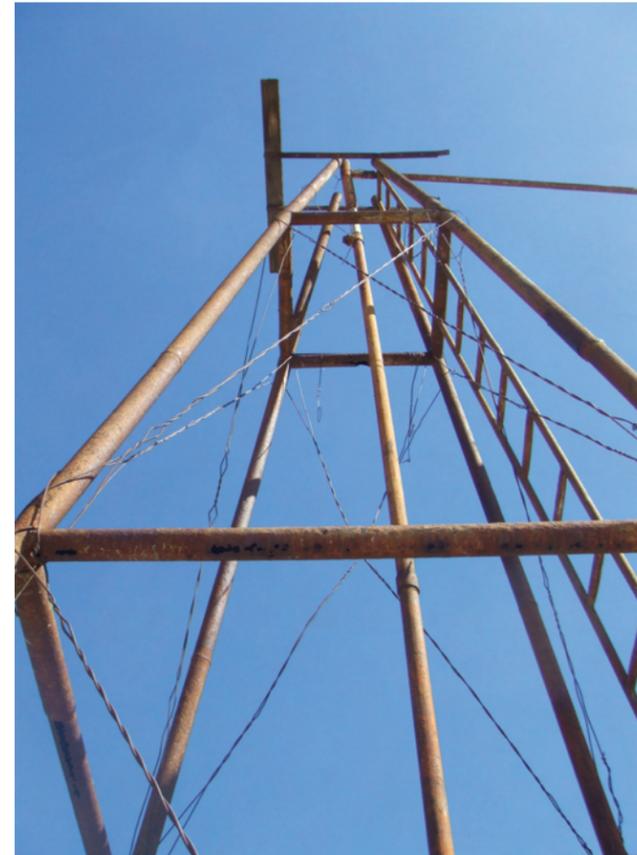
Figure 74: Windmill Base showing rusted structure.

The Adkins Windmill Base will be documented and removed during environmental remediation of the site. Closure of the well beneath the Windmill Base requires removal of the structure. Furthermore, the Windmill Base is in poor condition with many of the steel pipes rusted through. The Windmill Base should be completely documented, including measured drawings, to allow for accurate interpretation. If the Adkins Residence is re-used and interpreted, the reconstruction of the Windmill Base should be considered.
