Preservation Plan

*for the
Adkins Parcel at Fort Lowell Park*

November 2009

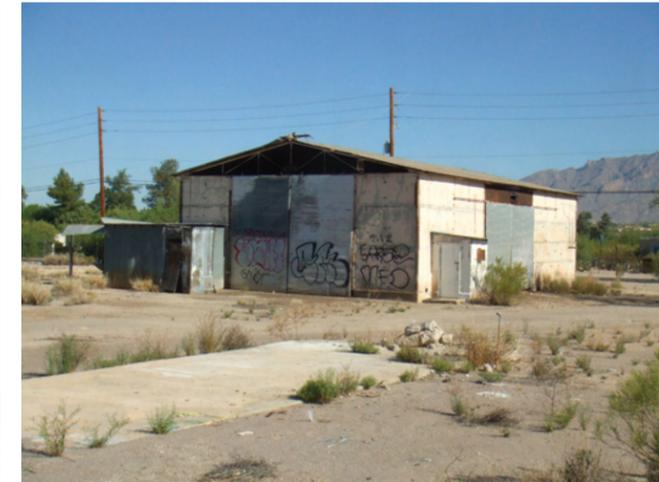
Figure 75: Fabrication Shed looking northwest.

The Adkins Steel Fabrication Shed will be documented and removed as part of the implementation of the Master Plan. The shed is in fair condition. The decision to remove the shed was based on the cost to make the building safe for re-use. The building’s structural elements are undersized and inadequately connected to meet current building codes. The location of the Steel Fabrication Shed is in conflict with the Fort-era buildings and landscape that will be interpreted and re-created at the western edge of the Parade Ground.

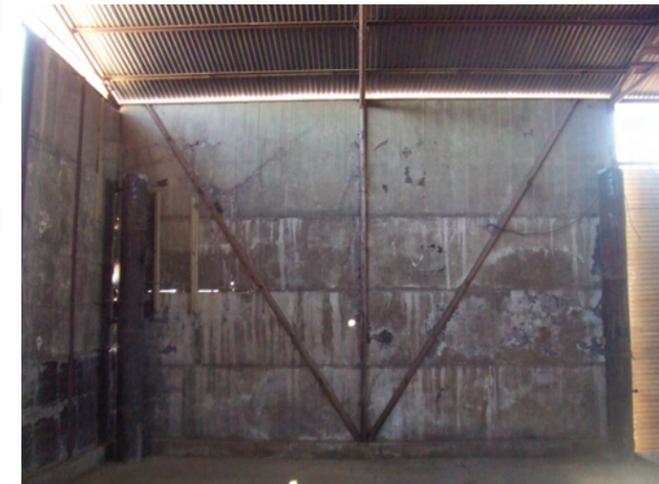
Figure 76: Interior bracing at Steel Fabrication Shed.

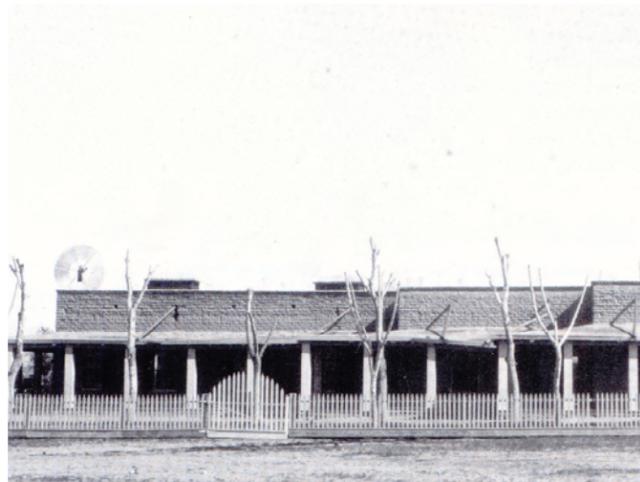
Figure 78: Fort Lowell Hospital, looking east, circa 1889.

The landscape on the Adkins Parcel has gone through a number of changes throughout its history of use. The area was once dominated by creosote and other native shrubs that are typical to largely undisturbed areas of the lower Sonoran Desert region such as prickly pear, catclaw, saguaro, palo verde and mesquite. Once the military moved onto the site in the late 19th century, the landscape transitioned to one that was more open and functional. The parade ground was the site of regular military routines and drills that required the elimination of large trees and shrubs to support the active uses. Historical photos from the Fort era document that the Adkins Parcel site was mostly bare ground with scattered native grasses, shrubs and trees towards the perimeter of the parade ground. Photos also indicate a picket fence (Figure 78) that lined the southern edge of the parade ground and the area to the west of the hospital.

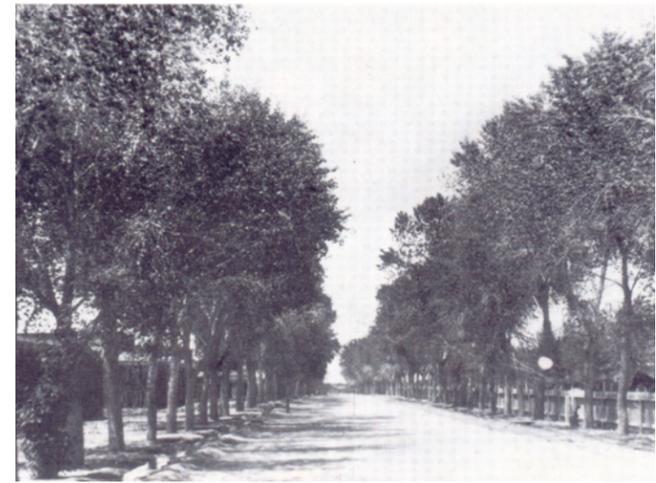
Figure 79: Cottonwood Lane, looking west, circa 1889.

The fence was located in direct association with the dominant landscape element of the Fort which was the introduced double row of cottonwood trees (Figure 79) that lined the Officer's Quarters and provided cooling shade for the soldiers stationed there. The Officer's Quarters were also home to a number of small kitchen gardens that supported vegetables and herbs used for cooking. Once the military abandoned the site at the turn of the century, the cottonwoods were cut down for use as firewood and the surrounding native vegetation slowly re-established itself on the former parade ground area.

Cottonwood Lane and the associated fencing are recommended to be re-introduced to the site as they were dominant features of the Fort period landscape. The existing native desert vegetation that is on-site should largely remain in place except for within the footprint of the parade ground and immediately surrounding the officer's quarters. This will create a central activity area surrounded by a mix of creosote, cholla, barrel cactus, prickly pear, acacia and mesquite which is reminiscent of how the area looked during the Fort era. The kitchen gardens should also be re-established to give an accurate representation of how the landscape supported the uses of the site.

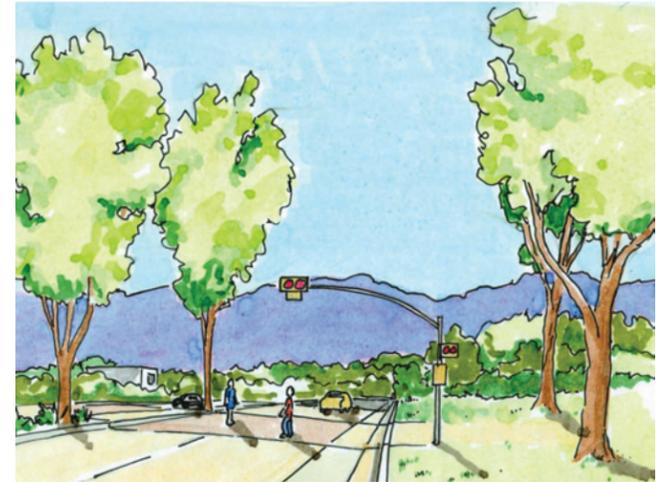
Figure 80: Proposed HAWK signal at Craycroft Rd.

The proposed pedestrian "HAWK" crossing at Craycroft Road is an important item to be included with the Preservation Plan. The HAWK provides a safe place to cross Craycroft Road within the boundaries of Fort Lowell Park. The funding for the HAWK crossing is not included in the 2004 Pima County Bond Funding.

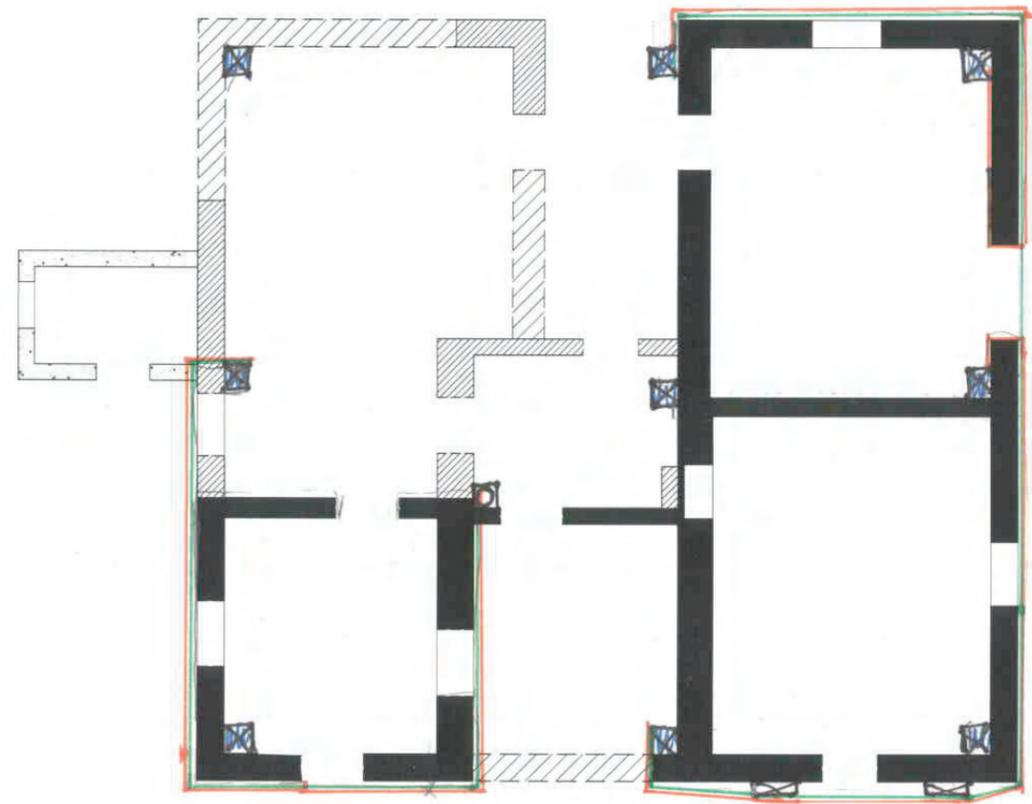
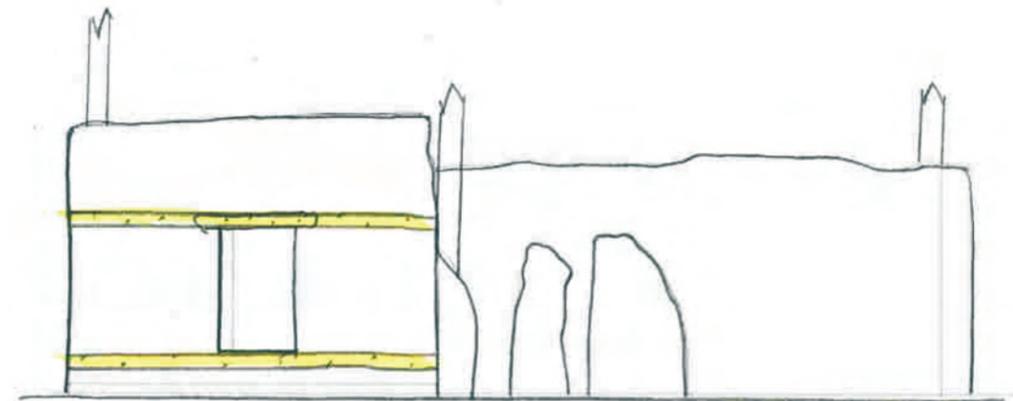
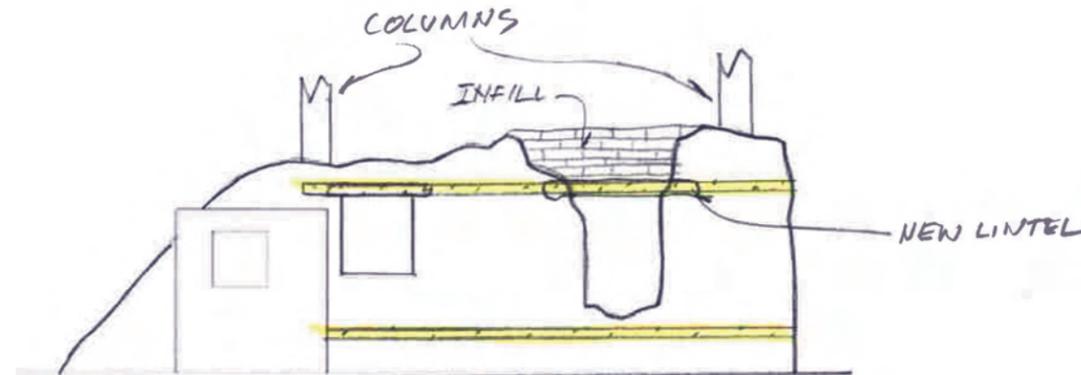
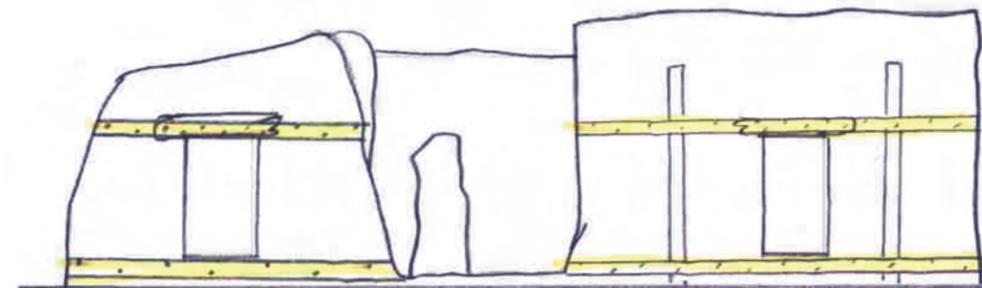
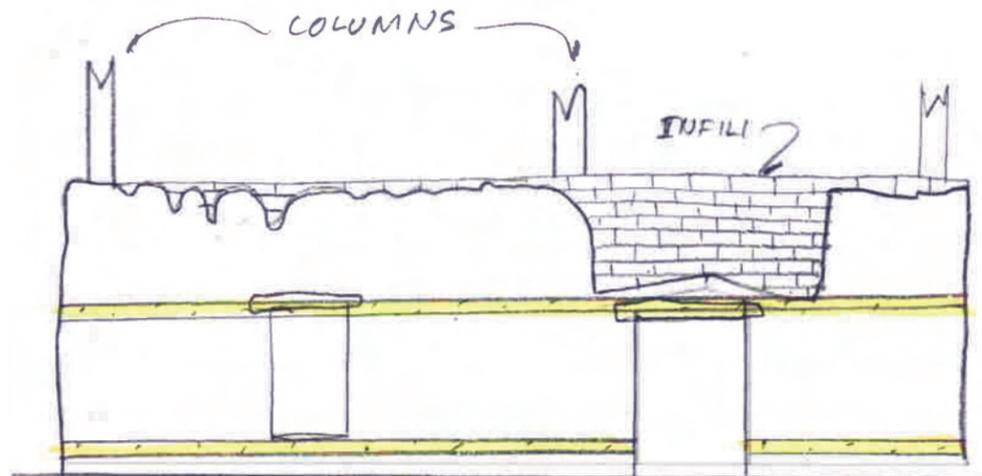
Proposal to “capture the walls” on Officer’s Quarters #2 using polyester webbing. This strategy is one option being considered to stabilize the walls. This design was completed before the lower porch ghosting was added. Since the lower porch ghosting will help to stabilize the walls, the polyester webbing may not be needed or may be reduced in scope.

- Columns
- Upper Strap
- Lower Strap
- 2 x 6 Stiles
- Bollard

North

West

South

East

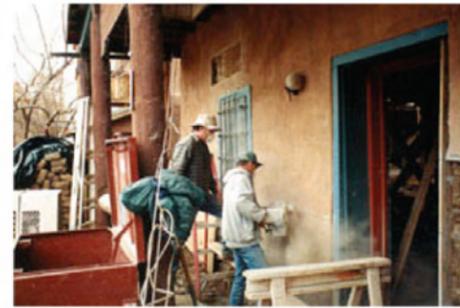
The “Adobe Cage” method, developed by Crocker, Ltd., for stabilizing earthen walls for a failing building in Arroyo Seco, New Mexico.

The hard plaster is cut and removed, revealing the damaged wall beneath.

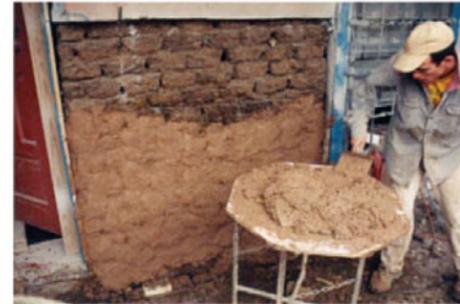
A lime-rich mud is cast onto the damaged wall without removal and replacement of adobe.

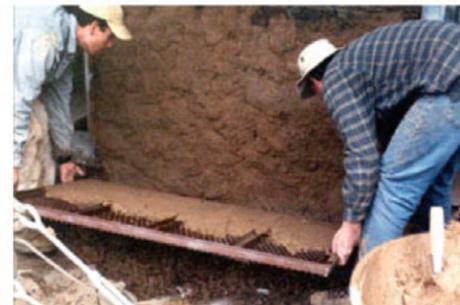
Mud is cast onto the steel “cage,” a frame that is one inch thick and fabricated on site to fit the building’s pathologies.

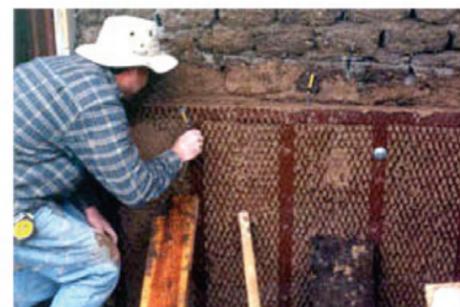
Once in place, holes are drilled through the wall to match up with the cage on the opposite side. All-thread through-bolts are used to draw the two cages together and sandwich the damaged wall.

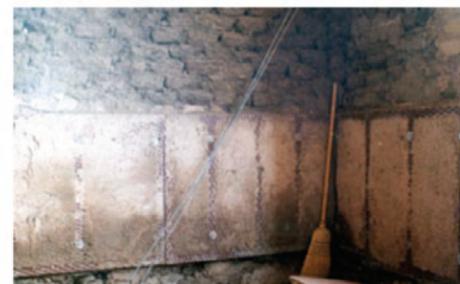
The cages are left essentially flush with the vertical plane of the walls and can be plastered over without the use of lath.
