**TECHNICAL DATA NOTEBOOK
FOR**

**Camino Real Wash,
Pima County, AZ**

Contract #25-59-C-13522-0507

**Prepared For:
Pima County Regional Flood Control District
97 E. Congress, 3rd Floor
Tucson, AZ 85701**

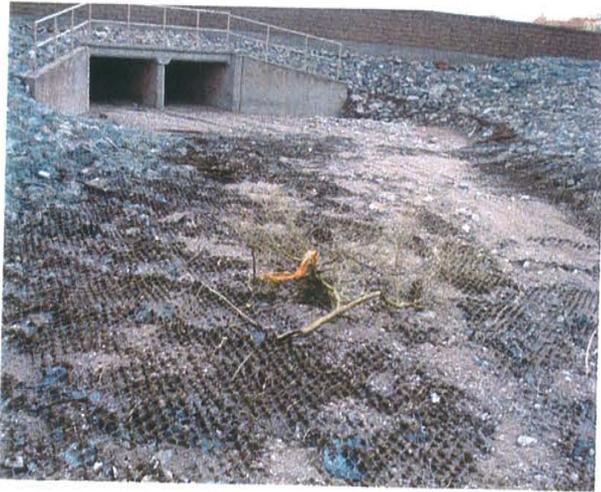
East Upstream Inlet (Looking Downstream)

On July 28, 2007 a severe storm hit the Camino Real Wash Watershed. While the Camino Real Wash watershed is not gauged, adjacent watershed gages indicated that 2.52” of rain fell (2 inches of that occurred in a two hour period). The following pictures show the aftermath of the storm and substantiate that sedimentation is not a problem as the improvements have sufficient capacity to convey the sediment supply.

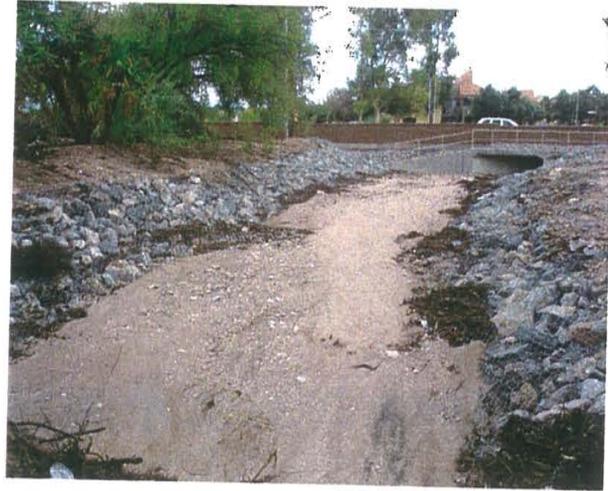
West Upstream Inlet (Looking Downstream)

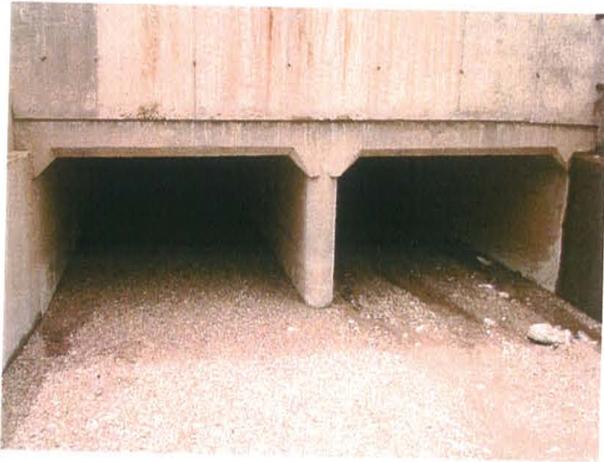
East Upstream Outlet (Looking Upstream)

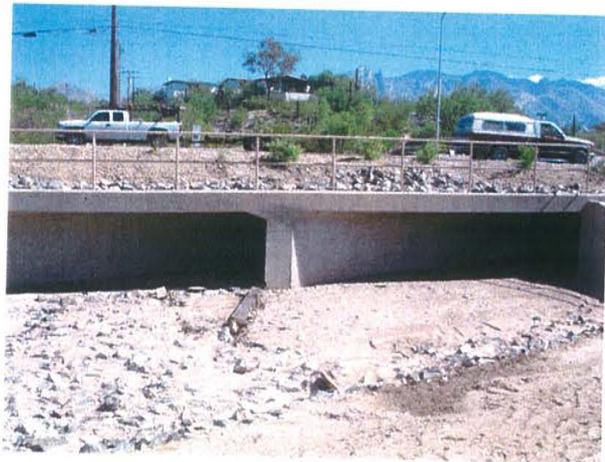
West Upstream Outlet (Looking Upstream)

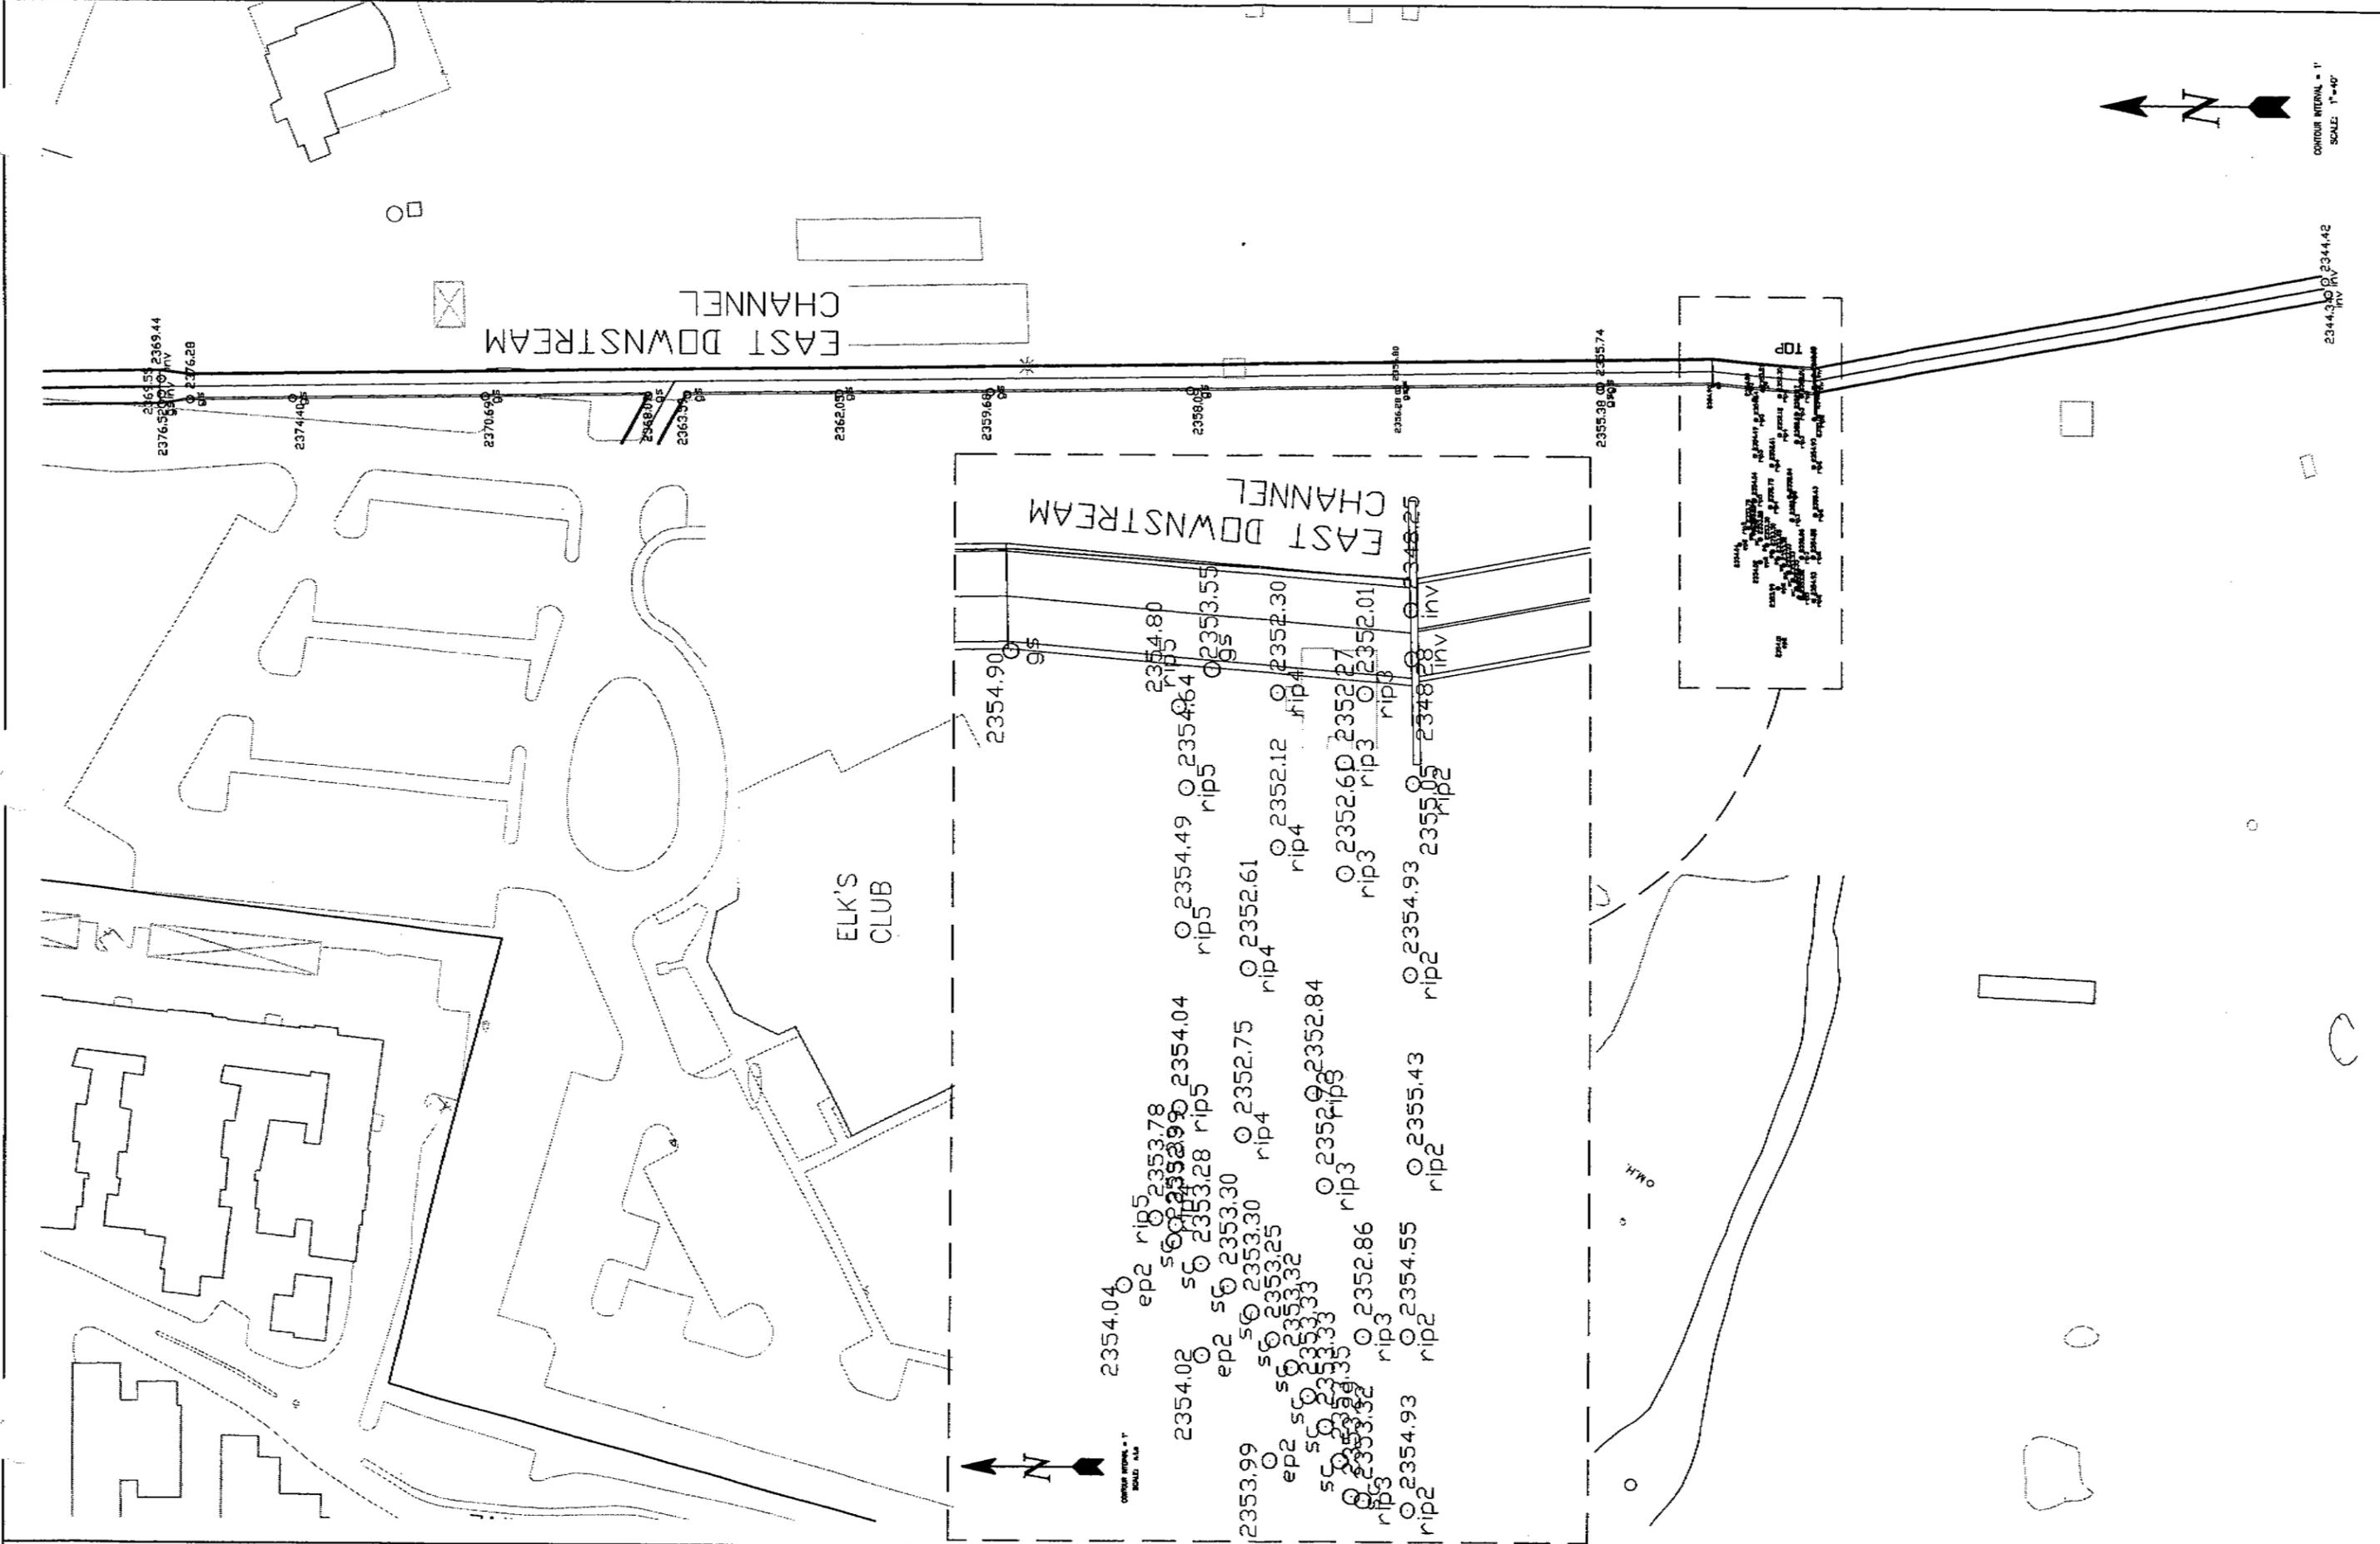
The existing 2-barrel 6'x4' RCBC at the downstream end of the east downstream channel (River Station 7+77) was surveyed. This culvert was built as anticipated by an adjacent development and is consistent with the CLOMR analysis.

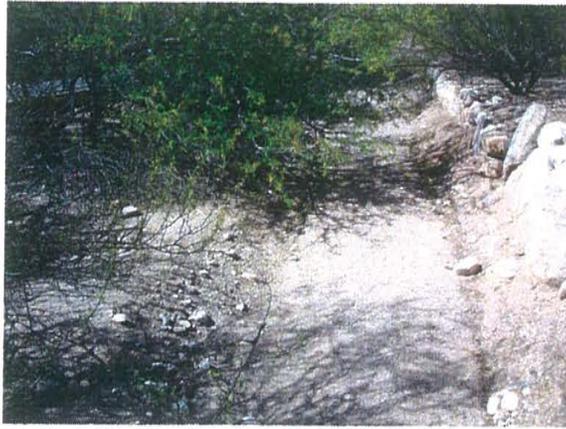
APPENDIX B.1
FEMA MT-2 FORMS
FOR
CAMINO REAL WASH
LOMR

Manning’s Roughness coefficients were estimated using the Table 8.1: Manning’s Roughness Coefficients in the ‘Standards Manual for Drainage Design and Floodplain Management In Tucson, Arizona’ December, 1989 (Revised July, 1998). The method to determine Manning’s Roughness was observation and analysis of aerial photos provided by Pima County, along with field visits to verify findings. Photos were taken to show field conditions of the Camino Real Wash. For all cross-sections that were established in the CLOMR by Castro Engineering, the Manning’s roughness value was maintained.

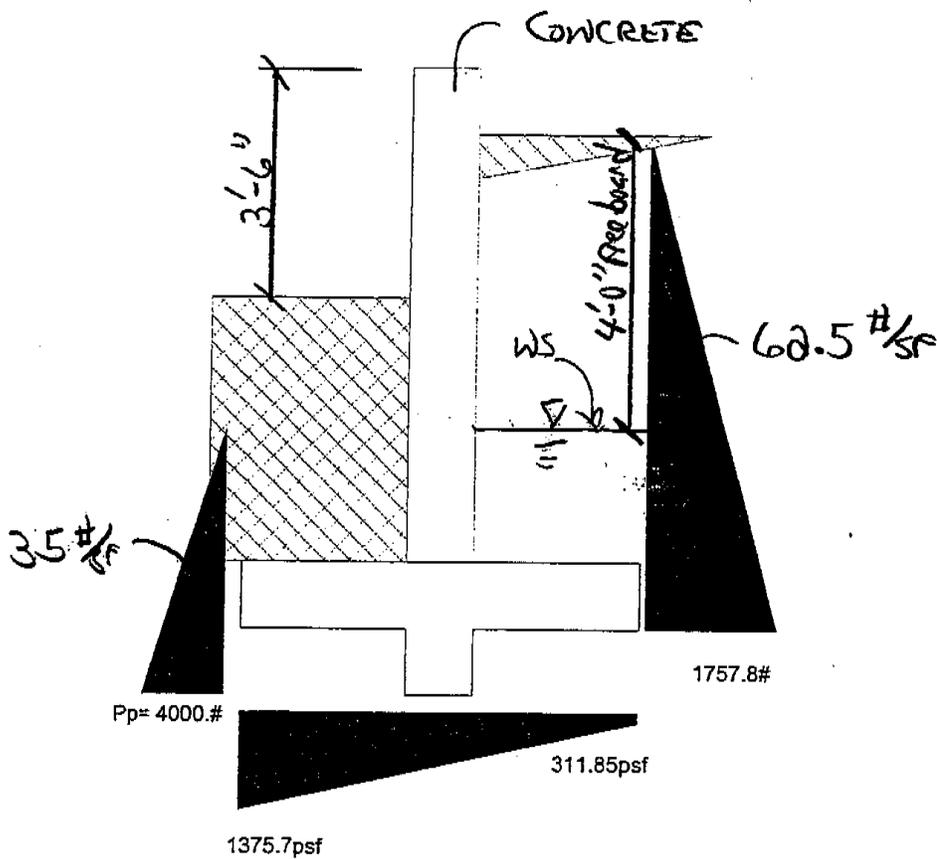
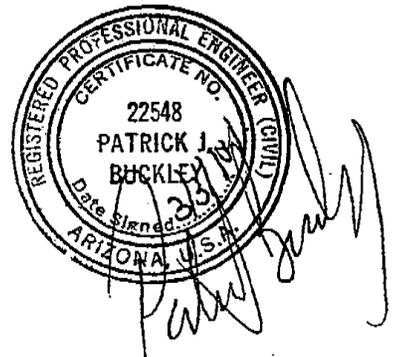
RIVER ROAD FLOOD WALL
CAMINO REAL WASH

DESIGN OF WALL: TOP OF WALL 3'-6" OF ROADSIDE GROOVE.
WALL DESIGN: 4' WATER (FLOOD) ABOVE PROPOSED WATER SURFACE (W.S.)
CONCRETE DESIGN

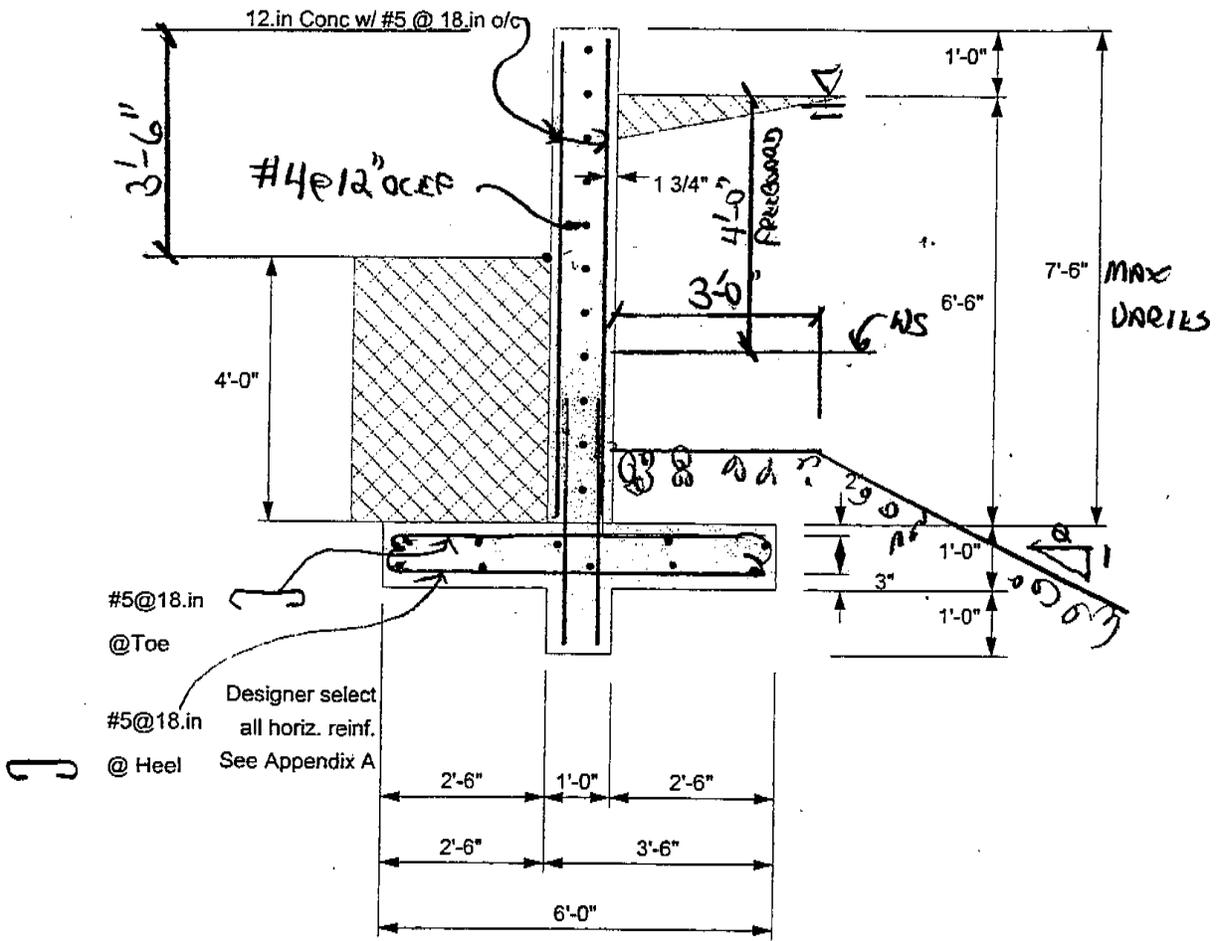
Footing Design Results		
	Toe	Heel
Factored Pressure	= 1,926	437 psf
Mu' : Upward	= 5,372	2,011 ft-#
Mu' : Downward	= 2,581	3,784 ft-#
Mu: Design	= 2,791	1,774 ft-#
Actual 1-Way Shear	= 15.41	10.18 psi
Allow 1-Way Shear	= 76.03	76.03 psi
Toe Reinforcing	= # 5 @ 18.00 in	
Heel Reinforcing	= # 5 @ 18.00 in	
Key Reinforcing	= None Spec'd

Concrete Data	
fc	psi = 3,000.0 3,000.0
Fy	psi = 60,000.0 60,000.0
Other Acceptable Sizes & Spacings	
Toe:	#4@ 13.25 in, #5@ 20.50 in, #6@ 29.00 in, #7@ 39.25 in, #8@ 48.25 in, #9@ 4
Heel:	Not req'd, Mu < S* Fr
Key:	Not req'd, Mu < S* Fr

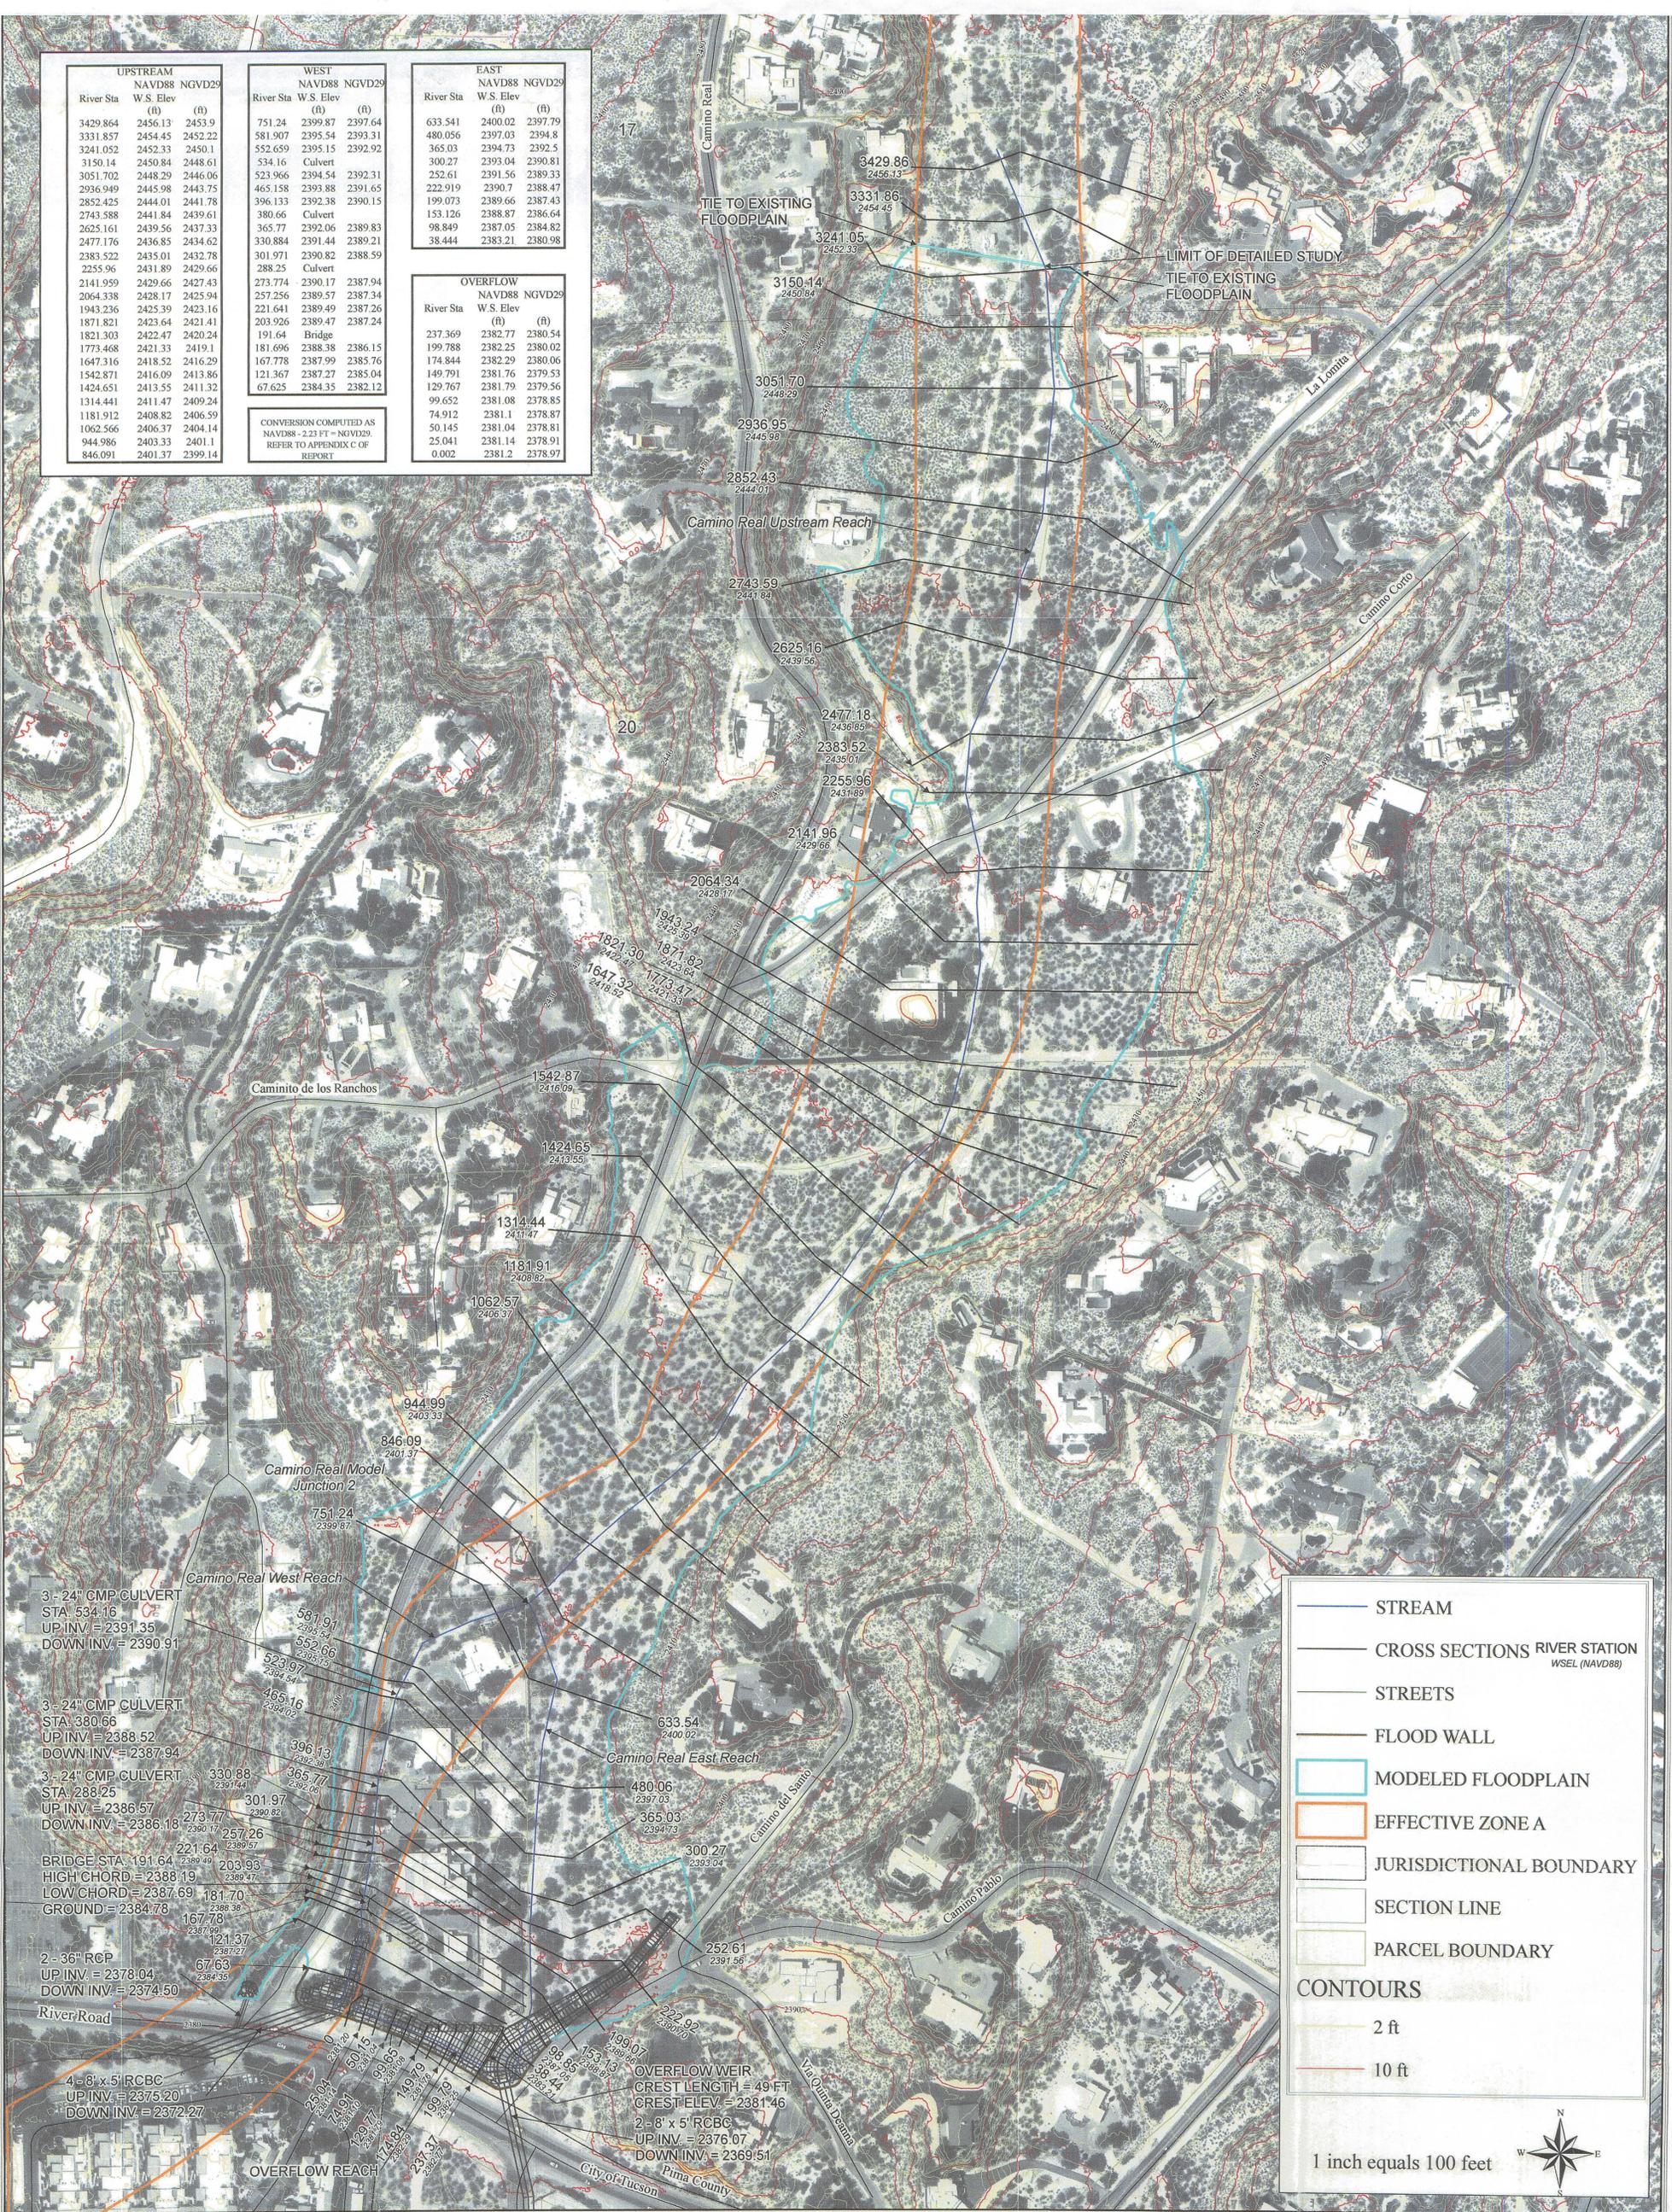
CAMINO REAL LOMR HYDRAULIC STUDY: FIGURE 2 - UPSTREAM REACH

NOTES
 Project view is within FIRM Panel 04019C1645K
 Located in: T. 13 S, R. 14 E, Sections 17 & 20
 No LOMR or LOMA are in this view
 Vertical Datum NAVD88

Work maps are provided to display the stream alignments, cross-sections, structures, floodplain delineations, topography, and aerial photos. The work maps are separated into the Upstream Reach, Figure 2, and the Downstream Reach, Figure 3. See Exhibit Maps for figures.

- **FIGURE 2**, CAMINO REAL WORKMAP NORTH OF RIVER ROAD
- **FIGURE 3**, CAMINO REAL WORKMAP SOUTH OF RIVER ROAD

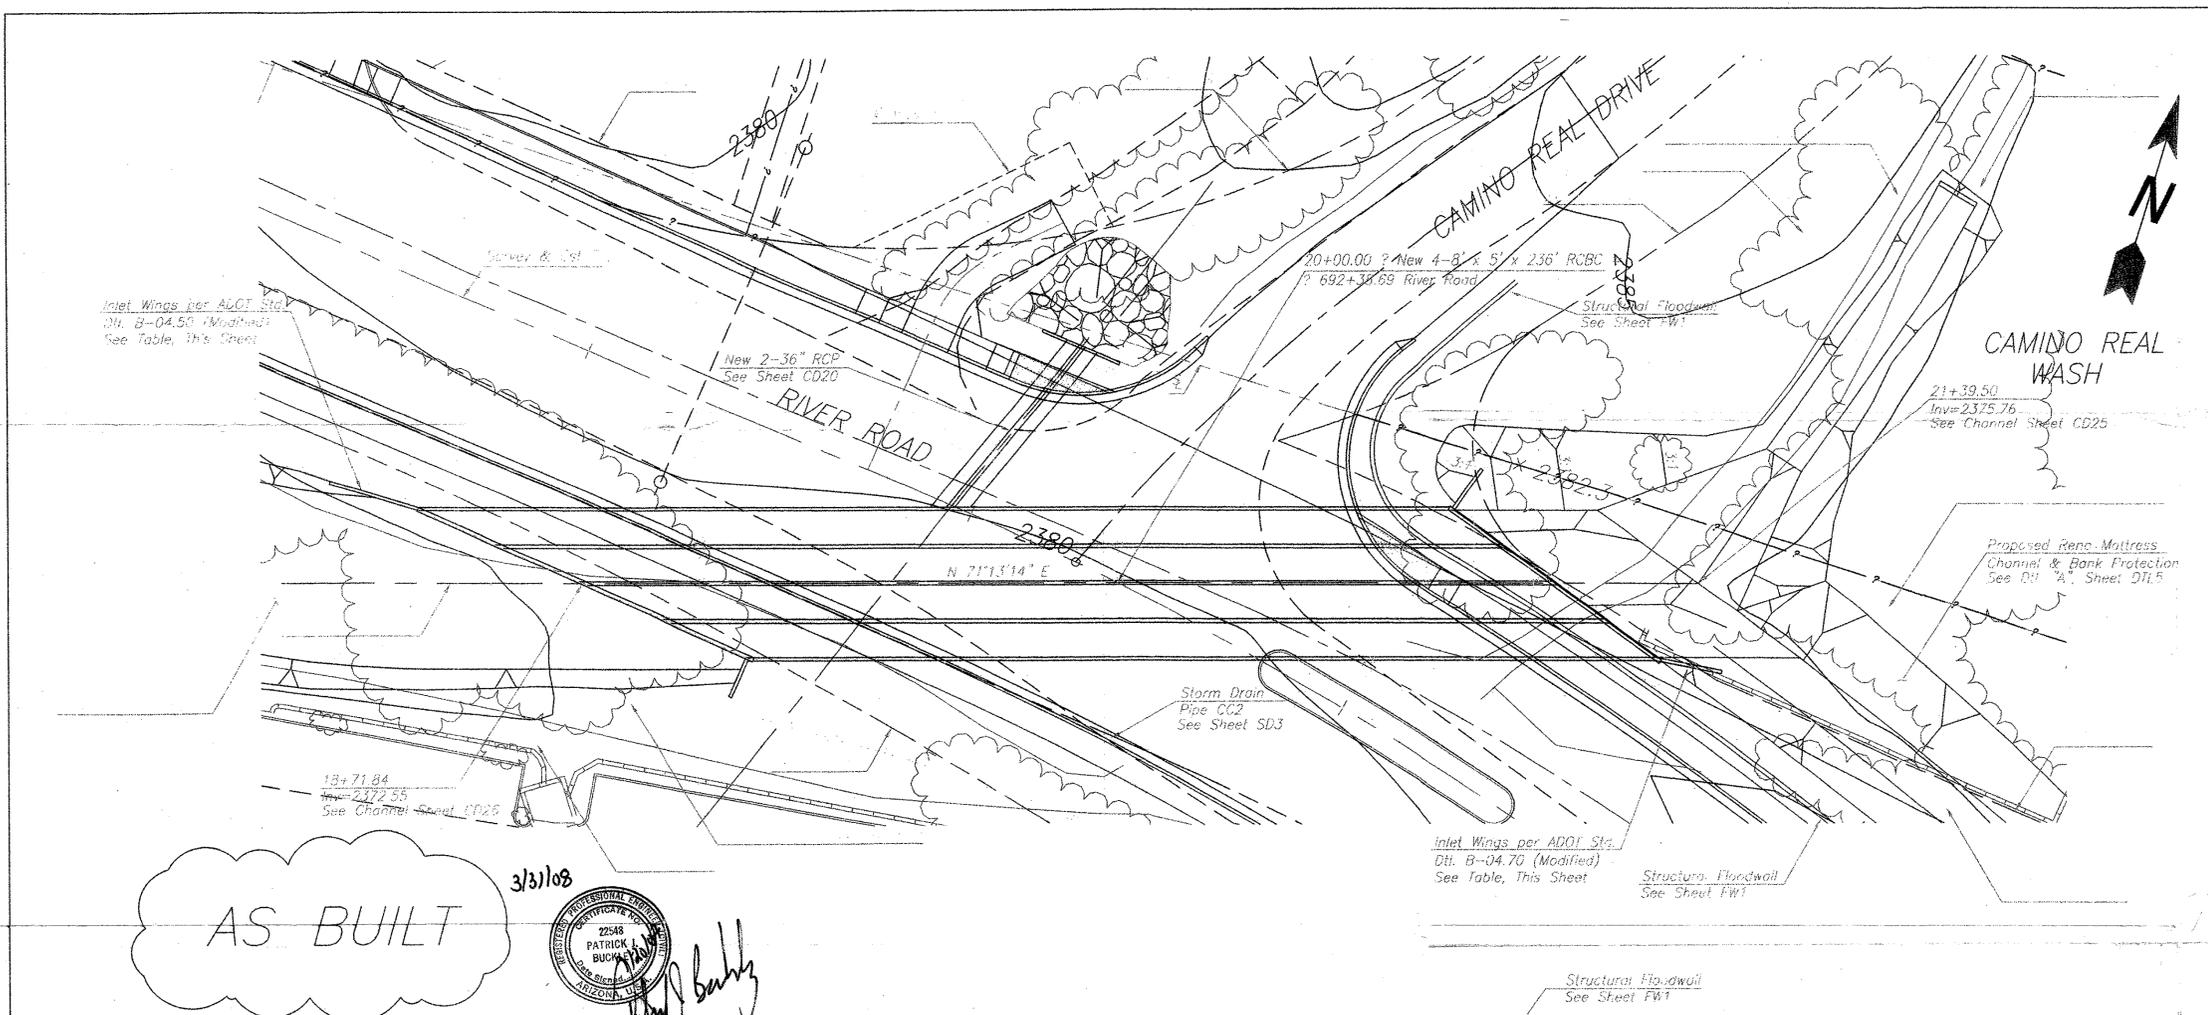
EARTHWORK QUANTITIES

Structural Excavation: 1334 CY
 Pipe Excavation: N/A
 Drainage Excavation: N/A
 Structural Backfill: 274 CY
 Pipe Backfill: N/A
 Trench Backfill: 0 CY

MODIFIED WINGWALL TABLE

Inlet	Outlet
A	1'-6"	1'-6"
B	1'-1"	1'-1"
C	1'-0"	1'-0"
D	3'-7"	3'-7"
E	12'-0"	10'-0"
F	2'-8"	2'-8"
G	16'-0"	22'-0"
J	2'-4"	2'-4"
K	1'-1 1/2"	1'-1 1/2"
L	3'-7"	3'-7"
M	3'-9"	3'-9"
Ø	35.5'	23.8'
⊕	25.0'	7.0'

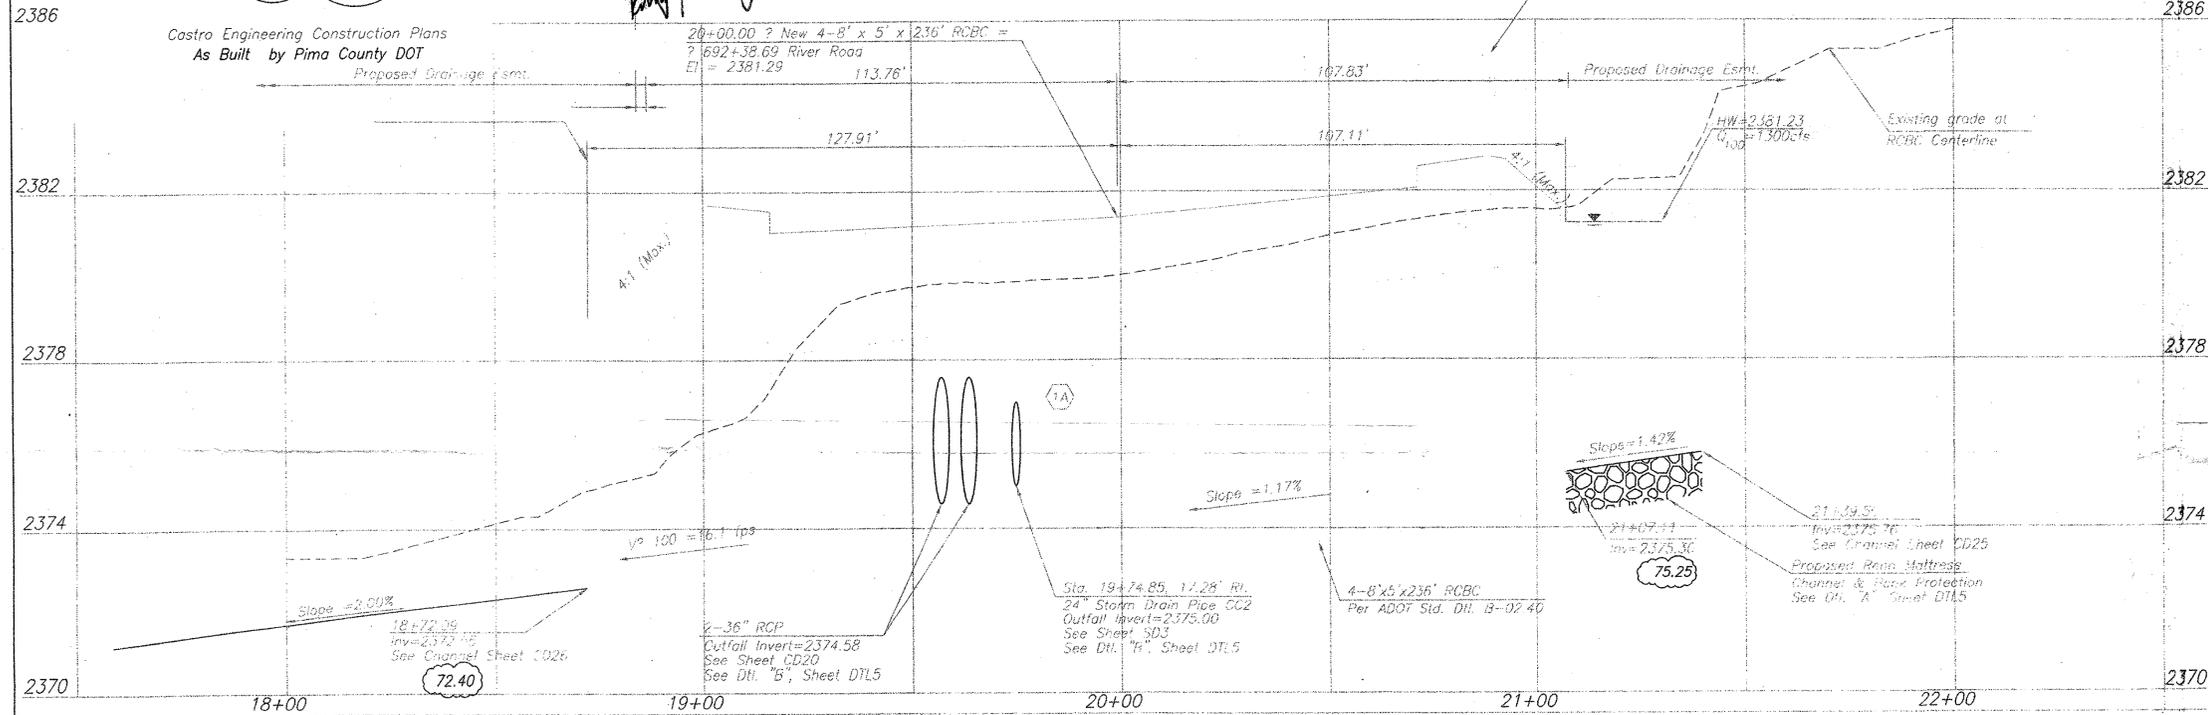
River Road Sta. 692+38.69
New 4 - 8' x 5' x 236' RCBC at Skew 64° Rt

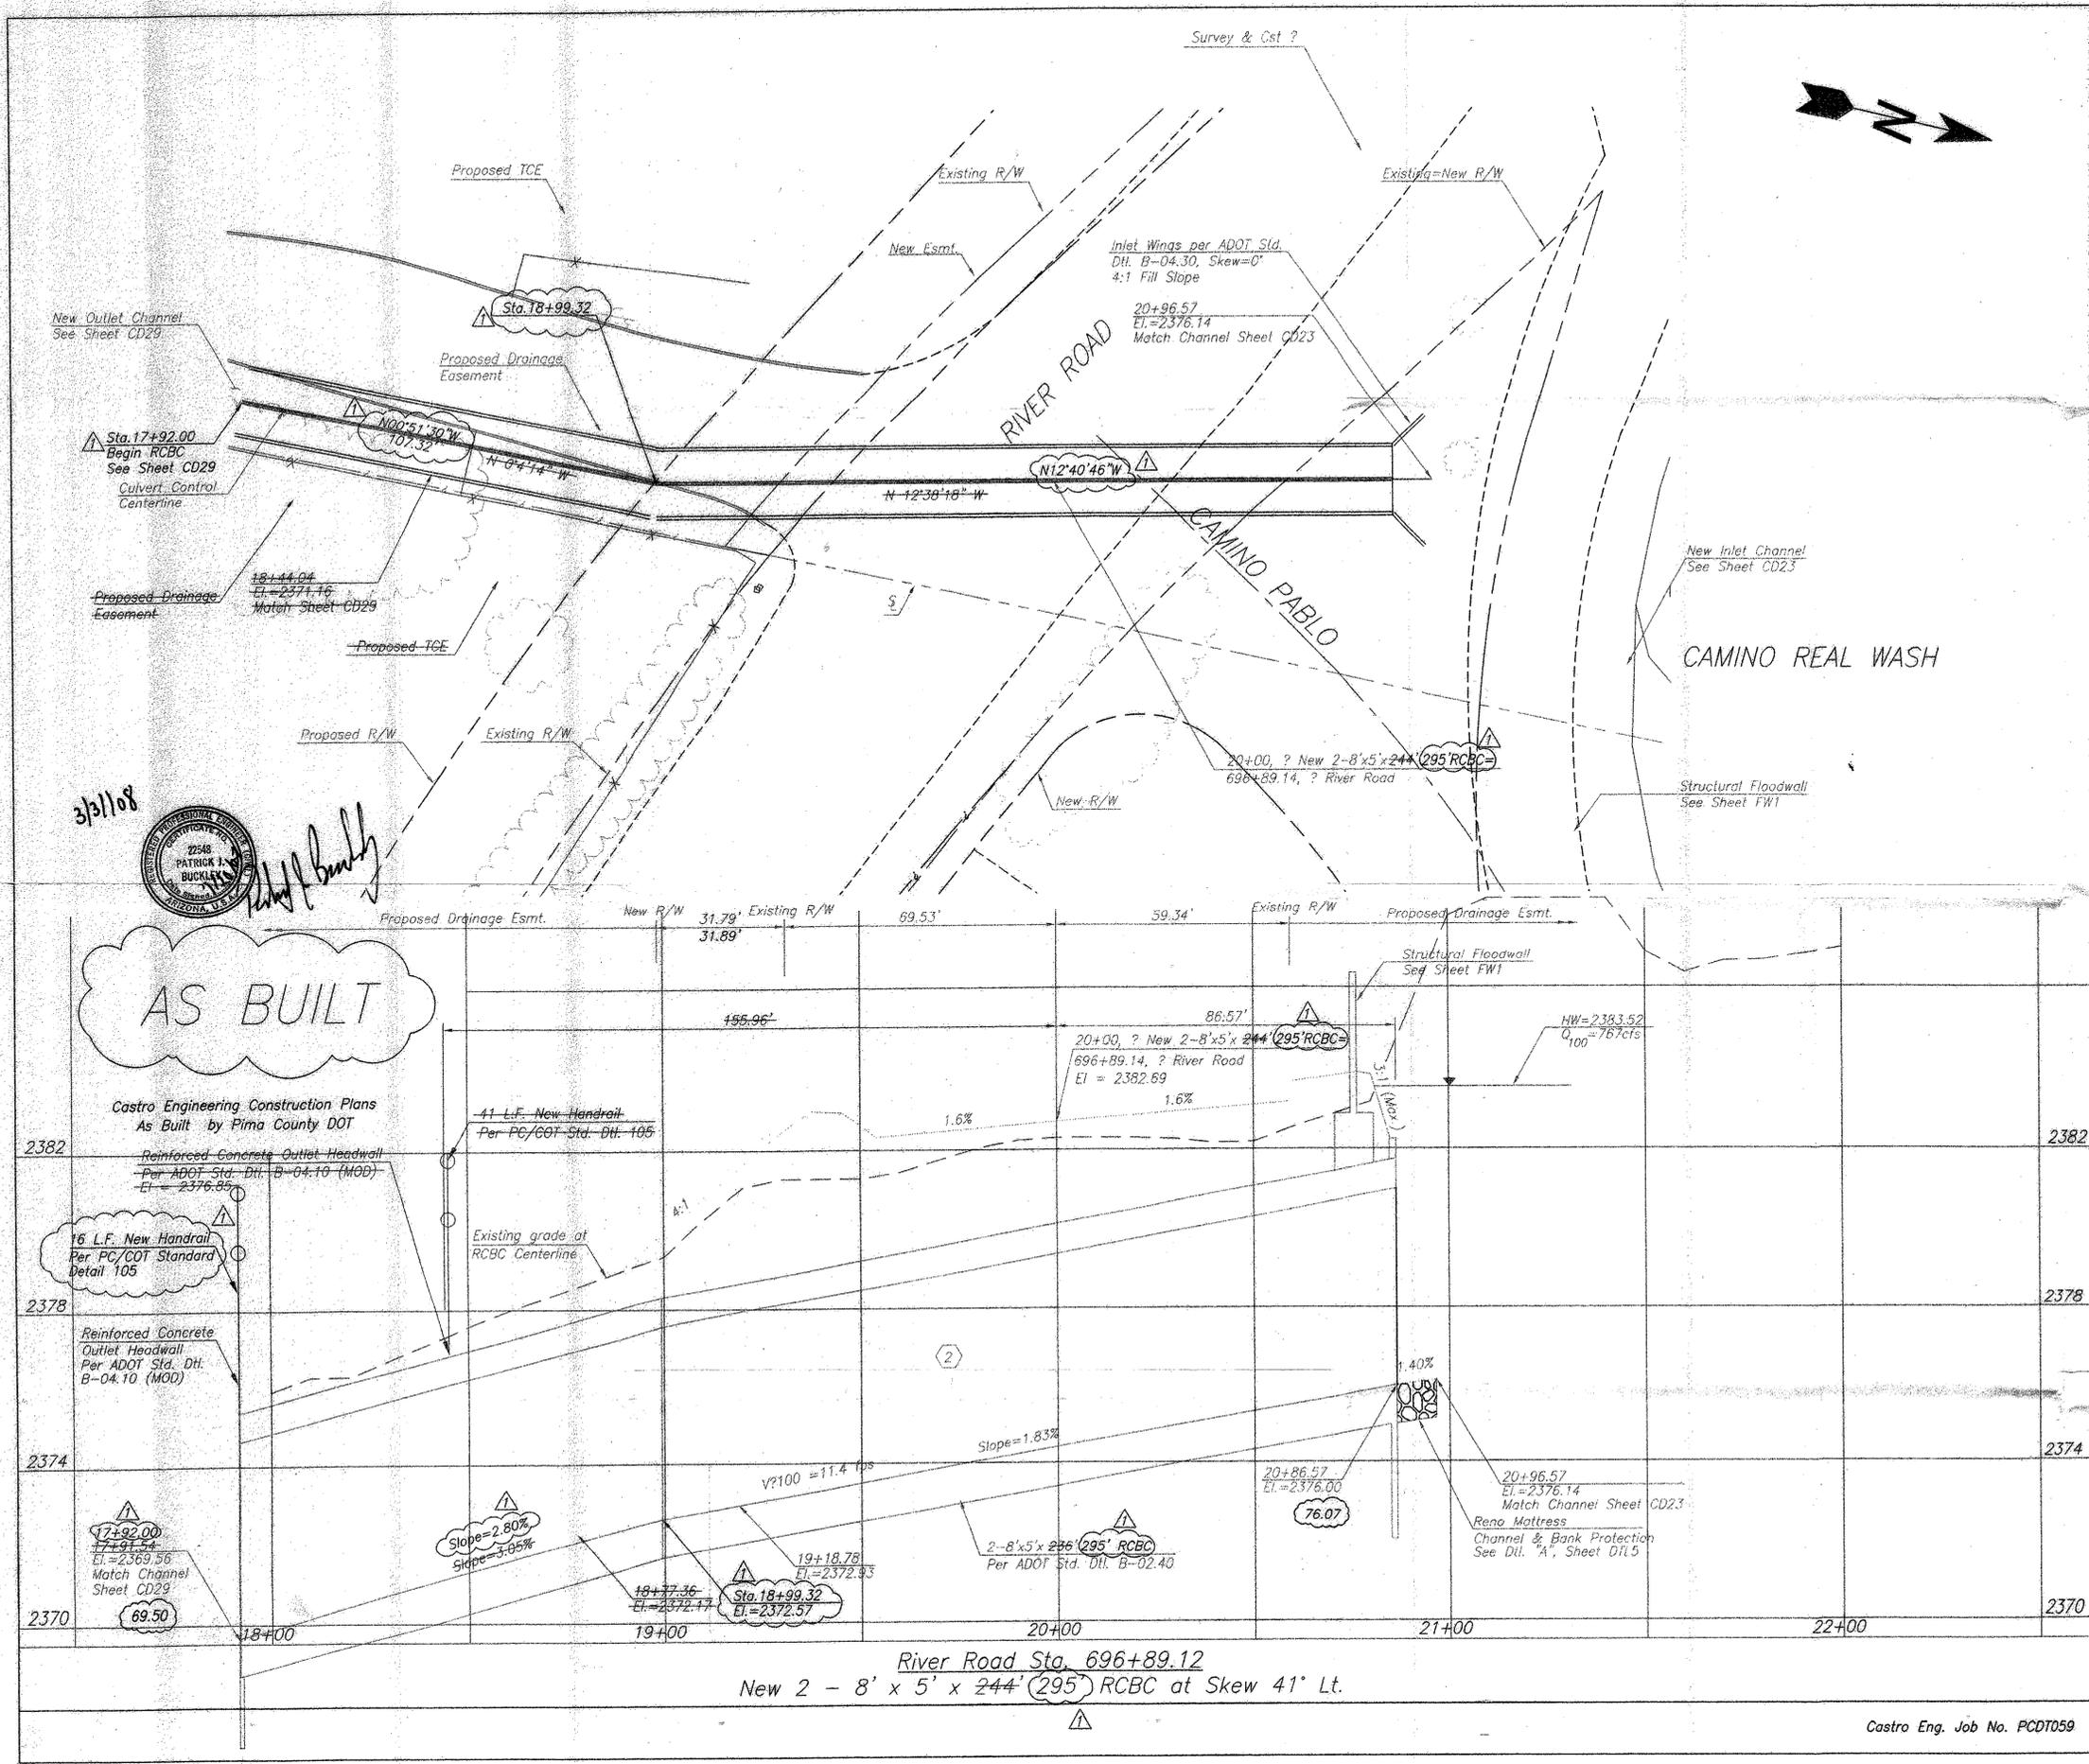
RIVER ROAD
 CAMPBELL AVE TO ALVERNON WAY
 CROSS DRAINAGE PLAN & PROFILE
 STA. 696+89
 W.O. 4TRCA

EARTHWORK QUANTITIES
 Structural Excavation: 1892 CY
 Pipe Excavation: N/A
 Drainage Excavation: N/A
 Structural Backfill: 40 CY
 Pipe Backfill: N/A
 Trench Backfill: 492 CY

REVISED QUANTITIES
 1. (2)-8'x5' RCBC Length: (+)51 LF
 -Revised from 244' to 295'
 2. Handrail Length: (-)25 LF
 -Revised from 41' to 16'

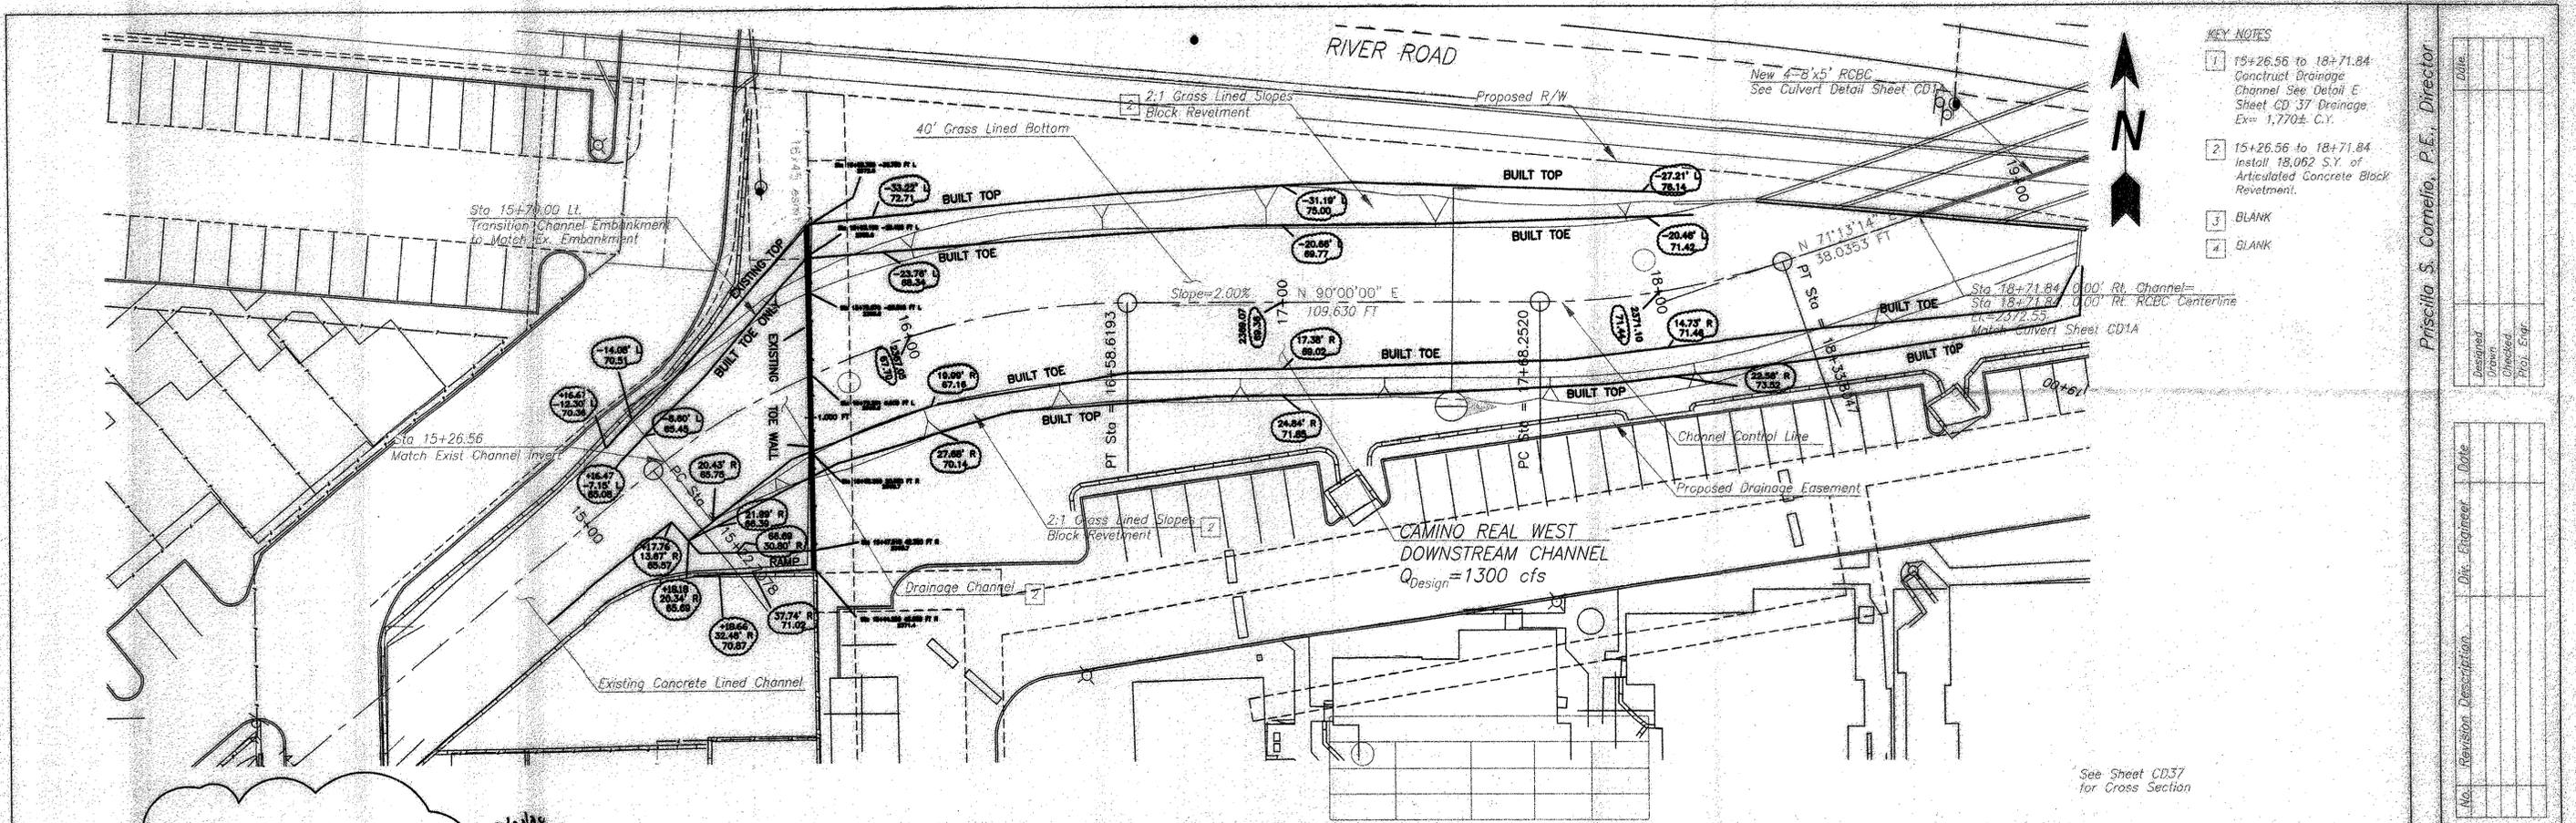
RIVER ROAD
CAMPBELL AVE. TO ALVERNON WAY
CHANNEL IMPROVEMENT PLANS
STA. 10+50 TO 13+25
W.C. 4/FRRCA

- KEY NOTES**
- 1 15+26.56 to 18+71.84 Construct Drainage Channel See Detail E Sheet CD 37 Drainage Ex= 1,770± C.Y.
 - 2 15+26.56 to 18+71.84 Install 18,062 S.Y. of Articulated Concrete Block Revetment.
 - 3 BLANK
 - 4 BLANK
