**TECHNICAL DATA NOTEBOOK
FOR**

**Camino Real Wash,
Pima County, AZ**

Contract #25-59-C-13522-0507

**Prepared For:
Pima County Regional Flood Control District
97 E. Congress, 3rd Floor
Tucson, AZ 85701**

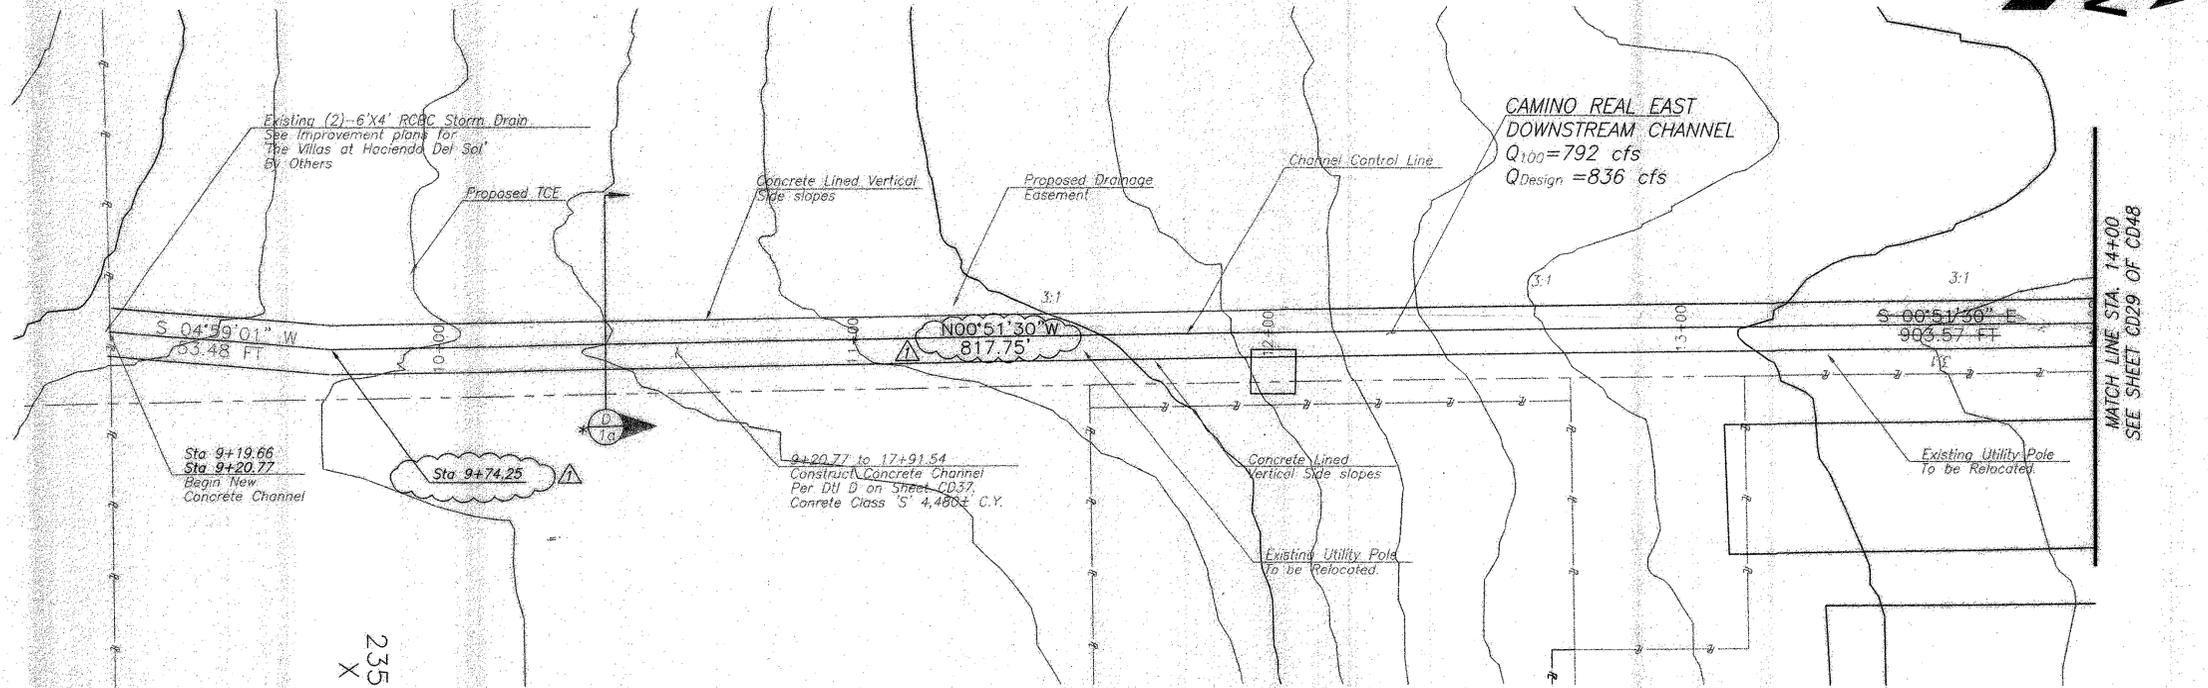
Pima County Department of Transportation
RIVER ROAD
CAMPBELL AVE. TO ALVERNON WAY
CHANNEL IMPROVEMENT PLANS
CHANNEL REAL WEST CHANNEL
CAMINO W.G. 4TRCA

CAMINO REAL EAST
DOWNSTREAM CHANNEL
Q₁₀₀ = 792 cfs
Q_{Design} = 836 cfs

MATCH LINE STA. 14+00
SEE SHEET CD29 OF CD48

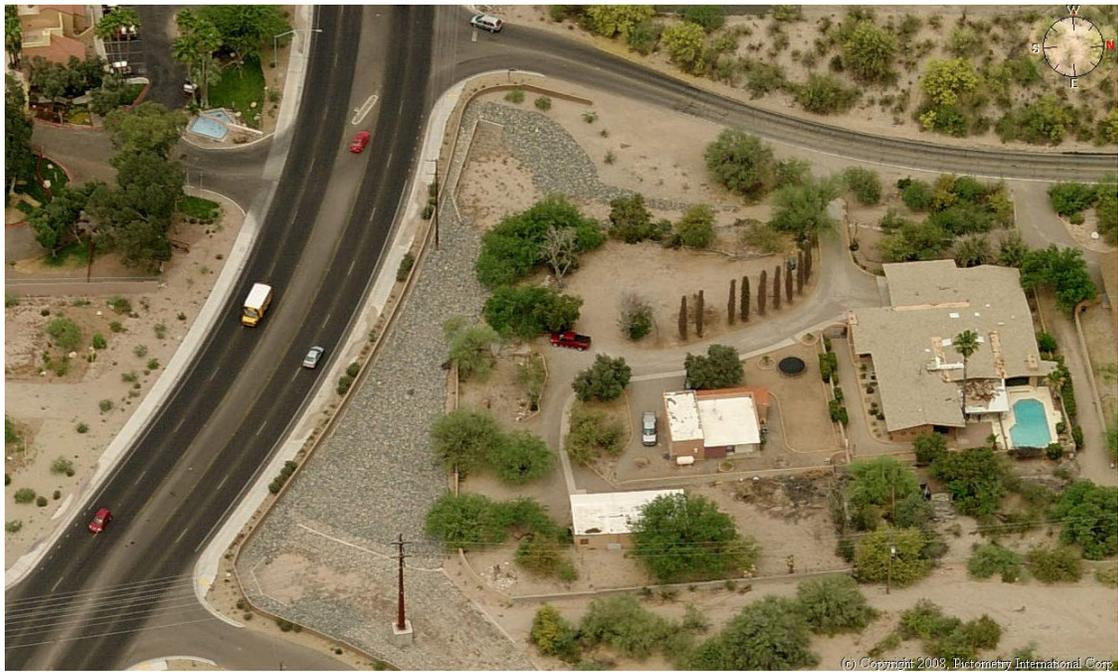
New culvert inlets and overflow channel along upstream side of north wall.

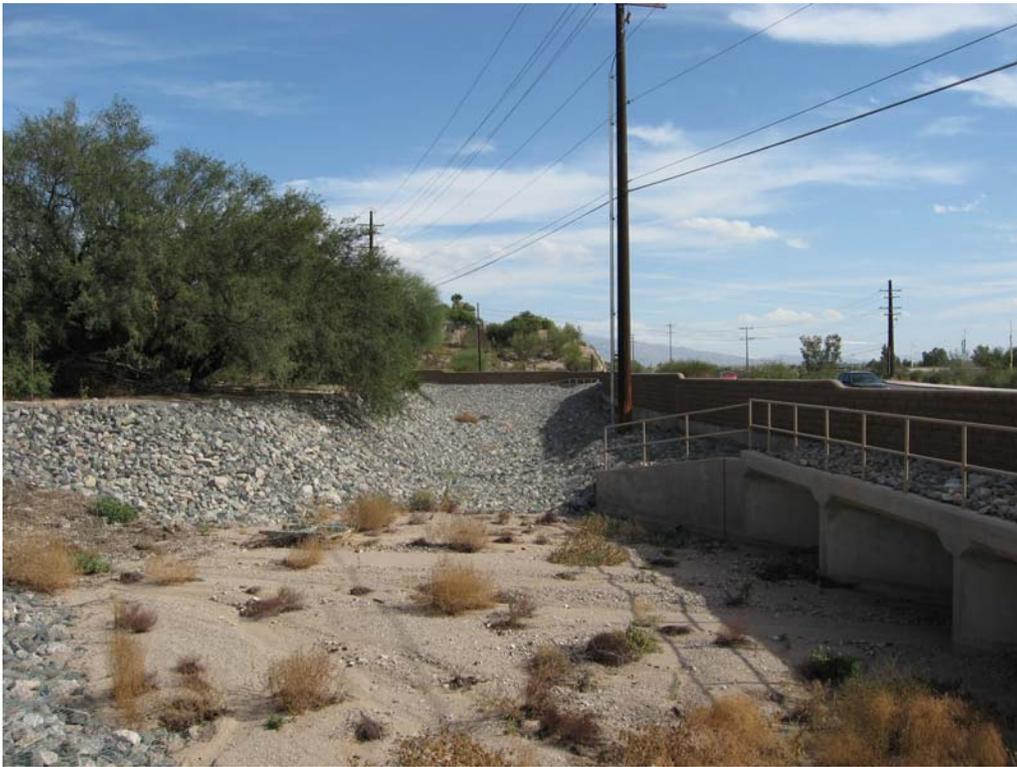
Looking east along overflow channel from inlet to the new 4-8'x5' RCBC. The north wall is visible along northern edge of River Road.

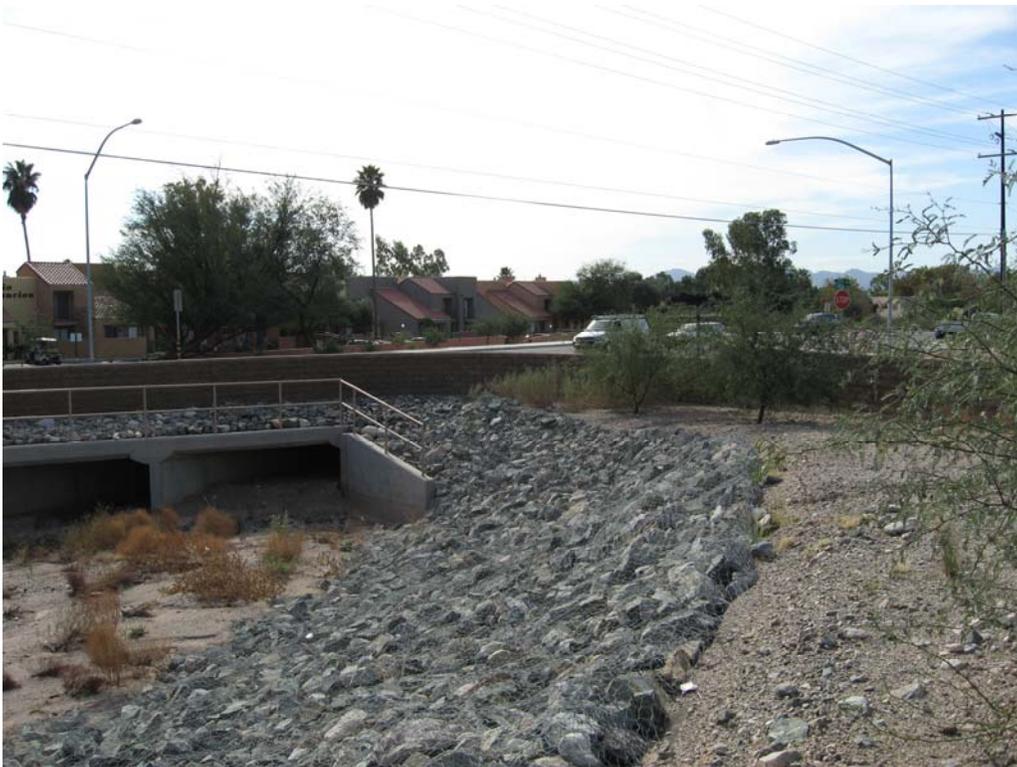
Looking southwest at River Road and properties to the south from inlet to new 4-8'x5' RCBC. The north wall, including the western tie-back portion, is also shown.

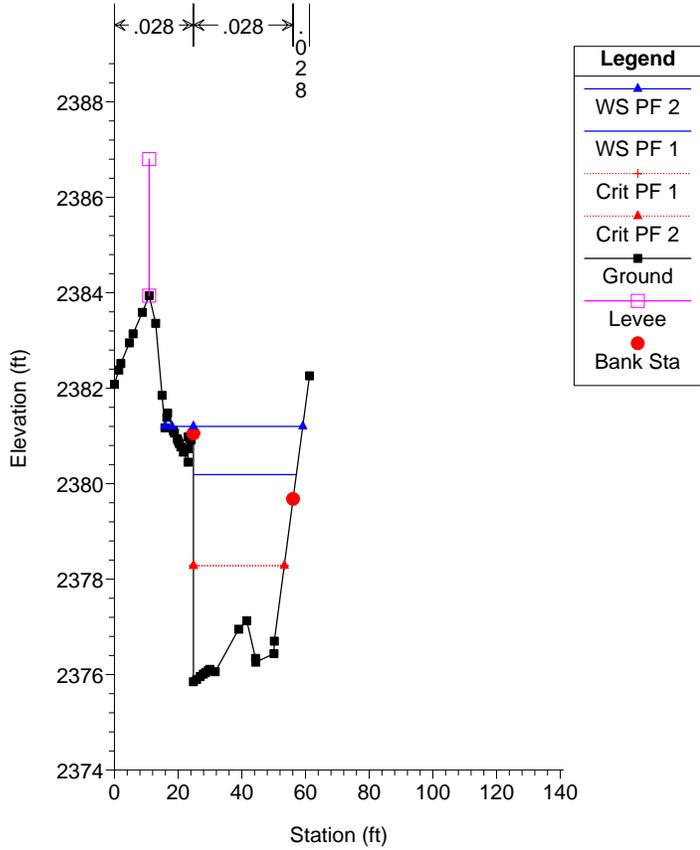
River = Overflow Reach = South RS = 0.002

Camino Real Plan: 1956cfs 6/19/2008

Geom: CaminoReal with walls

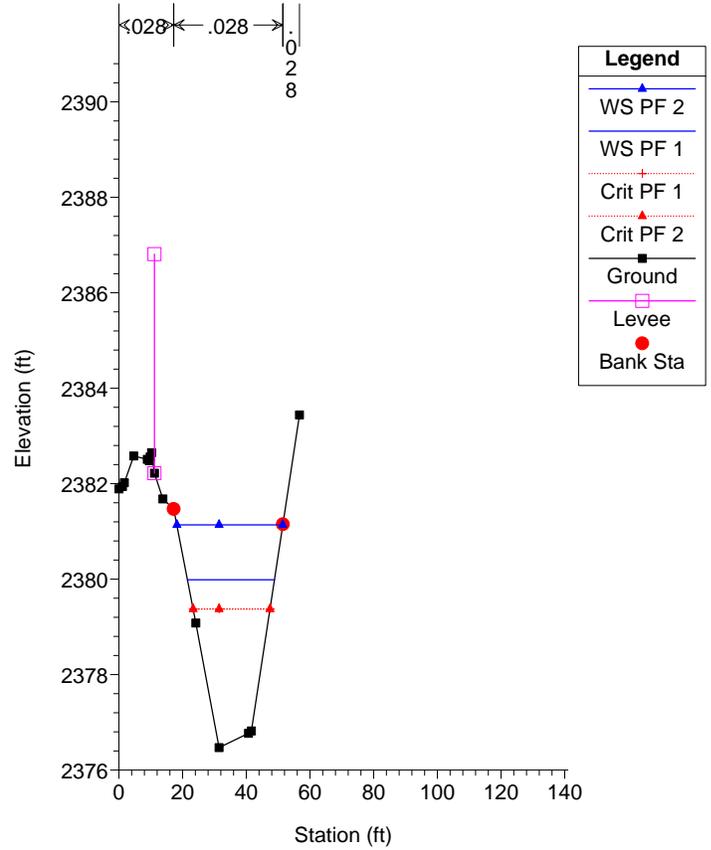
River = Overflow Reach = South RS = 25.041

Camino Real Plan: 1956cfs 6/19/2008

Geom: CaminoReal with walls

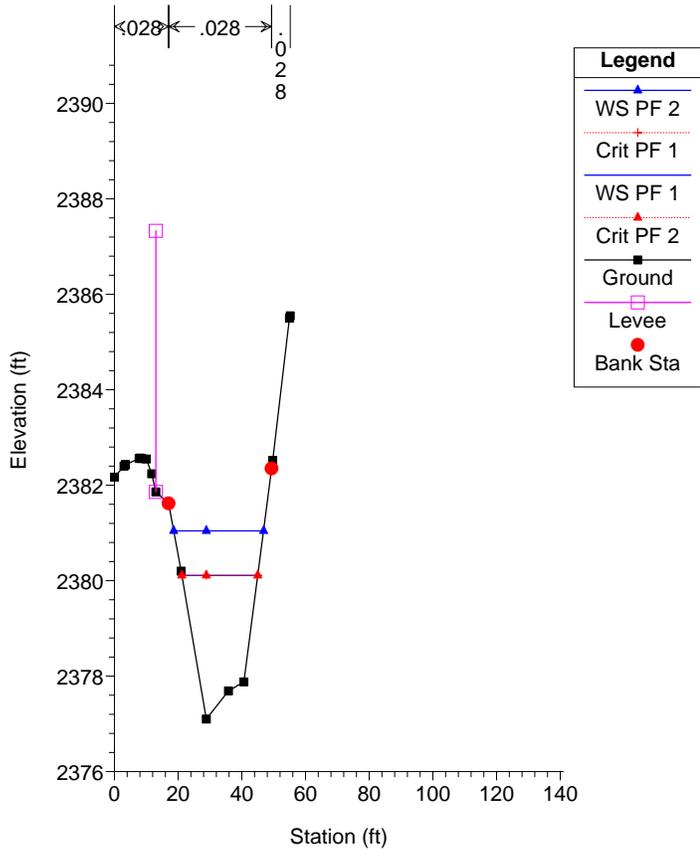
River = Overflow Reach = South RS = 50.145

Camino Real Plan: 1956cfs 6/19/2008

Geom: CaminoReal with walls

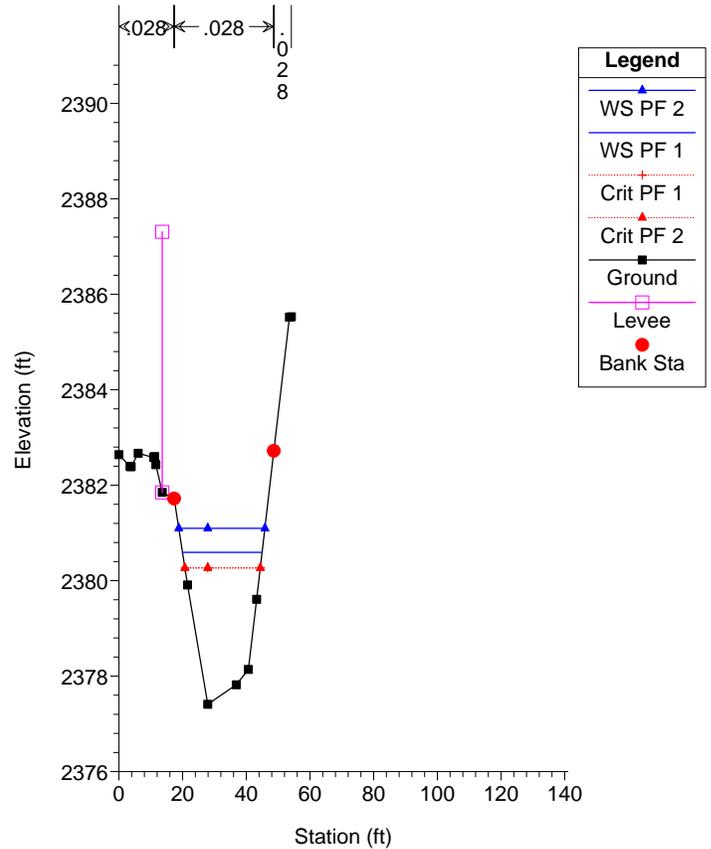
River = Overflow Reach = South RS = 74.912

Geom: CaminoReal with walls

1 in Horiz. = 60 ft 1 in Vert. = 4 ft

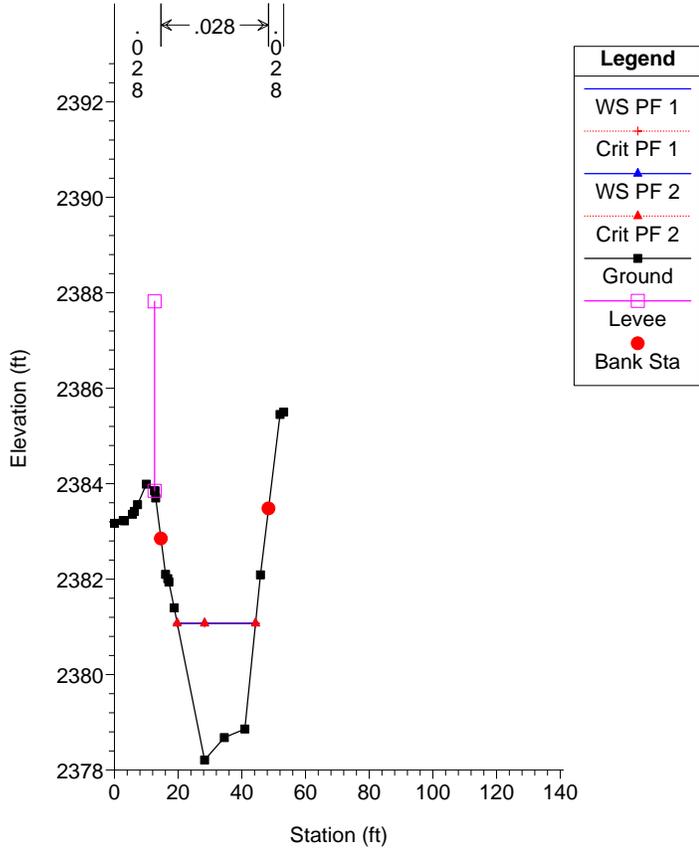
River = Overflow Reach = South RS = 99.652

Geom: CaminoReal with walls

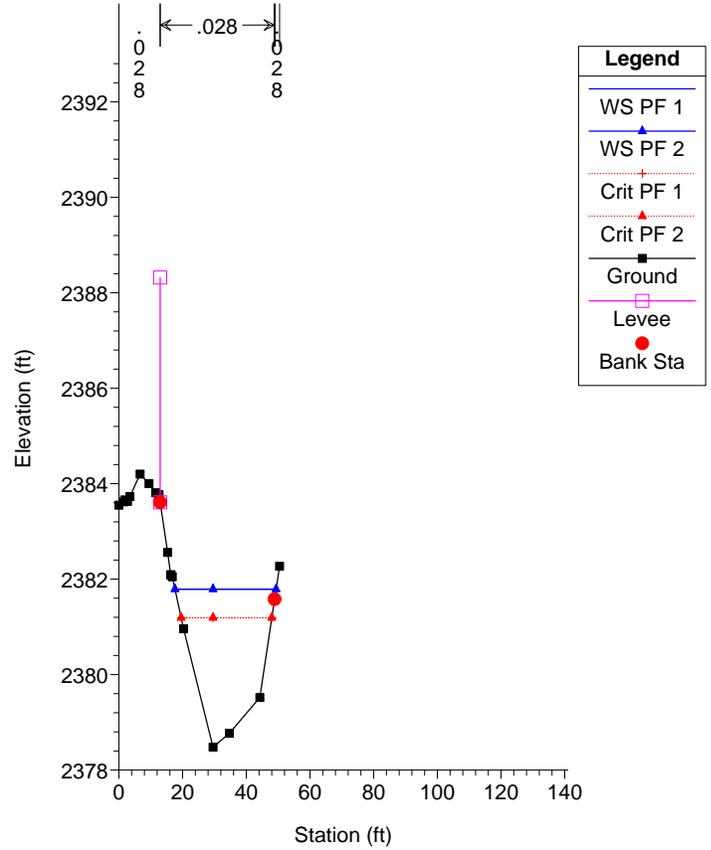
River = Overflow Reach = South RS = 129.767

Geom: CaminoReal with walls

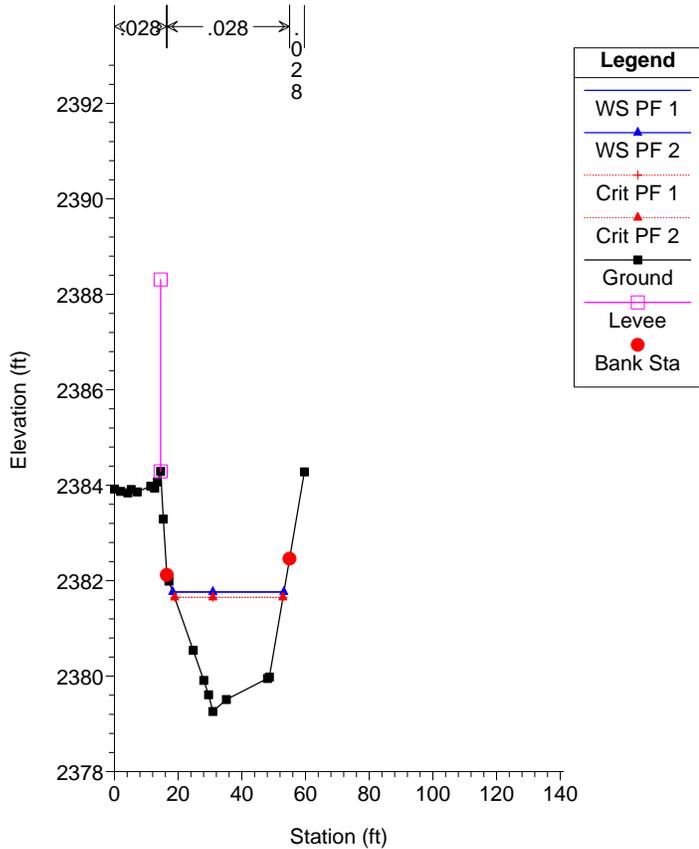
River = Overflow Reach = South RS = 149.791

Geom: CaminoReal with walls

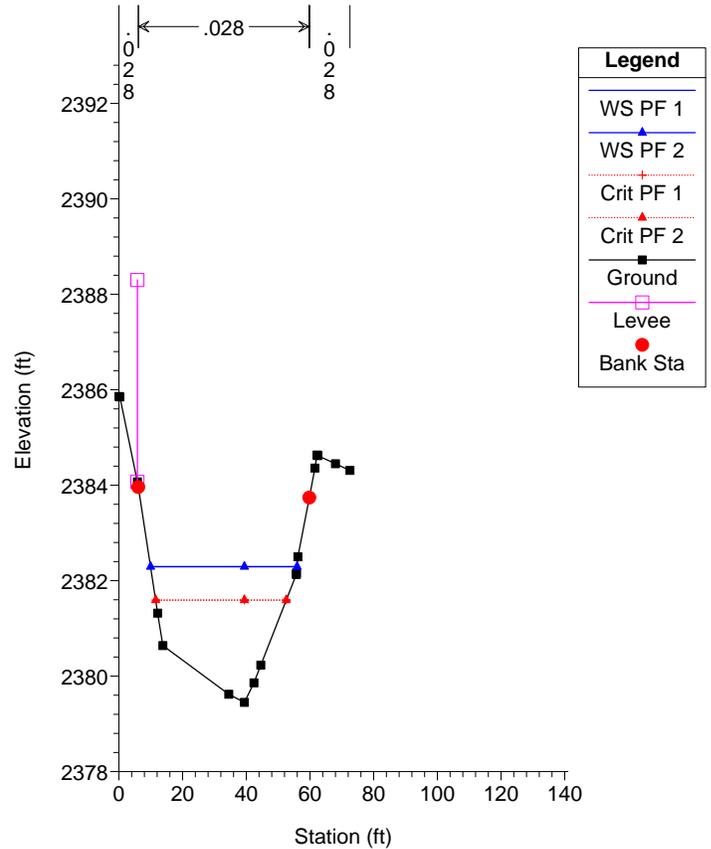
River = Overflow Reach = South RS = 174.844

Geom: CaminoReal with walls

1 in Horiz. = 60 ft 1 in Vert. = 4 ft

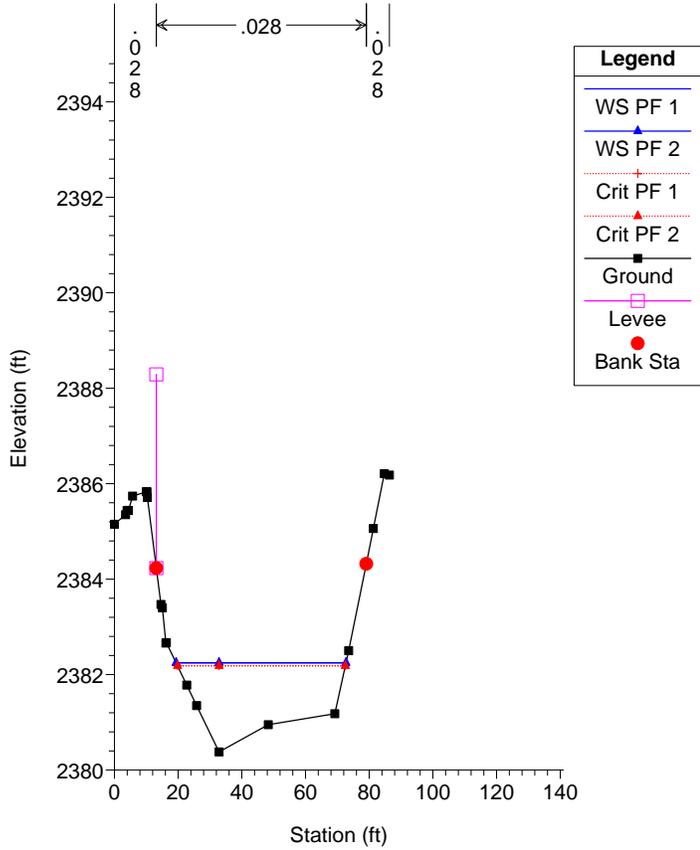
River = Overflow Reach = South RS = 199.788

Geom: CaminoReal with walls

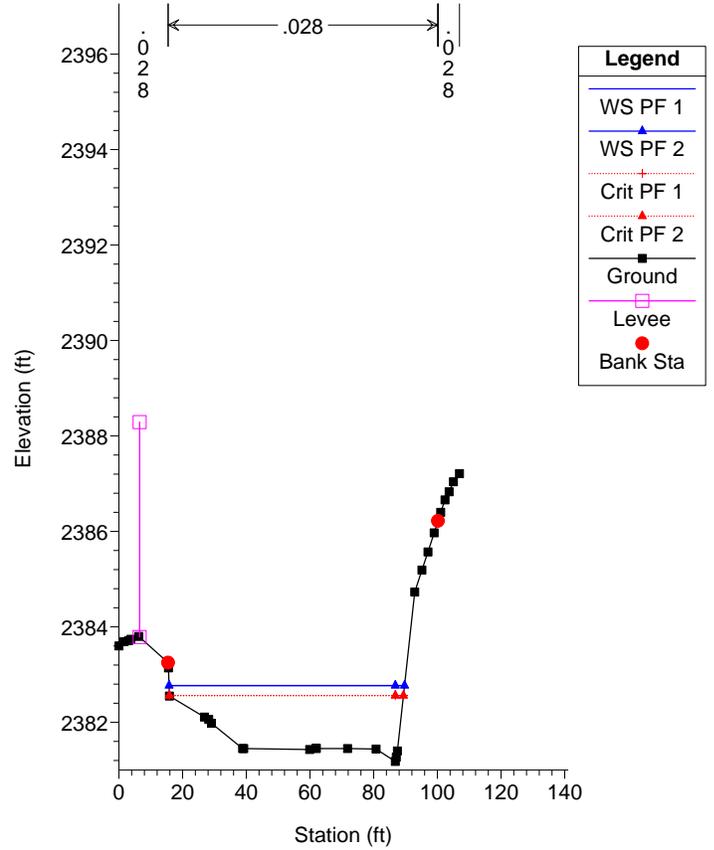
River = Overflow Reach = South RS = 237.369

Geom: CaminoReal with walls

1 in Horiz. = 60 ft 1 in Vert. = 4 ft

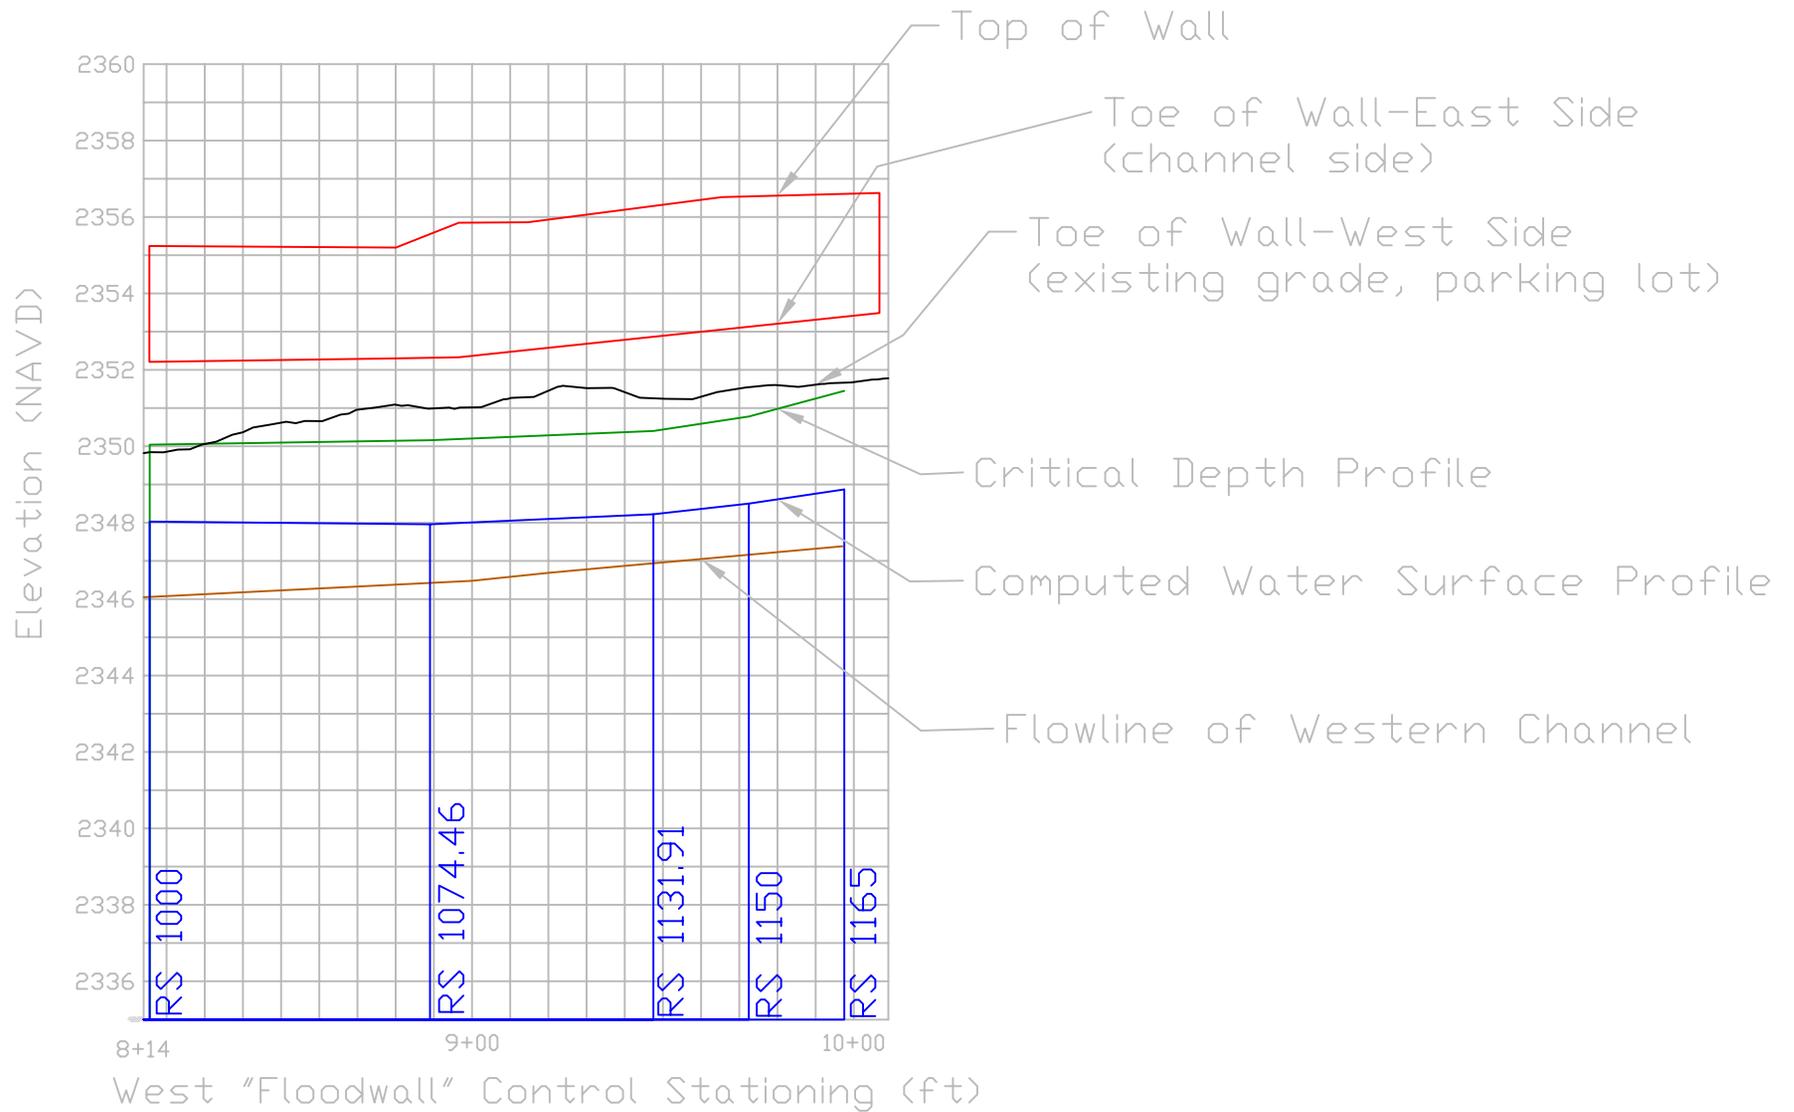
Exhibit 2a

Profile of West Wall

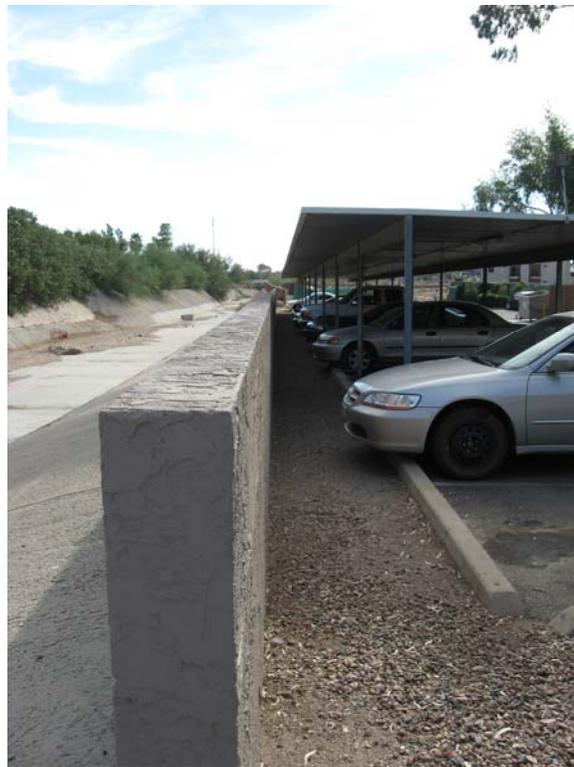
Looking south along the parking lot side of the west wall from the north limit.

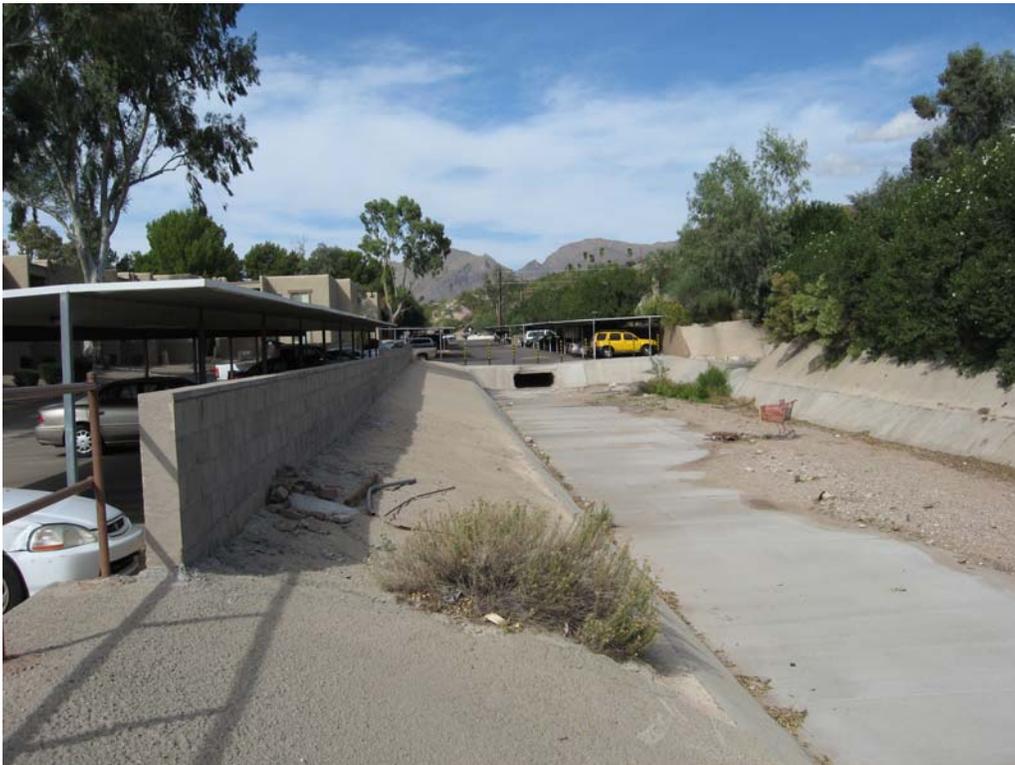
Looking north (upstream) at the junction of the north to south reach of the western channel with the northeast to southwest reach, including the southern limit of the west wall.

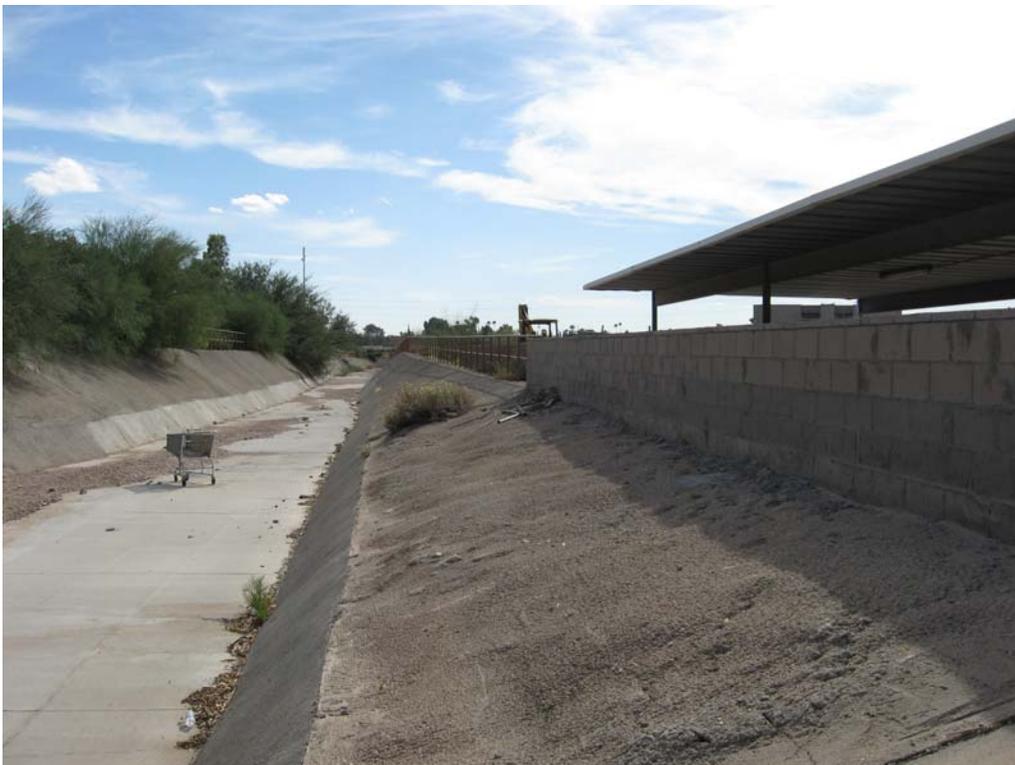
Looking downstream along the west bank from the junction of the north to south reach of the western channel with the northeast to southwest reach.

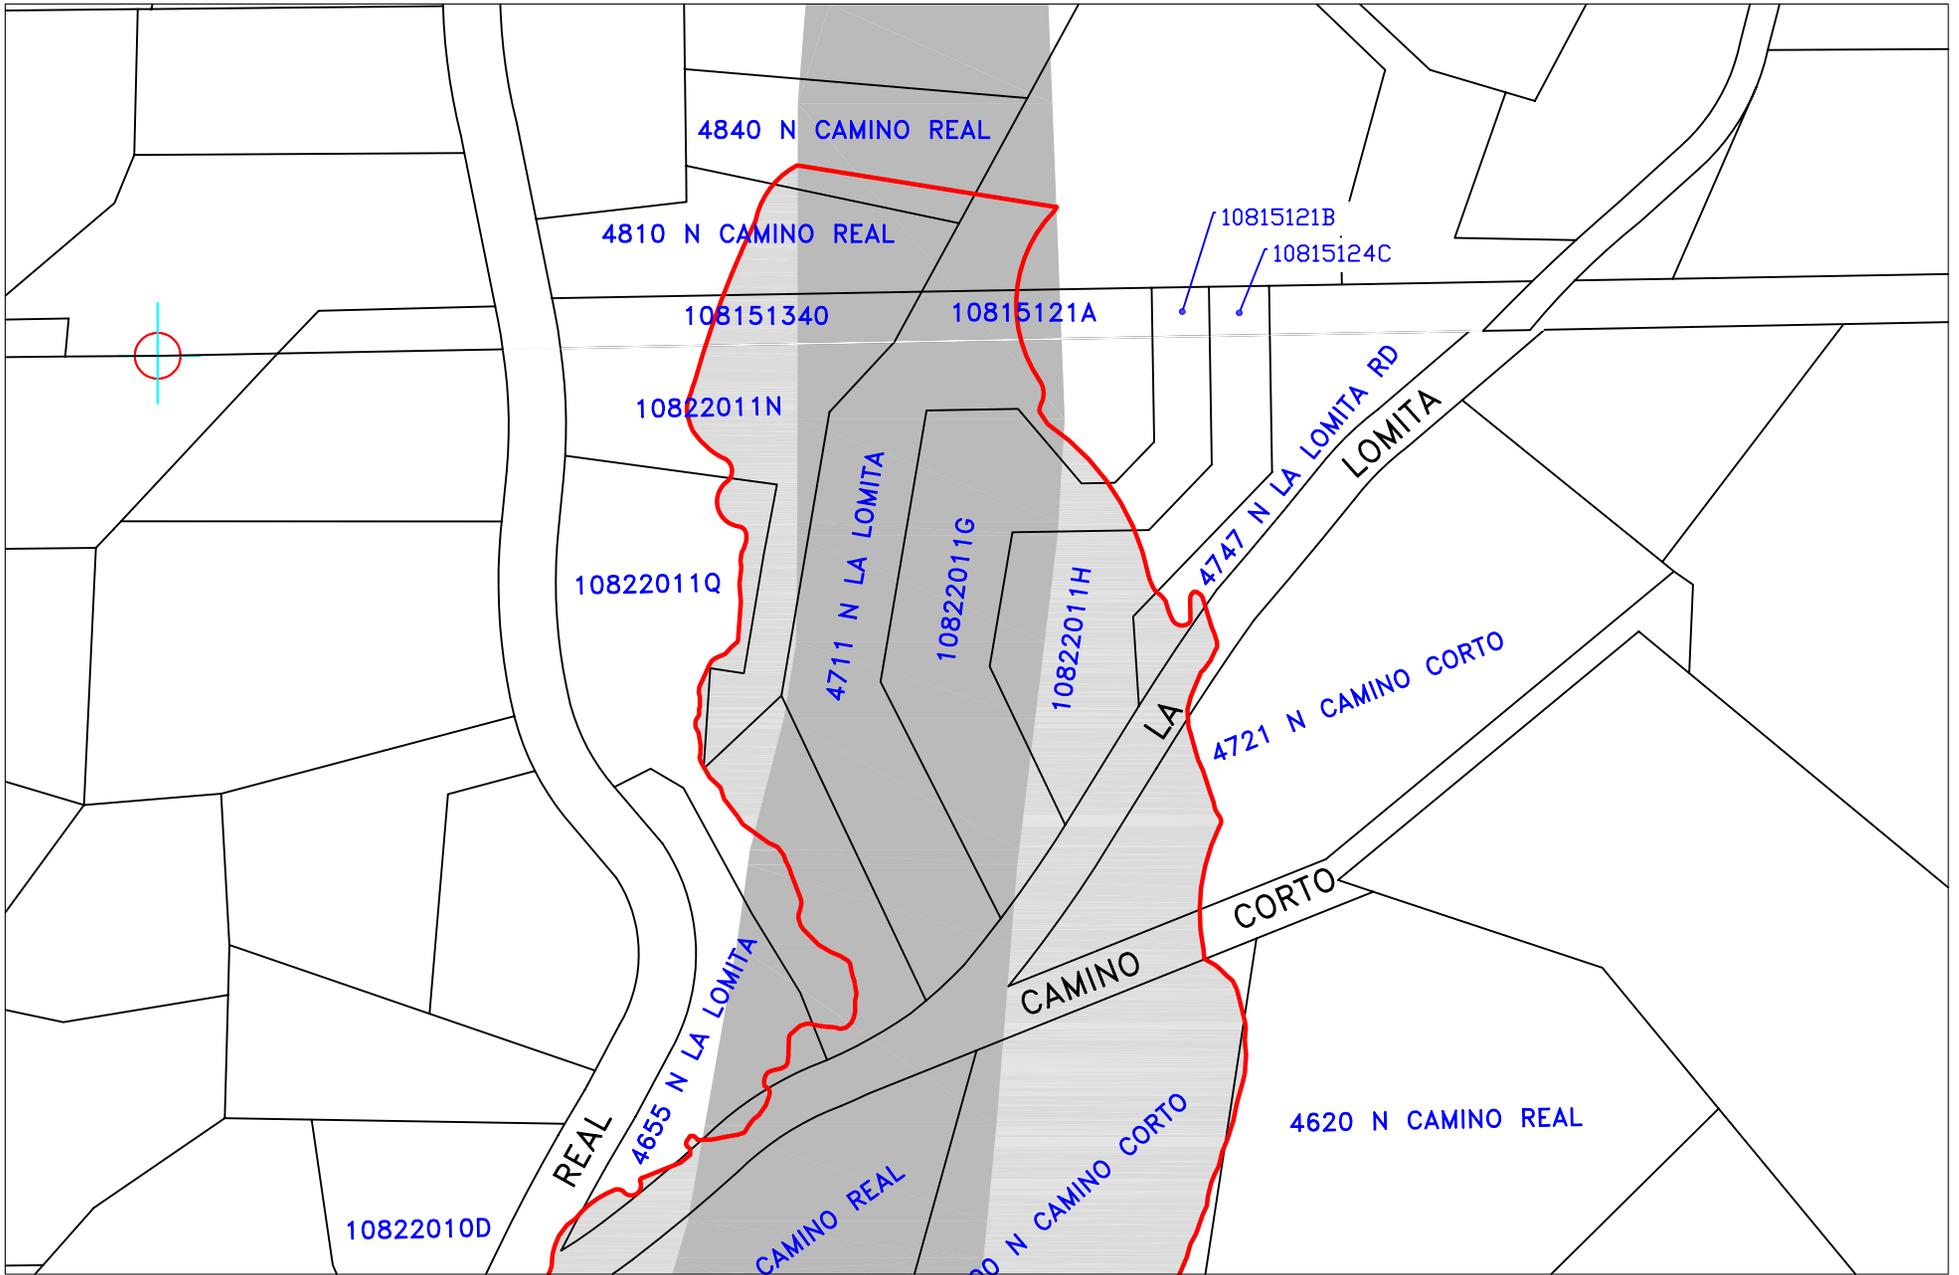
Revised Zone A Boundary (Map 1)

Revised Floodplain Exhibit

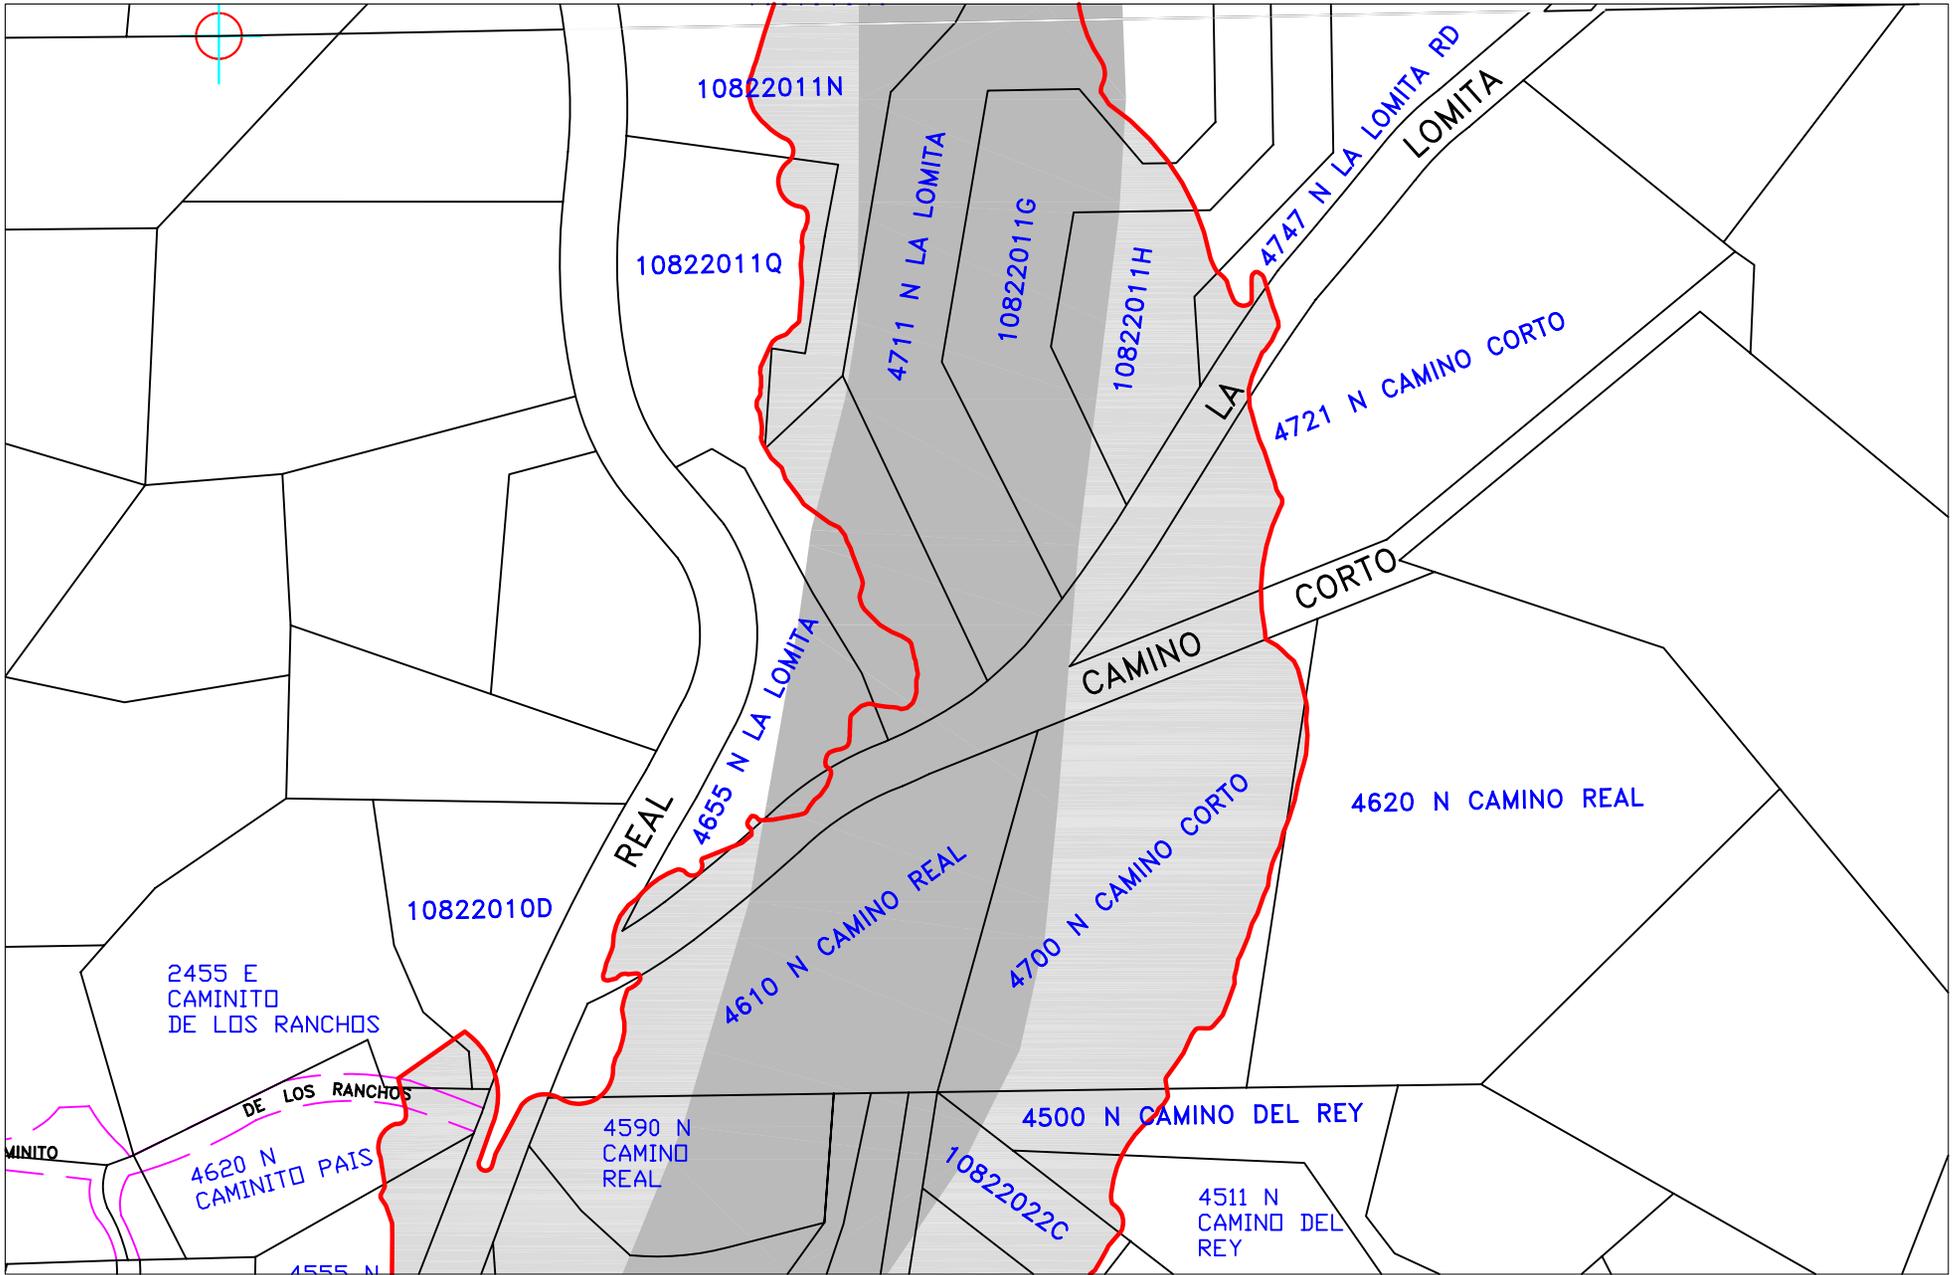
Revised Zone A Boundary (Map 2)

SCALE: 1 INCH = 200 FEET

Revised Floodplain Exhibit

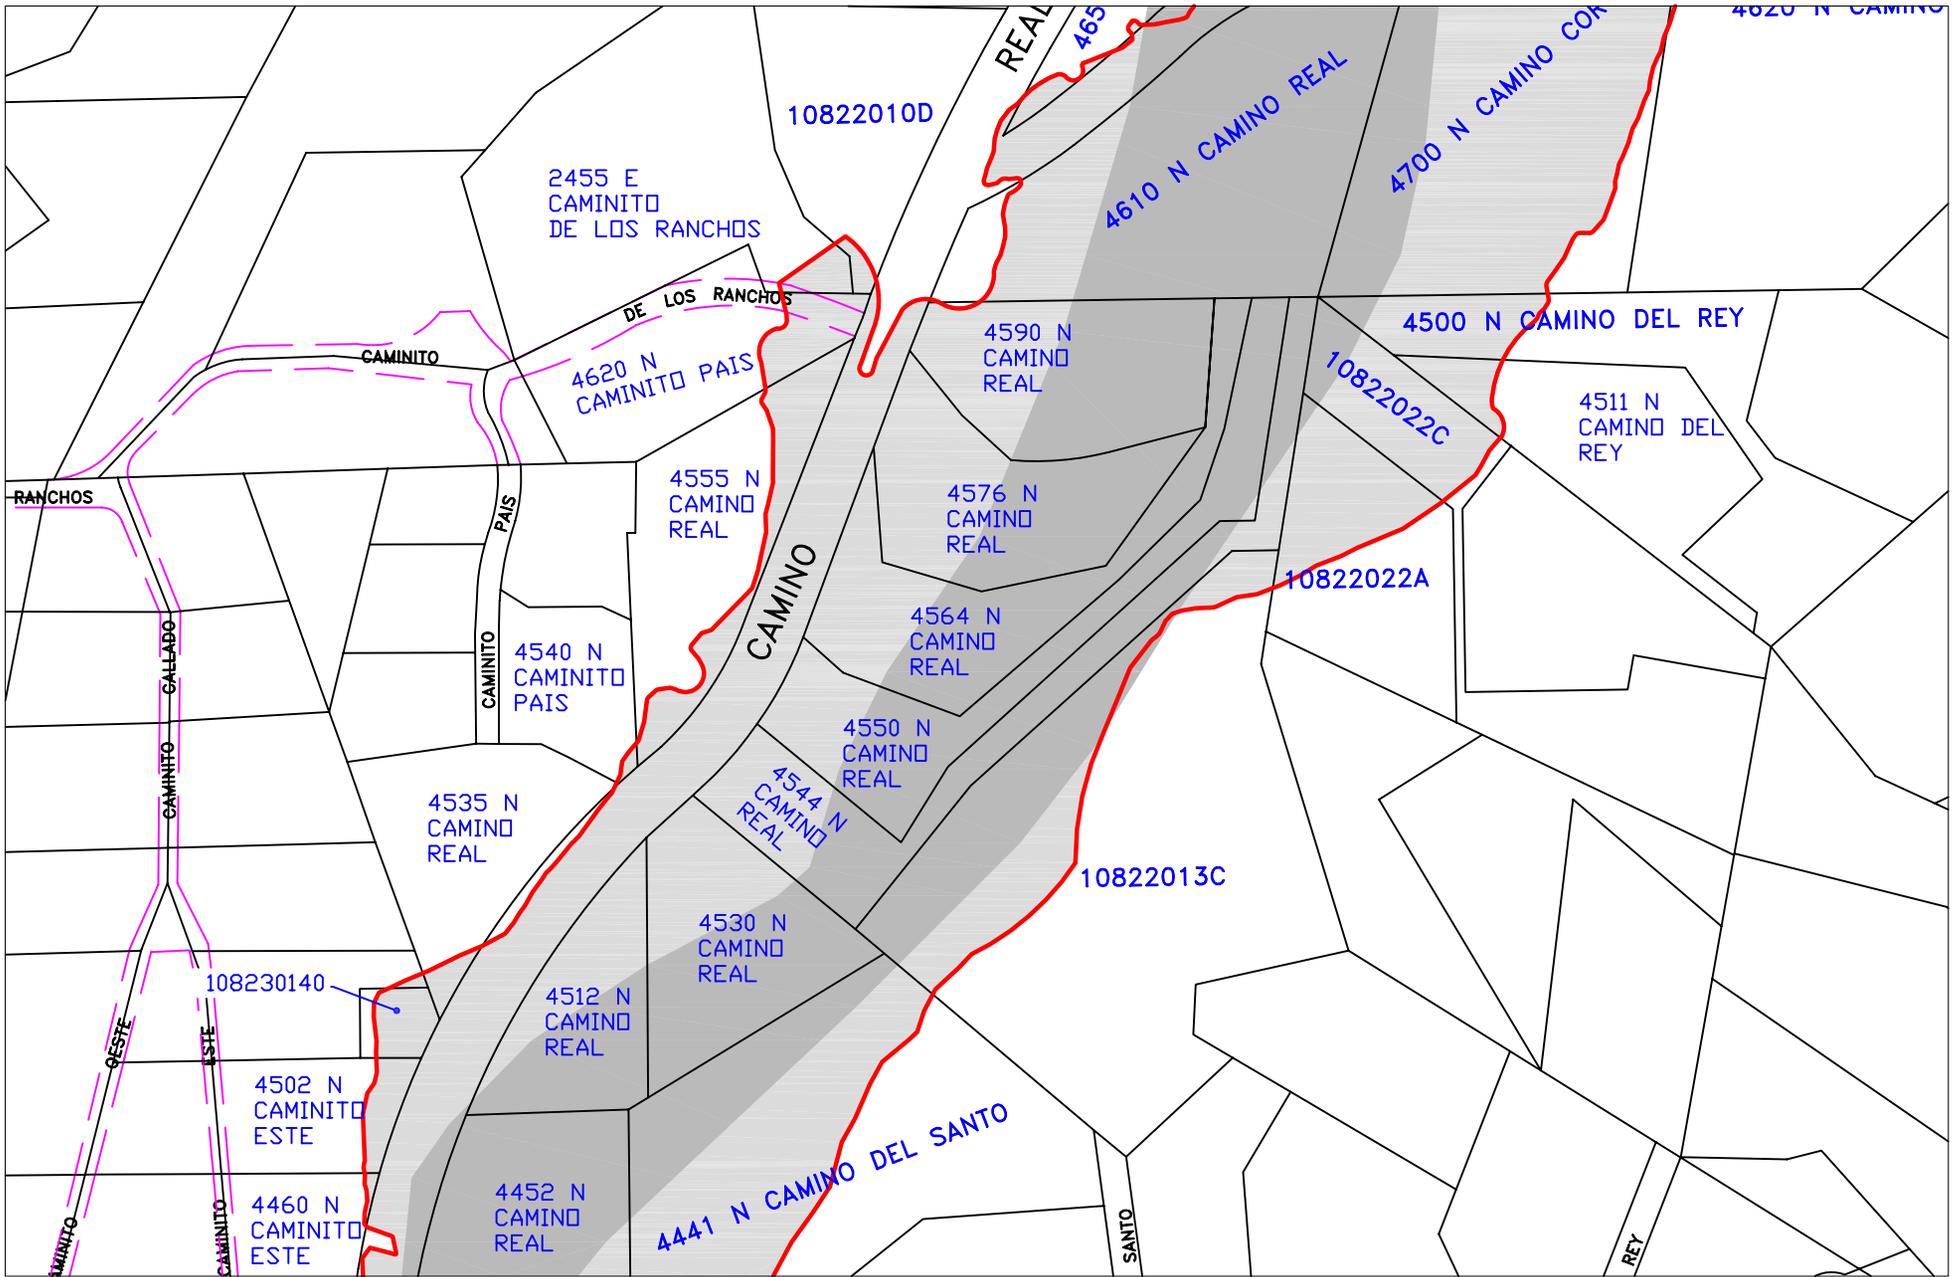
Revised Zone A Boundary (Map 3)

Revised Floodplain Exhibit
