**TECHNICAL DATA NOTEBOOK
FOR**

**Camino Real Wash,
Pima County, AZ**

Contract #25-59-C-13522-0507

**Prepared For:
Pima County Regional Flood Control District
97 E. Congress, 3rd Floor
Tucson, AZ 85701**

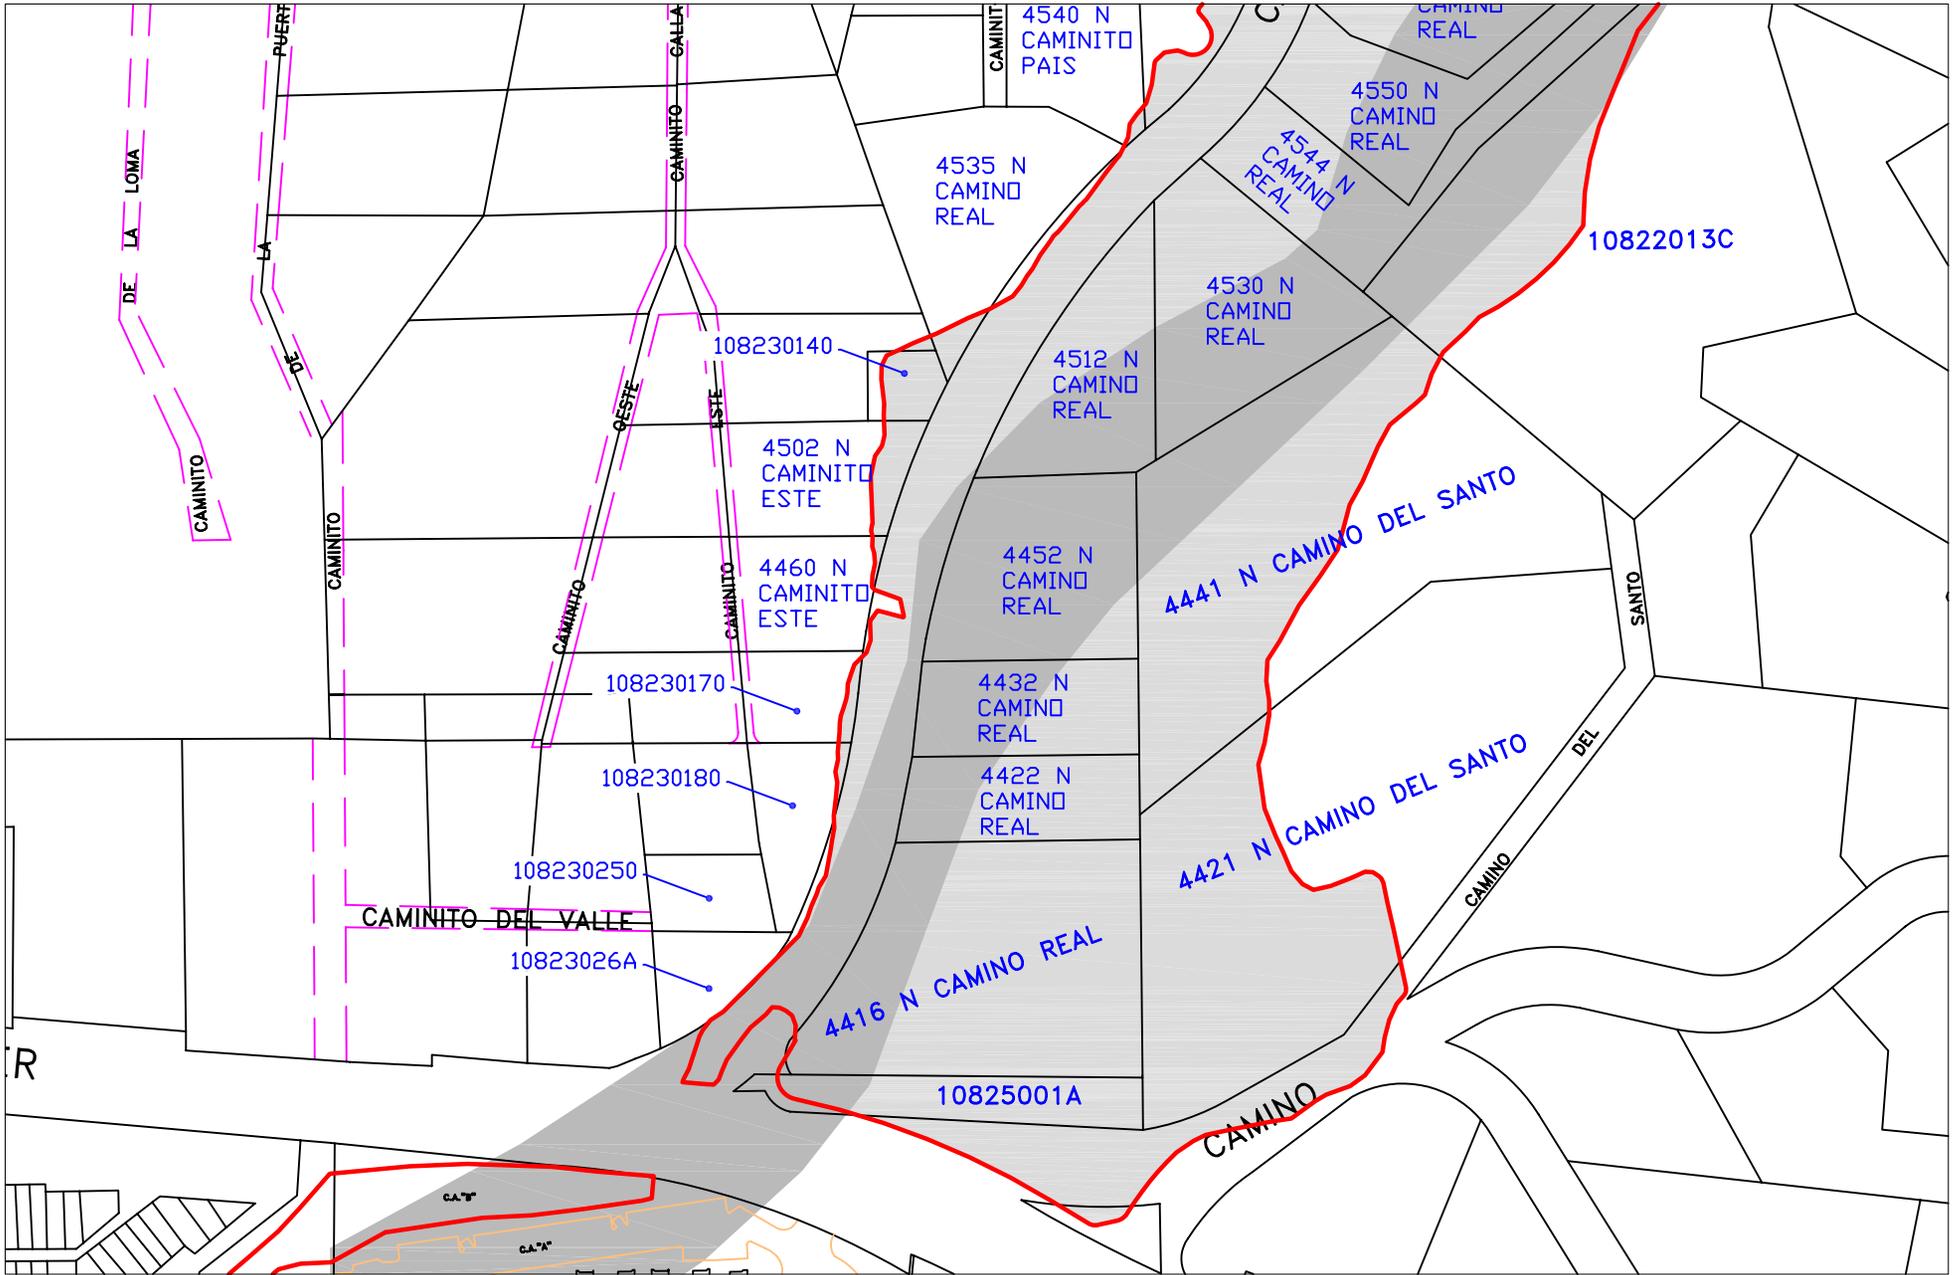
- Current Zone A Boundary
- Revised Zone A Boundary (Map 4)

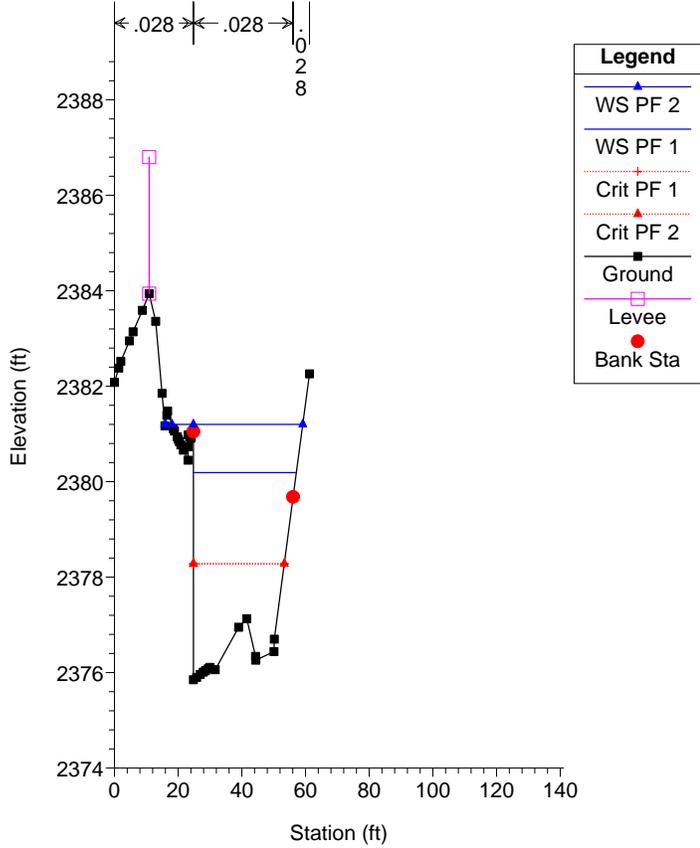
River = Overflow Reach = South RS = 0.002

Geom: CaminoReal with walls

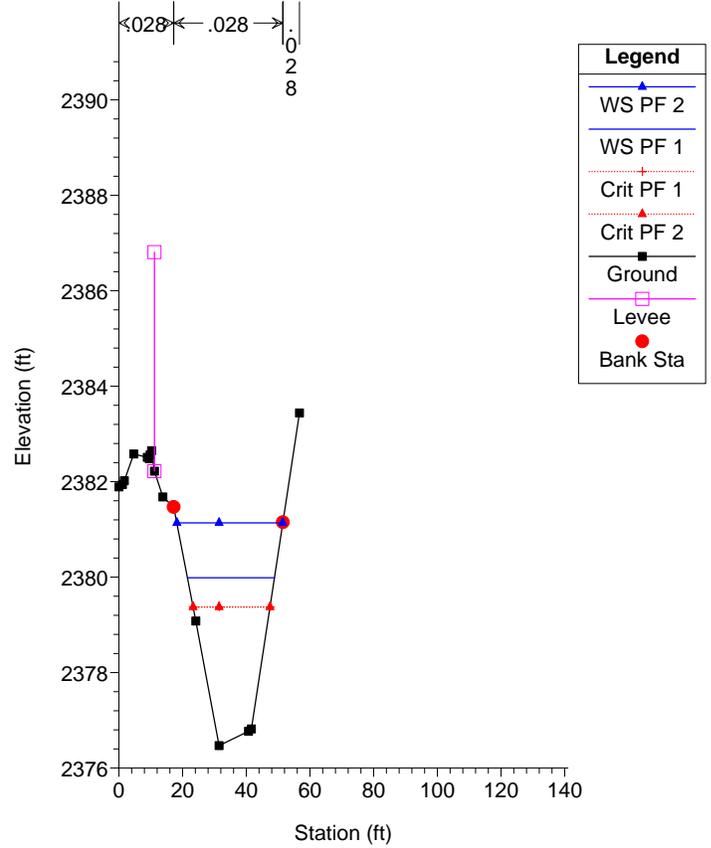
River = Overflow Reach = South RS = 25.041

Geom: CaminoReal with walls

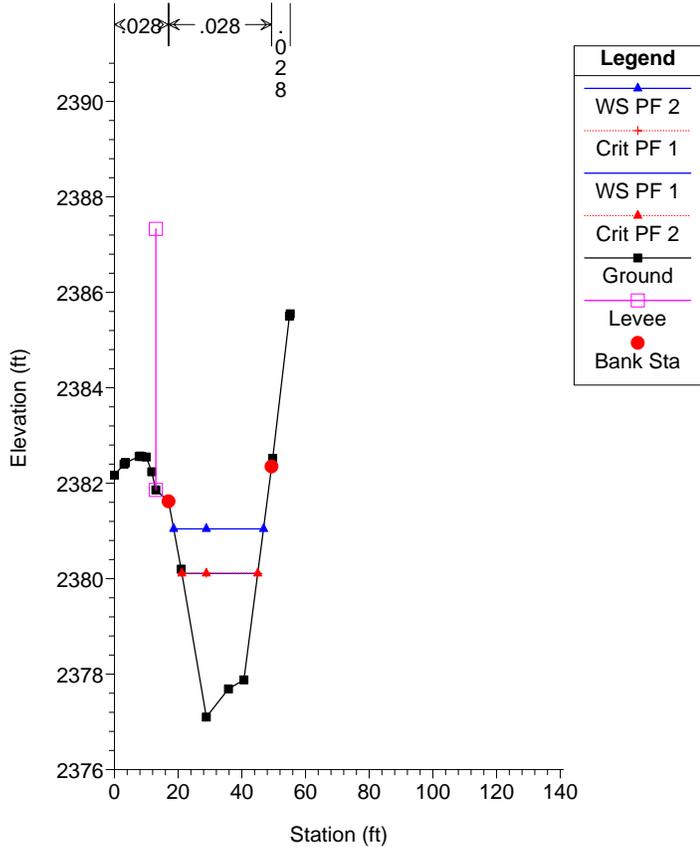
River = Overflow Reach = South RS = 50.145

Geom: CaminoReal with walls

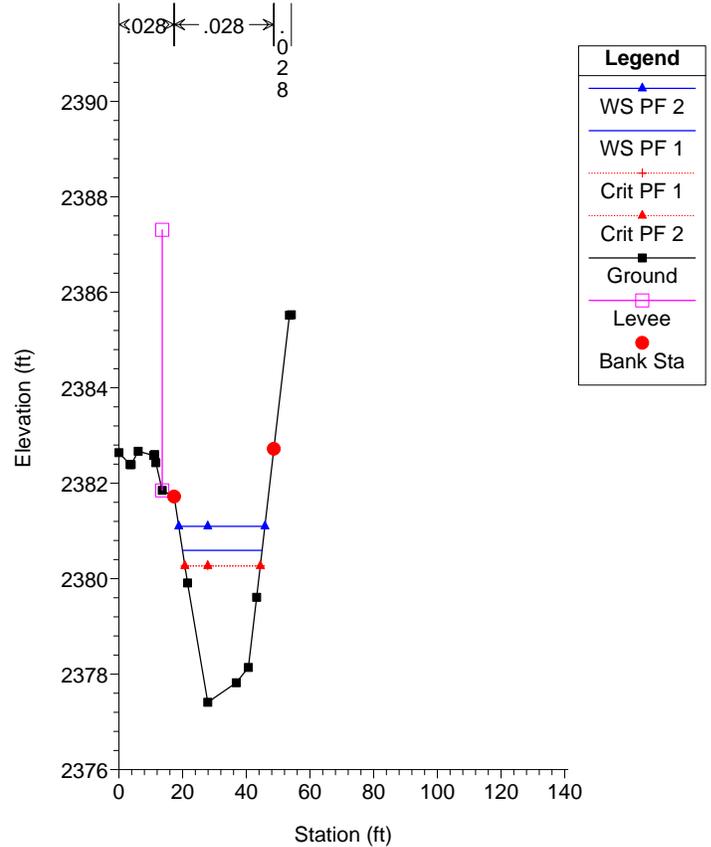
River = Overflow Reach = South RS = 74.912

Geom: CaminoReal with walls

1 in Horiz. = 60 ft 1 in Vert. = 4 ft

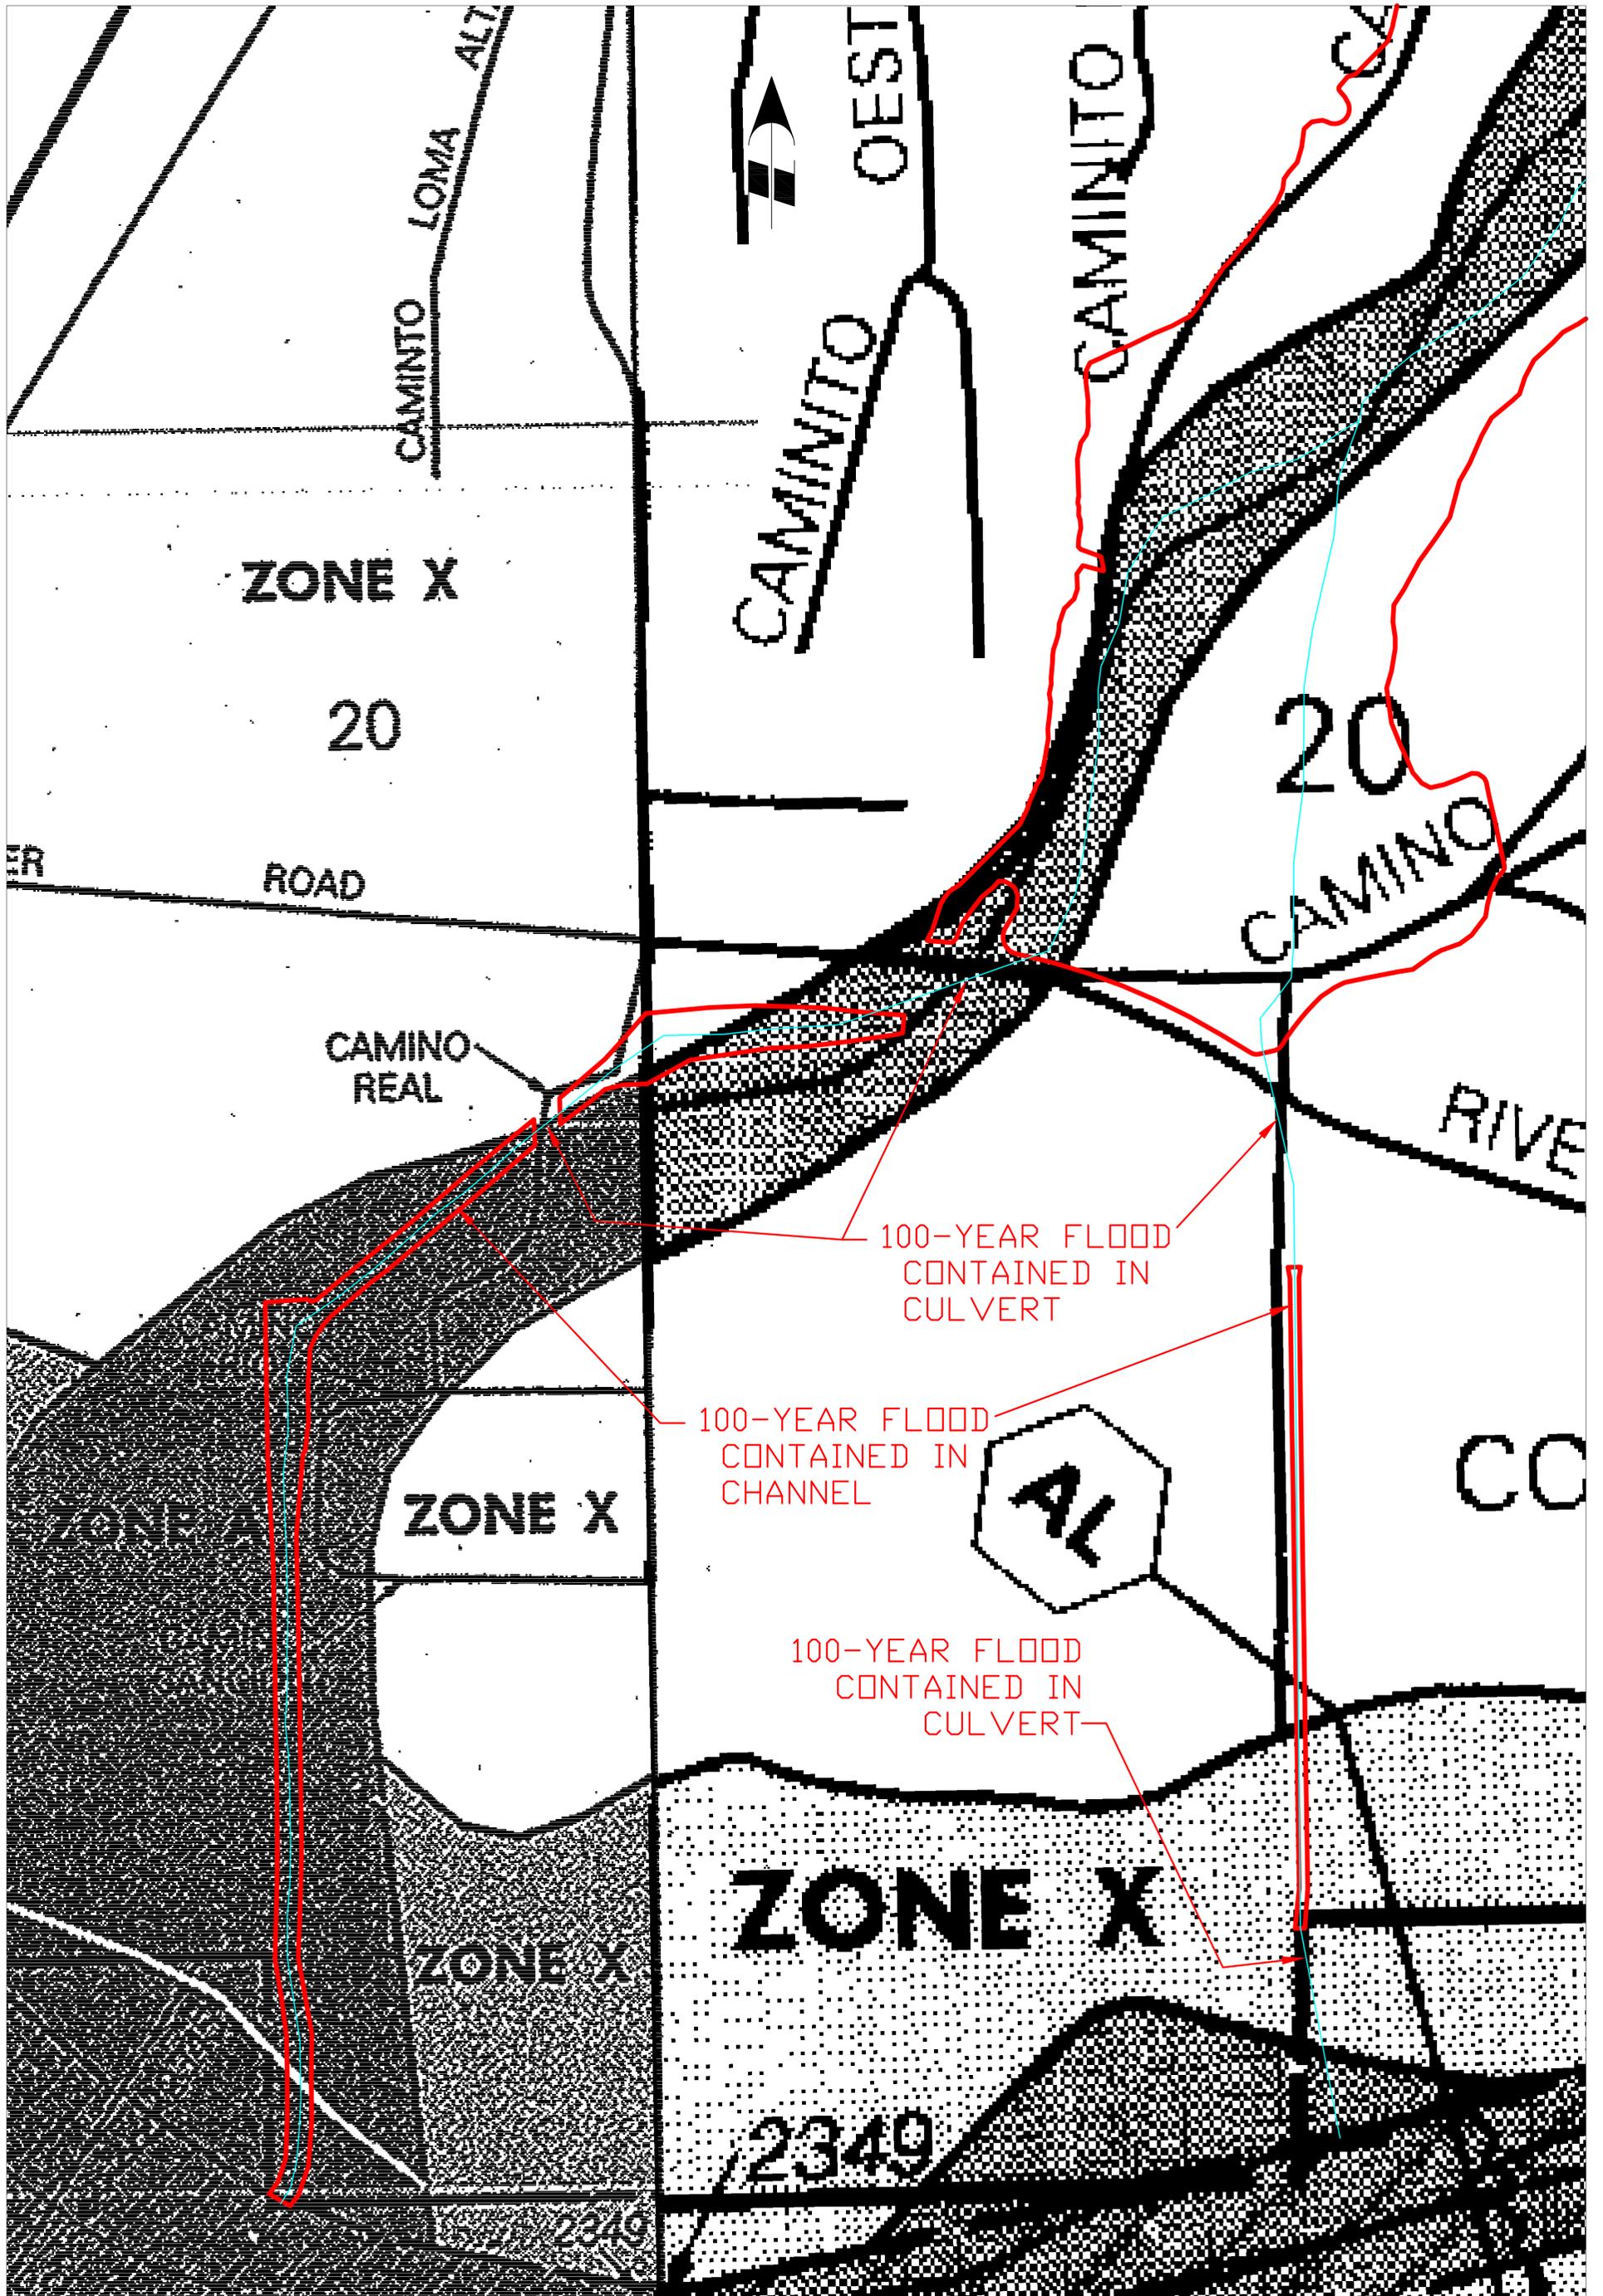
Exhibit 3

Annotated FIRM
