5.4.3.1 Flood Characteristics

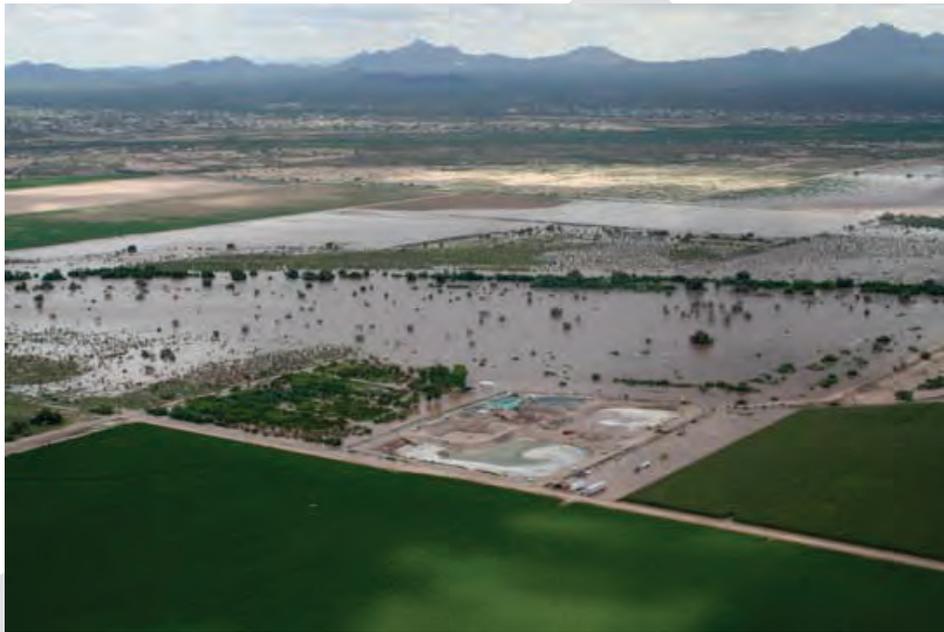
Wastewater Treatment Plant during the 2006 Flood

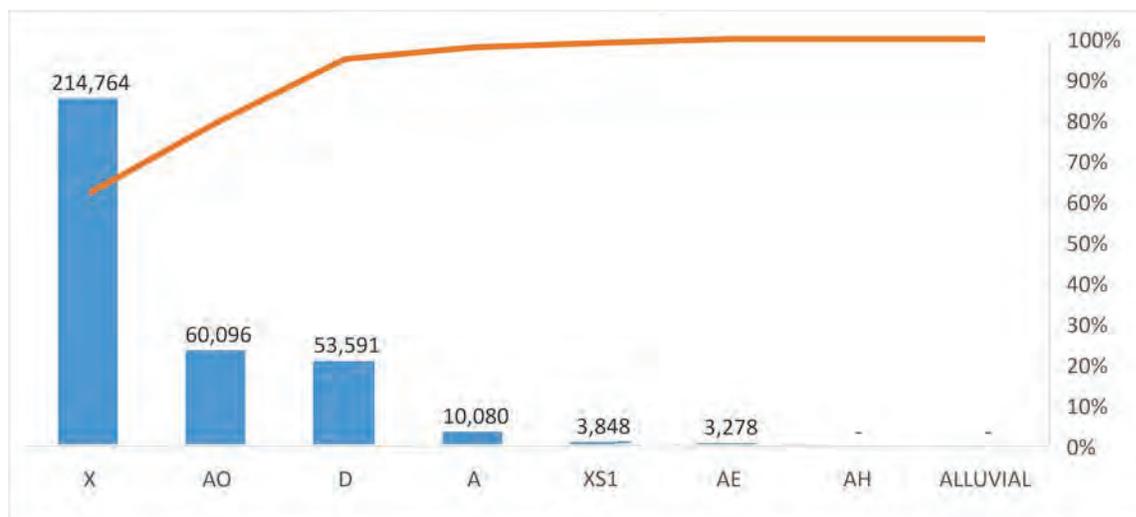
Figure 44 - Brawley Wash Federal Floodplain Designations in Acres

In addition to the 73,453 acres (114.7 square miles) of SFHA included on the chart above, there are also 513 acres of District Special Studies Floodplains and 87,082 of local sheet flood area in this watershed. Together these mapped floodplain areas are 46 percent of the total watershed area!

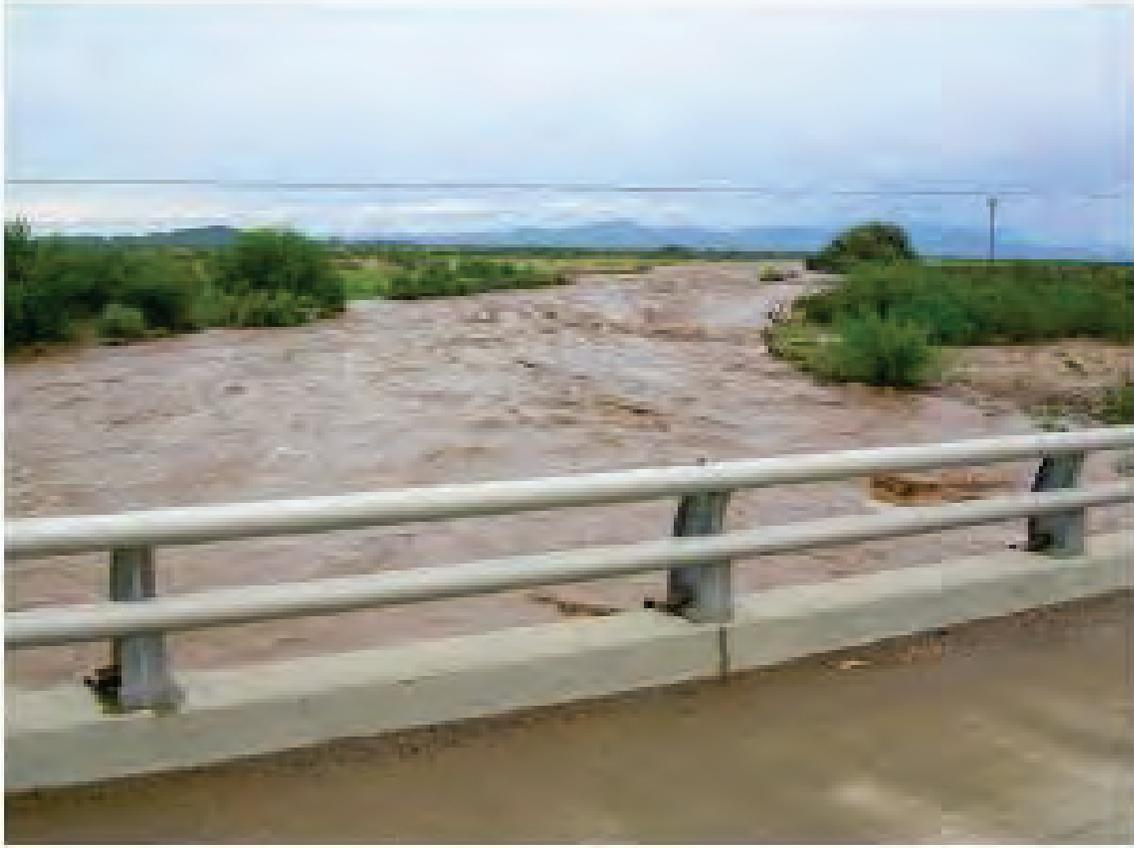
Ajo Highway Bridge during 2006 Flood, looking north

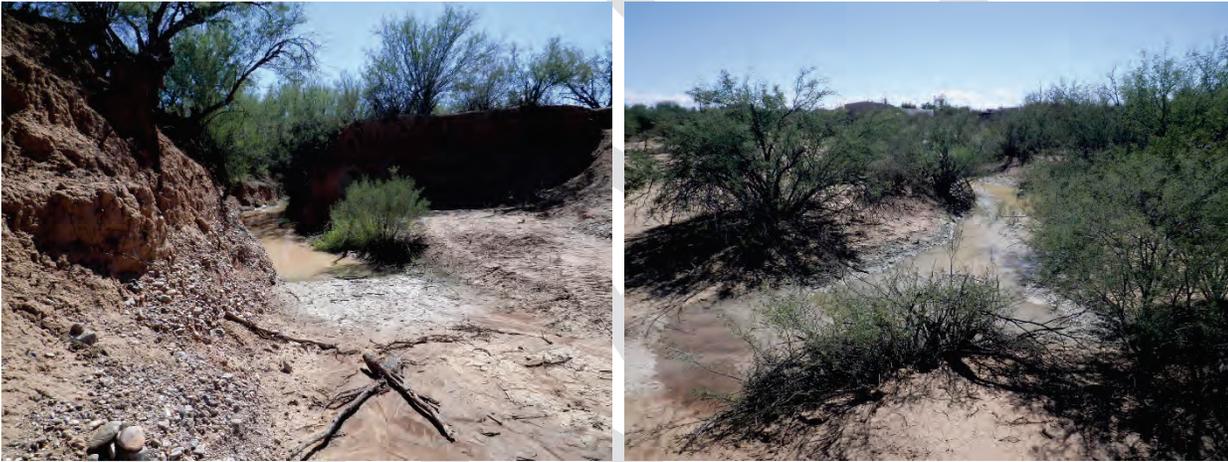
Distributary flow areas in the Brawley Wash contain unique ephemeral water features located in both the floodplain overbank and in channel. These features fill with water during flood events and due to the deposition of fine sediments, hold water for a period afterwards, providing a water source for wildlife.

In-channel ephemeral water (left) and floodplain overbank ephemeral water (right)

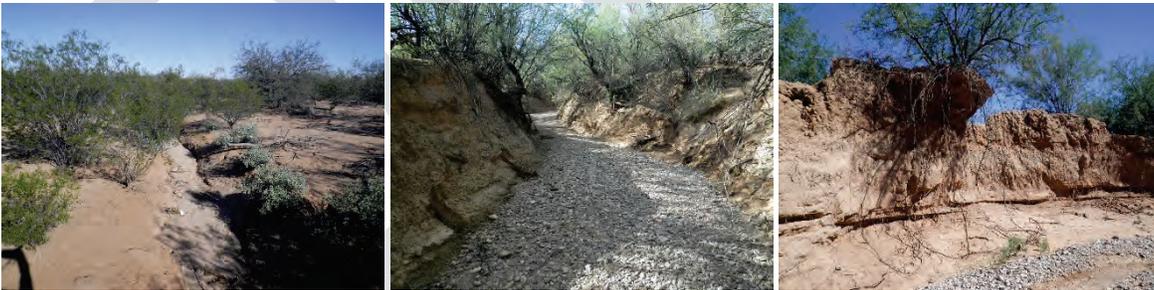
Over the years, the watershed has been impacted by human development, the primary impact being flow diversions. Historic agricultural activities bermed large areas for farming, redirecting natural flow to create areas of dense vegetation on the upstream side of berms, and areas of vegetation die-off on the downstream side. This paired with diversions due to roads, development, and drought has resulted in wash channelization, creating a disconnection between the main channel and floodplain overbank. This “disconnect” results in vegetation die-off and soil erosion. Wash channelization becomes more severe moving downstream in the watershed, with channel depths exceeding 15 feet or more near Silverbell Road.

Upper watershed near 3-points (left), middle watershed (middle), and lower watershed (right)

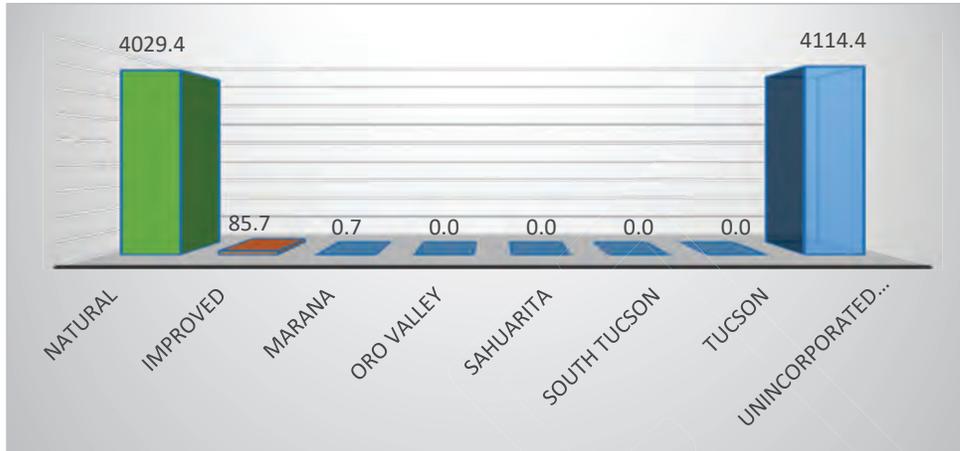
Figure 51 - Brawley Wash Drainageway Acreage

In this watershed, there are 3,751 acres of improved drainageways and 3,569 acres that are designated open space.
