5.4.5 Catalina Foothills

5.4.5.1 Flood Characteristics

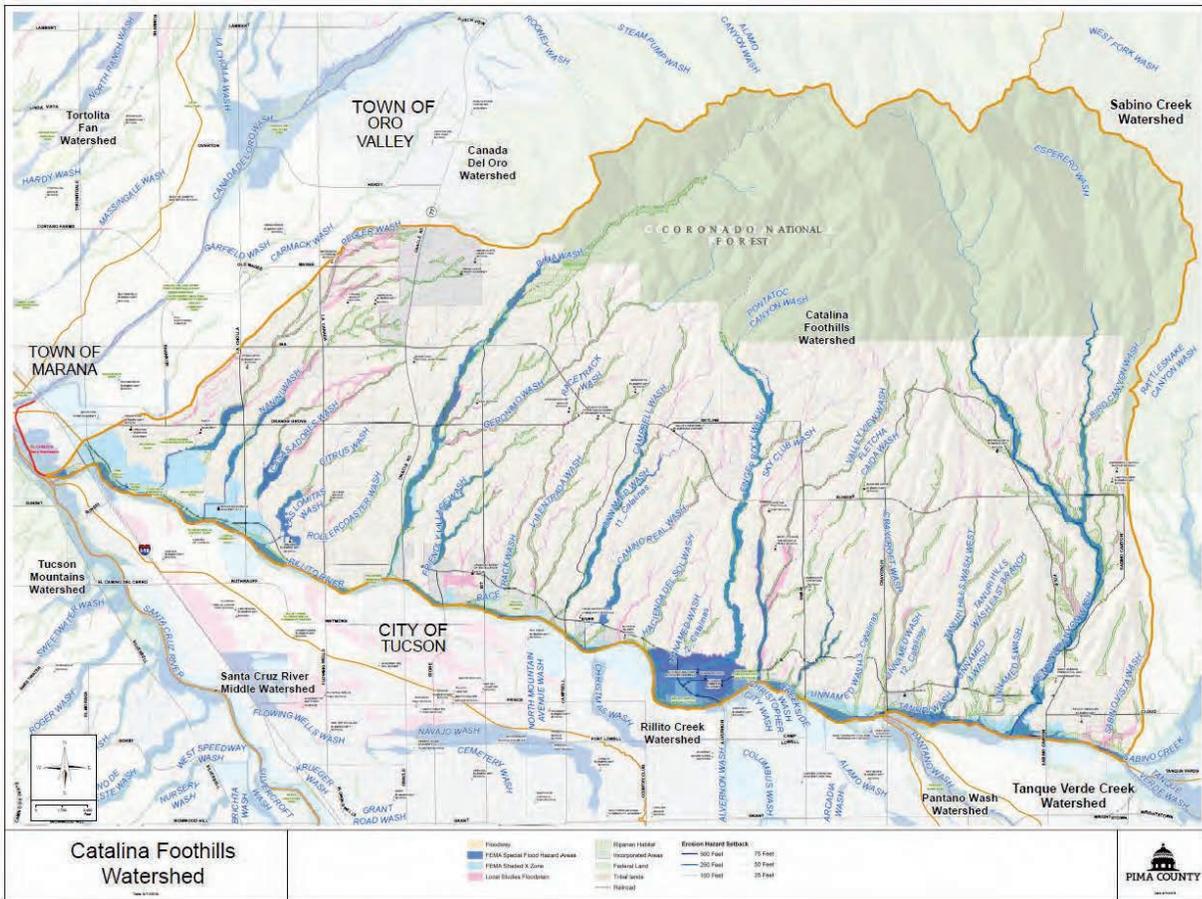
Figure 62 - Catalina Foothills Floodplain Map

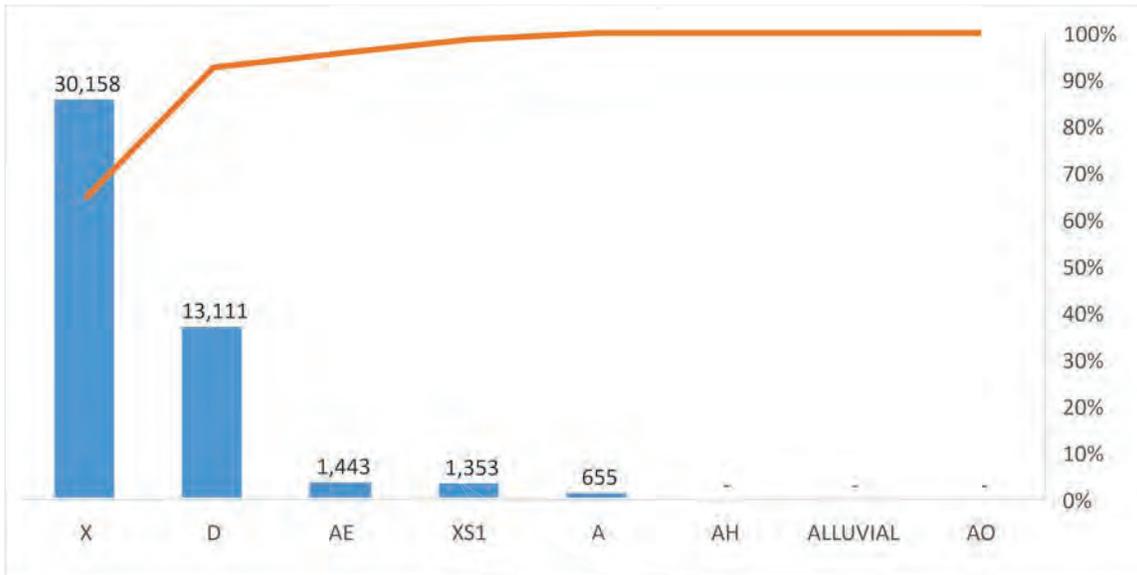
In addition to the 1,490 acres of SFHA included on the pie chart below, there are also 1,035 acres of District Special Studies Floodplains in this watershed. Together these mapped floodplain areas are 6.6 percent of the total watershed area.

Figure 63 - Catalina Foothills SFHA in Acres

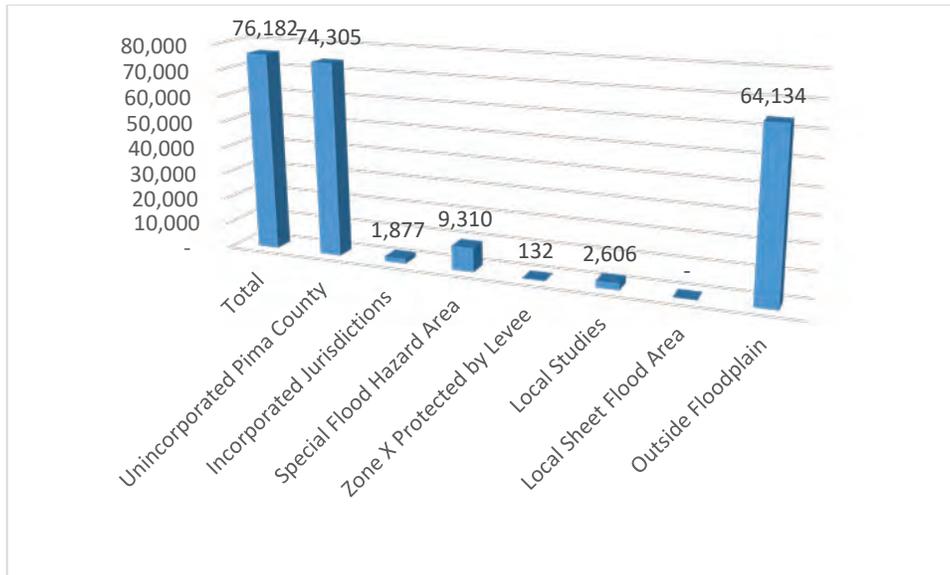
The chart below shows the distribution of residents within known floodplains, and distribution between incorporated and unincorporated areas. In this watershed 16% of the population lives on parcels within the floodplain, another 132 people live in areas protected by a levee.

Figure 64 - Catalina Foothills Watershed Population Distribution

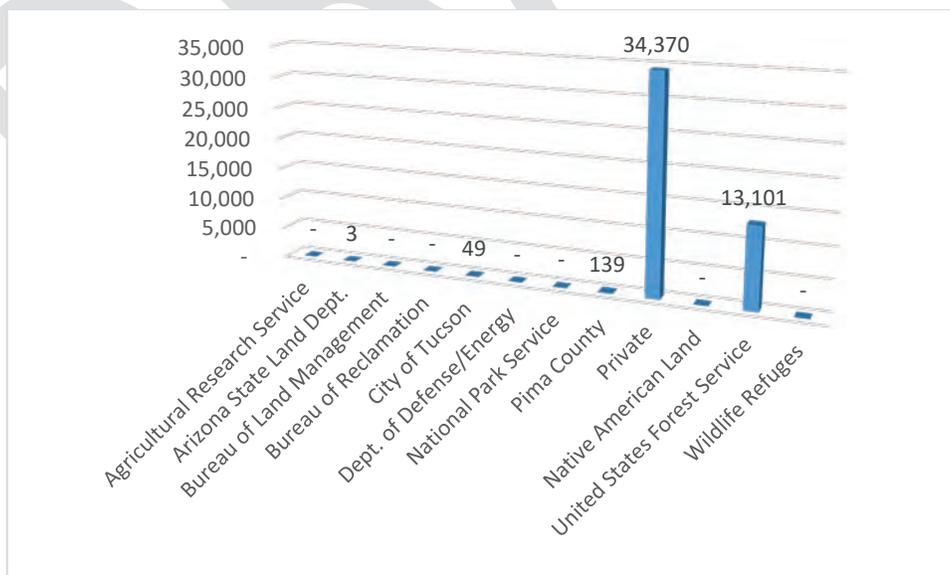
Located at the base of the escarpment of the Coronado National Forest, within unincorporated Pima County 72% of this watershed is private.

Figure 65 - Catalina Foothills Watershed Ownership in Acres

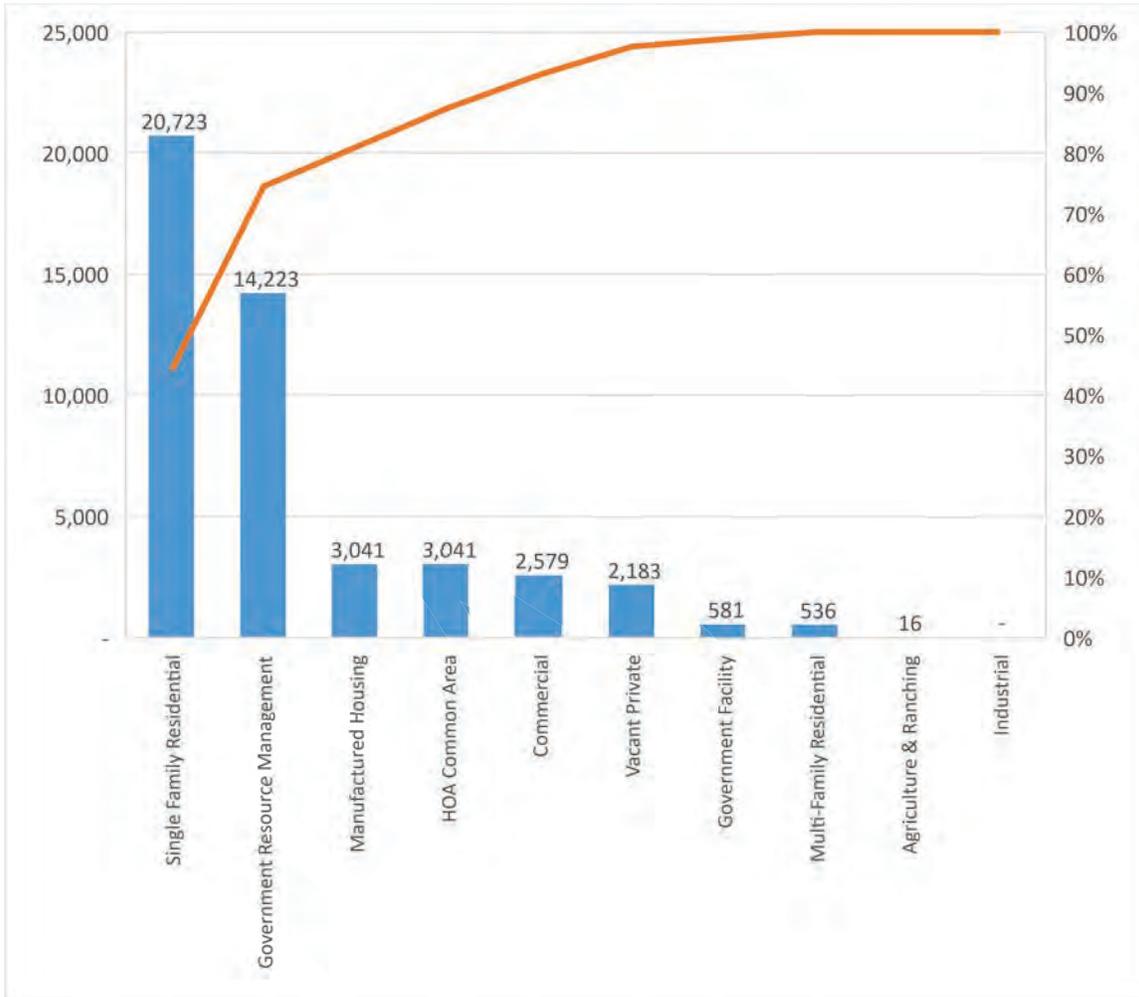
Much of the private land is residential site built homes on large lots of one to five acres, or clustered housing with common areas intended to remain natural by covenant.

Figure 66 - Catalina Foothills Watershed Land Use in Acres

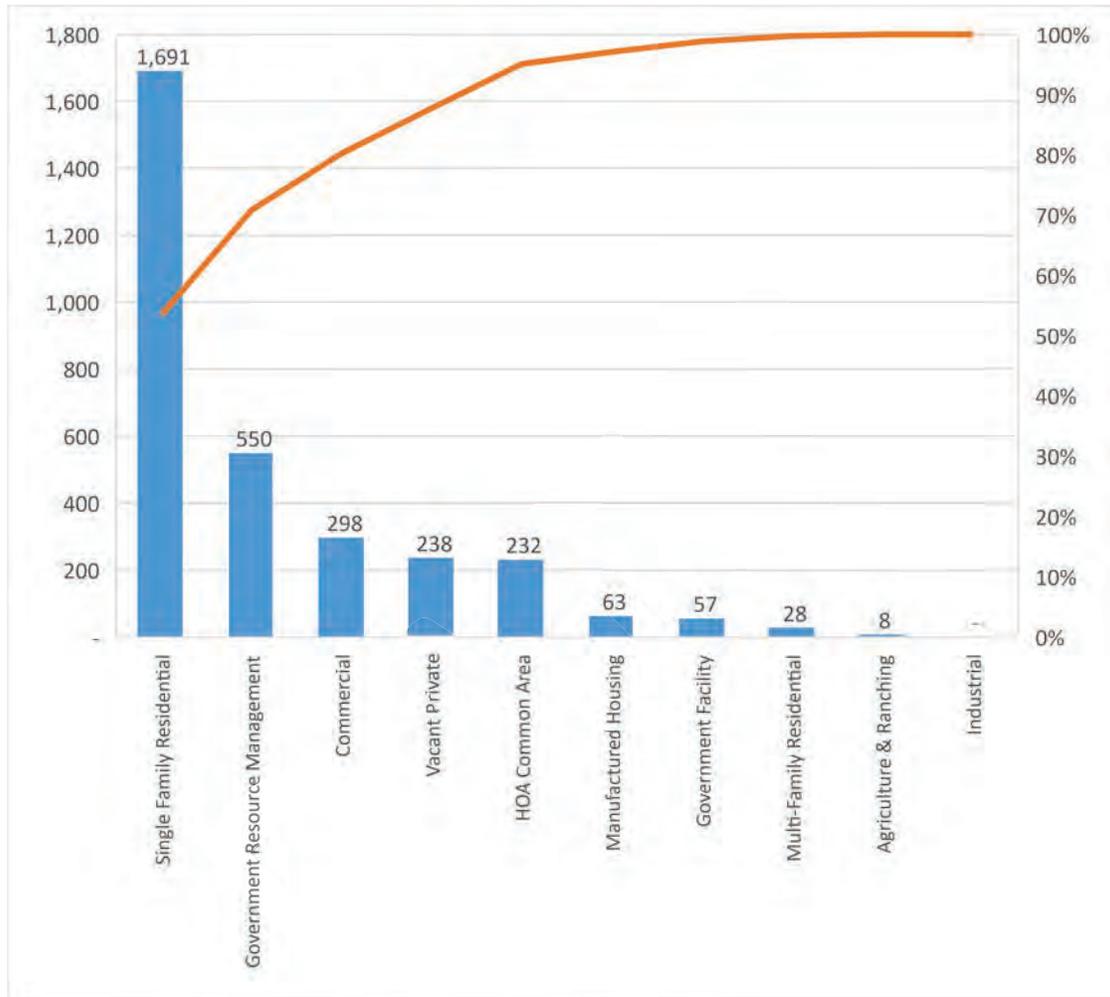
As indicated below while drainageways may be preserved, they are within common area controlled by Homeowners Associations and not public ownership.

Figure 67 - Catalina Foothills Floodplain Land Use

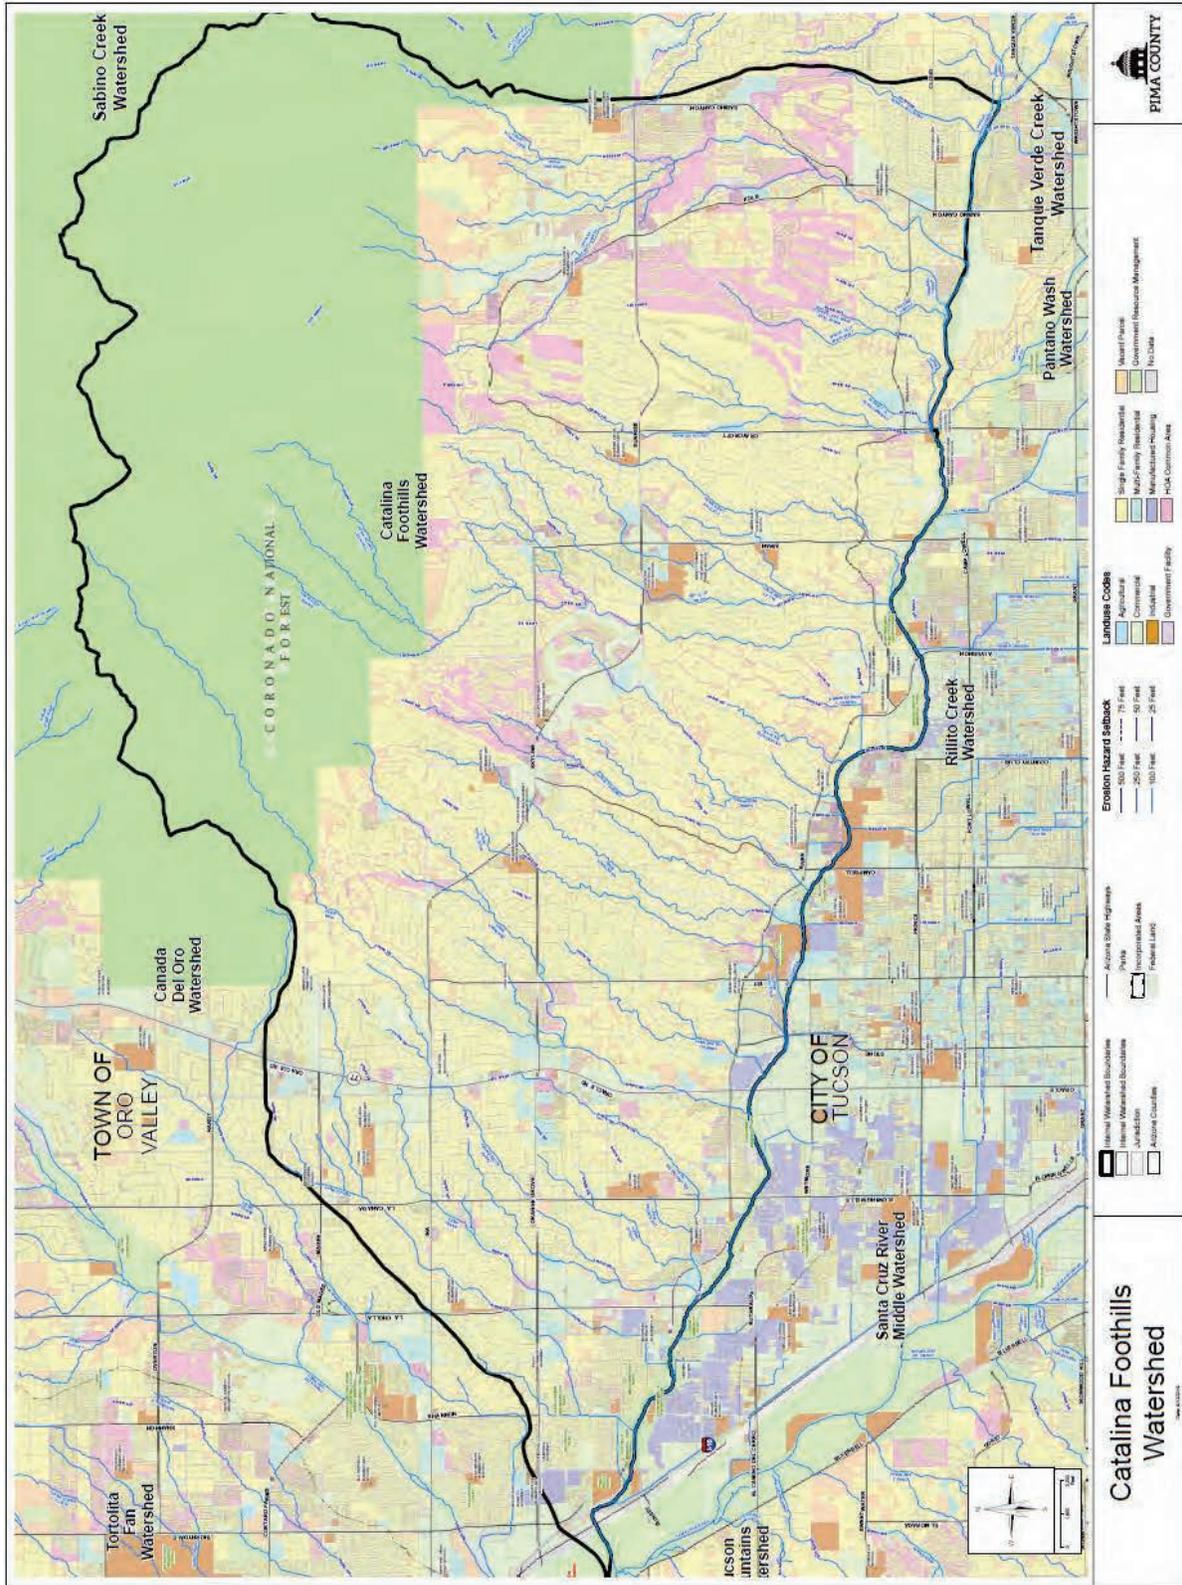
Owners may not always dedicate floodplains to the county. There is, therefore a high percentage of residential floodplain. It is also notable that little is vacant. Preservation may depend upon regulation of and choices made by private landowners. The map below shows these patterns.

Figure 68 - Catalina Foothills Land Use Map

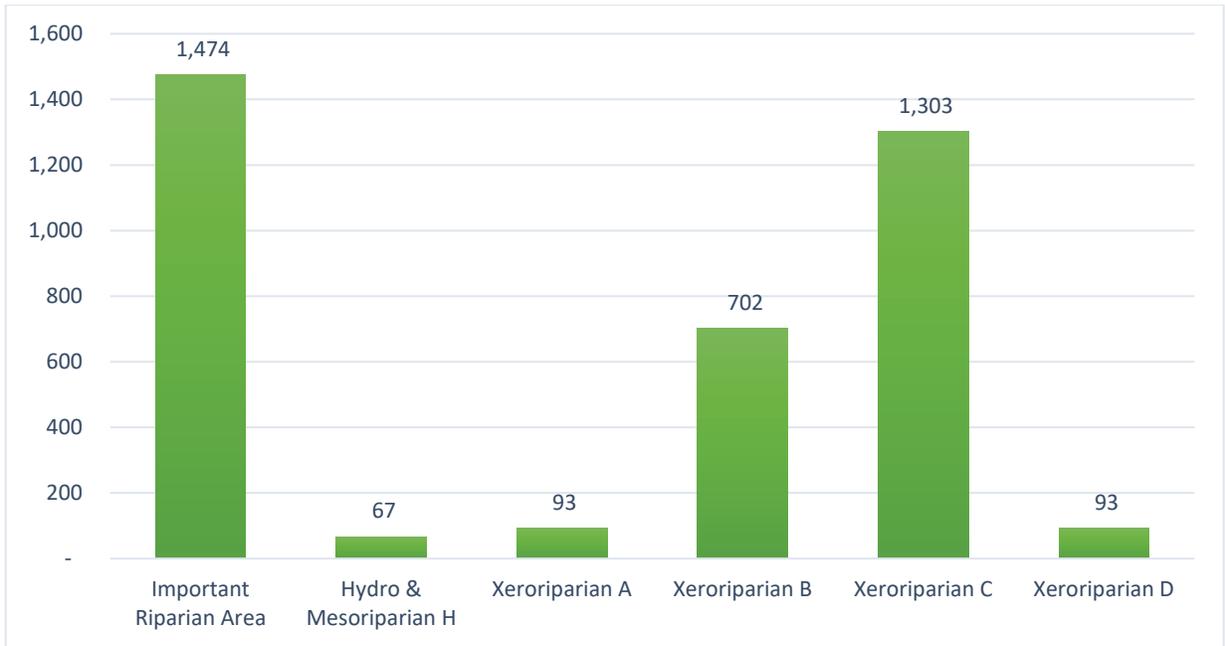
As shown on the bar chart below, there are 2,258 acres of Pima County Regulated Riparian Habitat in this watershed; 1,474 acres is IRA. There are also 13,215 preserved acres in this watershed, including 12 in regulatory floodplain.

Figure 69 - Catalina Foothills Watershed Riparian Habitat in Acres

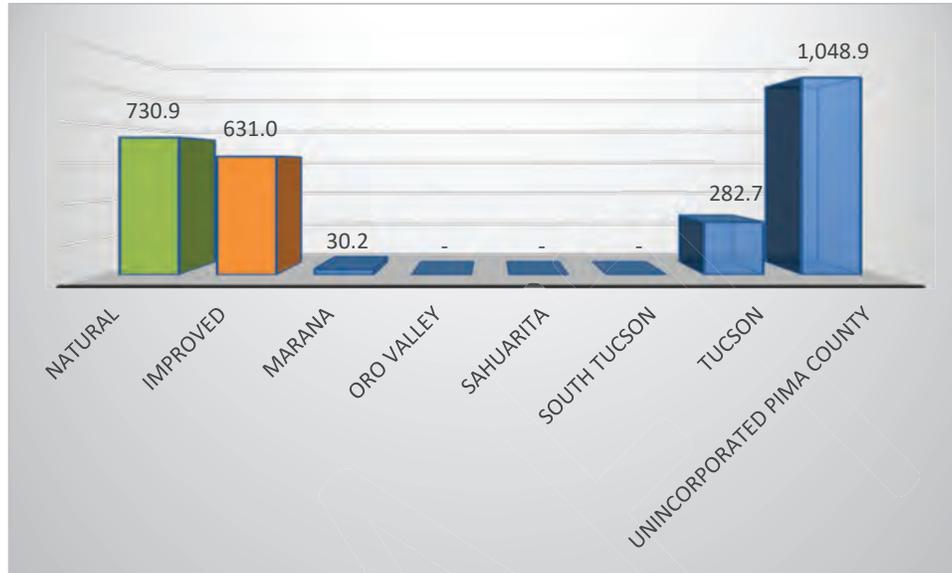
The figure below shows the split between natural and improved drainageways, and how many acres the District is responsible for in each jurisdiction.

Figure 70 - Catalina Foothills Drainageway Acreage

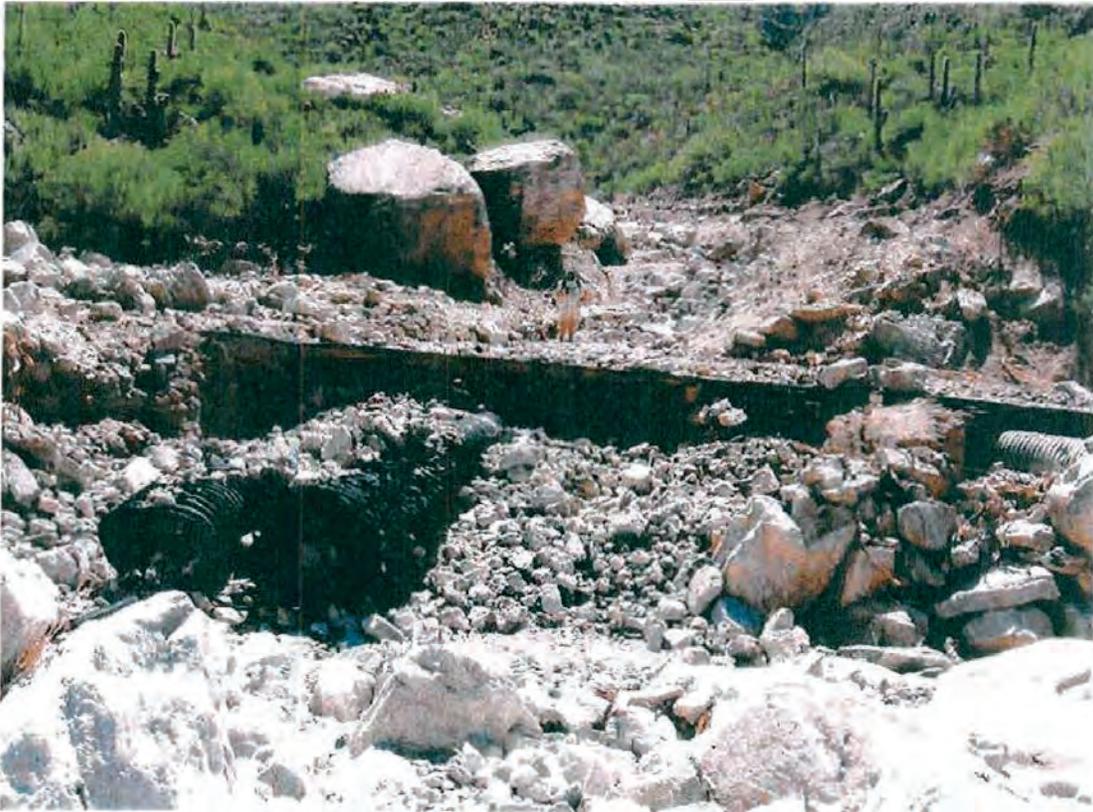
Figure 71 - Sabino Canyon Debris Flow Photo

- Continue special studies where needed
- Old mapping is inaccurate 50 yr. or none mapped
- Cumulative improvements impacts on residential roads in older subdivisions built to old standards
- Lack of HOA maintenance
- Large lot splits where allowed
- Debris flows
