5.4.11 Sabino Creek

Sabino Creeks' origins are near the summit of Mount Lemmon and the community of Summerhaven. Originating at nearly 9000', it descends steeply through dramatic canyon walls before spilling out onto the bajada foothills and geologic floodplains associated with the Tanque Verde where they merge to become the Rillito Creek. Within Pima County, it is comprised of 140,539 acres (219.6 square miles).

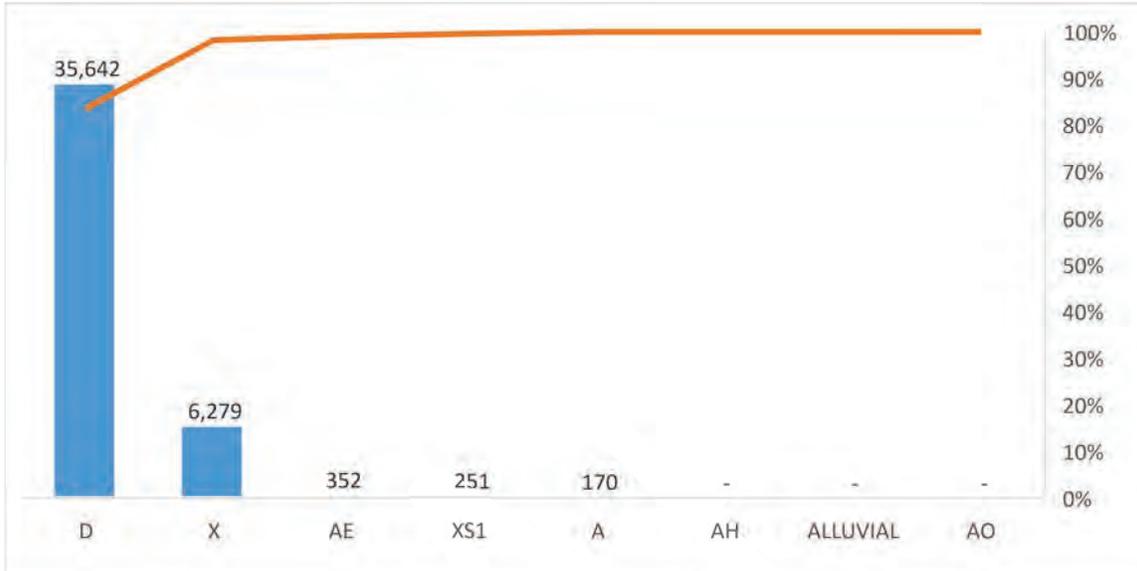
Figure 120 - Sabino Creek SFHA in Acres

In addition to 522 acres of SFHA zones included on the bar chart below, there are also 844 acres of District Special Studies Floodplains in this watershed.

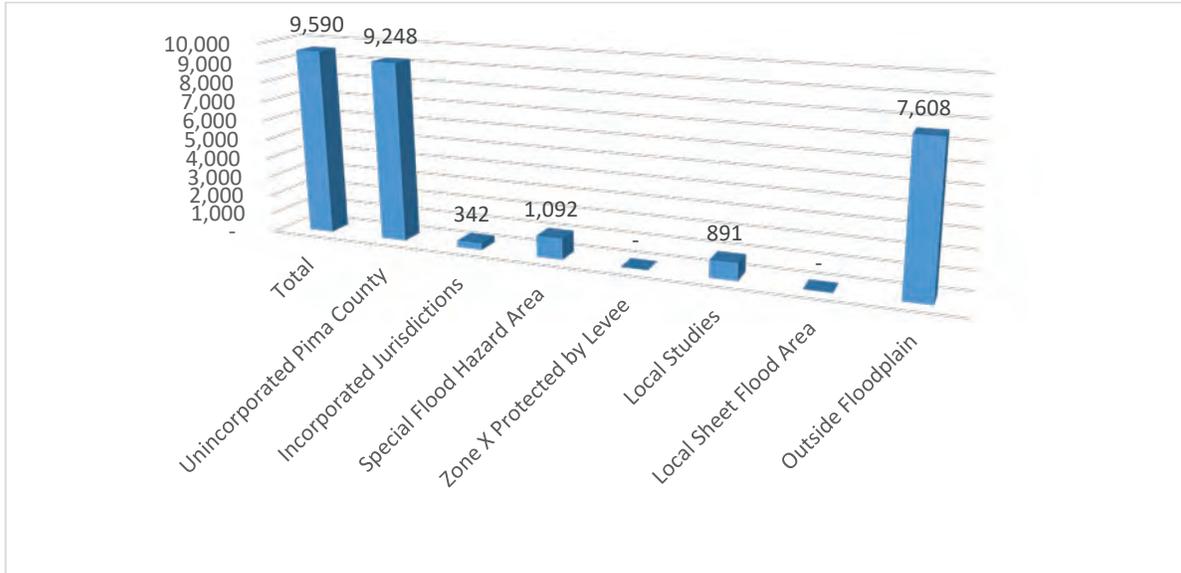
Figure 121 - Sabino Creek Watershed Population Distribution

The chart below shows the distribution of residents within known floodplains, and distribution between incorporated and unincorporated areas.

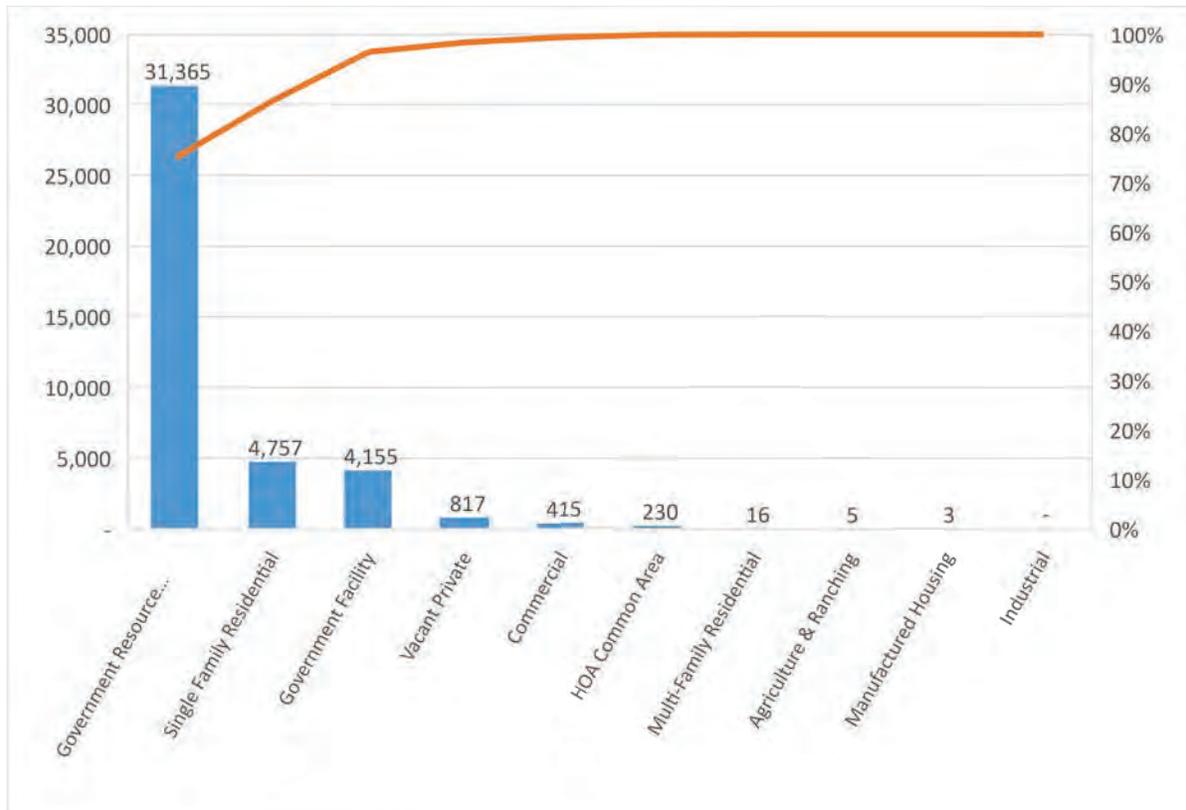
Figure 123 - Sabino Creek Watershed Land Use in Acres

Single family residential is the predominant use throughout this watershed.

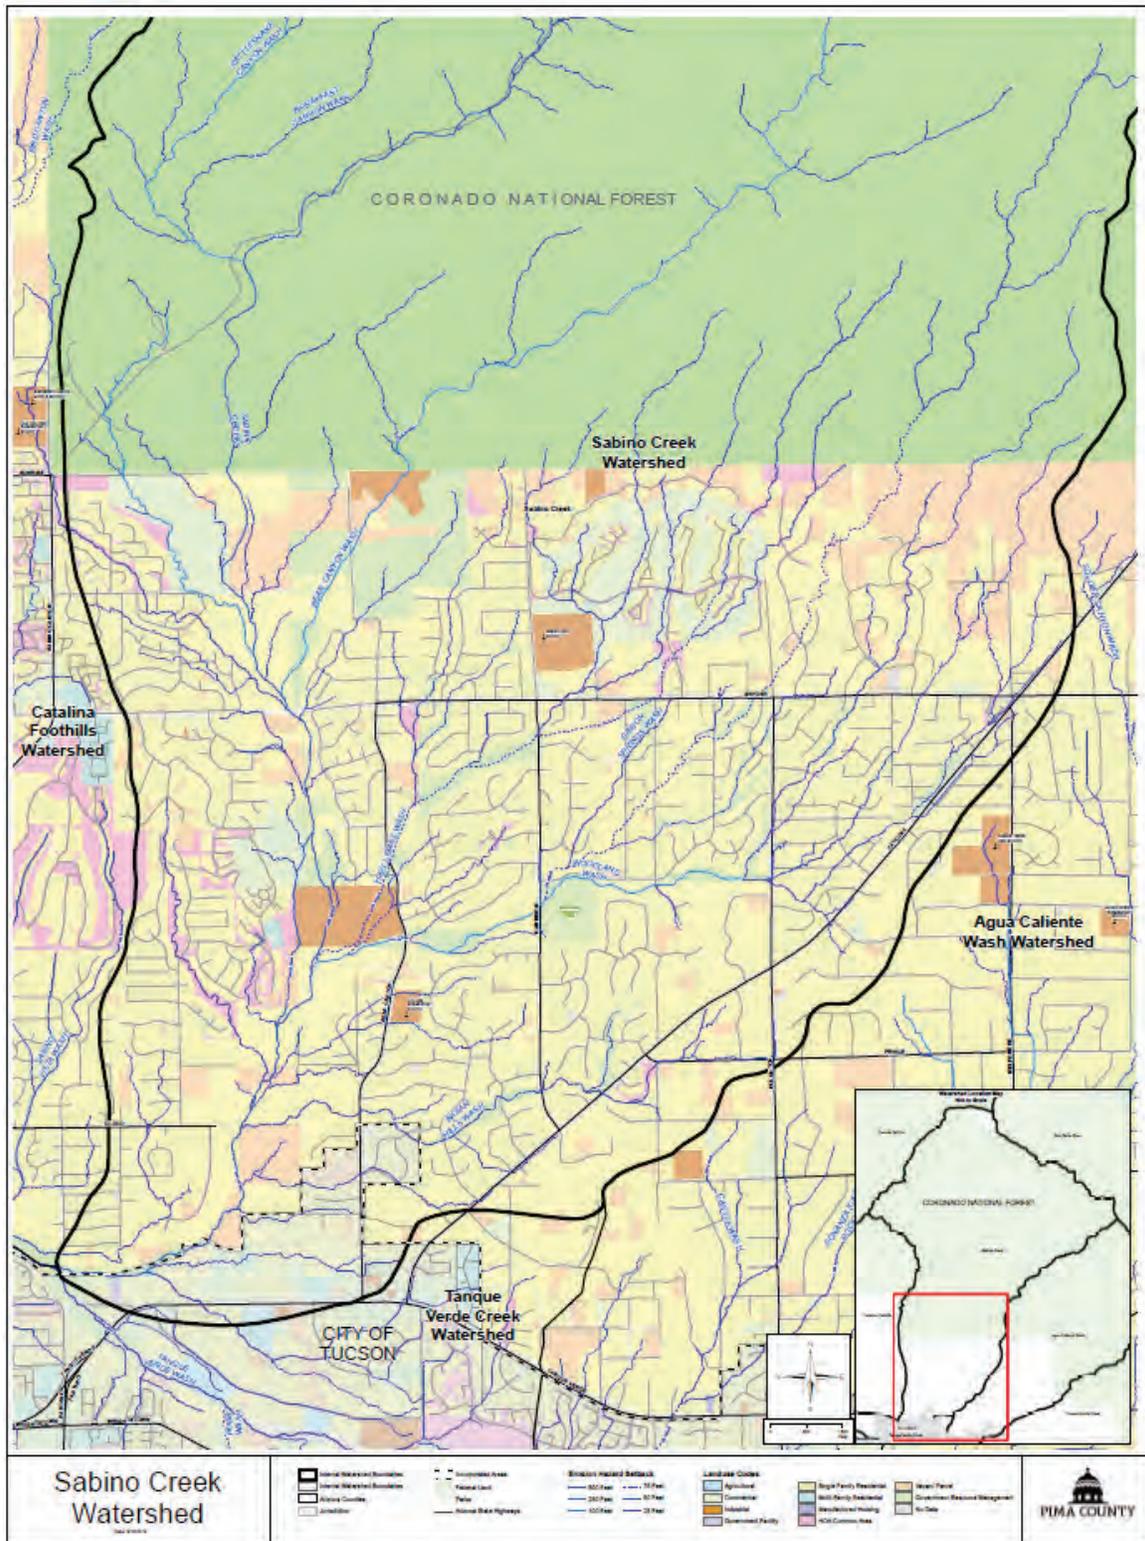
Figure 125 - Sabino Creek Watershed Land Use Map

As noted above for these watersheds as a whole single family residential is the largest use of private floodplain land. The map below shows these land use patterns.

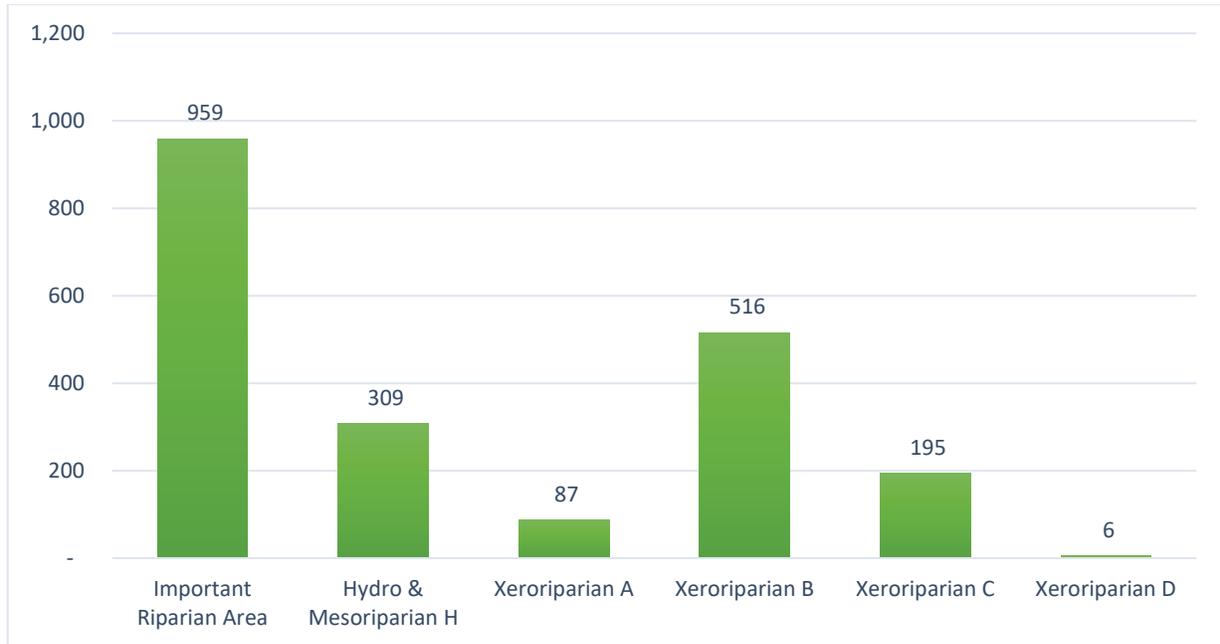
Figure 126 - Sabino Creek Watershed Riparian Habitat in Acres

As shown on the figure below, there are 1,112 acres of Pima County Regulated Riparian Habitat in this watershed; in addition, there is 959 acres of IRA. It is also interesting to note the quality of this habitat as reelected in the higher percentages of H, A and B. There are also 35,214 preserved acres in this watershed, including 68 in regulatory floodplain.

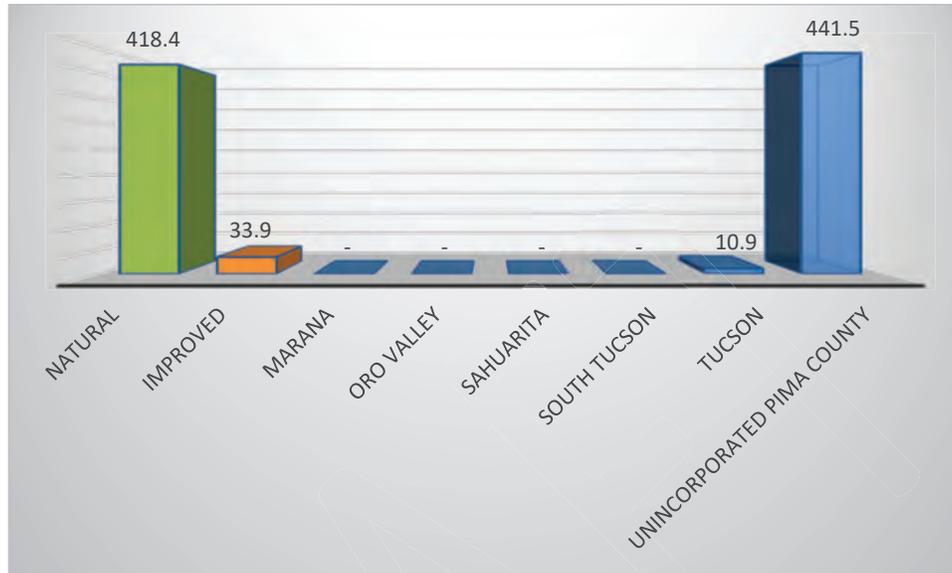
Figure 127 - Sabino Creek Drainageway Acreage

The figure below shows the split between natural and improved drainageways, and how many acres the District is responsible for in each jurisdiction.
