5.5.9 Tenmile Wash

5.5.9.1 Flood Characteristics

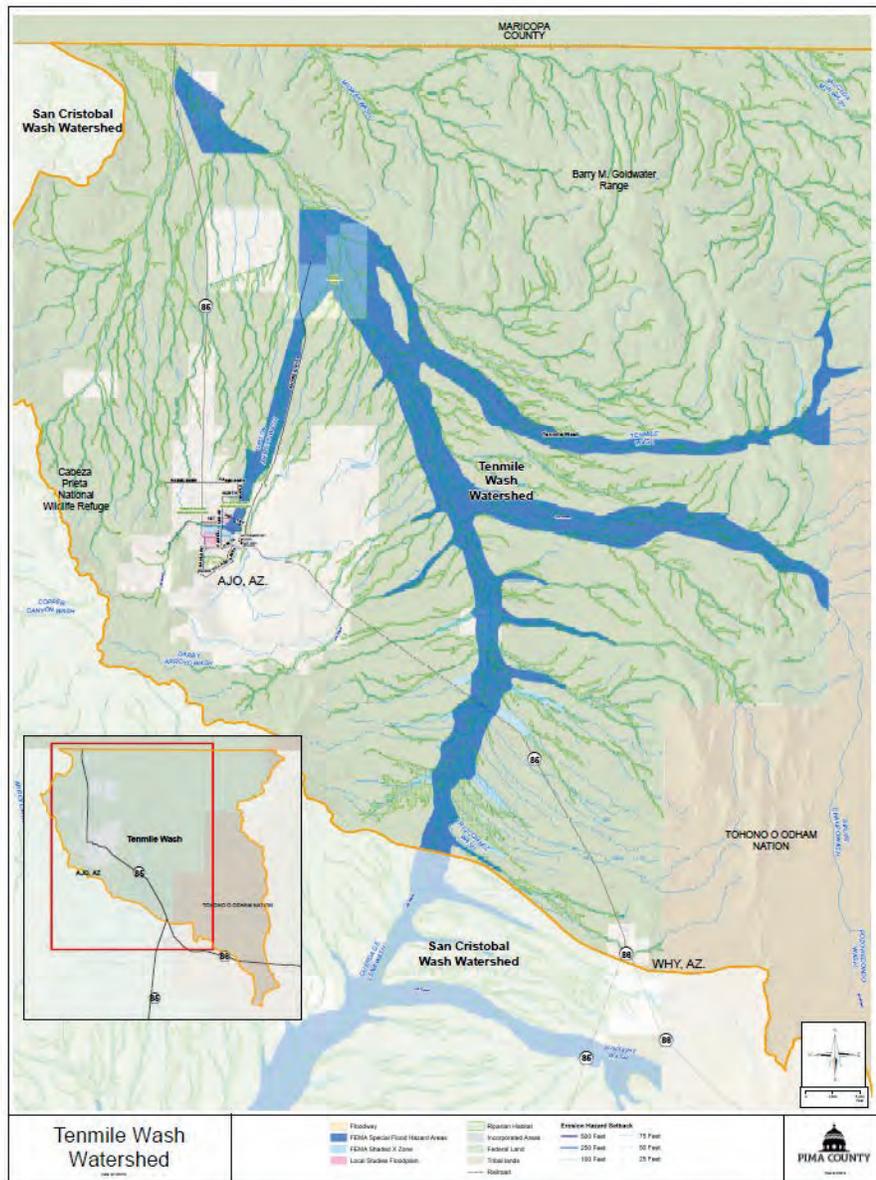
Figure 244 - Ajo Watershed Map

This watershed includes Gibson Arroyo within the community of Ajo that is within Tenmile Wash watershed. While the watershed is mostly rural, the Town of Ajo, while remote, is urbanized. This watershed also includes roughly the northern half of the community of Why. The watershed extends from the Pozo Redondo and Batamote Mountains in the east across the basin floor to the Little Ajo and Childs Mountains in the west. From these headwaters, this watershed then drains northward into Maricopa County. It is tributary to the Gila River and the confluence is approximately 40 miles west of Gila Bend. The entire watershed is within unincorporated Pima County and is 207,096 acres (323.6 square miles).

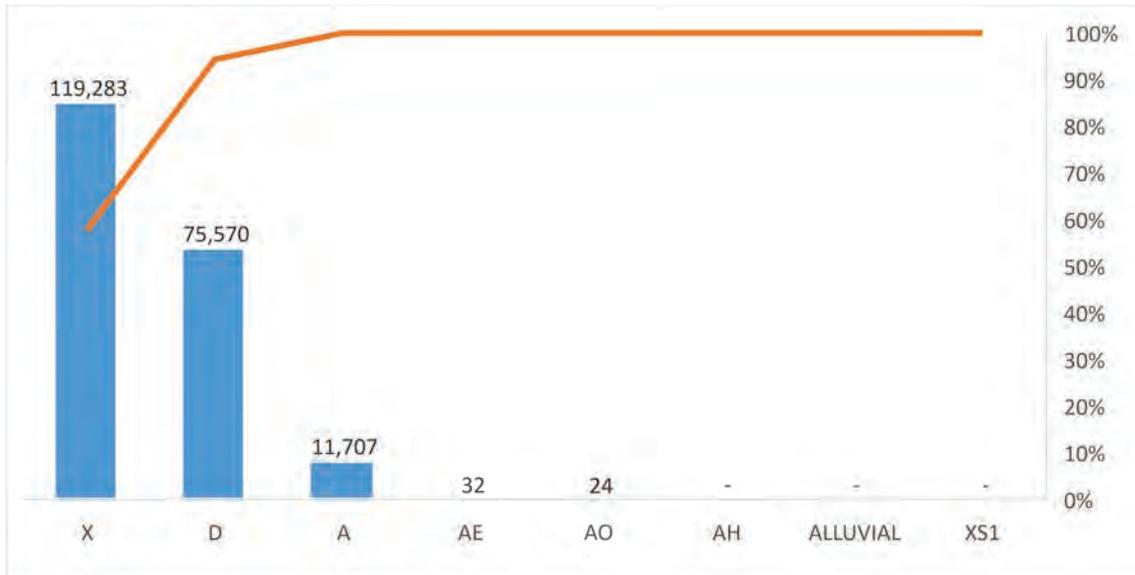
Figure 245 - Tenmile Watershed Federal floodplains

While the majority of mapped regulatory floodplains in this watershed are SFHA Zone A (11,707 acres), the District has conducted Special Studies in the urbanized areas most impacted by flooding including Gibson Arroyo in downtown Ajo, where there are 54 acres of Special Studies Floodplains.

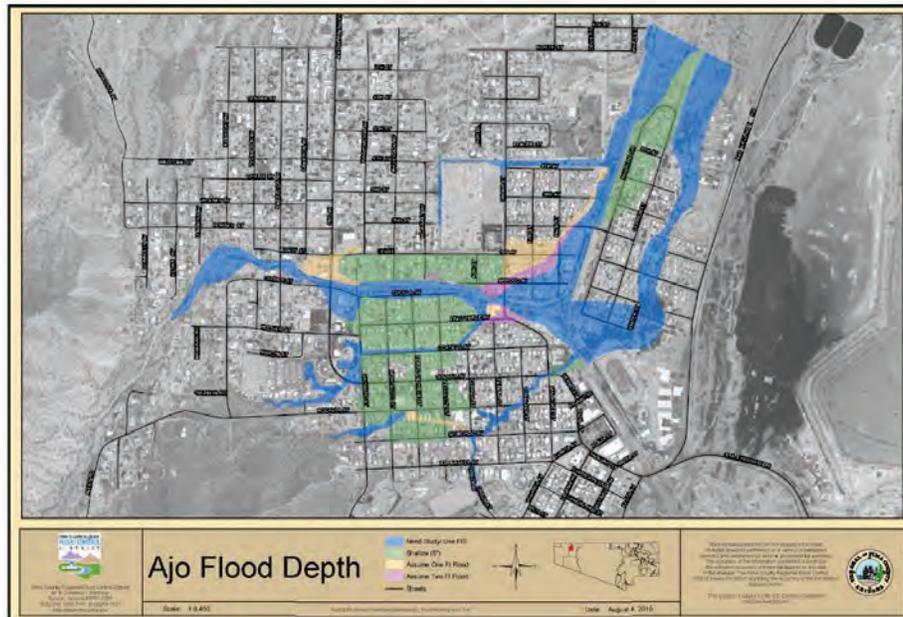
Figure 246 - Ajo Flood Map

Flooding occurred in Ajo along the Gibson Arroyo on July 29, 2003, when a storm centered over the western portion of Ajo in the areas identified by the Special Study. Rainfall data associated with this storm is unofficial, due to lack of radar data and rainfall gauges. However, unofficial reports claim rainfall ranged from 2.7 to 4.0 inches of rain in approximately one hour. This high intensity event caused flooding throughout the community of Ajo, including many residences. The greatest flood depths occurred on the eastern end of Arroyo Avenue, west of the railroad. Tetra Tech analyzed peak flow rates from this storm event. They estimated a peak flood of 3,100 cfs for the Gibson Arroyo at Sartillion Ave. The flood-recurrence estimate was slightly greater than once every 500 years, on average. With the Special Study data available, the District has been able to inform property owners about the magnitude of flood risk to existing development and to provide flood depths when landowners propose new development within the Special Study floodplains.

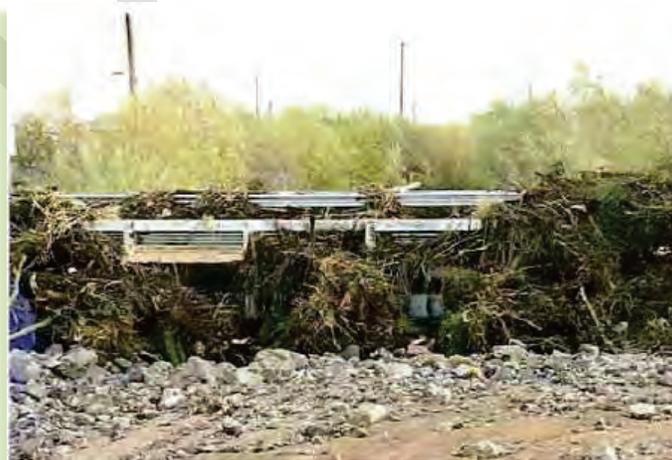
The Gibson Arroyo travels through Ajo in what looks to be a natural flow path until the arroyo intersects the railroad. Once intersecting the railroad the wash makes almost a 90 degree bend to then parallel the railroad tracks and flow northward. In the July 2003 flood, this location was subject to the greatest flow depths, and the railroad tracks were overtopped. Sediment transport is a concern within the Gibson Arroyo. In the July 2003 flood, sediment and debris blocked the bridge at E. 2nd Avenue. Tetra Tech estimated that the storm event yielded 4.61 acre-feet of sediment at Sartillion Ave. In 2007, the County replaced the bridge with a new con arch bridge designed to contain the channel's capacity, but not the 1% annual chance discharge. It was determined that the new bridge decreased the downstream water surface elevation by about 1.5 feet. The removal of the piers should decrease blockage from debris.

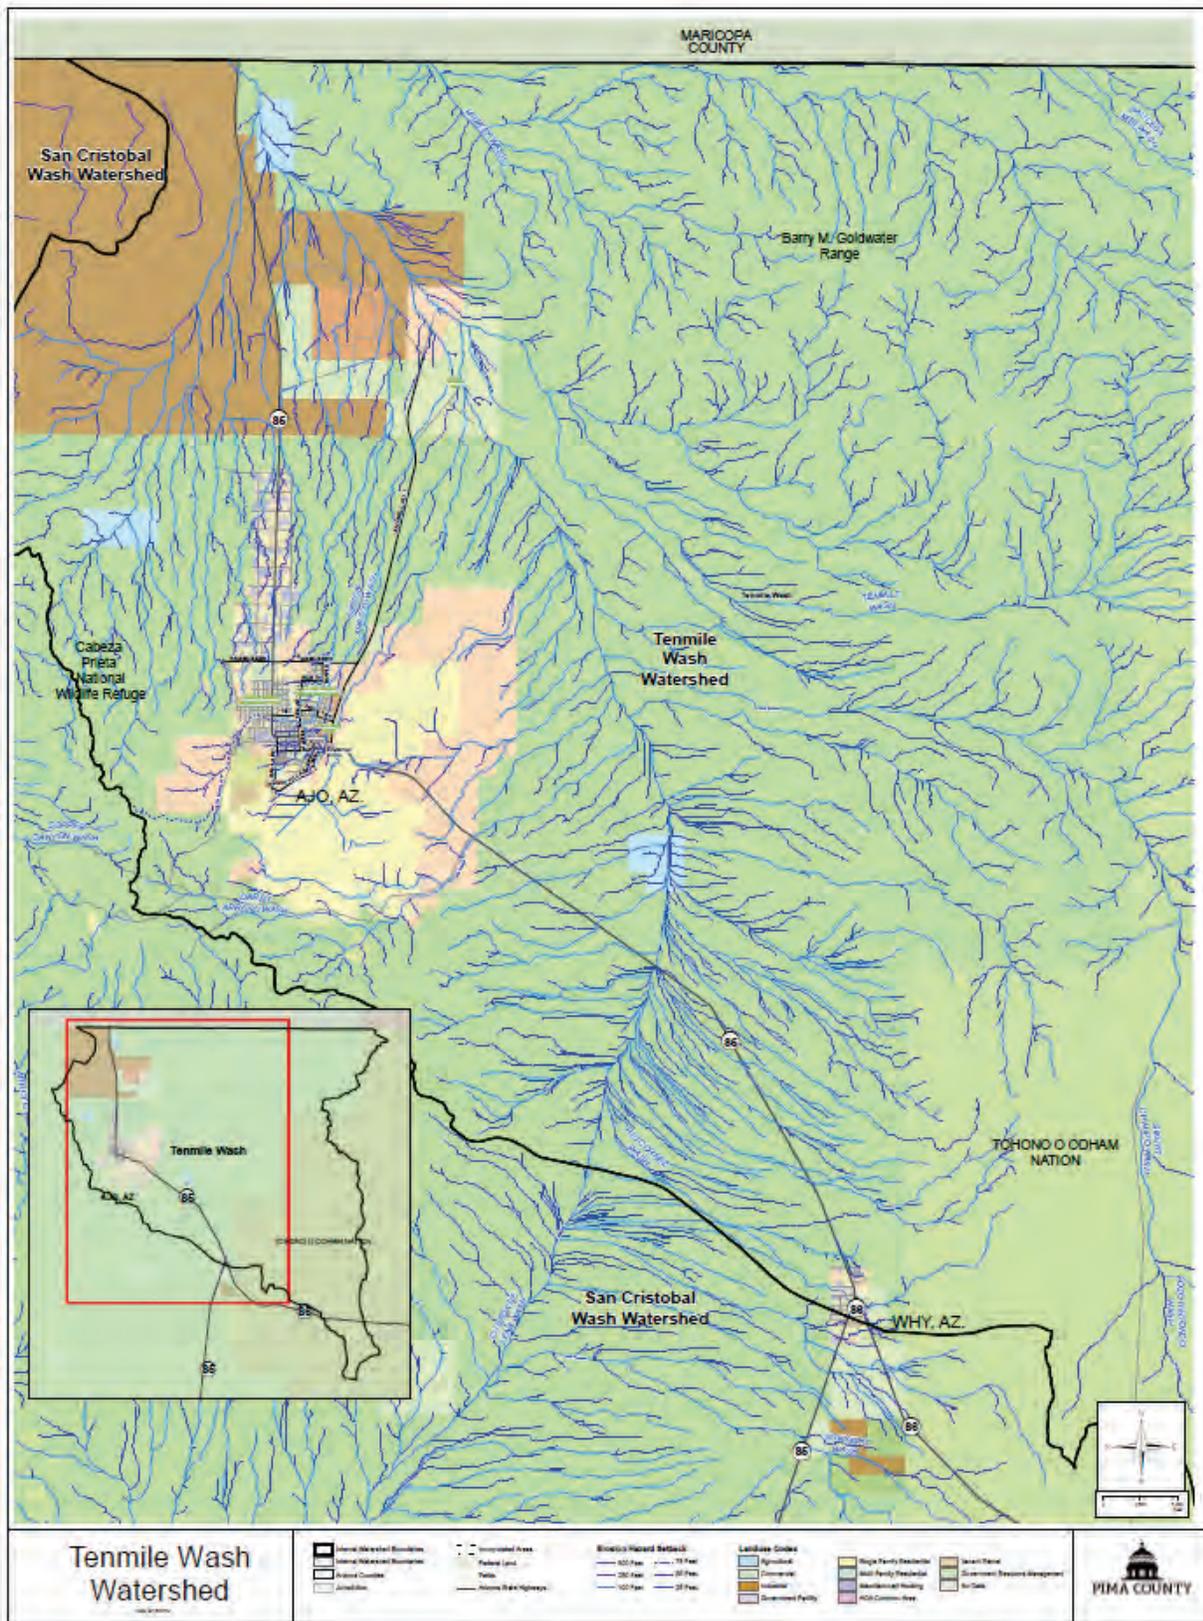
Figure 251 - Tenmile Wash Land Use Map

While there are residential and commercial areas this watershed is predominately rural. Less than 10% is urban as shown on the land use chart above and map below.

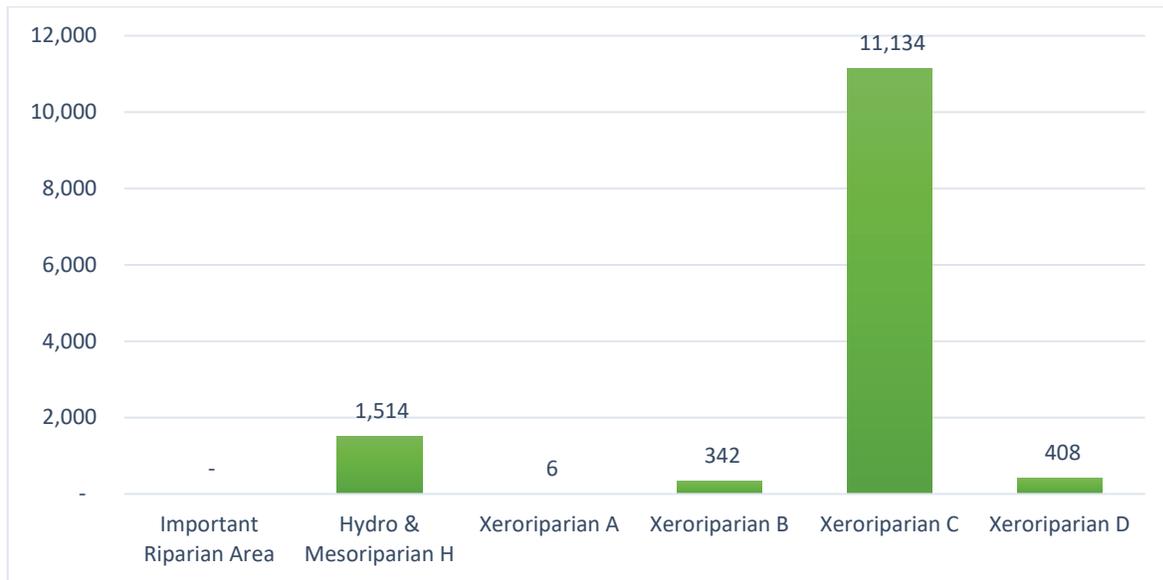
Figure 252 - Gibson Arroyo & Tenmile Wash Riparian Habitat in Acres

As shown on the figure below, there are 13,405 acres of Pima County Regulated Riparian Habitat in this watershed. Much more exists in a natural condition outside the unincorporated area where the District has not completed mapping. There are also 12,110 preserved acres in this watershed, including 157 in regulatory floodplain.

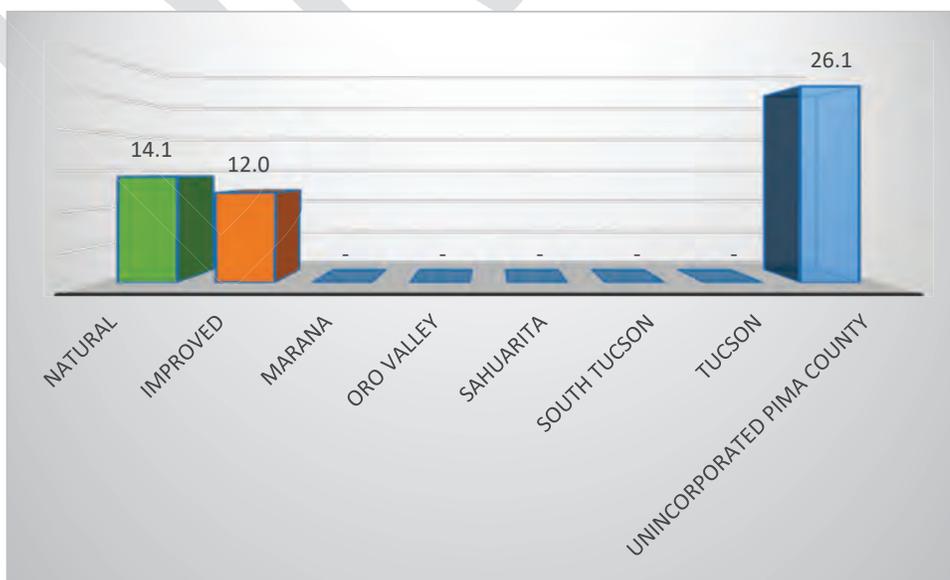
Figure 253 - Tenmile Wash Drainageway Acreage

The figure below shows the split between natural and improved drainageways, and how many acres the District is responsible for in each jurisdiction.

As shown on the chart above, 100% of the drainage system managed by the District in this watershed is natural. In addition, there are 11,593 acres of preserved open space managed by multiple entities. In reality, as shown on the map almost the entire watershed is natural with the exception of the mine and towns of Ajo and Why, however much of the land is either part of the Tohono O’odham Nation, is managed by the Bureau of Land Management, or is a part of military reserves used largely for flight training. Each of these lands are in a largely natural condition but are not preserves.

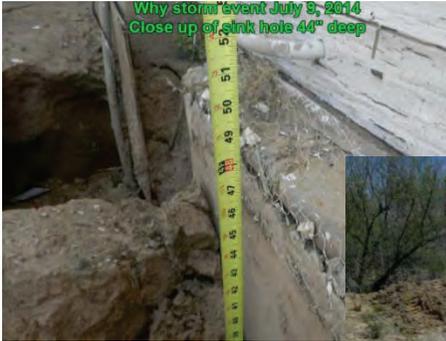
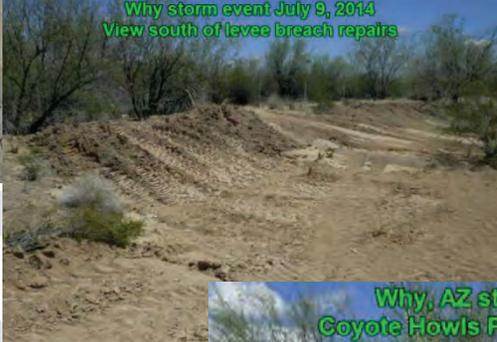
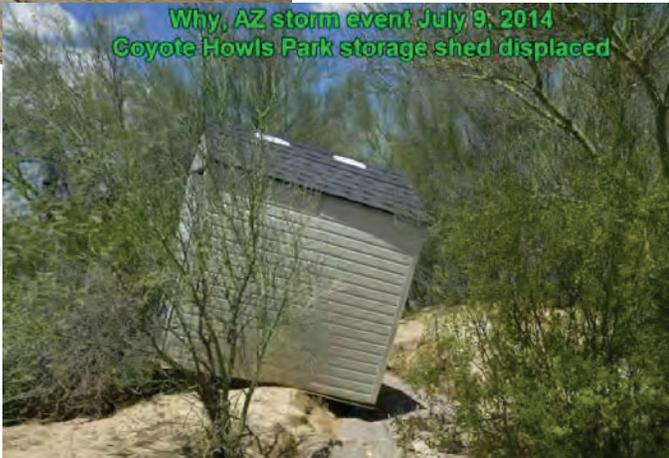
2014 Why Flood Damages

In July 2014, floods affected those living in the community of Why.

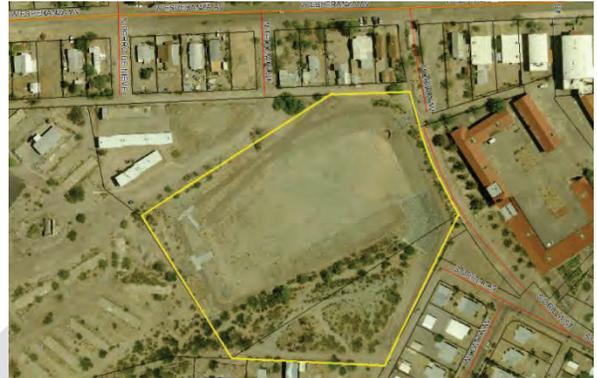
- The Curly School Detention Basin near Esperanza Ave. and Orilla Ave. The old high school football field has been transformed into a storm detention basin. Inspect the conditions of the inlet spillways and note if slope erosion has occurred along the basin walls. The culvert outlet should also be inspected for debris blockage. (T12S R06W Sec. 22) <GIS Point ID: AJO- INF-002>

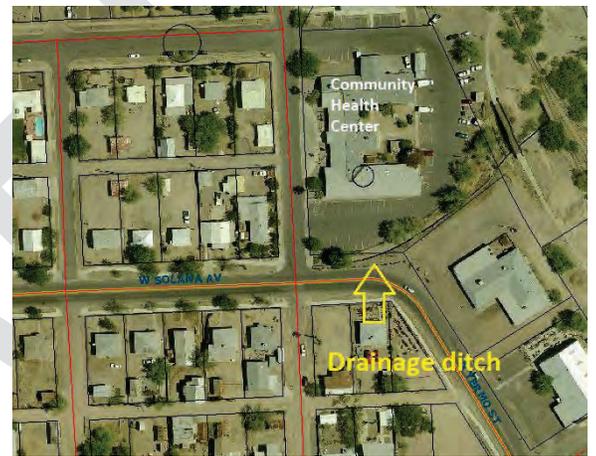
- The drainage ditch along the south side of the Ajo Community Health Center. Inspect for damage to or blockage of the drainage ditch south of the Community Health Center. County maintenance responsibilities stop at the north side of Solana Avenue. The culvert at Solana Ave. belongs to the Arizona Department of Transportation and the drainage upstream (south) of Solana is private. (T12S R06W Sec. 14) <GIS Point ID: AJO- INF-003>

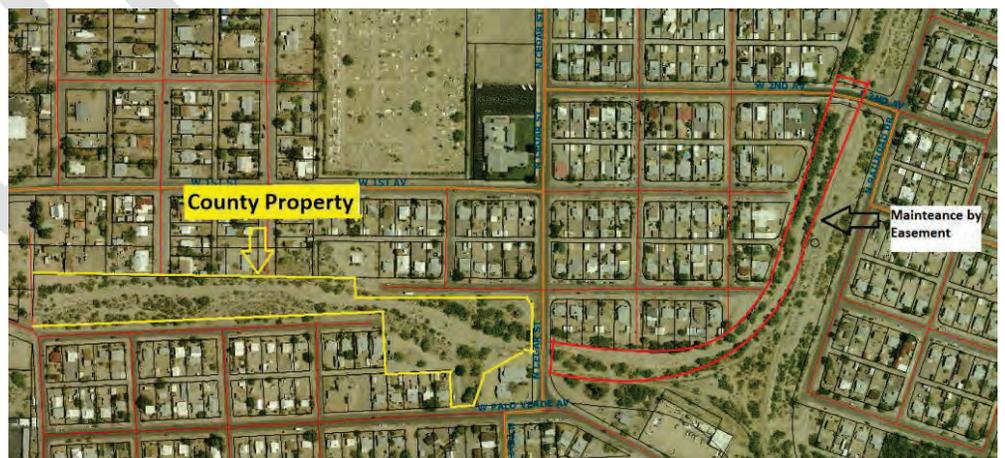
- The County maintains the Gibson Arroyo upstream of 2nd Avenue to Cedar Street via a maintenance easement granted by Phelps Dodge. This area is subject to deposition. Bank erosion can occur in upstream and downstream of Cedar Street

Upstream of Cedar street there are no construction plans for the channel. Utilities crossing to the channel are shallow and in

some locations exposed. The channel lacks capacity for moderate to strong storm events and widespread flooding is likely. Flood damage reports should address channel conditions. (T12S R06W Sec. 15) <GIS Point ID: AJO-INF-004>

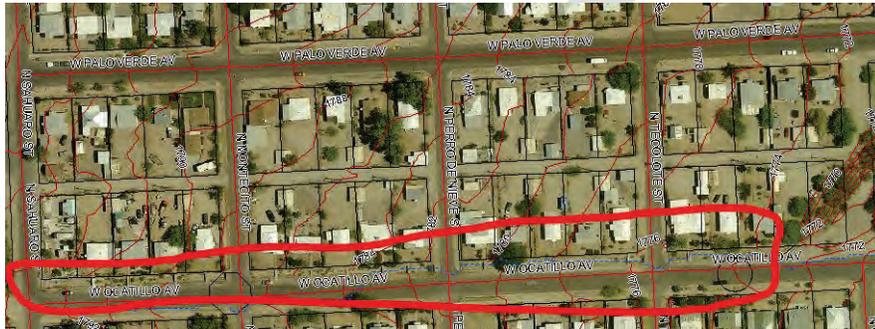
- The County maintains that portion of the drainage ditch north of Ocatillo Avenue that lies within the road right-of-way from Sahuaro Street east to a point approximately 170 feet east of Tecolote Street, at which point the channel leaves the road right-of-way. It is unknown if we maintain the footbridges across the channel. Flood damage reports should address the condition of the channel. (T12S R06W Sec. 15) <GIS Point ID: AJO-INF-005>
