VALLEY VIEW WASH
FLOOD AND EROSION CONTROL STUDY FOR
THE CALLE DEL PANTERA AREA
(PHASE II: FLECHA CAIDA FLOOD
IMPROVEMENT STUDY)

Pima County Department of Transportation
and Flood Control District
1313 S. Mission Road
Tucson, Arizona 85713

Simons, Li & Associates, Inc.
110 South Church, Suite 2170
P.O. Box 2712
Tucson, Arizona 85702

February 15, 1989

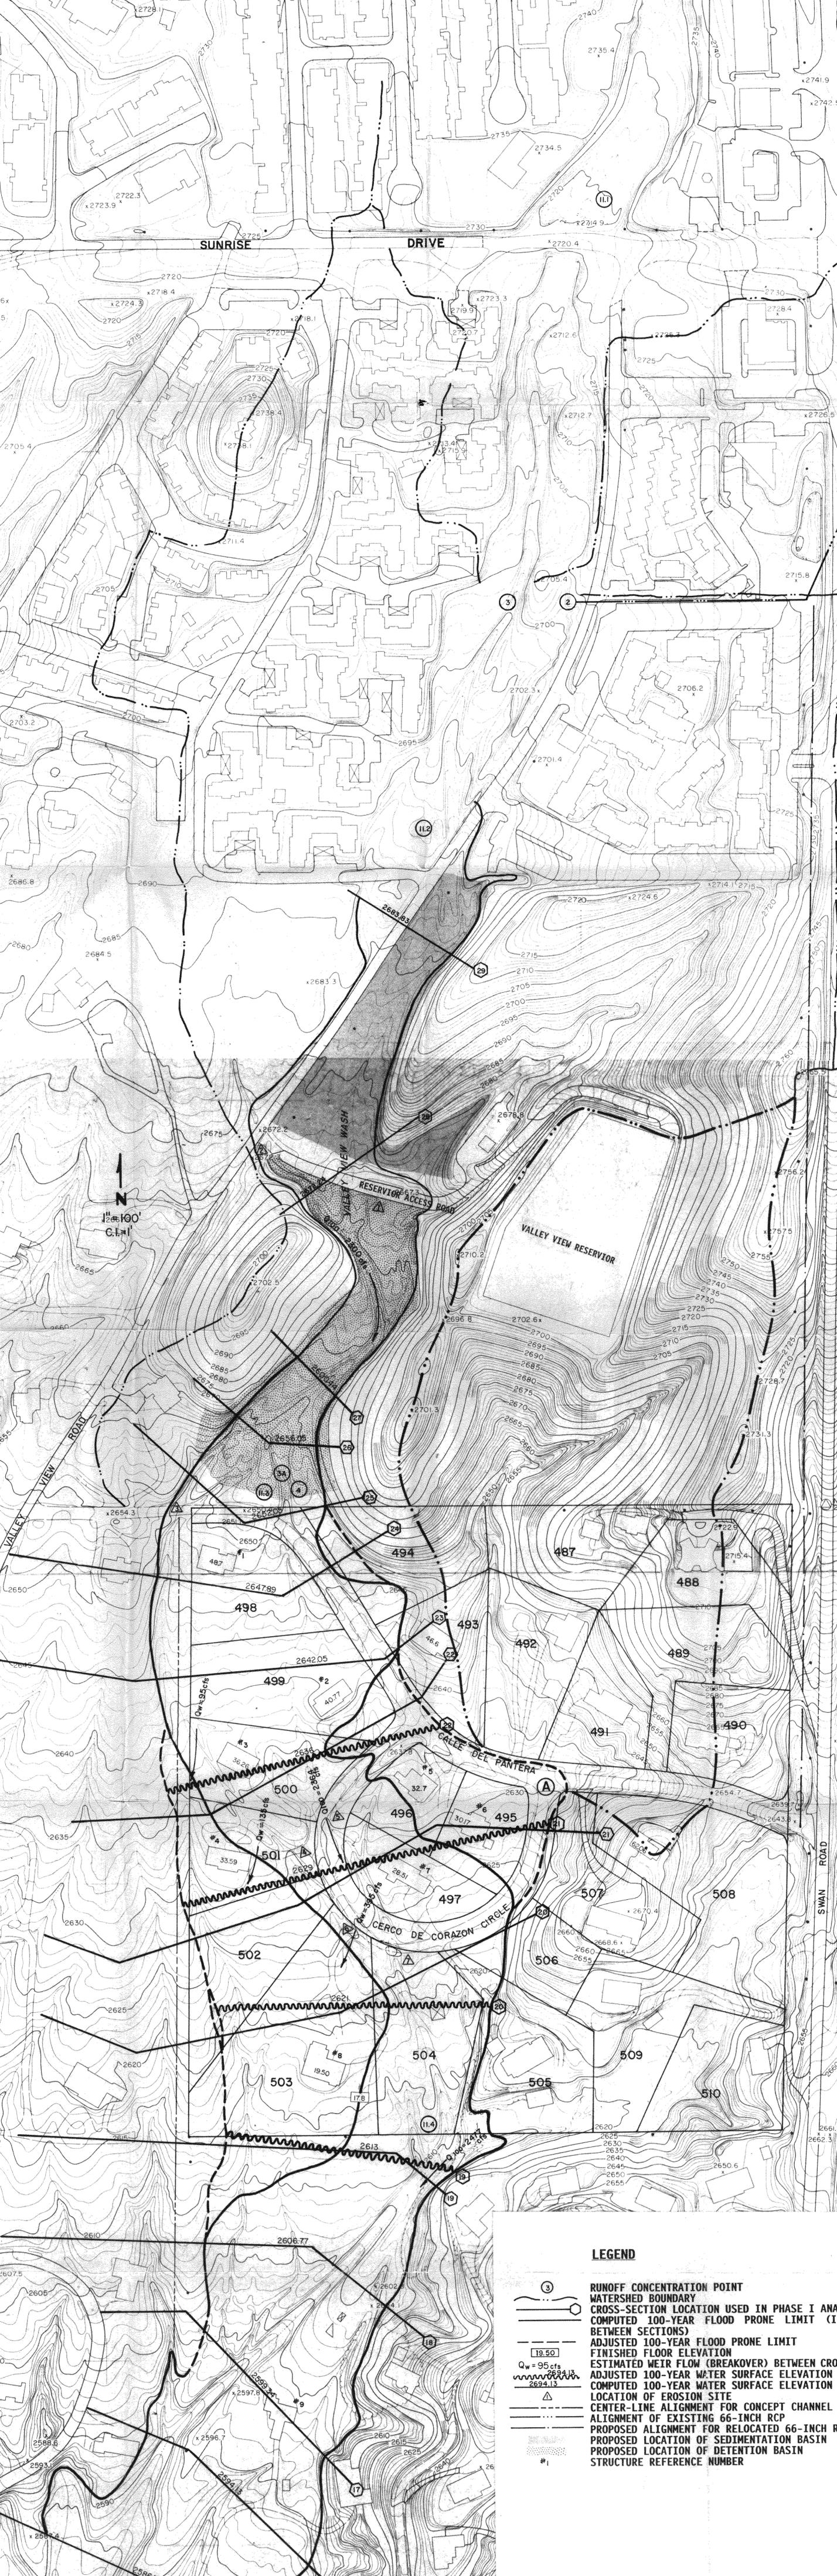
PROPOSED ALIGNMENT FOR RELOCATED 66-INCH RCP
- PROPOSED LOCATION OF SEDIMENTATION BASIN
- PROPOSED LOCATION OF DETENTION STRUCTURE REFERENCE NUMBER

This report presents the results and recommendations of a comprehensive drainage study of the Calle del Pantera area which is located adjacent to and west of Swan Road, approximately one half mile south of Sunrise Drive (see Figure 1). The study area, which includes Tucson Water's Valley View Reservoir site and Flecha Caida Ranch Estates #9, has experienced numerous drainage-related problems. These problems include inundation, erosion, and limited access during the rainy season. For the most part, these problems stem from the fact that a portion of the reservoir site and approximately one-half of the subdivision are both located in the 100-year flood plain of the Valley View Wash (see Figure 2).

The peak-discharge computation sheets for each return period at the respective concentration points shown on Figure 2 are contained in Appendix B. The input/output listing associated with the multi-frequency hydraulic analysis of the respective flood plains are contained in Appendix C.

If runoff conveyed within the 66-inch RCP is to be diverted around the Calle del Pantera subdivision, a similar conduit must be constructed within the Swan Road right-of-way. This conduit would extend along the western side of Swan Road from just south of Sunrise Drive to Calle del Pantera (see Figure 2). All flow would then be released into Tributary "X", which joins the Valley View Wash on the downstream side of the Calle del Pantera area.

With regard to the concept channelization scheme, the first step was to select the most appropriate alignment. The primary goal was to select an alignment that would (1) minimize the length of the channelization reach, and (2) minimize the physical and aesthetic impacts on the neighborhood. After due consideration, there was only one alignment that met these criteria. This alignment is shown on Figure 2.

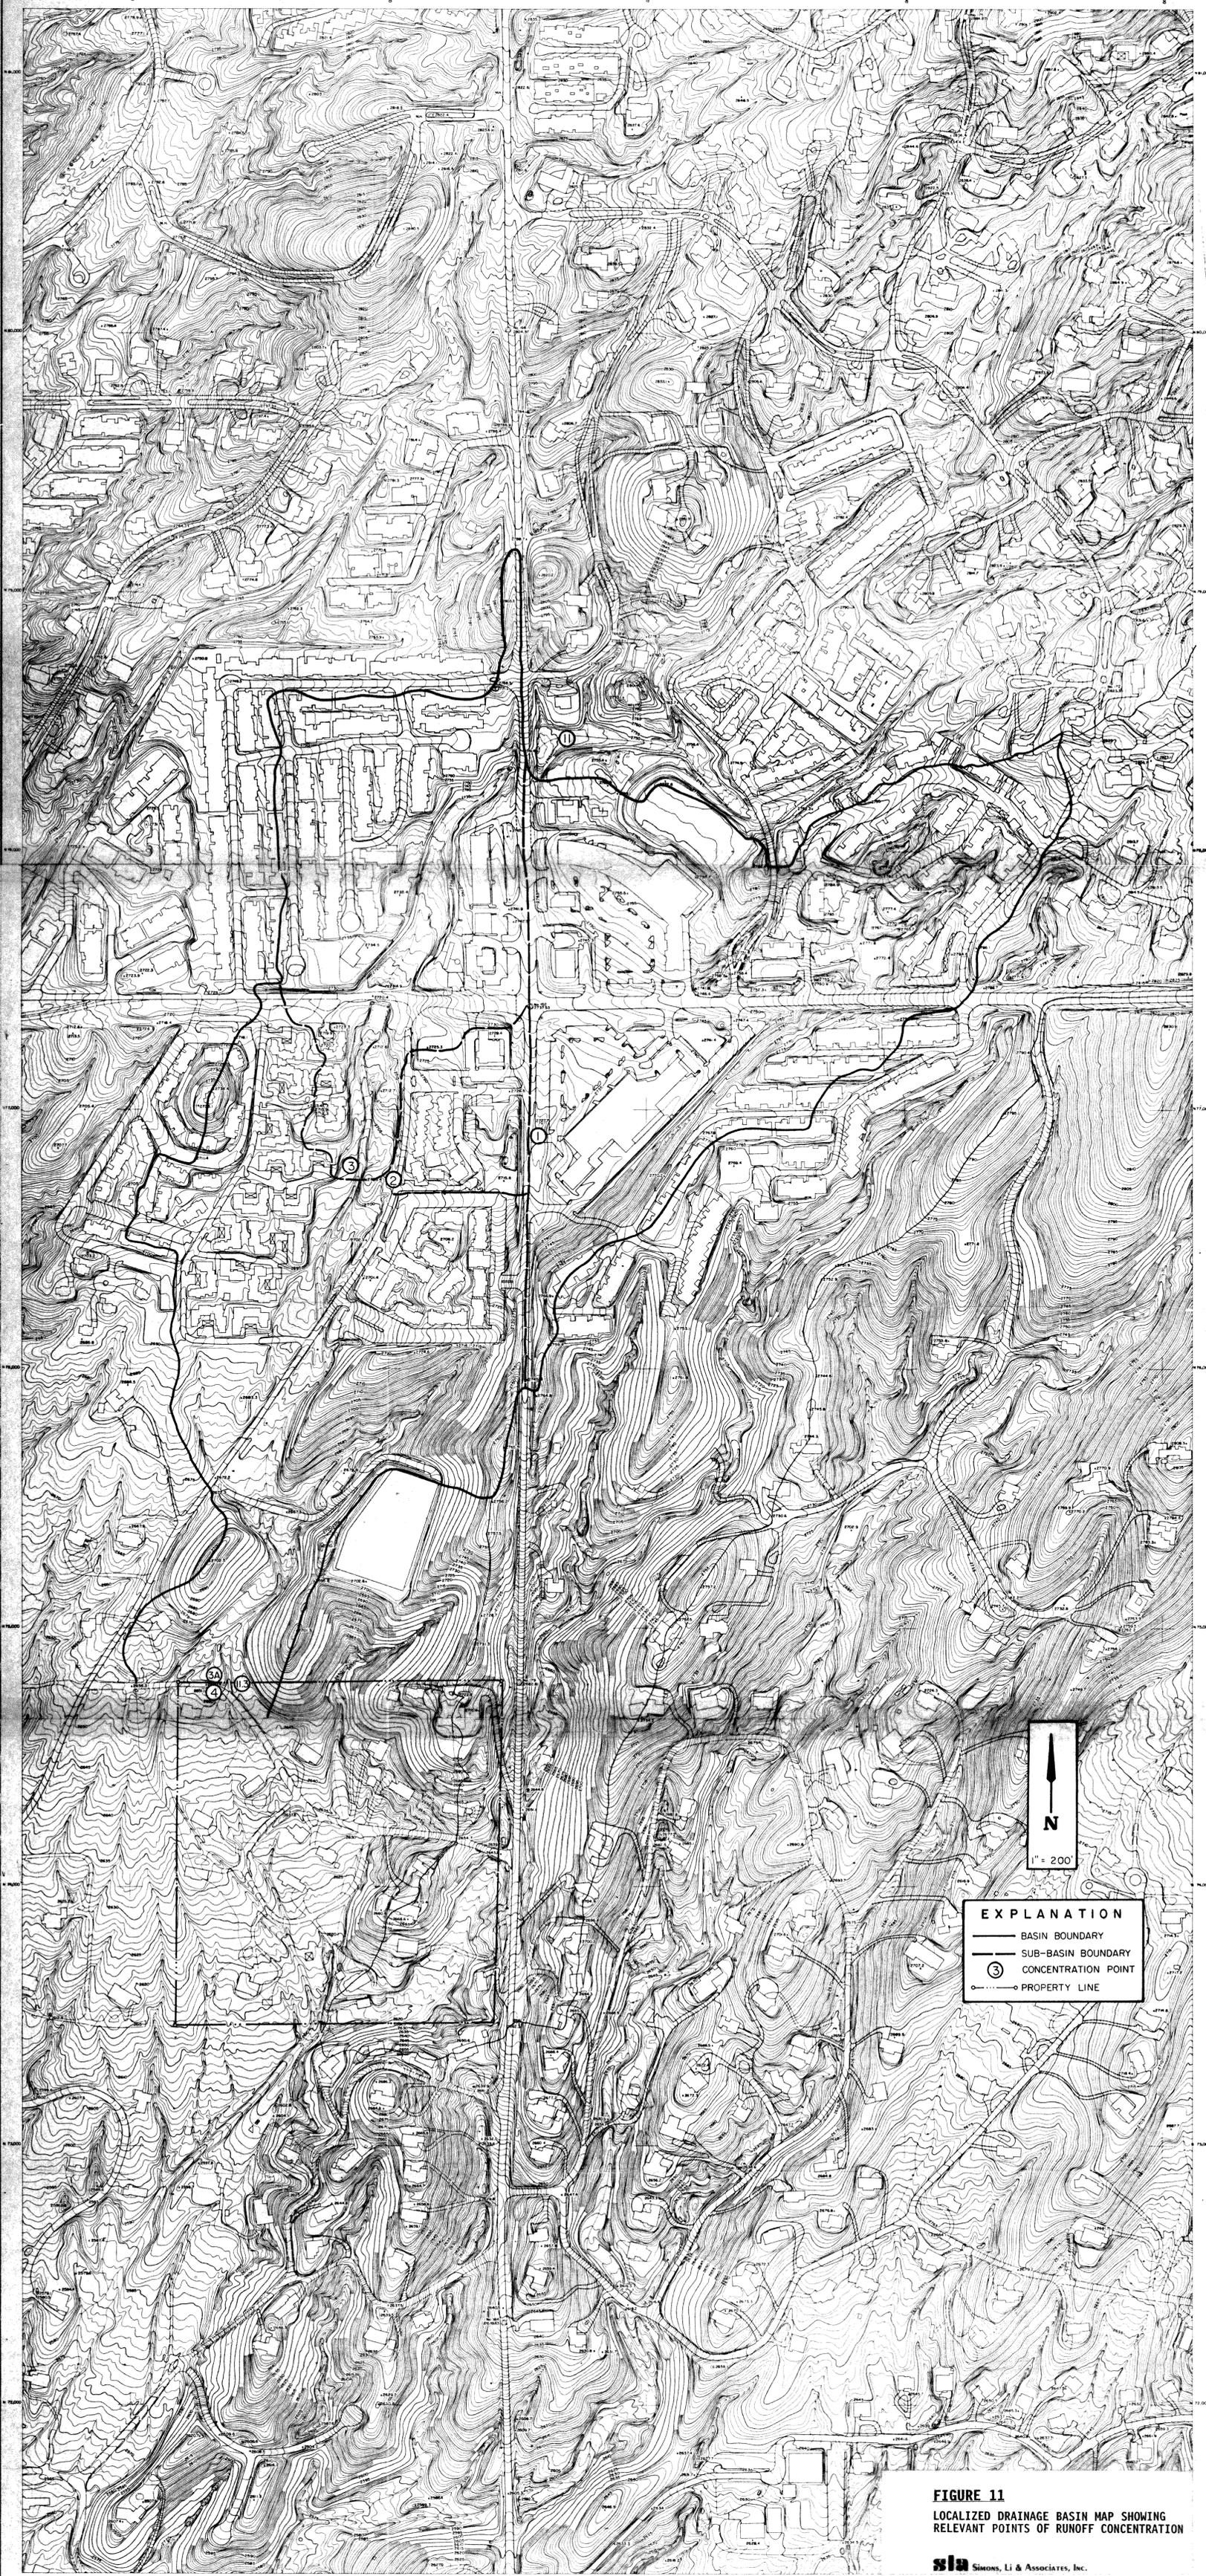
EXPLANATION	
	BASIN BOUNDARY
	SUB-BASIN BOUNDARY
	CONCENTRATION POINT
	PROPERTY LINE

Once the individual drainage areas and concentration points were defined (see Figure 11), a hydrograph analysis was performed to establish how these areas would interact with each other, and to what degree such interaction would affect the study area. This analysis was performed using the procedures outlined in Pima County's hydrology manual (Reference 3). Figure 12 summarizes the peak-discharge magnitudes at the various concentration points for each return interval. The hydrologic computation sheets for the respective concentration points shown on Figure 11 are contained in Appendix E).
