PIMA COUNTY REGIONAL FLOOD CONTROL DISTRICT ADMINISTRATIVE PROCEDURE

PROCEDURE NO.: ADM-202

PROCEDURE TITLE: Flood Response Guidelines and Field Manual

FLOOD RESPONSE FIELD MANUAL

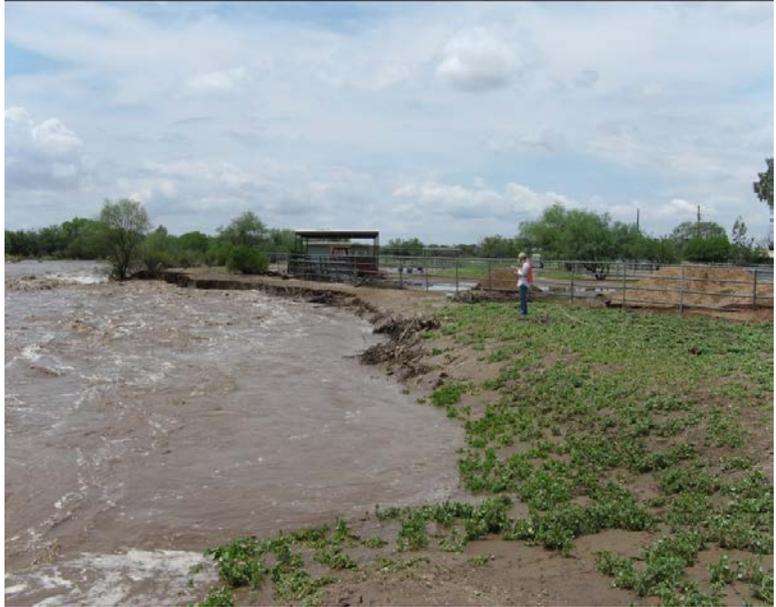
- Do not walk along the top of vertical, unprotected embankments. If you do have to monitor a watercourse along a vertical embankment, look for stress cracks and stay on the landward side of those cracks. If there are no cracks visible, stay a minimum of 6 to 8 feet away from the embankment. Further away is preferred. You may find you will get just as good of an observation by climbing higher (i.e. standing on a vehicle). (Moments after the photo at right was taken, the tree on the left fell into Tanque Verde Creek.)
- Never park your vehicle near a vertical unprotected embankment. The added weight of the vehicle could accelerate bank failure. This is especially true during the receding limb of the hydrograph.
- When an embankment is obscured by water, assume it is a vertical embankment.

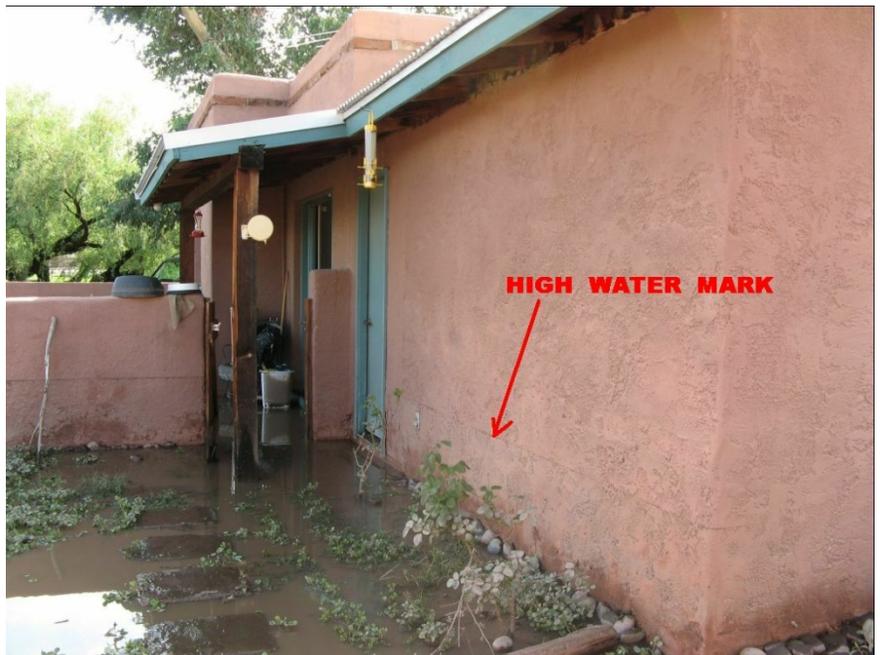
- Inquire about the possibility of damages to electrical services or to presence of gas. (Note in the photo above that the power is still on in the house, as the exterior porch light is on. Water got inside this structure to roughly the same depth as the exterior, therefore it is likely that the electrical wiring is wet and may pose a significant hazard.)

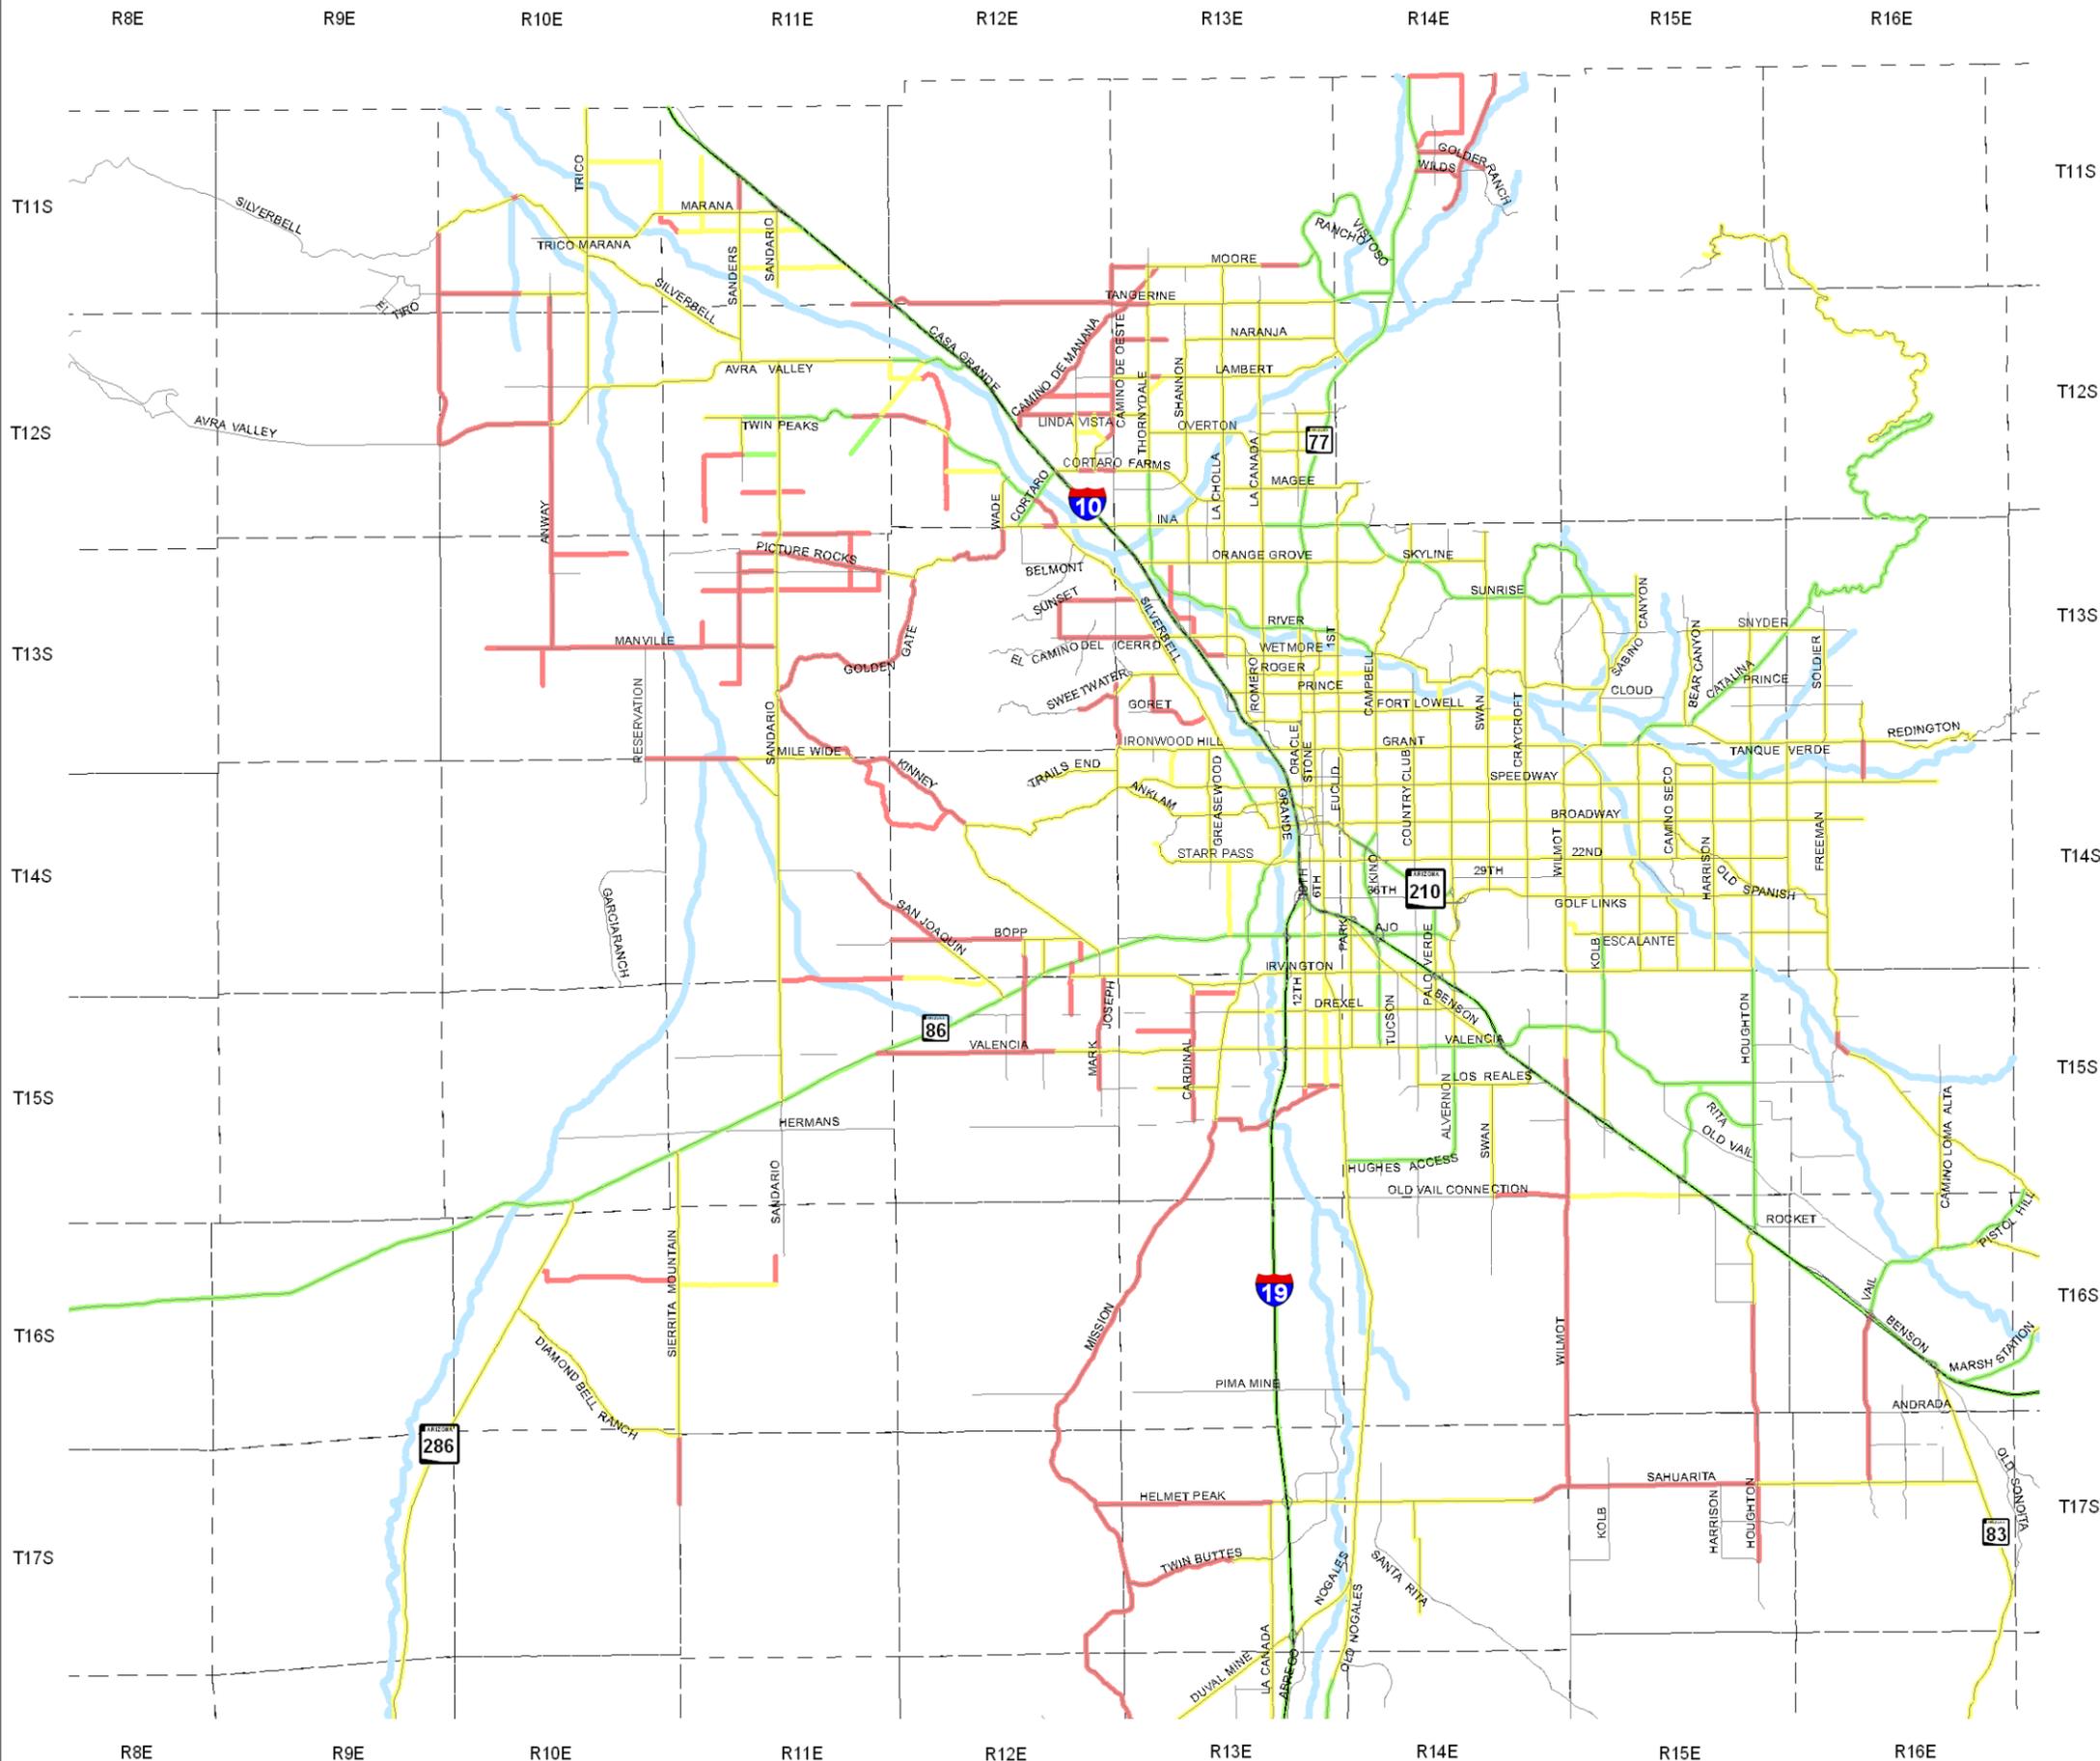
EMERGENCY VEHICLE ACCESS DURING FLOODING TUCSON AREA

- Road Questionable During Storms
- Roads Passable During Moderate Storms
- Roads Passable During Major Floods
- Major Washes
- Township / Range

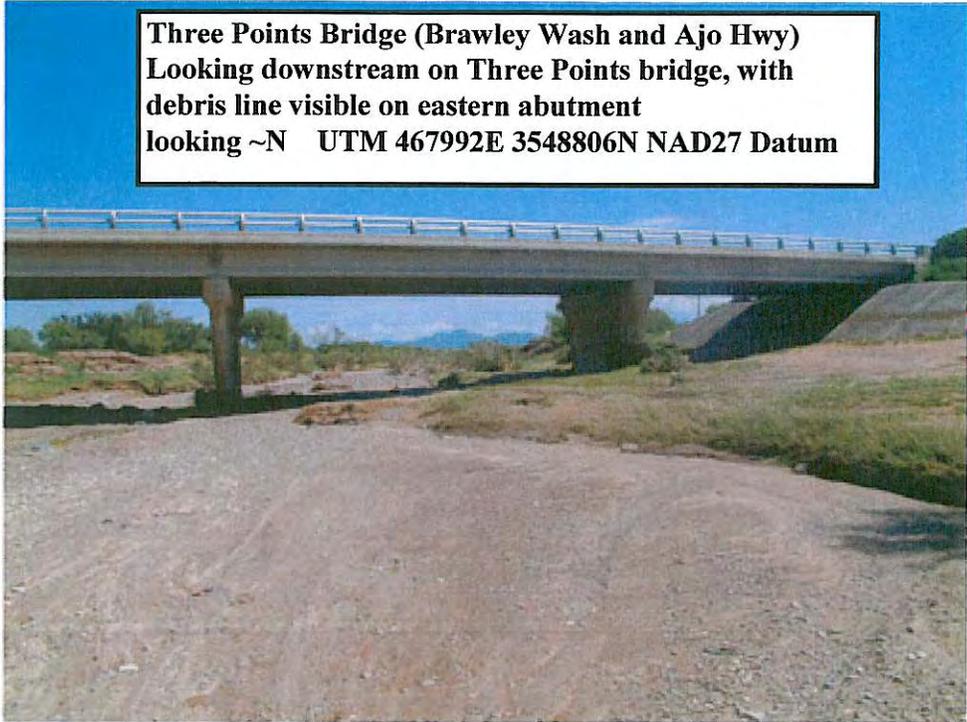
IMG_MISC_BrawleyFlood08-15-05_05

**Three Points Bridge (Brawley Wash and Ajo Hwy)
Looking downstream on Three Points bridge, with
debris line visible on eastern abutment
looking ~N UTM 467992E 3548806N NAD27 Datum**

**Debris
line
approx. 5
ft below
the bottom
of the
deck of
the bridge**

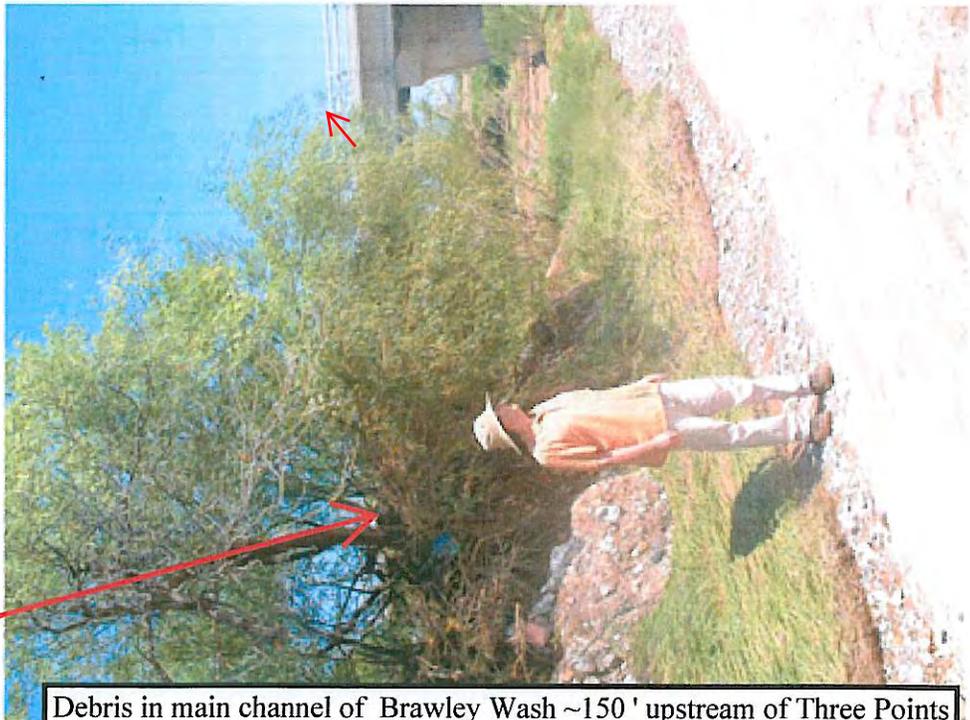
IMG_MISC_BrawleyFlood08-15-05_06

**Debris
line**

**Debris in main channel of Brawley Wash ~150 ' upstream of Three Points
bridge - Debris approximately 9-10 ft. above channel bottom
approx UTM 467990E 3548806N (NAD27 Datum)**

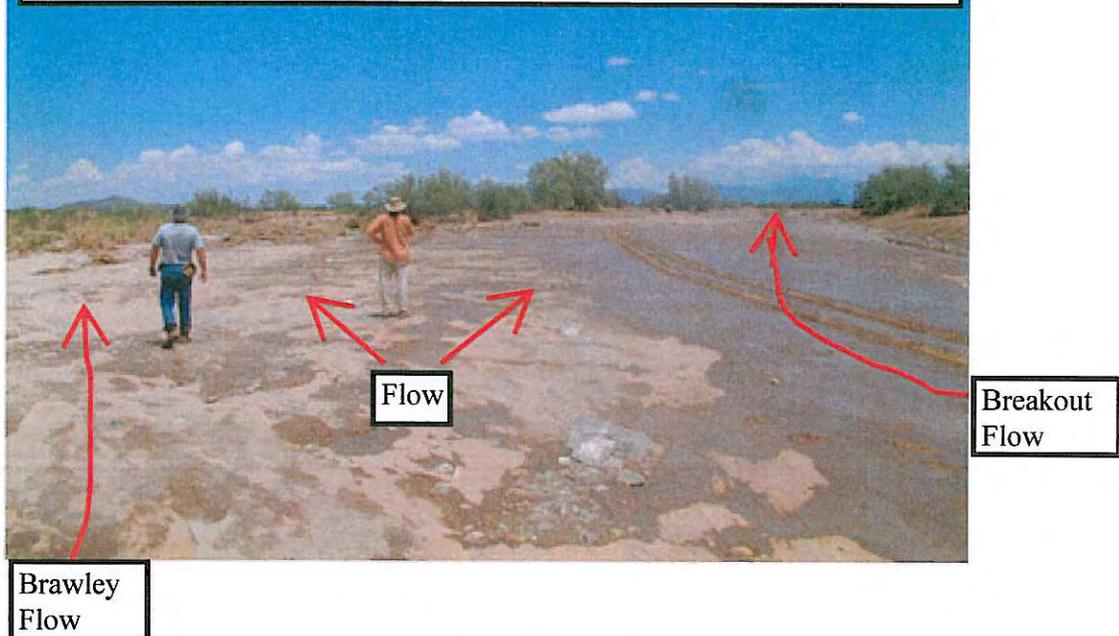
IMG_MISC_BrawleyFlood08-15-05_33

Brawley Wash (left) and breakout (right) that sent water towards 16478 W. Quinlin Tr. (left) and 16482 W. Quinlin Tr. The elevation of the breakout channel is approximately 5-6 ft above the main channel of the Brawley approx UTM 469342E 3550194N WGS84 Datum

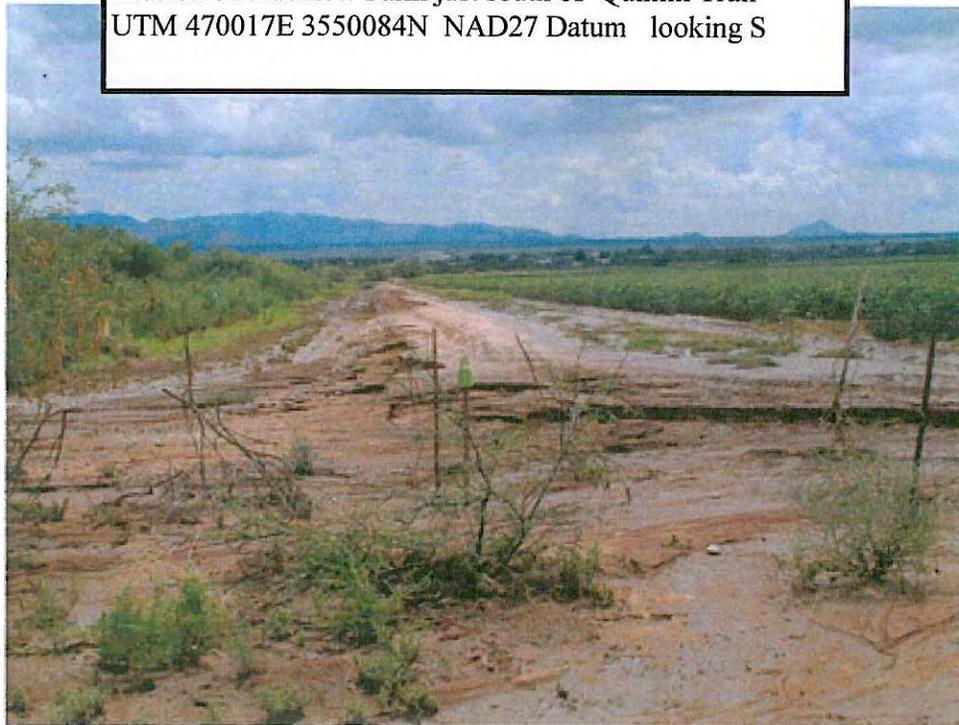
IMG_MISC_BrawleyFlood08-15-05_34

Erosion on Bucklew Farm just south of Quinlin Trail
UTM 470017E 3550084N NAD27 Datum looking S

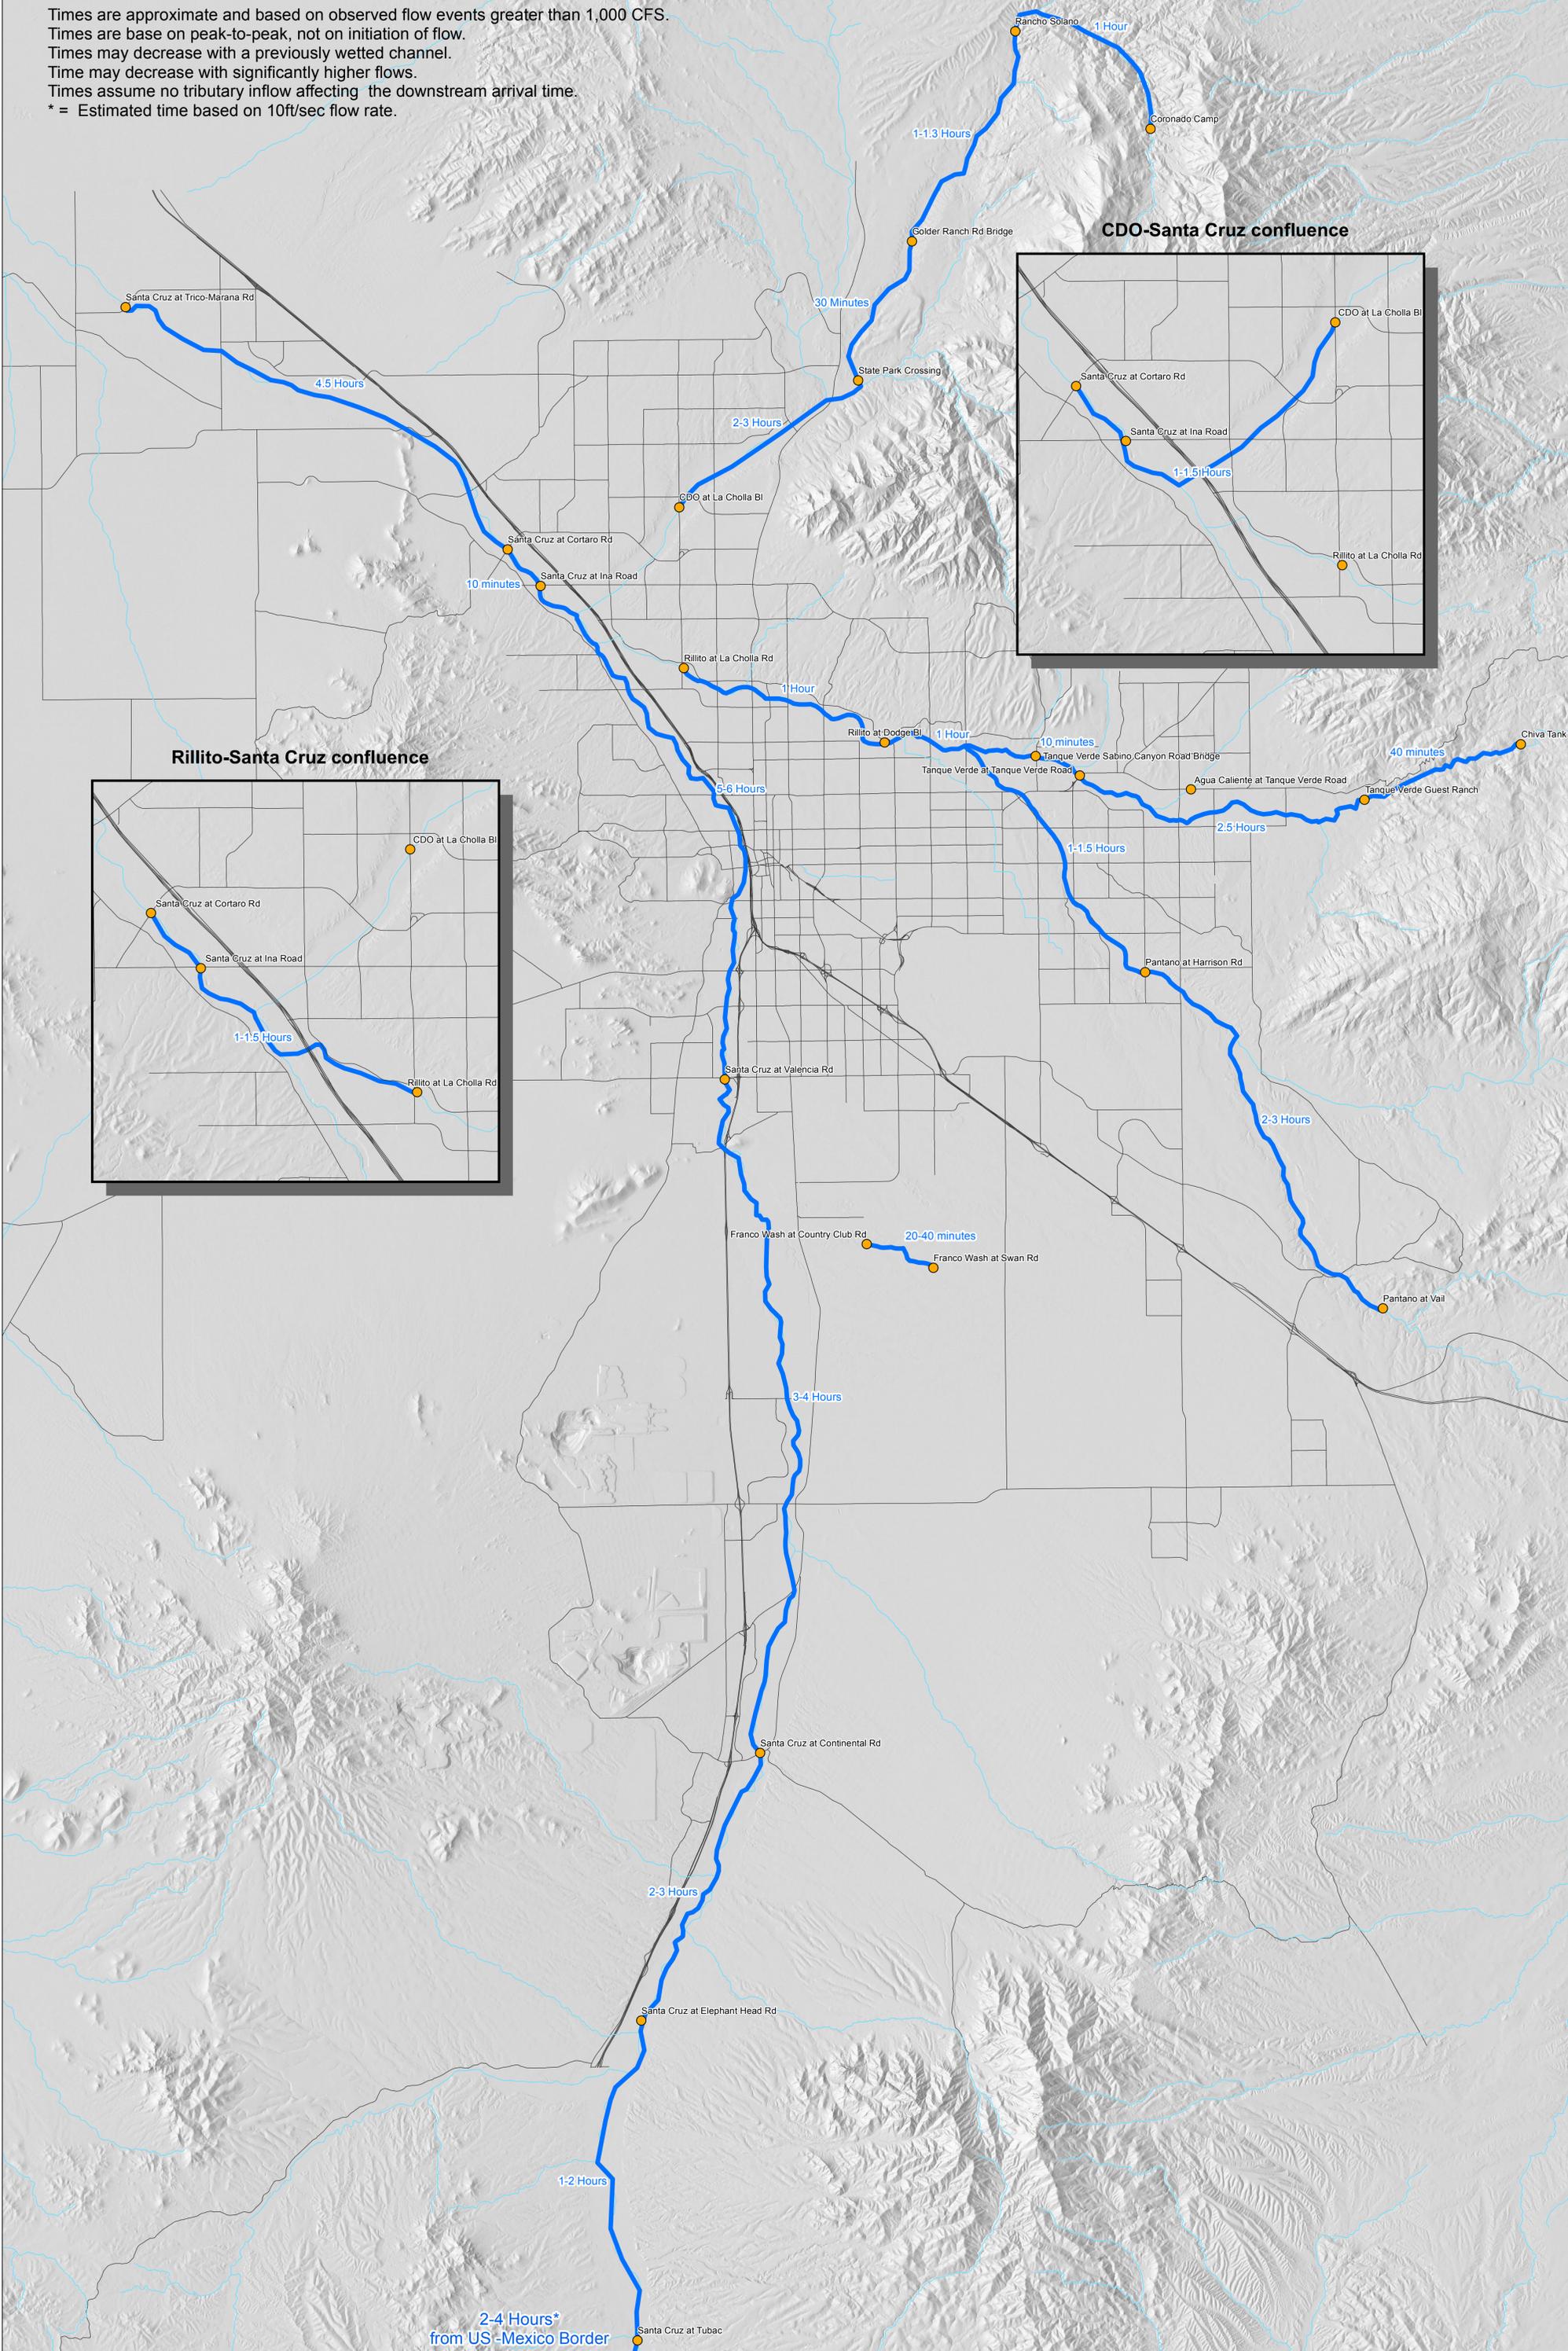
Flood Peak Travel Times (01/01/2014)

Times are approximate and based on observed flow events greater than 1,000 CFS.
 Times are base on peak-to-peak, not on initiation of flow.
 Times may decrease with a previously wetted channel.
 Time may decrease with significantly higher flows.
 Times assume no tributary inflow affecting the downstream arrival time.
 * = Estimated time based on 10ft/sec flow rate.

Times are approximate and based on observed flow events greater than 1,000 cfs..
