HISTORIC PROPERTY INVENTORY FORM

Historic Name(s): Fort Lowell Guard House Ruin
(Enter the name(s), if any, that best reflects the property's historic importance.)

Address: 5444 E. Fort Lowell Road

name of property Fort Lowell Guard House

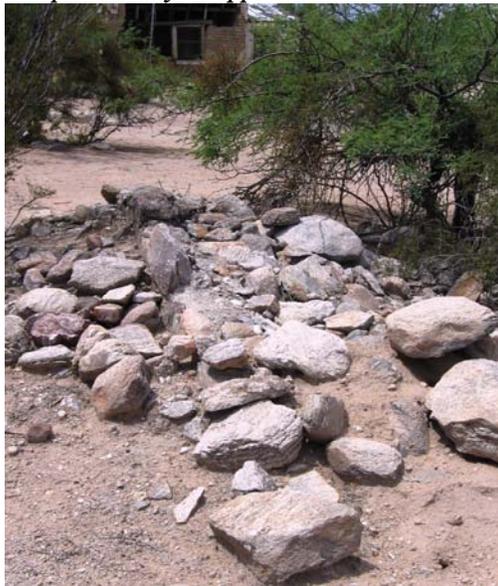
south
Negative No.: Img_1642

Built as a guardhouse/jail for temporary housing of soldiers committing infractions

- 4. MATERIALS (Describe the materials used in the following elements of the property)
Walls (structure): Adobe/Stone Foundation: None (adobe) Roof: Wood framed with earth
Cover
Windows: _____
If the windows have been altered, what were they originally? _____
Wall Sheathing: Exposed adobe/stone
If the sheathing has been altered, what was it originally? _____

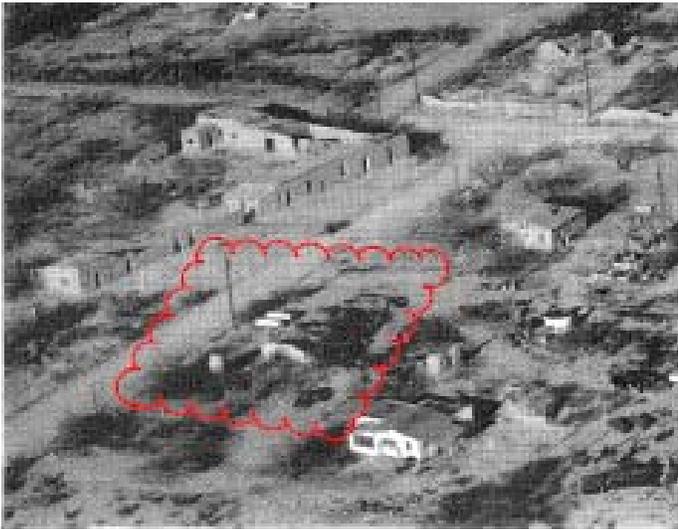
This is from a photograph supplied by David Faust of the Arizona Historical Society: It is an aerial, unattributed and not dated, and shows the entire Fort Lowell site. This portion of the photograph shows more extensive ruins similarly located to the existing ruins.

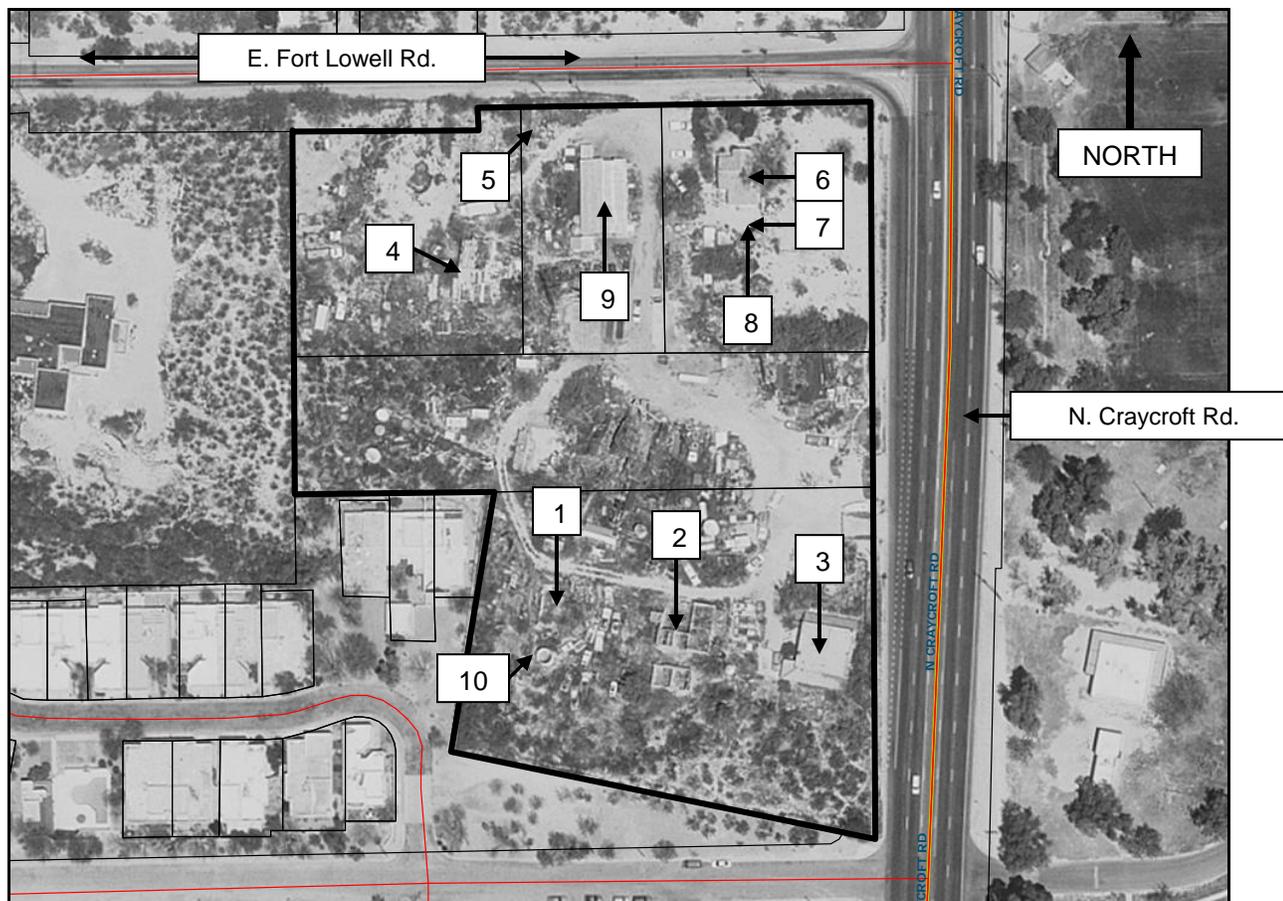
Location of Buildings and Structures

The following location map shows the Guard House on the site (#5).

1. Officers' Quarters No. 1 (ruin, includes kitchen remains)
2. Officers' Quarters No. 2 (partial ruin, includes kitchen building)
3. Officers' Quarters No. 3 (intact)
4. Adobe Building (located west of the Steel Tank Fabrication Shed).
5. Guard House (ruin located north-west of the Steel Tank Fabrication Shed).
6. Adkins Residence (located east of the Steel Tank Fabrication Shed)
7. Water Tower
8. Windmill base
9. Steel Fabrication Shed
10. Circular concrete structure (located south of Officers' Quarters No.1)
