Community Advisory  
Committee Meeting  
September 20, 2016

*Regional Transportation Authority*

# Draft Design Concept Report

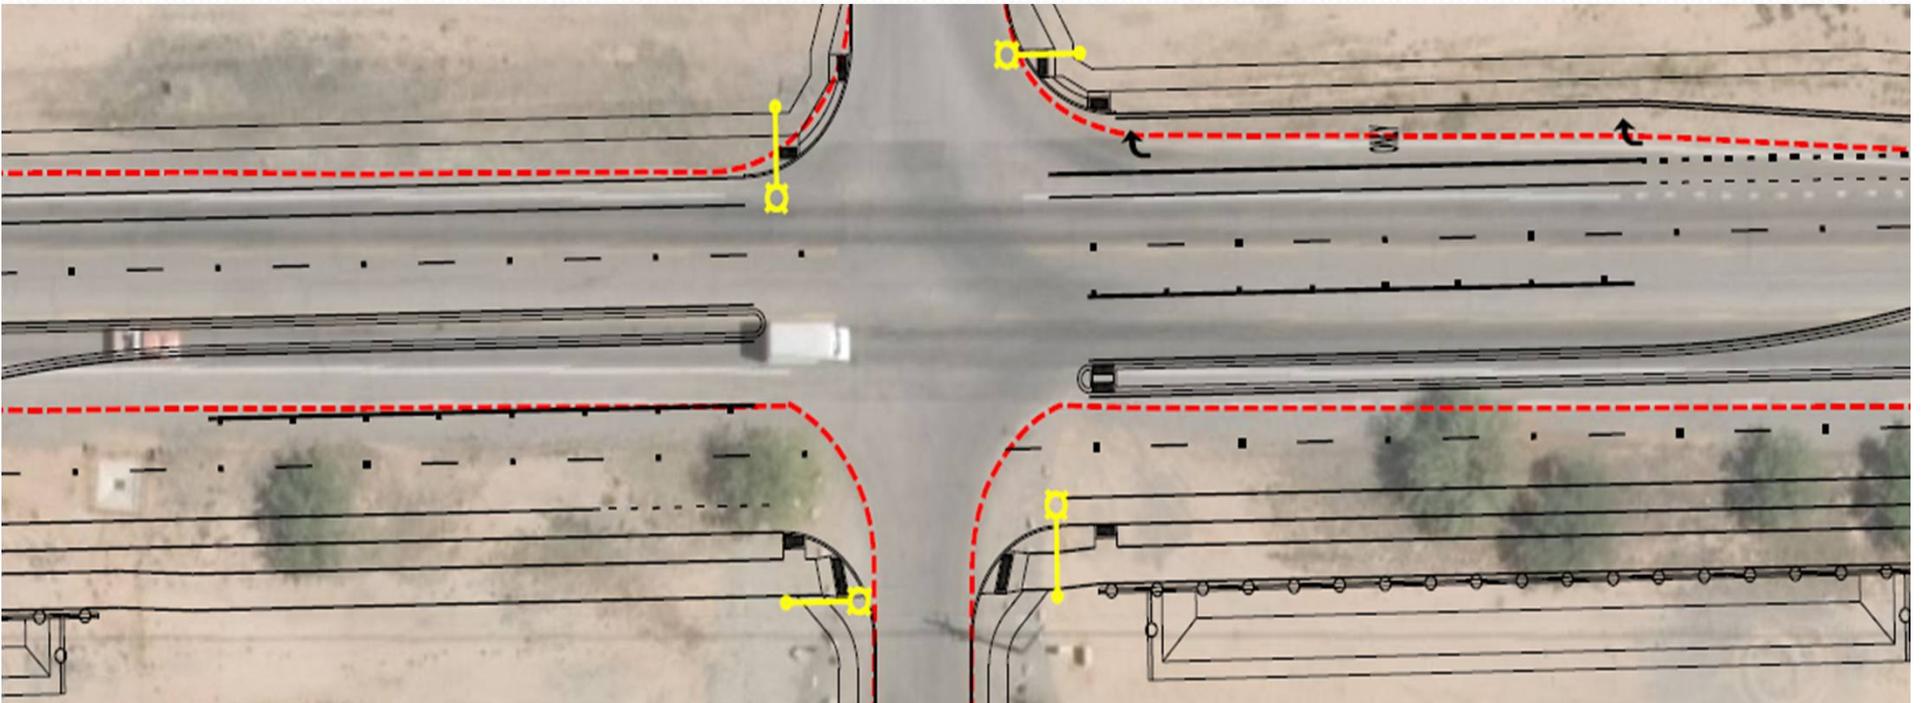
# Roadway Design

- A majority of the new roadway widening will be along the south side of the existing Valencia Road pavement
- Street Lighting
- ADA Compatible

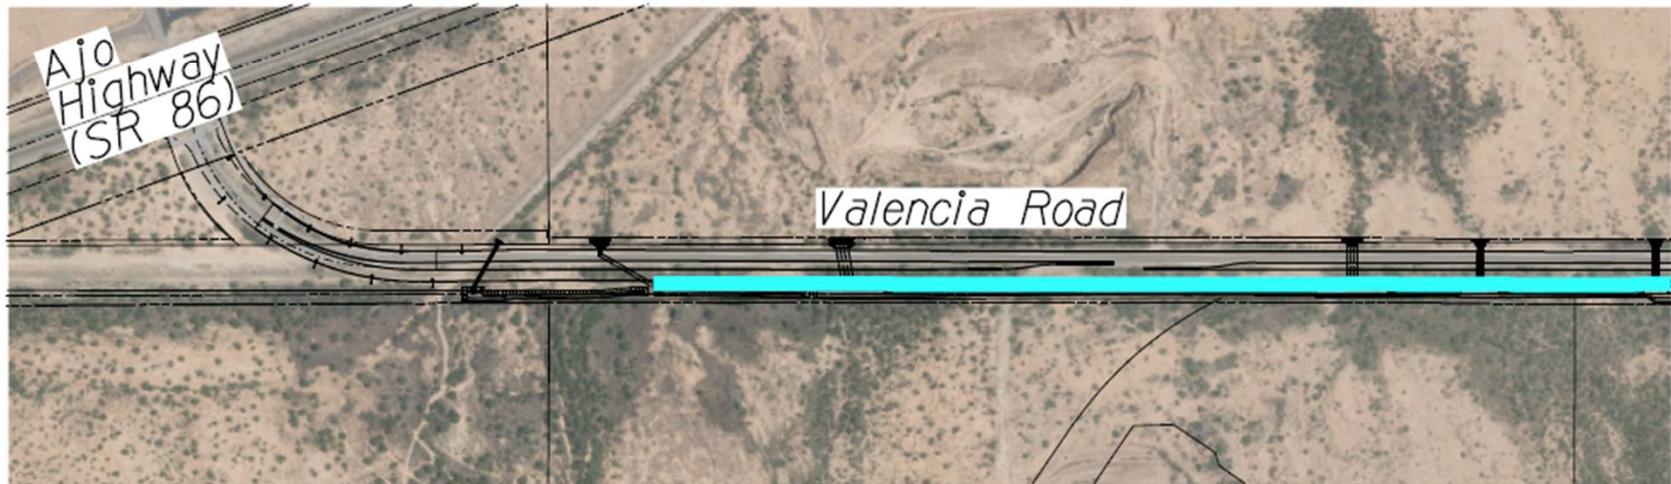
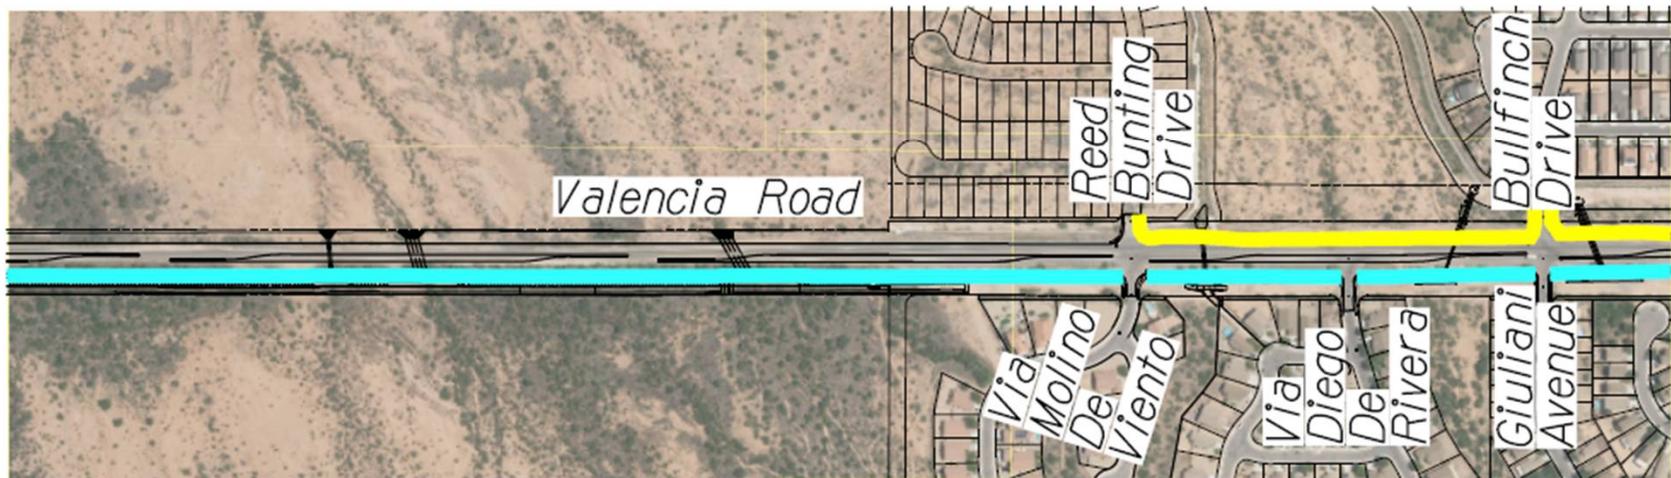
## Pedestrian Movements - West

5 Feet Wide Concrete Sidewalk
-

8 Feet Wide Asphalt Path

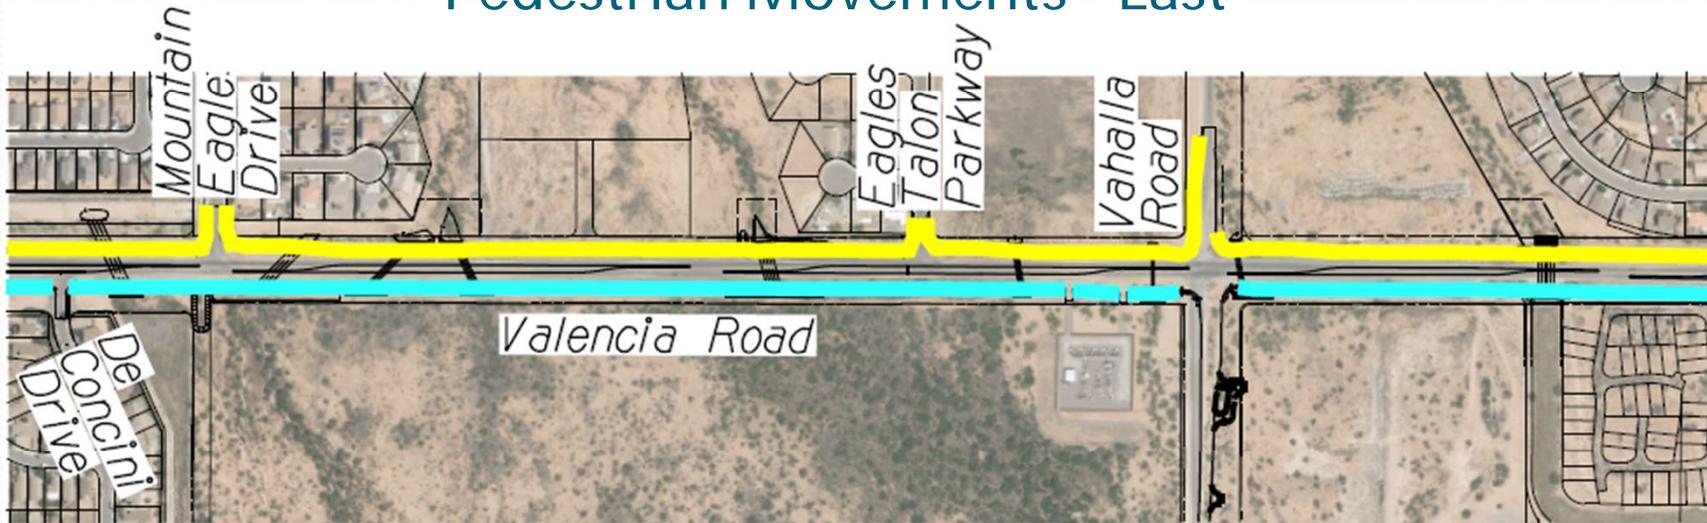
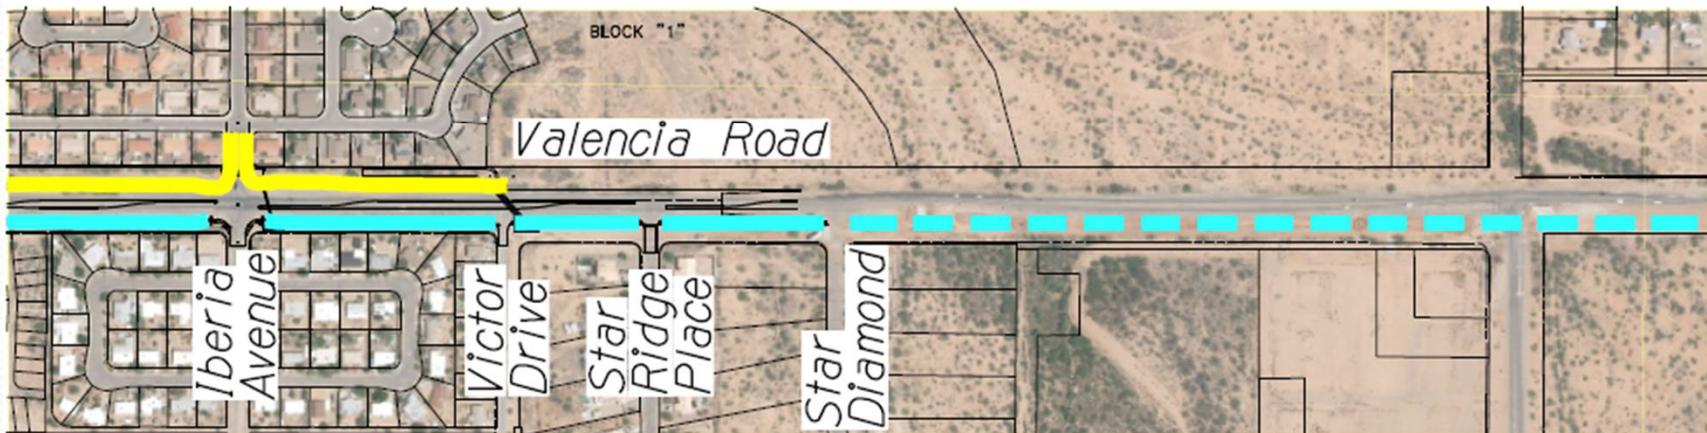
## Pedestrian Movements - East

5 Feet Wide Concrete Sidewalk
-

8 Feet Wide Asphalt Path

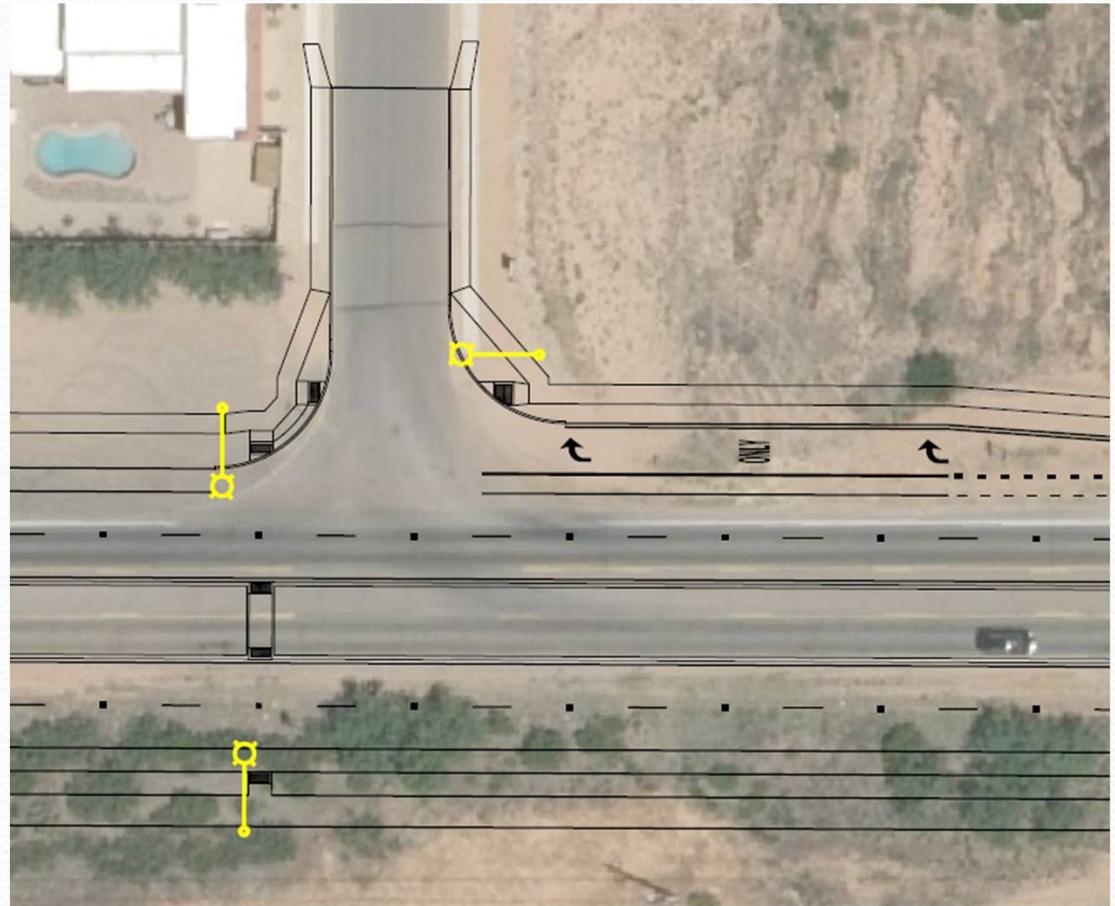
## Pedestrian Movements – Eagles Talon

- 700'+ west of Vahalla  
"mid-block crossing"

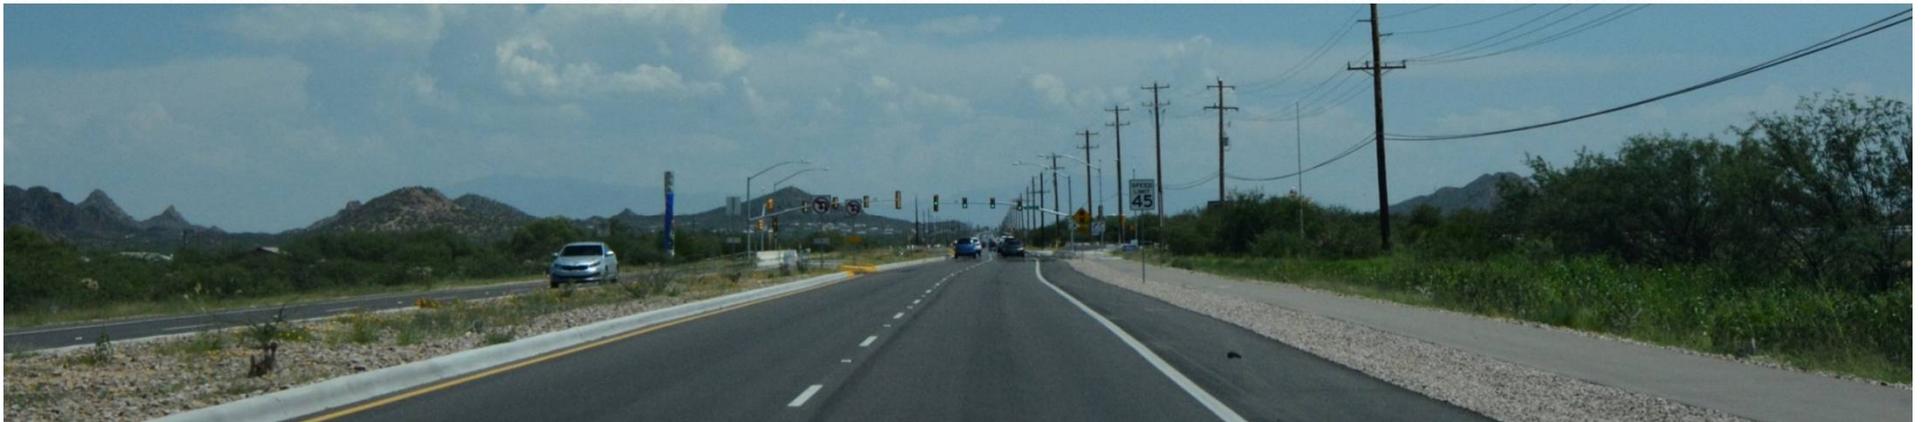
# Landscape/Re-vegetation

- Criteria based on previous section with the exception of the existing developed areas
- Approach to **developed** areas
  - Rock mulch with accent planting – **no seed mix**
- Approach to **undeveloped** areas
  - Rock mulch with seed mix
  - Revegetation using native plant species found in the project area
