# LIVING RIVER PROJECT

WHAT WE ARE LEARNING ABOUT THE LOWER SANTA CRUZ RIVER

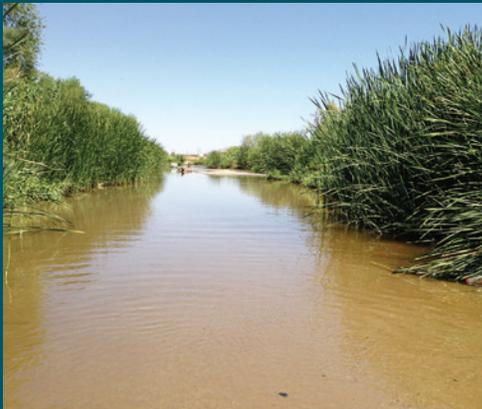
Cloudy water, before upgrade

- **Water clarity much improved:** Elevated levels of suspended solids can increase water temperature and rob water of dissolved oxygen. Suspended solids in the effluent flows greatly decreased, yielding a much clearer flow.
- **More diverse life:** Fish, turtles, and a greater diversity of pollution-sensitive aquatic invertebrates (which include insects, crustaceans, and worms) are being seen in the river.
- **Vegetation changes will be longer term:** No significant changes in herbaceous vegetation along the water's edge. Changes in trees and shrubs will be evaluated next.
- **Urban stormwater a source of pollutants:** Stormwater was sampled in two monsoon flood events upstream of the effluent flows. Besides high concentrations of suspended solids like clay and silt, pollutants in stormwater included organic nitrogen, copper, and selenium.

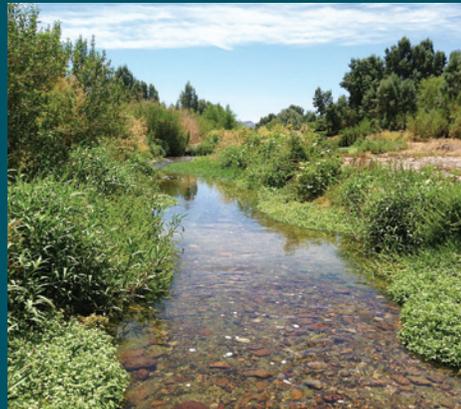
Clear water, after upgrade
