Re: **Santa Cruz River Capacity Restoration**

SUBJECT: Draft JE Fuller Sedimentation and Capacity Analysis

**SANTA CRUZ RIVER MAINTENANCE PROJECT
GRANT ROAD TO STAR PASS BLVD
PIMA COUNTY, AZ
PIMA COUNTY CONTRACT # 16-32910**

SANTA CRUZ RIVER SEDIMENT REMOVAL
GRANT ROAD TO 29TH STREET
PLAN & PROFILE SHEET P02

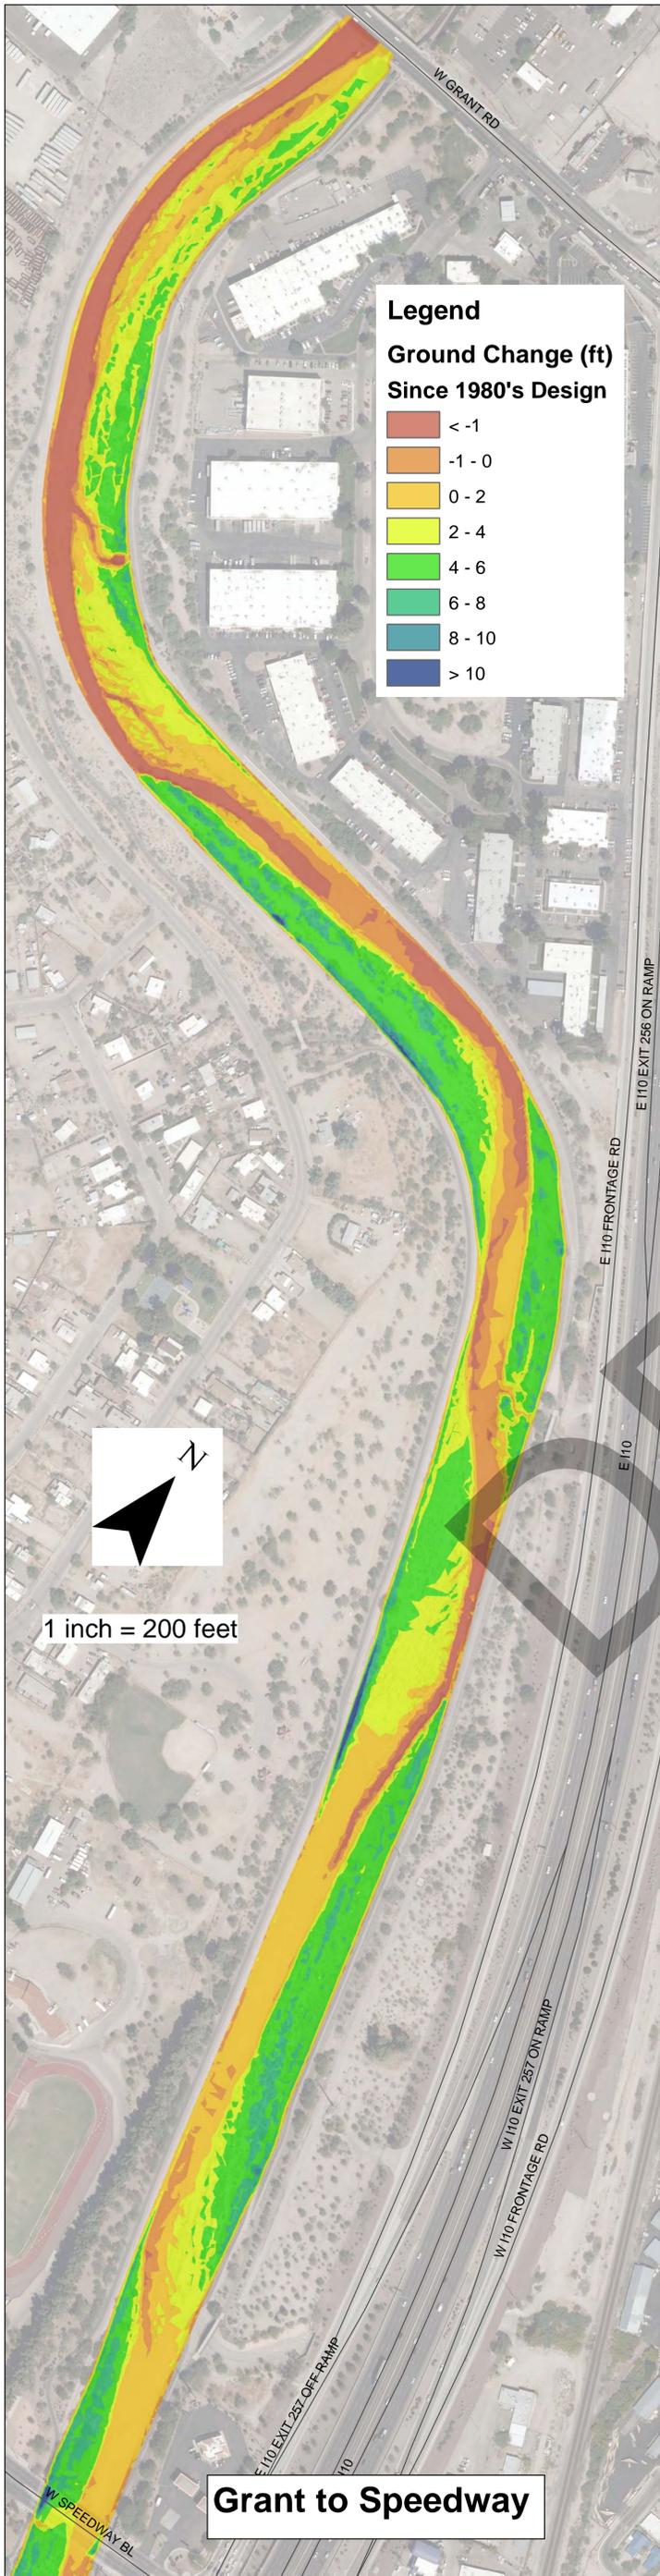
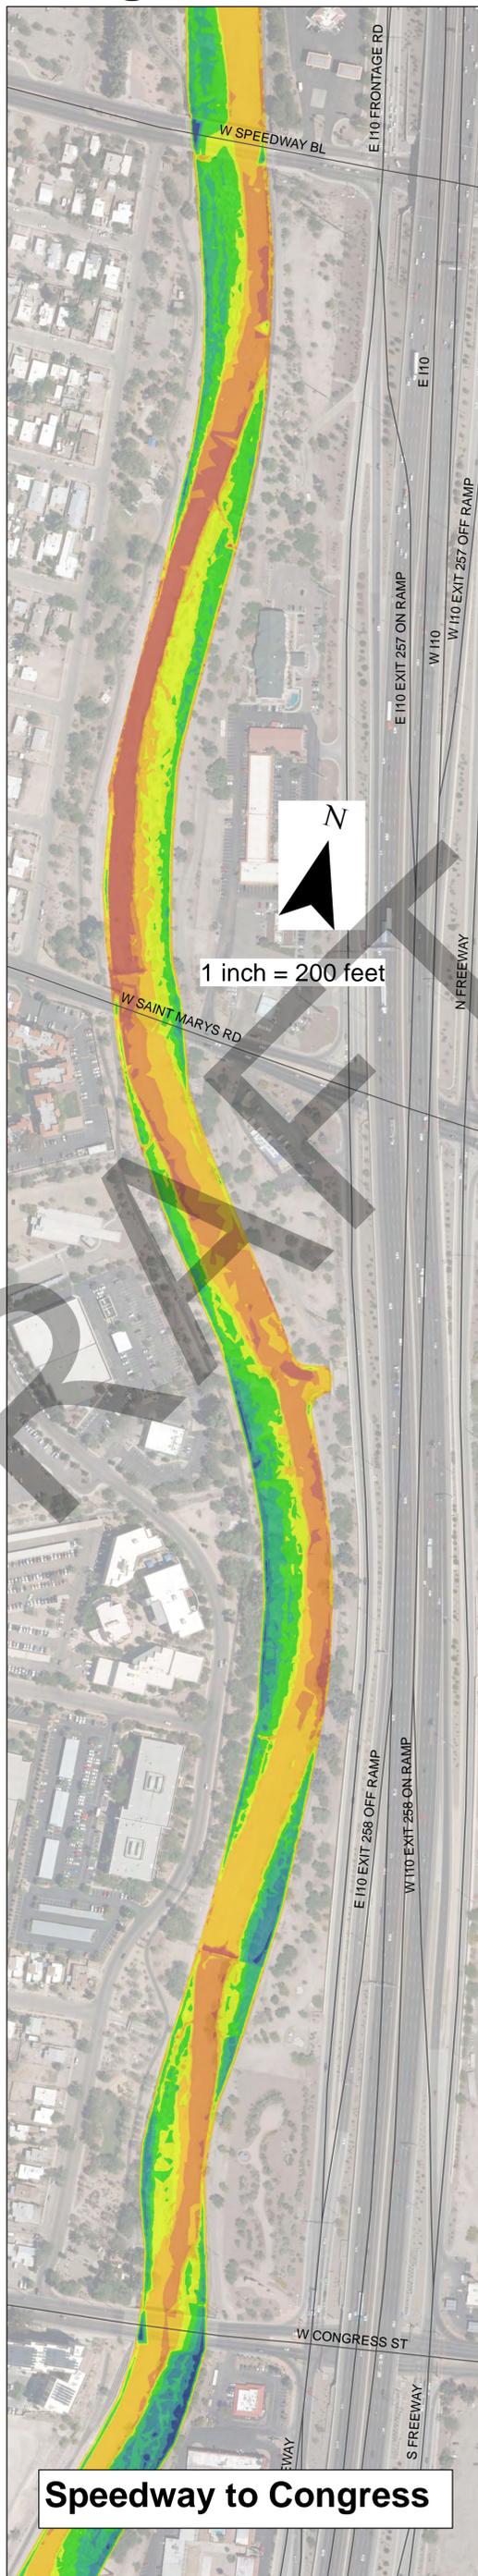
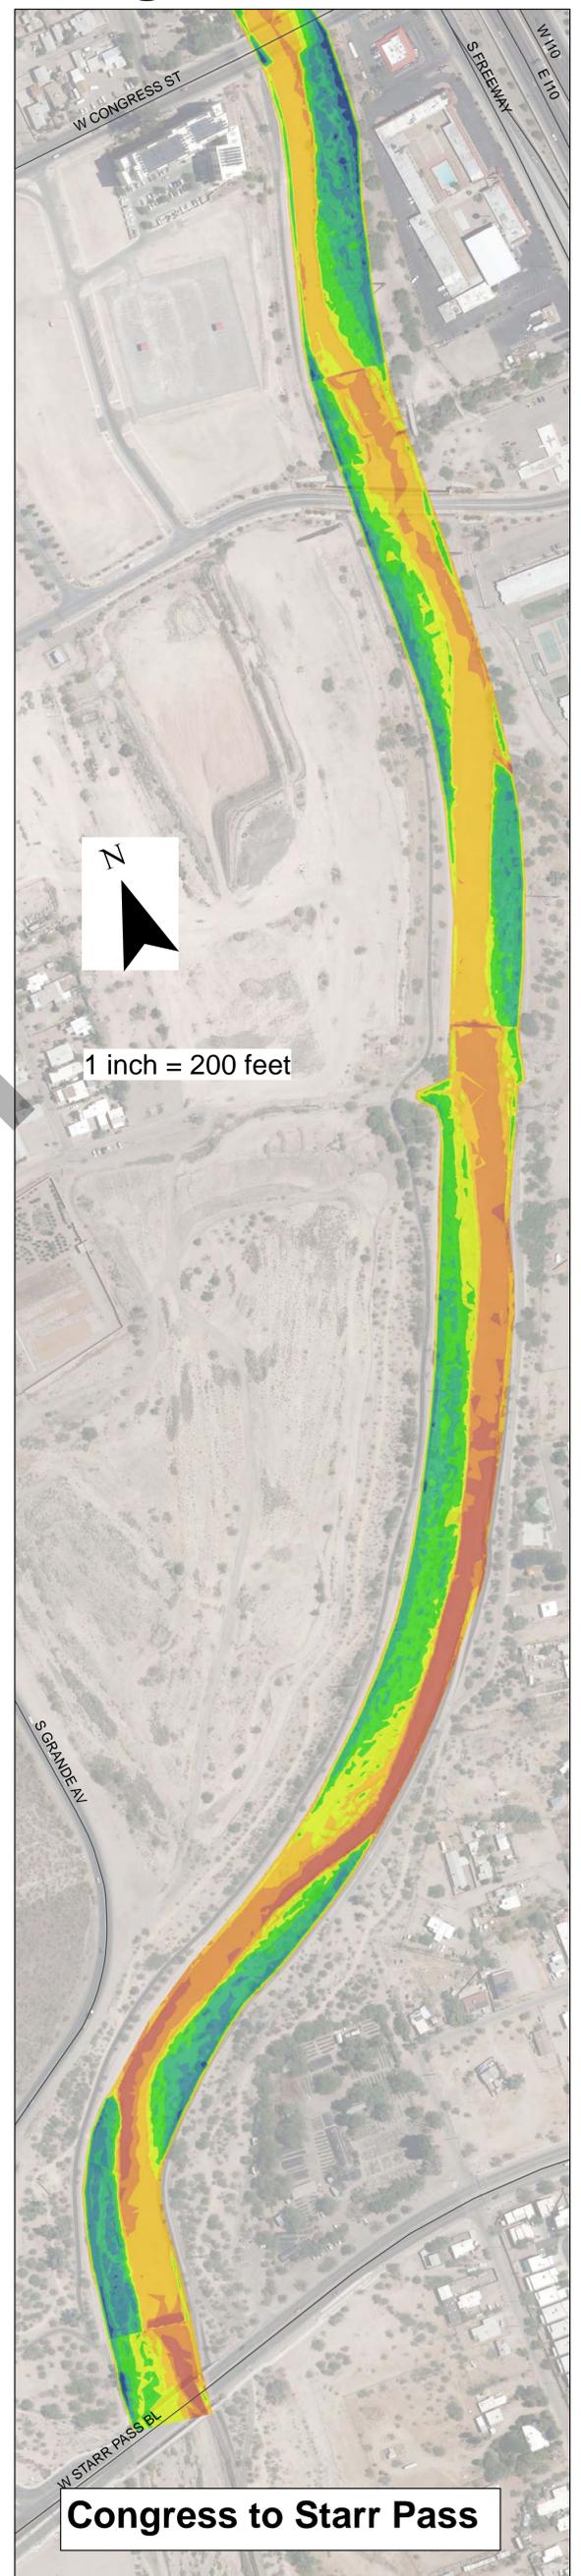
Figure 3 - Santa Cruz River - Grant Rd. to Star Pass Blvd. Channel Ground Change Since 1980's Design

The 2015 DEM referenced in the previous section was utilized to create a digital surface of the existing channel and surrounding overbank areas. This surface was later utilized for hydraulic modeling of the floodplain. The 1980s era design plans and the 2013 URS as-built centerline referenced previously were used to create a digital surface of the channel condition associated with the design condition from that time. These two surfaces were compared digitally to assess the degree of ground change (aggradation and degradation) within the channel of the river. Figure 3 provides an illustration of the results of that effort. As shown in Figure 3, ground changes since the 1980's design varies from < -1 feet (degradation) to > 10 feet (aggradation). Most degradation occurred in the low flow channel, primarily on the outside of channel bends, while most aggradation occurred on the inside of bends. Of particular note is the aggradation at Congress Street where the 1980's design channel slope was only 0.1% (half the slope of most other segments). Another area of note for aggradation is just downstream of the Starr Pass Blvd bridge. Figure 4 provides a sampling of channel cross-sections showing the changes between the 1980's design condition and the 2015 condition.

The table below provides a summary of the collective amount of aggradation and degradation – relative to the 1980's plans - by reaches defined by the various roadway crossings. Review of the table below indicates a general pattern of higher aggradation and lower degradation along those reaches with a flatter design slope. It should be noted that the Grant to Speedway reach has a wider design bottom width (200' vs 150' for the others), and therefore might be expected to experience somewhat higher unit aggradation.

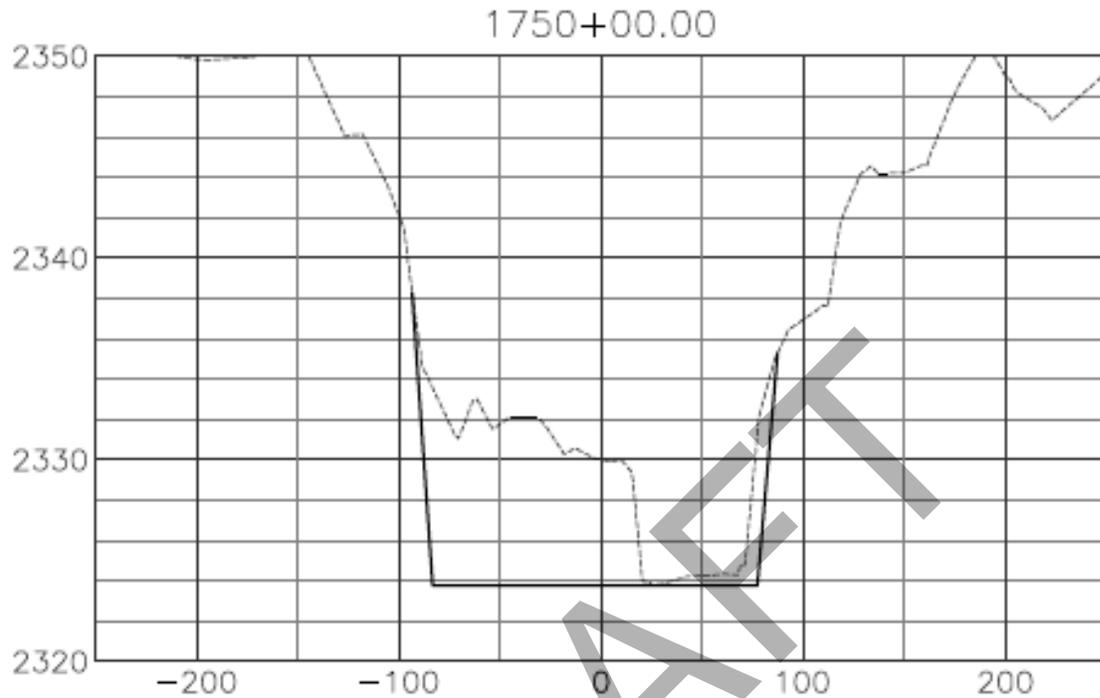
Just upstream of Congress Street

Figure 4 (cont) - Cross-Sections Showing Change from Design to 2015 Condition
(Solid line = Design, Dashed line = 2015, Sections are left to right looking upstream)

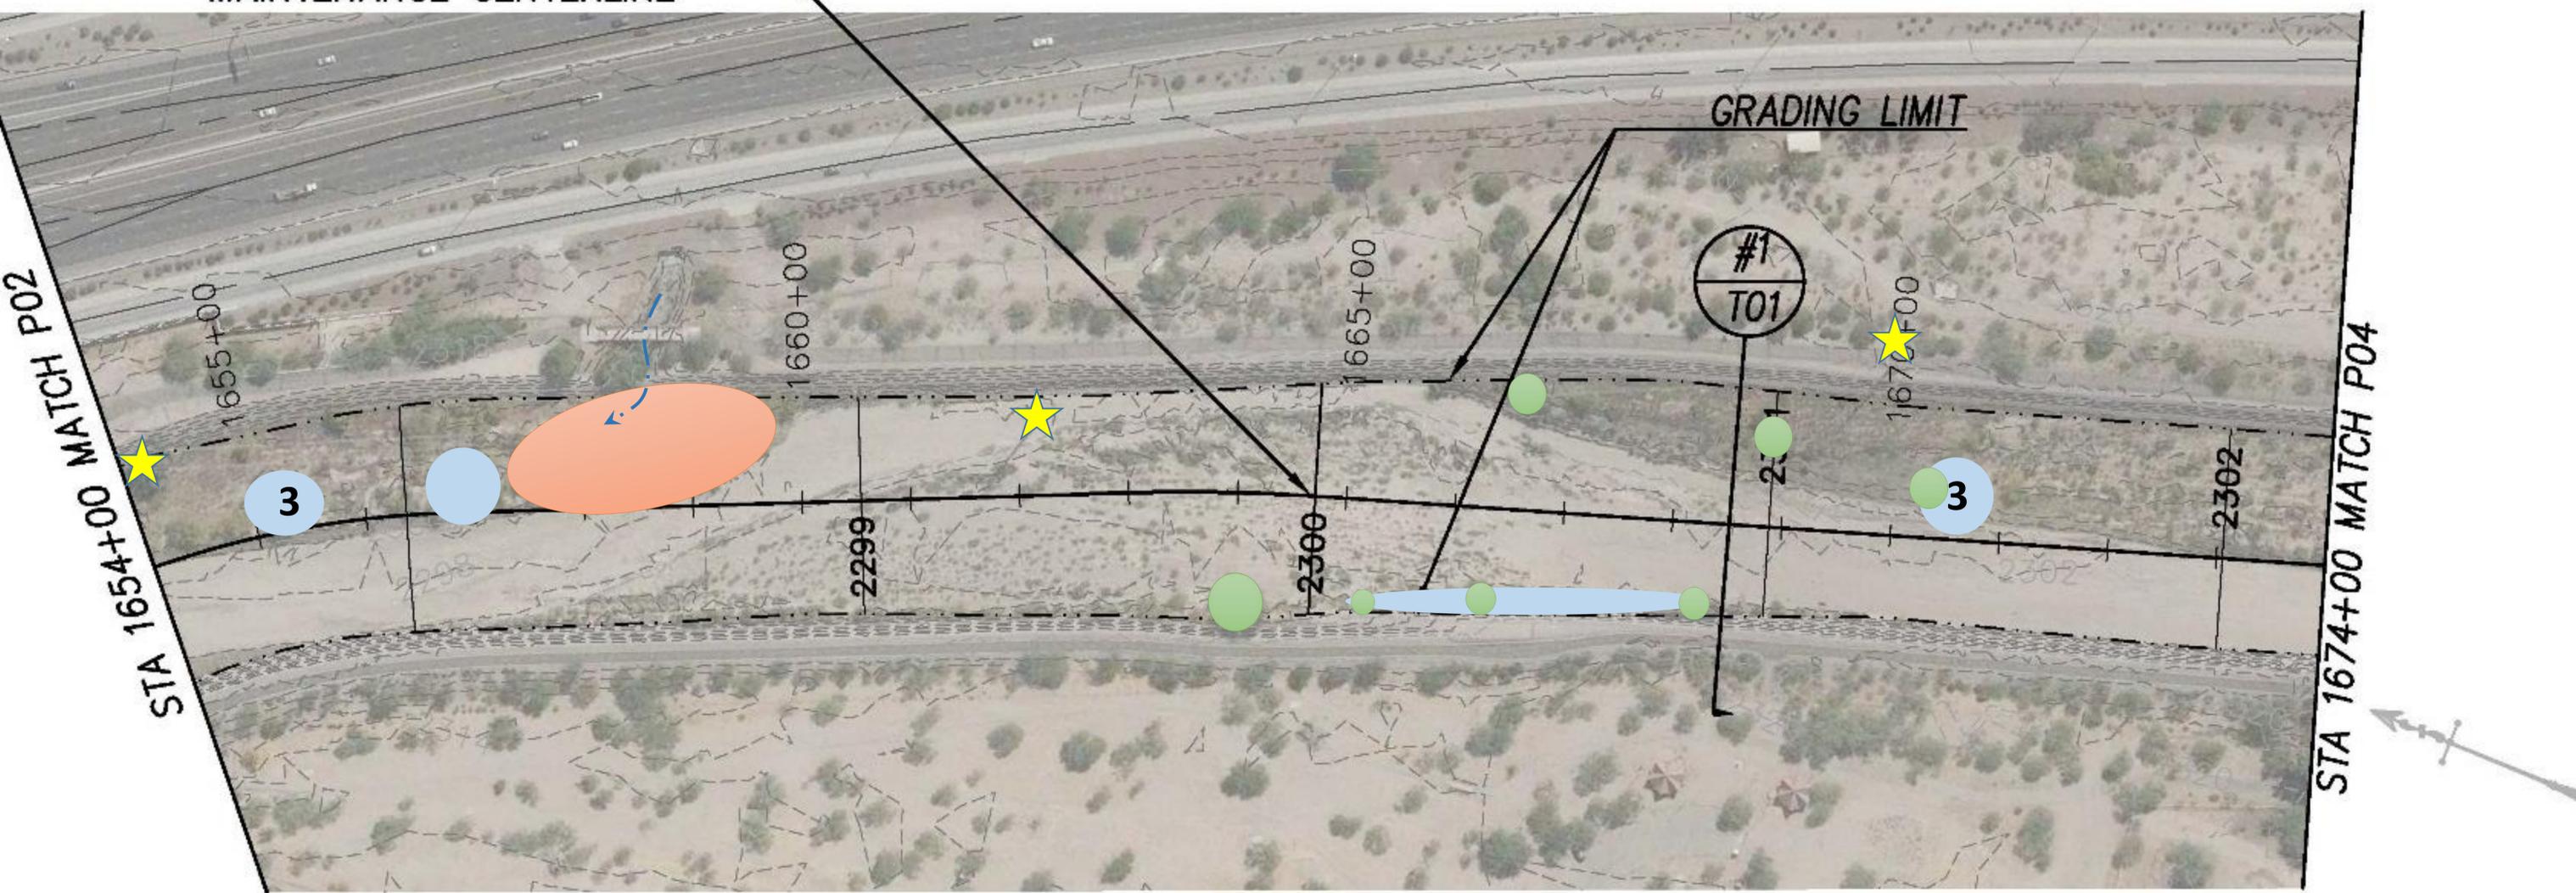
- KEY**
- Flow
 - Power pole
 - Mesquite to Preserve In Place
 - Tamarisk to Preserve In Place
 - Palo Verde to Preserve In Place
 - Tree Grouping to Preserve In Place
 - Remove (**A**=for safety)

- 1:** If a portion of vegetation specifically blocks culvert flow it may be removed
- 2:** Not specimen Palo Verdes. If necessary, they can be removed.
- 3:** Nice Mesquite w/ Mexican PV. Keep if possible

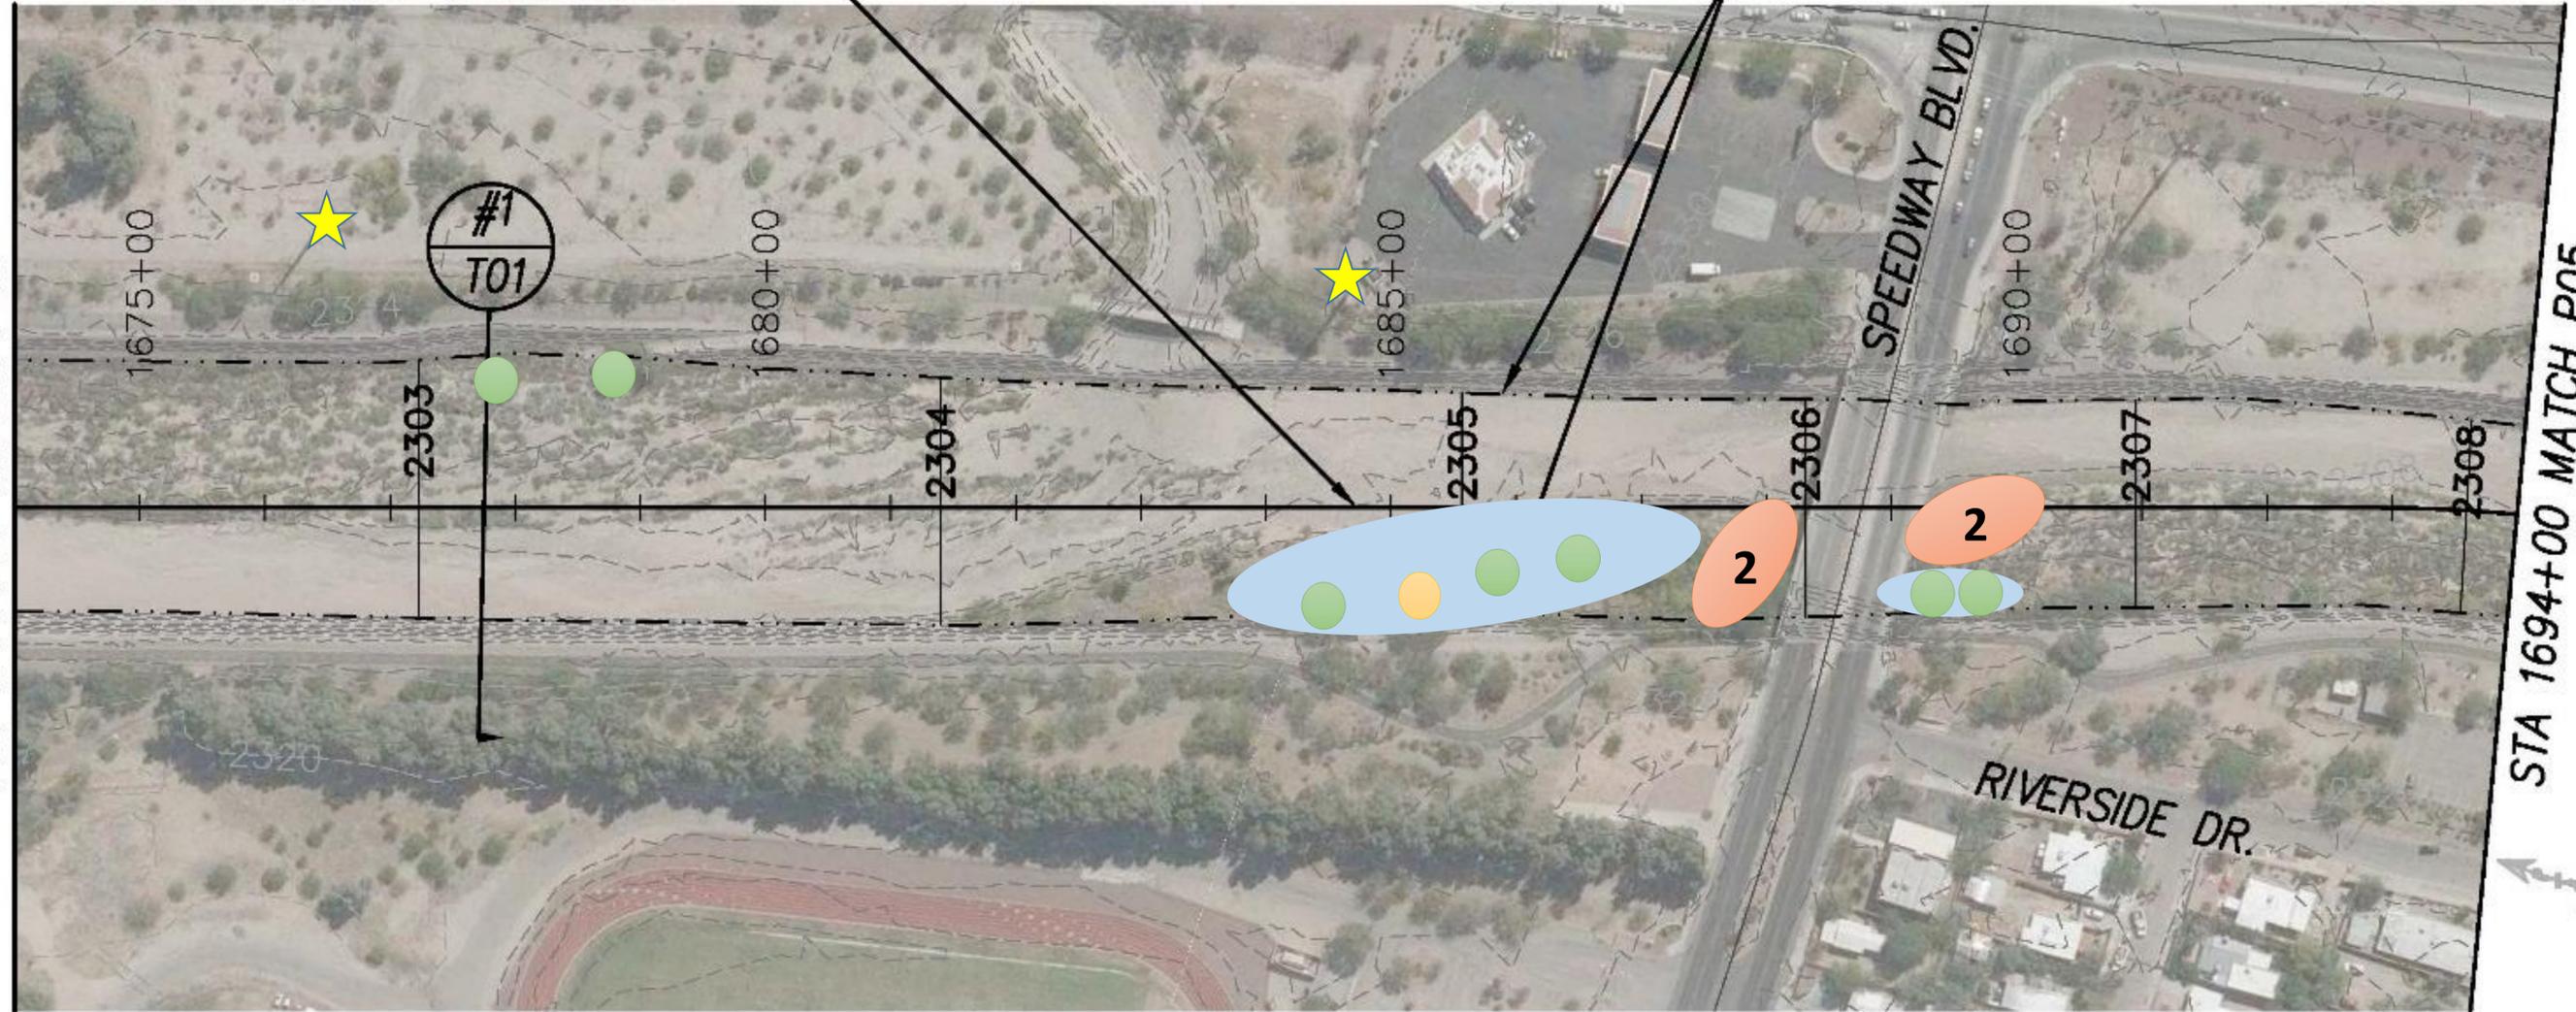
- KEY**
- Flow
 - Power pole
 - Mesquite to Preserve In Place
 - Tamarisk to Preserve In Place
 - Palo Verde to Preserve In Place
 - Tree Grouping to Preserve In Place
 - Remove (**A**=for safety)

- 1:** If a portion of vegetation specifically blocks culvert flow it may be removed
- 2:** Not specimen Palo Verdes. If necessary, they can be removed.
- 3:** Nice Mesquite w/ Mexican PV. Keep if possible
