Re: Santa Cruz River Capacity Restoration

Re: **Santa Cruz River Capacity Restoration**

SUBJECT: Draft JE Fuller Sedimentation and Capacity Analysis

SANTA CRUZ RIVER SEDIMENT REMOVAL
GRANT ROAD TO 29TH STREET
PLAN & PROFILE SHEET P01

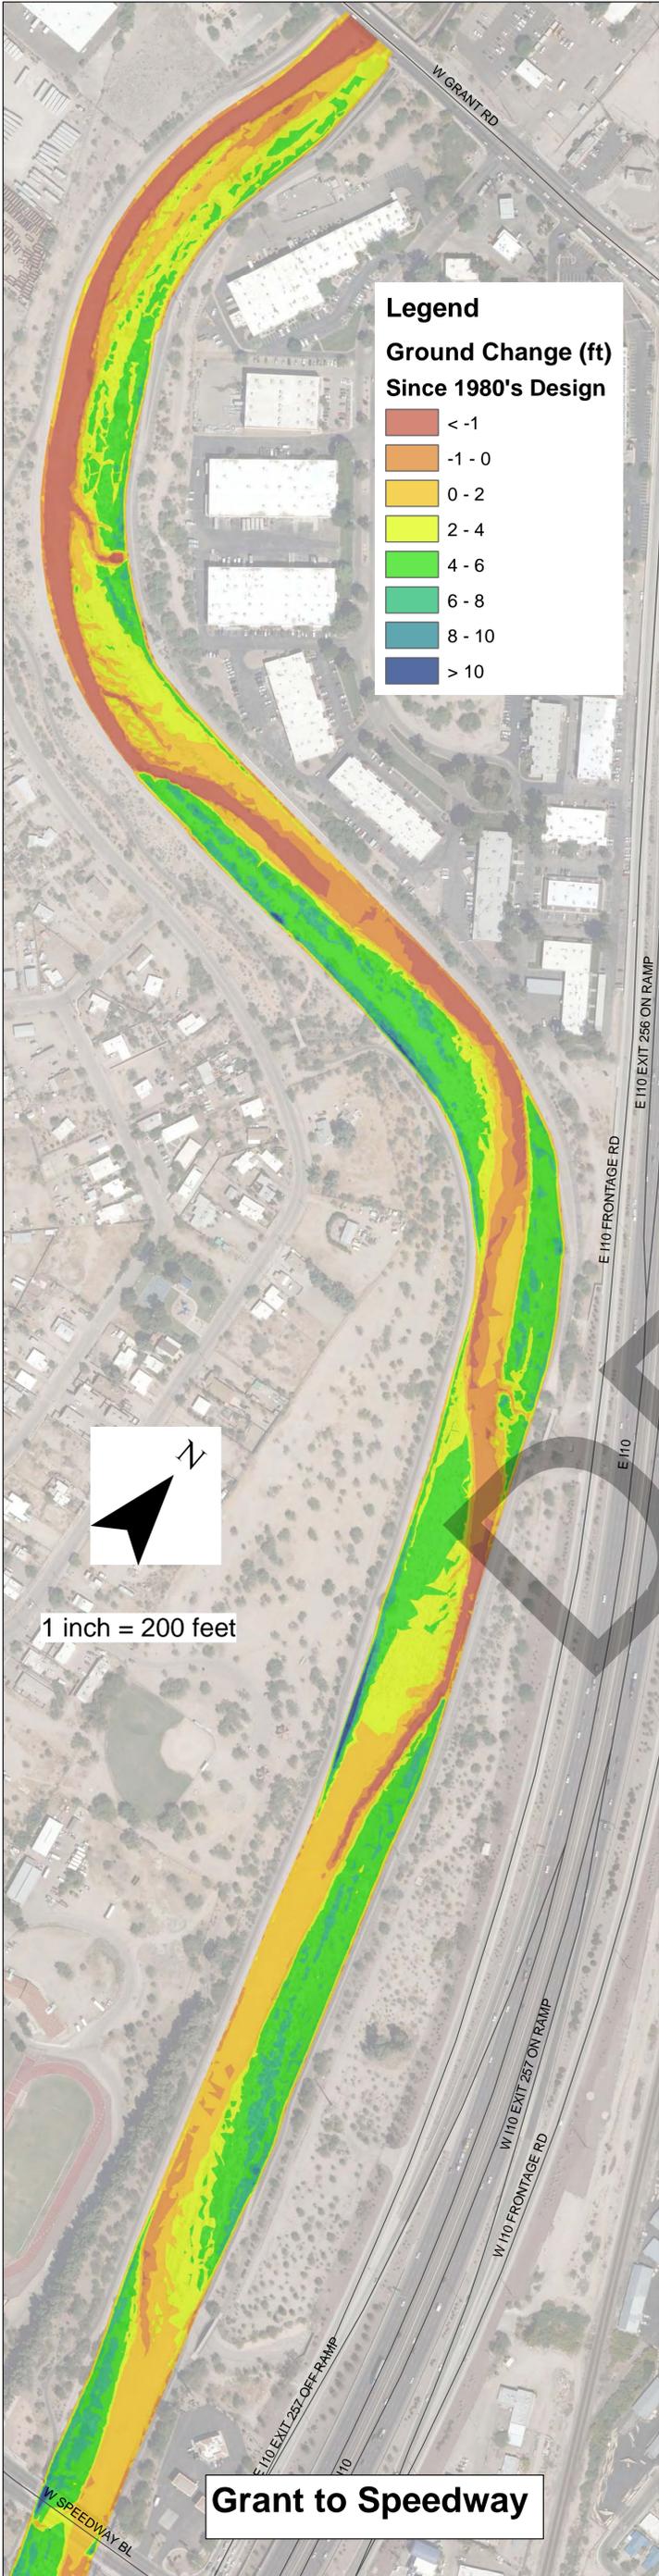
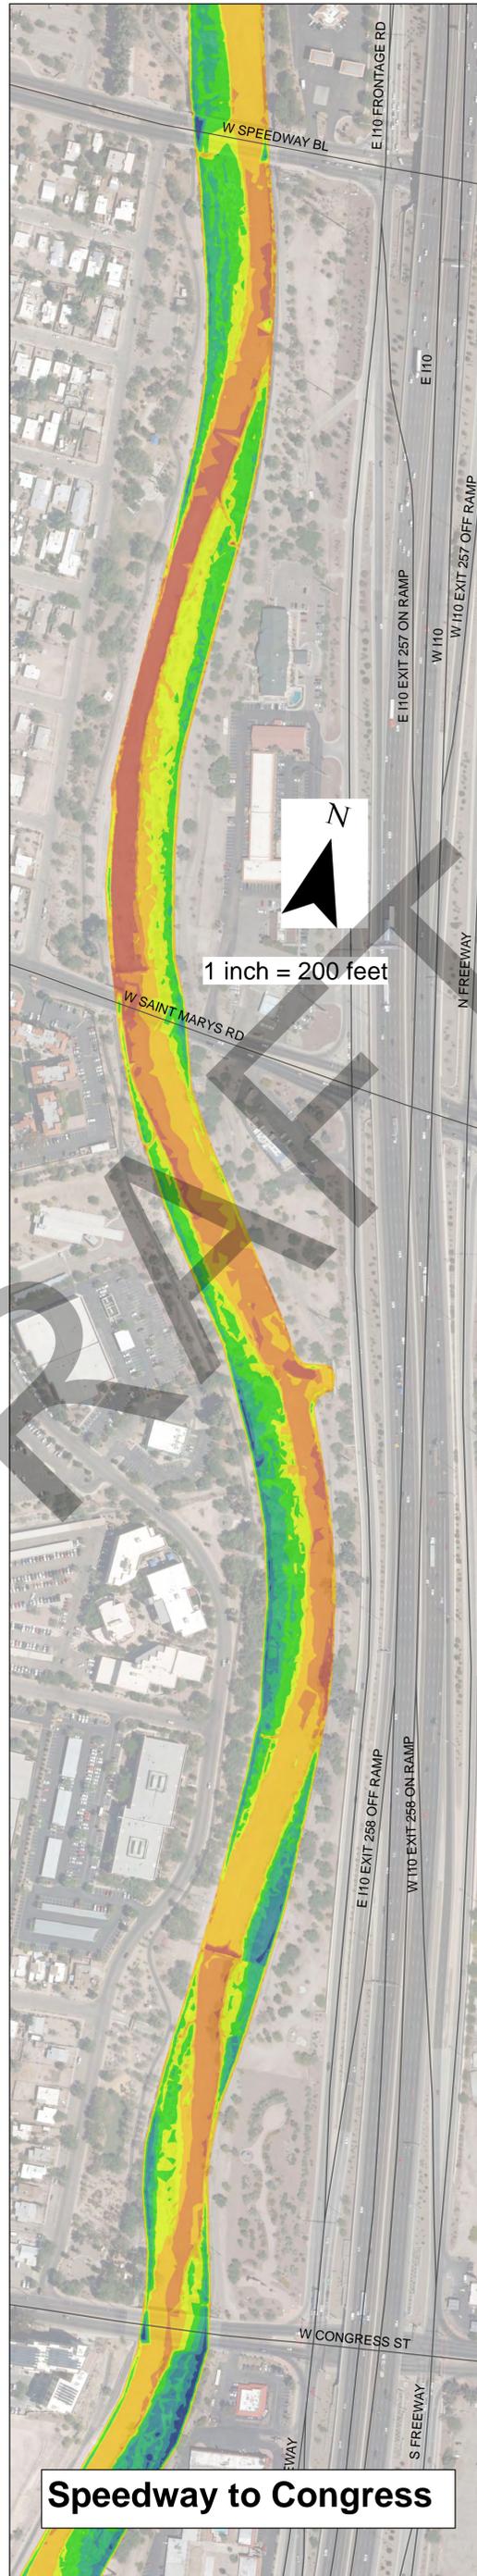
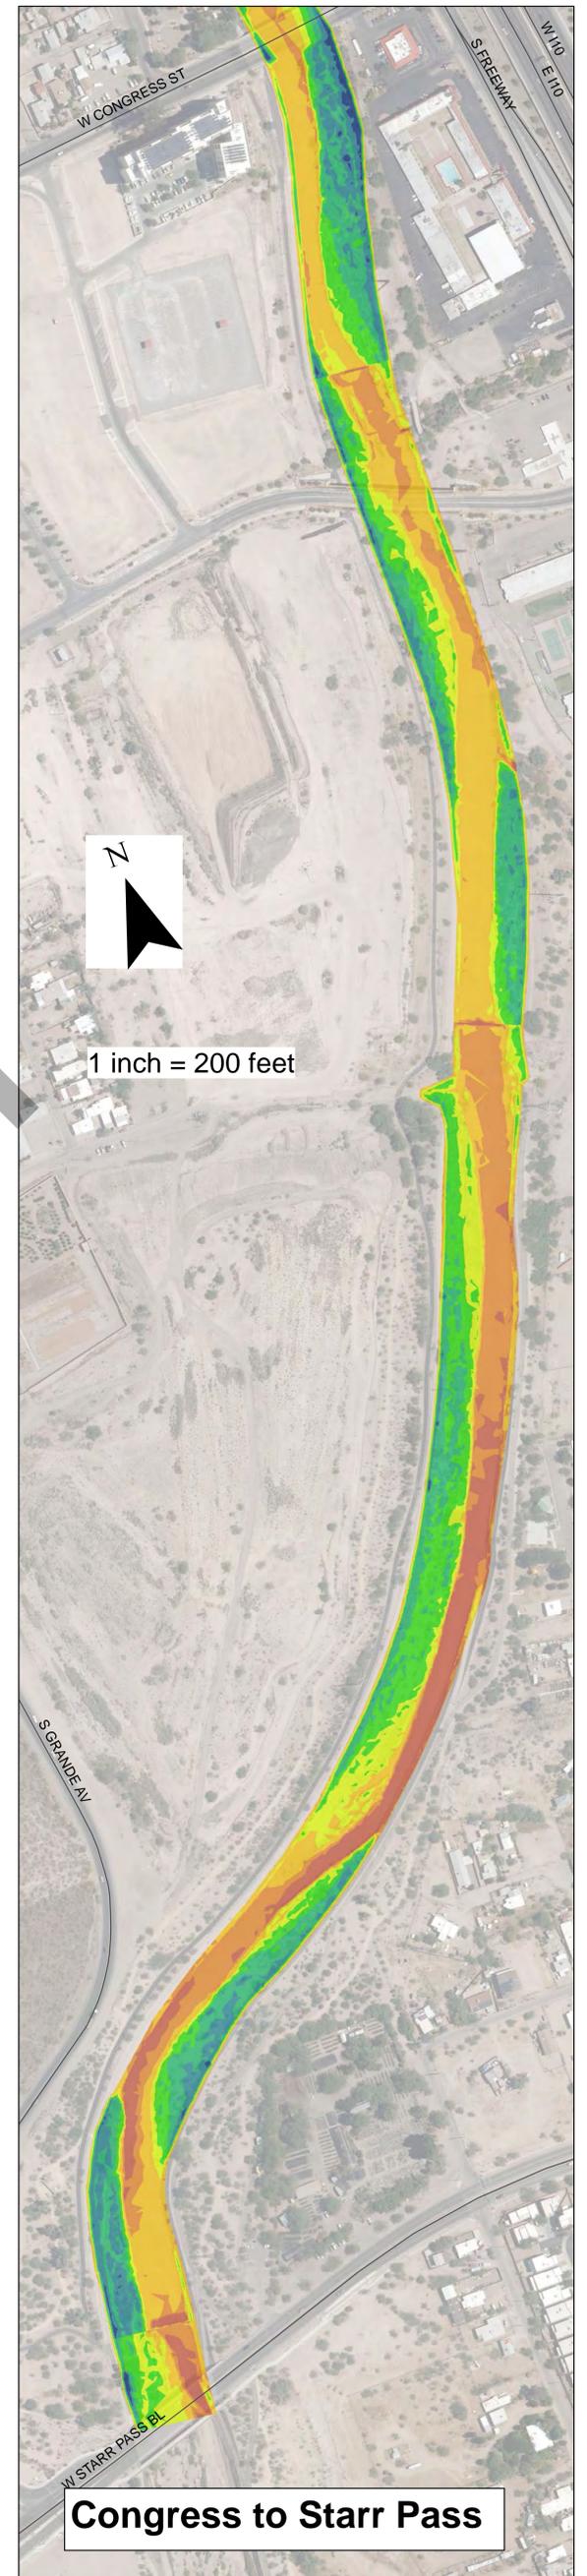
Figure 3 - Santa Cruz River - Grant Rd. to Star Pass Blvd. Channel Ground Change Since 1980's Design

The table below provides a summary of the collective amount of aggradation and degradation – relative to the 1980's plans - by reaches defined by the various roadway crossings. Review of the table below indicates a general pattern of higher aggradation and lower degradation along those reaches with a flatter design slope. It should be noted that the Grant to Speedway reach has a wider design bottom width (200' vs 150' for the others), and therefore might be expected to experience somewhat higher unit aggradation.

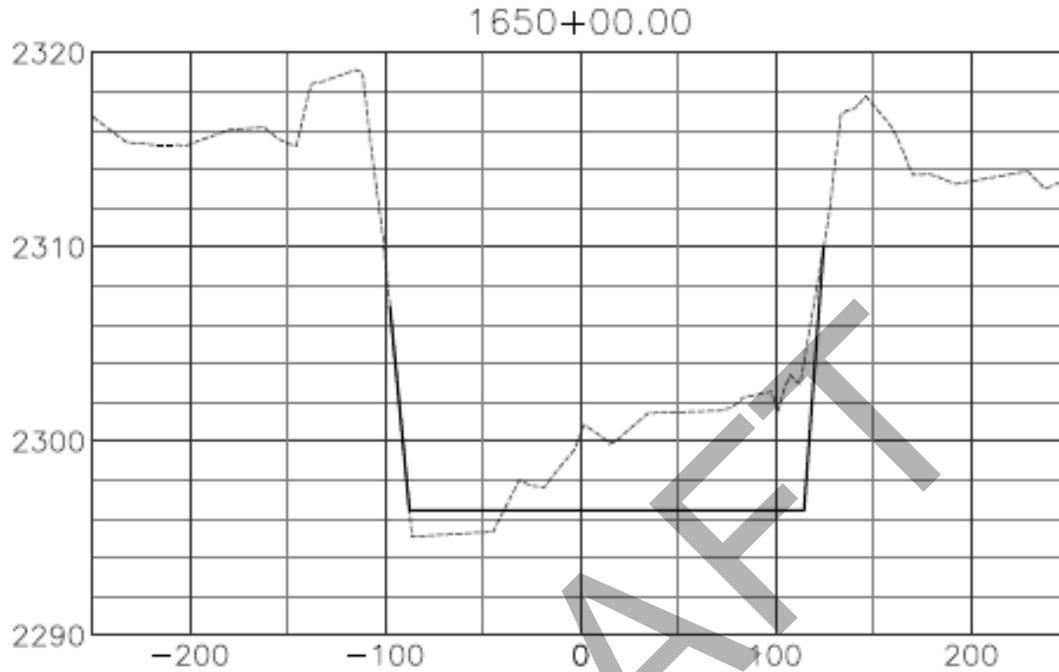
Figure 4 - Cross-Sections Showing Change from Design to 2015 Condition
(Solid line = Design, Dashed line = 2015, Sections are left to right looking upstream)

Midway between Grant Road and Speedway Blvd.

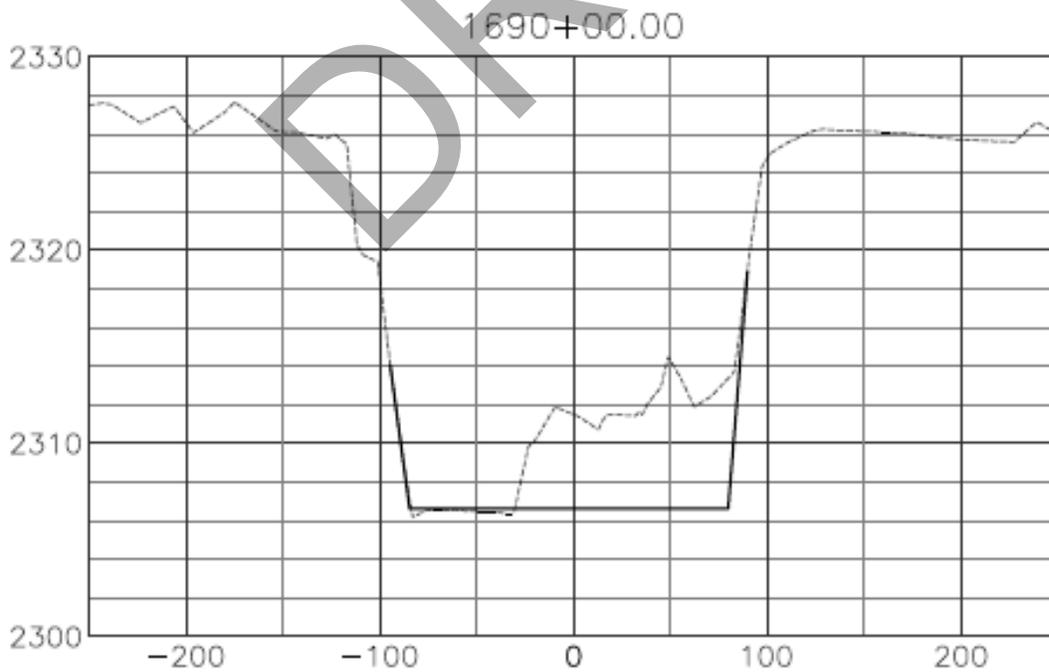
Just upstream of Speedway Blvd.

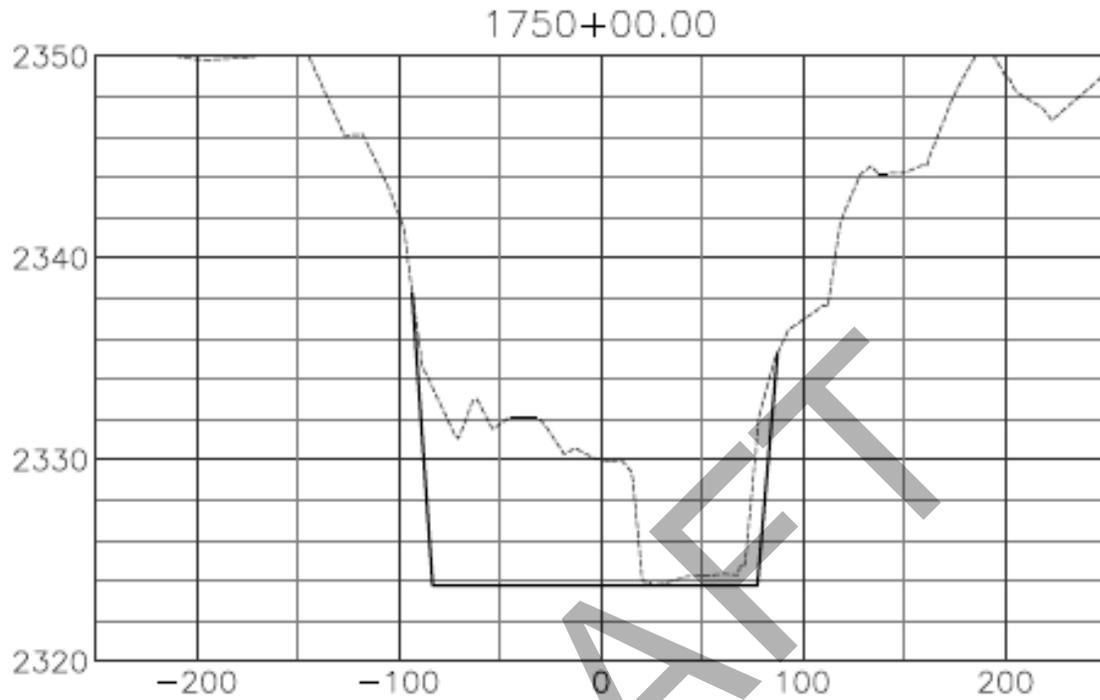
Figure 4 (cont) - Cross-Sections Showing Change from Design to 2015 Condition
(Solid line = Design, Dashed line = 2015, Sections are left to right looking upstream)

Just upstream of Congress Street

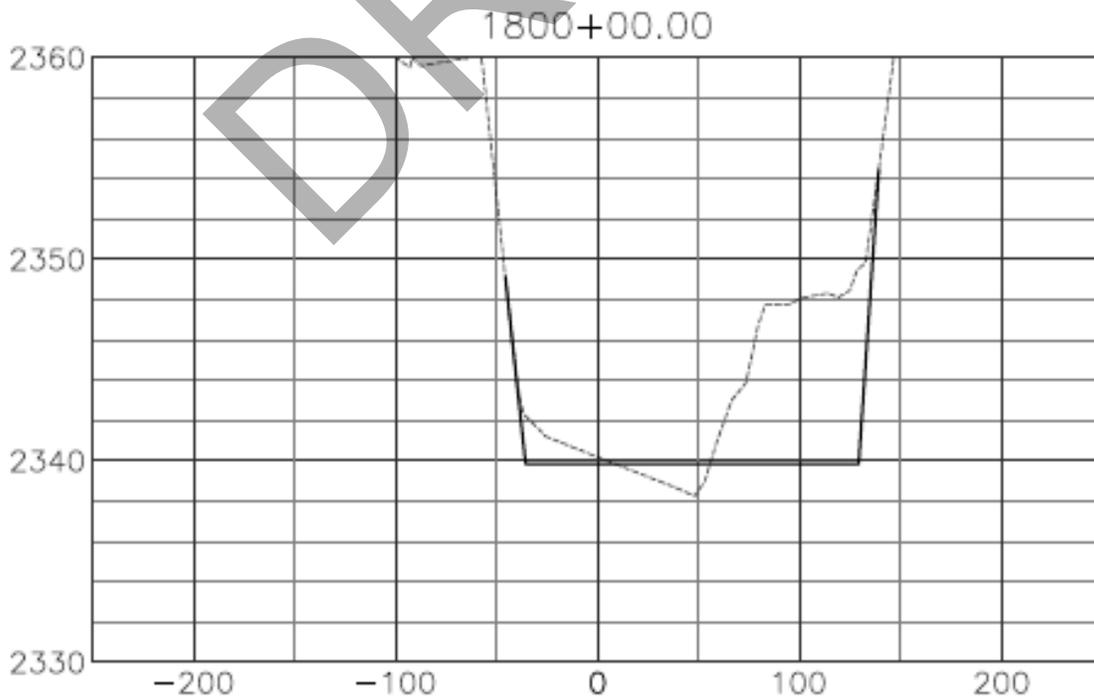
Just downstream of Starr Pass Blvd (22nd St)

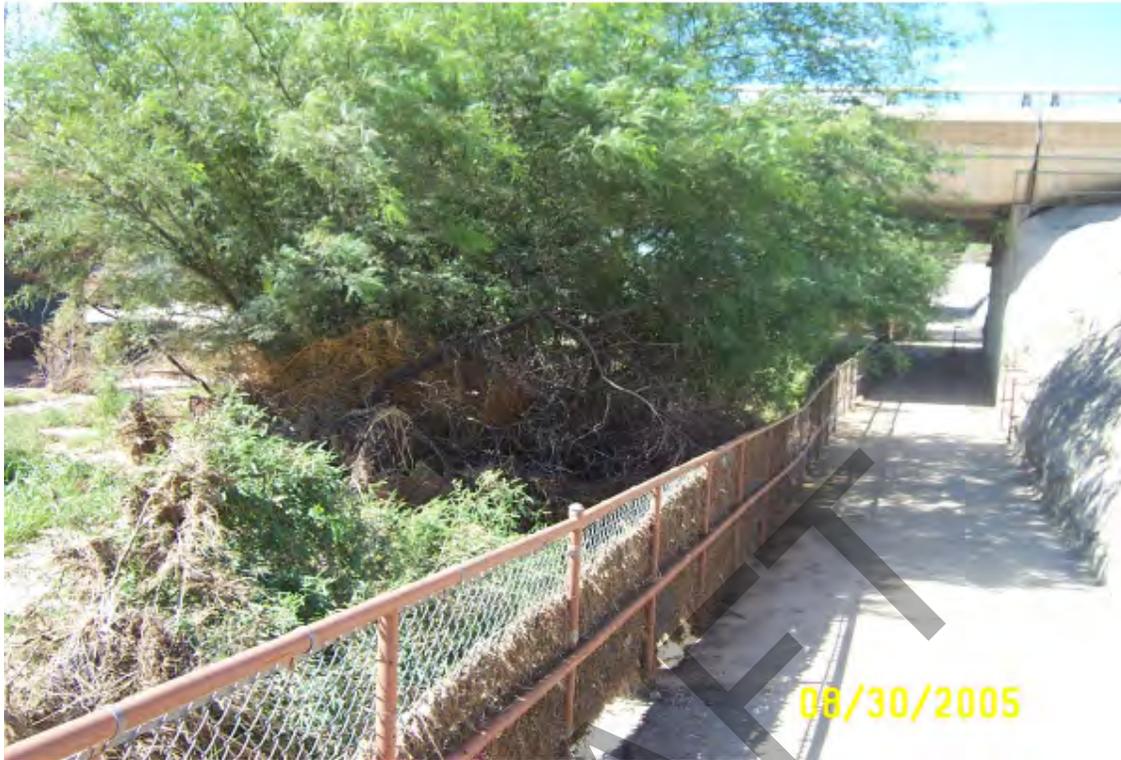
Figure 5 - Photographs from August 30, 2005 Flood Event Showing Effect of Vegetation

Upstream of Grant Road Bridge. Facing downstream (north) along right bank path. High water marks are observed as debris along the fence line.

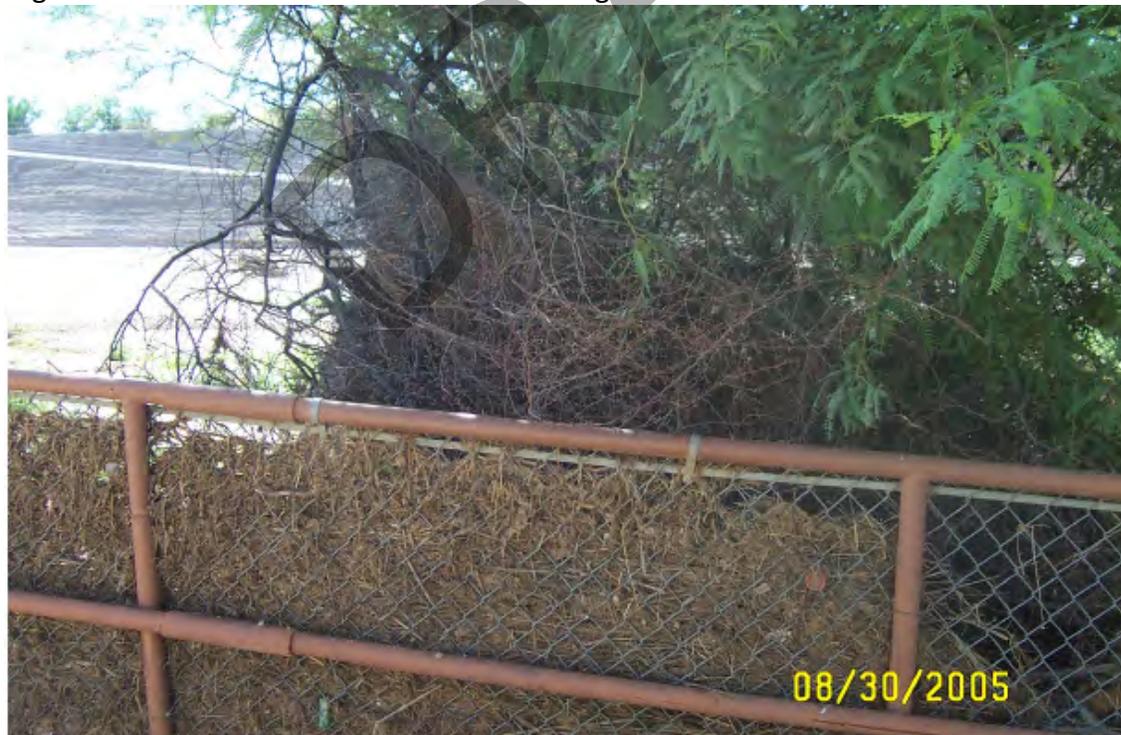
Same date and location as above, facing the tree (west).

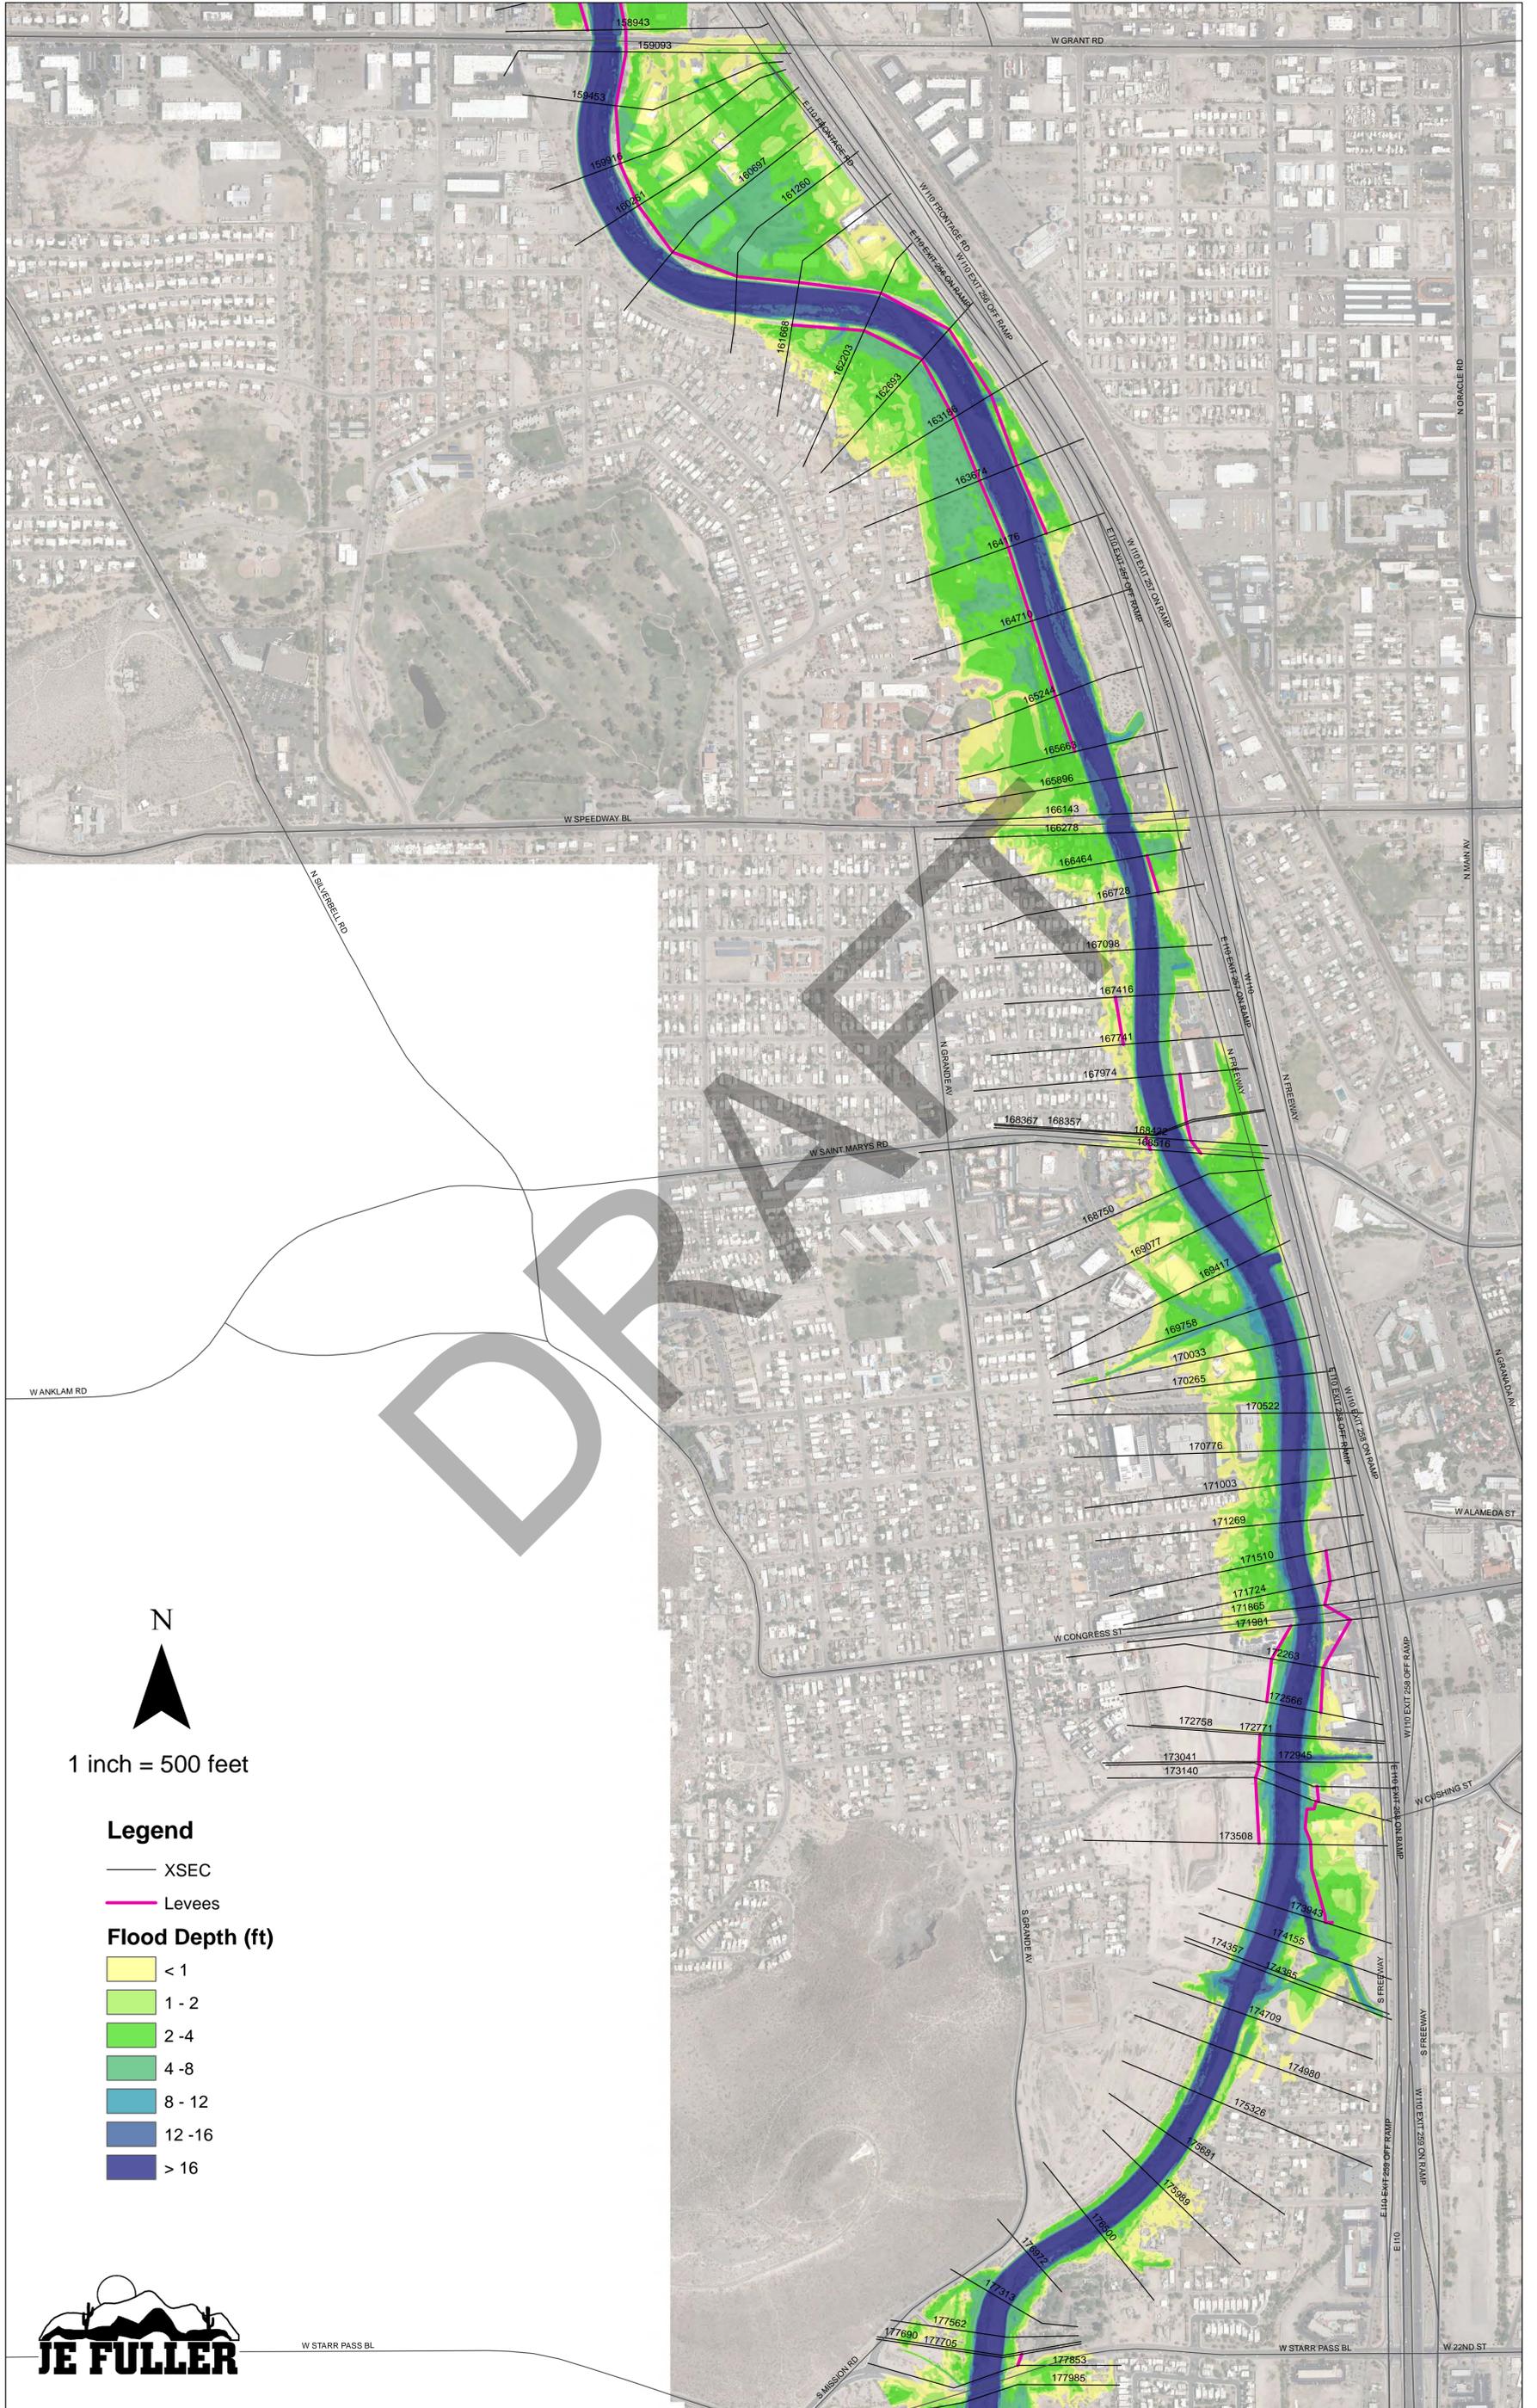
Figure 6 - Santa Cruz River - Grant Rd. to Star Pass Blvd. 100-yr Floodplain - 2015 Conditions

The results of the existing condition HEC-RAS modeling are shown in Figure 6. As shown in Figure 6, the 100-year flow of 60,000 cfs overtops the channel banks at most locations along the project reach. This is particularly true at bridge crossings, most of which were not designed for 60,000 cfs. Of particular concern are the overbank flow areas between Congress and Speedway and between Speedway and Grant.

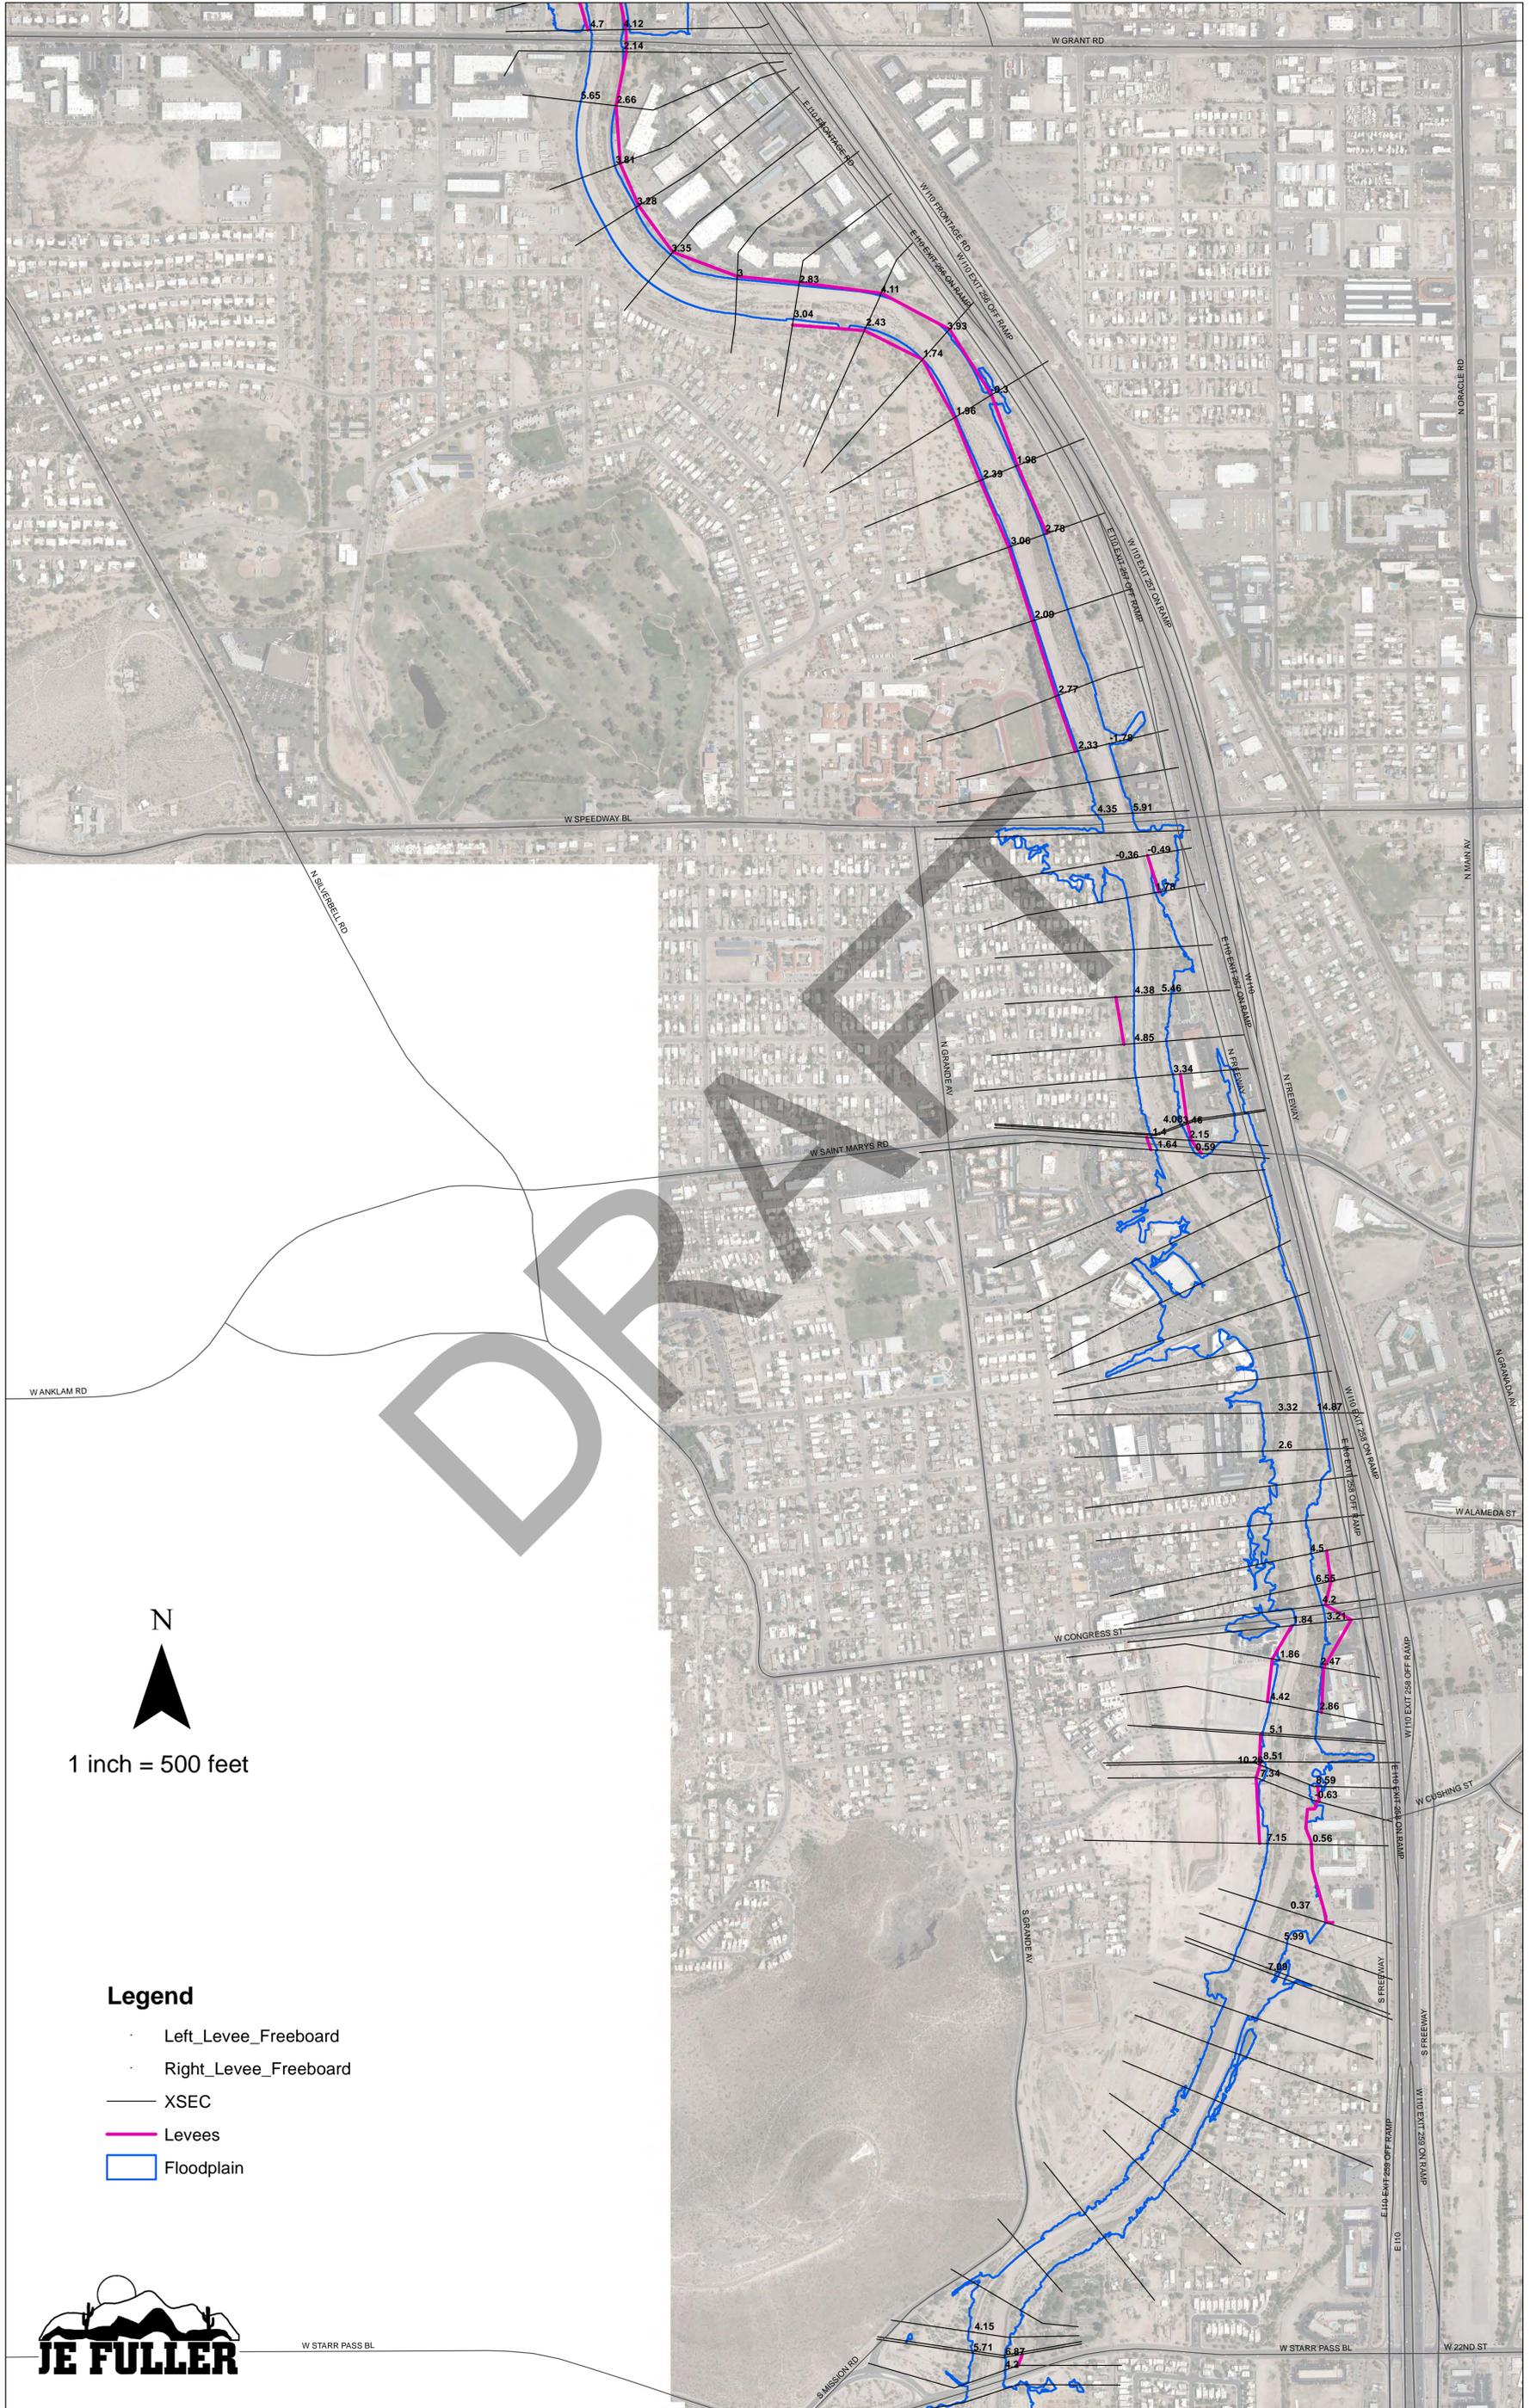
Figure 7A - Santa Cruz River - Grant Rd. to Star Pass Blvd. 100-yr Floodplain Outline with Original (1980's) Channel Design

The HEC-RAS model was revised to reflect excavation of the channel bottom to match the design section shown on the bank protection plans listed in the previous section of this report. The channel invert and section were modified in the HEC-RAS model to reflect the design plans for this purpose. Figure 7 shows the resulting floodplain condition with channel excavation to create the design plan condition. As indicated in Figure 7, overbank flooding between Grant and Speedway is all but eliminated. Overbank flooding along the remaining reaches is substantially reduced.

A separate set of Figures (Figures 6A – 9A) follow Figures 6-9 showing just the outline of the floodplain for each condition rather than the flood depths. These maps also indicate levee freeboard where applicable. It should be noted that all modeling reflects berms/levees where they exist along the project. The modeling documented herein does not define specific amounts of freeboard that occur along leveed sections under the various modeled scenarios. Based on FEMA standards, if insufficient freeboard exists, additional areas may be placed in the regulatory floodplain and that, as such, these maps should be considered best case scenarios.

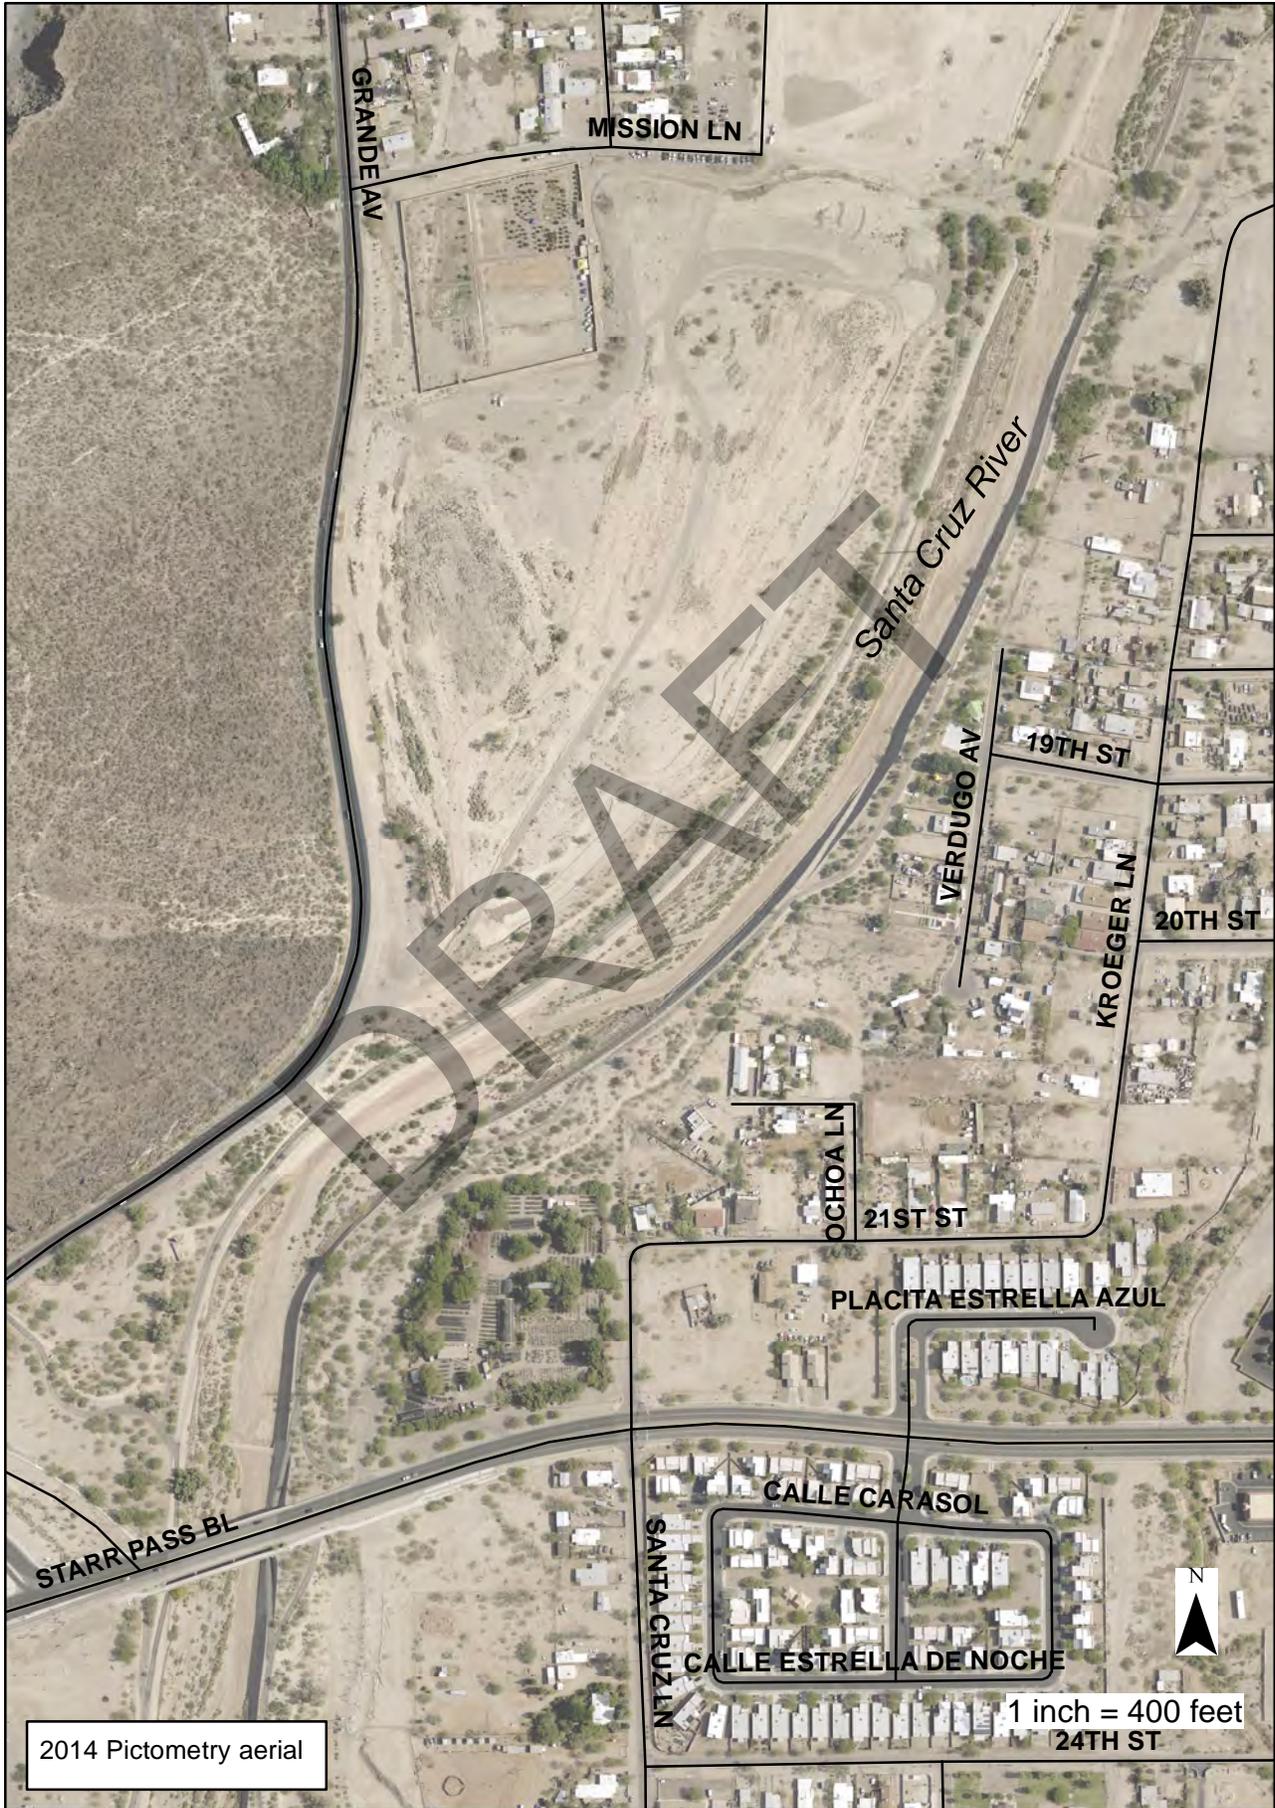
Santa Cruz River Maintenance Project - Manning's n Starr Pass Blvd to Mission Lane

Reference - Selection of Manning's Roughness Coefficient for Natural and Constructed Vegetated and Non-Vegetated Channels, and Vegetation Maintenance Plan Guidelines for Vegetated Channels in Central Arizona, Jeff V. Phillips and Saeid Tadayon, Scientific Investigations Report 2006-5108, U.S. Department of the Interior, U.S. Geological Survey (SIR 2006-5108).

2014 Pictometry aerial

1 inch = 400 feet
24TH ST

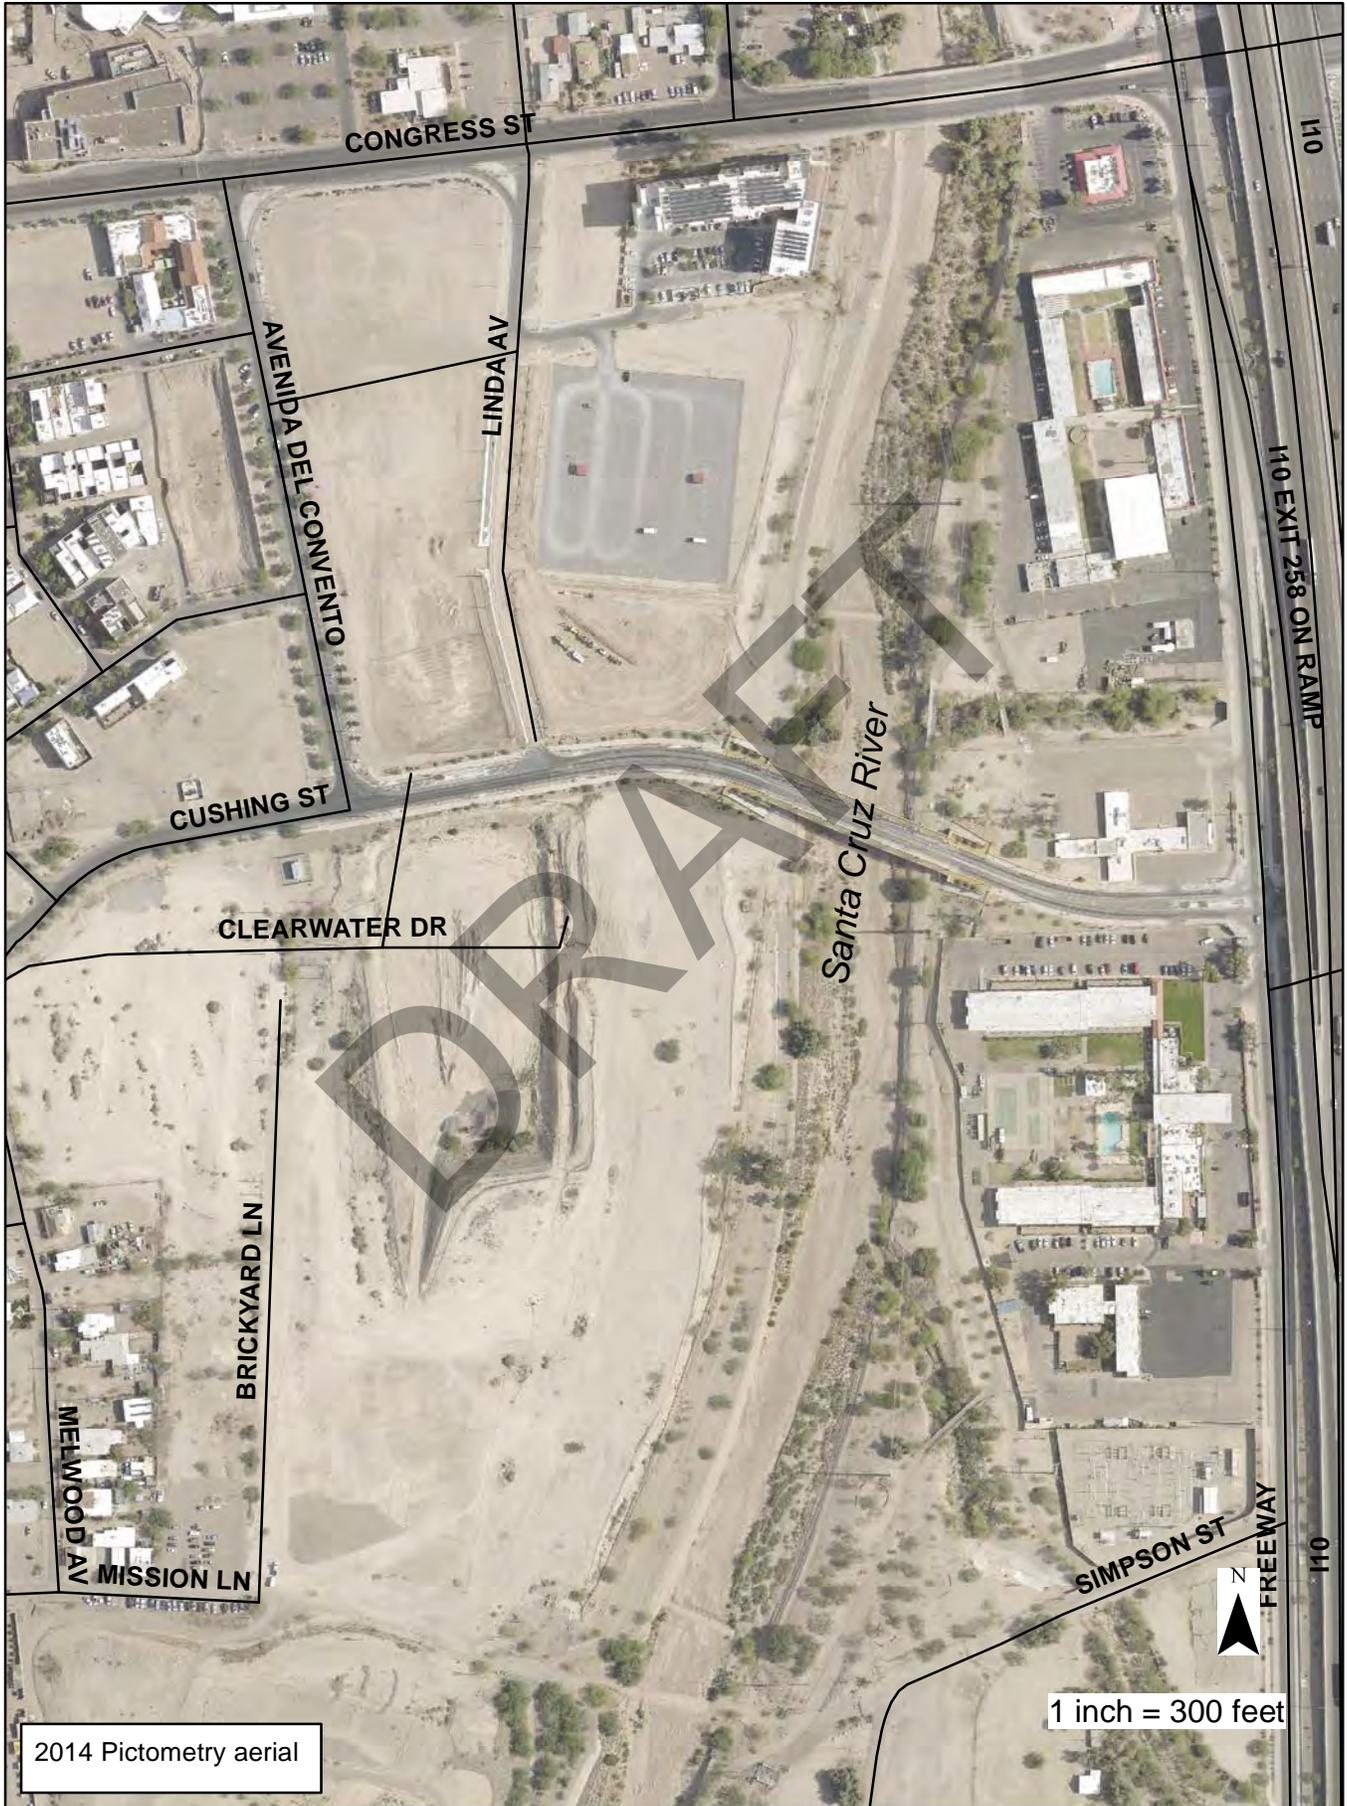
Santa Cruz River Maintenance Project - Manning's n Mission Lane to Congress Street

2014 Pictometry aerial

1 inch = 300 feet
