Re: Santa Cruz River Capacity Restoration

Re: **Santa Cruz River Capacity Restoration**

SUBJECT: Draft JE Fuller Sedimentation and Capacity Analysis

SANTA CRUZ RIVER SEDIMENT REMOVAL
GRANT ROAD TO 29TH STREET
PLAN & PROFILE SHEET P01

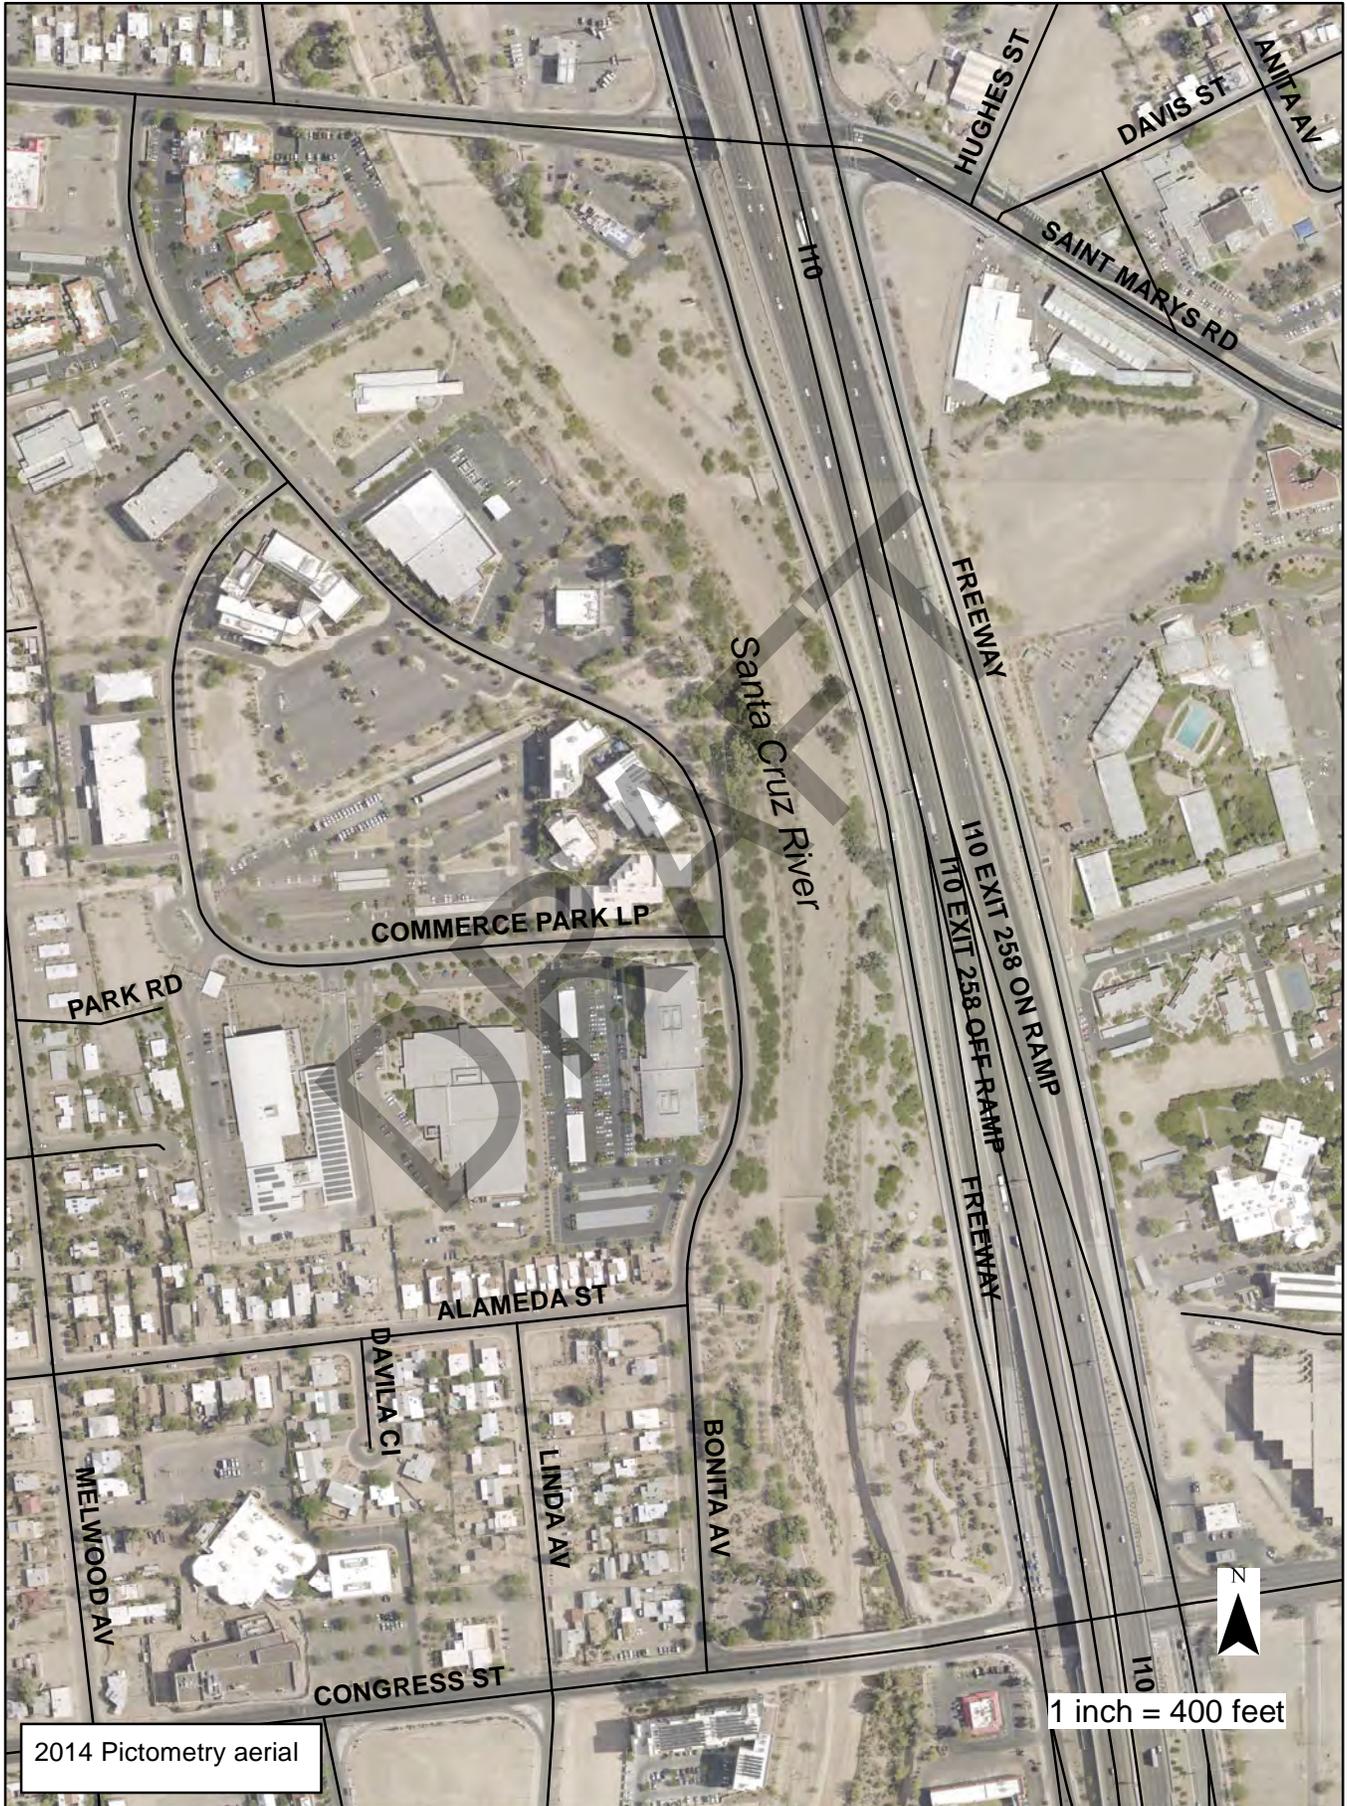
Santa Cruz River Maintenance Project - Manning's n Congress Street to Saint Mary's Road

2014 Pictometry aerial

1 inch = 400 feet

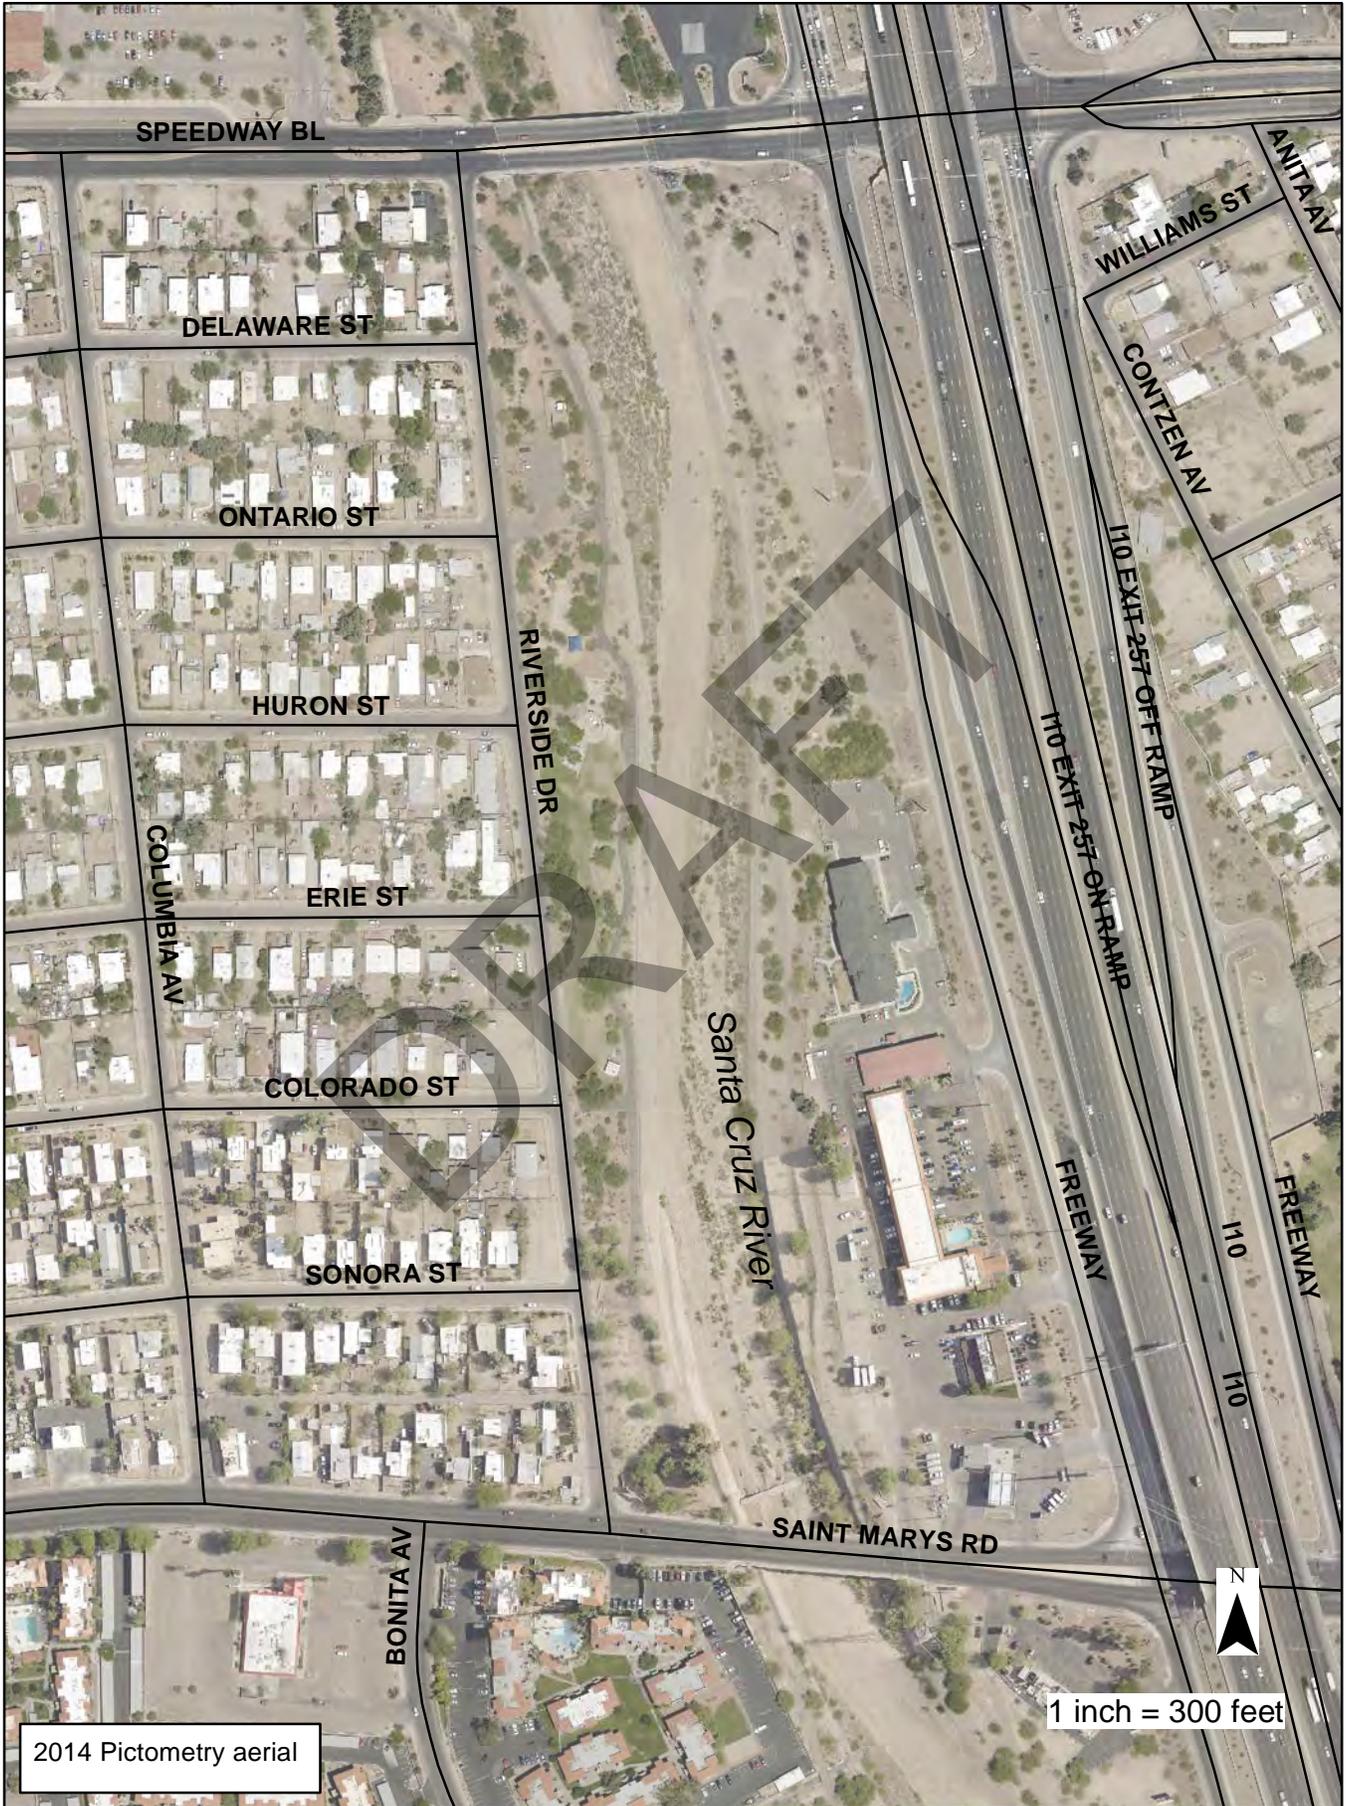
Santa Cruz River Maintenance Project - Manning's n Saint Mary's Road to Speedway Blvd

2014 Pictometry aerial

1 inch = 300 feet

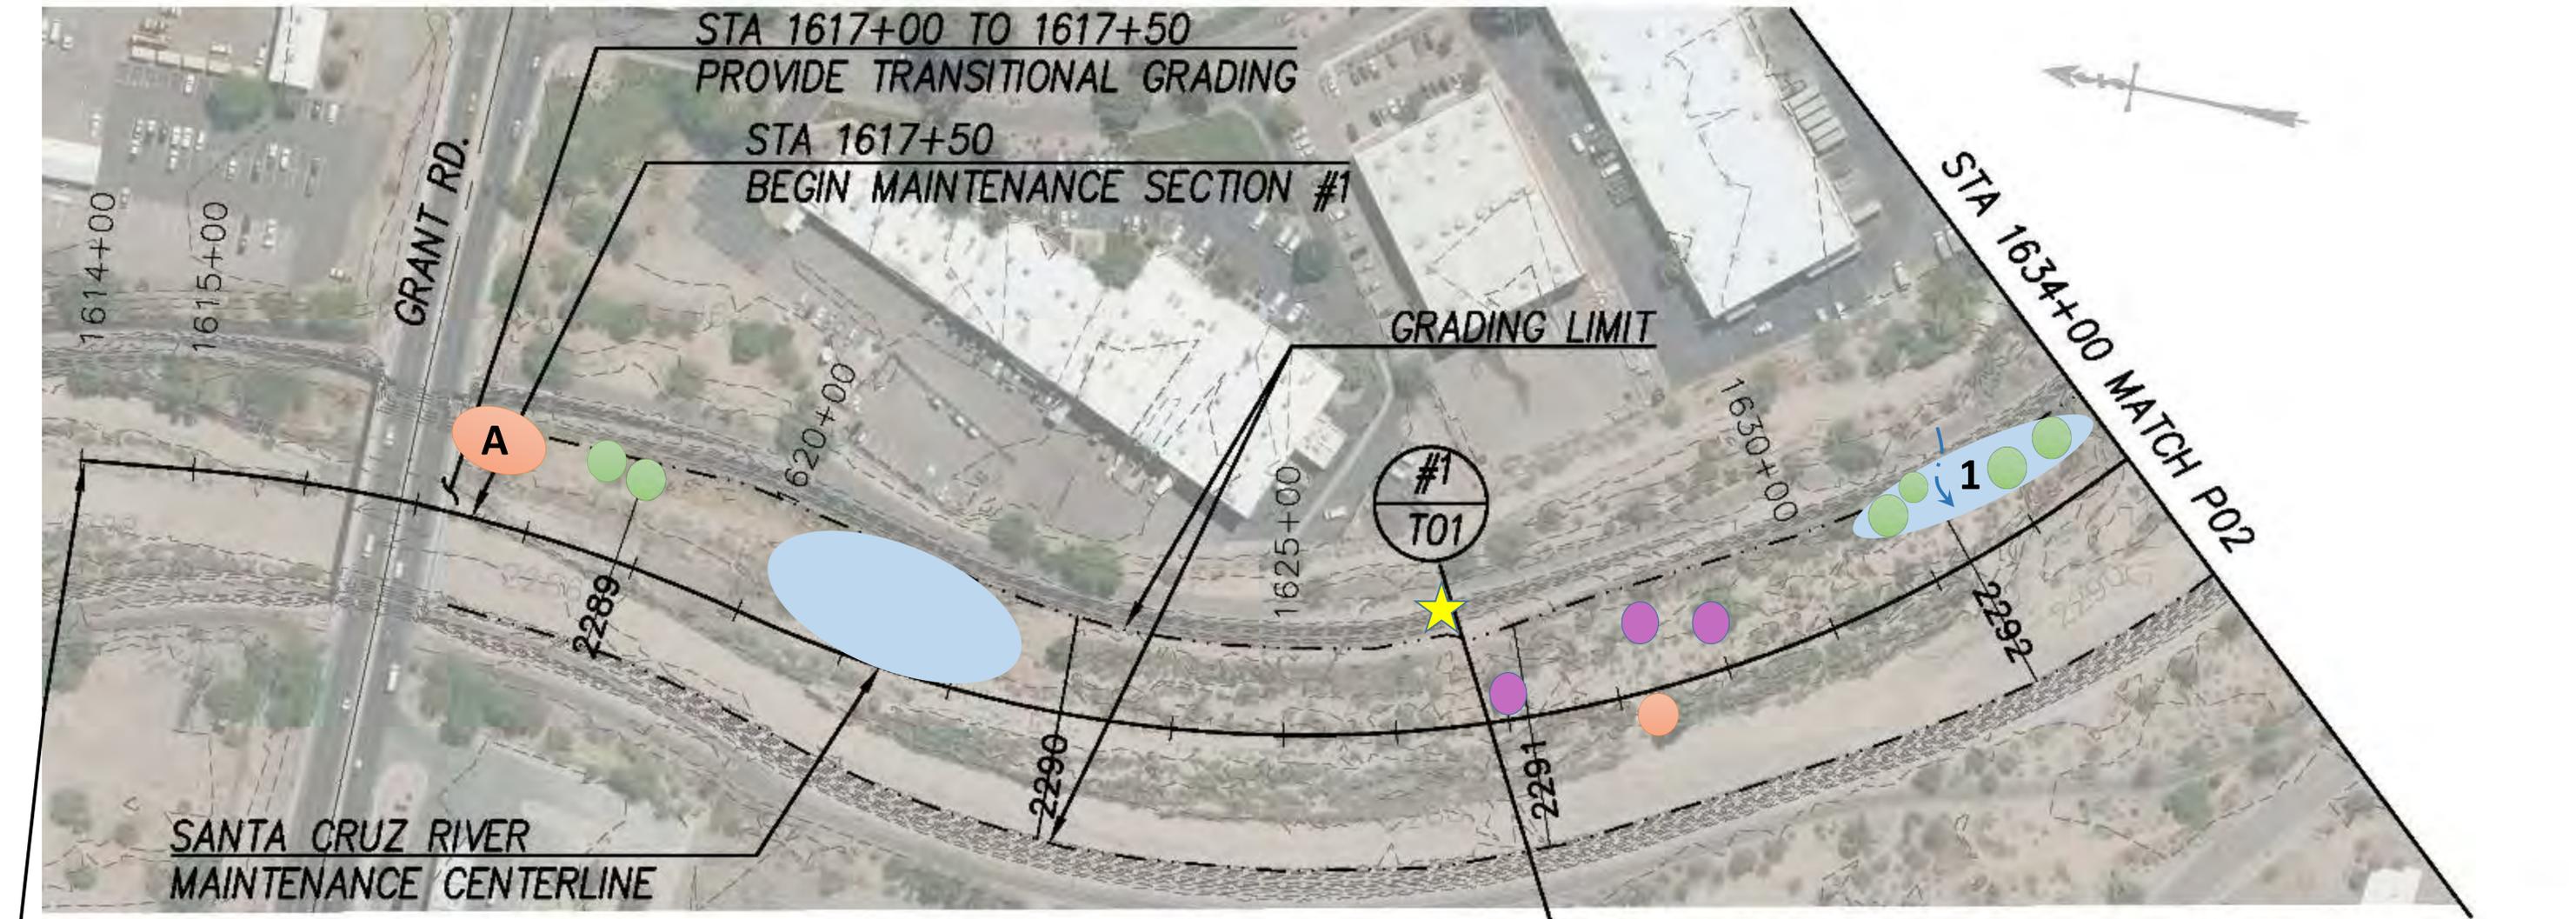
BEGIN SANTA CRUZ RIVER
 MAINTENANCE CENTERLINE
 N=984,318.77
 E=456,349.89

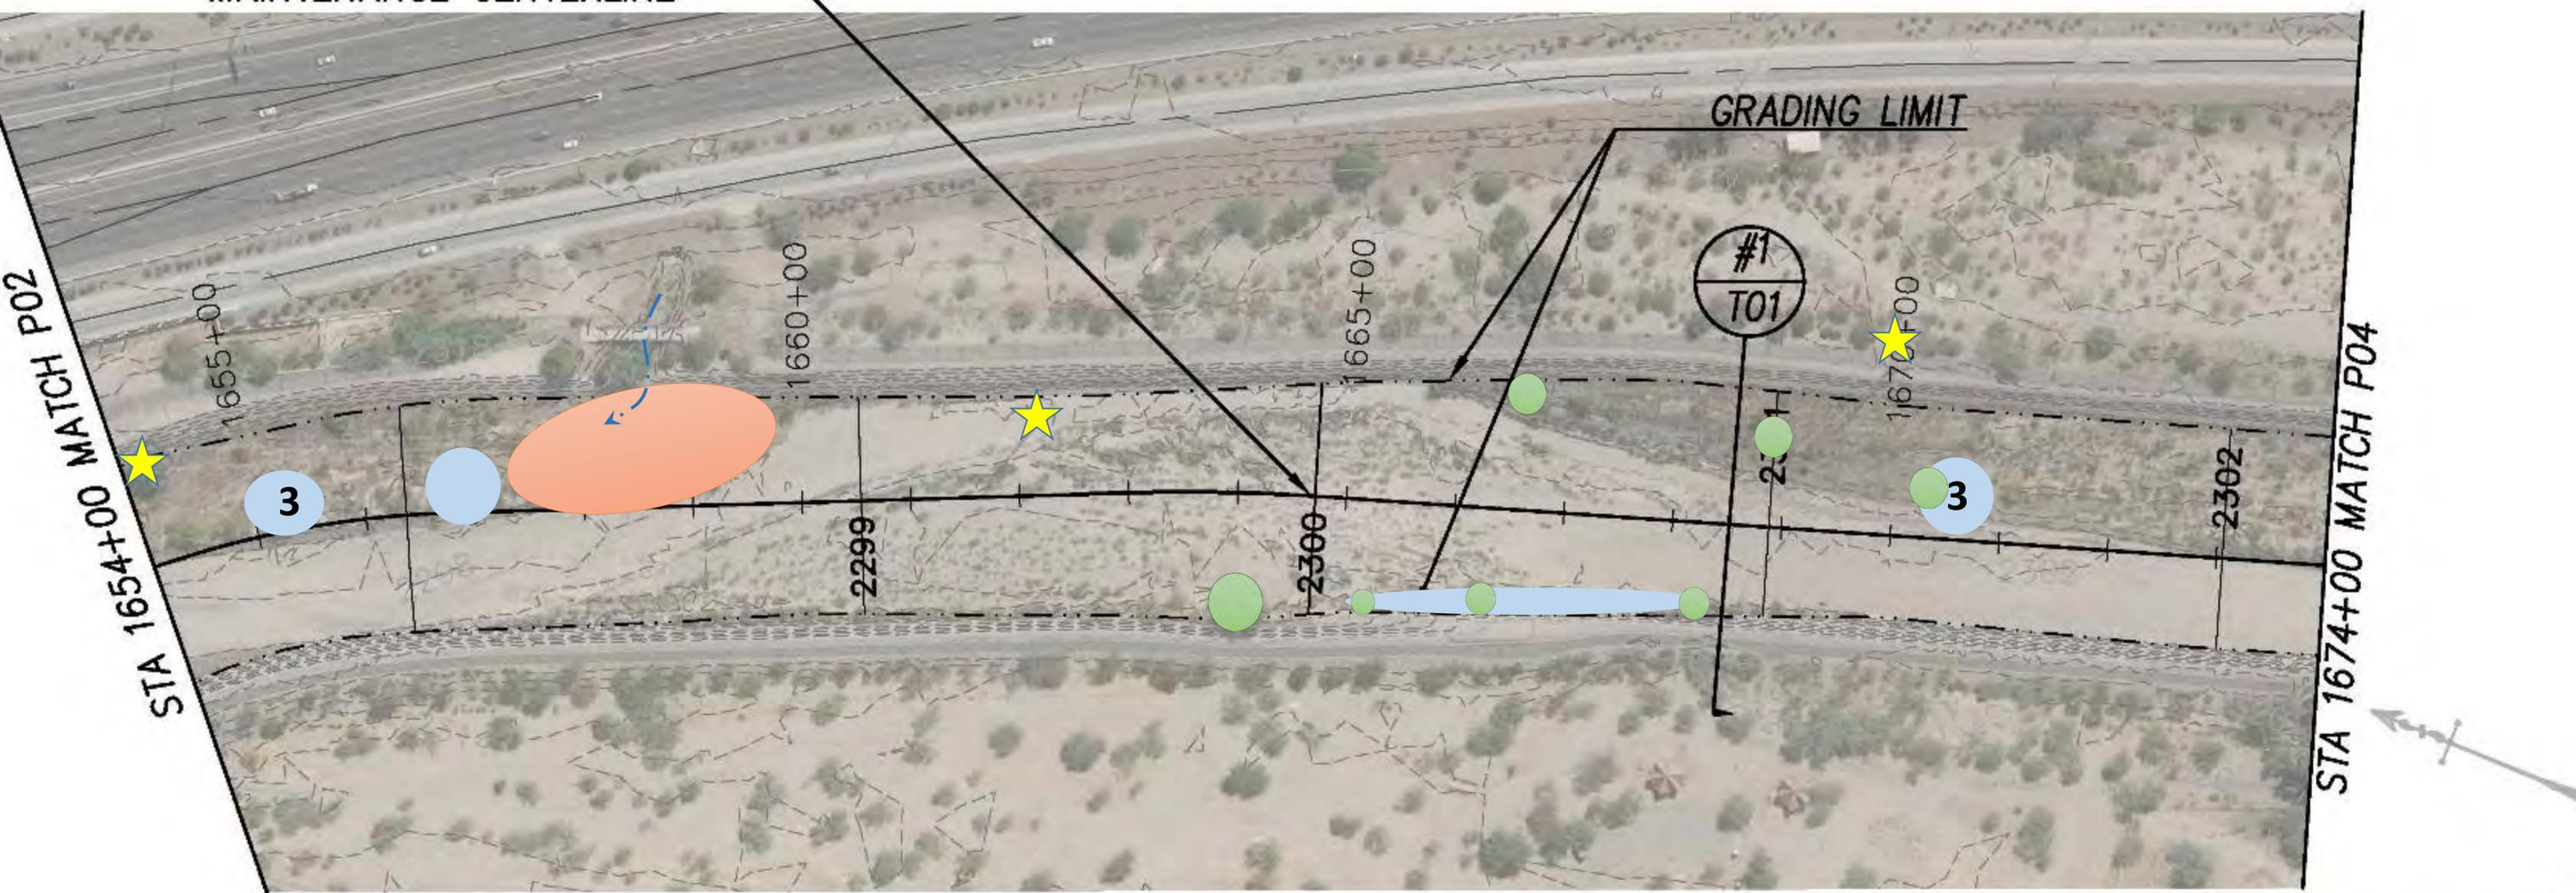
- KEY**
- Flow
 - Power pole
 - Mesquite to Preserve In Place
 - Tamarisk to Preserve In Place
 - Palo Verde to Preserve In Place
 - Tree Grouping to Preserve In Place
 - Remove (**A**=for safety)

- 1:** If a portion of vegetation specifically blocks culvert flow it may be removed
- 2:** Not specimen Palo Verdes. If necessary, they can be removed.
- 3:** Nice Mesquite w/ Mexican PV. Keep if possible

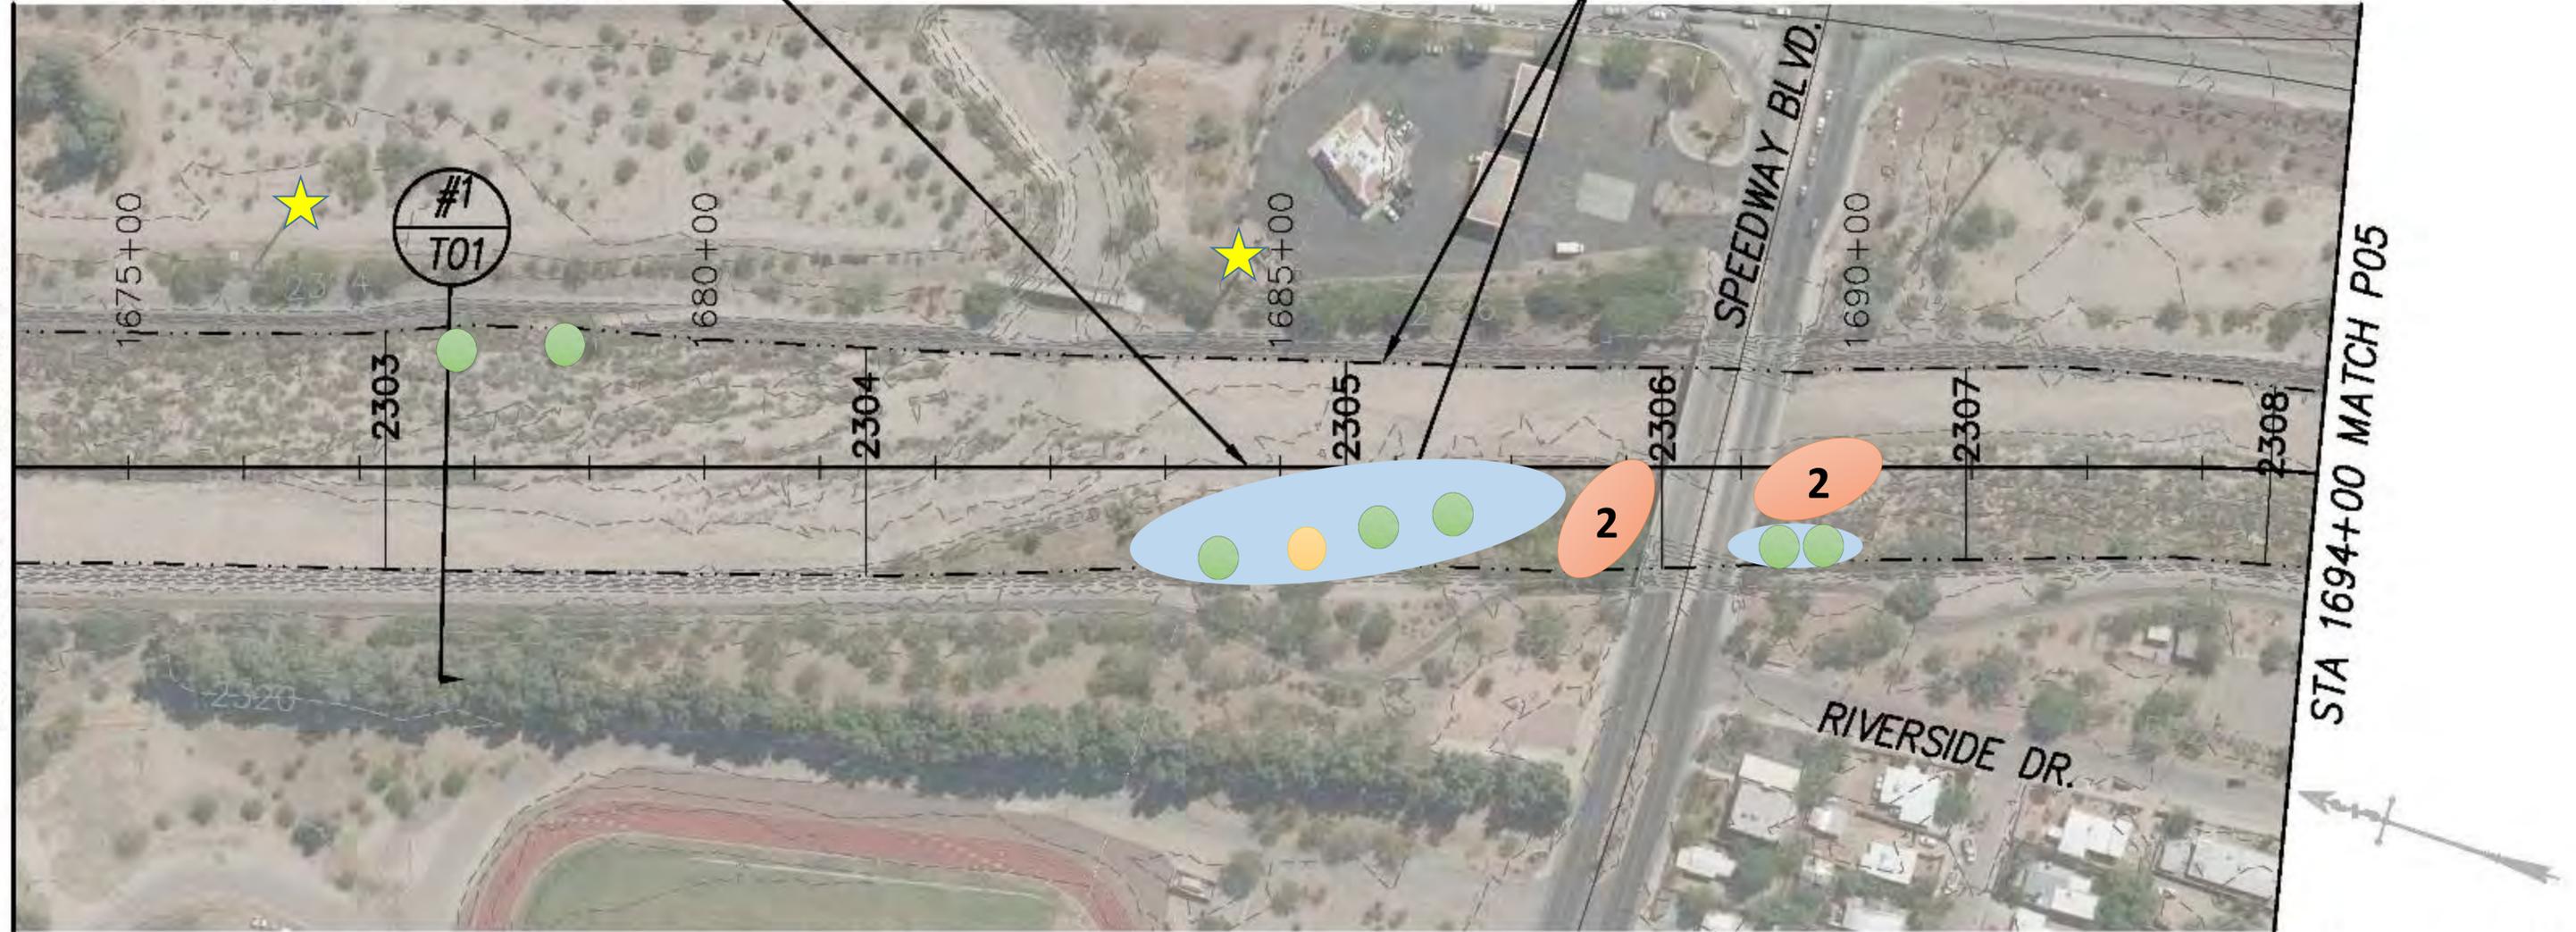
- KEY**
- Flow
 - Power pole
 - Mesquite to Preserve In Place
 - Tamarisk to Preserve In Place
 - Palo Verde to Preserve In Place
 - Tree Grouping to Preserve In Place
 - Remove (**A**=for safety)

- 1:** If a portion of vegetation specifically blocks culvert flow it may be removed
- 2:** Not specimen Palo Verdes. If necessary, they can be removed.
- 3:** Nice Mesquite w/ Mexican PV. Keep if possible
